# 2019 Annual Dam and Dike Inspection Report

## Bottom Ash Pond Complex

John E. Amos Plant  
Appalachian Power Co.  
Putnam County, West Virginia

May 16, 2019

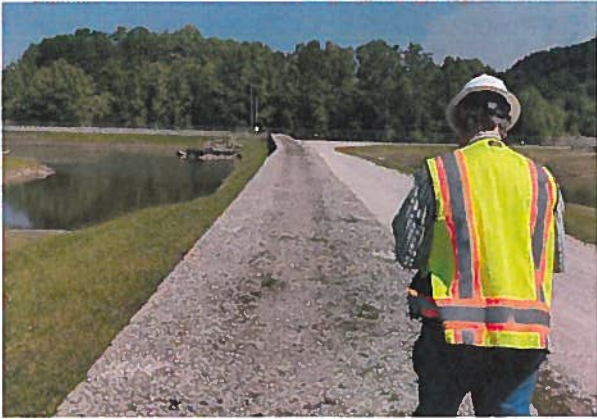
- The crest of the main perimeter dike was observed to be in good condition. No significant settlement, misalignment, erosion, or seepage could be observed on the crest or the slopes of the main perimeter dike (Photos 1, 2 and 3).
- The riprap revetment on the downstream toe of the main perimeter dike appeared in good shape. (Photo 4).

Photo 1 – Typical view of block wall and inboard slope showing good conditions.

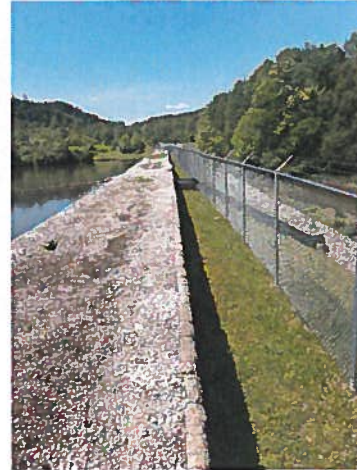
Photo 2 – Typical view of the block wall and exterior earthen embankment. Vegetative cover is well maintained and no misalignment or erosion was observed.

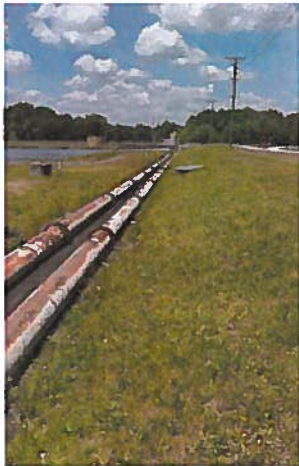
Photo 3 – Typical view of the crest and slopes of Bottom Ash Pond 1A showing good conditions.

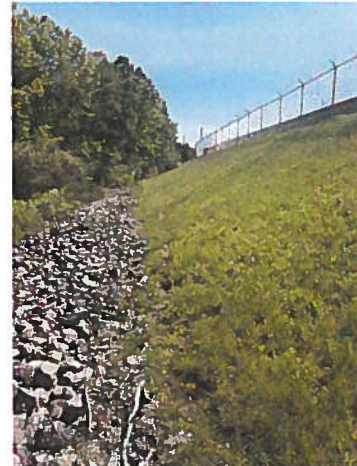
Photo 4 – Typical view of exterior embankment showing good conditions of the slope and rip rap.

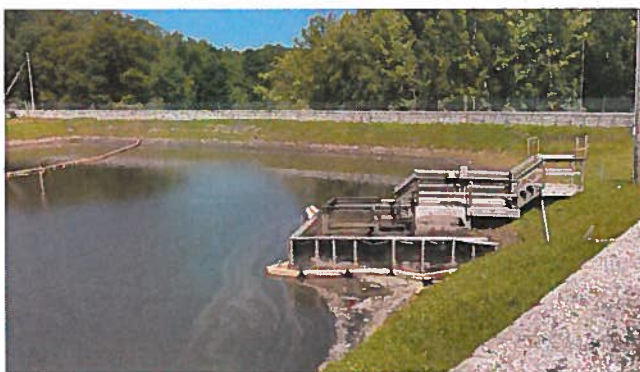
- The inboard slope of the main perimeter dike exhibited a good vegetative cover. There were no visual signs of misalignment, settlement, sloughing, erosion, or bulging that would indicate any instability within the dike. The primary decant skimmer structure was observed to be in an excellent condition (Photo 5).

Photo 5 – Typical view of the inboard slope (reclaim pond) and skimmer structure showing good conditions and a well maintained vegetative cover.

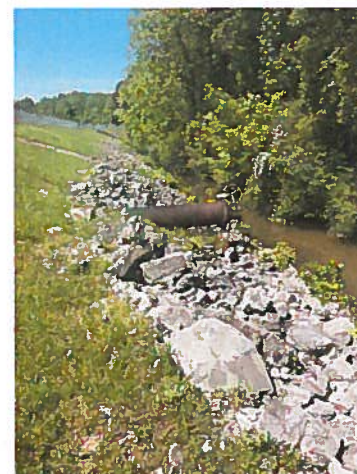
- No erosion or seepage was noted along the pipe that extends out from exterior slope of the Main Perimeter dike at the Reclaim pond. This pipe was permanently abandoned by welding a steel plate at the discharge end of the pipe (Photo 6).

Photo 6 – Typical view of a former discharge pipe. No seepage was observed around the pipe.

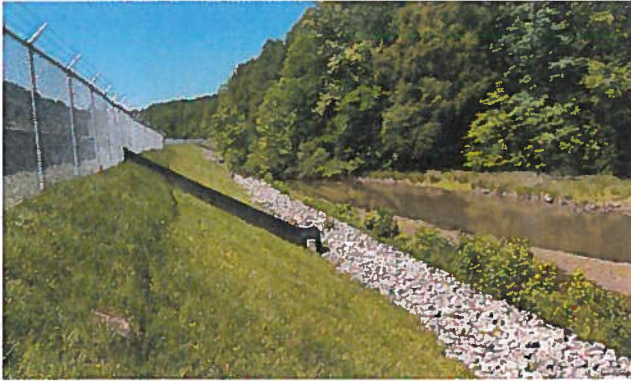
- The reclaim pond's 36 inch diameter HDPE overflow pipe was observed to be in good condition from the block wall and no erosion was noted along the pipe. (Photo 7).

Photo 7 – Typical view of the reclaim' s pond 36 inch diameter HDPE overflow pipe showing good conditions with no obstructions to flow and no visible erosion.

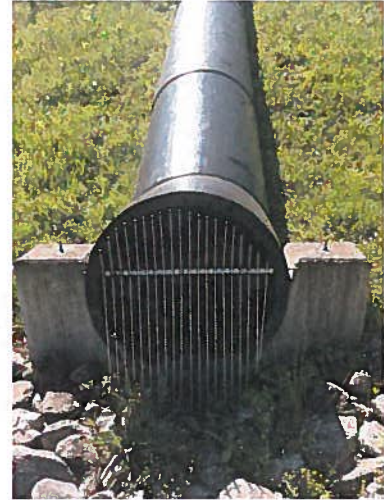
- The outlet to the 36 inch diameter overflow pipe was free of vegetation and could flow unobstructed to Bills Creek. (Photo 8).
- The 36 inch diameter HDPE overflow pipe (bottom ash pond 1B) was observed to be in good condition. No settlement, misalignment or other defects were observed for the two overflow spillways. The inlet and outlet to the overflow pipe were observed to be in satisfactory condition (Photos 9 and 10).

Photo 8– Typical view of 36 inch diameter overflow pipe showing good conditions with no obstructions to flow and no visible erosion along the pipe.

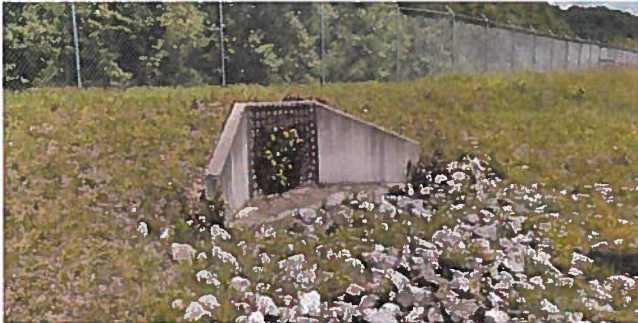
Photo 9 – Typical view showing good conditions of the inlet for the bottom ash pond 1B overflow pipe. The concrete headwall was in excellent condition and no separation of the pipe to the headwall was observed.

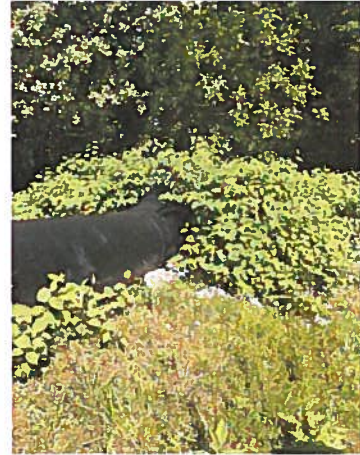
Photo 10- Atypical view of the overflow pipe showing encroachment of vegetative growth at the outlet of the pipe. This area is scheduled to be cut and the vegetation is to be removed.

1. Control of the vegetation cover (i.e. mowing) should be continued on its current regularly scheduled basis.

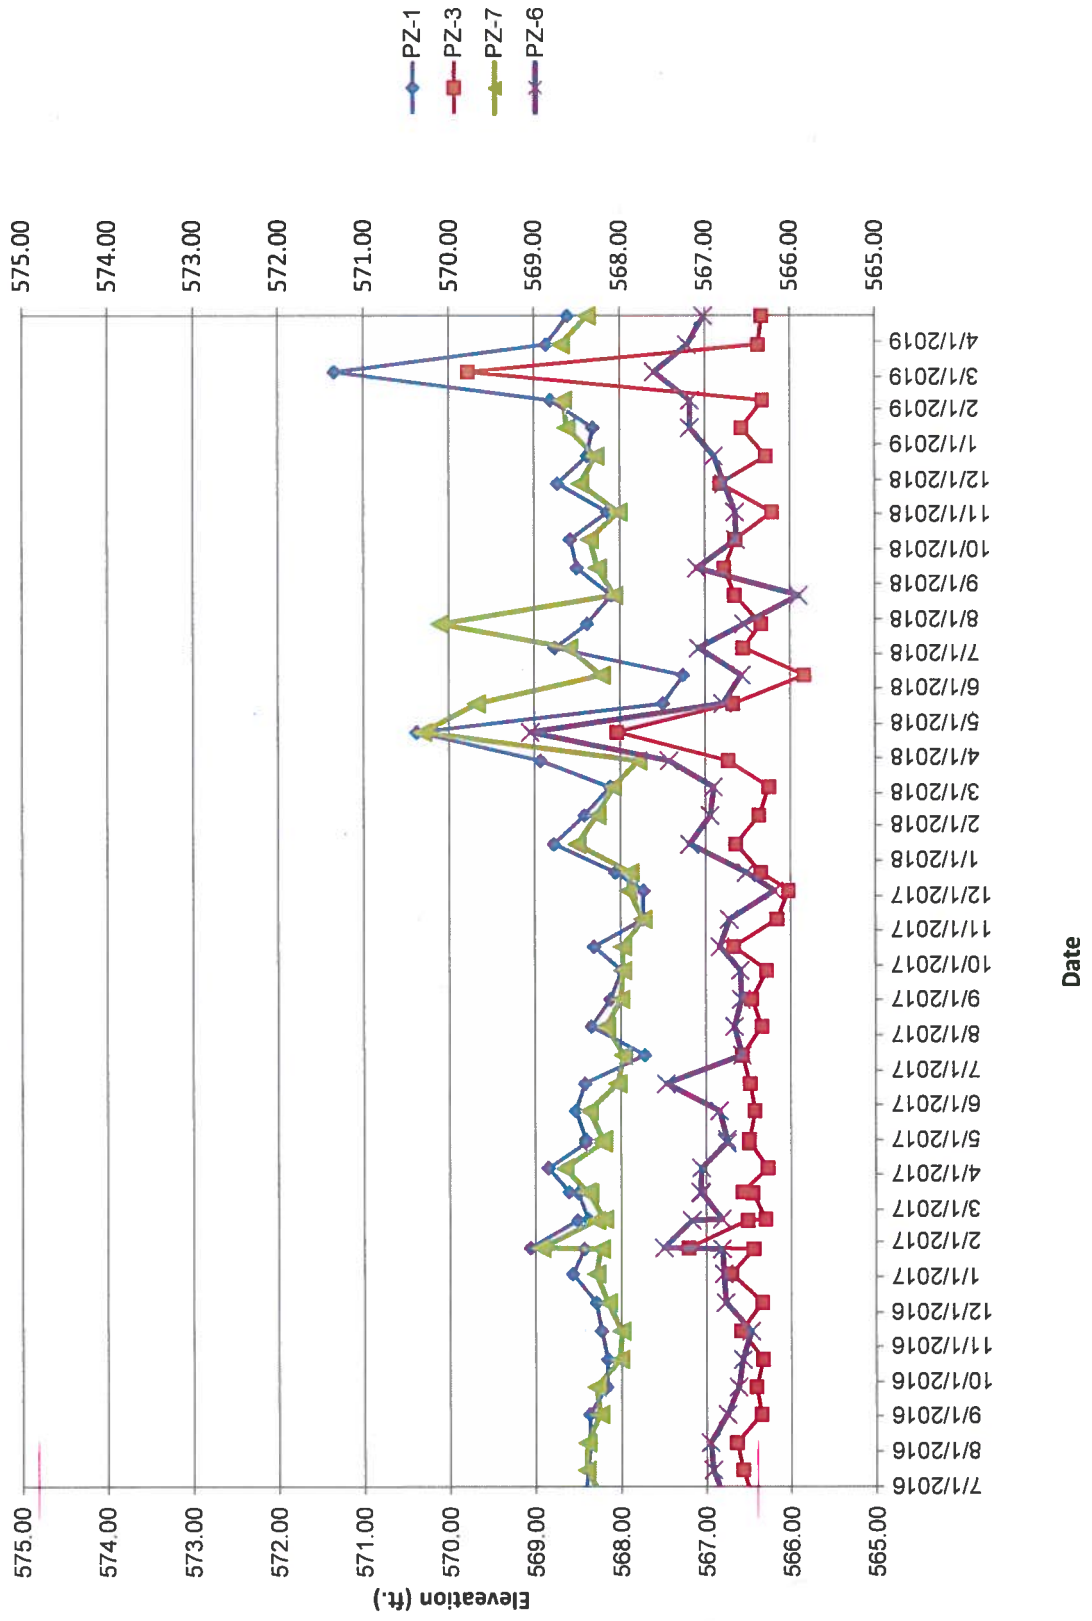
John E Amos Plant  
Piezometer Readings  
Bottom Ash Pond

The elevations of pond water levels and respective piezometer water levels have remained fairly constant with no adverse trends observed that would impair the structural stability of the perimeter dike. An increase in piezometric levels, however, was recorded on March 5, 2019 for three of the four piezometers and is coincident with high river stages for the Kanawha River (Kanawha River's normal pool stage is 566 ft elev.). The fourth piezometer (PZ-7) also recorded its highest static water level within the same month on March 29<sup>th</sup>, 2019.

A review of these water level measurements did not exceed levels that would impair the slope stability of the bottom ash pond embankments (GeoEnvironmental Assc., 2015). Piezometer water levels are contained in Attachment C.

1. Static water levels should continue to be measured on its current frequency for piezometers PZ-1, PZ-3, PZ-6 and PZ-7.
2. The pond pool stages should continue to be recorded on a periodic basis.
