2019 Annual Dam and Dike Inspection Report

Clinch River Ash Pond 1A/1B

**Clinch River
Appalachian Power Company
Carbo, Virginia**

Document ID: GERS-19-049

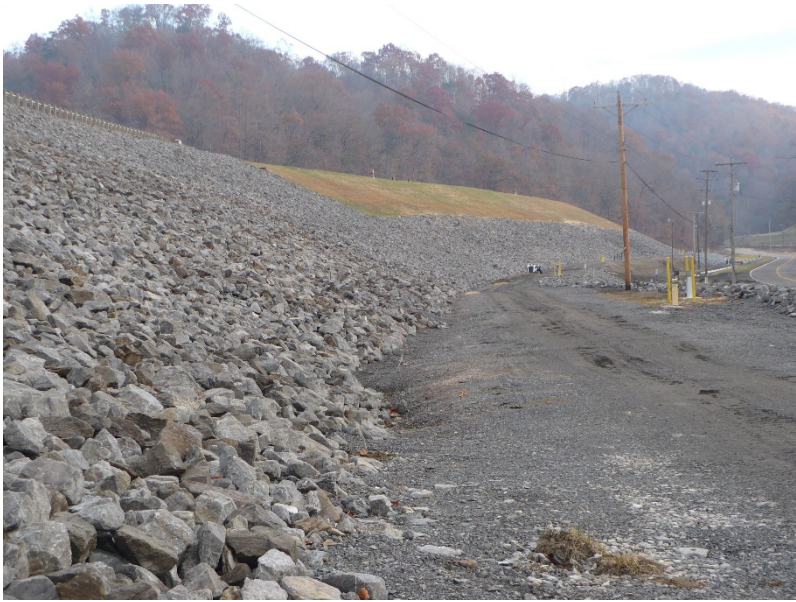
1. In general, there were no signs of slope instabilities, uncontrolled seepage, or erosion of the downstream slopes of the dam. The slopes are covered with a combination of riprap and vegetation. Vegetation is adequate and was recently mowed before the inspection. The condition of the riprap appeared sound and there was no displacement of the riprap. [photos 1-4]

Photo #1 – exterior slopes of Ponds 1A and 1B

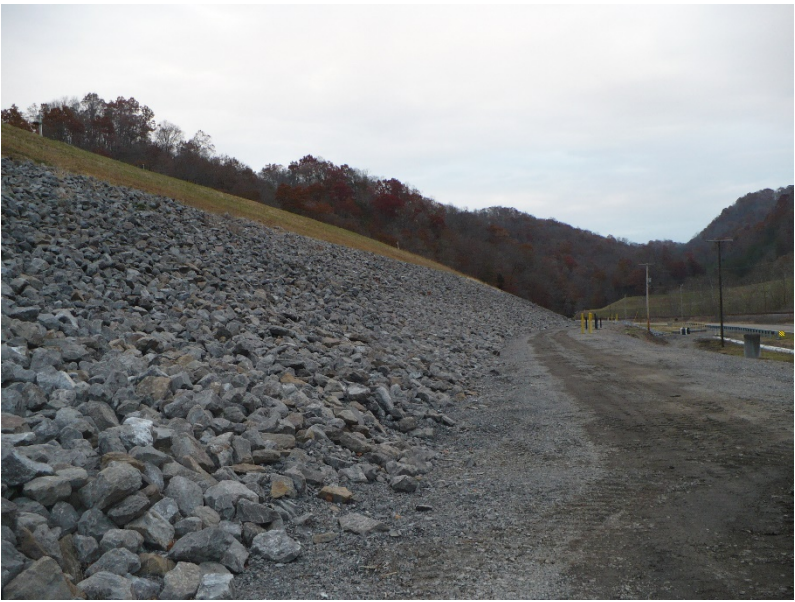
Photo #2 – exterior slopes near transition of 1A and 1B

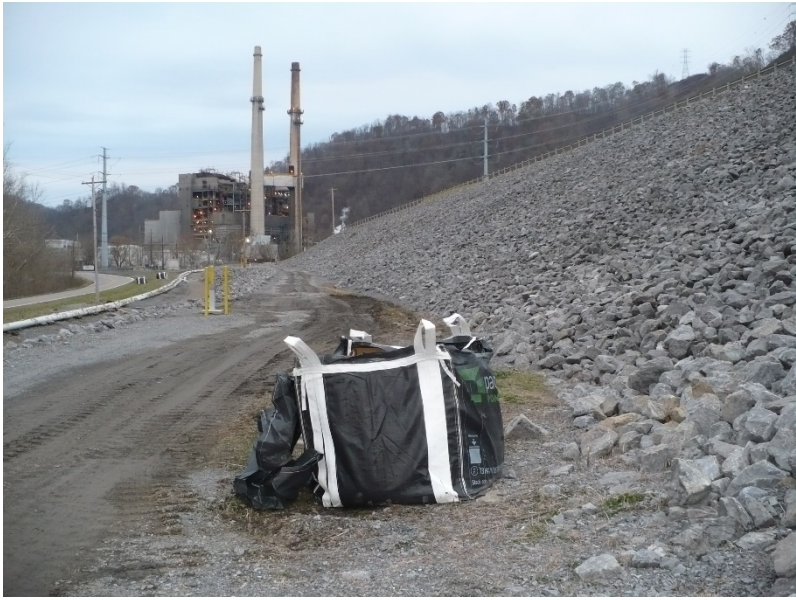
Photo #3 – exterior slope of Pond 1A

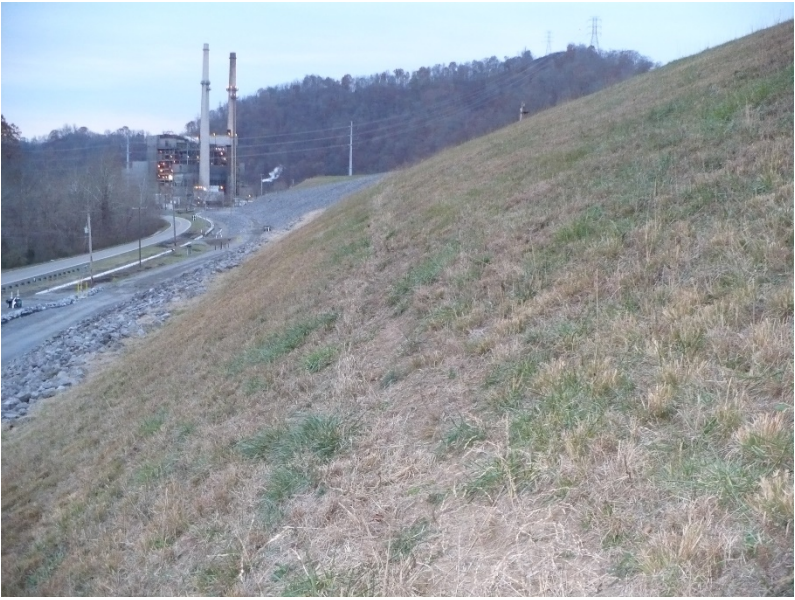
Photo #4 – grass cover on slopes of Pond 1B, above riprap

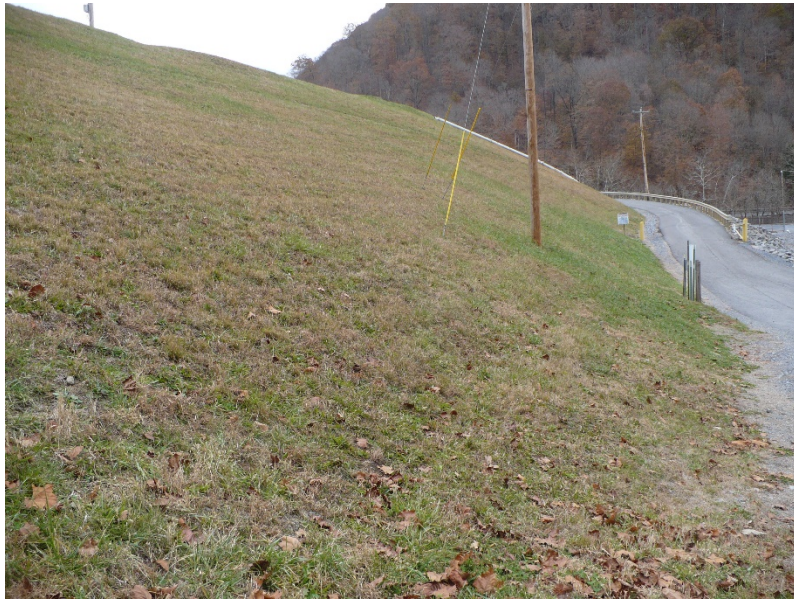
2. The slope of the most southern dike is all grassed and in good condition. There were no observed signs of instabilities, erosion or seepage [photo 5].

Photo #5 – exterior slope of south dike

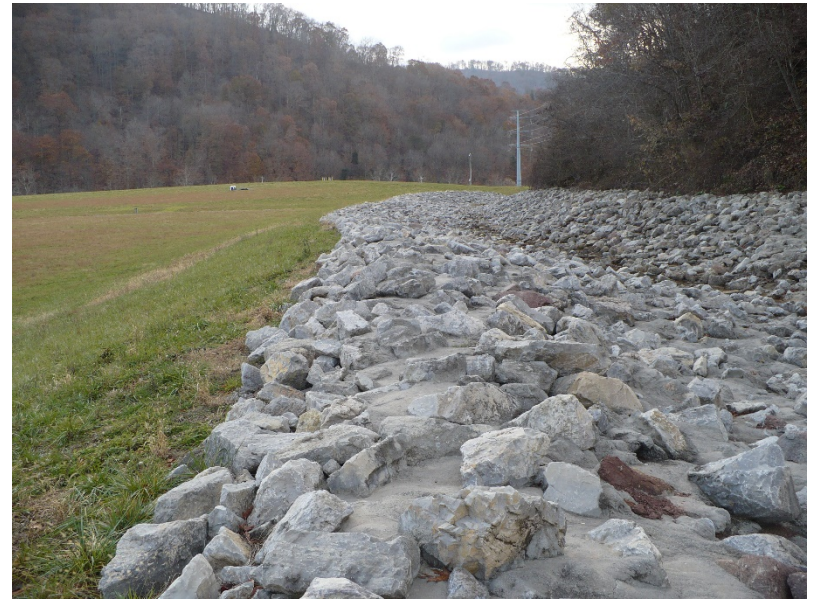
3. The Pond 1A diversion ditch along the right abutment was in good condition. The riprap lining was observed to be in good condition. The concrete downchute for the diversion ditch was also in good condition. [photos 6-7]. The spring observed last year flowing into the ditch had very little discharge this year.

Photo #6 – Pond 1A diversion ditch

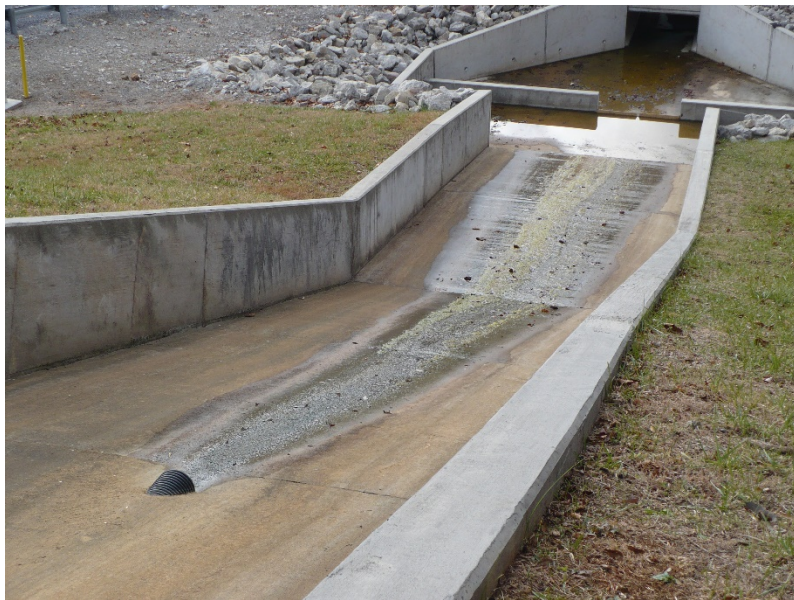
Photo #7 – concrete chute for Pond 1A diversion ditch

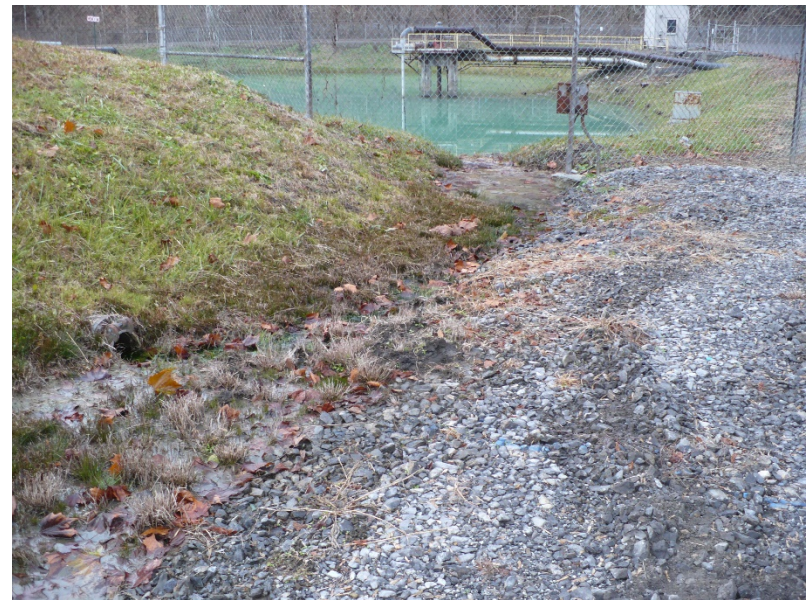
5. There is the wet/moist area near the concrete vault at the toe of the south dike. This vault is related to waterlines from the local water district [photo 8].

Photo #8 – seepage leading towards weir #5

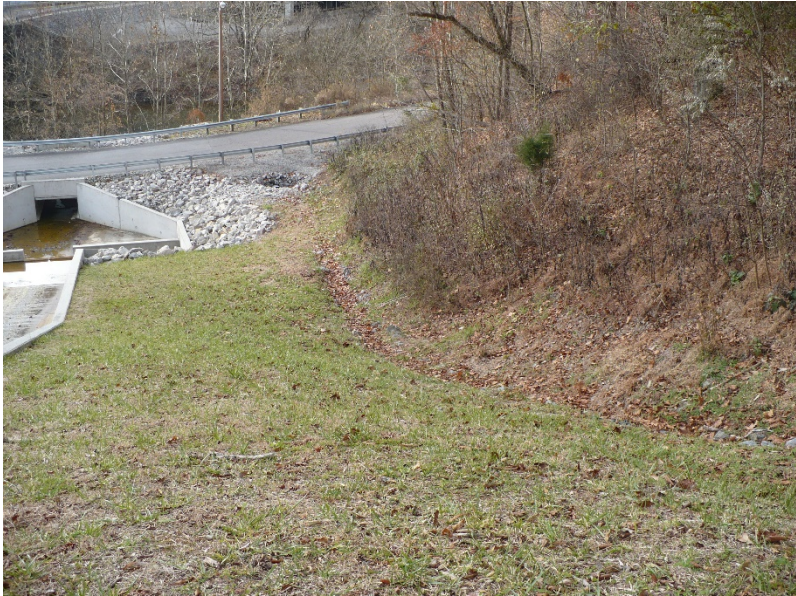
6. The right abutment area is cleared of brush within 25 feet of the dam embankment, except for a short section near the toe. [photo 9]
7. The seepage collection sump was operational at the time of the inspection. The majority of the seepage was flowing in from the left segment of the system. All of the flow appeared clear. There is significant precipitate at the ends of both inlet pipes.

Photo #9 – right abutment, 25-ft clear zone

1. Remove any mineralization and/or obstructions from the seepage weirs as noted during periodic inspections.
2. Maintain the vegetation within the regulatory 25-foot zone beyond the toe and abutments as required by VDCR Dam Safety.

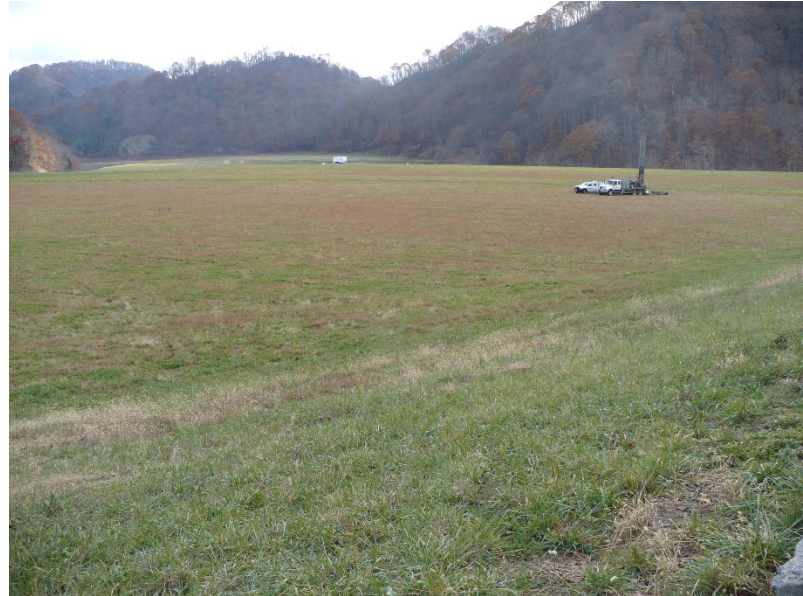
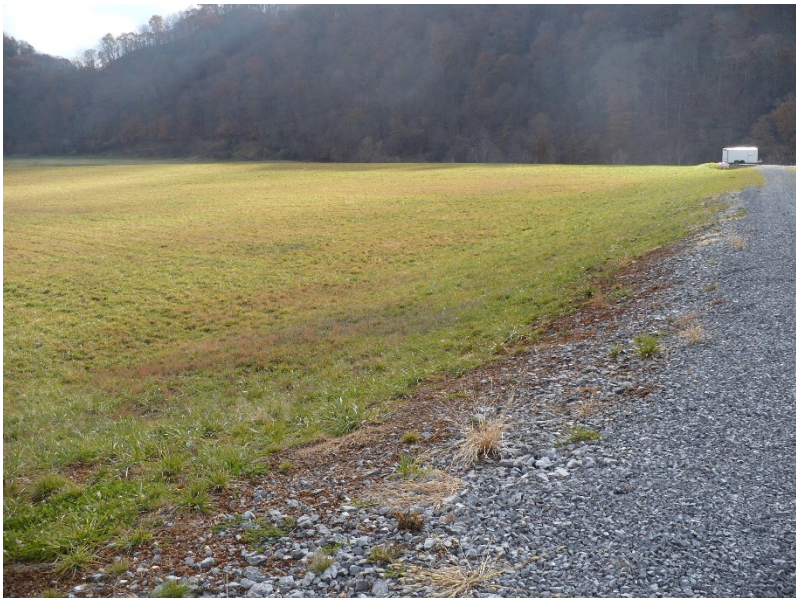
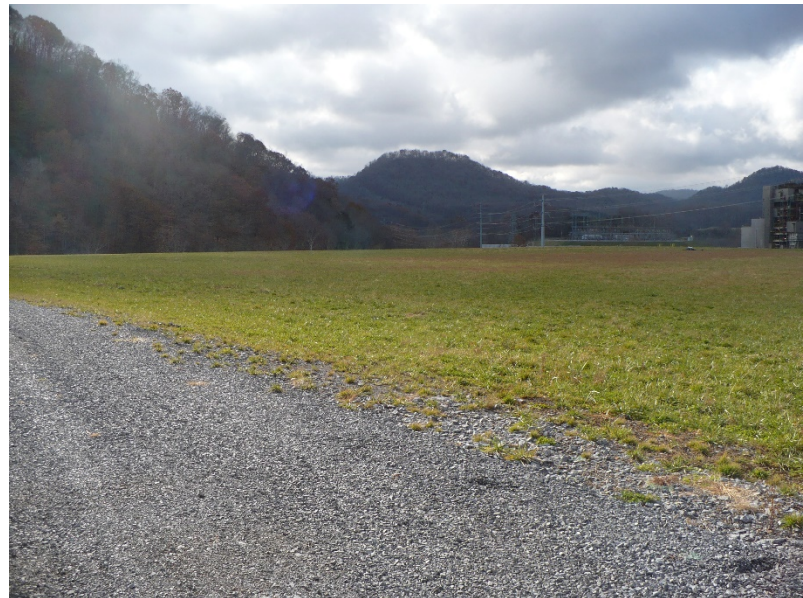
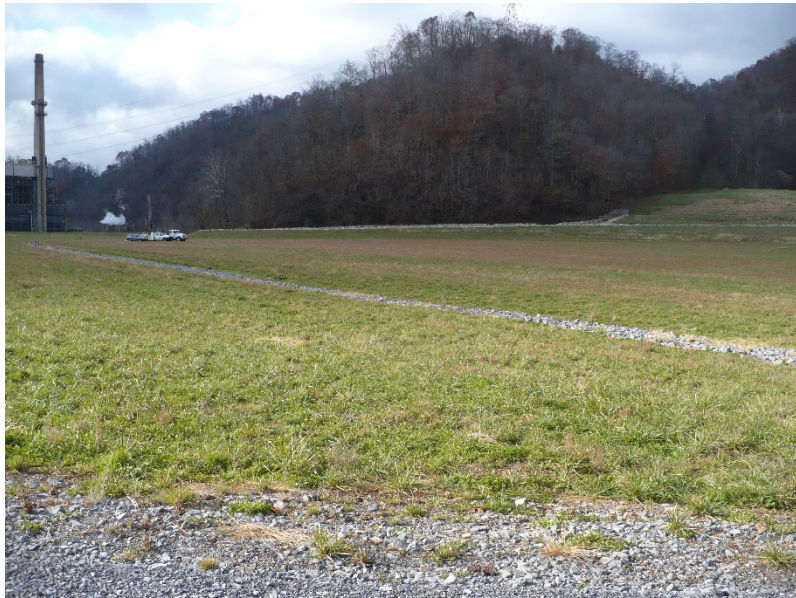
8. The surface area of the impoundment has been capped and covered. The vegetative growth is good over the entire surface. [photos 10-13]
9. Surface drainage appears adequate but there is still evidence of poor drainage at the inlet of the south swale into the east diversion ditch [photo 14]

Photo #10 – cap surface of Pond 1A

Photo #11 – cap surface of Pond 1B

Photo #12 – cap surface of Pond 1A

Photo #13 – cap surface of Pond 1A

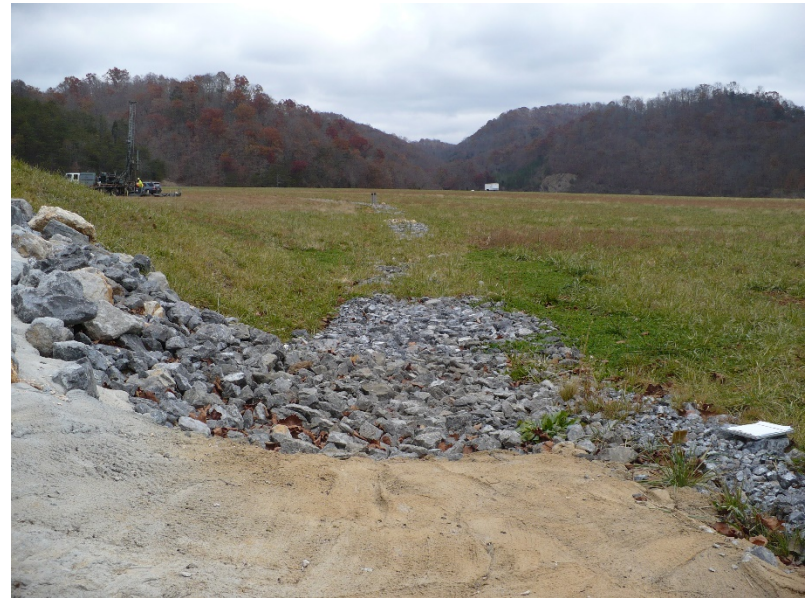
Photo #14 – drainage swale into Pond 1A diversion channel

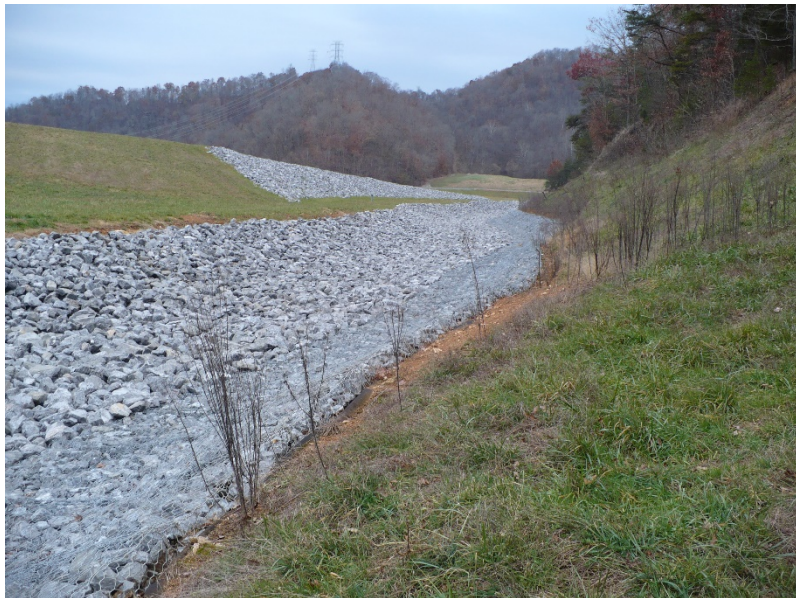
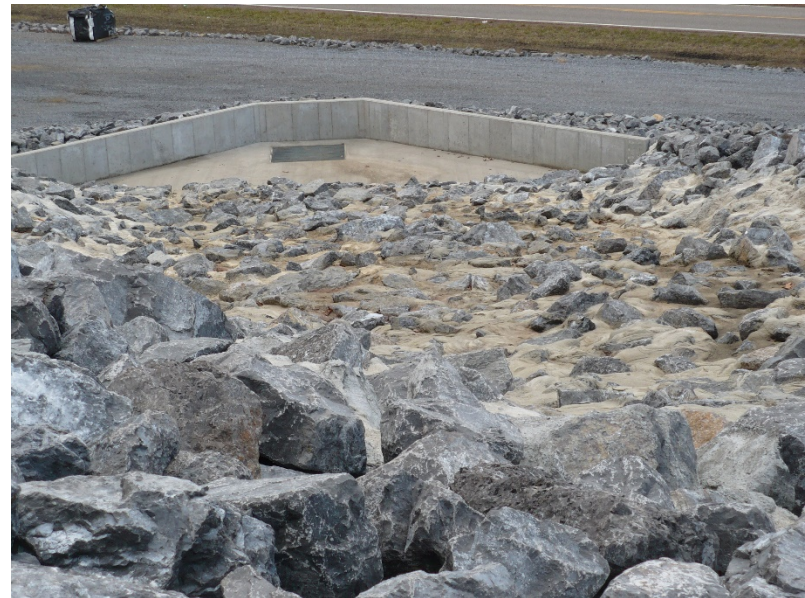
12. Pond 1B diversion ditch system and collection basin appeared to be in good condition. No debris was observed in the collection basin [photos 15-16].

Photo #15 – Pond 1B diversion ditch

Photo #16 – collection basin at toe of Pond 1B diversion ditch

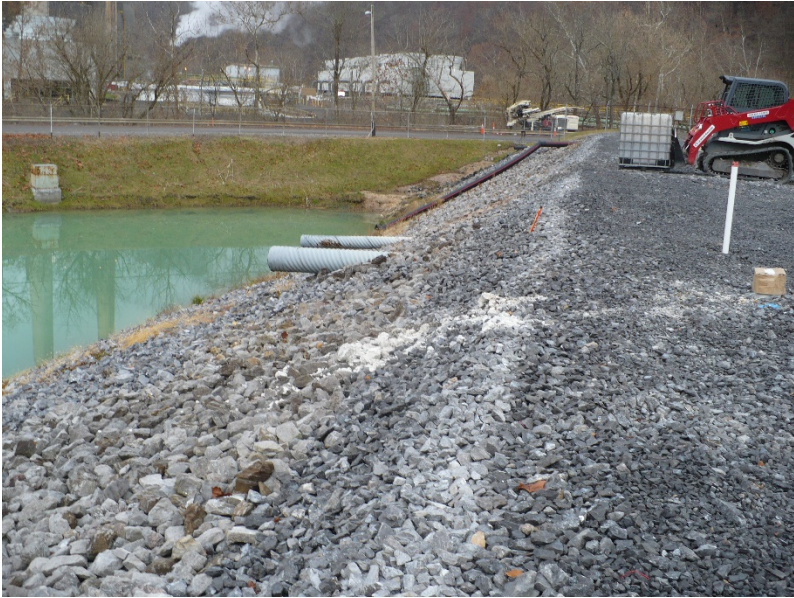
14. The interior slopes of the reclaim pond appeared stable and there was no displacement of the riprap cover or erosion of the grassed slopes [photo 17].

Photo #17 – reclaim pond interior slopes
