2019 Annual Landfill Inspection Report

**Northeastern Plant
Public Service Company of Oklahoma
Oologah, OK**

December 2019

Document ID: GERS-19-043

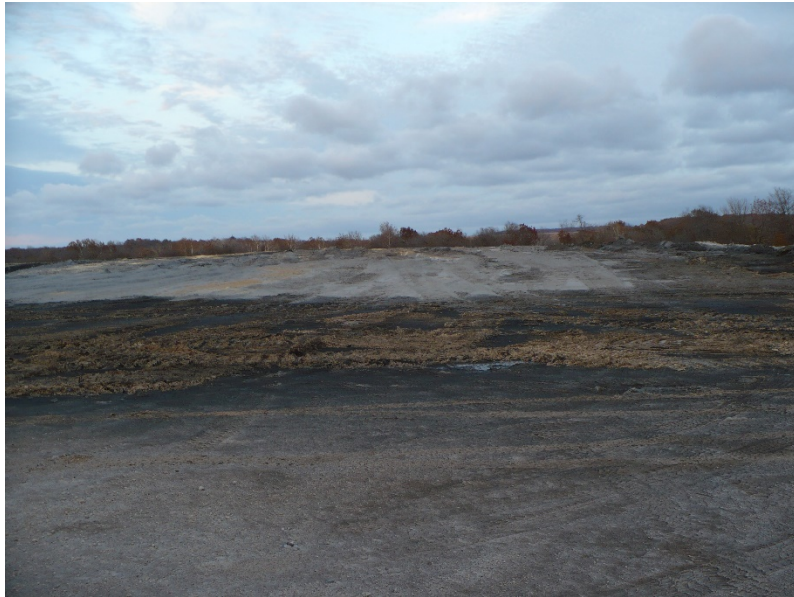
1. Cell 2 is the active disposal area (photo 1). No ponding of water was observed on the surface. The material in the Cell is separated from the inactive areas by a low splitter berm.
2. There was no erosion of the CCR material in the active area. The height of the fill above the intermediate liner is relatively small (< 12 feet).
3. No slopes or other areas of the active landfill have received permanent cover.

Photo #1 – active disposal Cell 2

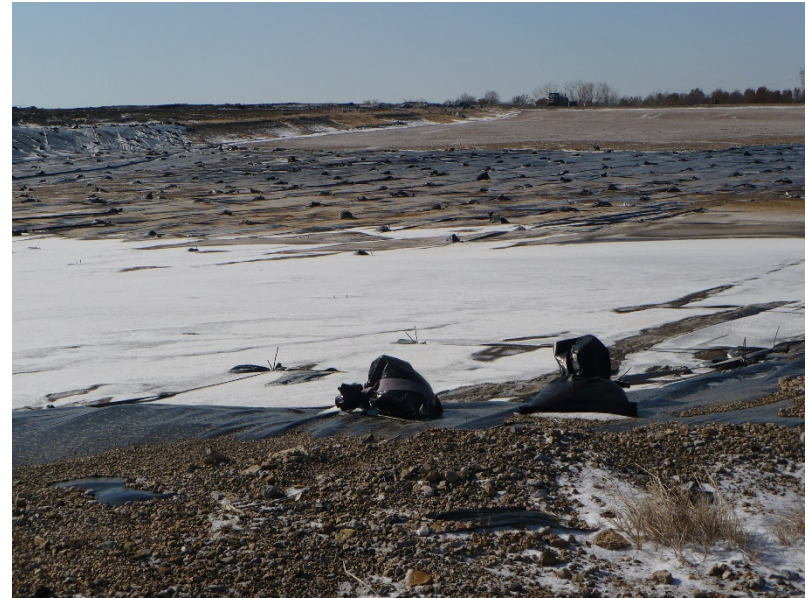
4. The surface of the inactive disposal areas is the protective cover material over the intermediate liner system. There were no observations of erosion or other unsatisfactory conditions of the areas. Photo 2 shows the rainflap cover over portion of the inactive disposal area.
5. There was no ponding of water on the surface of the inactive areas. The areas drain to the perimeter stormwater channels. The channels flow into Basin C, which is pumped to the permitted outfall.
6. The west end of the landfill has exposed geomembrane as a temporary cover over the slopes of the CCR material. No damage to the temporary cover was observed. (photo 3)
7. The exterior slopes of the north containment berm were covered with high vegetative growth (photos 4-5).

Photo #2 – Rainflap cover – Cell 1

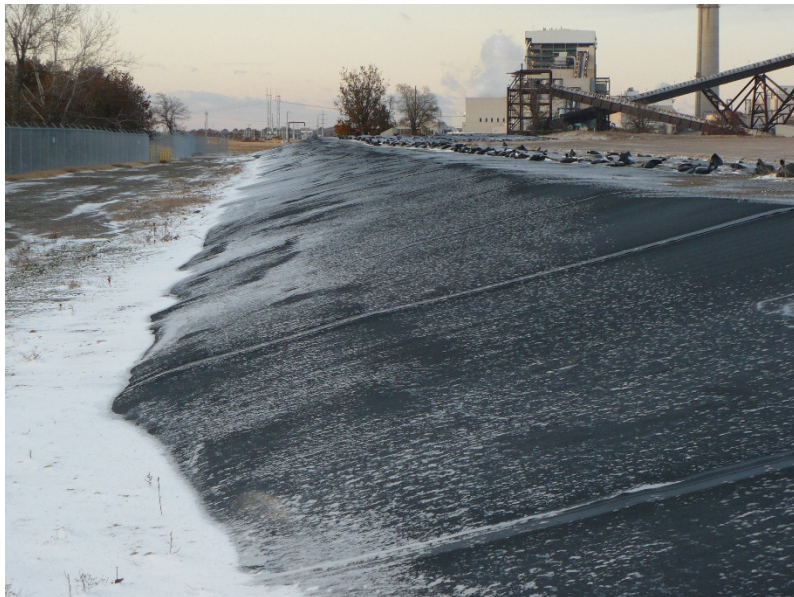
Photo #3 – geomembrane cover of west slope

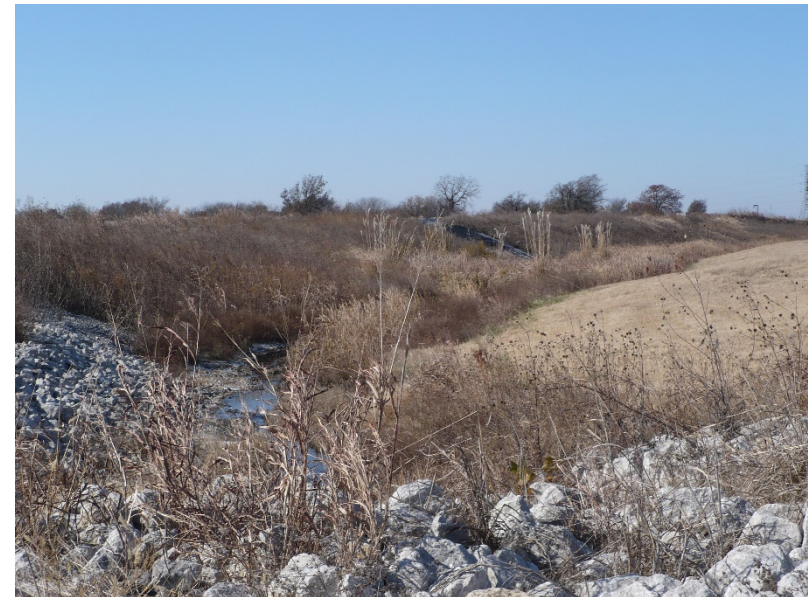
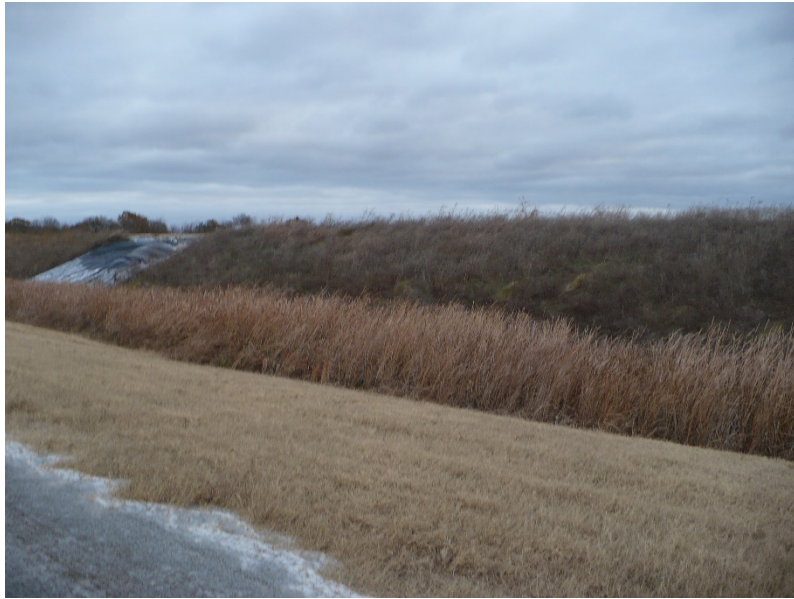
Photo #4 – exterior slope North containment berm-looking west

Photo #5 – exterior slope of North containment berm, looking east

- 1) Mow the exterior slope of the north containment berm to control woody vegetation.

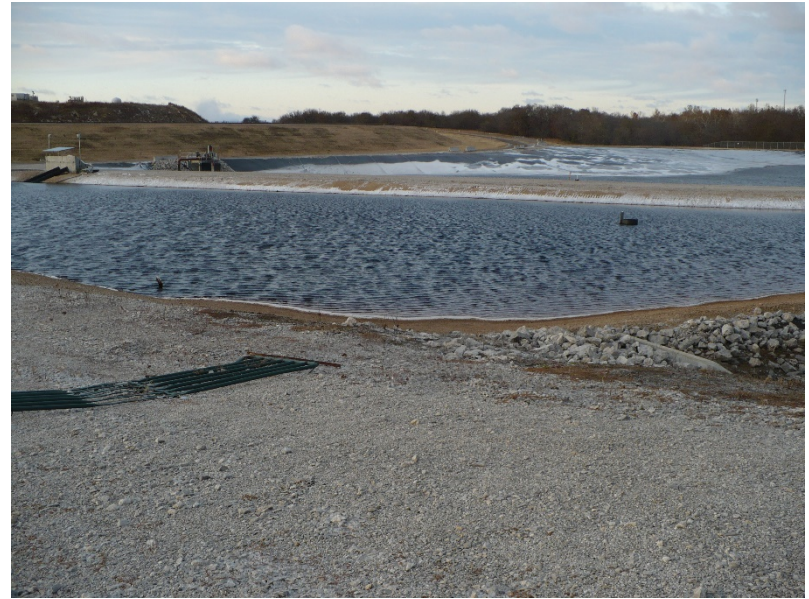
8. The pond was full due to the recent precipitation events over the past several weeks prior to the inspection (photo 6). The outlet of the two leachate pipes that discharge into the pond were not visible.
9. The plant has switched to a manual pumping system instead of the existing leachate pumping system. Generally, the leachate is used for dust control and compaction water for the CCR material placed in the active area.

Photo #6 – Leachate collection pond – almost full

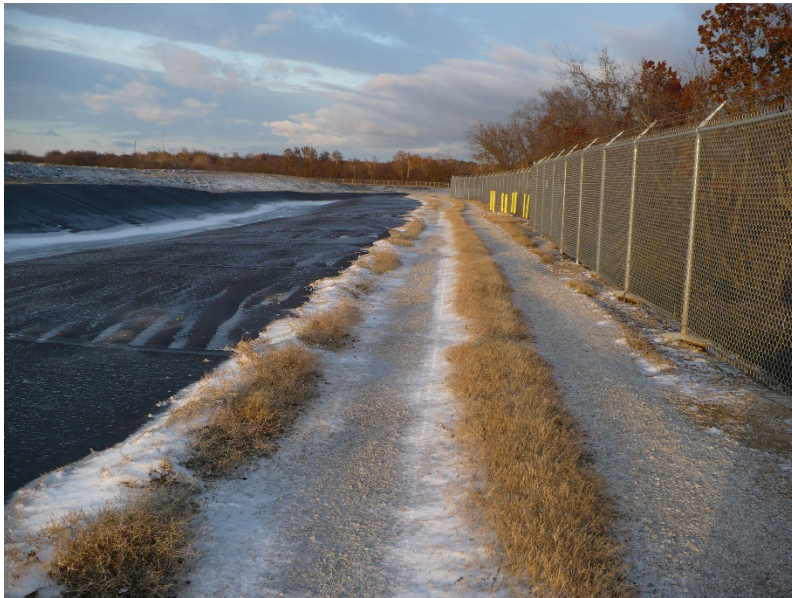
13. The crest of the perimeter was in fair condition (photo 7). There were a few minor ruts in the surface of aggregate road surface.
14. The exterior slope of the berm is steep and heavily vegetated. The natural riverbank slope is exposed rock.

Photo #7 – crest of containment berm along the river

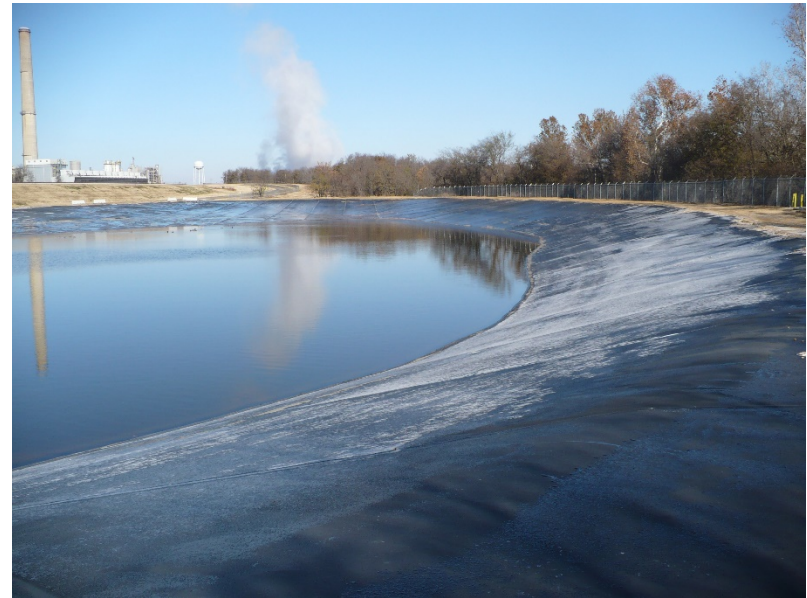
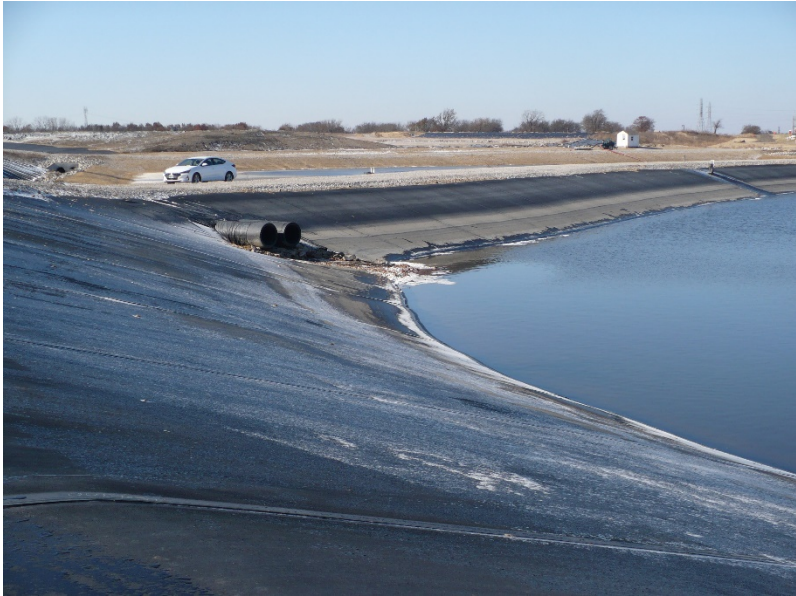
10. The perimeter ditches were in good condition. The ditches are currently lined with exposed geomembrane. There were some local areas of very shallow ponding due to either minor sediment or small wrinkles in the geomembrane.
11. No damage to the geomembrane was observed during the inspection.
12. The exposed geomembrane liner in Basin C was observed to be in good condition (photos 8-9)

Photo #8 – Interior slope of non-contact water pond (Basin C)

Photo #9 – outlet of south non-contact water culverts into Basin C

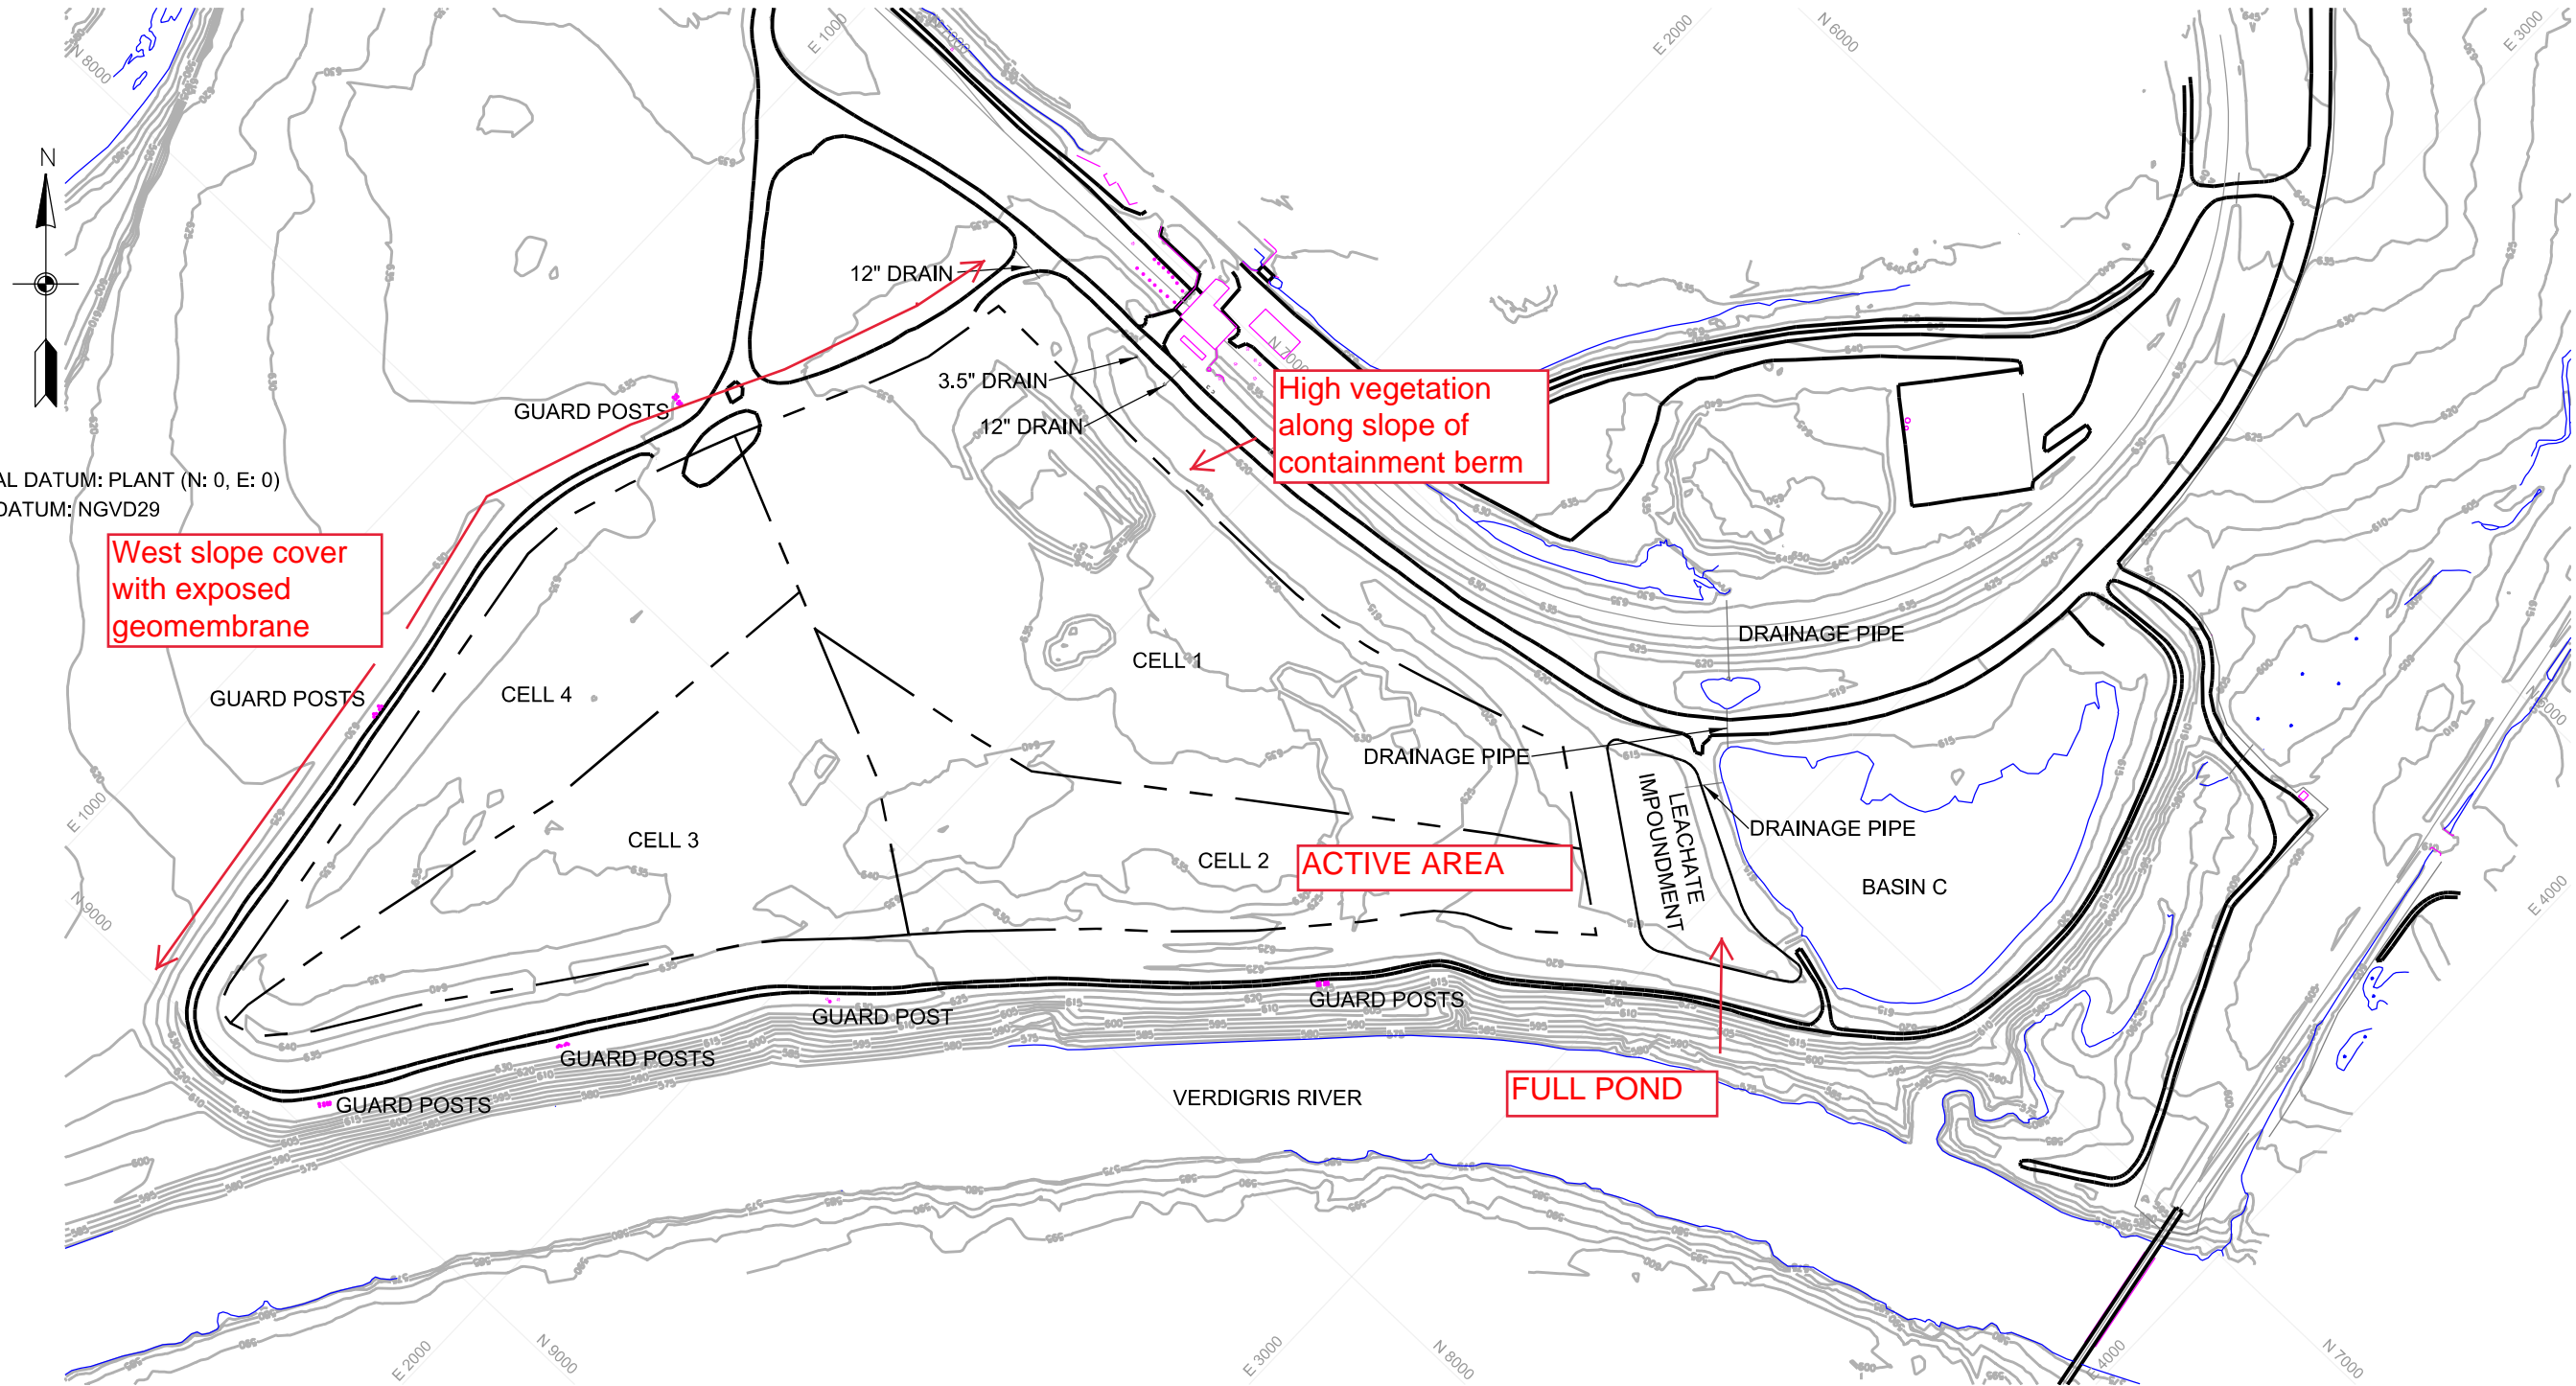
DRN BY:	GEOTECHNICAL	 AEP SERVICE CORP. 1 RIVERSIDE PLAZA COLUMBUS, OH 43215
DATE:	PUBLIC SERVICE COMPANY OF OKLAHOMA NORTHEASTERN PLANT	
SCALE: 1"=300'	LANDFILL FIGURE 1

West slope cover with exposed geomembrane

High vegetation along slope of containment berm

FULL POND
