2019 Annual Landfill Inspection Report

CCR Landfill

**Turk Power Plant
Southwestern Electric Power Company
Fulton, Arkansas**

Document Number: GERS-19-036

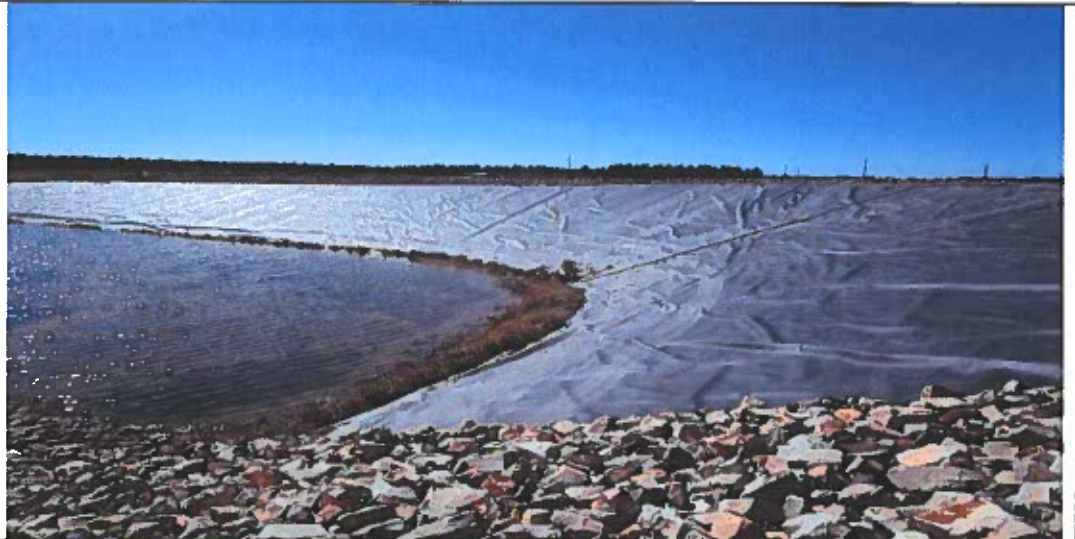
4. The pond consists of north, south, and east slope covered with vegetation. A slip had occurred at the west slope few years ago. In 2018, the west slope was repaired by replacing soil cover with the HDPE liner. Photograph No. 6 illustrates typical condition of the interior vegetated slopes. The interior vegetated slope appeared in good and stable condition. Small area at the northeast side upper section of the north slope was not mowed as marked in the photograph. Photograph No. 7 shows the west slope after the completion of the slip repair and HDPE liner. The slope and the liner appeared in good and stable condition and functioning as design.

<p>Photo #7 West slope lined with HDPE liner.</p>

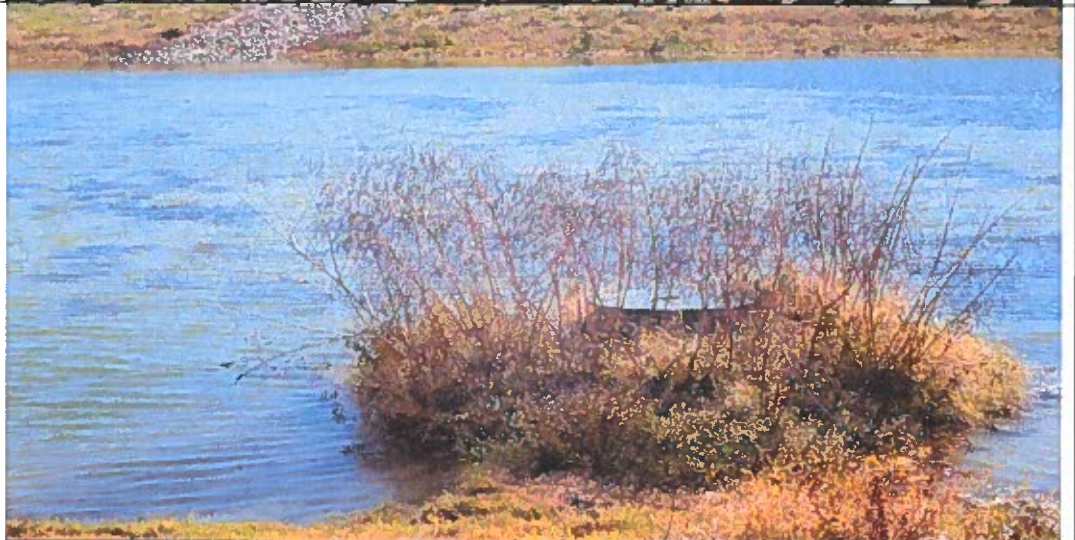
5. The leachate pond inlet structure is illustrated in Photograph No. 8. It was surrounded with overgrown vegetation.

<p>Photo #8 Leachate pond inlet structure covered with vegetation.</p>

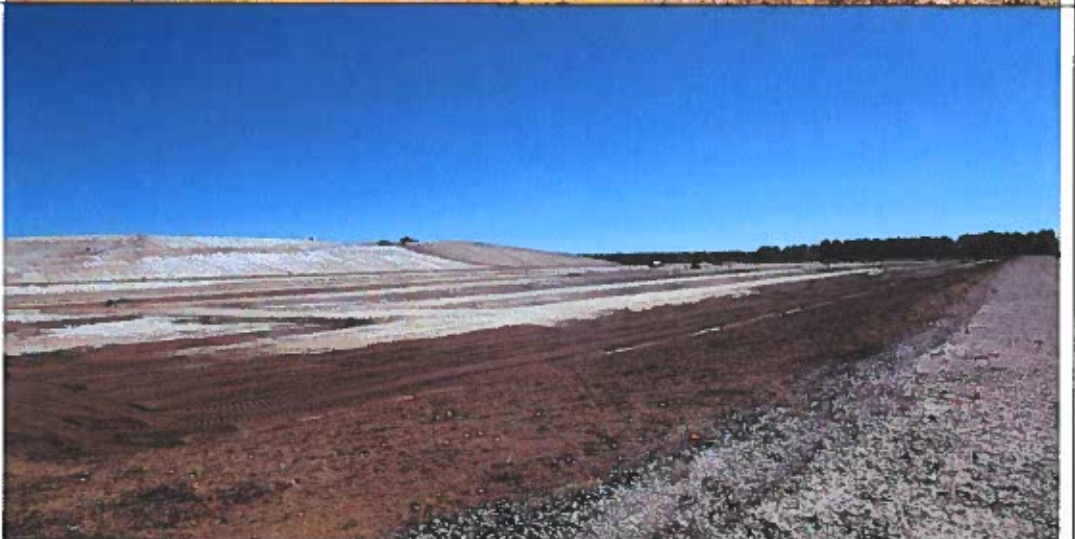
6. Photograph No. 9 shows Cell 1 and Cell 2. Cell 2 was recently completed and active waste disposal. Cell 1 is close to reaching its final disposal design grades (capacity) and thus the contractor is working on the final grading. Both cells appeared in good and stable condition. Plans are to place temporary cover over the constructed portion of finally graded slopes of Cell 1.

<p>Photo #9 Landfill Cell 1 and Cell 2.</p>

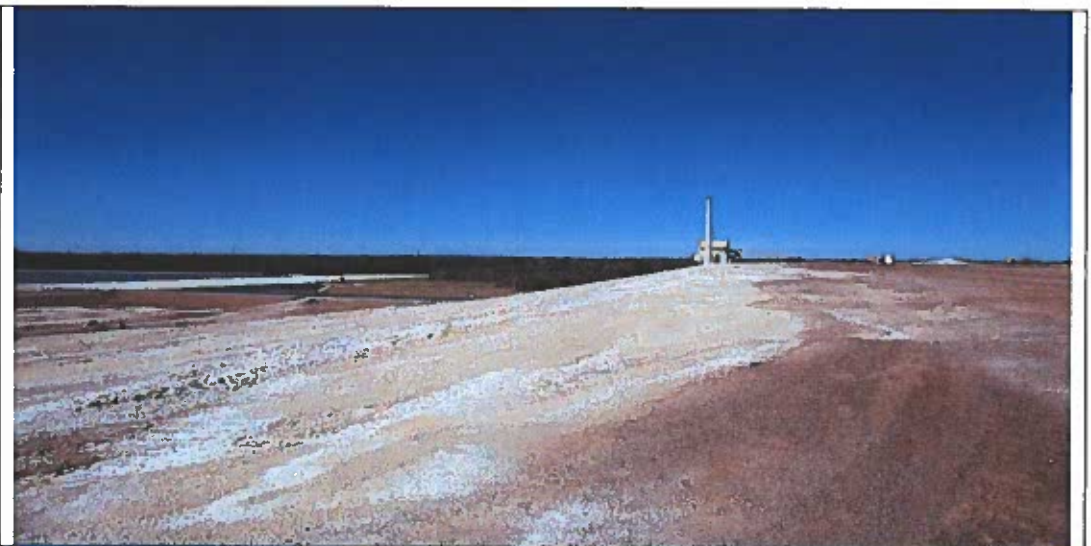
7. Overall condition of the landfill Cell 1 and Cell 2 is illustrated in Photograph No. 10. This photograph was taken from top of Cell 1 looking down towards Cell 2. Existing landfill Cell 1 and newly completed Cell 2 were in good condition with no sign of instability and significant erosion of the slopes.

<p>Photo #10 Overall view of the landfill.</p>

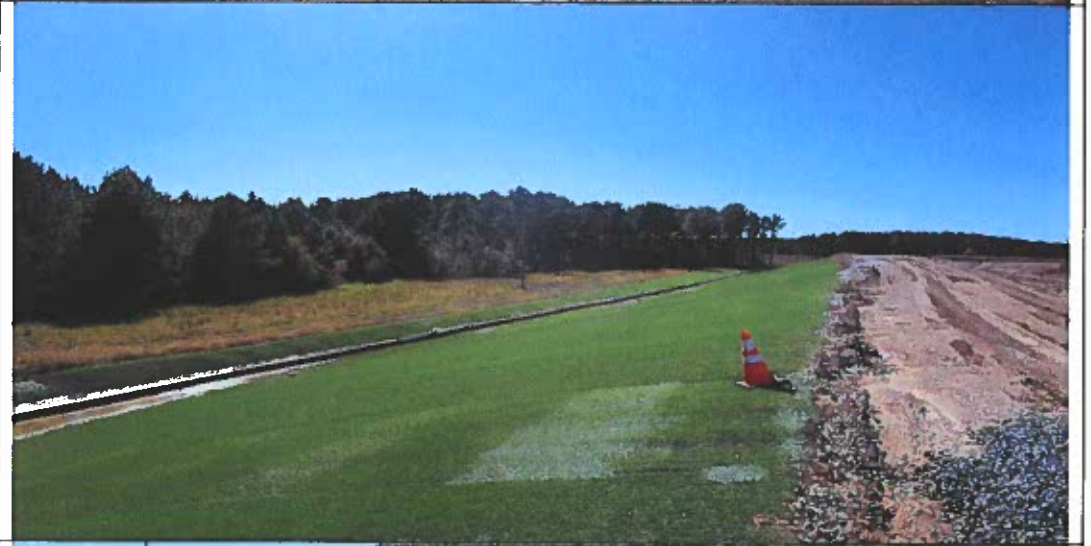
8. A perimeter berm with a toe ditch was constructed for the landfill to support the landfill and control runoff from the landfill. The south perimeter berm is shown in Photographs No. 11 and 12. The slope of the berm consists of artificial turf appeared in good and stable condition. It appears that some of the sand that was placed as ballast over the artificial turf may have by runoff into the toe ditch. The eastern end of the toe ditch exhibited overgrown vegetation.

A wide-angle photograph showing a large, flat, reddish-brown area, likely a landfill, under a clear blue sky. In the distance, a tall, thin structure, possibly a smokestack or chimney, is visible against the horizon.
<p>Photo #11 South perimeter berm slope and toe ditch.</p>

1. The east and south perimeter ditch those being filled with sediments needs to be excavated from the perimeter ditch to maintain the design hydraulic capacity and also to control run-on from the slopes. All the overgrown vegetation should be cleared from the ditch and the ditch should be restored to its design condition.

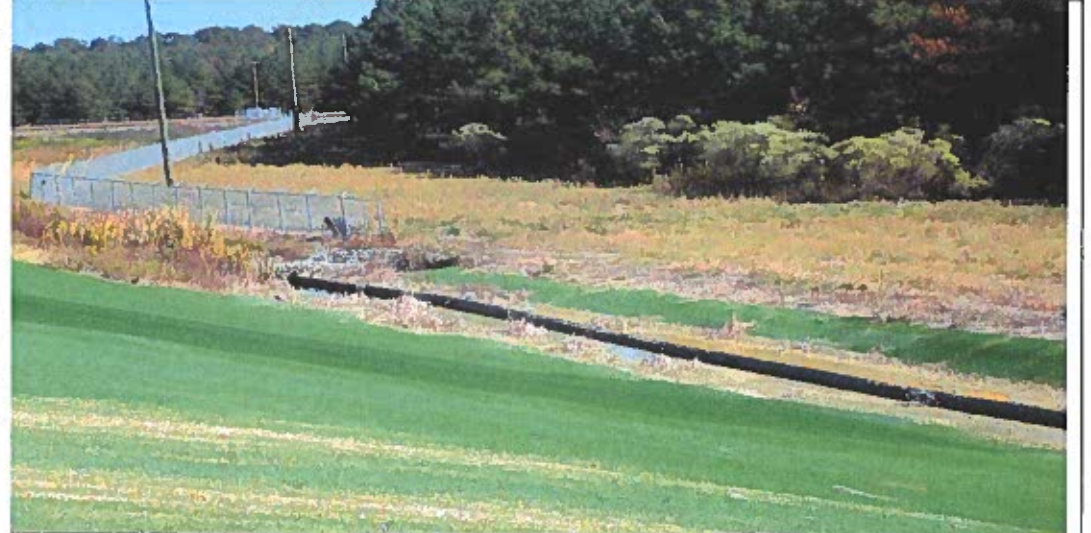
A photograph showing a green grassy slope on the left, a dark, narrow ditch or berm in the middle, and a dirt road on the right. A red and white traffic cone is visible on the dirt road. The background shows a line of trees under a blue sky.
<p>Photo #12 Close up view of the south perimeter berm toe ditch.</p>

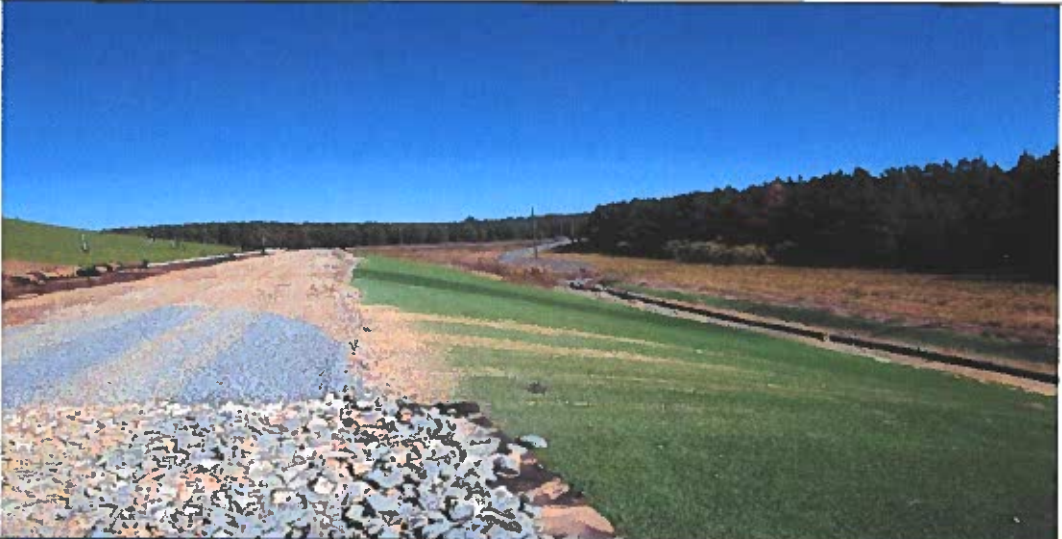
9. Typical condition of the perimeter haul road is exhibited in Photograph No. 13. The haul road appeared in good condition with no sign of noticeable settlement, misalignment, and cracks/erosion. Significant amounts of sediments were seen on the haul road mostly carried by the runoff water.

<p>Photo #13 Typical condition of the south perimeter haul road.</p>

3. The south haul road covered with sediments should be removed and properly maintained to avoid sediments accumulation in future.

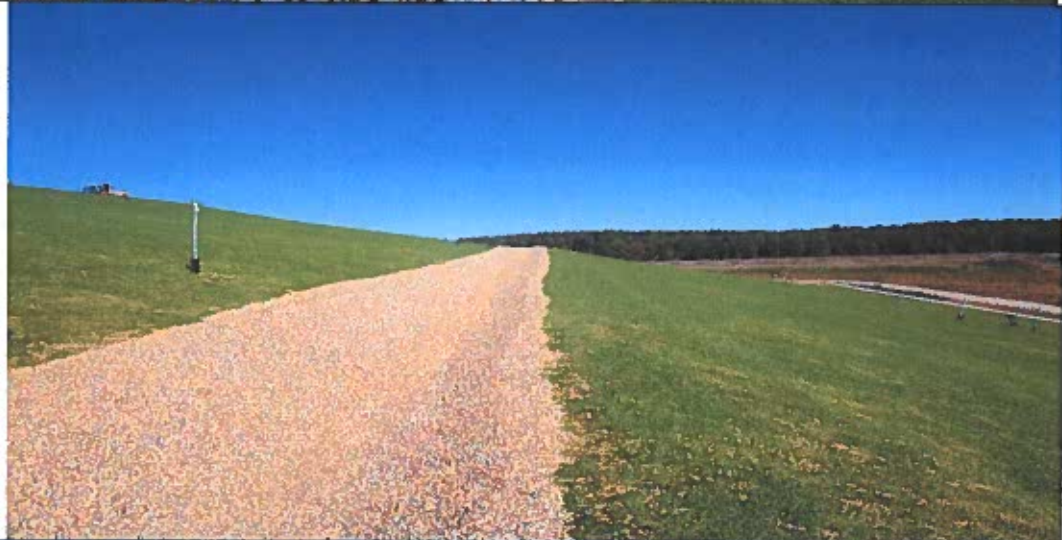
10. A test pad using closure turf for the permanent cover system installation was completed in October 2019 at the southeast slope of the landfill (Photograph No. 14). The closure turf cover system is designed to be in compliance with the CCR rules and approved by the ADEQ for the test pad. The test pad of the cover system appeared in good intact and stable condition.

A wide gravel haul road runs parallel to a green grassy area. The road is composed of light-colored gravel and extends into the distance. The grassy area is well-maintained and vibrant green. The sky is clear and blue. In the background, there is a line of trees and a slight rise in the land.
<p>Photo #14 Closure turf test pad area in the southeast corner of Cell 1.</p>

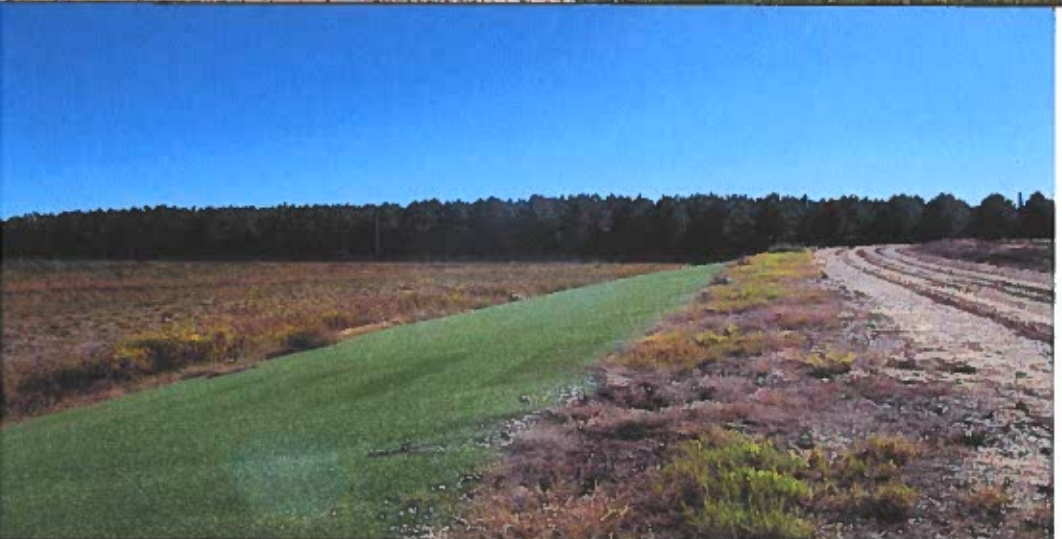
11. The east perimeter berm, road, and toe ditch is shown in Photographs No. 15. This slope of the berm consists of artificial turf appeared in good and stable condition. Some ruts were observed at the haul road, but road appeared in stable condition with no sign of settlement or misalignment. The toe ditch exhibited overgrown vegetation. The north slope of the landfill

A gravel test pad area is visible, adjacent to a grassy slope. The gravel is light-colored and appears to be a different texture or composition than the main haul road. The grassy area is green and slopes upwards. The sky is clear and blue. A utility pole is visible in the distance on the grassy slope.
<p>Photo #15 Typical condition of the east perimeter berm and toe ditch.</p>

2. Minor rutting of the haul road should be repaired by regrading and keeping up regular maintenance in future.

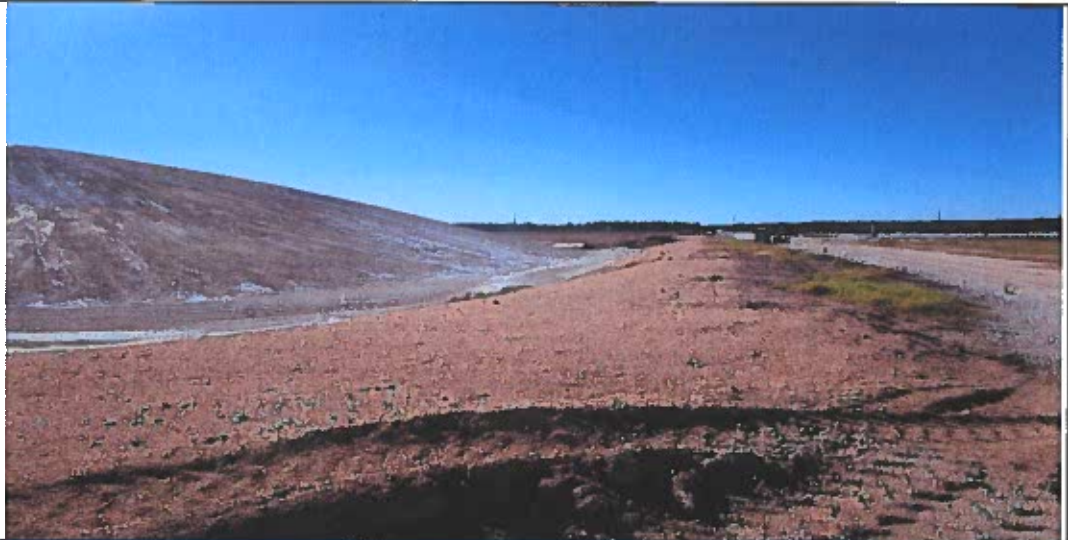
and perimeter haul road, and berm are exhibited in Photograph No. 16. The berm with the haul road appeared in good and stable condition.

<p>Photo #16 The north side of the landfill Cell 1 area.</p>

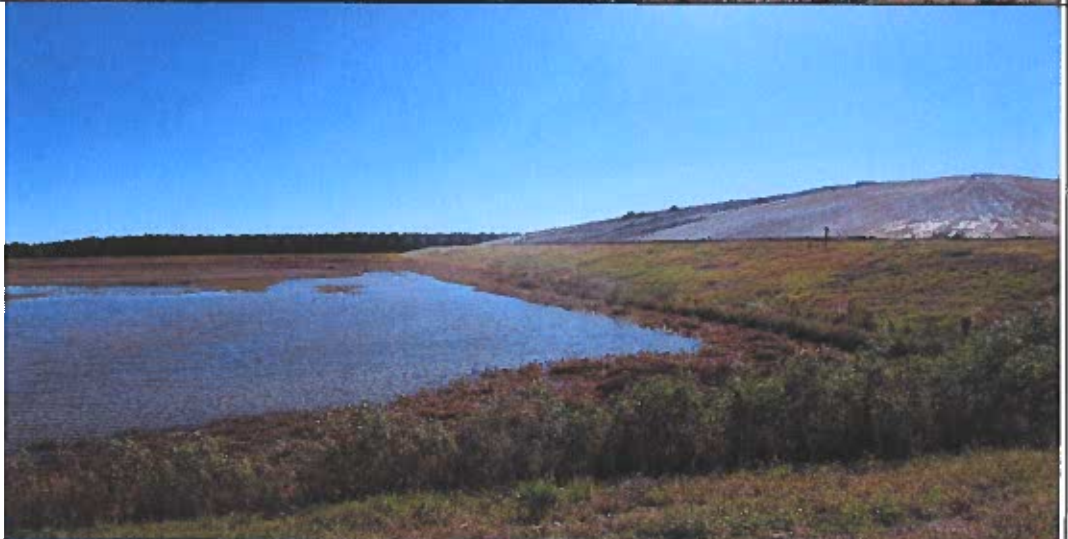
12. The storm water pond is located to the east of the landfill and receives non-contact storm water run-on from areas outside the active Cells of the landfill. The pond appeared to be functioning as designed (Photograph No. 17).

<p>Photo #17 Overall view of the storm water pond</p>

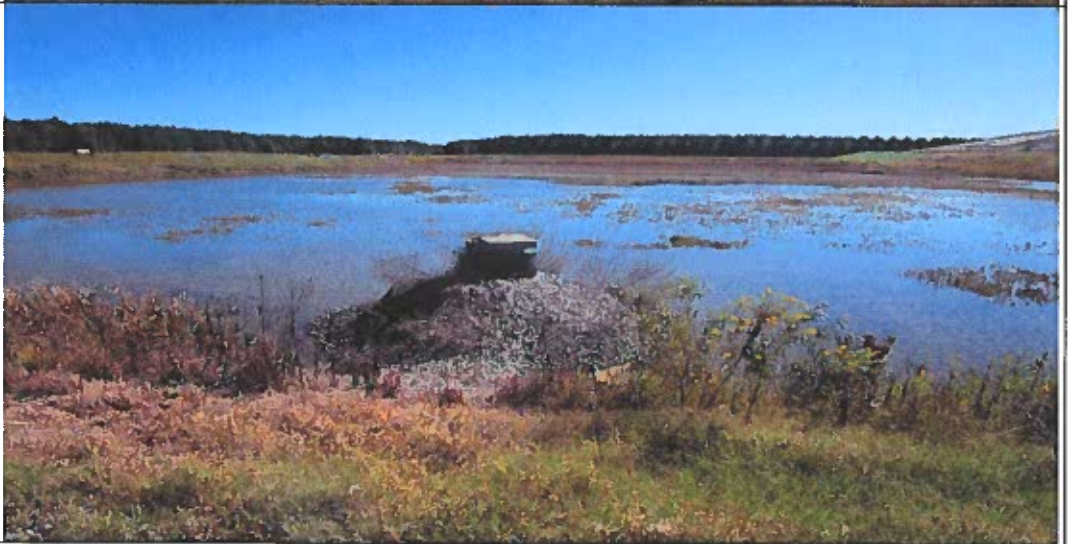
13. The inlet and outlet of the overflow pipe structure of the storm-water pond are exhibited in the Photographs No. 18 and 19. The overflow pipe structure appeared in good condition. No water was flowing at the time of inspection from the outlet pipe.

<p>Photo #18 The inlet of the overflow discharge structure.</p>

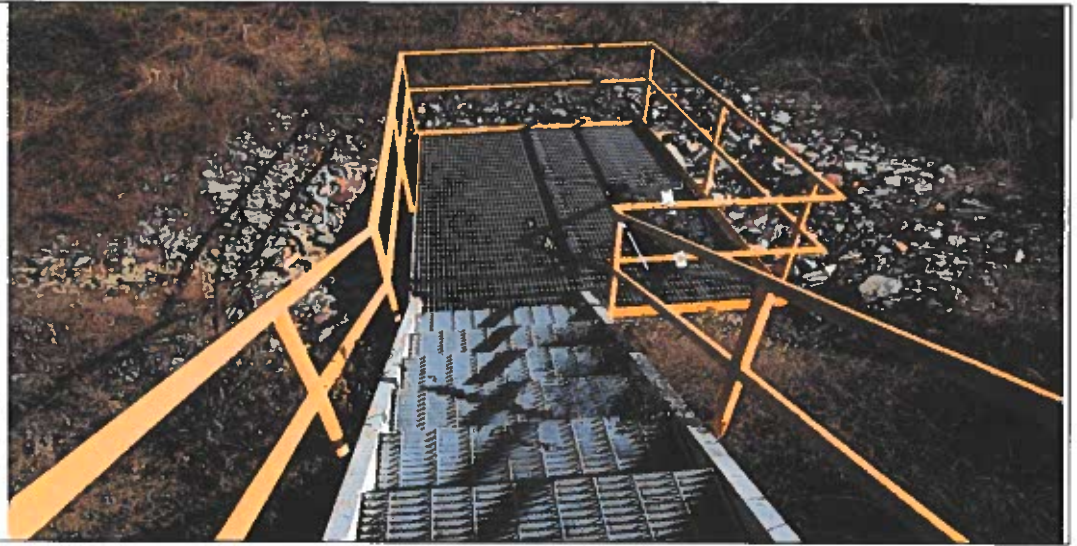
Photo #19
The overflow pipe
discharge structure.
