**2019 DAM AND DIKE INSPECTION REPORT  
BOTTOM ASH COMPLEX  
(Facility ID #05307)**

**GERS-19-017**

**APPALACHIAN POWER COMPANY  
MOUNTAINEER PLANT  
NEW HAVEN, WEST VIRGINIA**

**INSPECTION DATE: August 14, 2019**

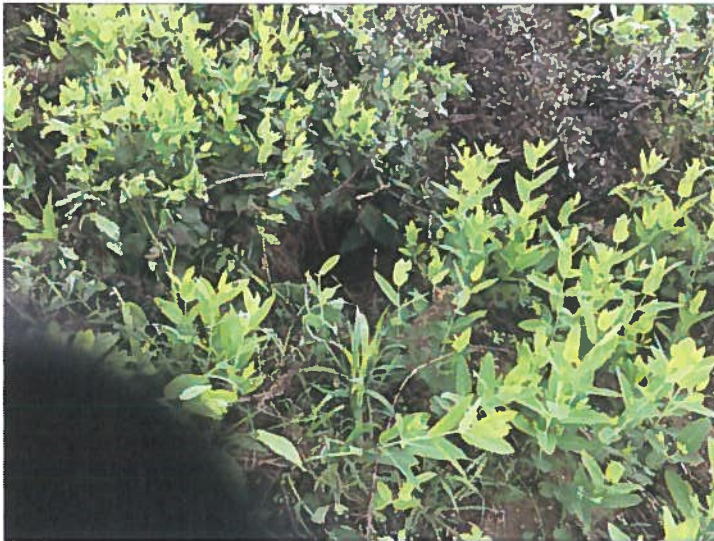
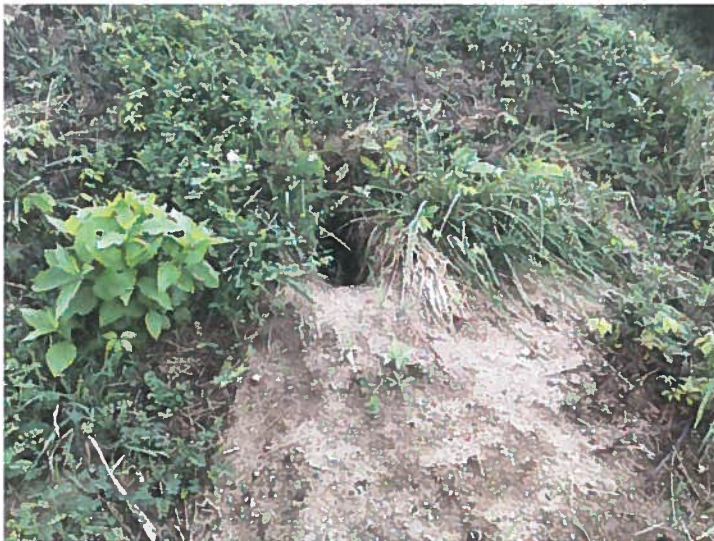
1. Photographs No. 1 and No. 2 illustrate animal burrows located on the east downstream slope of the CWP. In general, the crest and downstream slope of the CWP were in satisfactory condition. The crest of this dike, also used as haul road, is seen in this photograph. The gravel base on the crest and vegetation cover on the slope appeared satisfactory. The existing sulfuric acid tanks are not in use for treatment and will be removed later. The access walkway to the overflow structures appeared safe and in fair condition.

- (i) A few animal holes were encountered during this inspection. These holes shall be mitigated by filling them in with compactible backfill and compact the final lift to finish at the existing grades.
- (ii) Water level measuring staff gauges should be installed at the overflow discharge structure or pipe locations. The staff gauges should have elevation marked and labelled in the mean sea level (msl). The length of the staff gauges shall be such that will provide full depth measurements in case of high pool level during significant flood events.
- (iii) The settlement around the manhole of the outfall pipe should be excavated to the bottom of the settled ground and backfilled with soil, compacted, and regraded.

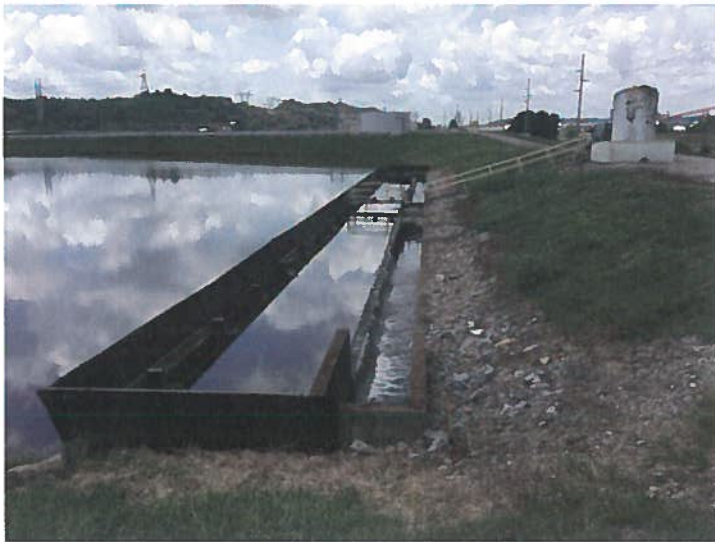
2. Photograph No. 3 illustrates the east dike upstream slope and the effluent flume structure of the CWP. The effluent structure was functioning as design. The lower sections of the upstream slope are protected by stone and the upper sections are covered by vegetation.

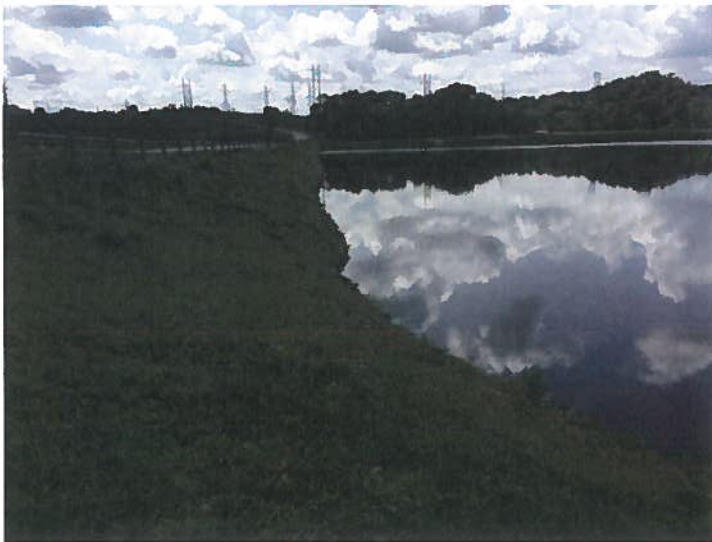
3. Photograph No. 4 illustrates the upstream slope of the southern dike. This photograph also depicts the typical condition of the CWP interior slopes. The interior slopes appeared in satisfactory and stable conditions.

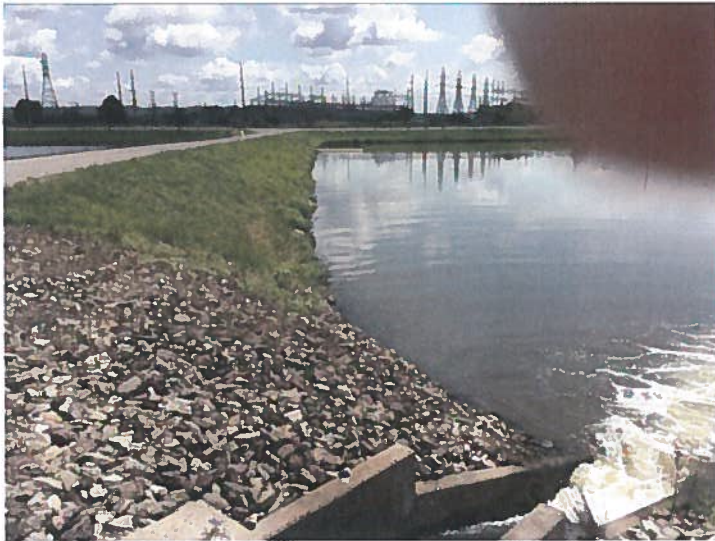
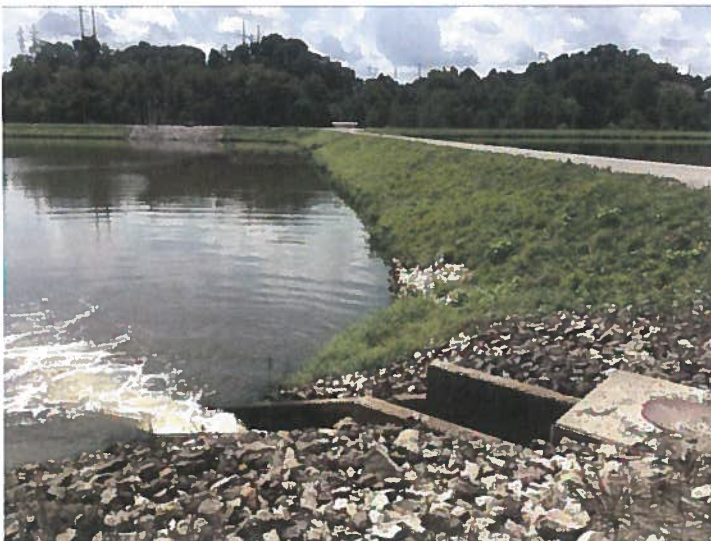
4. Typical interior dikes, crest and slopes of the RWP are depicted in Photographs No. 5 and No. 6. The stone material around the discharge culvert was in satisfactory condition. Overall, the interior dikes, crest and slopes of the CWP and RWP appeared to be in satisfactory condition with no signs of rutting misalignment or cracking.

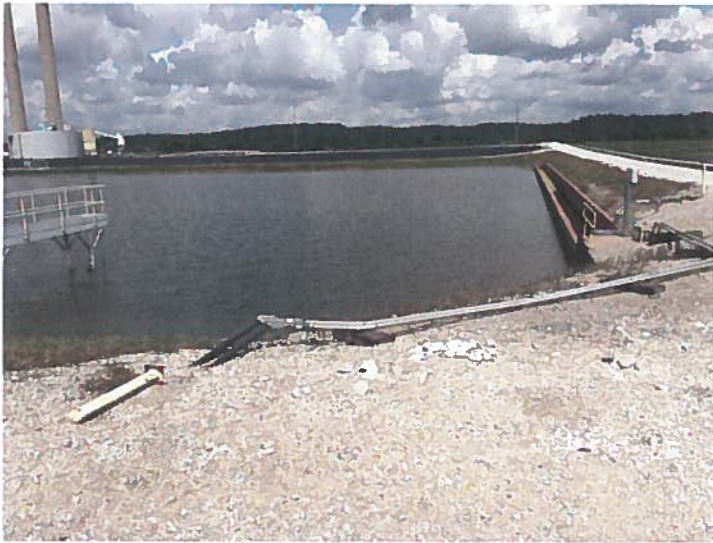
1. The EWP interior slope condition and effluent flume and concrete weir is shown in Photographs No. 7. This slope appeared to have intermittent grass cover, but some isolated areas were found to be bare.

5. The effluent flume concrete and the steel weir components of the EWP and WWP are illustrated in Photographs No. 7 and No. 9. The flume and weir structure appeared to be in satisfactory and working condition.

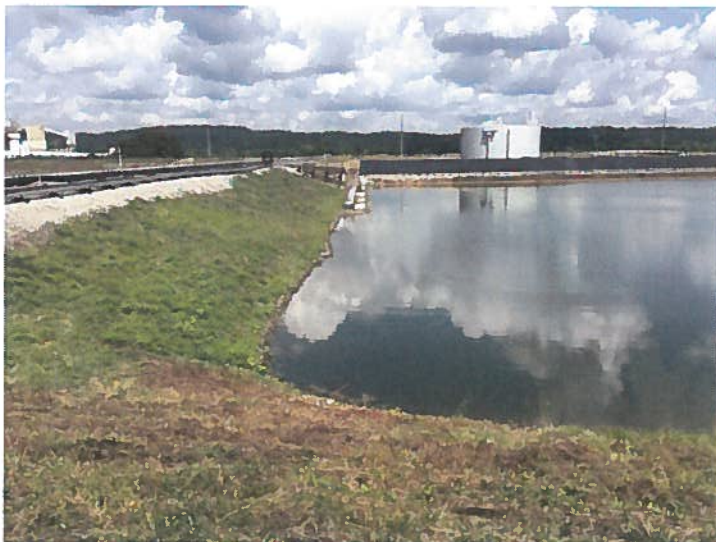
2. The EWP interior slope conditions and discharge header pipe is depicted in Photograph No. 8. Overall, the dikes and slopes were in satisfactory and stable condition and the vegetation cover was good.

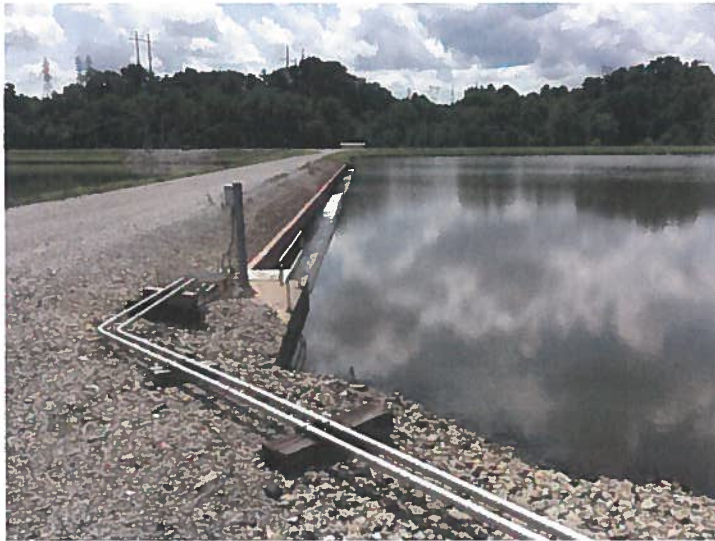
3. The WWP interior slope condition and effluent flume and concrete weir is depicted in Photographs No. 9. This slope appeared to have intermittent grass cover, but some areas were found to be completely bare.

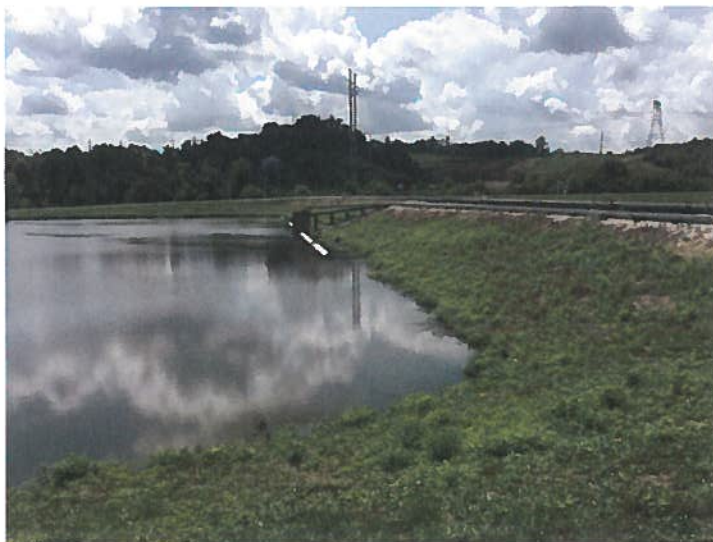
4. The WWP interior slope conditions and discharge header pipe is shown in Photograph No. 10. Overall, the dikes and slopes were in satisfactory and stable condition and the vegetation cover was good.

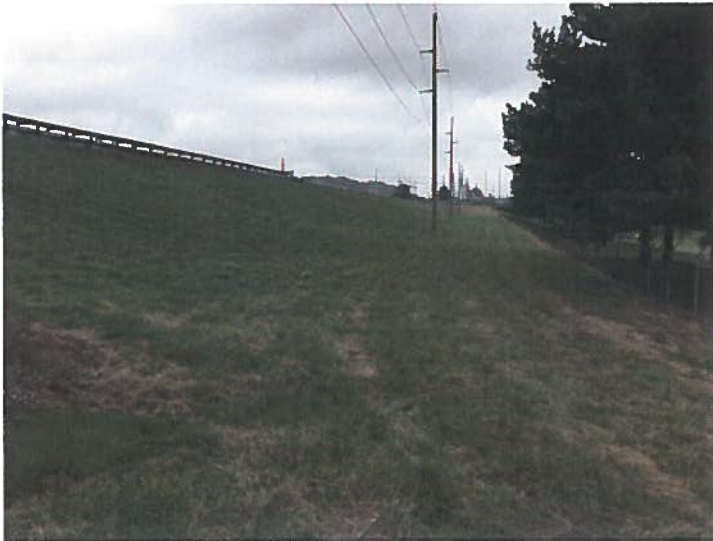
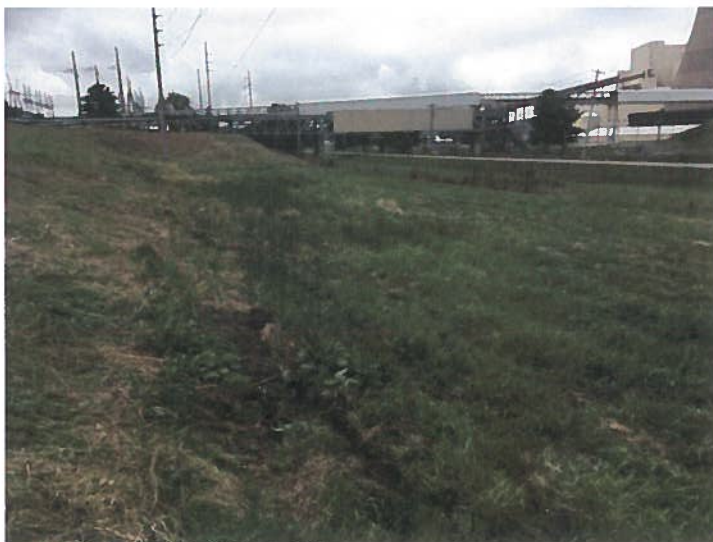
1. The overall condition of the downstream slope of the east dike is presented in Photographs No. 11 and 12. The condition of the east exterior slope was fair. An extended area of excessive wetness approximately 900 feet long was observed adjacent to the toe of the dike. Standing water was noticed in the tire ruts apparently from previous mowing activities. The slope above this elevation appeared satisfactory.

- (i) Potential seepage along the east dike downstream slope of the EBAP is most likely to be contributing to the wet area between the toe of the dike and the fence. The root cause of the potential seepage is under monitoring and currently considered for investigation. A monitoring plan including a survey of the area shall be prepared and implemented by AEPSC Civil Engineering & Geotechnical Services to find the root cause of this issue. Data from existing and additional monitoring instruments shall be

reviewed as part of the monitoring plan. When a root cause is determined, appropriate corrective action shall be implemented.

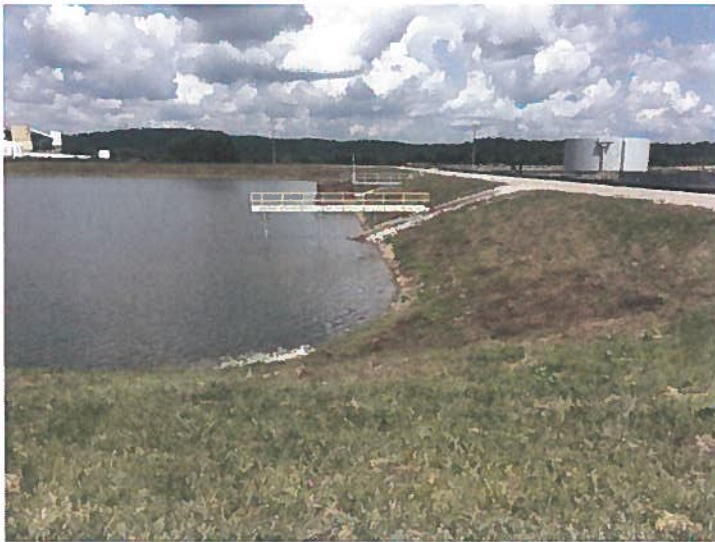
2. Photograph No. 13 depicts the typical condition of the EBAP interior slopes and overflow and low water outlet structure. The overflow discharge structure, access platform, and side rail appeared to be in satisfactory and working condition. Some erosion was noticed at the outlet end of the pipe that should be repaired.

- (v) Some erosion around the overflow header structure of the EBAP was noticed. Part of the discharge pipe was out of alignment or damaged. Although access may be an issue, this condition should be remediated as part of maintaining the facility.

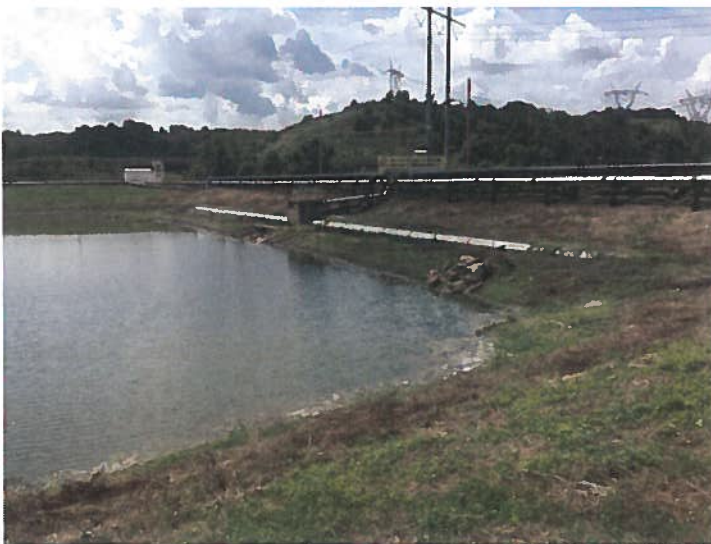
3. Photograph No. 14 depicts the typical condition of the EBAP interior slopes and discharge header pipe structure. The discharge header pipe appeared to be in satisfactory working condition. There was some erosion noticed at the junction box for the discharger header pipe.

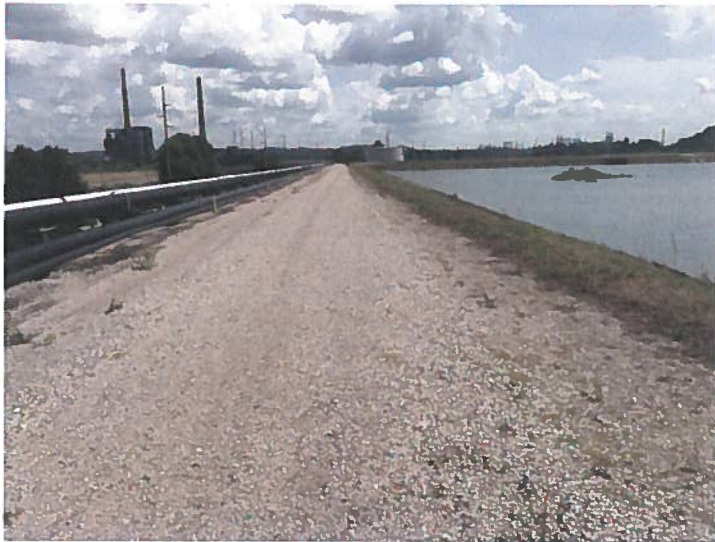
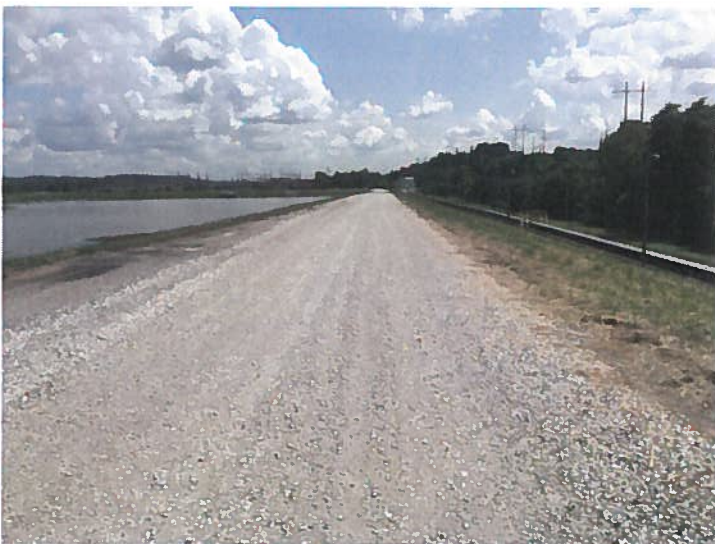
4. Photographs No. 15 and No. 16 show the typical conditions of the EBAP and WBAP crest areas. The crest areas appeared to be in satisfactory and stable condition without any sign of settlement, misalignment, or cracking.

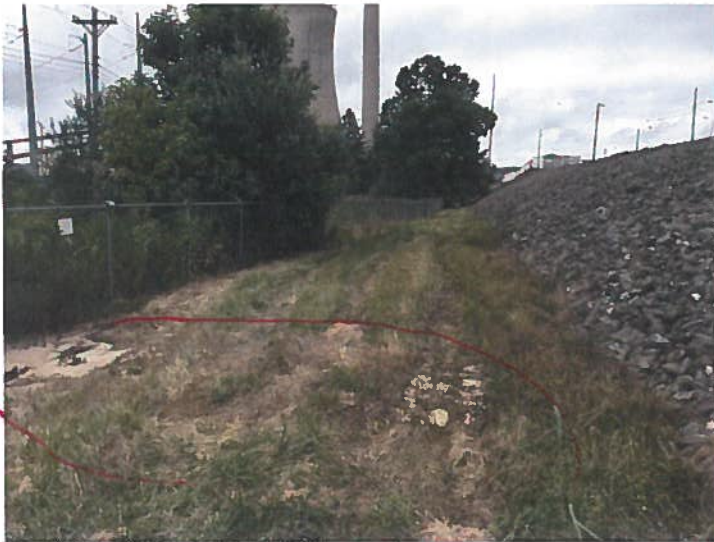
5. The north exterior slopes of the EBAP and WBAP were in satisfactory good and stable condition. Photograph No. 17 shows a wet/soft area along the toe of the WBAP northern downstream slope. This area is present from the toe of the slope to the existing chain-link fence. It appears that this condition is due to poor drainage and needs to be investigated to properly develop a repair plan.

- (vi) There were two areas at the toe of the downstream slopes of the EBAP and WBAP that exhibited wetness. One area is along the north dike (Photograph No. 17) that was wet and soft and may have some potential drainage issue. Another area is along the east dike (Photograph No. 12) that has soft ground, ponding water, and exhibit significant rutting. There seems to be some seepage contributing to the wetness this area since this area is relatively flat and located

adjacent to the downstream slope. A monitoring plan was discussed with the plant in order to determine a root cause and to develop a remedial plan.

(ii) Similarly, the wet area observed at the toe of the downstream slope of the WBAP close to the chain link fence should be investigated for poor drainage and water ponding issues. A monitoring plan including a survey of the area shall be prepared and implemented by AEPSC Civil Engineering & Geotechnical Services to find the root cause of this issue.

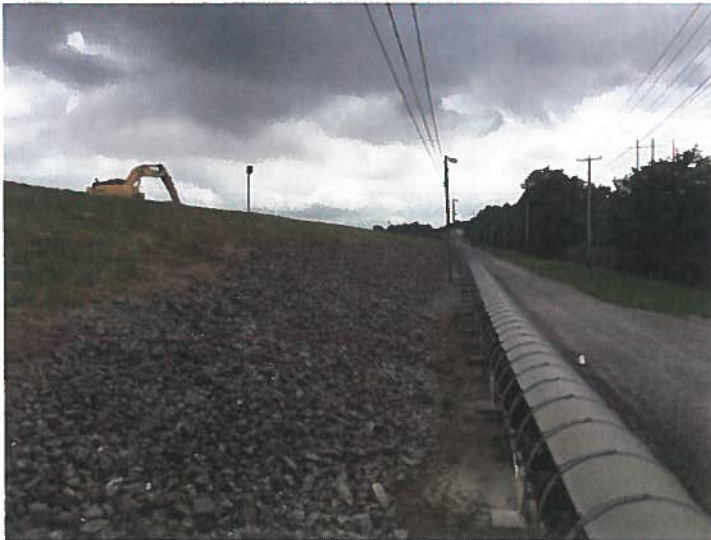
6. Photograph No. 18 shows the typical conditions of the WPAB western exterior slopes. The condition of the exterior slope is satisfactory. The lower portions are protected by riprap and the upper portions are properly vegetated.

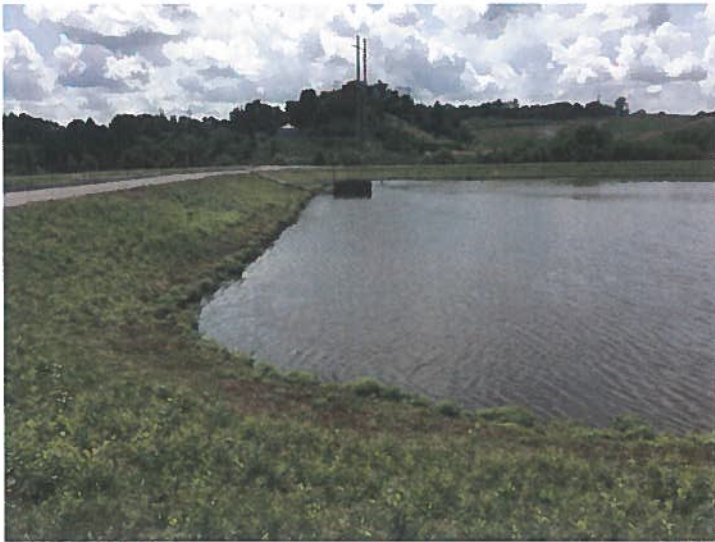
7. Photograph No. 19 depicts the typical condition of the WBAP interior slopes and overflow and low water outlet structure. The overflow discharge structure, access platform, and side rail appeared to be in satisfactory and working condition.

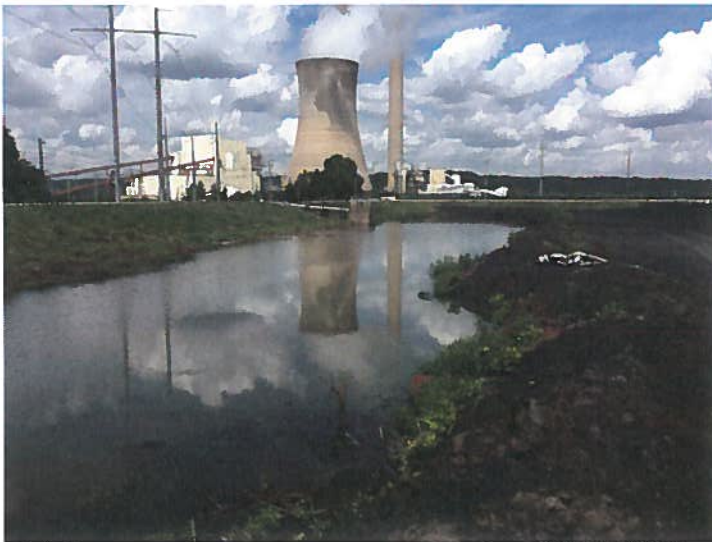
8. Photograph No. 20 shows the typical condition of the WBAP interior slopes and discharge header pipe structure. The discharge header pipe appeared to be in satisfactory working condition. There was some erosion noticed at the cribbing supporting the access walk way.
9. The north section of the WBAP is used for the temporary stockpile of bottom ash. This area also contains the ash sluice pipe for the discharge of bottom ash in this section of the pond. This area appeared to be well maintained and properly controlled for the handling of the bottom ash.

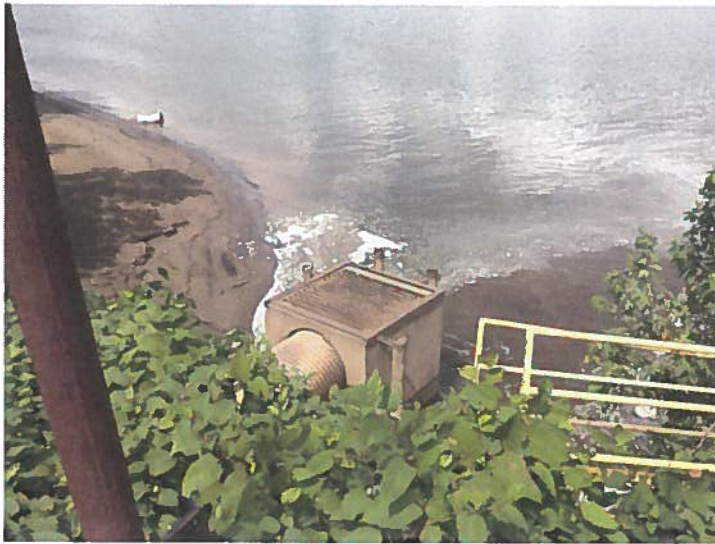
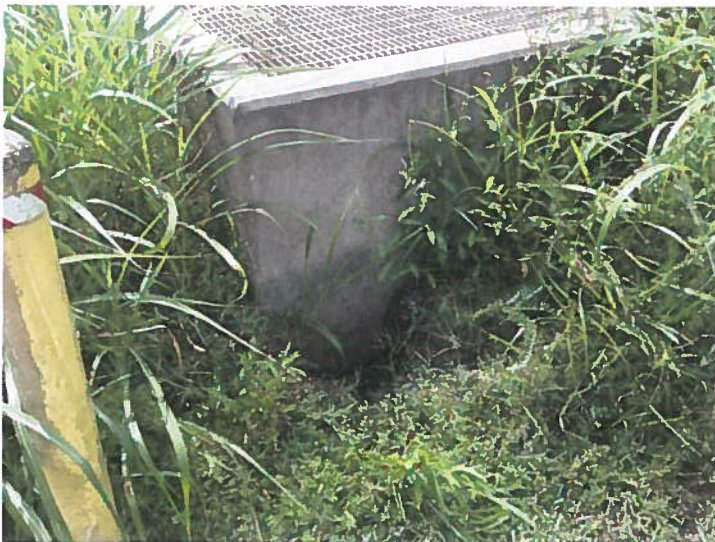
Photographs No. 23 and No. 24 show outfall 001 and the transfer basin connected to the outfall pipe at the riverbank. The transfer basin is located just before the outfall pipe to the river. The ground appeared to have settled around the manhole. The water flow appeared to be uninterrupted at the time of inspection.

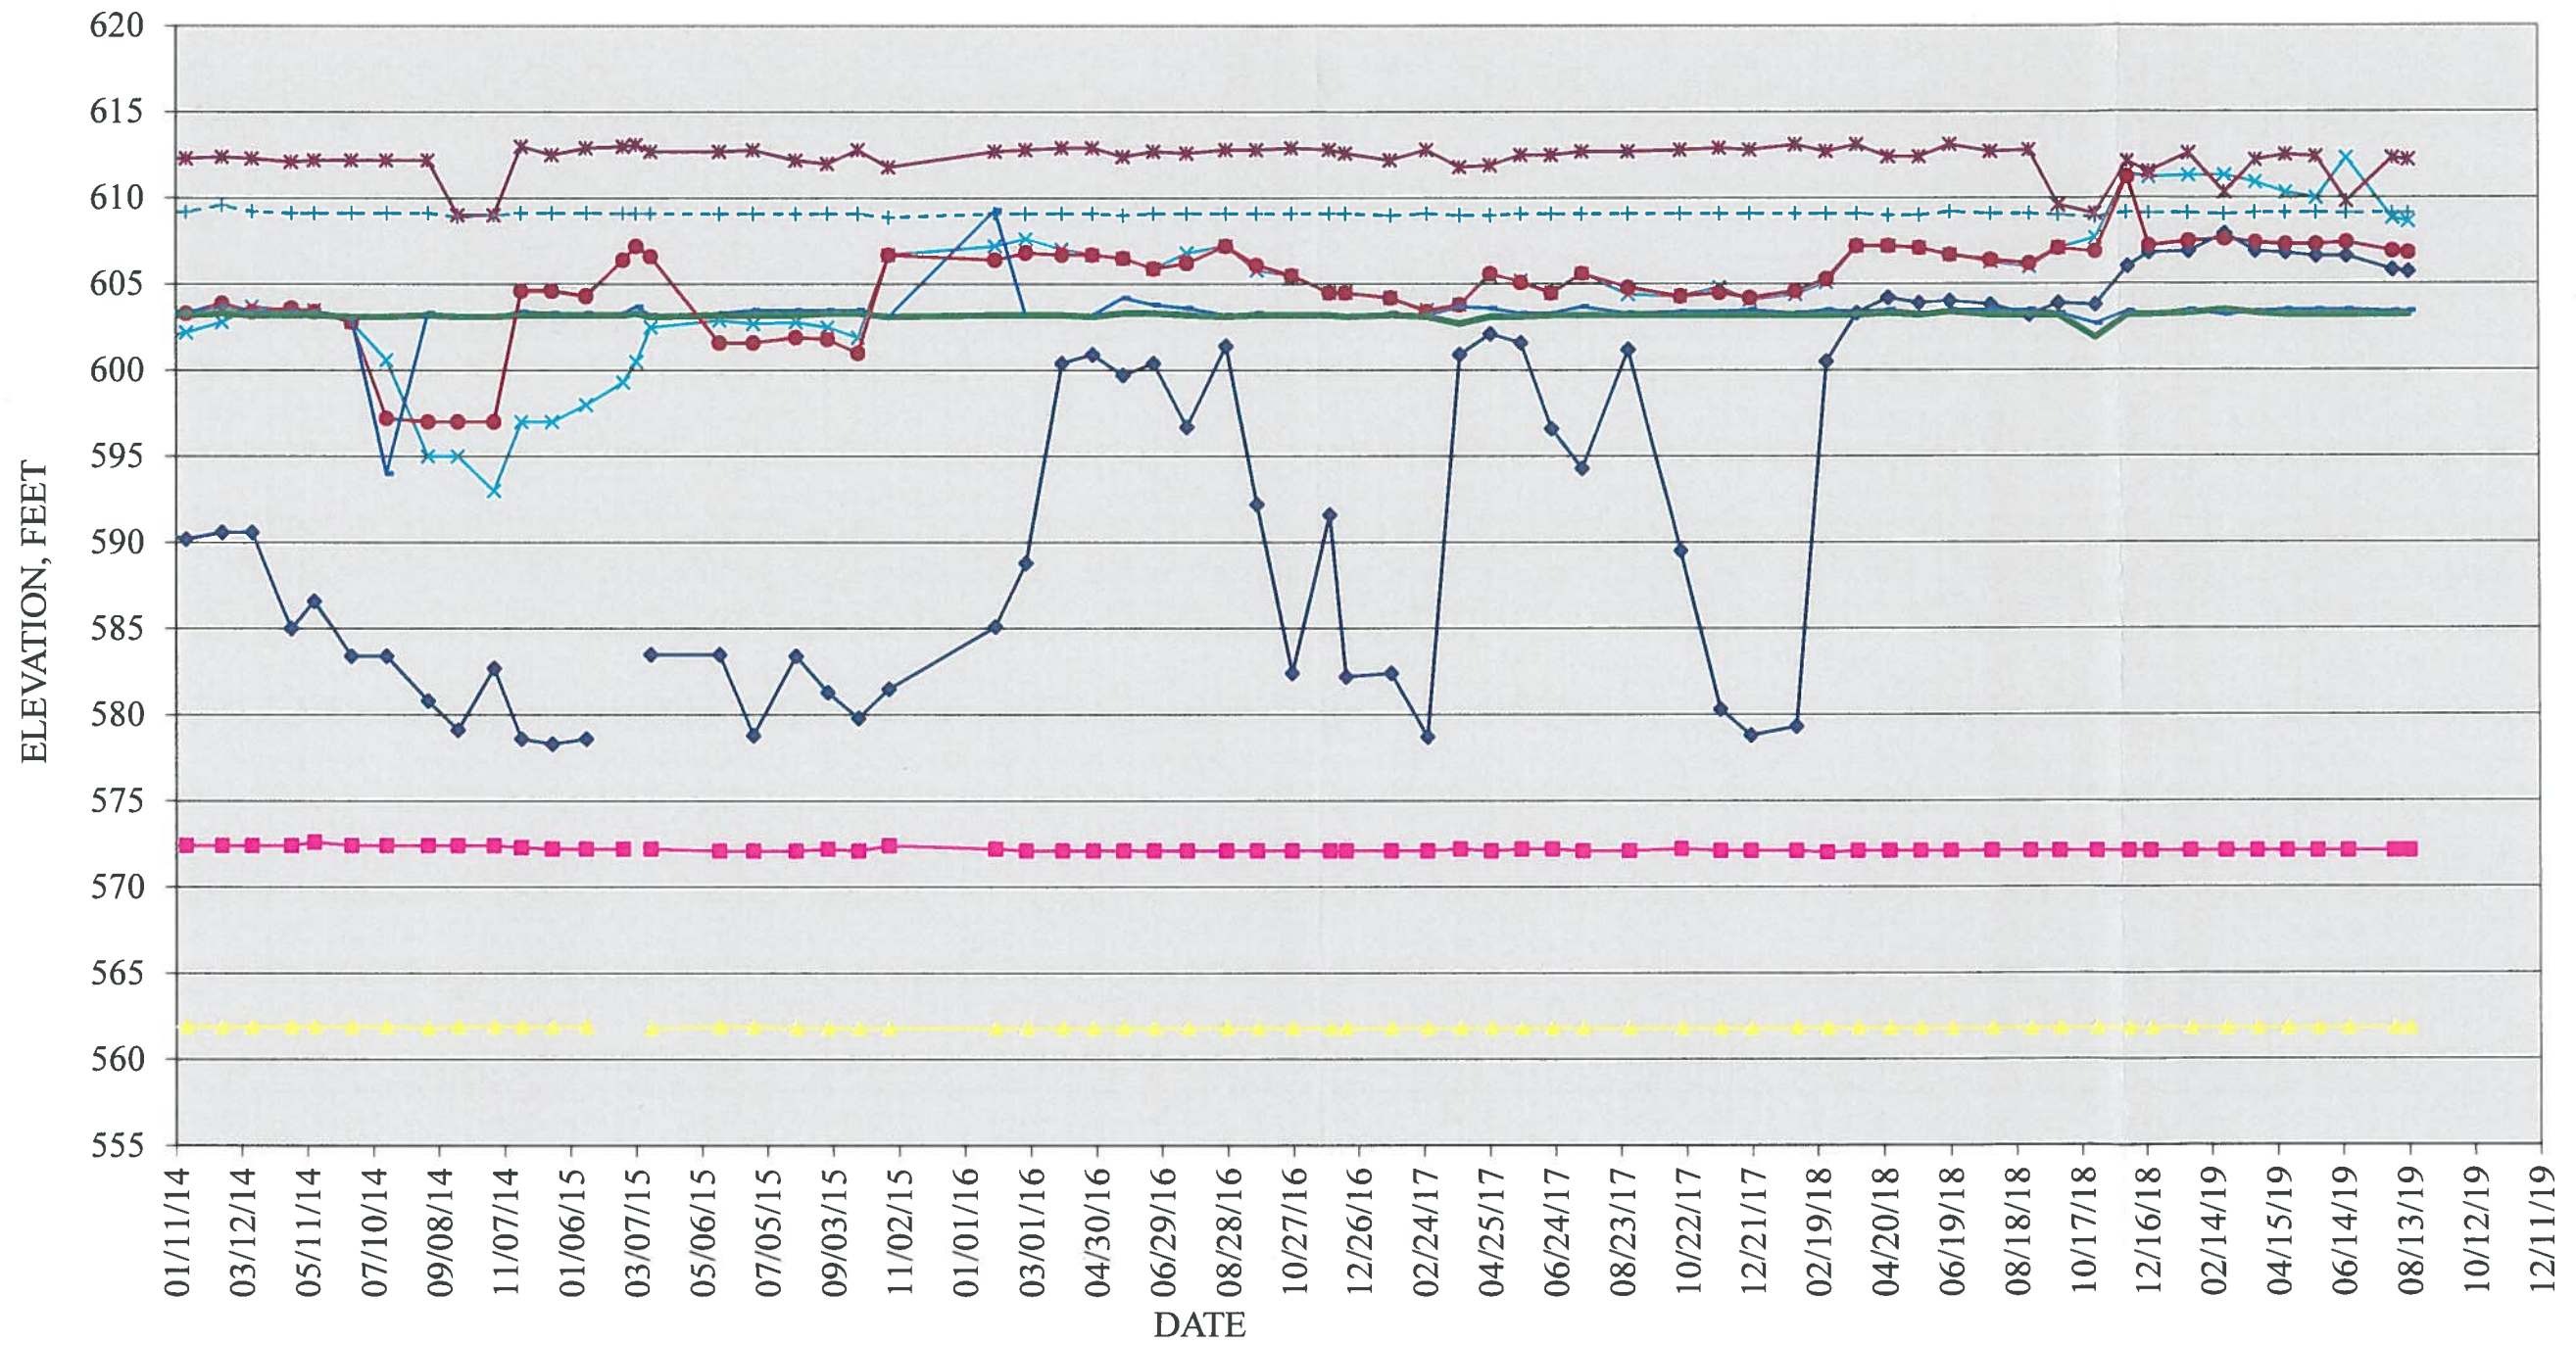
**FIGURE 5 - MOUNTAINEER BOTTOM ASH COMPLEX STATIC WATER LEVELS**

Piezometers PZ-09-04 and PZ-09-05 indicated no significant change in the static water levels from 2009 to present. Piezometer PZ-09-03, which is located at the crest of EBAP indicated significant fluctuation in the water level. In the last three years, the static water levels varied between 578.7-607.9 feet. This fluctuation is consistent with the water level changes in the EBAP. Even though the EBAP is out of service, the plant will periodically send process waters to the EBAP dramatically affecting the water levels.

(iii) Piezometer PZ-09-03 shall be flushed and continue to be used in monitoring and the data be reviewed for further corrective action.
