# 2019 ANNUAL CCR LANDFILL INSPECTION REPORT

**Ash Landfill**

**Welsh Plant  
American Electric Power Service Corporation  
(SWEPCO)  
Cason, Texas**

Document Number: GERS-19-034

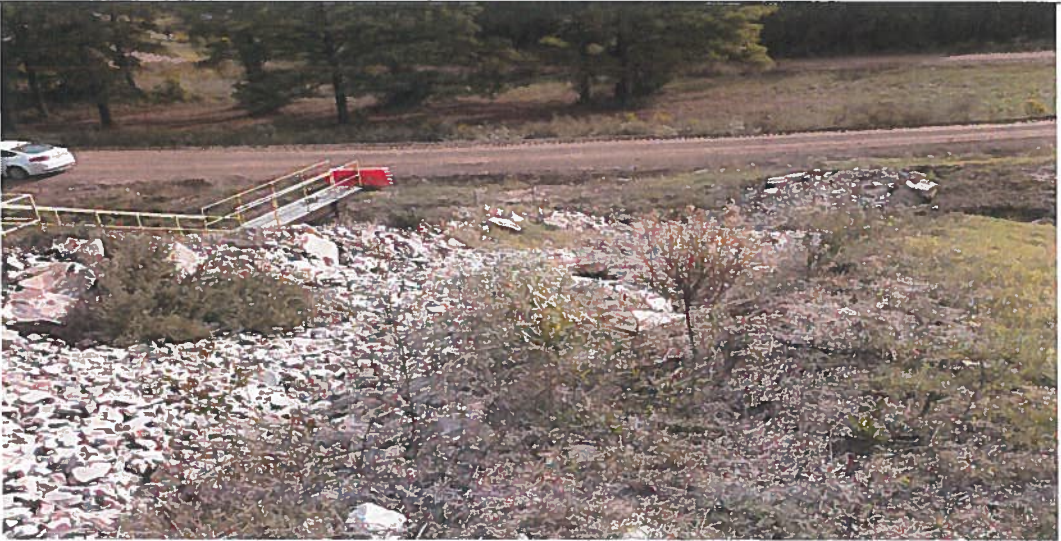
<p><u>Photo #1</u></p>

1. Photograph No. 1 illustrates the southeast corner of the landfill where the riprap lined letdown channel is located. The channel appeared in good functional condition. Some overgrown bushes and erosion of the surface cover (Photograph No. 1) were noticed.

- 1 The erosion of the cover soil over the clay cap at the southeast corner, east slope, and northeast corner should be repaired.
- 2 Positive drainage shall be maintained over the landfill and in the ditches and any water ponding issue should be fixed by regrading or backfilling the areas.
- 3 Vegetation growth on the newly capped and covered slopes is good, but several areas had excessive vegetation that needs to be cut down or mowed and managed properly

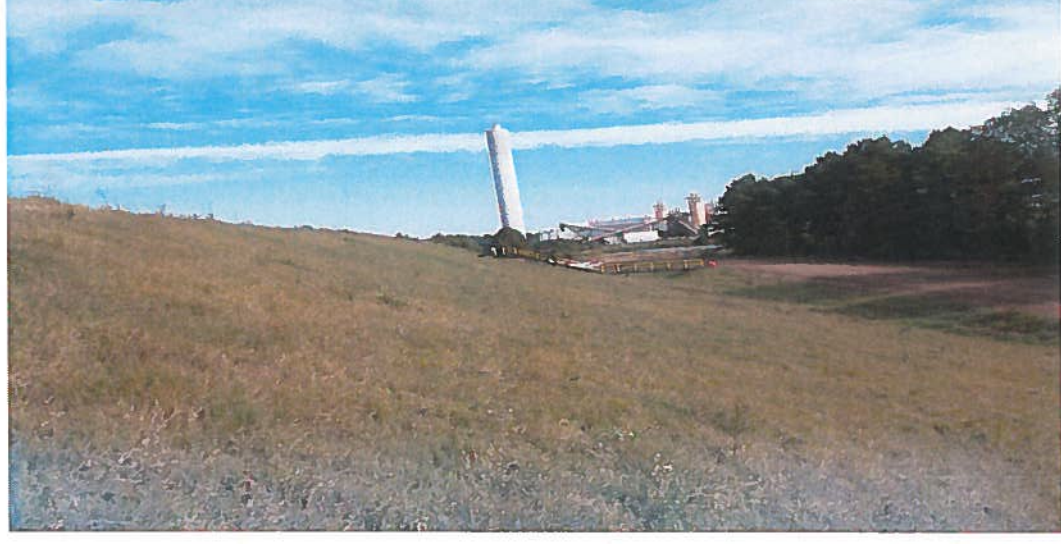
<p><u>Photo #3</u></p>

2. The east slope of the landfill and the toe ditch is illustrated in Photographs No. 3 and 4. The slope appeared in good condition with no signs of seepage, erosion, or sloughing. The toe ditch at the time of inspection appeared mostly dry. An area of the toe ditch below the access walkway on the northern end had standing water (Photograph No. 4). Minor surface erosion was noticed in the clay cap at the northern end (Photograph No. 5). Significant erosion was noticed at the area adjacent to the letdown channel in the northeast corner (Photograph No. 6). Eroded soil from the slope appeared to have washed out and accumulated in the toe ditch. The bottom section of the letdown channel is lined with concrete with energy dissipater blocks.

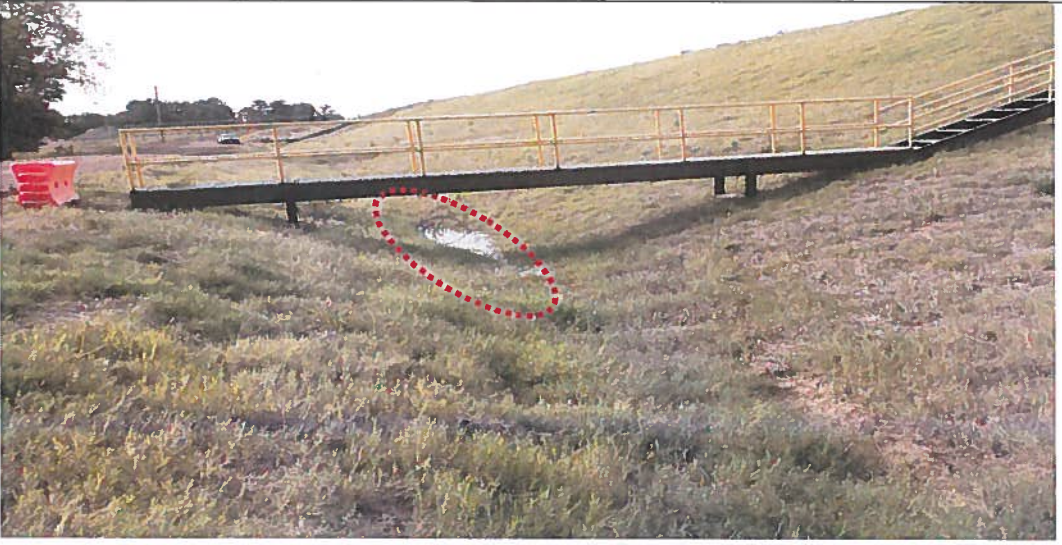
<p><u>Photo #4</u></p> <p>Typical condition of the east slope of the landfill (looking south).</p>

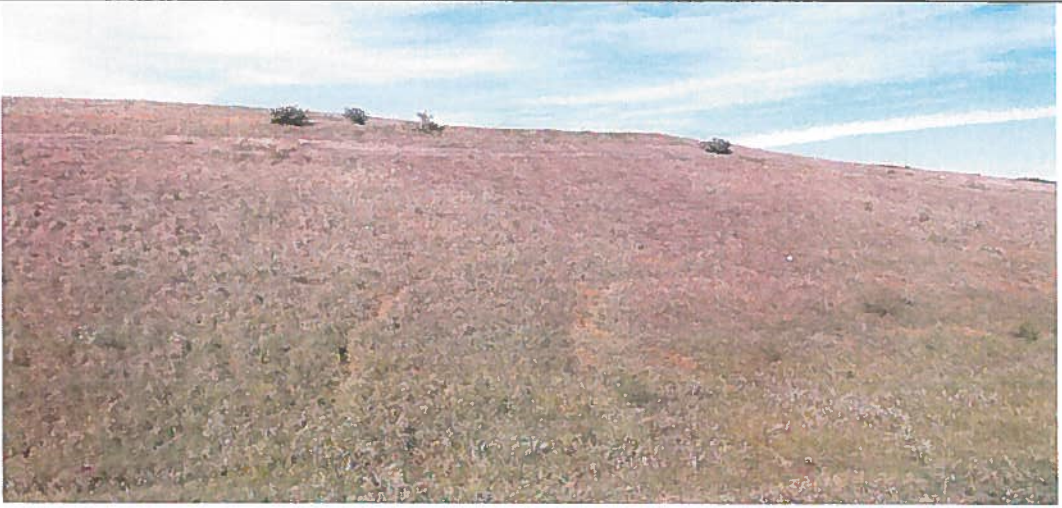
A photograph showing a grassy slope of a landfill. A metal walkway with railings runs across the slope. A small, shallow pond is visible in the grass, circled with a red dotted line. A red plastic barrier is on the left.
<p><u>Photo #5</u></p> <p>Typical condition of the northern section of the east slope of the landfill.</p>

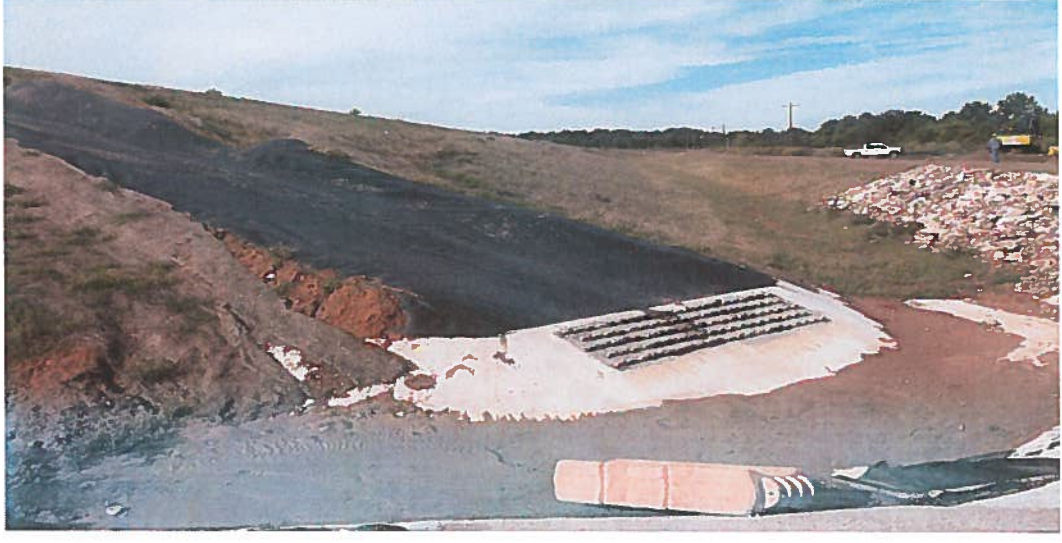
A wide-angle photograph of a grassy slope. The grass is a mix of green and brown. The sky is blue with some light clouds.
<p><u>Photo #6</u></p> <p><i>The channel in the northeast corner.</i></p>

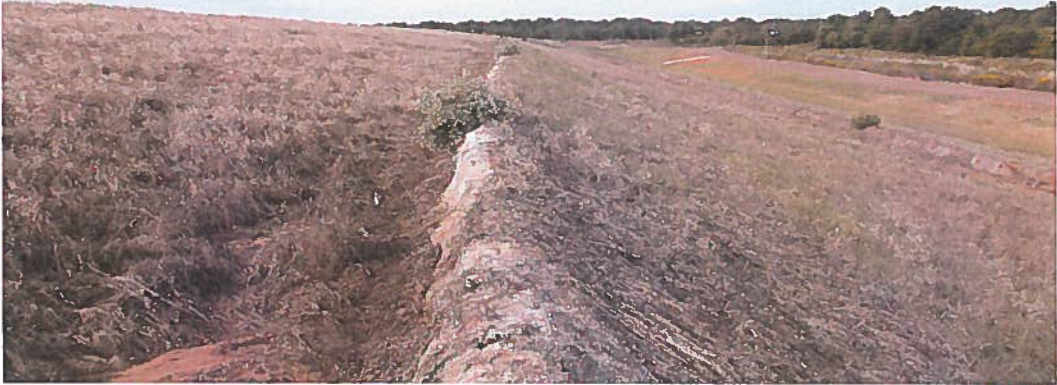
3. Photographs No. 7-9 illustrate the outer slopes at the north side of the landfill. The cover soil over the clay cap at the outer slopes shows some erosion gullies, soft areas, and uneven surface.

<p><u>Photo #7</u></p>	
<p>Typical condition of the north slope (looking west).</p>

- The cover soil over the clay cap at the north slope of the landfill indicated minor erosion gullies and soft surface. This slope should be monitor on a regular basis and its condition should be recorded in the monthly inspection report. Contact AEP-Geotechnical Engineering immediately if the clay cap condition deteriorate any further potentially exposing waste material underneath.

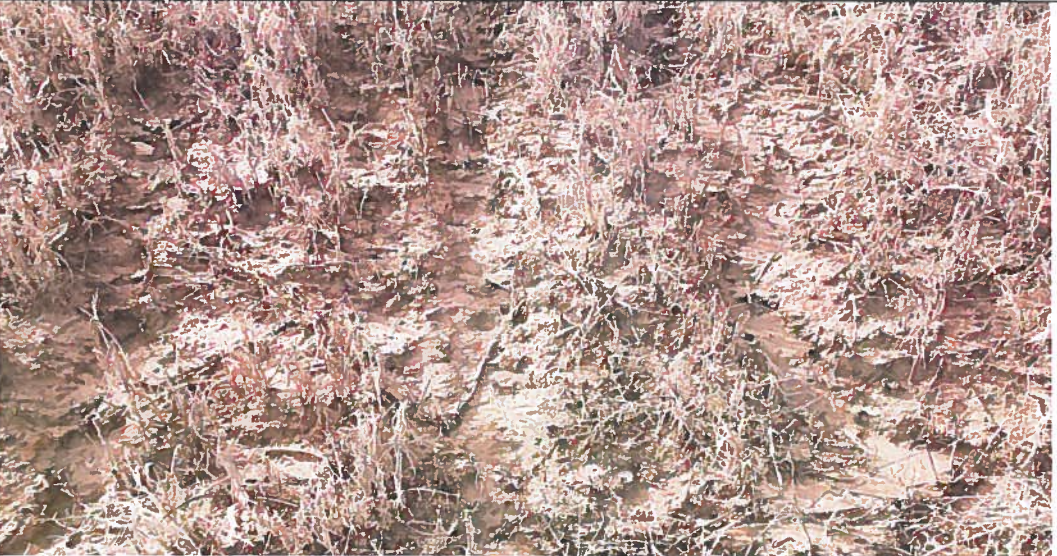
<p><u>Photo #8</u></p>	
<p>Close up view of the soft surface.</p>

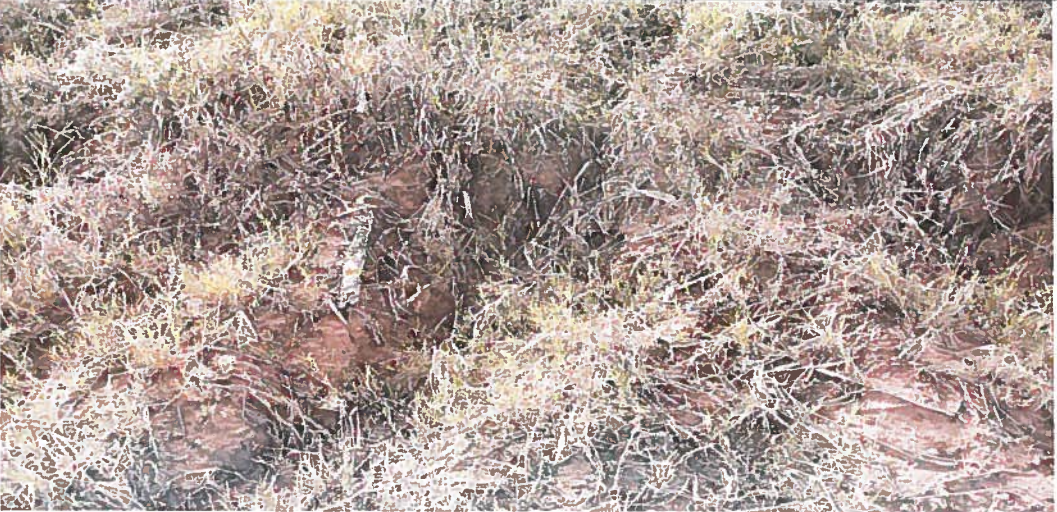
<p><u>Photo #9</u></p>	
<p>Surface erosion of the cover soil over the clay cap.</p>

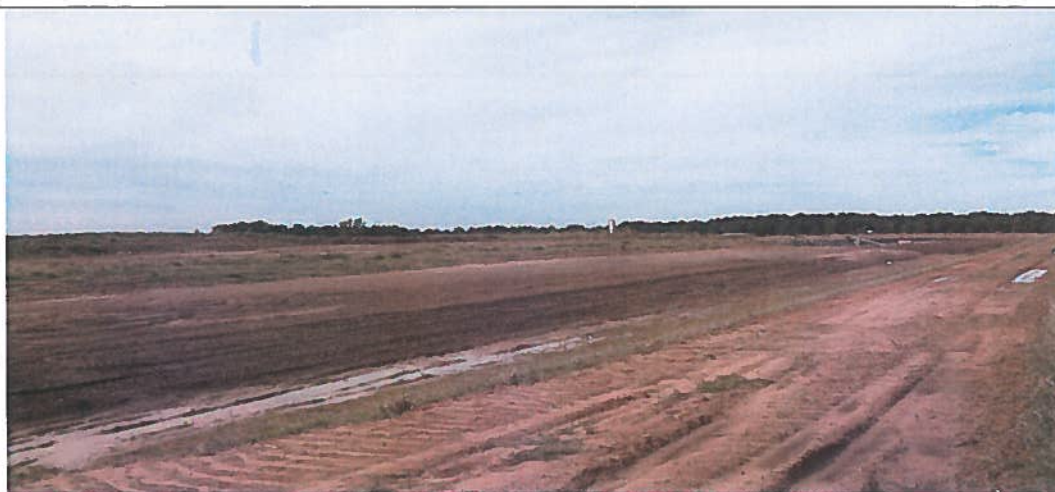
Photo #10

4. Photographs No. 10-12 illustrate the overall view of the top of the landfill. The eastern one-third of the area (Photograph No. 10) used for waste placement and rest of the western two-third of the area is used for processing waste materials (Photographs No. 11 and 12). The landfill waste placement and material processing appeared to have been performed properly and did not show any impact to the components of the landfill. An area to the northwest appeared to have standing water.

General view of the top of the landfill (looking southwest).

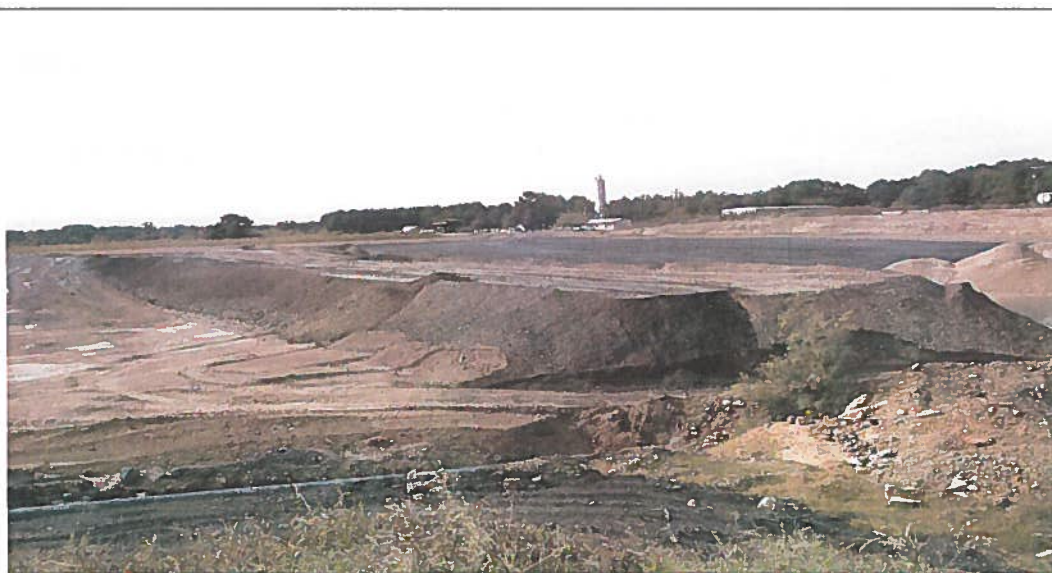
Photo #11

Another view of the top of the landfill (looking northeast).

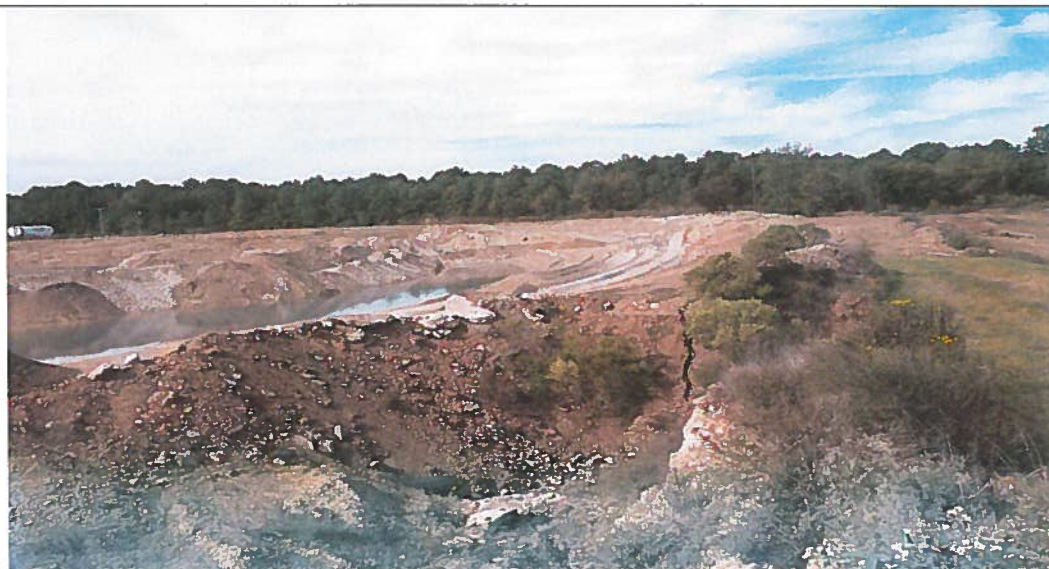
Photo #12

Ponding water noticed in the northwest area.

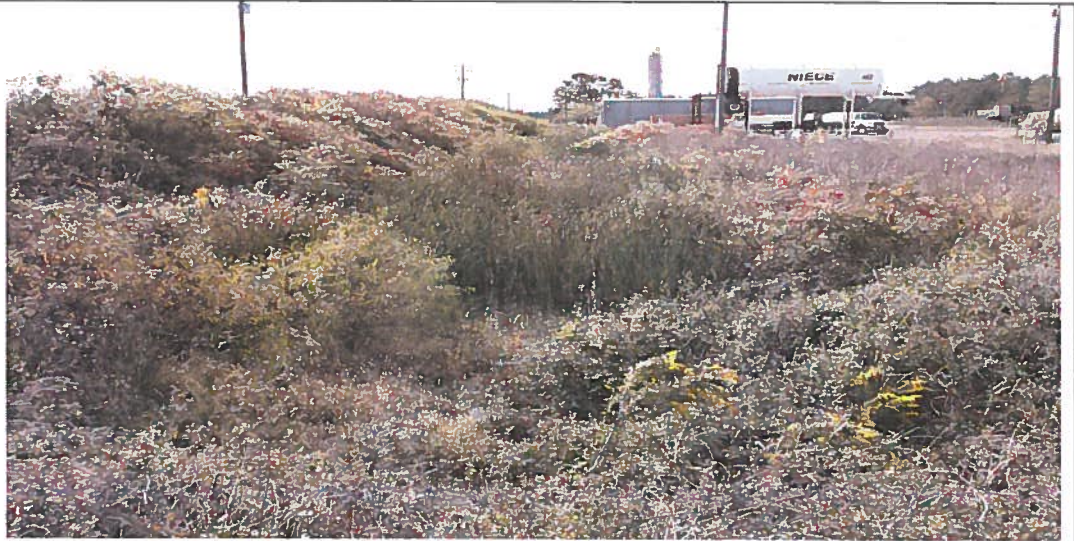
Photo #13

5. The outer slopes of the western berm of the landfill was partially constructed of temporary soil cover and CCR material and have sparse vegetation cover. Photographs No. 13 and 14 illustrate the condition of the exterior slope and toe ditch. The outer

slopes appeared to be in satisfactory and functioning condition with no signs of seepage, erosion or sloughing. Excessive vegetation was noticed on the slope and in the toe ditch. The pipe culvert installed in the toe ditch was found covered with vegetation and standing water.

Typical condition of the west slope.

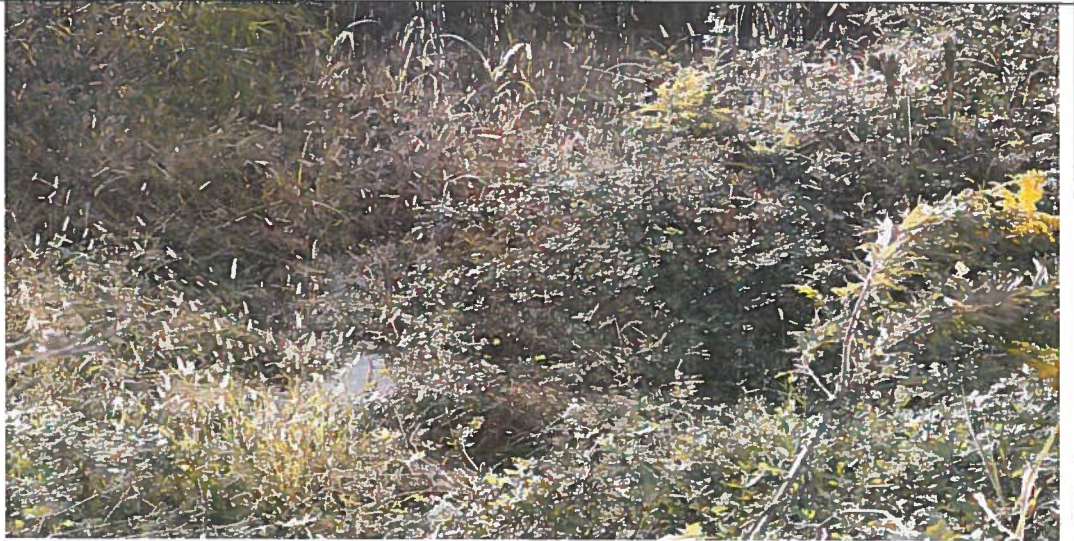
Photo #14

Close up view of the toe ditch.
