**MT LBR Landfill Deficiency Corrective Measure Report
for
Area 7 Leachate Collection System High TSS Levels**

**Appalachian Power Company
Little Broad Run Landfill
Mountaineer Plant
New Haven, WV**

August 2020

Document ID: GERS-19-056

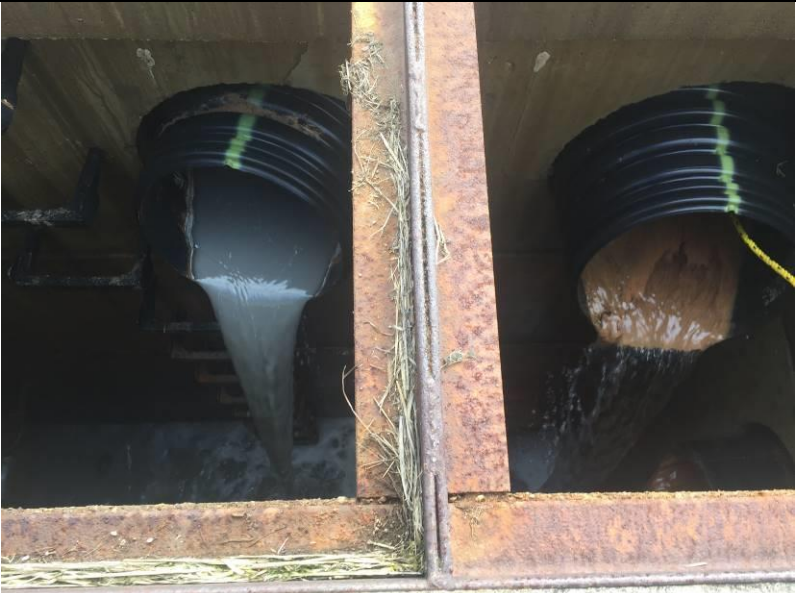
Photo # 1

The deficiency was first identified on March 20, 2019 during a 7-day landfill operational inspection. Plant personnel noted that there were high levels of TSS in the Area 7 Leachate Collection Lines at Manhole #1. The source location of ash had not been determined. Video inspection of the lower leachate piping was originally scheduled for March 22, 2019. Photos of the area are included in Appendix B. TSS levels in the leachate water were 6600 ppm or 0.6 % of leachate volume in the lower leachate collection system. The area was monitored daily until video inspections began on March 28, 2019.

This photograph illustrates Landfill Area 7 leachate lines at Man Hole #1.

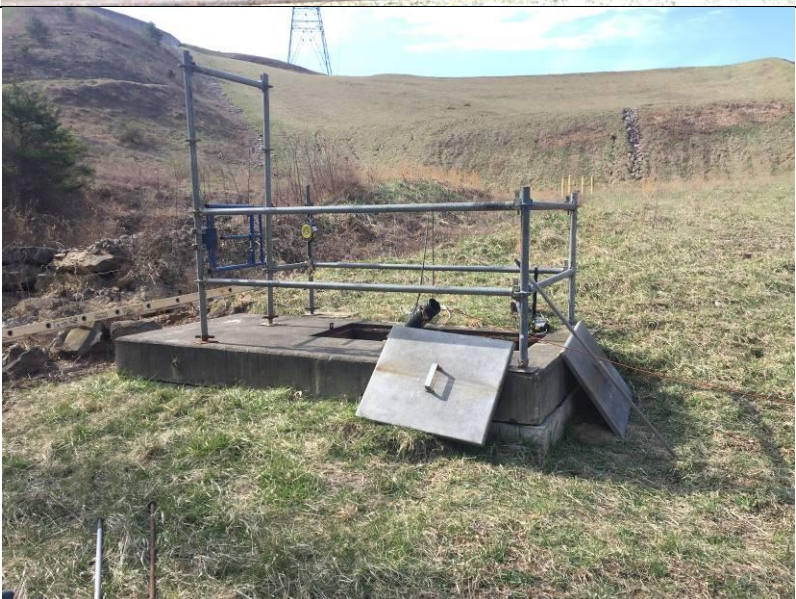
Photo # 2

Area 7 Leachate Collection system Man Hole #1 Area.

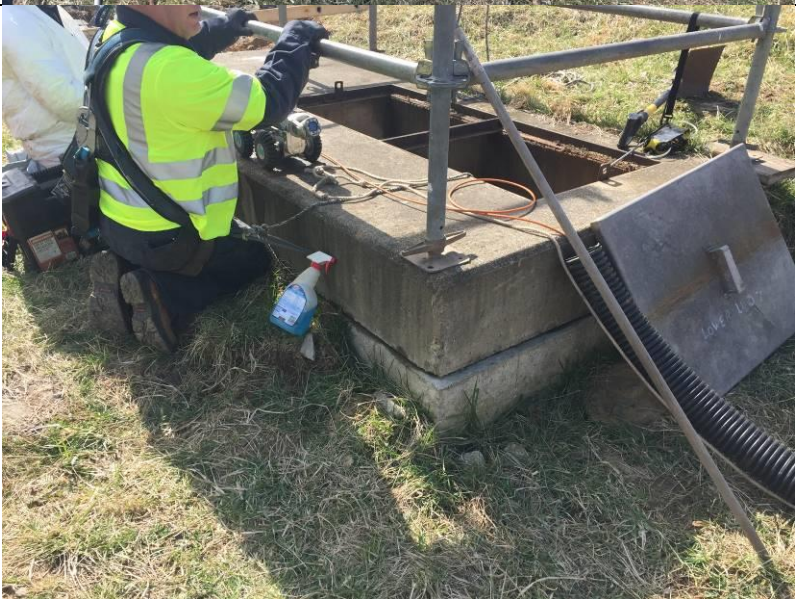
Photo # 3

Camera Crew Preparing for Video Inspection.

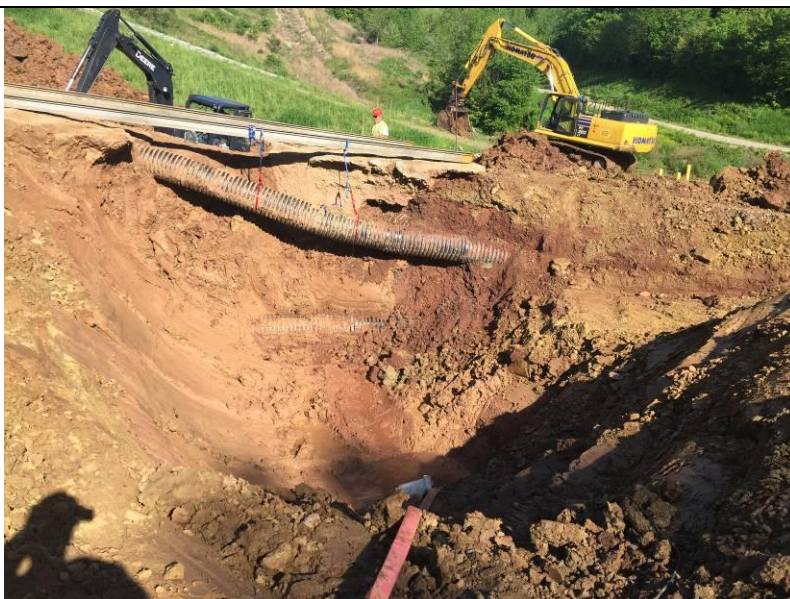
Photo # 4

Excavation Activities to access the leachate pipes outside of Area 7.

During April, R.B. Jergens excavated down to the lower leachate pipes.

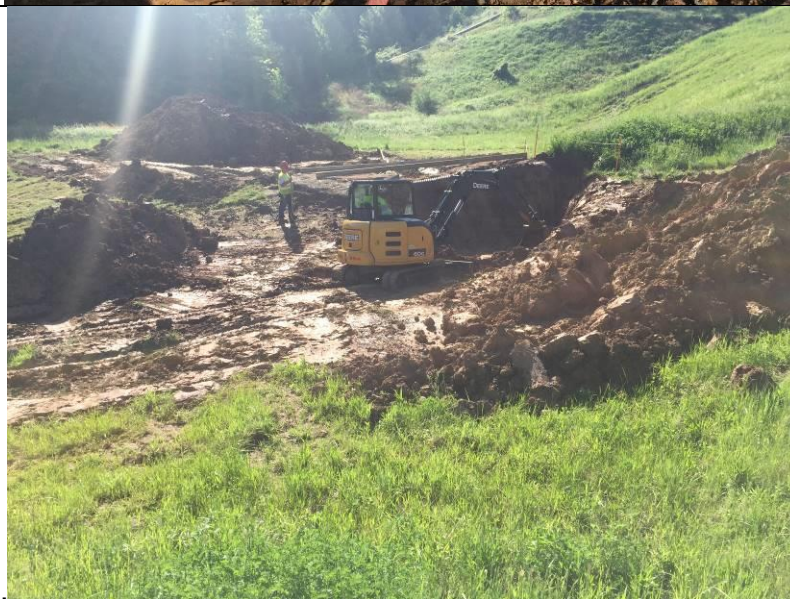
Photo # 5

Excavation Activities to access the leachate pipes outside of Area 7.

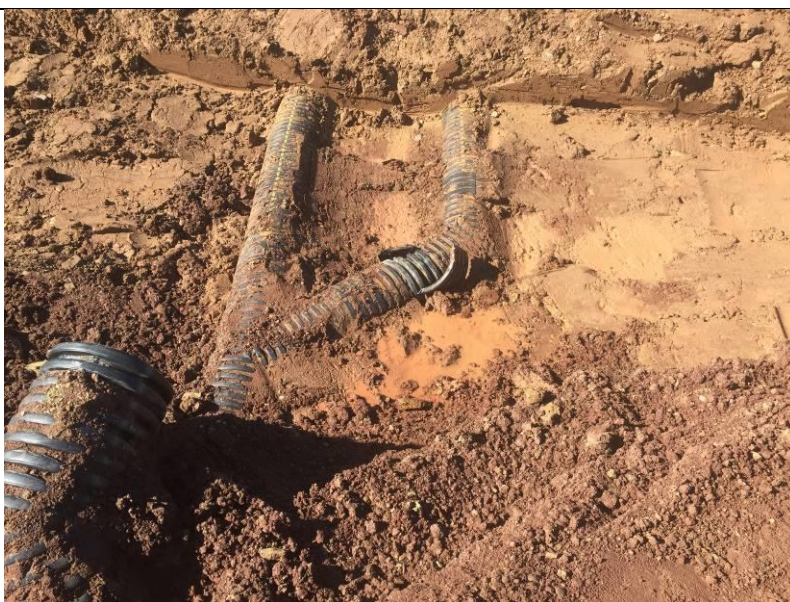
Photo # 6

View of the Wye Connection for the Lower Leachate Lines.

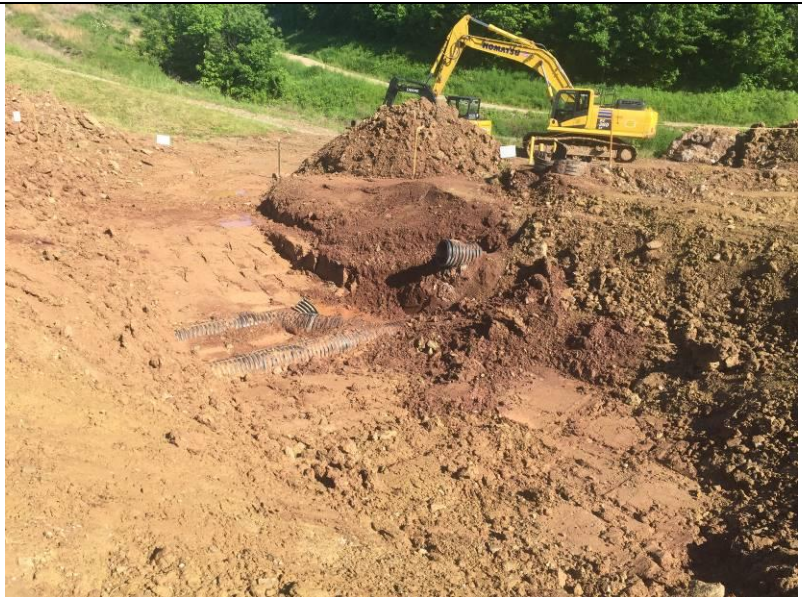
Photo # 7

View of the Upper and Lower Leachate Lines Exposed.

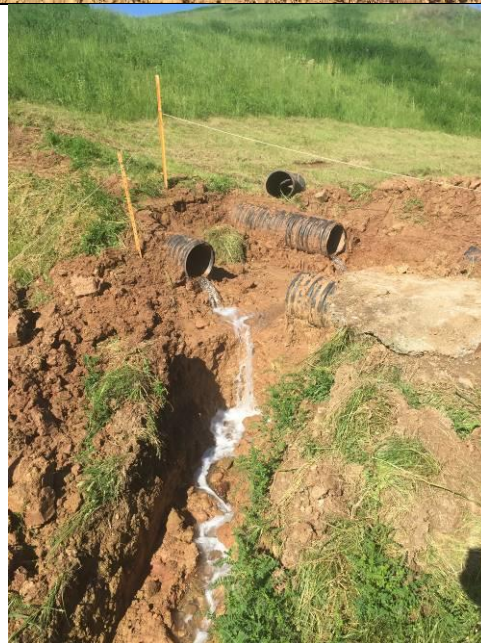
Photo # 8

Overall View of Upper Leachate Lines Before the Wye Connector.

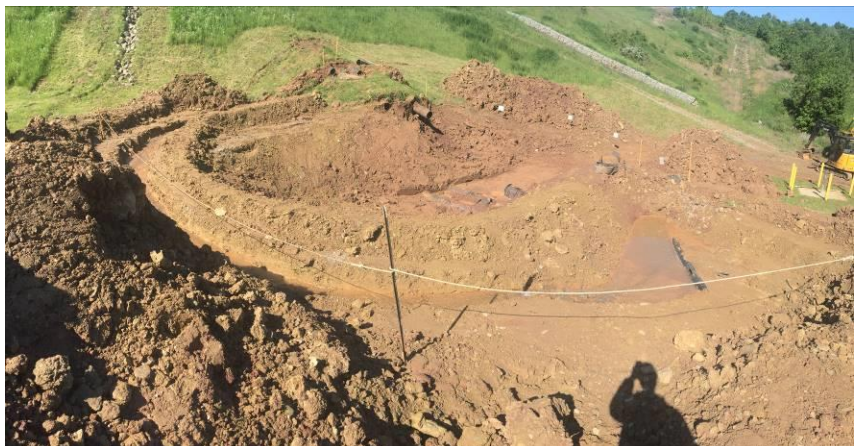
Photo # 9

Overview of Bypass Ditches for the open Leachate Lines.

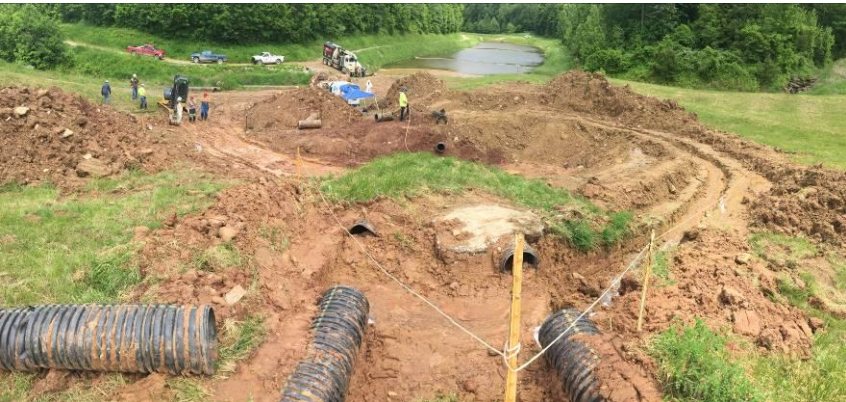
Photo # 10

Overall view of the Bypass Ditches for the Leachate Lines.

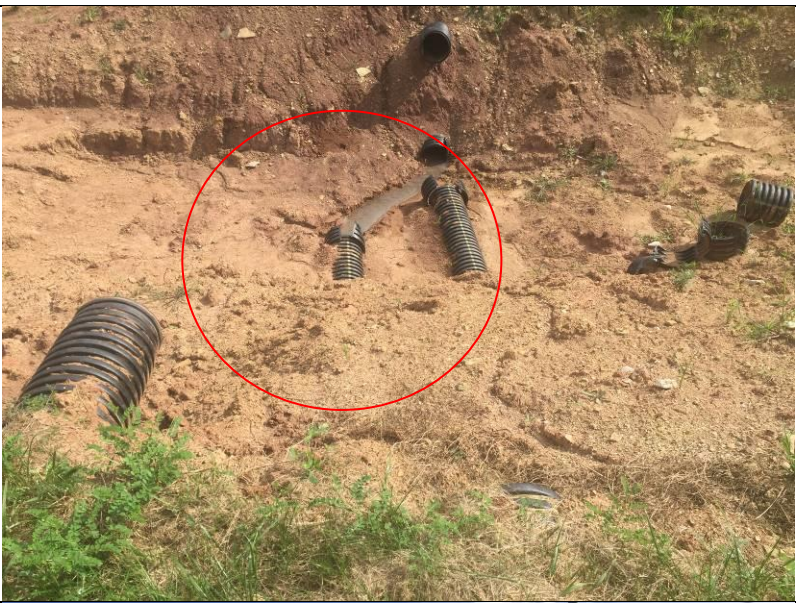
Photo # 11

Overview View of the Lower Leachate Lines.

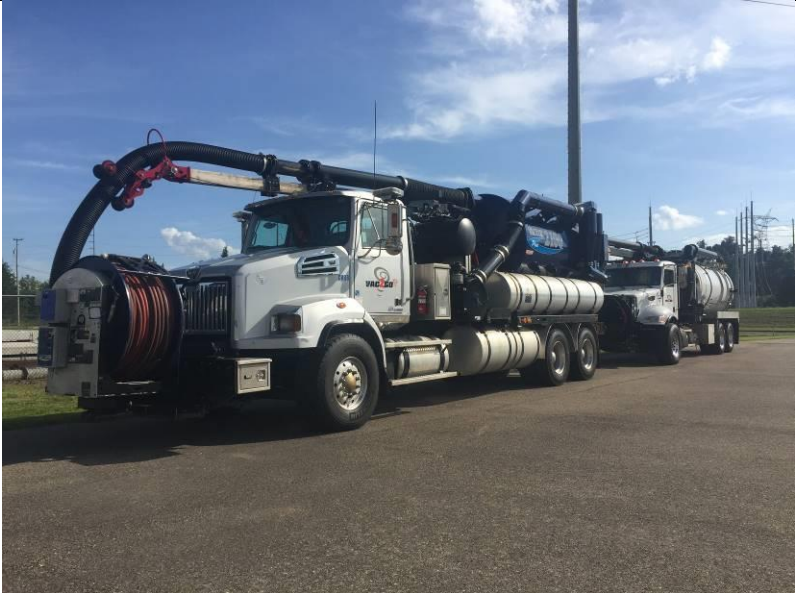
Photo # 12

View of the Hydro Vac Truck with Jetting Hose.

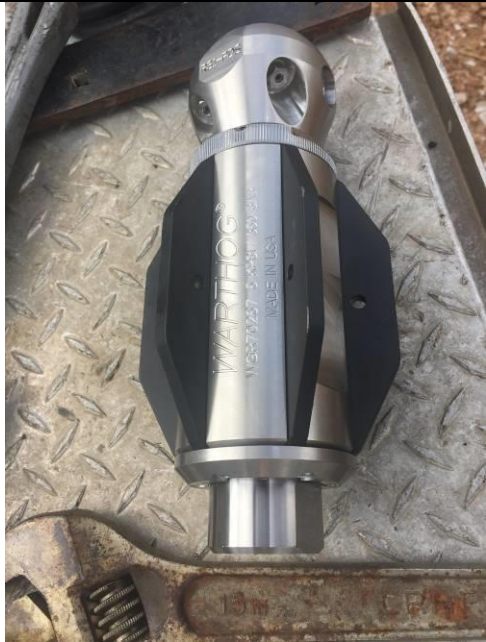
Photo # 13

View of the Water Jet Tool for Jetting Activities.

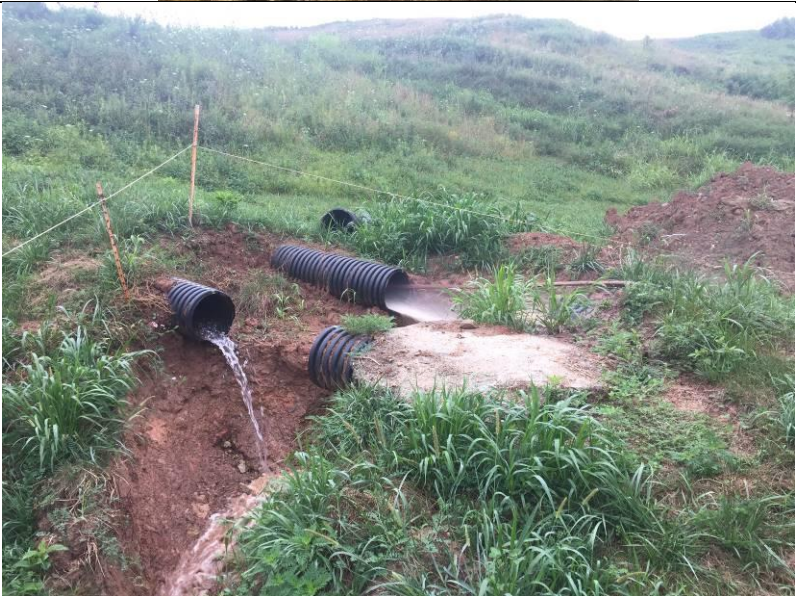
Photo # 14

Overview of Jetting Activities.

On July 19, 2019 MPW mobilized to water jet the Area 7 upper and lower leachate lines. They were able to clean and inspect several hundred feet of each of the four pipes (2-lower and 2-upper).

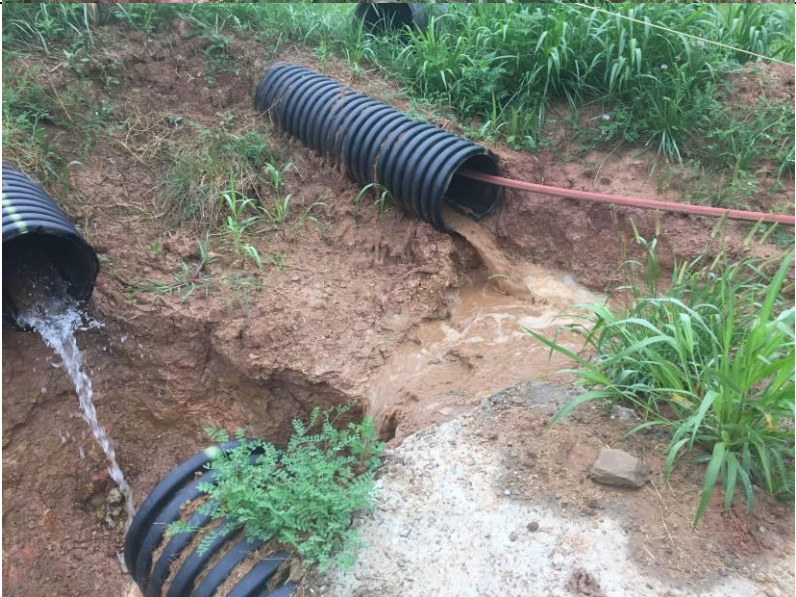
Photo # 15

Overview of Jetting Activities.

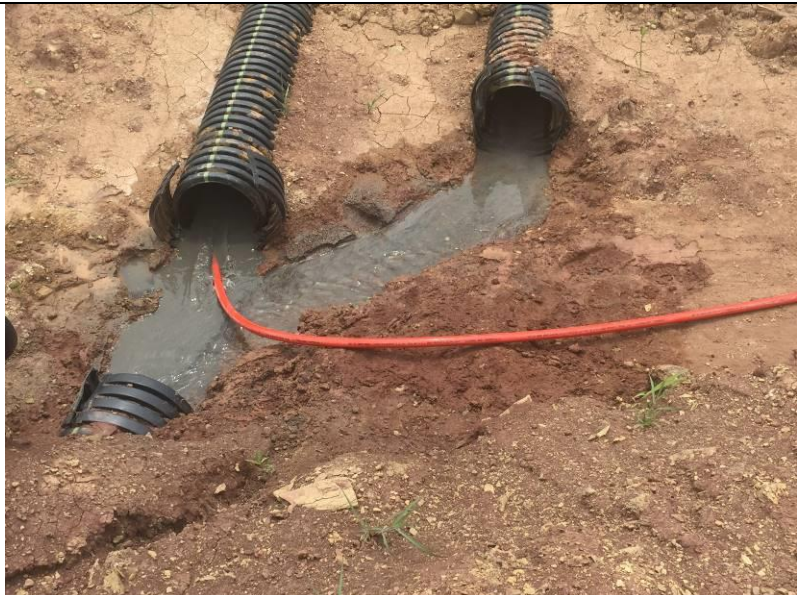
Photo # 16

Overview of Jetting Activities.

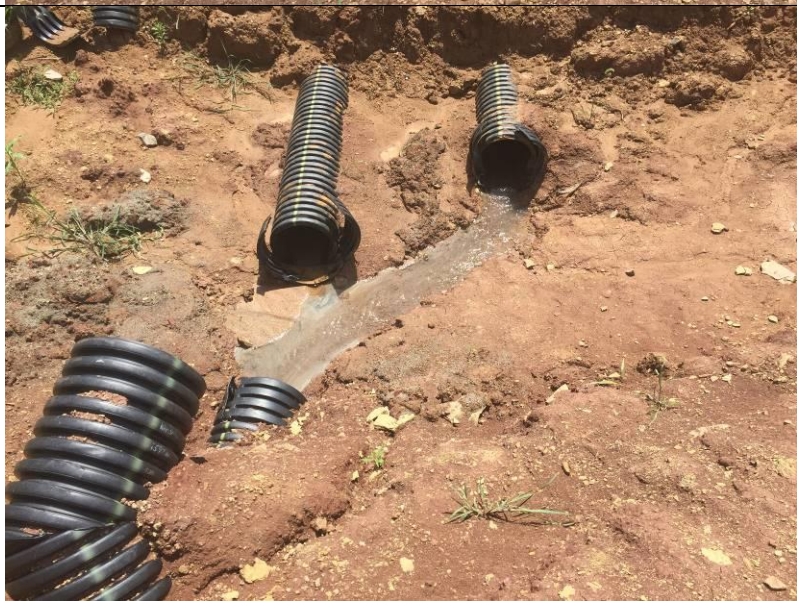
Photo # 17

On the same day (July 19, 2019) the pipes were inspected by video to check for sediment build up. All of the loose ash was removed from the pipes where water jetting activities occurred and the leachate water started to clear up. On August 14, 2019, the leachate water TSS levels were normal, the leachate lines were fitted with clean out portals and the area was backfilled around the pipes, regraded, seeded and mulched.

Overview of Lechate Flow After Jetting Activities.

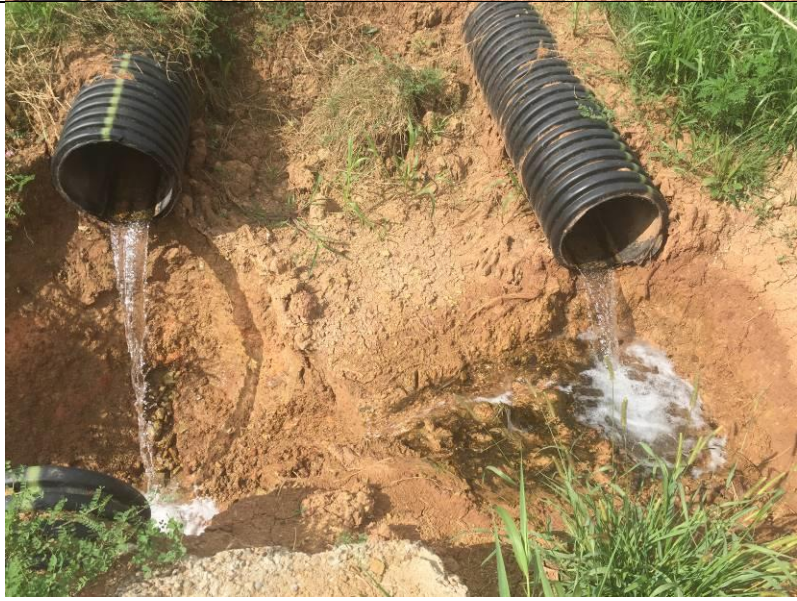
Photo # 18

Overview of Lechate Flow After Jetting Activities.

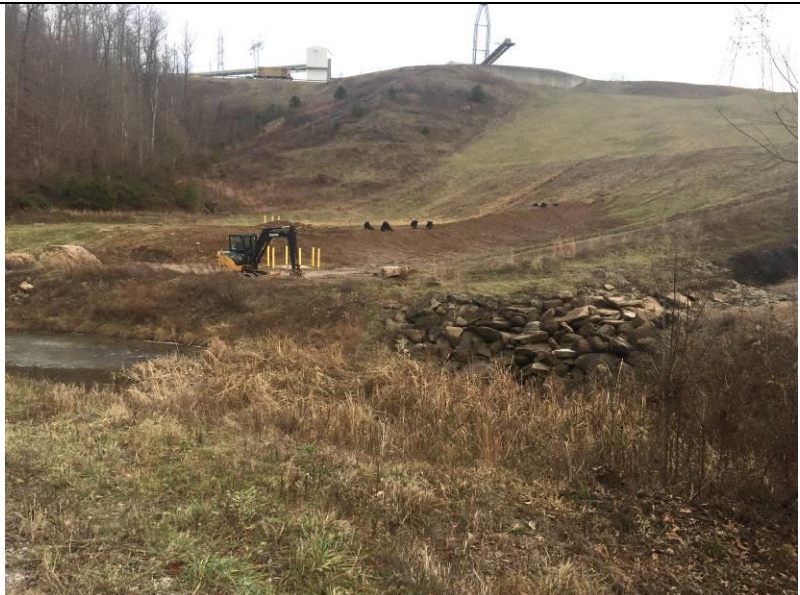
Photo # 19

Overview of side slop area after leachate line were re-connected, buried and graded.
