# **2020 Annual Dam and Dike Inspection Report**

**Bottom Ash Pond Complex**

**Mitchell Plant**

**Document ID: GERS-20-027**

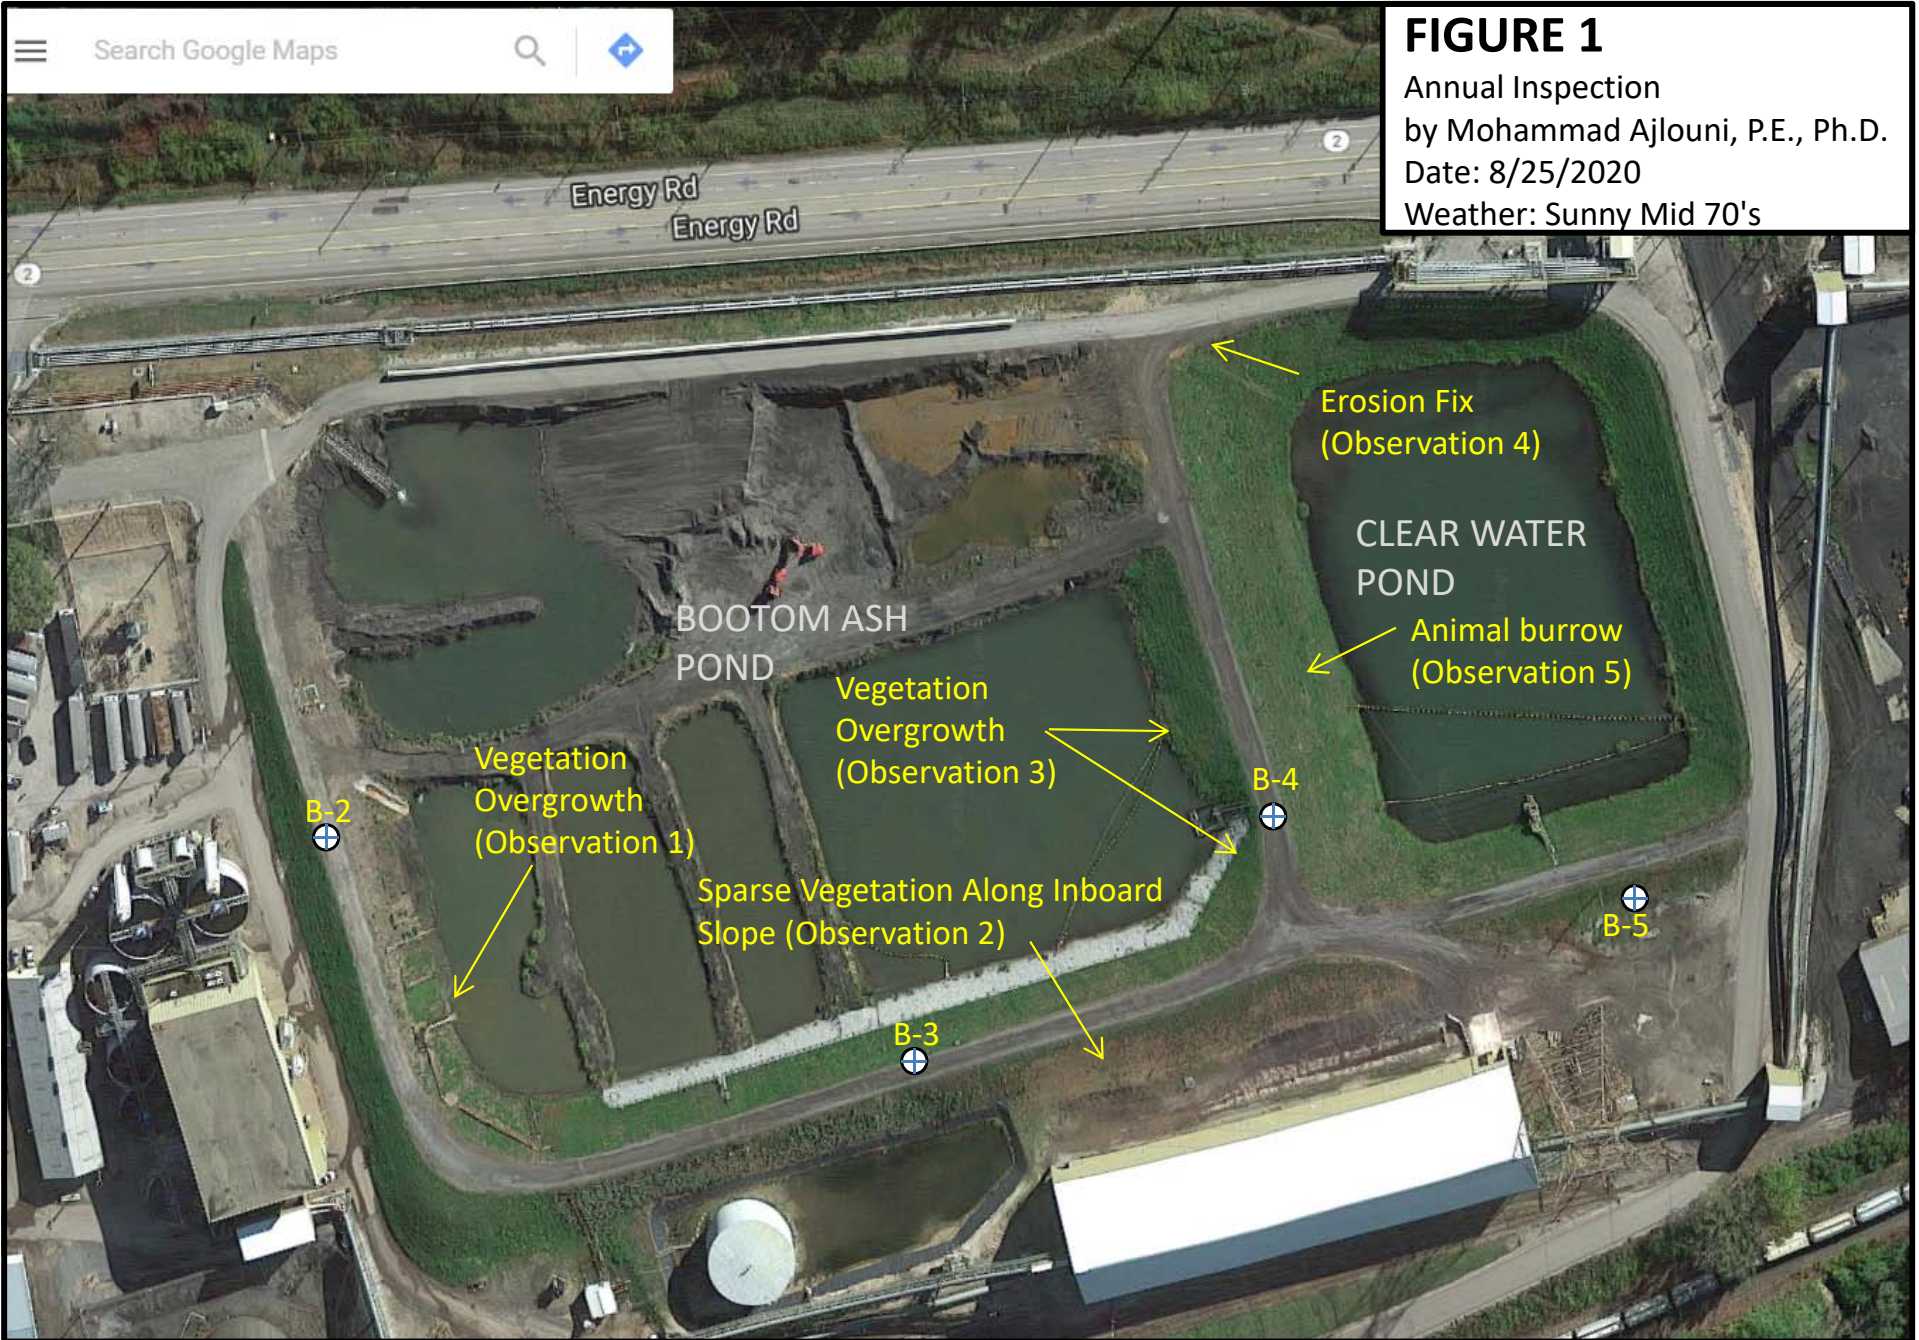
# FIGURE 1

Erosion Fix  
(Observation 4)

Animal burrow  
(Observation 5)

Vegetation  
Overgrowth  
(Observation 1)

Vegetation  
Overgrowth  
(Observation 3)

Sparse Vegetation Along Inboard  
Slope (Observation 2)

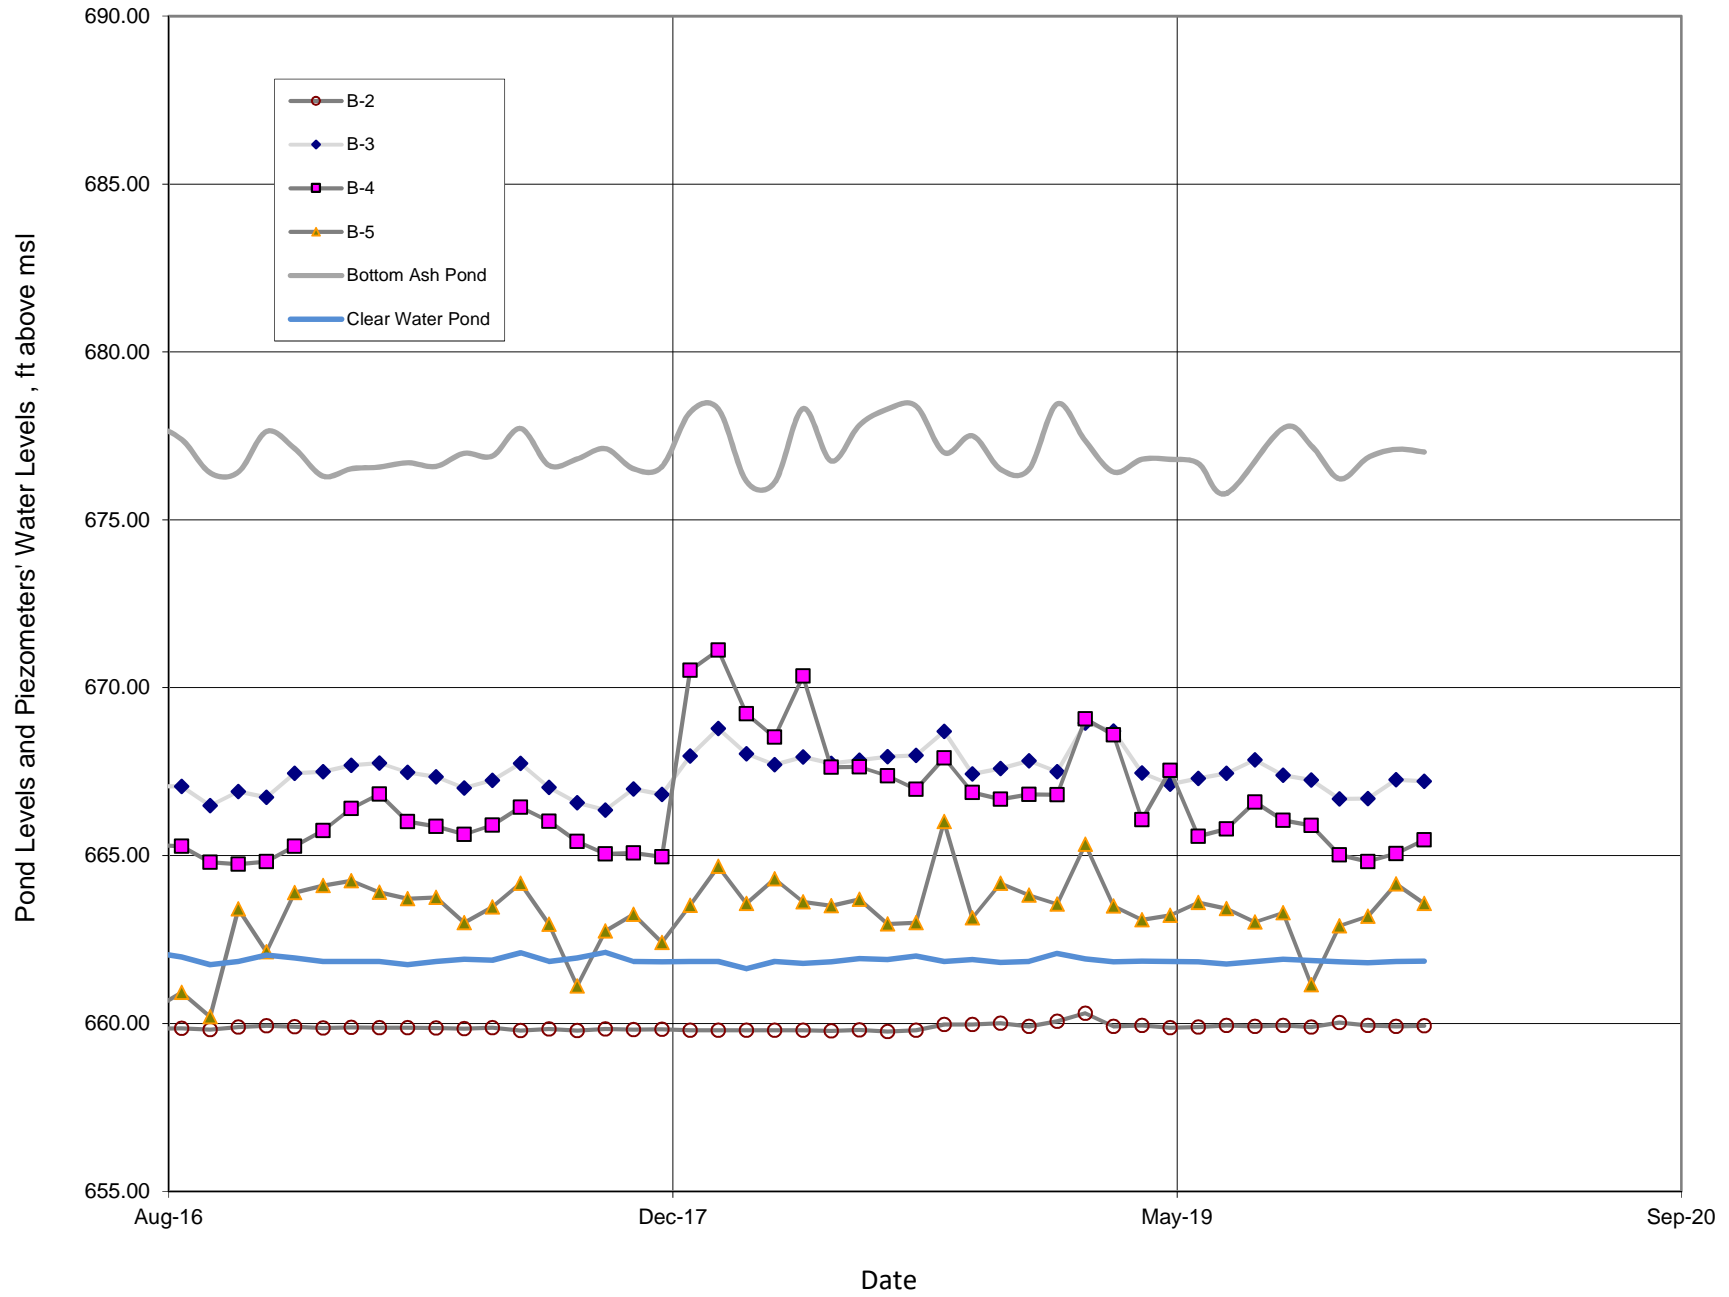
Figure 2 Bottom Ash Pond Complex Piezometers' & Ponds Level

Figure 2 presents the pond water levels as well as the piezometers water levels and rain fall record. Changes in piezometers levels correlate to the bottom ash pond level and to the rain fall intensity except for B-2 located to the north of the pond complex which appears to be dry.

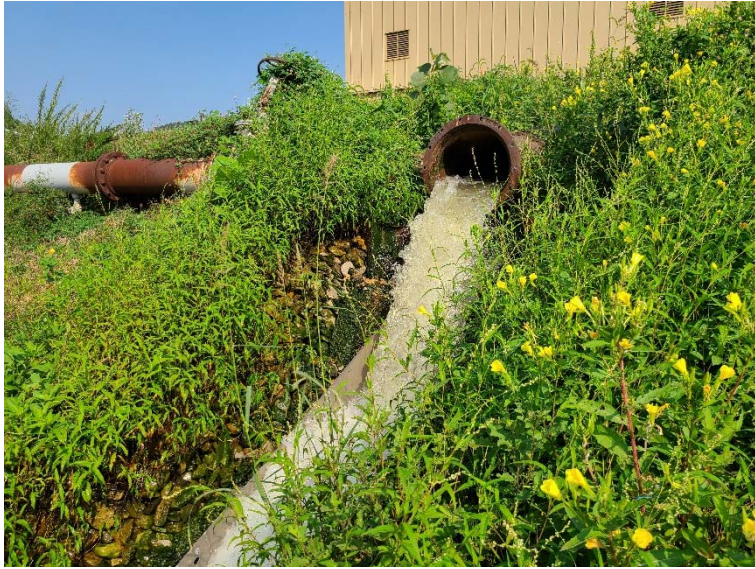
**Photo No. 1**

Observation 1: Overgrown Vegetation

Location: North inboard slope of Bottom Ash Pond

- 1) Continue vegetation growth control in the vicinity of pipes and other structures by weed eaters or sprays (Observation 1 and 3).
- 2) Seed and mulch areas on the outboard slope of the Bottom Ash Pond by replacement of soil and re-seed. (Observation 2).
- 3) Continue monitoring and control of animal activities in both ponds (Observation 5).

Recommendations: Repair by Weed eaters or spray.

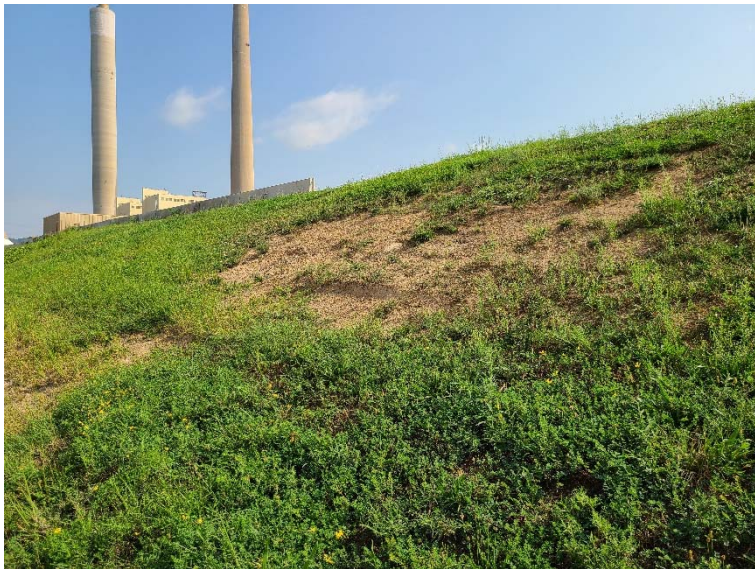
**Photo No. 2**

Observation 2: Sparse Vegetation

Location: West outboard slope of Clear Water Pond

Recommendations: Repair by Seed & Mulch.

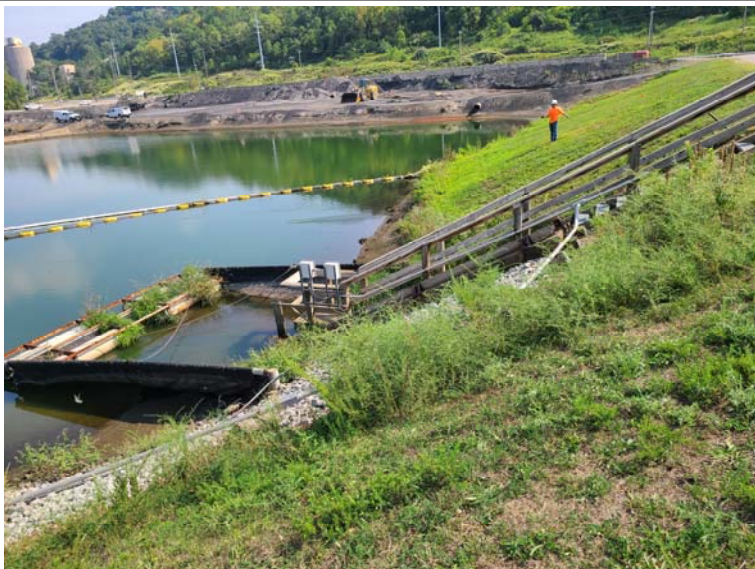
**Photo No. 3**

Observation 3: Overgrown Vegetation

Location: South inboard slope of Bottom Ash Pond

Recommendations: Repair by Weed eaters or spray

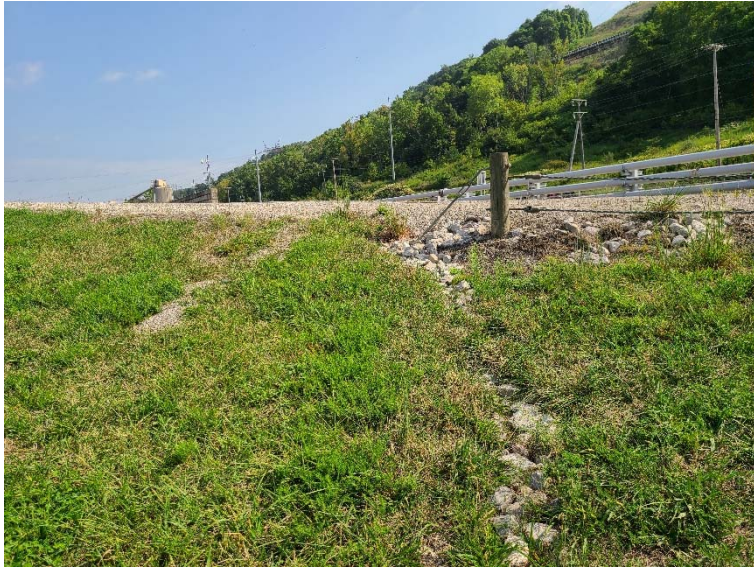
**Photo No. 4**

2. The interior slopes showed no signs of distress such as sloughing or bulges. The grass was recently mowed. The area of erosion observed during the last annual inspection at the northern east corner the pond was fixed by placing gravel and riprap (Observation 4).

Observation 4: Fixed Erosion area.

Location: North East Corner inboard slope of Clear Water Pond

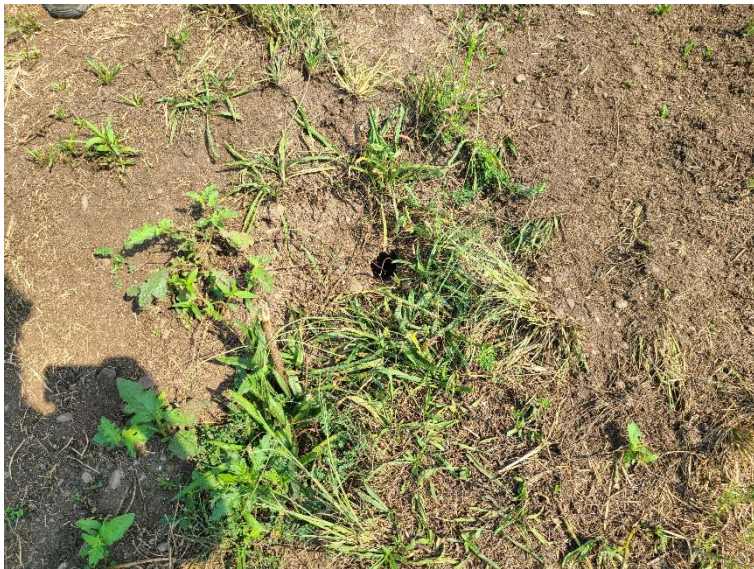
**Photo No. 5**

3. Animal activity was observed at the northern interior slopes (Observation 5).
4. The splitter dike separating the Clear Water Pond and BAP appeared to be in good condition and showed no signs of distress.

Observation 5: Burrow Hole

Location: North inboard slope of Clear Water Pond

Recommendations: Repair by fill in with soil.
