**2020 DAM AND DIKE INSPECTION REPORT  
BOTTOM ASH COMPLEX  
(Facility ID #05307)**

**GERS-20-031**

**APPALACHIAN POWER COMPANY  
MOUNTAINEER PLANT  
NEW HAVEN, WEST VIRGINIA**

**INSPECTION DATE:** October 13, 2020

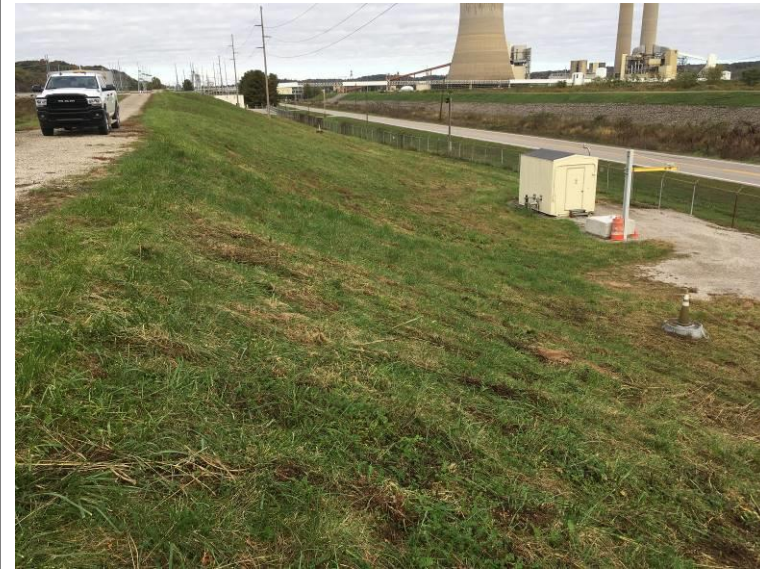
**Photo No. 1**

1. Photograph No. 1 illustrates the exterior slope conditions and Photograph No. 2 illustrate animal burrows located on the east downstream slope of the CWP. In general, the crest and downstream slope of the CWP were in satisfactory condition. The crest of this dike, also used as haul road, is partially seen in this photograph. The gravel base on the crest and vegetation cover on the slope appeared satisfactory. The existing sulfuric acid tanks are not in use for treatment and will be removed later based on comments by plant personnel. The access walkway to the overflow structures appeared safe and in fair condition.

Overview of East Exterior Slope of CWP. Generally Looking North

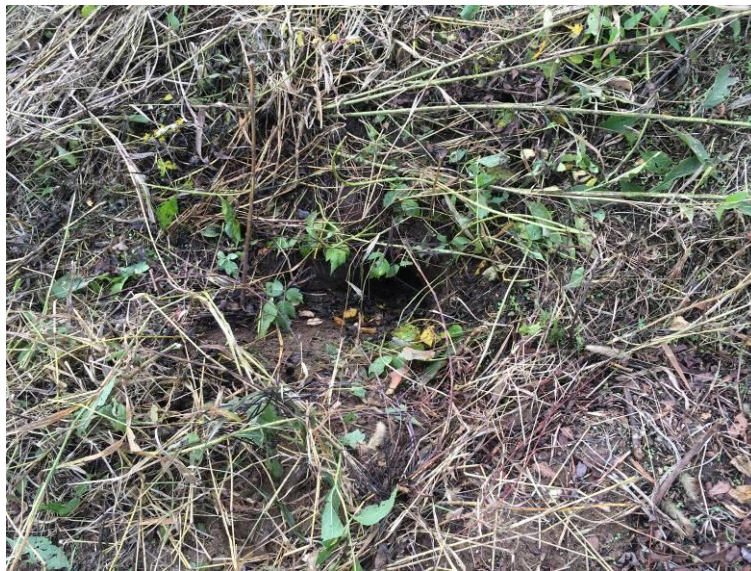
**Photo No. 2**

- (iii) The animal activity appears to be the same as in previous years and it is manageable as routine maintenance items. Excessive animal activities were not noticed during this inspection. Few animal holes were observed as noted in this report.

Typical View of Animal Burrows on East Exterior Slope of CWP.

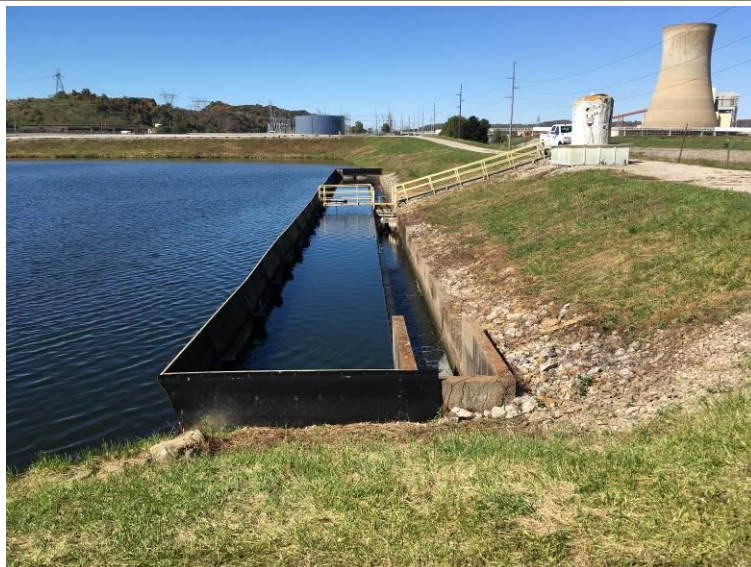
**Photo No. 3**

2. Photograph No. 3 illustrates the east dike upstream slope and the effluent flume structure of the CWP. The effluent structure was functioning as design. The lower sections of the upstream slope are protected by stone and the upper sections are covered by vegetation.

Overview of Clear Water Pond Effluent Flume and Weir Structure.

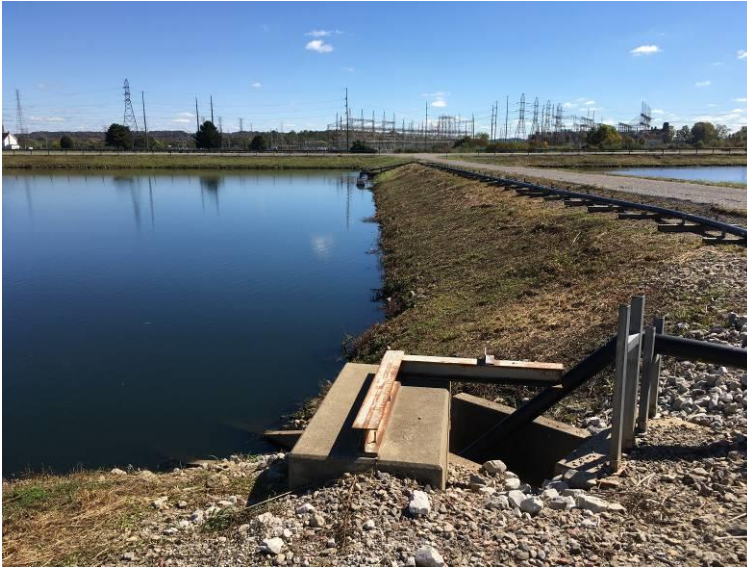
**Photo No. 4**

3. Photograph No. 4 illustrates the upstream slope of the western dike. This photograph also depicts the typical condition of the CWP interior slopes and the discharge culvert. The interior slopes appeared in satisfactory and stable conditions.

Overview of Clear Water Pond Interior Slope Conditions.

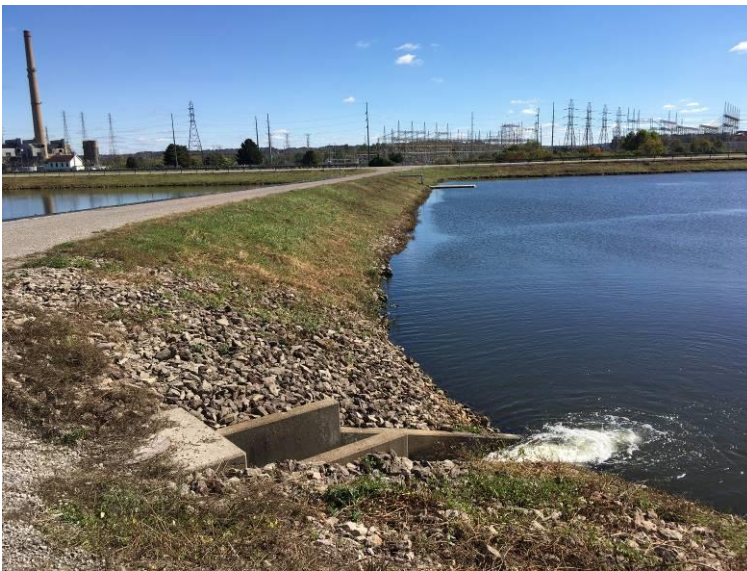
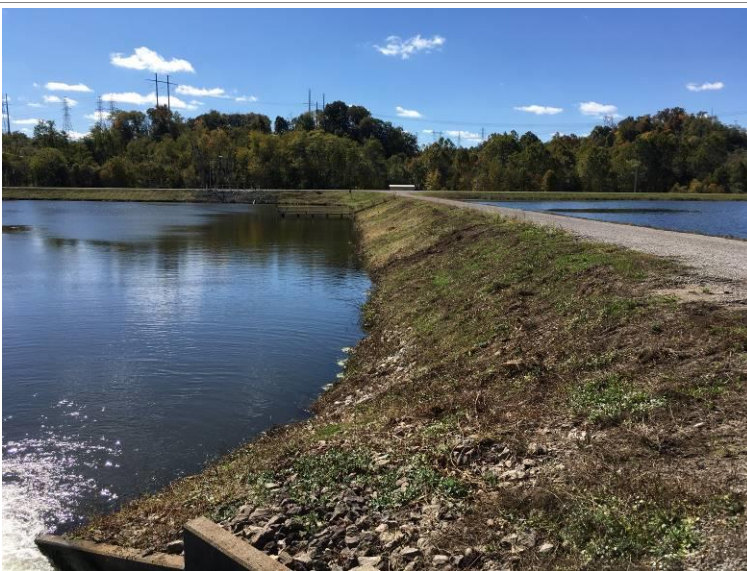
4. Typical interior dikes, crest and slopes of the RWP are depicted in Photographs No. 5 and No. 6. The stone material around the discharge culvert was in satisfactory condition. Overall, the interior dikes, crest and slopes of the CWP and RWP appeared to be in satisfactory condition with no signs of rutting misalignment or cracking.

Overview of Reclaim Pond Interior Slope Conditions and Discharge Culvert.

Overview of Reclaim Pond Interior Slope Conditions.

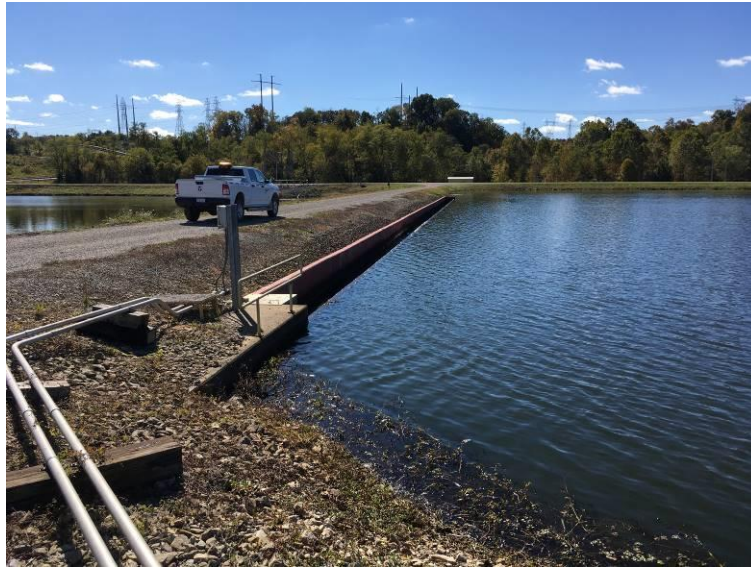
**Photo No. 7**

1. The WWP interior slope condition and effluent flume and concrete weir is shown in Photographs No. 7. This slope appeared to have intermittent grass

- cover, but some isolated areas were found to be bare. The flume and weir structure appeared to be in satisfactory and working condition.
2. The EWP interior slope condition and effluent flume and concrete weir is depicted in Photographs No. 8. This slope appeared to have intermittent grass cover, but some areas were found to be completely bare. The flume and weir structure appeared to be in satisfactory and working condition.

Typical Condition of West Waste Water Pond Effluent Flume and Weir.

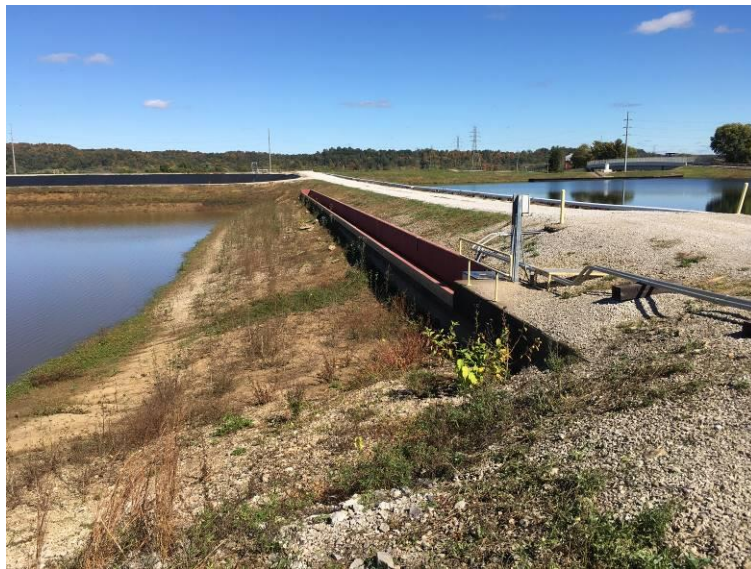
**Photo No. 8**

Typical Condition of East Waste Water Pond Interior Slope Conditions and Effluent Flume and Weir. East Waste Water Pond is Out of Service at Time of Inspection.

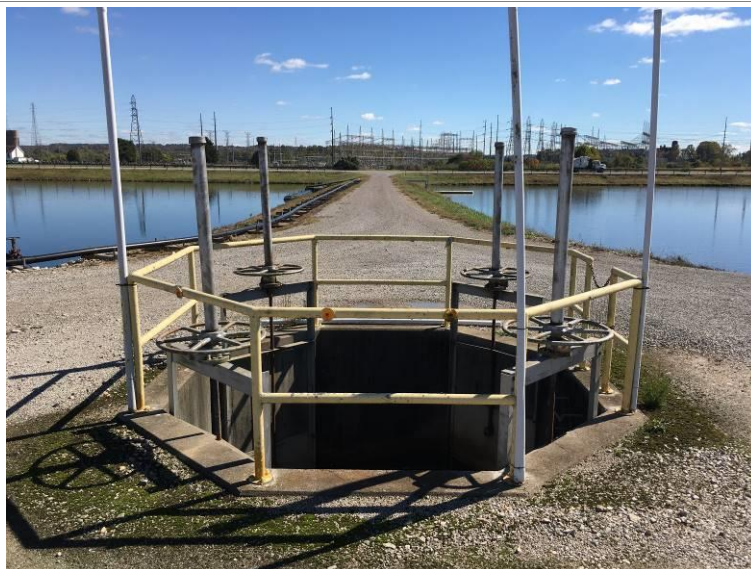
**Photo No. 9**

3. The main junction box between the wastewater ponds, reclaim pond and the clear water pond is shown in Photograph No. 9. In general, the main junction box was in satisfactory condition and appeared to be in functioning condition.

Main Junction Box Between Wastewater Ponds and Reclaim/Clear Water Ponds.

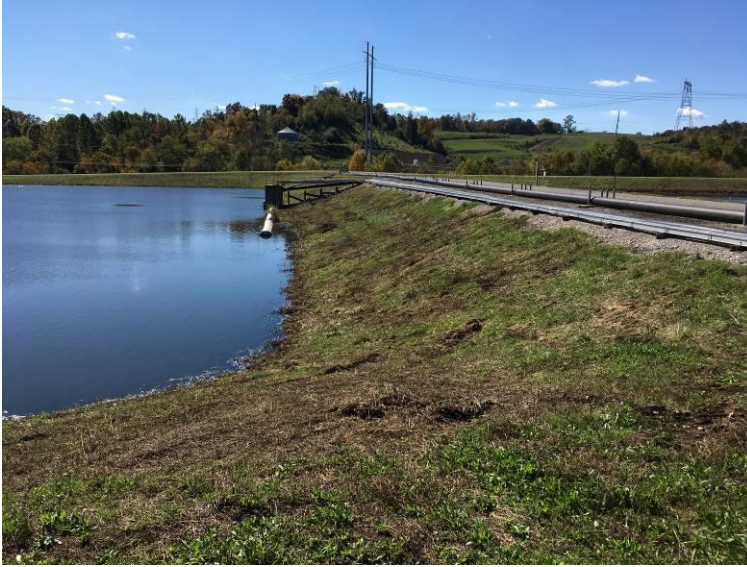
**Photo No. 10**

4. The WWP interior slope conditions and discharge header pipe is depicted in Photograph No. 10. Overall, the dikes and slopes were in satisfactory and stable condition and the vegetation cover was good.

Typical Condition of West Waste Water Pond Interior Slope Conditions and Discharge Header Pipe. East Waste Water Pond is Out of Service at Time of Inspection.

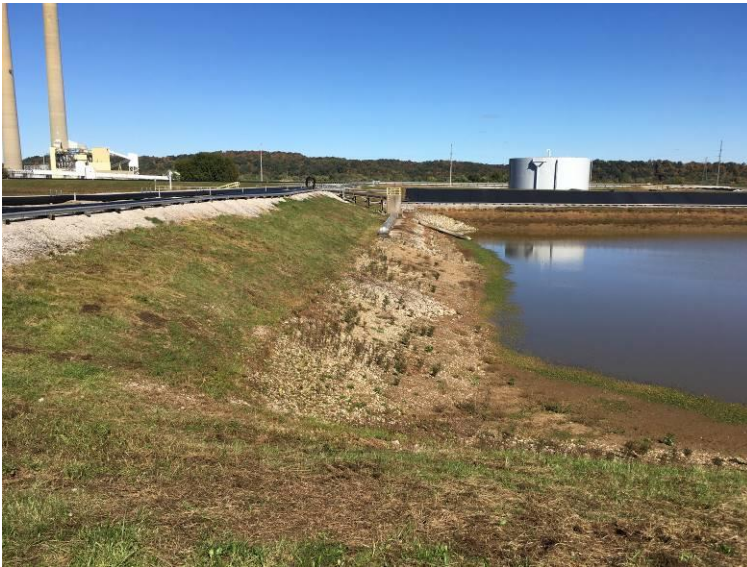
**Photo No. 11**

5. The EWP interior slope conditions and discharge header pipe is shown in Photograph No. 11. Overall, the dikes and slopes were in satisfactory and stable condition and the vegetation cover was good.

Typical Condition of East Waste Water Pond Interior Slope Conditions and Discharge Header Pipe. East Waste Water Pond is Out of Service at Time of Inspection.

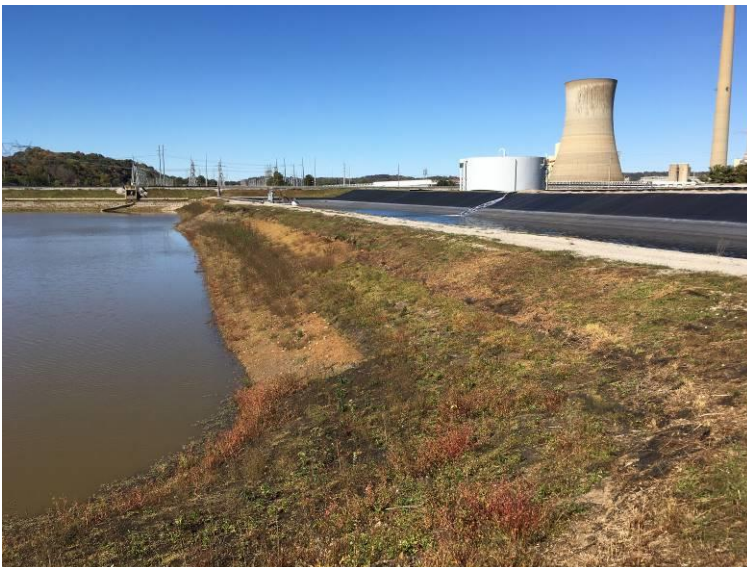
**Photo No. 12**

6. Photograph No. 12 show a long scarp along the upper interior slope on the east side of the EWP. In general, the scarp appears to be located at approximately the normal operating pool level, indicating that the scarp was possibly formed by wave action or the fluctuation of pond levels. In general the scarp appears stable, but the slope is sparsely vegetated.

Interior Slope Condition Showing a Long Scarp Across the Upper Slope of EWP. East Waste Water Pond is Out of Service at Time of Inspection.

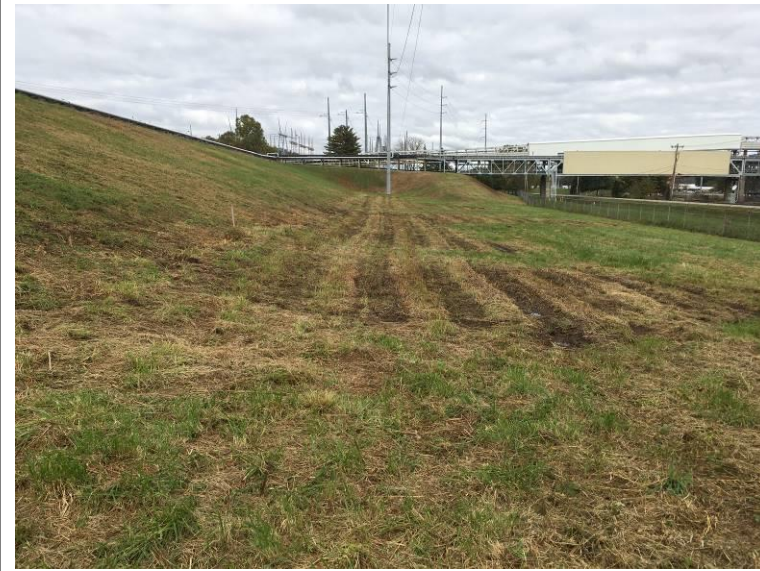
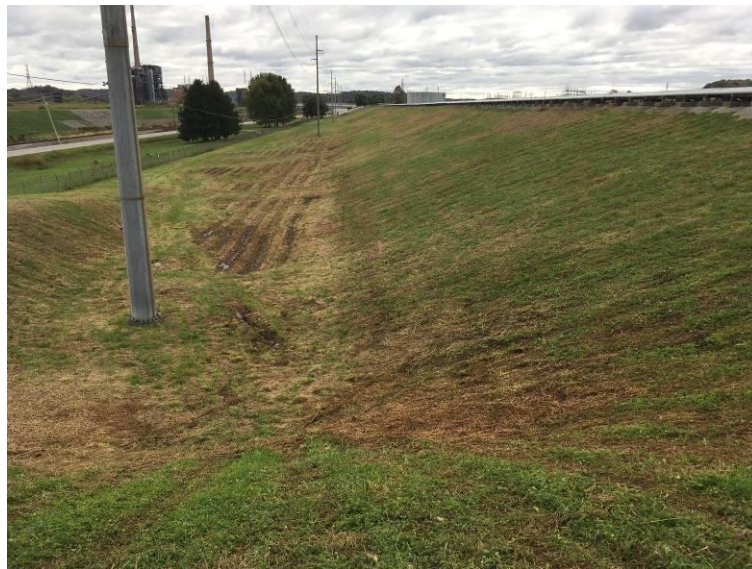
1. The overall condition of the downstream slope of the east dike is presented in Photographs No. 13 and 14. The condition of the east exterior slope was fair. An extended area of excessive wetness approximately 900 feet long was observed adjacent to the toe of the dike. Standing water was noticed in the tire ruts apparently from previous mowing activities. The slope above this elevation appeared satisfactory.

East Bottom Ash Pond Exterior Slope Wet Seepage Area.

Overview of East Bottom Ash Pond Exterior Slope Condition.

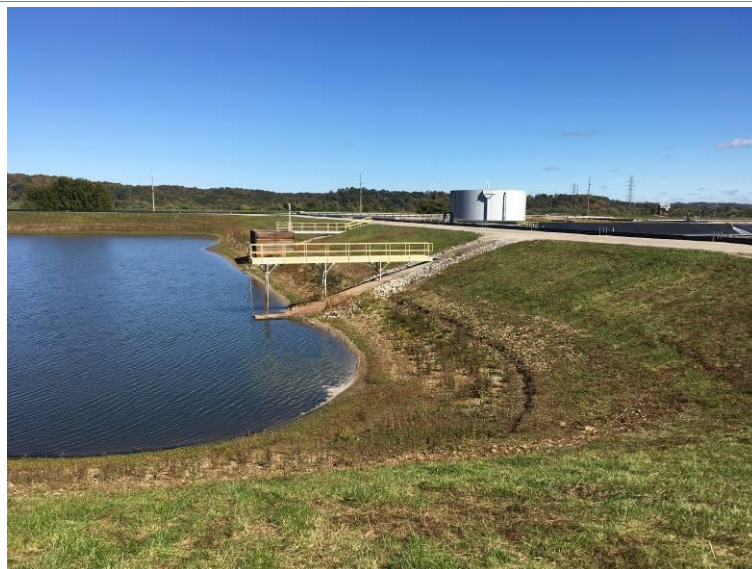
**Photo No. 15**

2. Photograph No. 15 depicts the typical condition of the EBAP interior slopes and overflow and low water outlet structure. The overflow discharge structure, access platform, and side rail appeared to be in satisfactory and working condition. Some erosion was noticed at the outlet end of the pipe that should be repaired.

- (iv) Some erosion around the overflow header structure of the EBAP was noticed. Part of the discharge pipe was out of alignment or damaged. Although access may be an issue, this condition should be remediated as part of maintaining the facility.

Typical Interior of East Bottom Ash Pond Overflow and Low Water Outlet Structure. East Bottom Ash Pond is Out of Service at Time of Inspection.

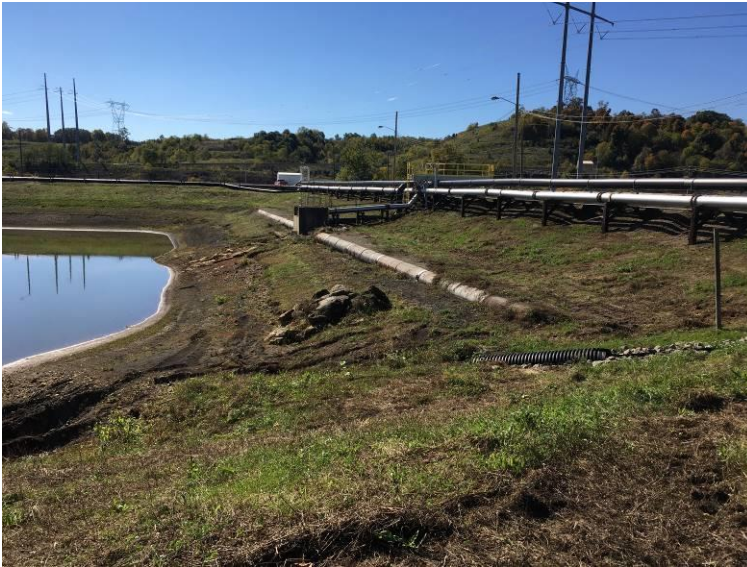
**Photo No. 16**

3. Photograph No. 16 depicts the typical condition of the EBAP interior slopes and discharge header pipe structure. The discharge header pipe appeared to be in satisfactory working condition. There was some erosion noticed at the junction box for the discharger header pipe.

Typical Condition of East Bottom Ash Pond Interior Slope and Discharge Header Pipe. EBAP is Out of Service at Time of Inspection.

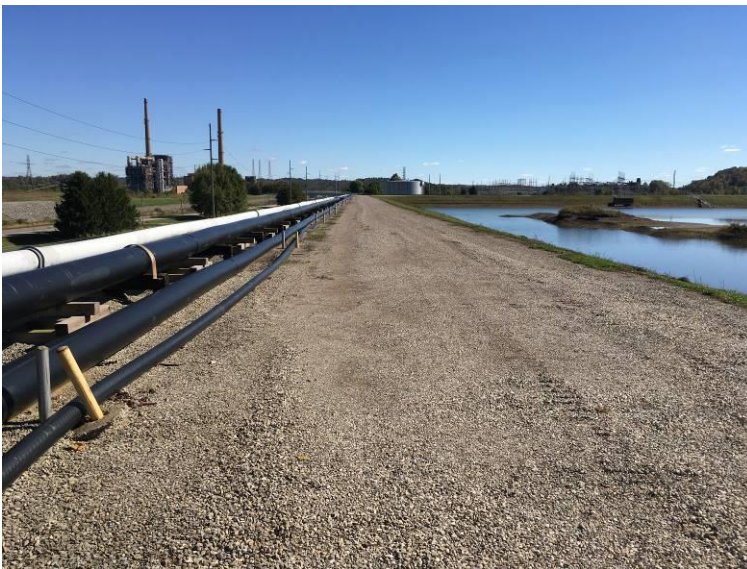
**Photo No. 17**

4. Photograph No. 17 show the typical condition of the crest area of the EBAP. The crest areas appeared to be in satisfactory condition with signs of rutting, crakes or misalignment. There is a minor erosion occurring under the pipe cribbing on the eastern edge of the EBAP crest area (Photograph No. 18).

Typical Crest Conditions of East Bottom Ash Pond.

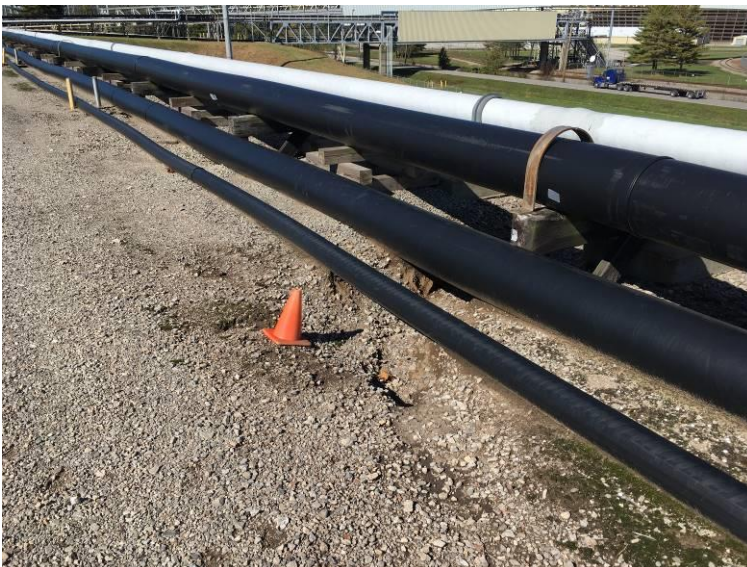
**Photo No. 18**

- (v) Some minor erosion has occurred under the pipe cribbing on the EBAP crest area (Photograph No. 18). There are some pipes that lie directly on the crest surface (next to the pipe cribbing) that may have caused concentrated water flow from rain events. The erosion does not appear to have any effect on the driving surface of the crest area, but should be repaired in a timely fashion.

Minor Erosion Under the Pipe Cribbing Along The East Bottom Ash Pond Crest Area.

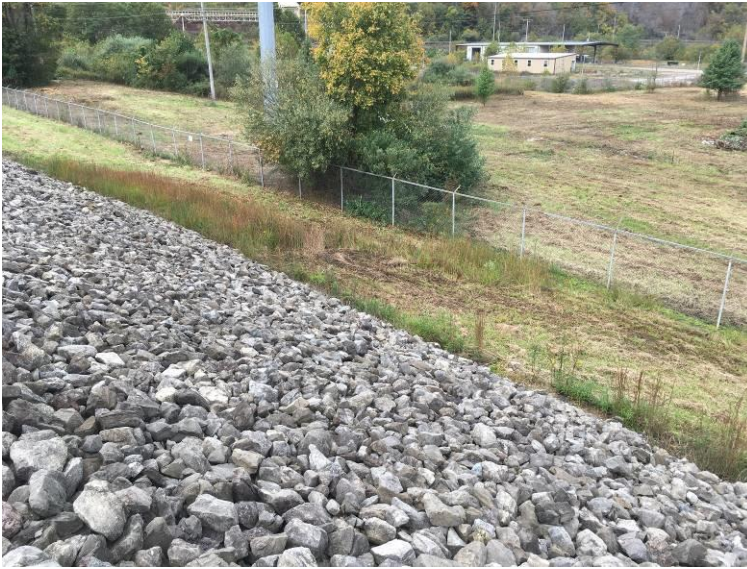
**Photo No. 19**

5. Overall, the north exterior slopes of the EBAP and WBAP were in satisfactory and stable condition. Photograph No. 19 shows a wet/soft area along the toe of the WBAP northern downstream slope. This area is present from the toe of the slope to the existing chain-link fence. It appears that this condition is due to poor drainage and needs to be investigated to properly develop a drainage control plan.

Wet Seepage Area of North Exterior Slope of Bottom Ash Ponds.

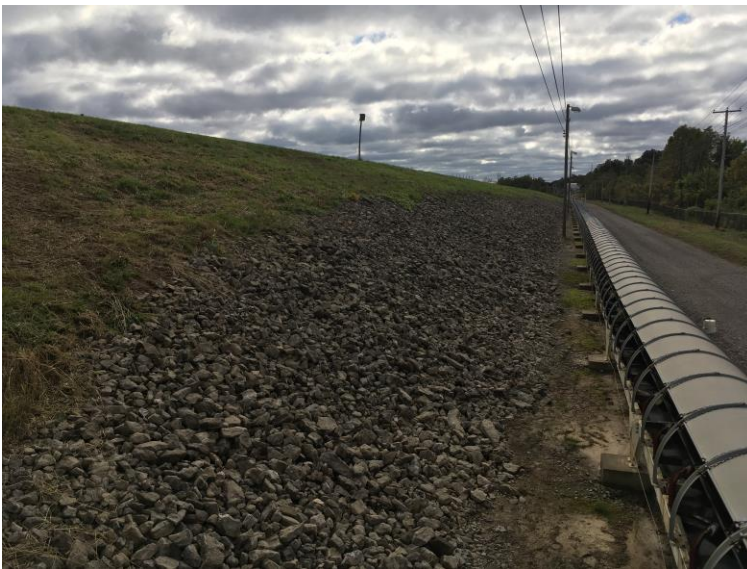
**Photo No. 20**

6. Photograph No. 20 shows the typical conditions of the WBAP western exterior slopes. The condition of the exterior slope is satisfactory. The lower portions are protected by riprap and the upper portions are properly vegetated.

West Exterior Slope of West Bottom Ash Pond.

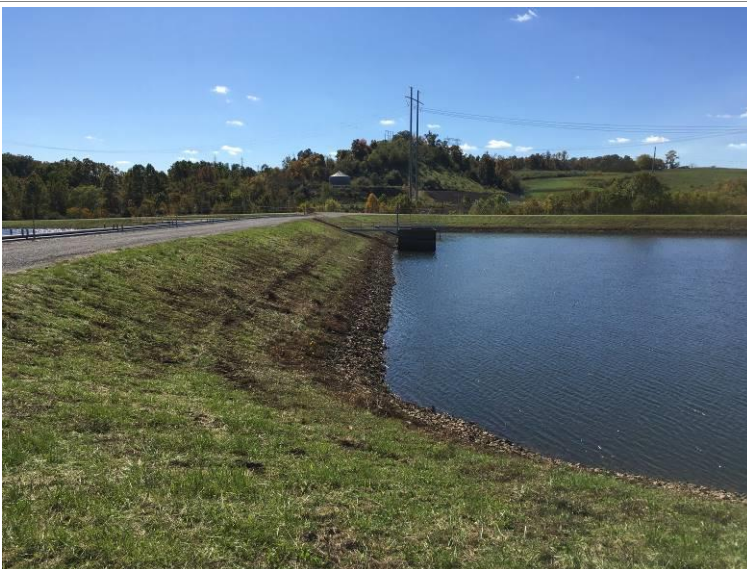
**Photo No. 21**

7. Photograph No. 21 depicts the typical condition of the WBAP interior slopes and overflow and low water outlet structure. The overflow discharge structure, access platform, and side rail appeared to be in satisfactory working condition.

West Bottom Ash Pond Interior Slope Conditions and Overflow and Low Water Outlet Structure.

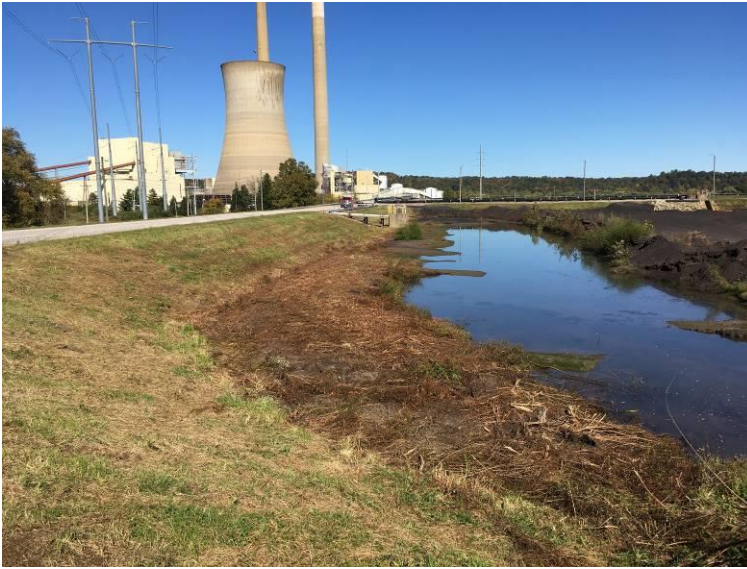
**Photo No. 22**

8. Photograph No. 22 shows the typical condition of the WBAP interior slopes and discharge header pipe structure. The discharge header pipe appeared to be in satisfactory working condition. There was some soil erosion noticed at the cribbing supporting the access walk way.

West Bottom Ash Pond Interior Slope Condition and Discharge Header Pipe.

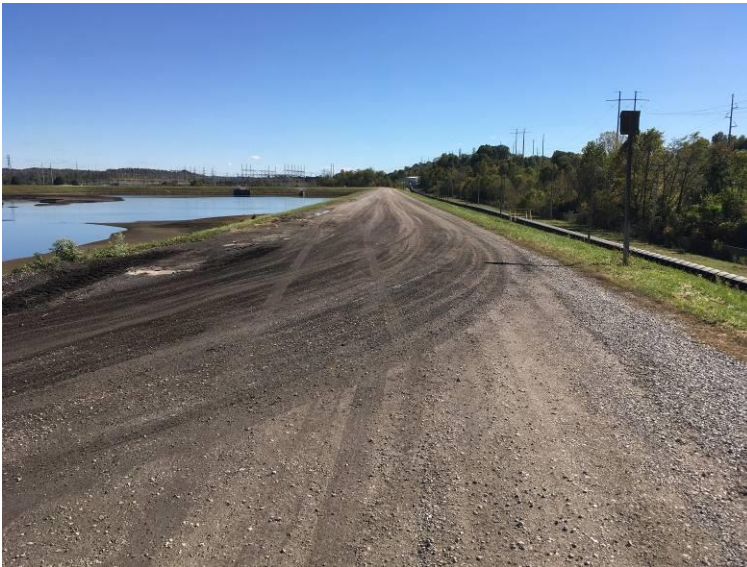
**Photo No. 23**

9. Typical conditions of the WBAP crest area is shown in Photograph No. 23. In general, the crest conditions are in satisfactory condition with no signs of rutting, cracks or misalignment.

Typical Crest Conditions of West Bottom Ash Pond.

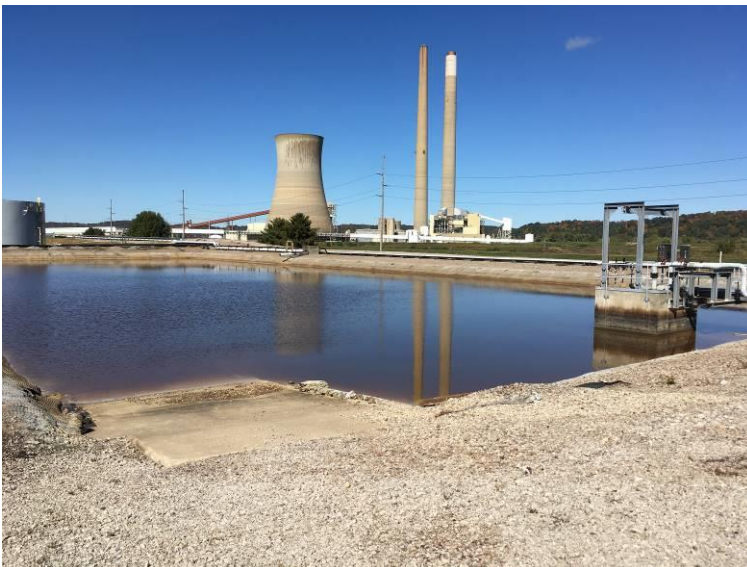
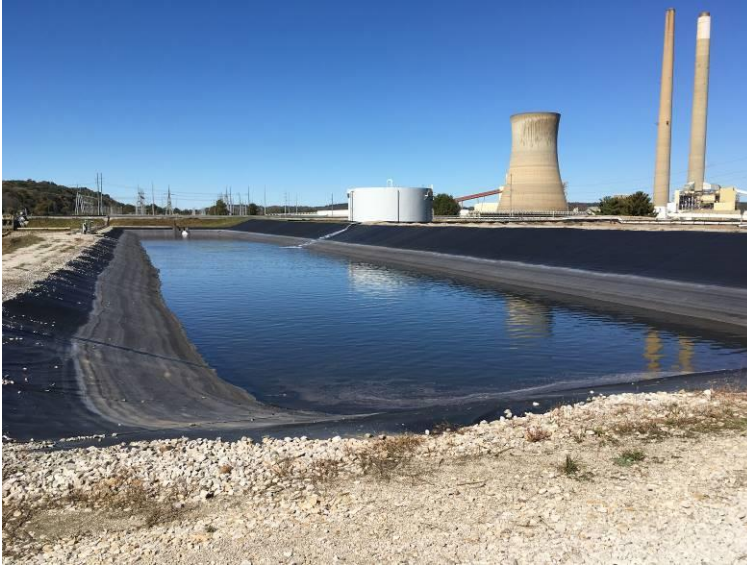
1. Overall, the FGD Scrubber Sludge Pond and leachate pond were in satisfactory condition (Photograph No. 24 and No. 25). The overflow discharge structures appeared to be functioning as designed. The interior slope lined with a HDPE liner appeared in satisfactory and stable condition.

FGD Scrubber Sludge Pond Interior Conditions.

Interior Leachate Collection Surge Pond Typical Conditions.

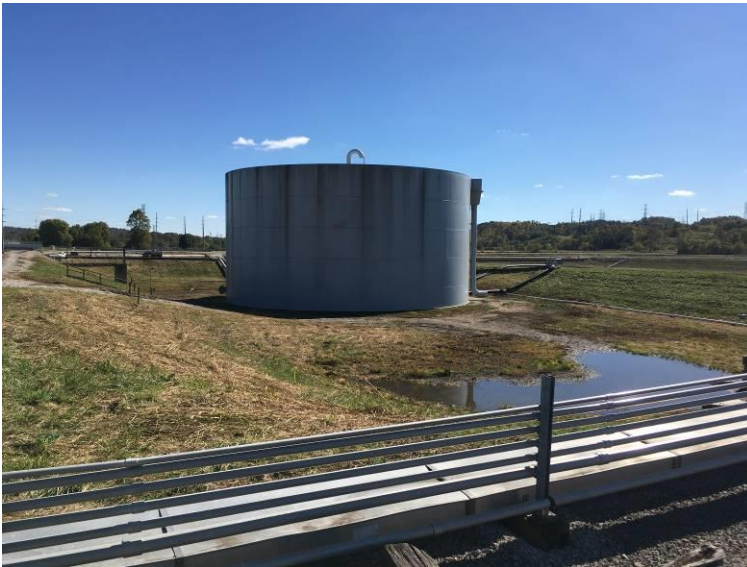
**Photo No. 26**

2. The metal cleaning tank containment dikes appeared in satisfactory and stable condition (Photograph No. 26). Some standing water was noticed inside the containment area. Two sump pumps are present at the north and south ends of the containment. Both sump pumps appeared to be not functioning at the time of this inspection.

Metal Cleaning Tank Containment Area Interior Conditions.

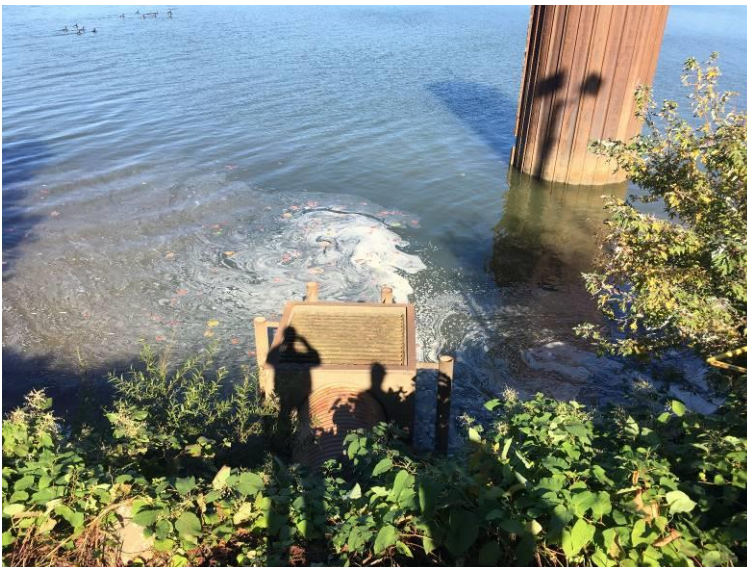
**Photo No. 27**

Bottom Ash Pond Complex Outfall 001 Located at River.
