2020 Annual Landfill Inspection Report

FGD Stackout Area

**H.W. Pirkey Power Plant
American Electric Power Service Company
(SWEPCO)
Hallsville, Texas**

Document ID: GEVR-20-024

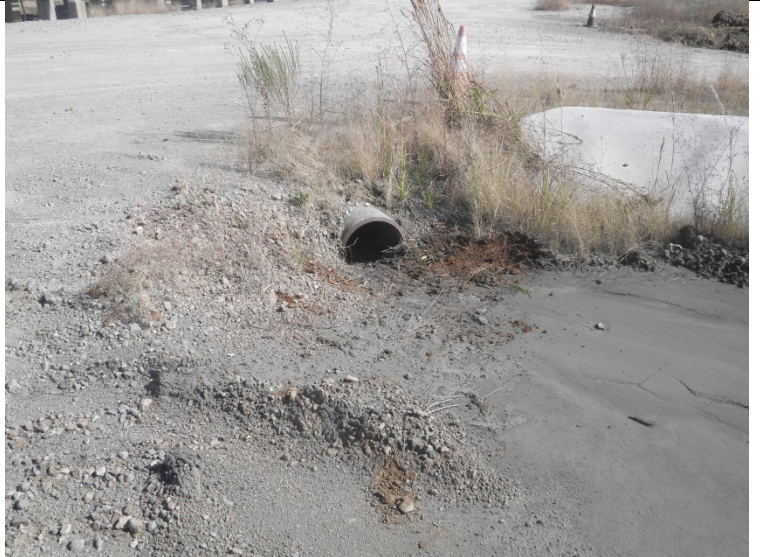
PHOTO #1

2. Surface water runoff from along the eastern gravel berm with a geomembrane cover is conveyed underneath an access road via a steel pipe culvert. Storm water from this culvert outlets onto a concrete slab with curb walls underneath the supports for the conveyor belt that supplies the radial arm stacker. A section of these curb walls has been notched to allow surface water runoff to drain to the Auxiliary Surge Pond. The steel culvert was not obstructed, but the area upstream of the culvert should be re-graded to maintain positive drainage to the culvert.

View of the upstream end of the eastern steel culvert

- 1) The area upstream of the culvert that drains the eastern perimeter ditch should be re-graded to maintain positive drainage to the culvert.
- 2) The minor obstruction in the concrete ditch on the north end should be removed.
- 3) Repair the erosion rills that have formed from the stackout pad to the Auxiliary Surge Pond. This area shall be backfilled properly due to the presence of shallow pipelines in this area. This erosion is considered a minor maintenance item.

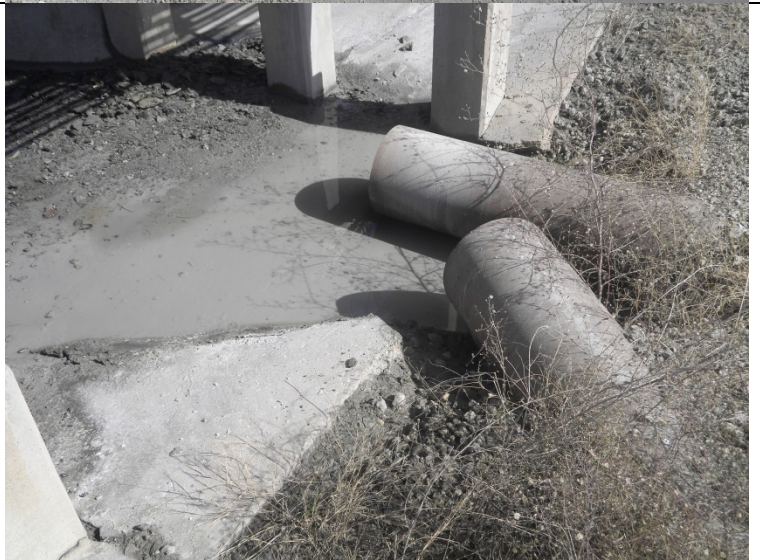
PHOTO #2

View of the downstream end of the eastern steel culvert

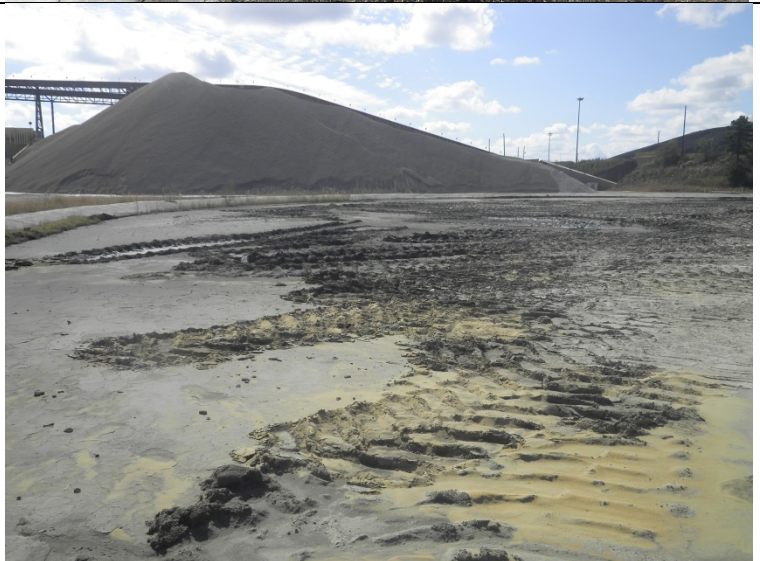
PHOTO #3

View of the eastern perimeter berm / ditch with minor ponding

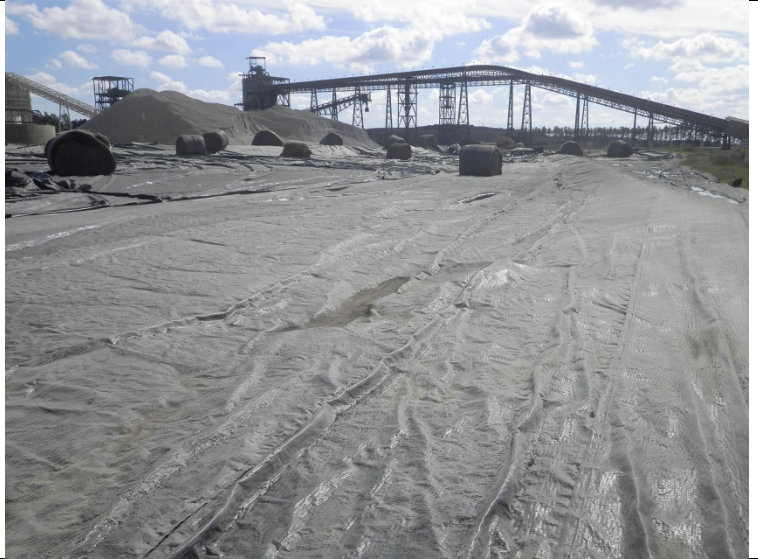
PHOTO #4

3. There is no vegetal cover on the FGD Stackout Area due to material constantly being stockpiled and removed.
4. The geomembrane rain flap that was recently installed is functioning in good condition. All contact water adjacent to the rain flap is directed away from it to the Surge Pond.

View of the western perimeter berm / ditch with rain flap

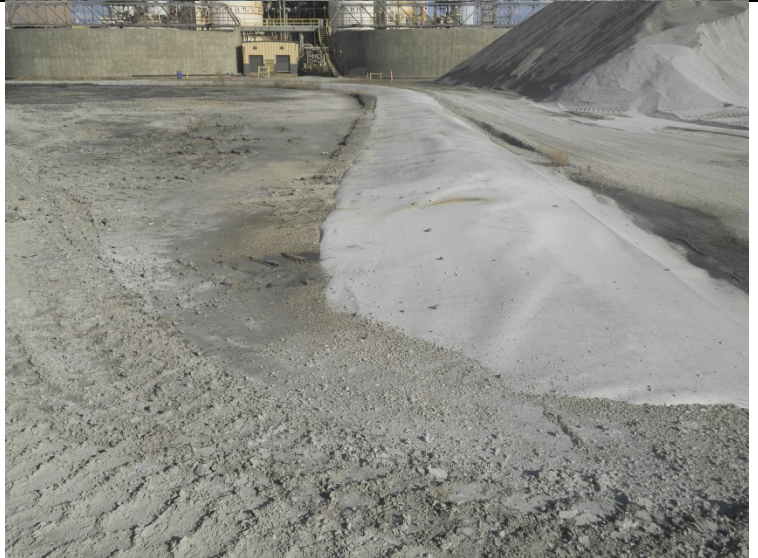
PHOTO #5

View of the northern perimeter berm / ditch

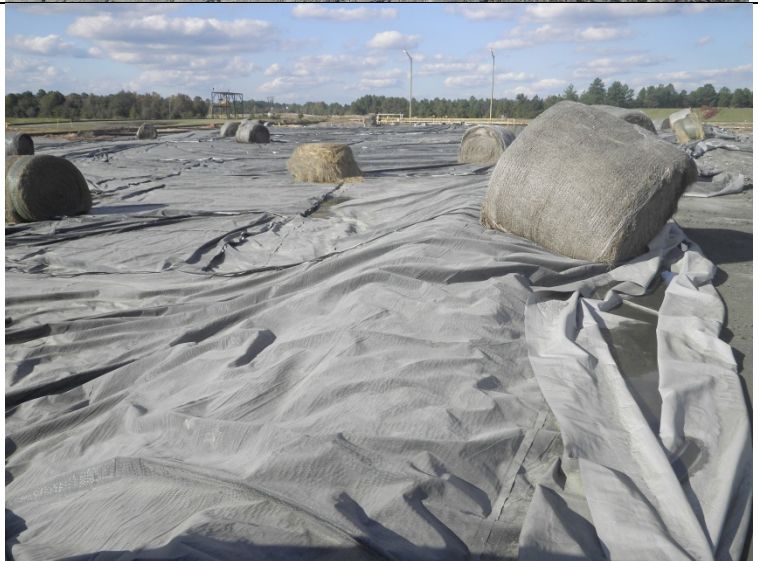
PHOTO #6

View of the eastern side of the rain flap

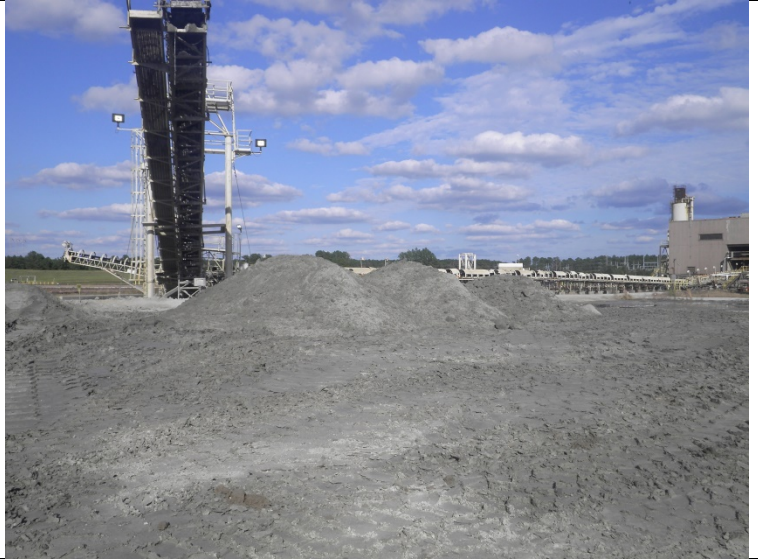
PHOTO #7

View of the conveyor, the radial arm stacker, and the active stackout area

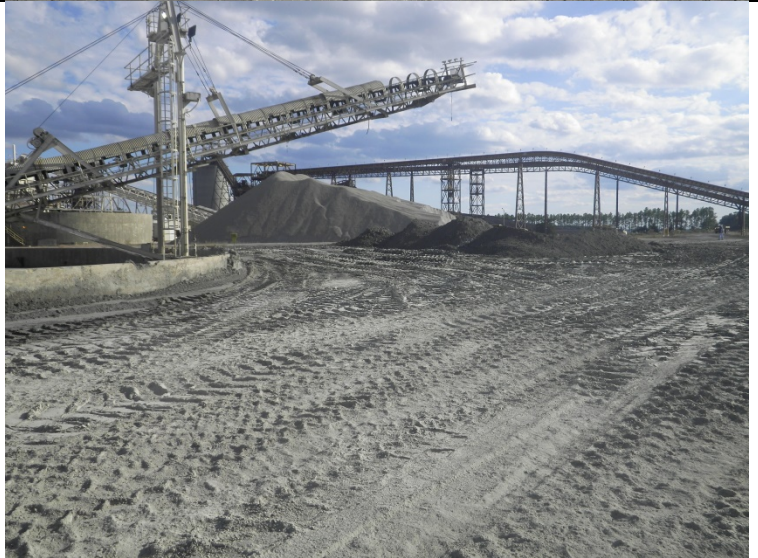
PHOTO #8

View of the radial arm stacker and the active stackout area with the limestone pile in the distance (outside of FGD Stackout Area)

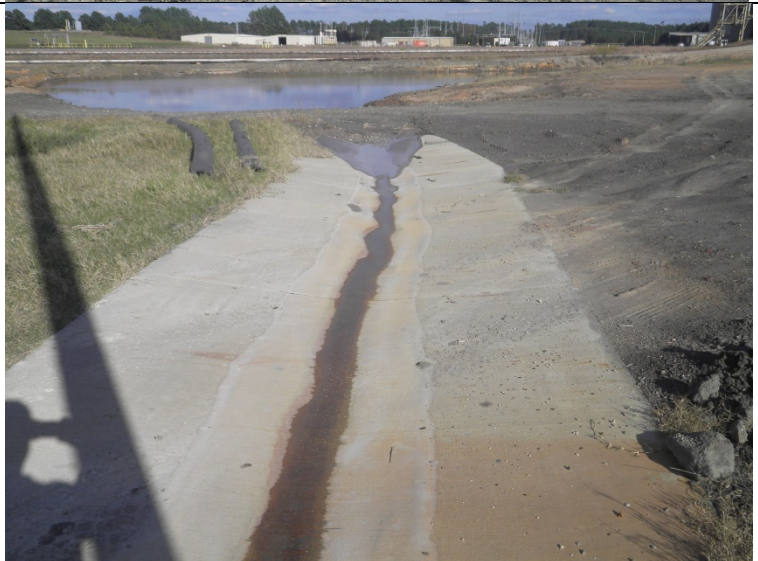
PHOTO #9

6. A minor obstruction was observed in the concrete ditch on the north end, which should be removed. Minor erosion was also observed where the FGD Stackout Pad surface drains into the Auxiliary Surge Pond, which should be repaired.

View of concrete ditch on the north end with minor obstruction

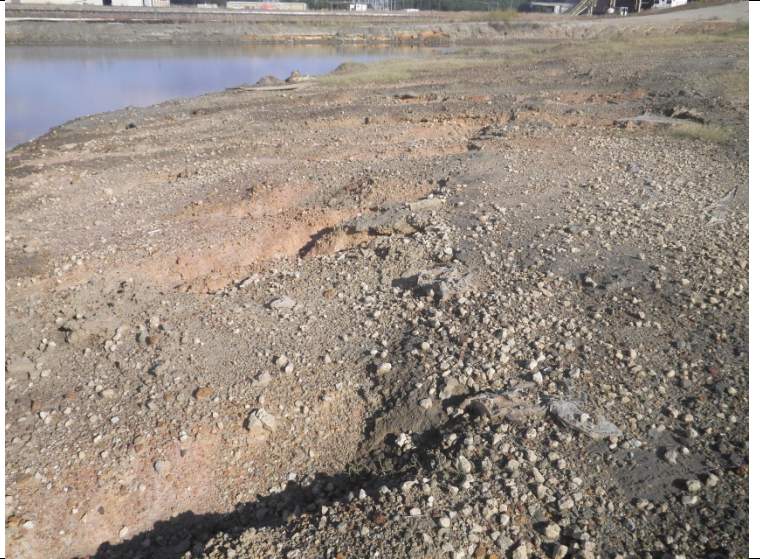
PHOTO #10

View of erosion between the stackout area and the Auxiliary Surge Pond

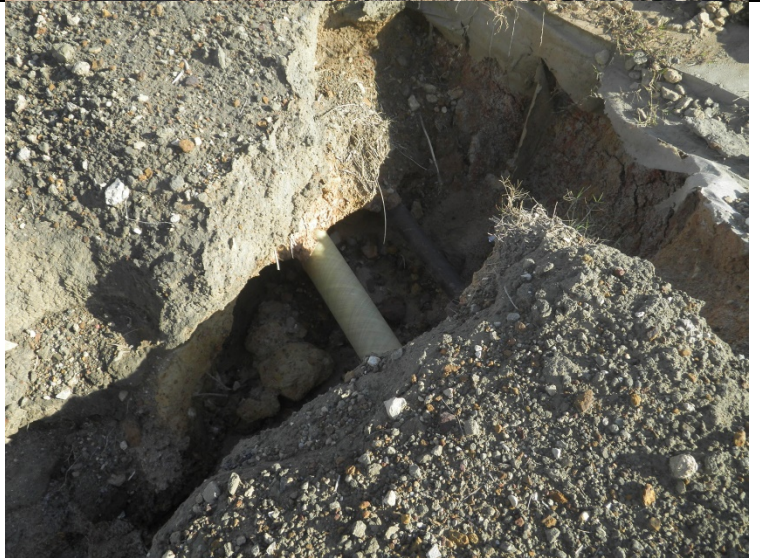
PHOTO #11

View of exposed shallow pipelines in one of the erosion rills
