# 2020 Annual Landfill Inspection Report

**Amos FGD Landfill**

**John E. Amos Plant  
Appalachian Power Company  
Putnam County, West Virginia**

**Document ID: GERS-20-038**

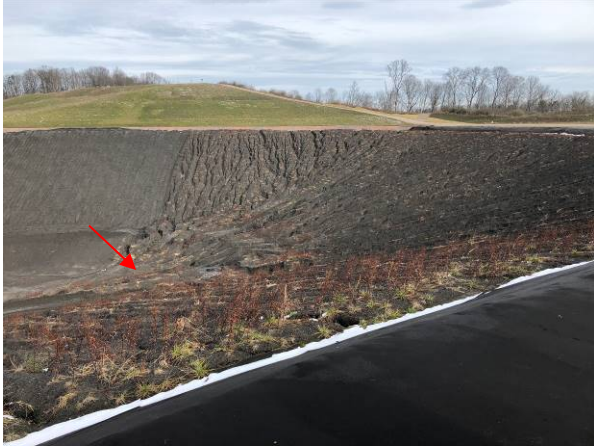
2. In the eastern bowl of Sequence 4, trapped groundwater has resulted in bubbles underneath the liner. The bubbles were noted in areas where the bottom ash cover soils have eroded away. There were also several areas where the liner had been cut to relieve the trapped groundwater and then the cut liner was repaired.
3. There were erosion rills noted through the protective cover layer/leachate collection system (bottom ash) overlying the geomembrane liner. These erosion rills were limited to the eastern bowl of Sequence 4 near the bubbles under the geomembrane liner noted in Observation 2. These erosion rills are not a concern, as future repair work in this area will result in the replacement of this material.

- 6) There is trapped water underneath the liner in the eastern bowl of Sequence 4. The liner system has a network of underdrains designed to collect groundwater and safely convey the water to the sediment collection ponds. It appears that this underdrain system is not functioning as intended in this location and therefore meets the definition of uncontrolled seepage deficiency.

The deficiency was identified on January 15, 2020. Several interim repairs were completed during 2020 but the root cause has not been determined. Plans to remedy this issue are being developed at the time this report was written and these efforts should continue to address this issue before placing CCR in this area.

Photograph 1: View of the eastern bowl of Sequence 4. The location of the groundwater bubbles under the liner are noted by the red arrow.

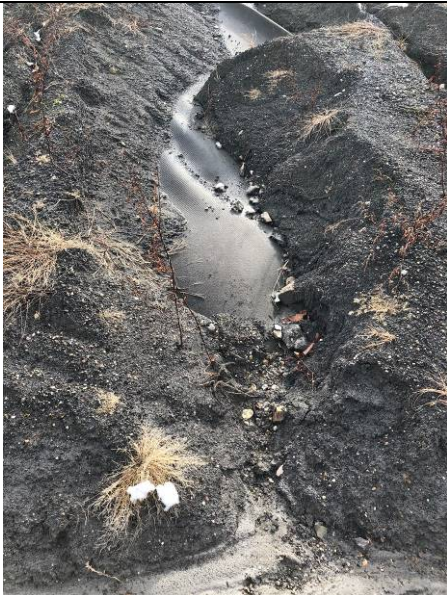
Photograph 2: View of the bubble under the liner in Sequence 4 area.

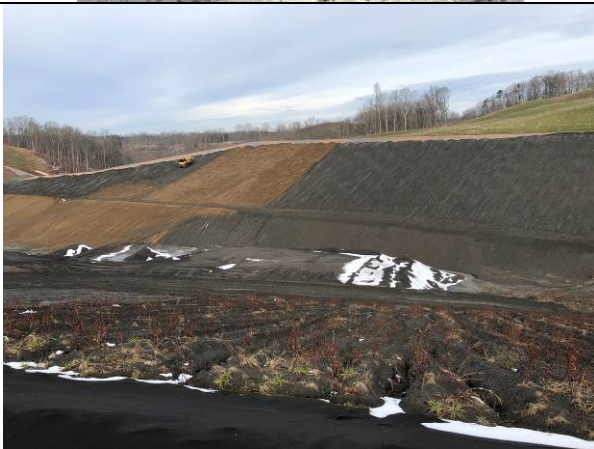
Photograph 3: View of the Sequence 4 area.

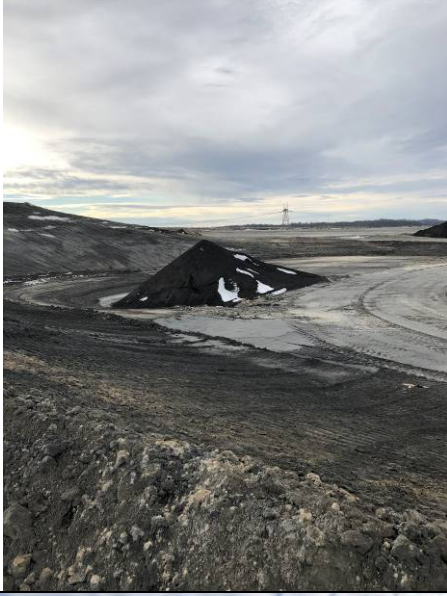
1. During the inspection, the active disposal area was being used for waste placement. The chimney drains were functioning as designed and there was no pooling of contact water around the drains. Waste was being compacted as it was placed.

Photograph 4: View of a chimney drain in the active CCR placement in Sequence 1.

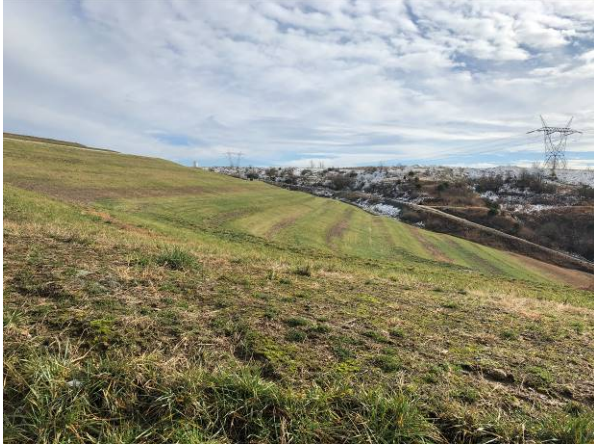
5. The final cover construction on the southwest slope of the South Valley is complete and dense grass cover vegetation is established. There were no signs of erosion or instabilities observed.
6. The final cover soil drain pipe outlets exposed in the fabric-formed concrete ditch were in good condition with no signs of obstructions or problems.

Photograph 5: View of the final vegetated cap on the south face of Sequence 3.

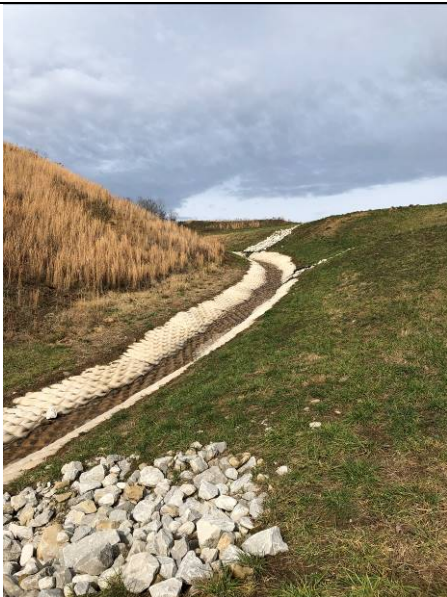
Photograph 6: Typical view of the fabric-formed ditch along the groin of the south face of Sequence 3.

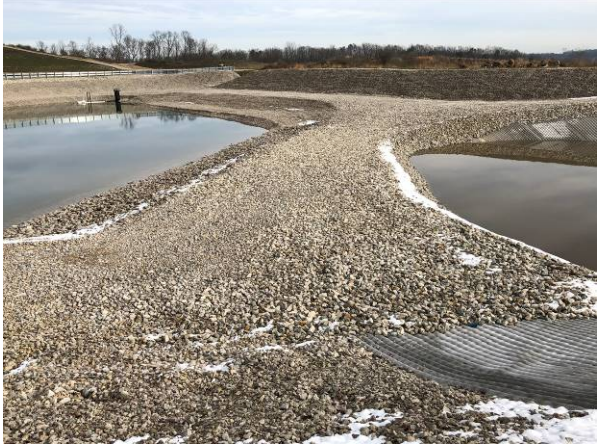
12. A section of the floating platform to access the principal spillway for the South Valley Sediment Pond has a damaged handrail.
13. The Plateau Sediment Collection Pond was lined with a geomembrane, which was then covered with aggregates in 2020.

Photograph 7: View of the plateau sediment pond.

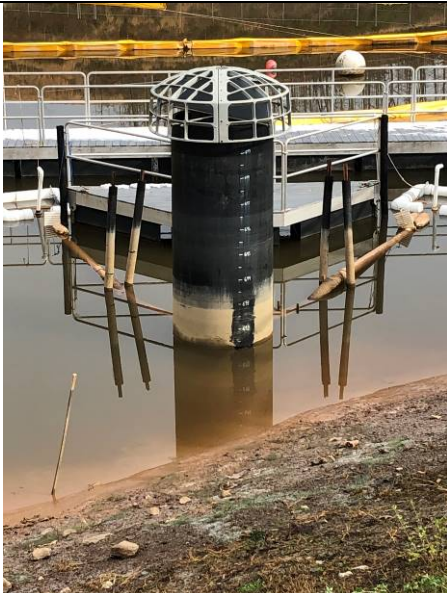
Photograph 8: View of the primary spillway at the north valley sediment pond.

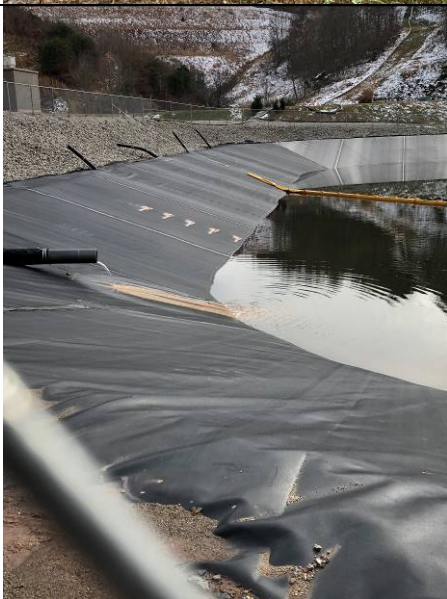
7. The leachate holding ponds are generally in good condition. There were no holes or problems observed with on the visible sections of the geomembrane liner.
8. The emergency spillways for both leachate ponds were observed to be unobstructed and in good condition for both of the leachate holding ponds.

Photograph 9: View of the north area leachate holding basin.

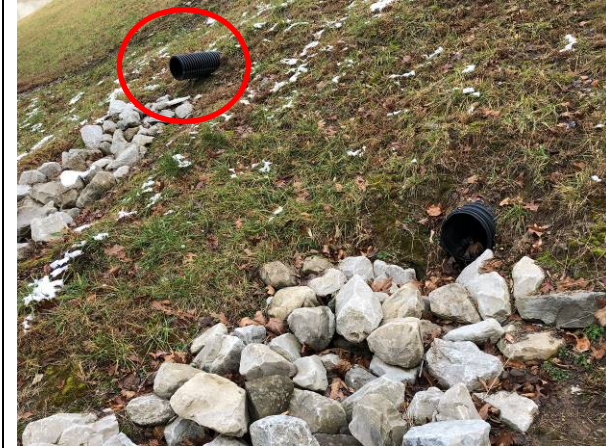
Photograph 10: View of the leachate detection outlet and underdrain outlet for the north area leachate holding basin.

The leachate detection pipe is circled in red.

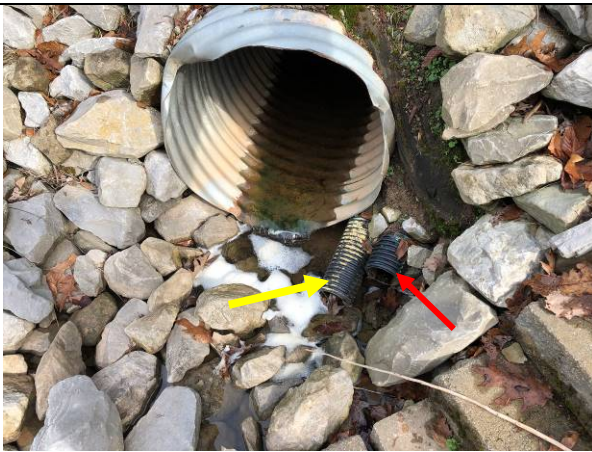
Photograph 11: View of the primary spillway outlet for the south valley sediment collection pond and the leachate detection & underdrain for the south valley leachate holding pond.

The leachate detection pipe is noted by the red arrow and the liner underdrain is noted by the yellow arrow.

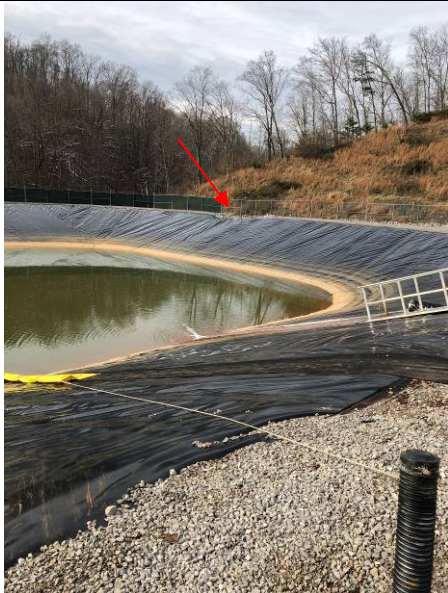
Photograph 12: View of the south valley leachate holding pond . The emergency spillway is noted by the red arrow.

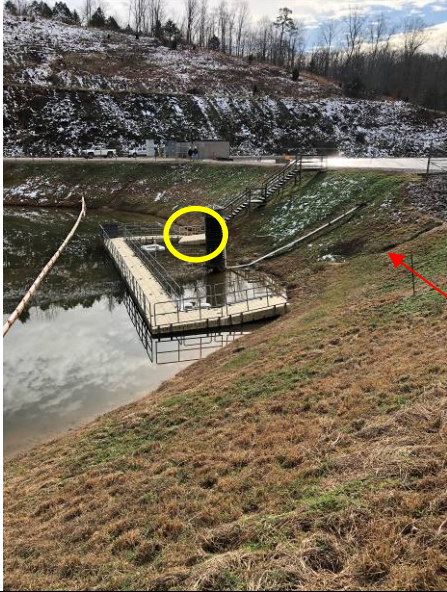
11. There was a small erosion rill noted upstream of the emergency overflow at the South Valley Sediment pond. Otherwise, the emergency spillway channels from the sediment collection ponds were in good condition with no observable signs of erosion.

Photograph 13: View of the primary spillway for the south valley sediment collection pond. The erosion rill found is noted by the red arrow.

The section of floating platform with a damaged handrail is noted by the yellow circle.

- 4) Repair the small erosion rill located just upstream of the emergency spillway for the south valley sediment collection pond.

- 5) Monitor the floating platform for accessing the skimmers for the principal spillway for the south valley sediment collection pond for additional distress or unsafe conditions for people walking out to the principal spillway.

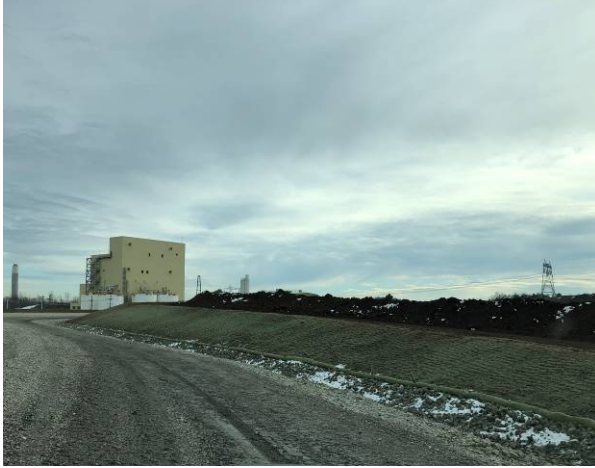
4. The northern portion of Sequences 1 & 2 has interim cover installed. Generally, the interim cover was in good condition with vegetation and no erosion. The most recent areas of interim cover appeared to have been recently hydro seeded and the vegetation has not become established yet.

Photograph 14: View of the temporary soil cover on the north side of Sequence 1. This area had been recently hydro seeded.

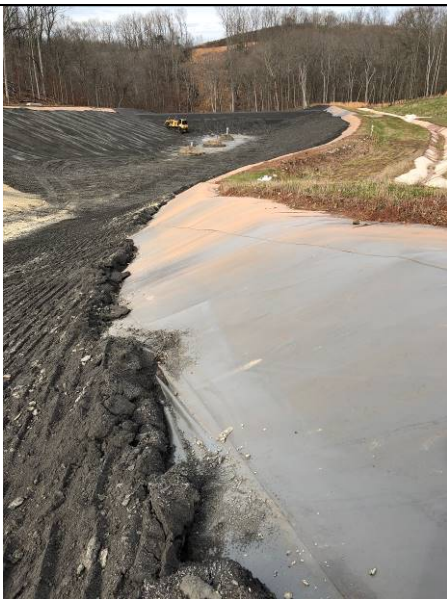
Photograph 15: View of the liner and chimney drains at the north side of Sequence 4.
