**Rockport Fly Ash Landfill Deficiency Corrective  
Measure Report  
For  
Intermediate Berm Leachate Seepage**

**Indiana Michigan Power Company  
Rockport Plant  
Rockport, Indiana**

**November 2021**

**Document ID: GERS-21-070**

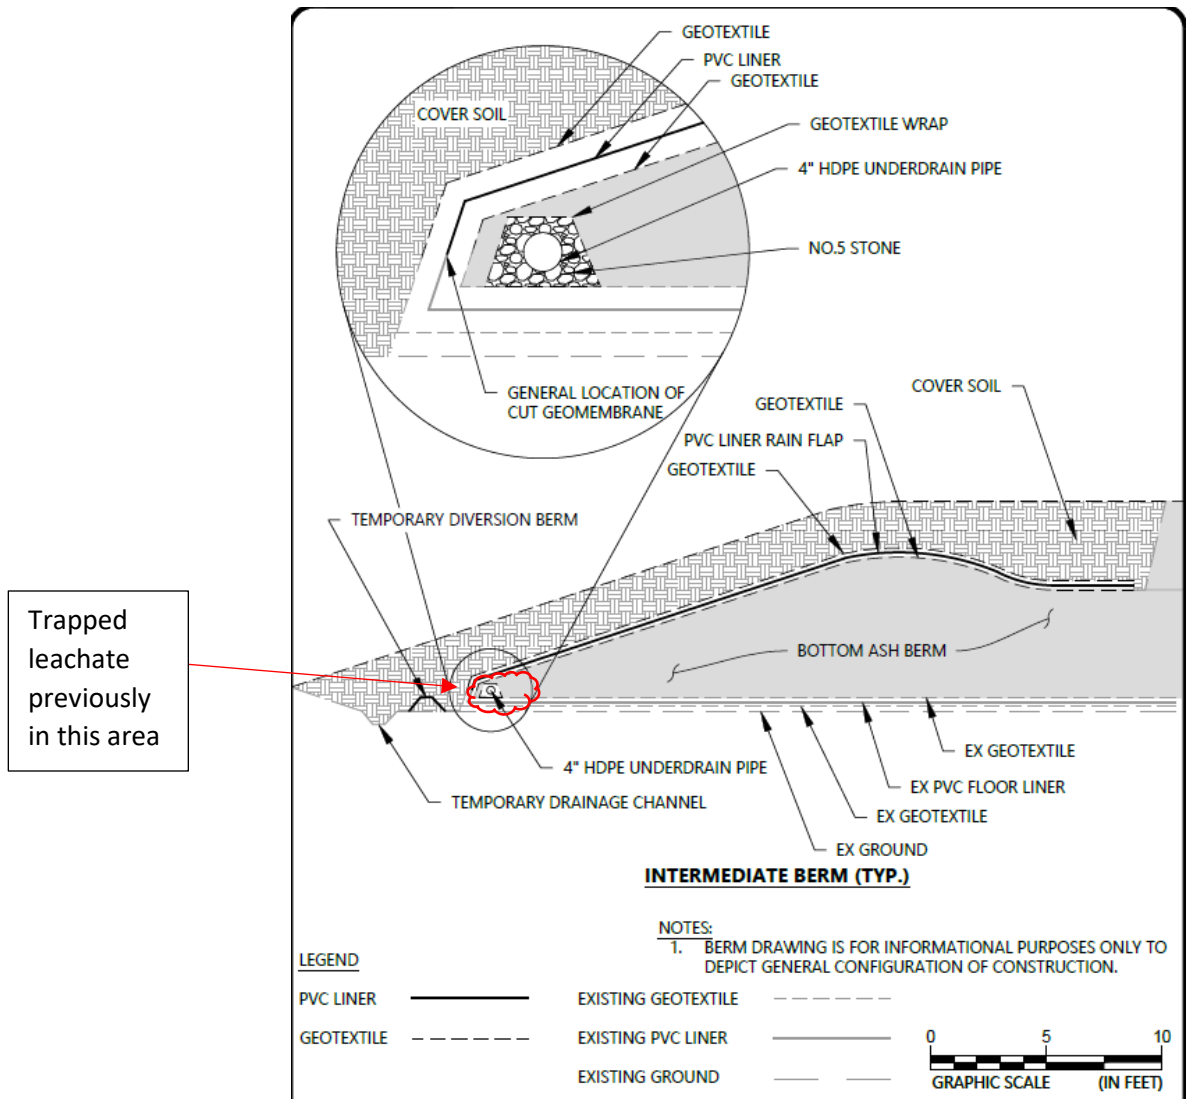
Figure 1: Intermediate Berm Cross Section. Reference Figure 5- S&ME Landfill Seepage Repair Report Nov.12, 2021

Leachate water was observed to be trapped between the PVC geomembrane layers of the intermediate berm. Upon initial observation after excavating to uncover the edge of the PVC floor liner, leachate was observed to be flowing above and below the PVC floor liner. The total amount of leakage was estimated to be less than 1 gallon per minute.

The PVC floor liner was then slightly propped up from the underlying clay liner with 2x4 boards to allow water to drain and to allow further observation of any leakage from the floor liner. Shortly after propping the PVC liner up, no flow was observed below the floor liner and no defects or imperfections were discovered on the floor liner during subsequent remedial measures when larger areas of the floor liner were exposed. Small imperfections were found on the PVC rainflap and the seam between the floor liner and the rainflap was observed to be leaking. Refer to Figure 1 for illustration.

The leachate initially observed flowing under the liner was likely standing water that backflowed under the PVC floor liner. Upon removing the standing water and excavating to expose the liner, this water was then free to flow out into the excavation.

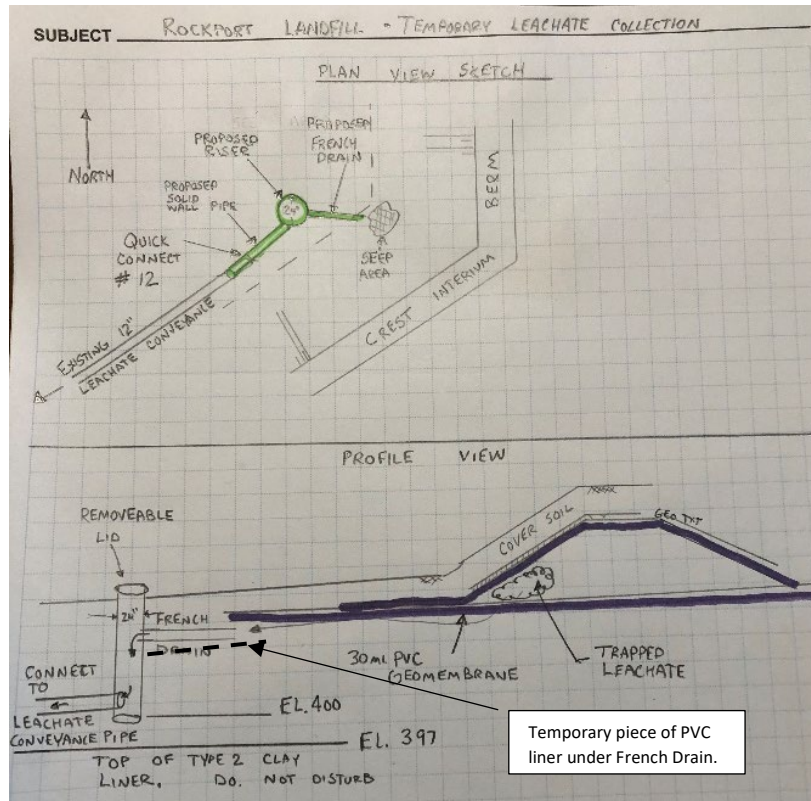
Figure 2- Sketch of Temporary Measures to collect leachate into the proper system.

A sketch of the temporary measure is included in Figure 2.

1. Excavate cover soils & geotextile to expose the 30-mil PVC rain flap.
2. Clean the liner and inspect the panel seams for bad seams/welds.
3. Install a section leachate collection pipe. The leachate collection pipe is perforated inside the intermediate berm and solid wall beyond the intermediate berm. The leachate collection pipe ties into the existing leachate collection system at Quick Connect #12.
4. Repair bad seams or defects by using wedge-welding techniques or solvent welding.
5. Replace the geotextile fabric, seaming the patches of geotextile into the existing geotextile. Place cover soils to match existing grades.
6. Remove the temporary leachate temporary riser pipe, French drain, backfill with cover soils and restore grass cover to disturbed areas.

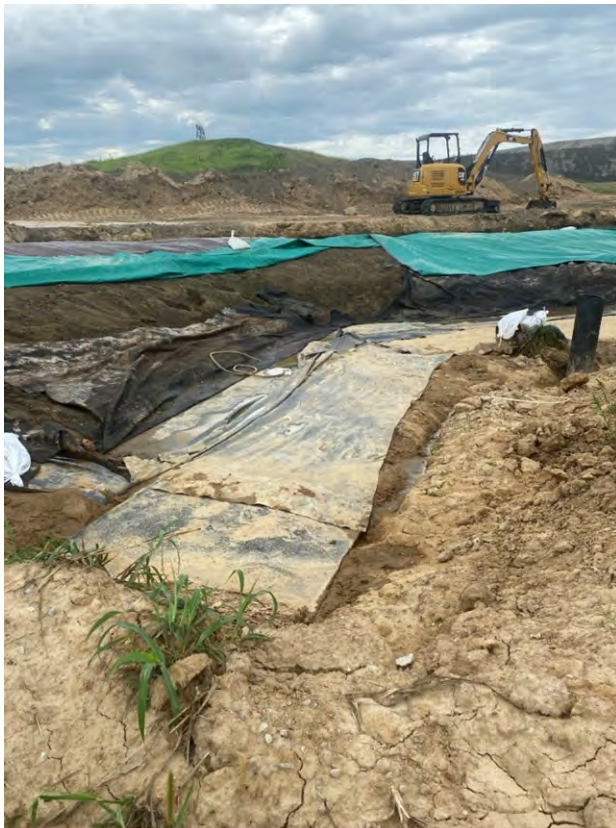
Photo 1: Exposed floor liner and rain flap prior to removal of existing geomembrane.

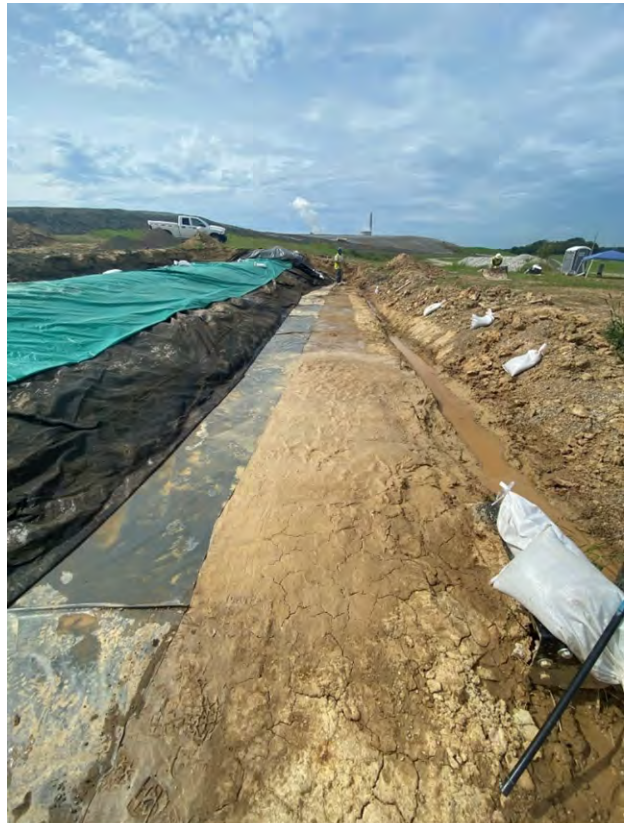
Photo 2: Floor liner and exposed subgrade after rain flap removal.

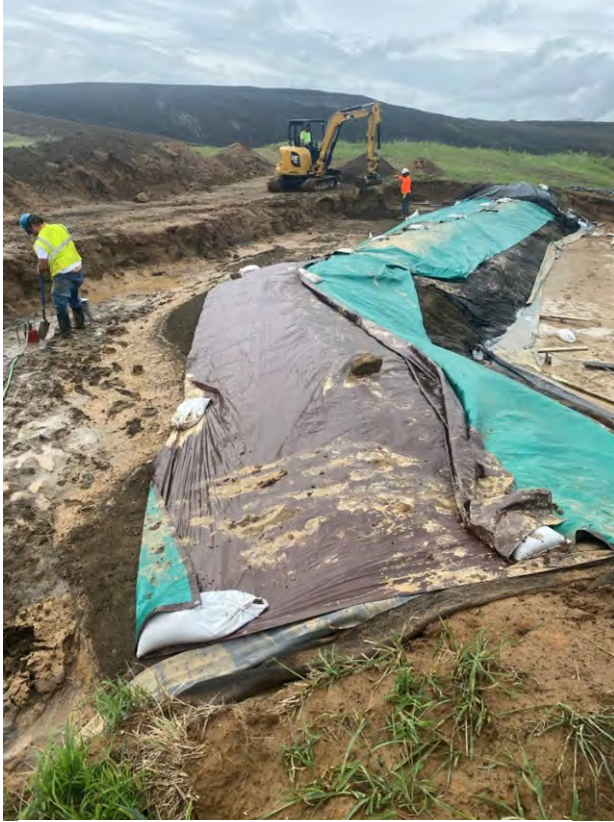
On the landfill side of the berm, the existing waste appeared saturated and was removed and replaced with bottom ash to allow for better control of water during construction and to provide a more stable work area.

Photo 1: Removal of saturated materials behind intermediate berm (landfill side).

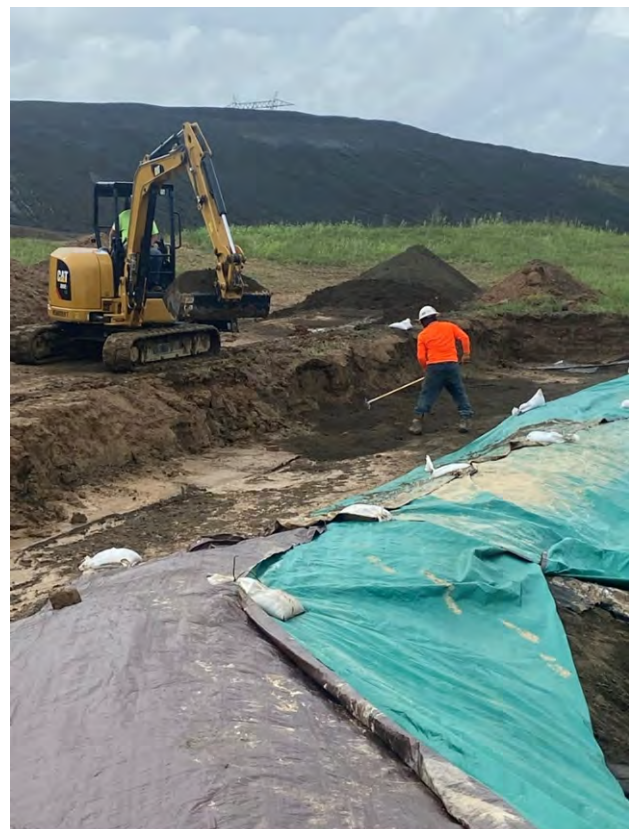
Photo 2: Placement of bottom ash behind intermediate berm (on landfill side).

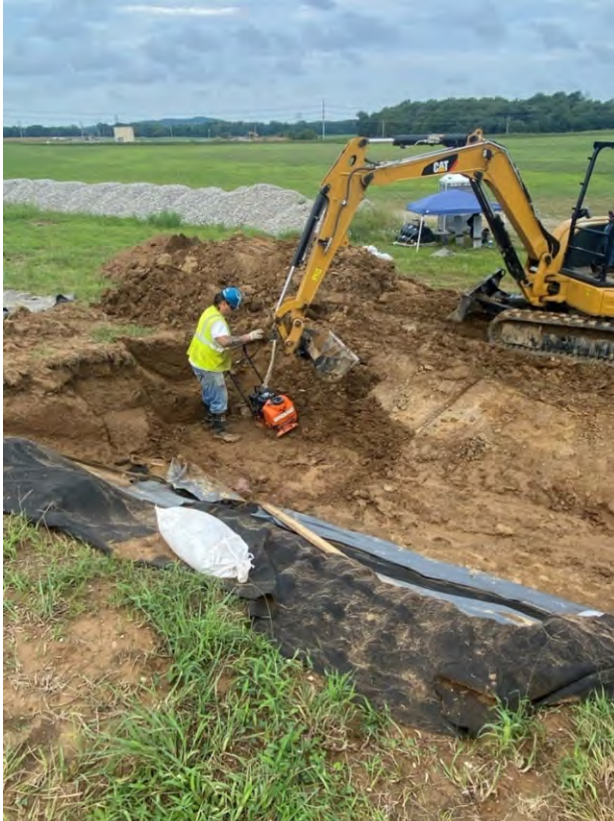
Photo 1: Re-compacting the south end of repair area to create a smoother subgrade after drying the surface in this area.

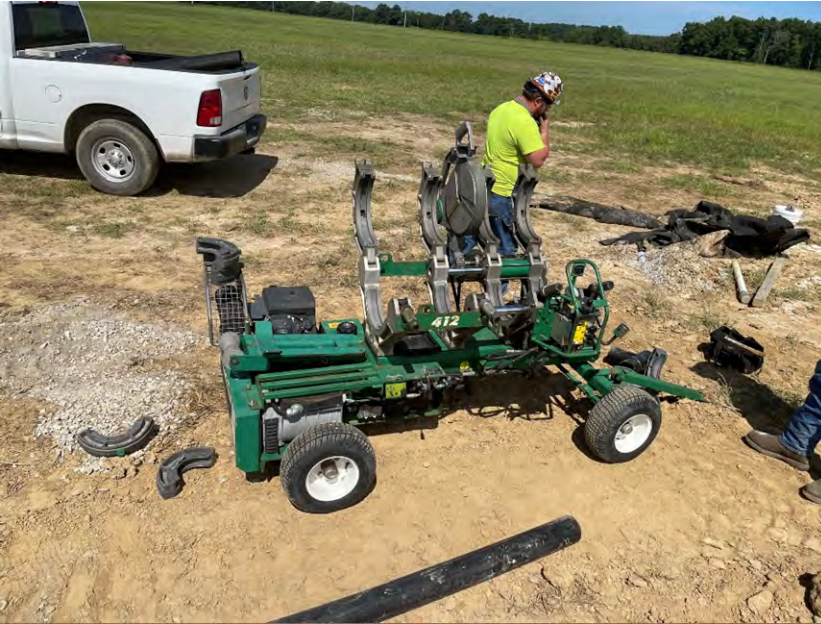
Photo 1: Butt fusion welding machine for 4-inch HDPE underdrain pipe. Machine is a McElroy Pitbull 212/618 HF

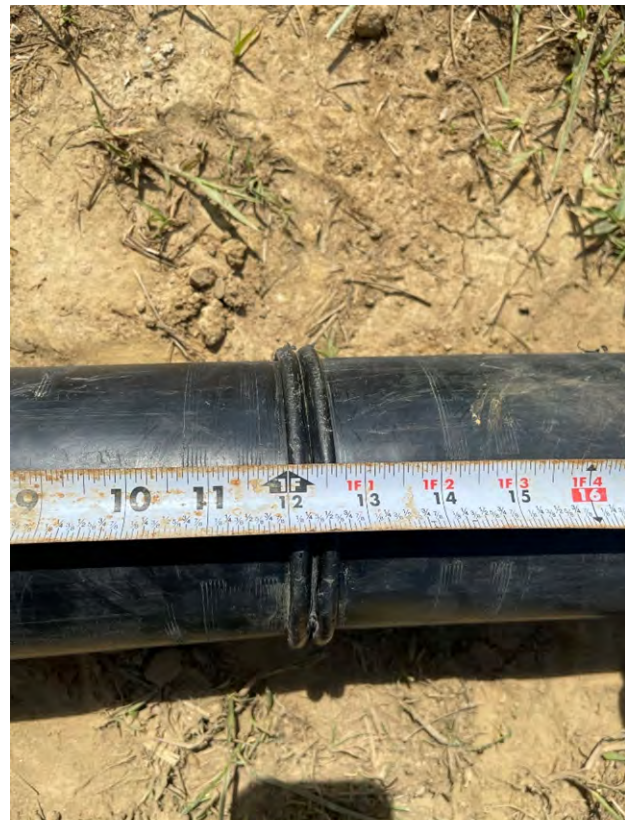
Photo 2: 4-inch HDPE perforated underdrain pipe weld performed off-site meeting minimum bead width of 3/16-inch.

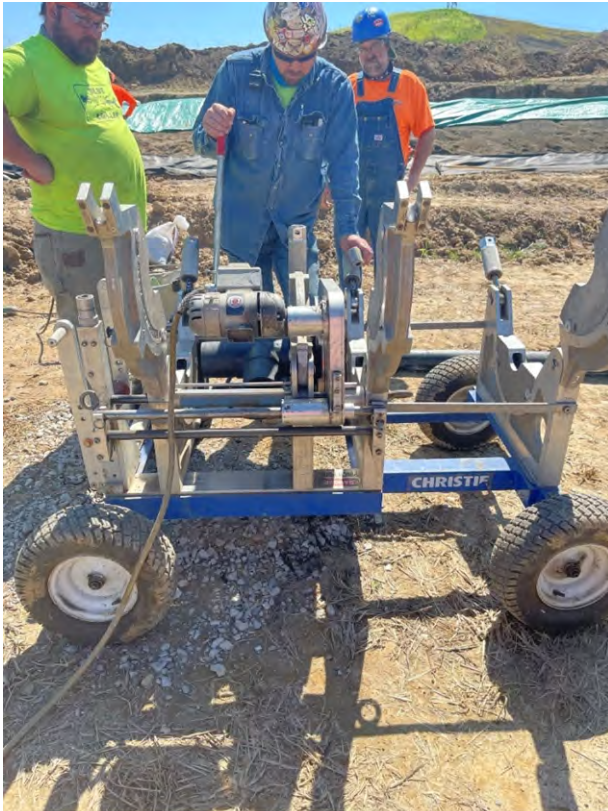
Photo 1: Christie fusion welding machine to replace the McElroy for welding the 4-inch hdpe underdrain pipe at the T section.

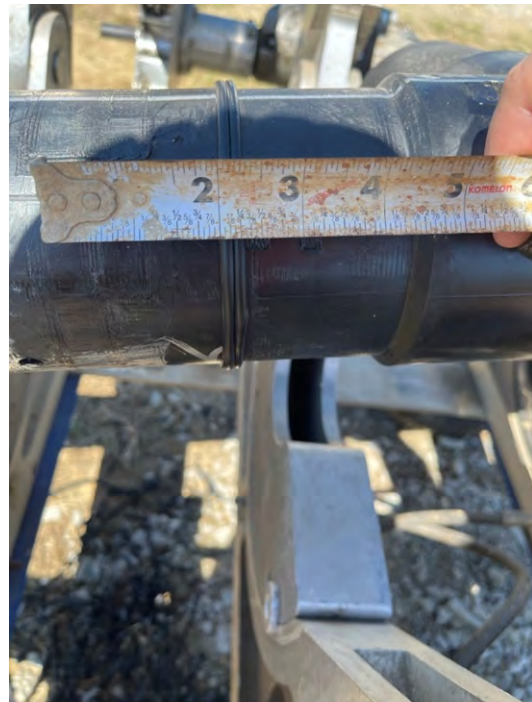
Photo 2: 4-inch HDPE T-section fitting, welded to the perforated underdrain pipe. Photo is shows the bead meeting a minimum width of 3/16-inch.

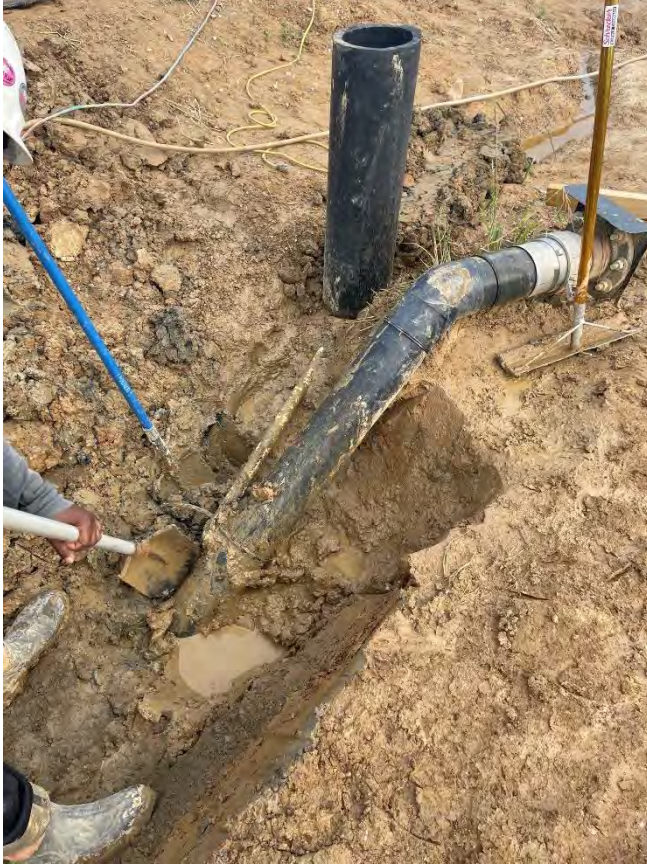
Photo 1: The large-diameter vertical pipe shown was placed temporarily to collect leachate within the construction area.

In this photo Enerfab is uncovering the existing junction in order to connect the new underdrain pipe at this location with a thermal coupling.

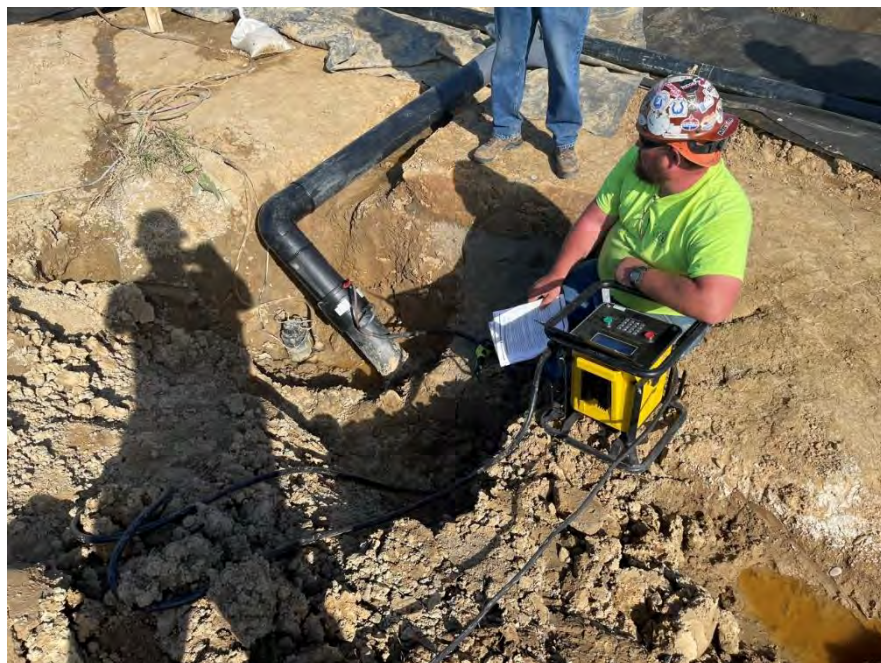
Photo 2: Enerfab is using the thermal coupling equipment to weld the underdrain to the existing leachate line.

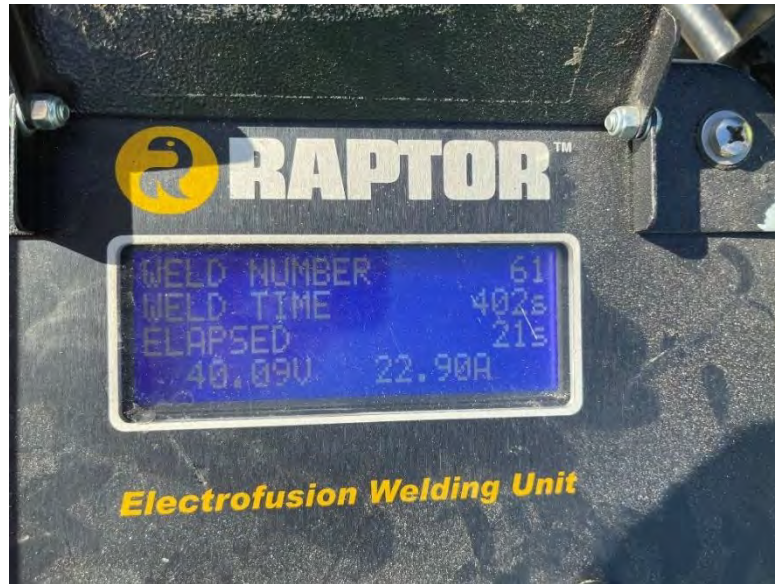
Photo 3: Raptor welding equipment shown during the welding sequence.

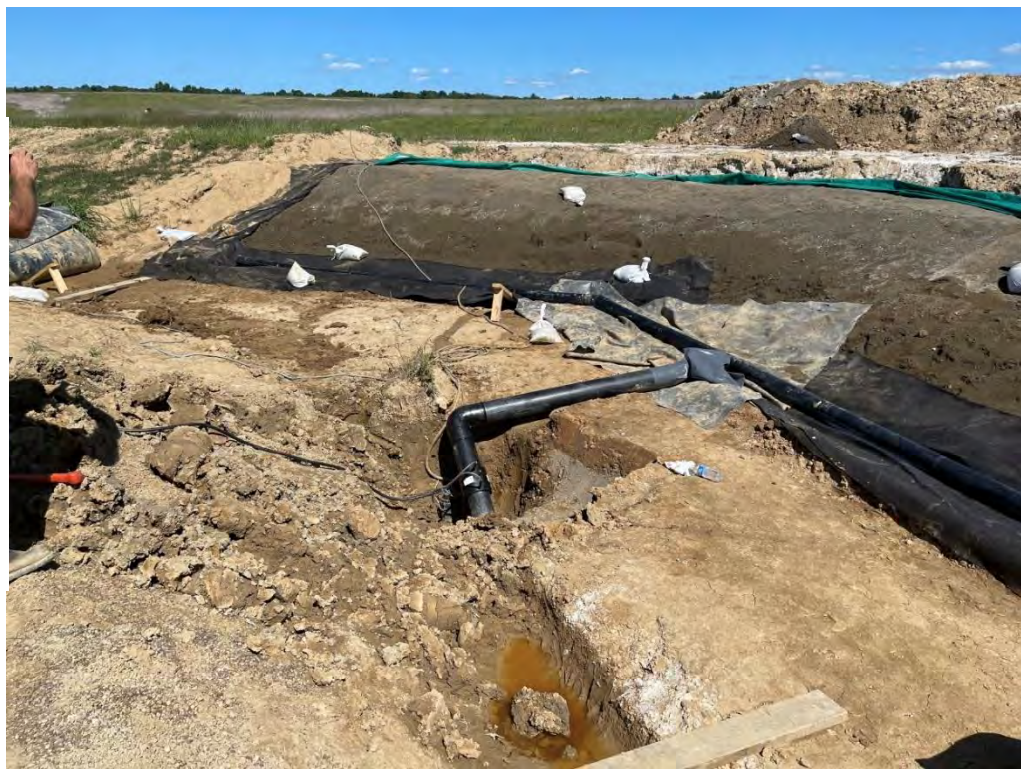
Photo 4: The underdrain has been connected to the leachate trunk line pipe. This photo shows the exposed underdrain pipe awaiting fabric and stone.

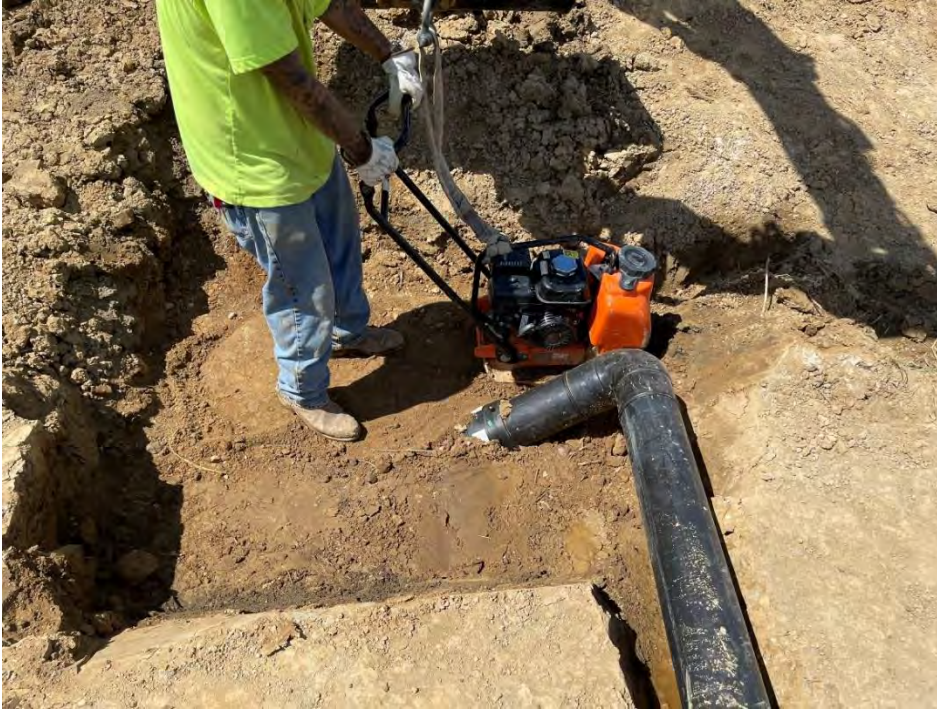
Photo 1: The electrofusion coupling is still visible in this photo. Enerfab has filled in the pipe excavation, and is using a vibrating plate to compact the soil back in place around the pipe.

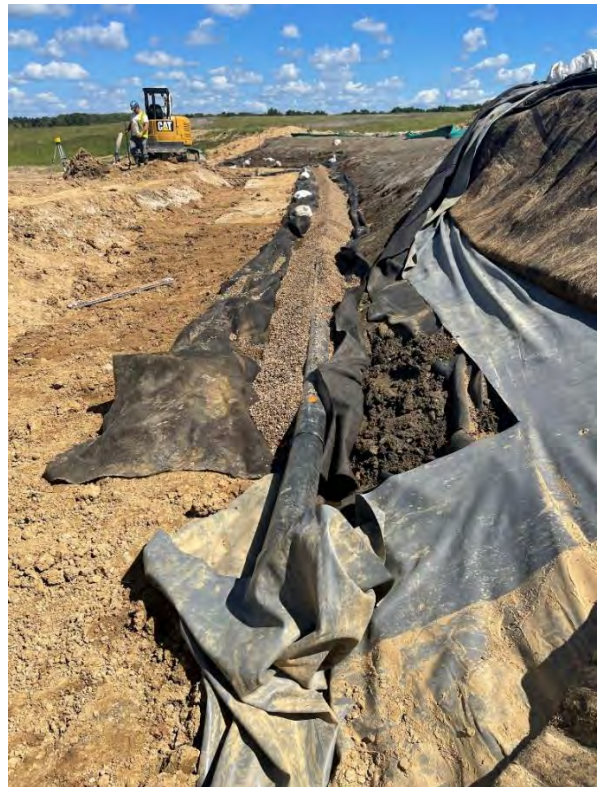
Photo 2: The underdrain pipe was surrounded with stone and wrapped with geotextile. Enerfab used a leister gun to thermal weld the geotextile together at the overlap.

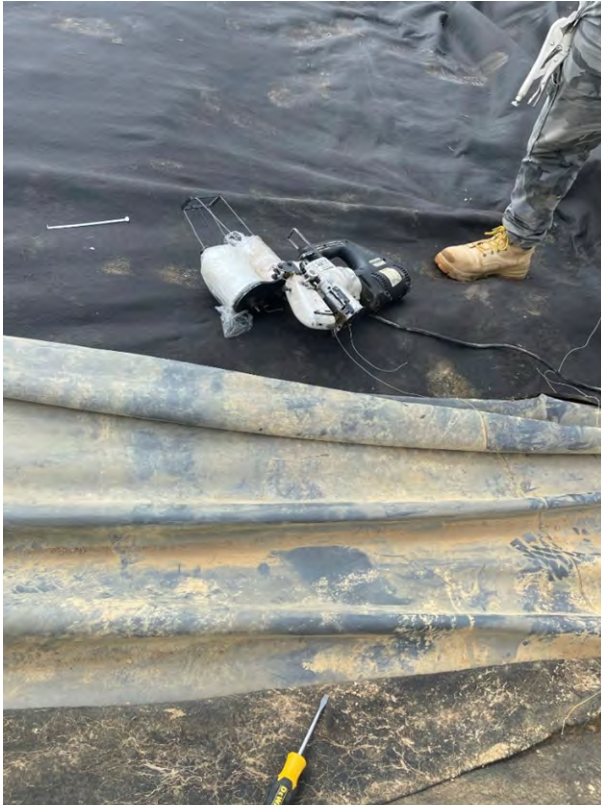
Photo 1: Sewing machine being used to stitch the geotextile panels together.

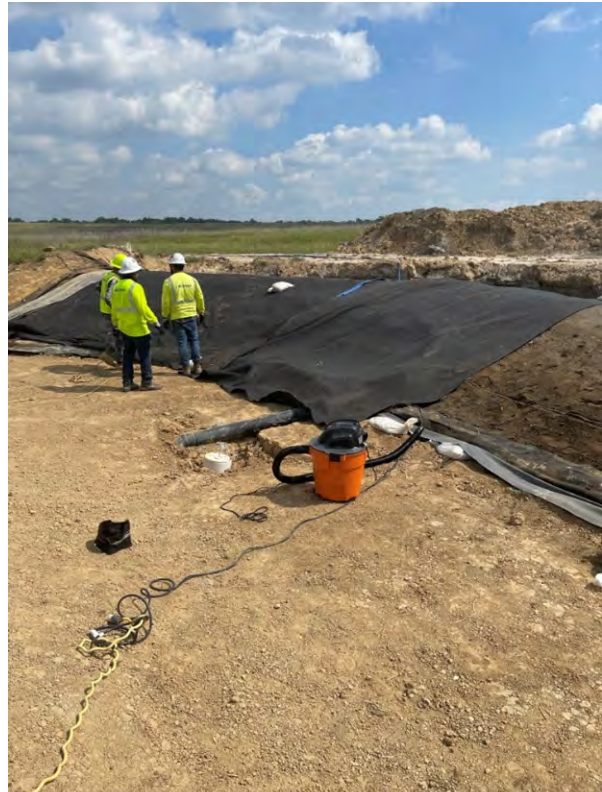
Photo 2: Looking north CCS has begun covering up the berm with geotextile.

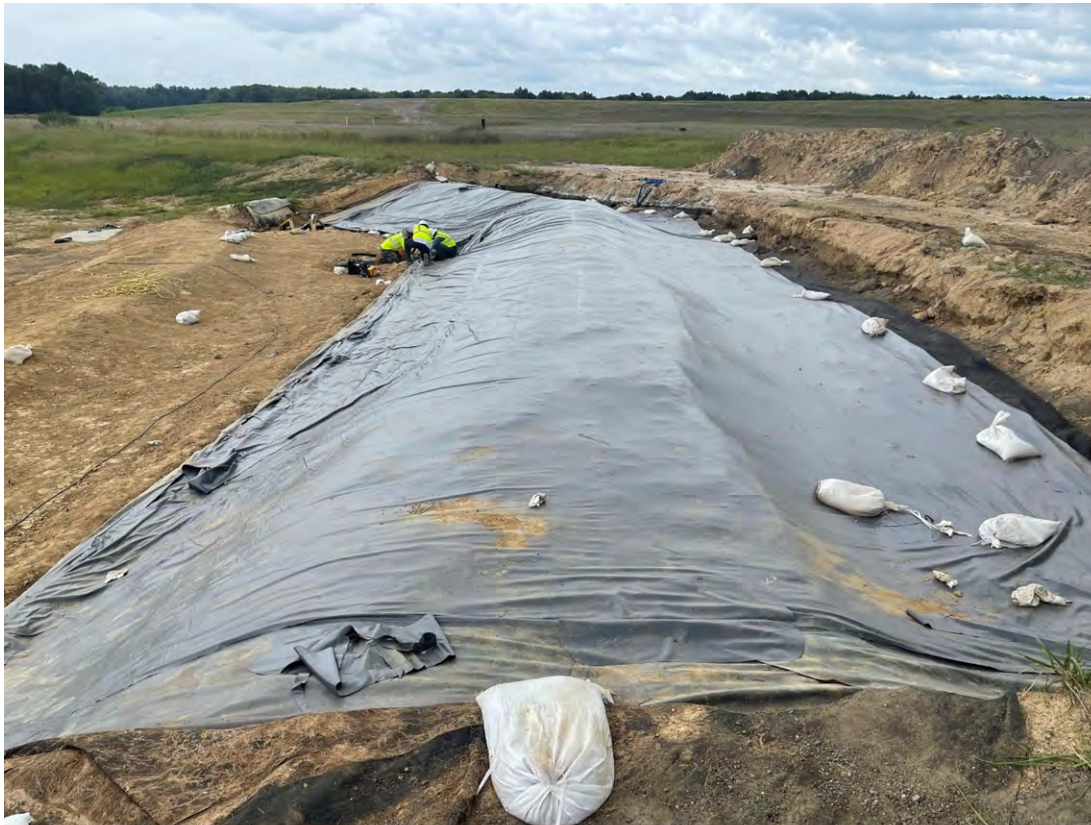
Photo 1: Looking north CCS deployed the PVC liner over the geotextile and bottom ash berm.

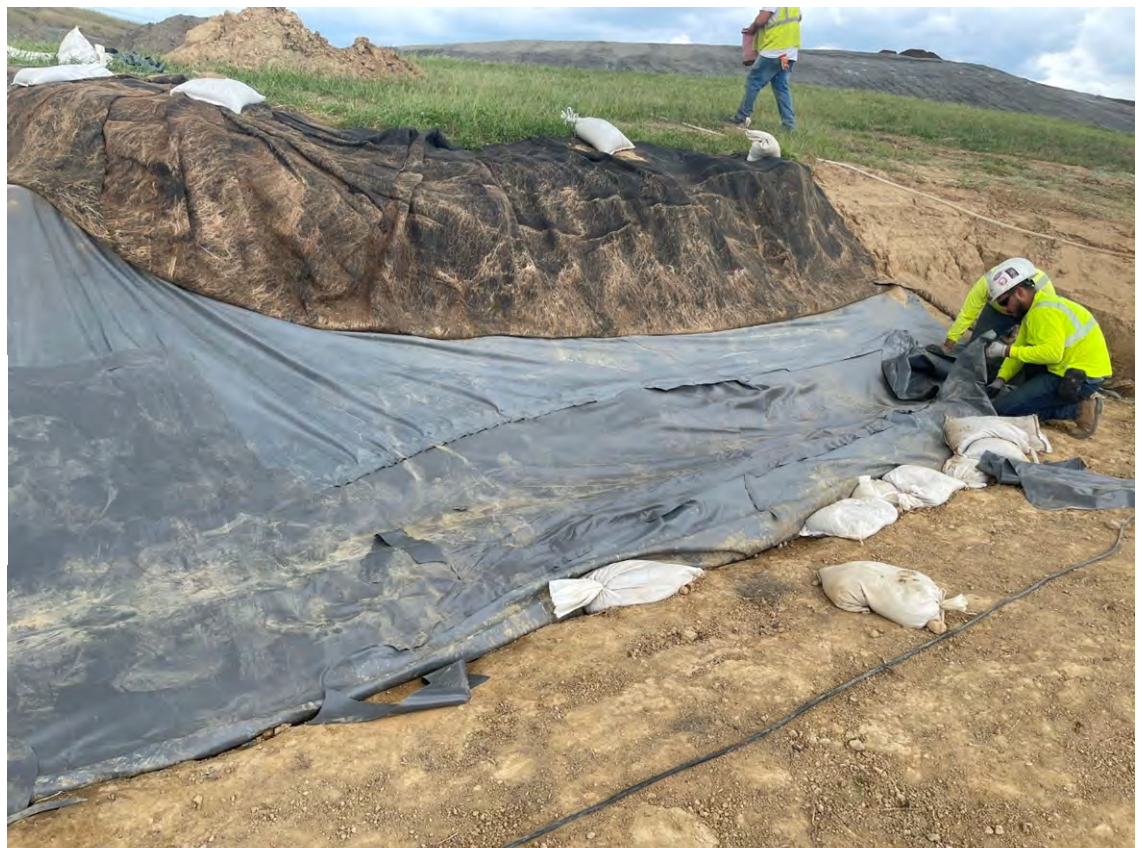
Photo 2: Looking at the south end tie-in points.

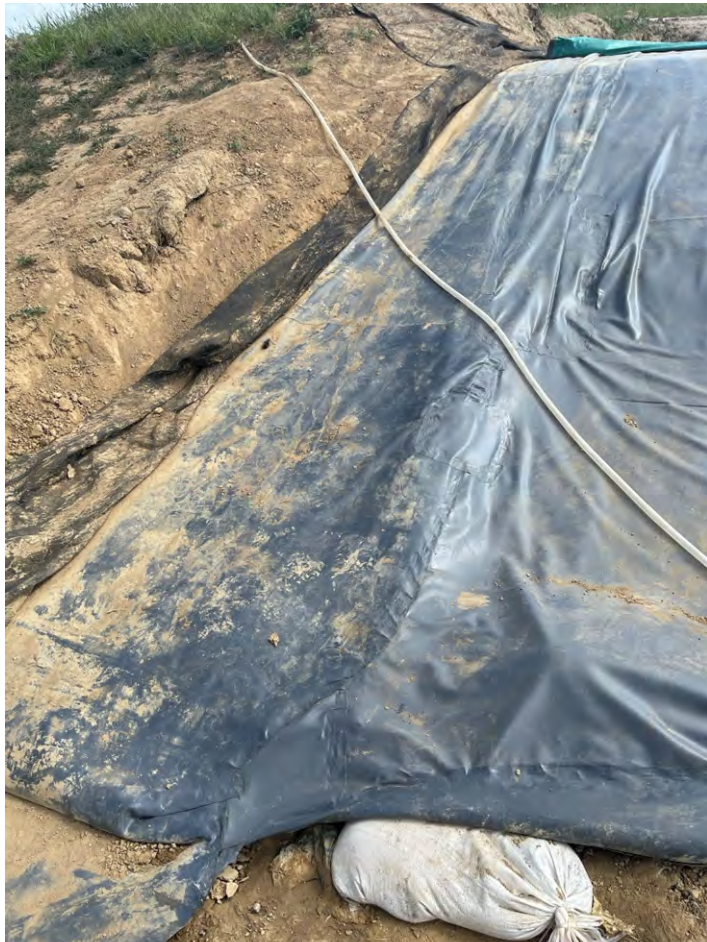
Photo 1: Looking at the north end the existing and new PVC liner has been fusion welded together.

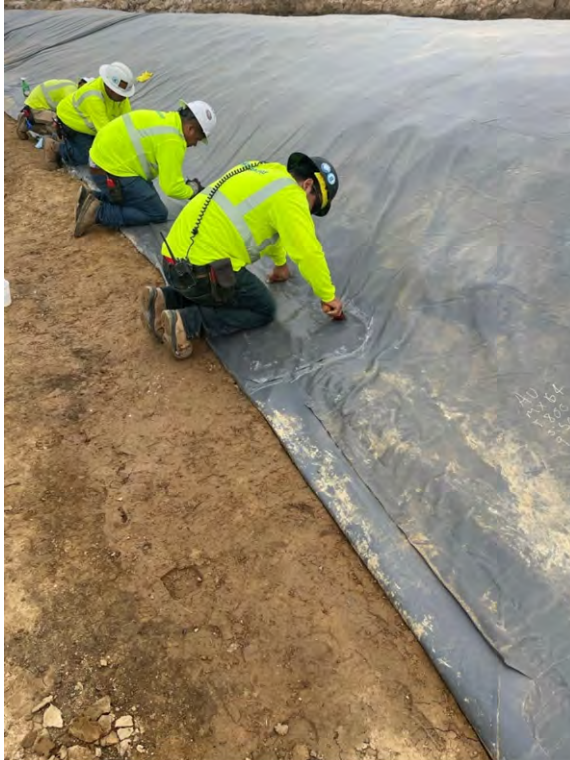
Photo 1: CCS removed and replaced the temporary leister repair at the toe of the berm with an adhesive patch.

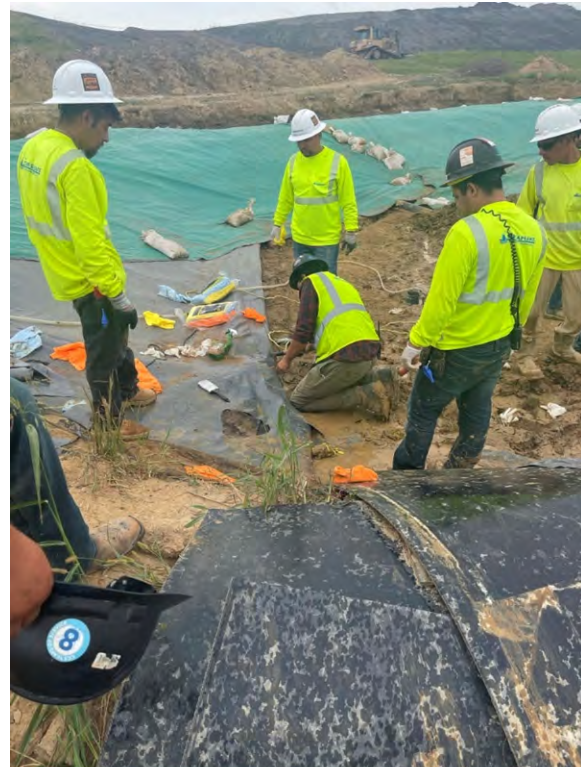
Photo 2: CCS working at the north end of the liner weld between existing and new PVC. The leachate in this area prevented a patch from being made today.

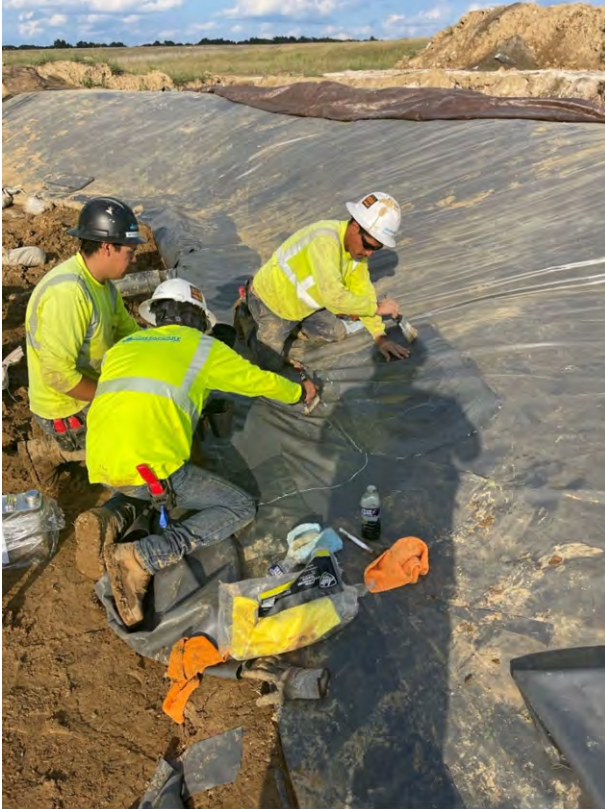
Photo 1: toward the south end CCS continues to replace the thermal welds at the toe of the berm with an adhesive repair.

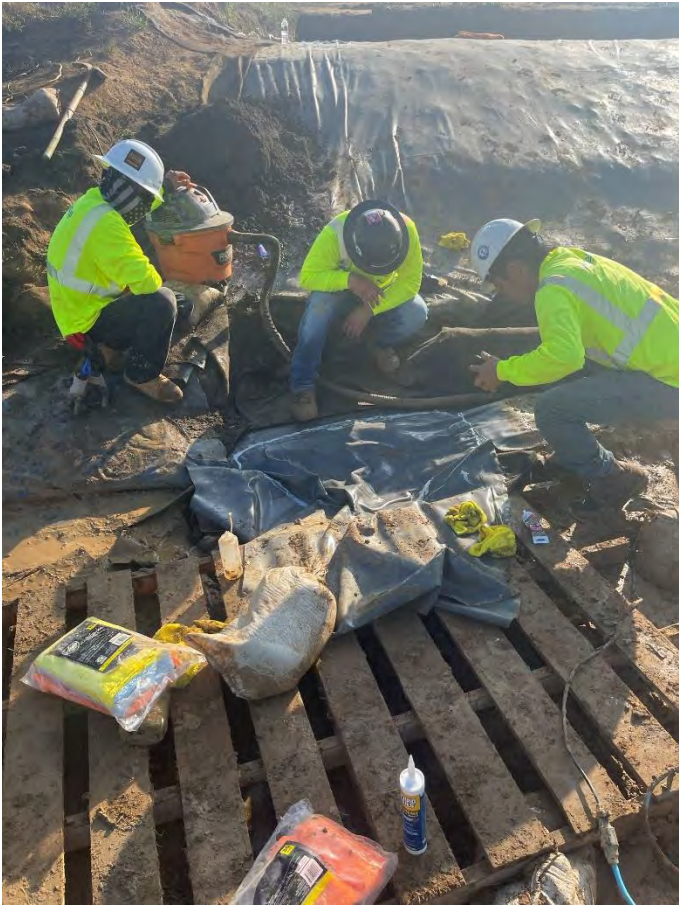
Photo 1: At the north end of the berm CCS is repairing the weld between the existing and new PVC liner.

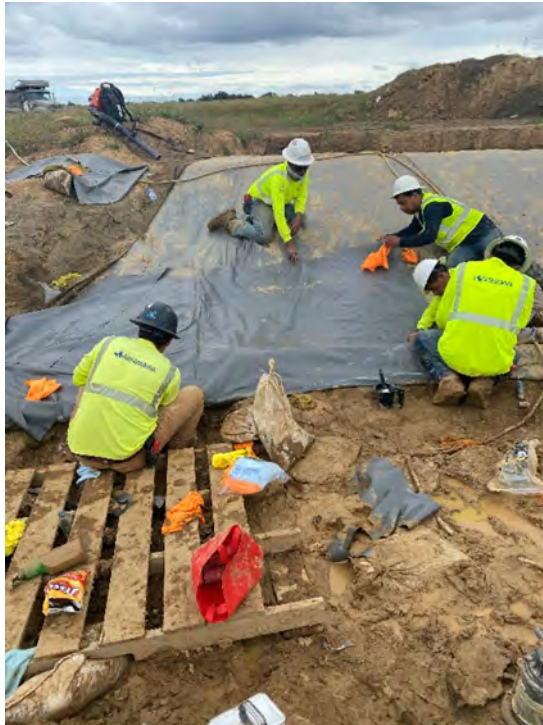
Photo 2: Preparing area to apply adhesive chemical patch.

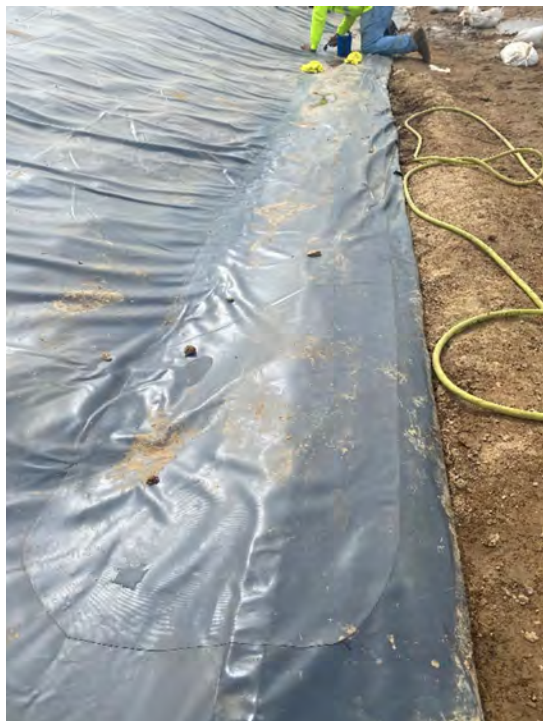
Photo 3: Applying chemical adhesive patch.

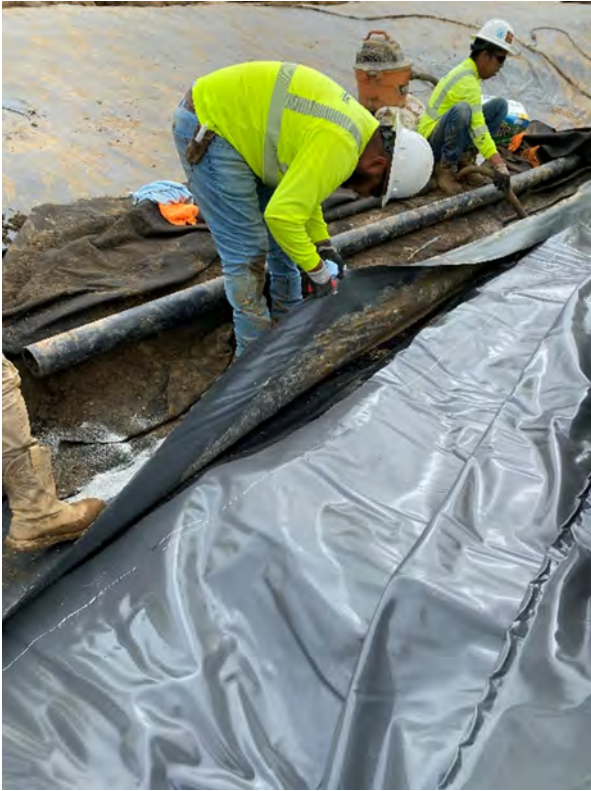
Photo 1: Placing new PVC panel to connect to existing floor liner.

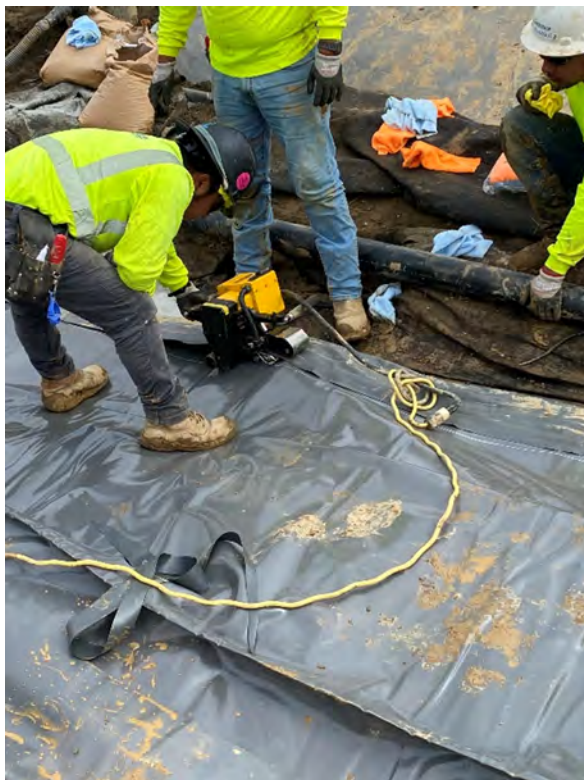
Photo 2: Wedge welding new PVC panel to existing floor.

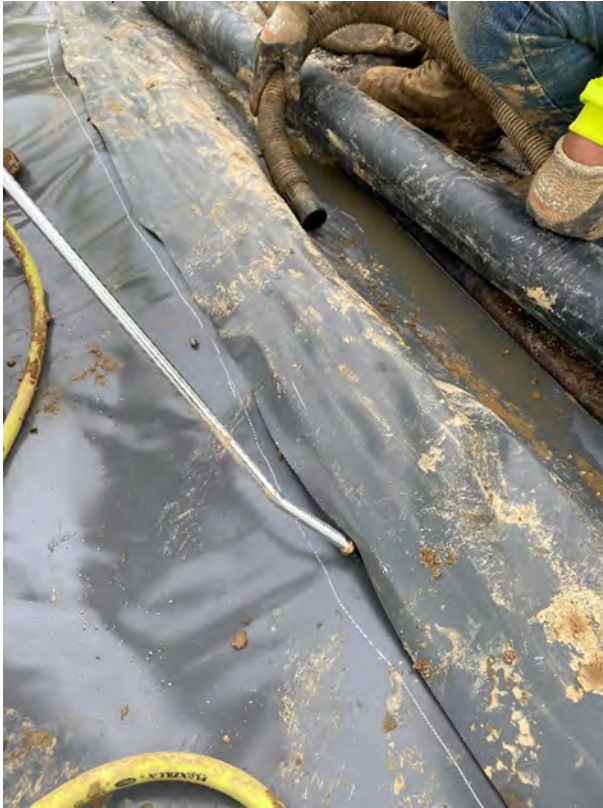
Photo 3: Air lance testing wedge weld seam at floor.

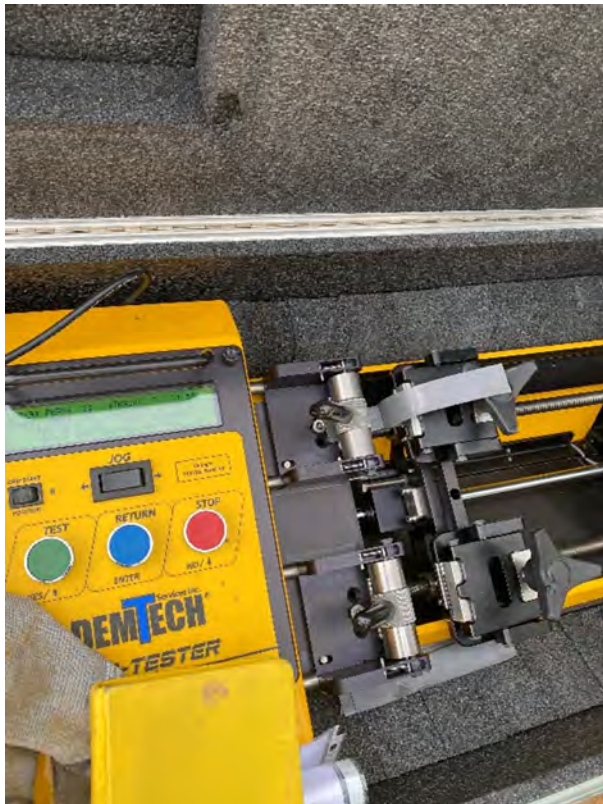
Photo 4: Field tests on fusion trial weld.

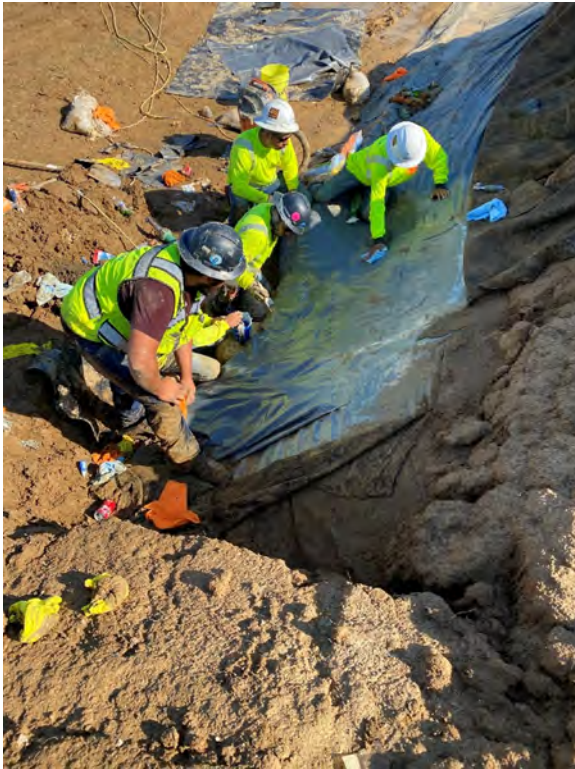
Photo 1: Placing new chemical patch over repaired area on south end of berm.

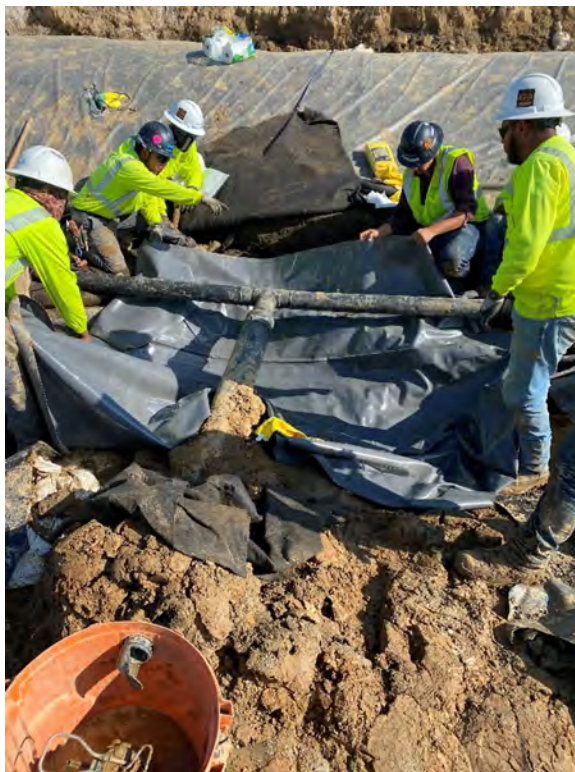
Photo 2: Adding PVC segments to begin construction of boot for outlet

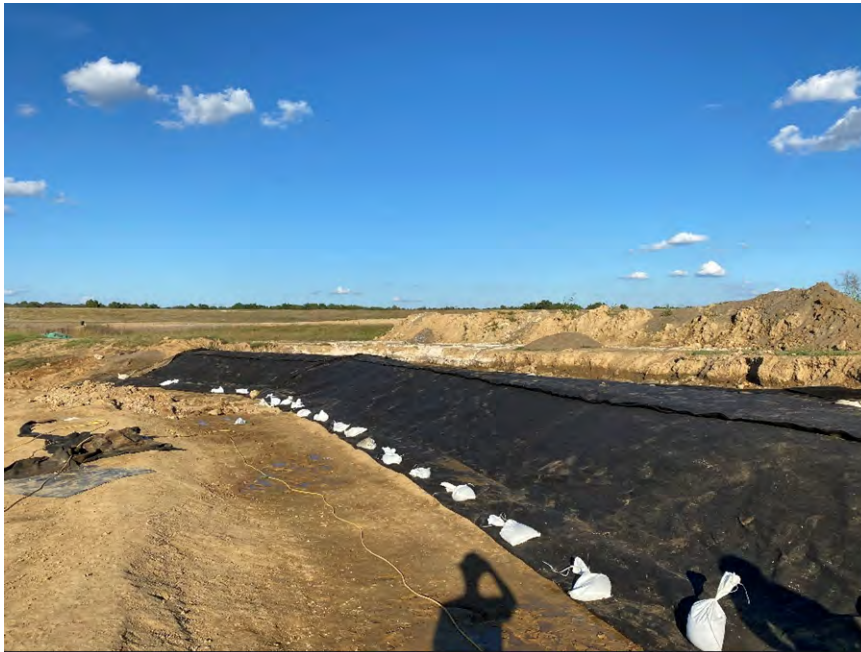
Photo 3: Geotextile fabric covering completed PVC geomembrane.

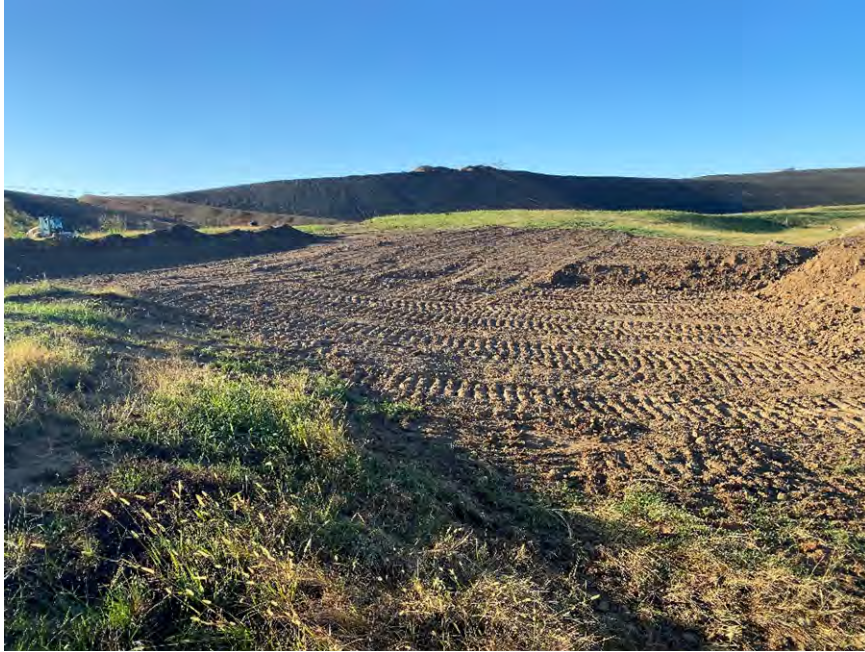
Photo 1: Clay backfill placed on berm on prior day.

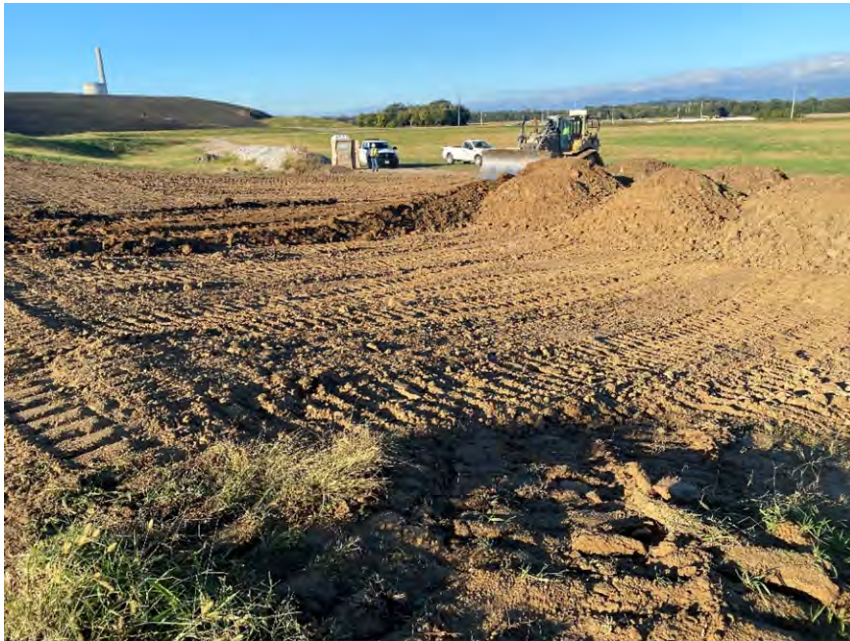
Photo 2: Topsoil stockpiled and ready for placement.
