**Rockport Fly Ash Landfill Deficiency Corrective  
Measure Report  
For  
Intermediate Berm Leachate Seepage**

**Indiana Michigan Power Company  
Rockport Plant  
Rockport, Indiana**

**November 2021**

**Document ID: GERS-21-070**

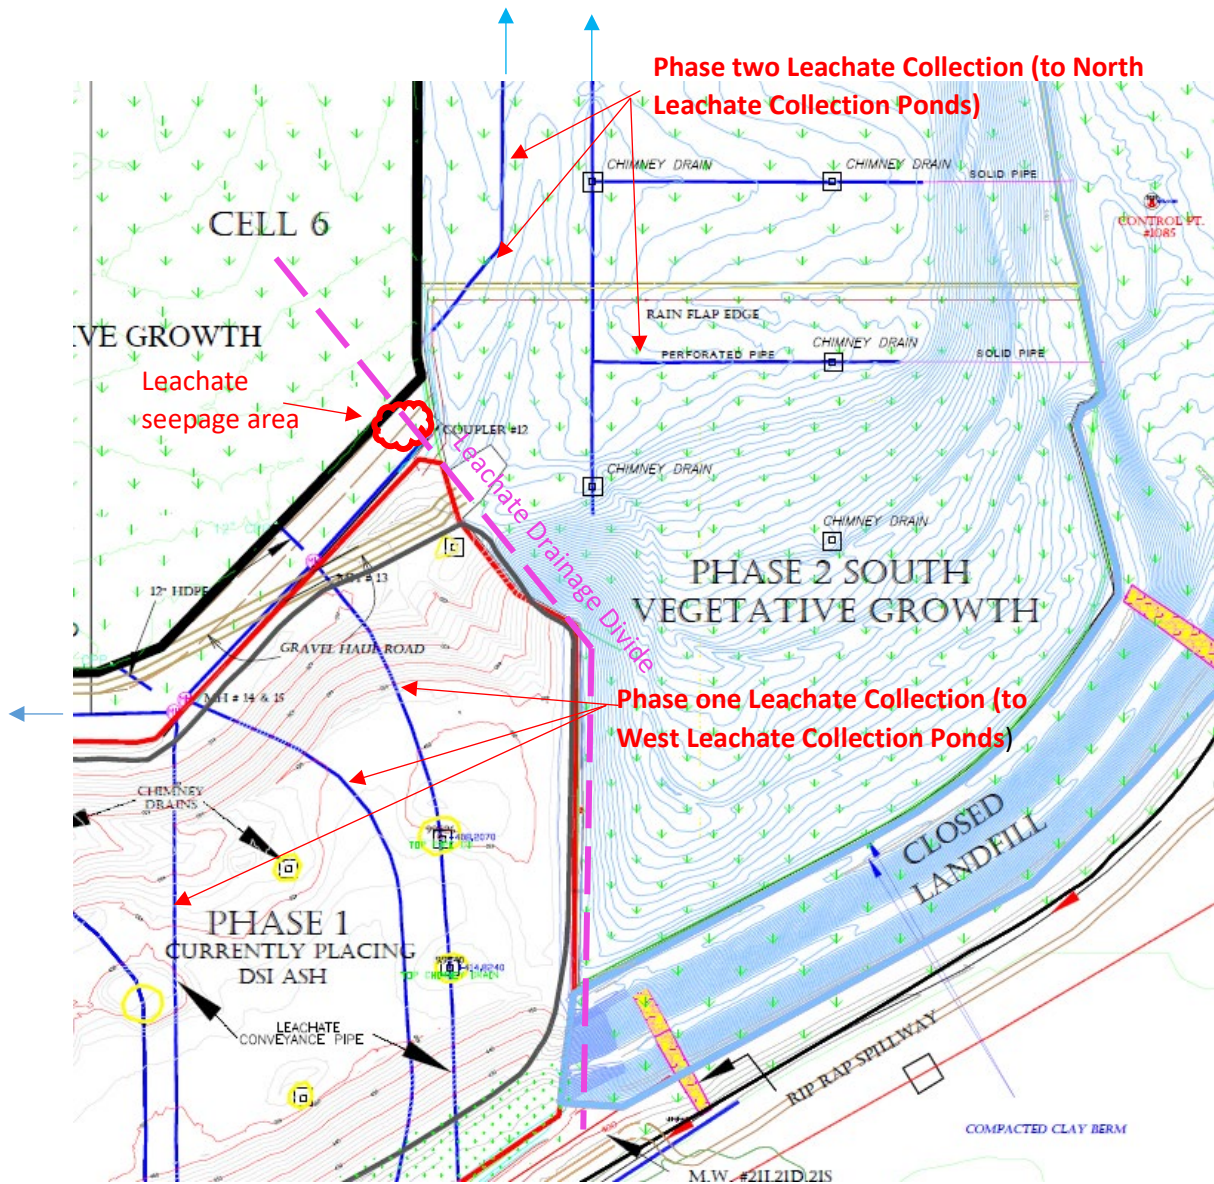
Figure 1: Site Plan Sketch

Leachate collected in Phase 2 is directed into the North Pond Complex. A blind flange that penetrates the intermediate berm is located about 100 feet to the north of the leachate seepage area is the farthest upstream component of the Phase 2 Leachate Collection System.

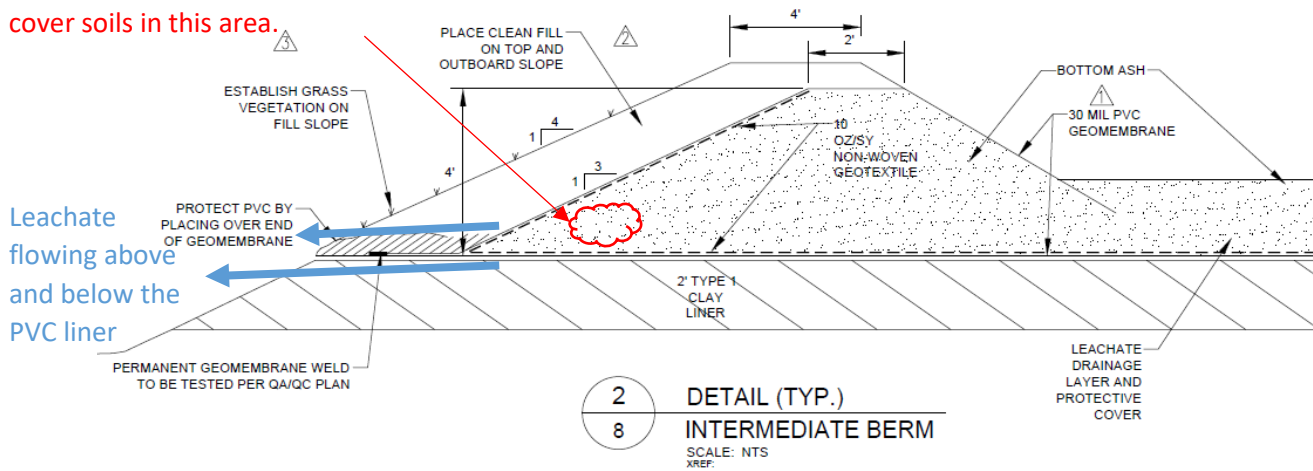
Figure 2: Intermediate Berm Cross Section. Reference Drawing 12-30470-3.

Trapped Leachate & pumping cover soils in this area.

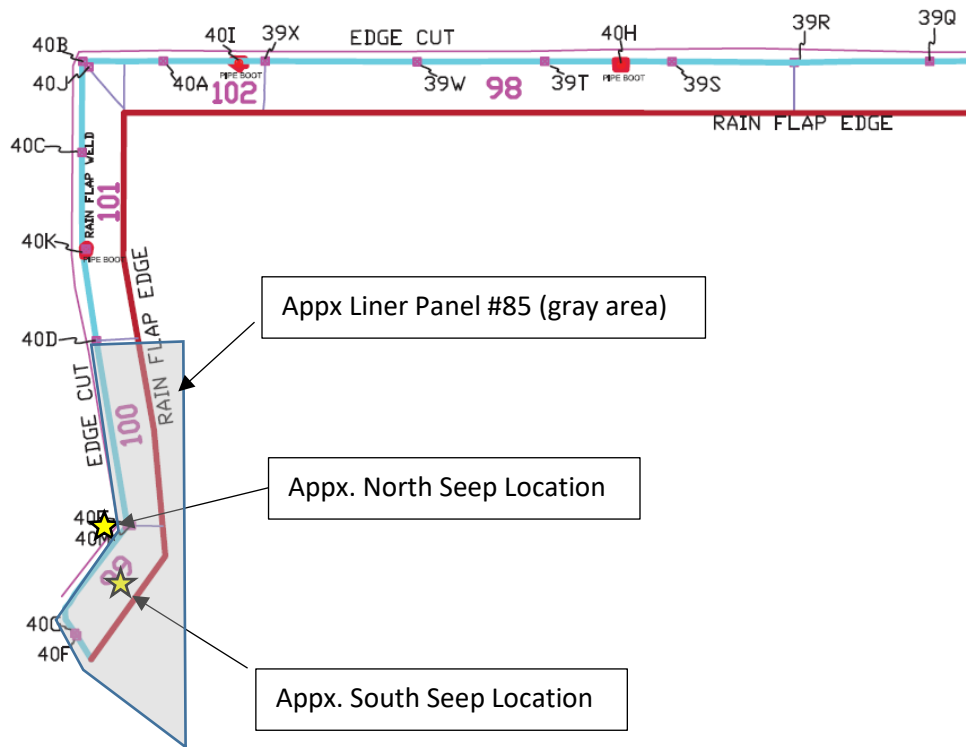
Figure 3: Approximate leachate seepage locations overlaid on Rain Flap Panel As-Built Drawing.

The 30 mil- PVC rain flap was seamed using hand leister methods. During construction, there was a Request for Information submitted concerning the need for destructive sample testing on the Intermediate berm Rain flap. Terracon responded by waiving the need for destructive testing on the rain flap, however, one sample of the hand leister seams for Rain Flap Panel 101 was destructively tested with passing results.

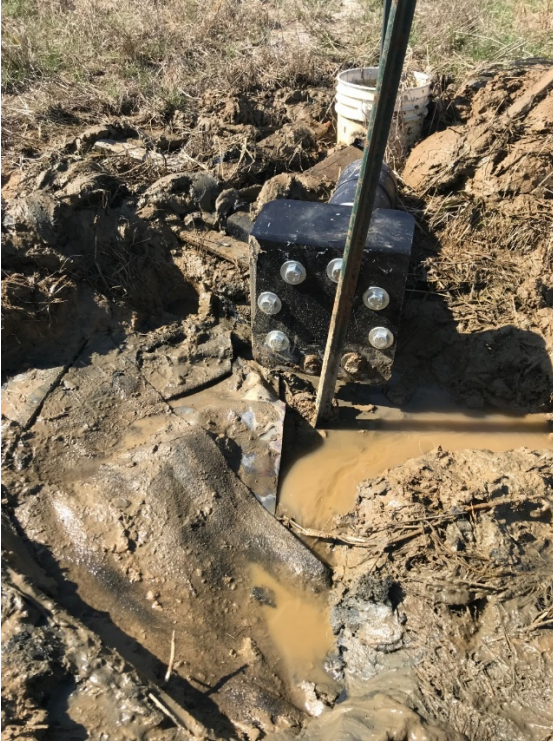
Photograph 1: View of the leachate seepage shortly after initial discovery in the area around Quick Connect #12.

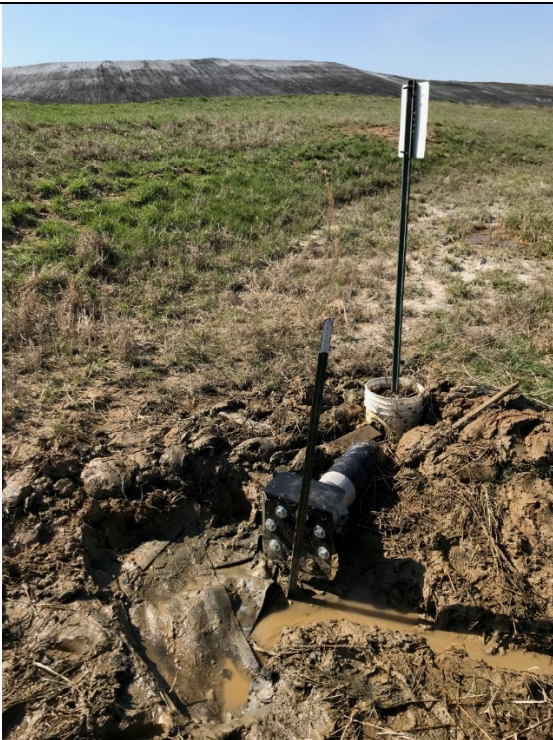
Photograph 2: Another view of the leachate seepage shortly after initial discovery in the area around Quick Connect #12, with the active Phase 1 area in the background.

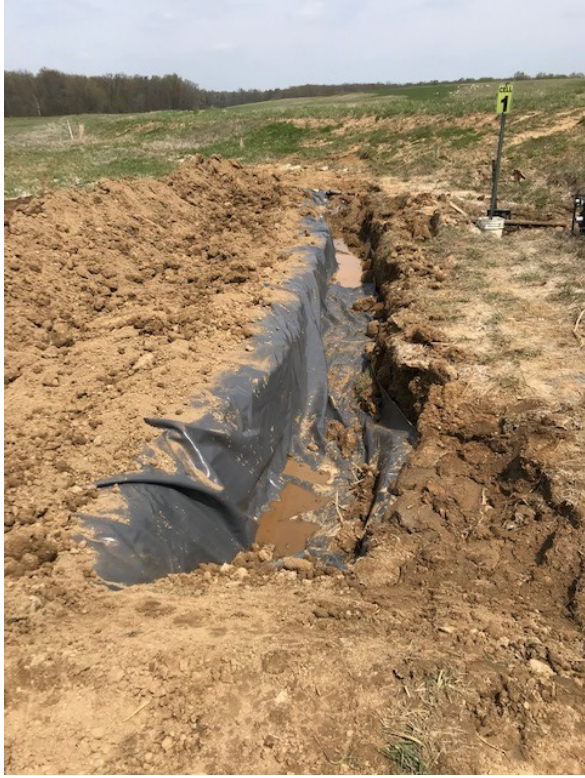
Photograph 3: View of the temporary leachate collection trench excavated upon initial discovery of the leachate seepage issue.

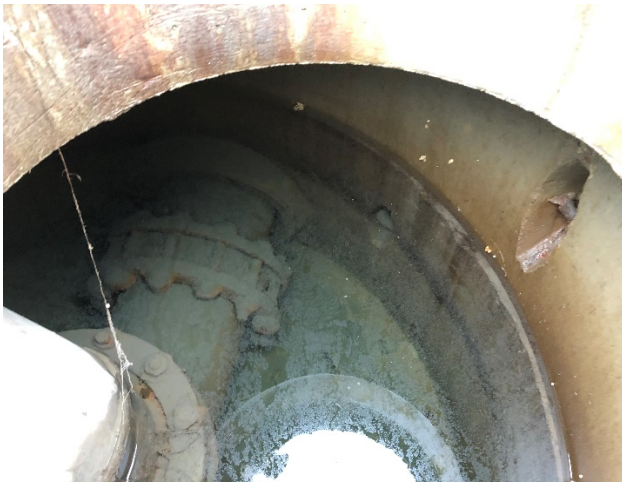
Photograph 4: View inside Manhole #13 before pumping out the standing (clean water).

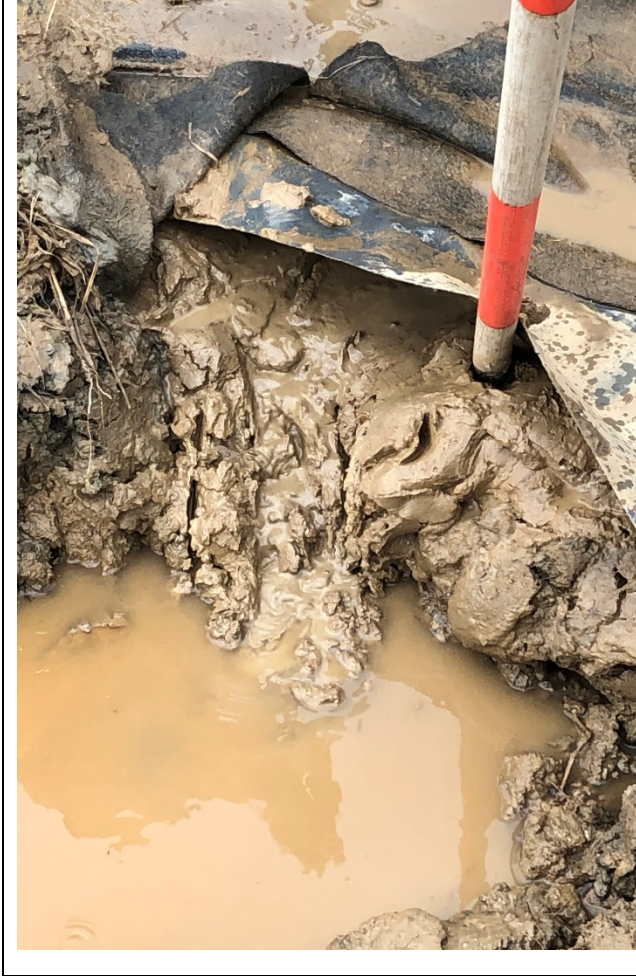
Photograph 5:

Close up view of the exposed PVC liner at the exterior toe of the intermediate berm. Notice the water flowing under the liner.

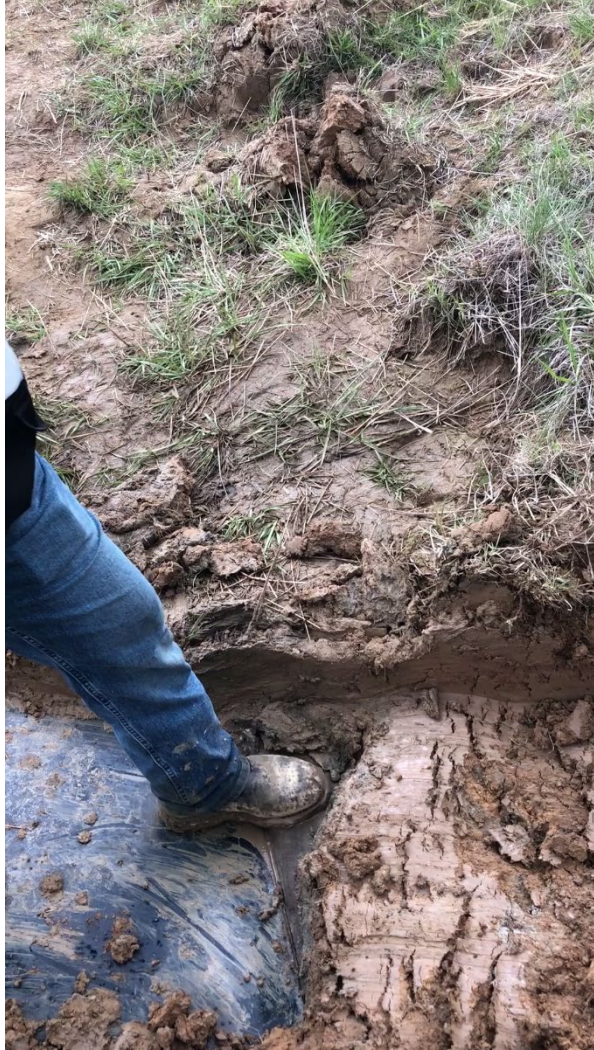
Photograph 6: View of the trapped leachate water between the PVC geomembrane layers of the intermediate berm.

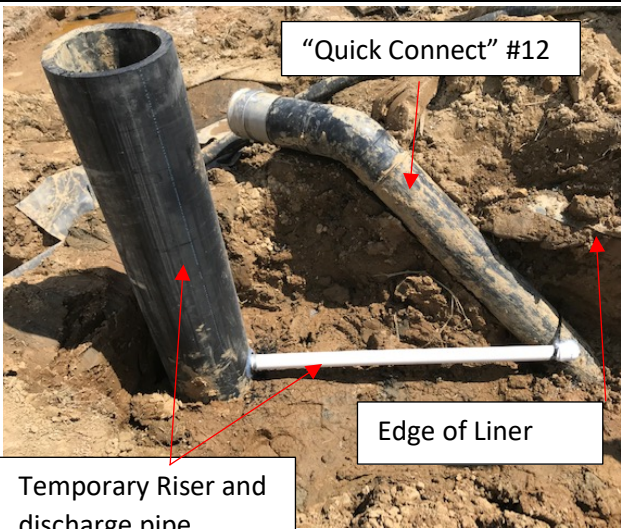
Photograph 7: View illustrating the temporary measures installed to collect the leachate seepage and convey into the leachate conveyance system at Quick Connect #12.

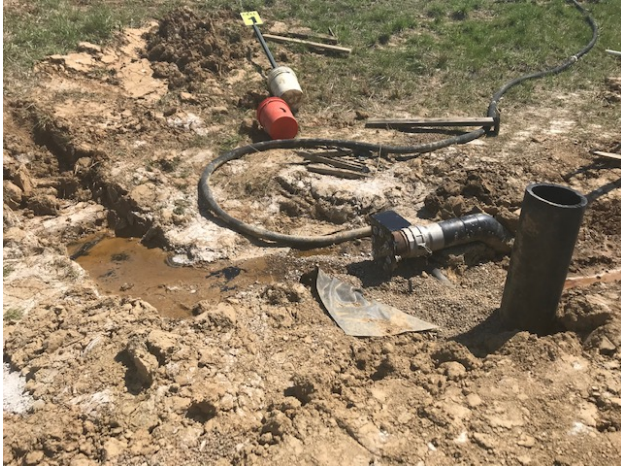
Photograph 8: View of the French drain being built to collect the leachate seepage and direct into the riser pipe. Notice the piece of PVC geomembrane under the French drain stone.
