# 2021 Annual Dam and Dike Inspection Report

**Fly Ash Pond**

**Big Sandy Plant  
Kentucky Power  
Lawrence County, KY**

**September 27, 2021**

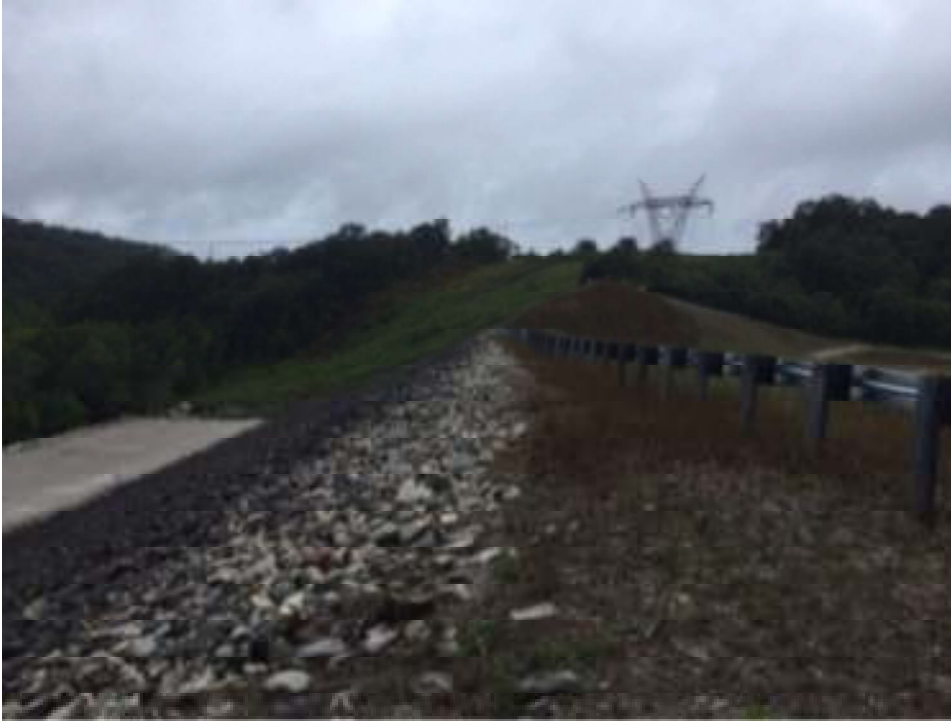
General condition of downstream slope and crest looking east

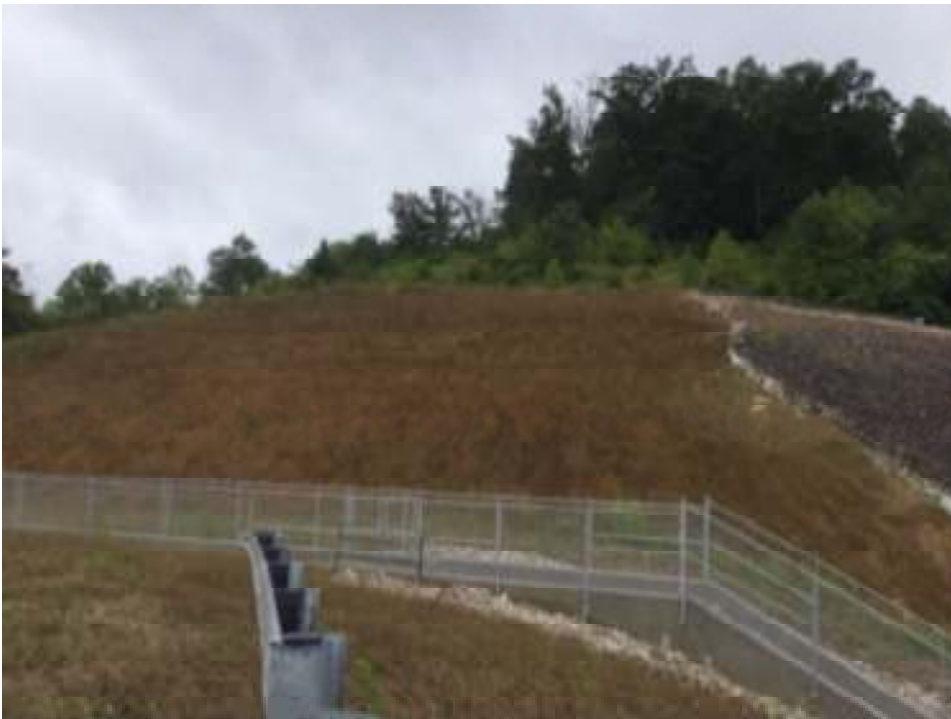
- 14) The left downstream abutment impacted by the construction of the new concrete spillway. The area did not show visible signs of instability. Area appeared to be in fair condition but needs to be re-seeded.

General condition of the left abutment with Main Spillway in foreground.

- 2) Re-seed the crest and areas of the upstream and downstream slope as required to establish appropriate vegetation.

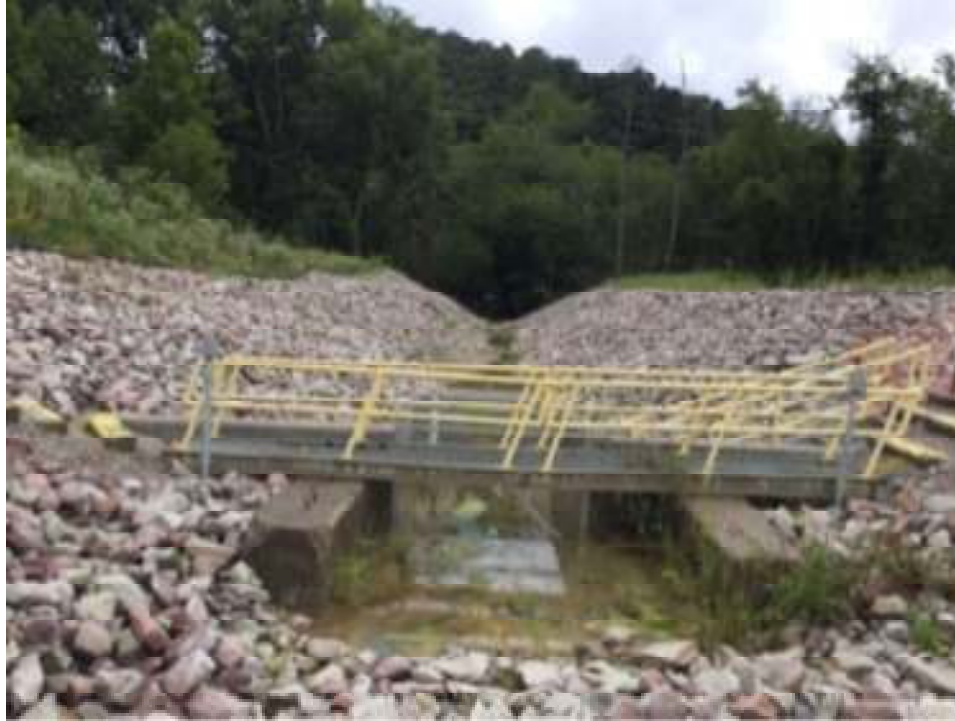
Photo #: 21

The discharge spillway looking looking north from the plunge pool rock berm. Walkway across main channel to access seep monitoring

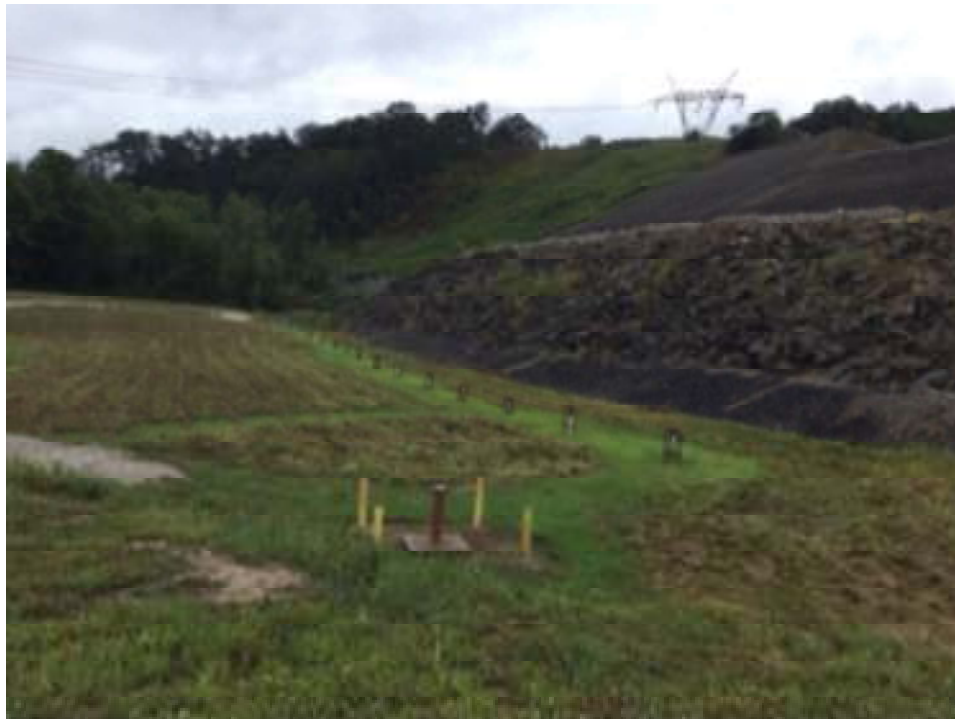
Photo #: 22

General condition of toe and downstream slope of 590 buttress.

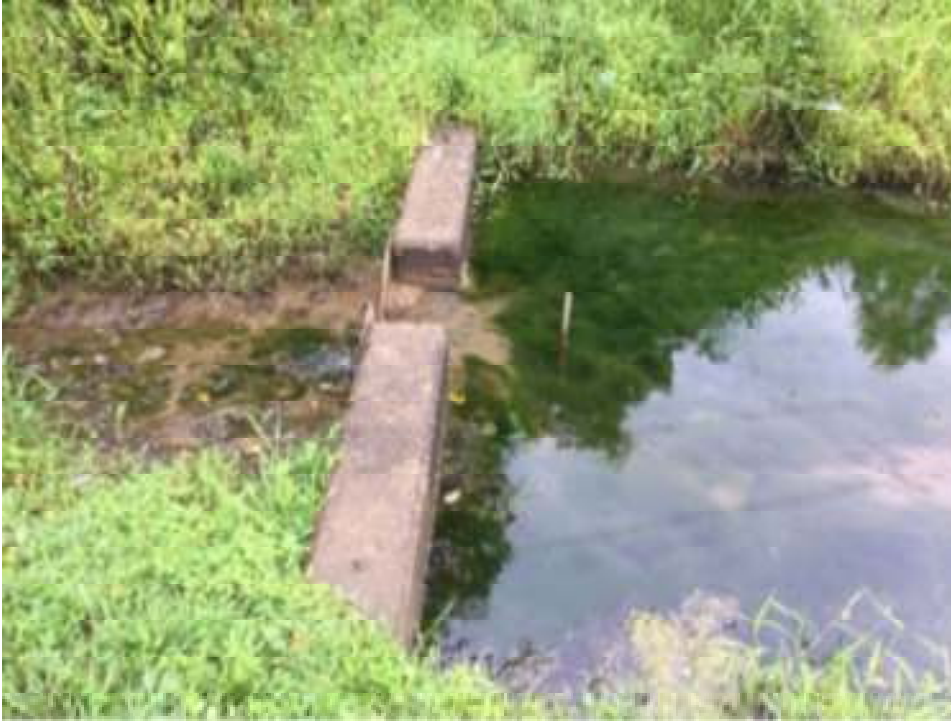
General condition of of seepage channel outfall 018 (right toe)

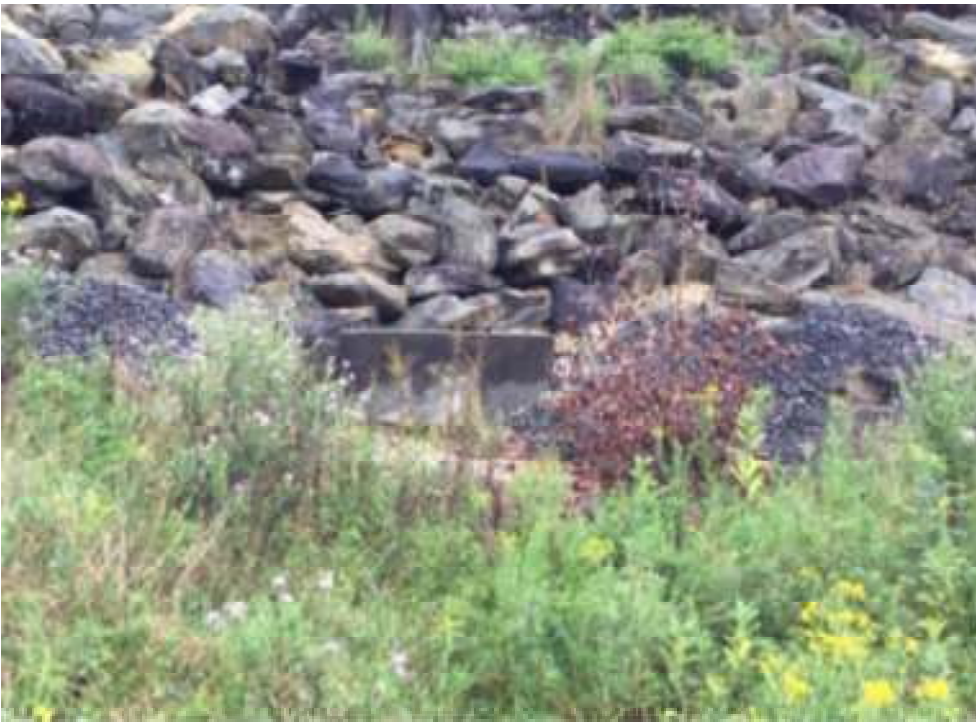
Photo #: 24

- 18) The v-notched weir (Outfall 018) and channel on the right downstream side of the dam was functional and good condition.
- 19) The abandoned outfall pipe located near the middle of the stone buttress did not show any signs of seepage around or through the grouted pipe.

General condition of old outfall pipe. No signs of seepage.

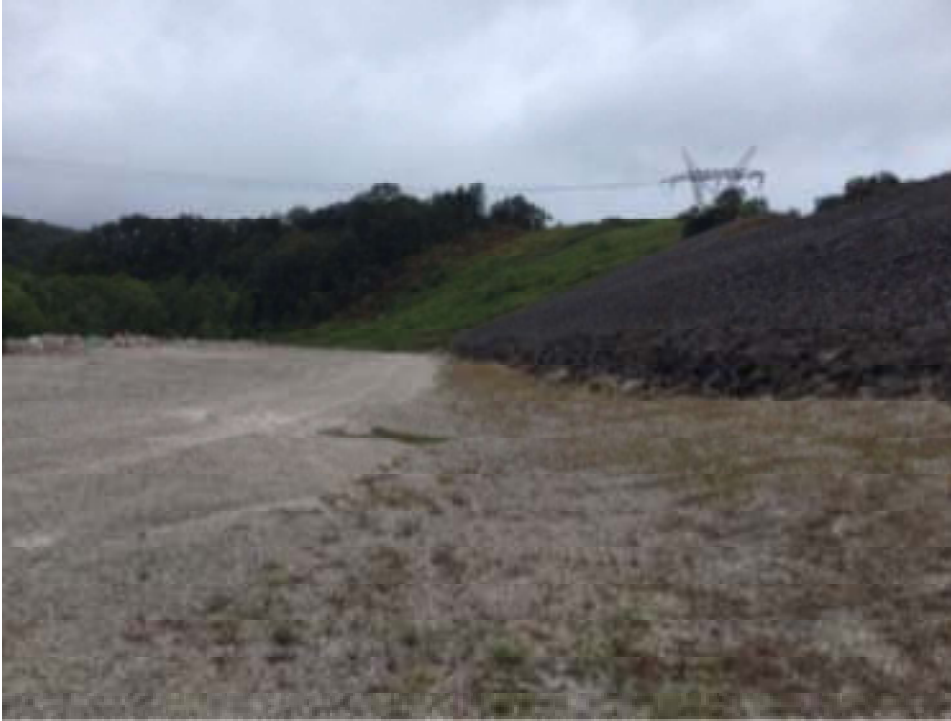
General condition of top of 590 buttress crest at toe of dam raising looking east.

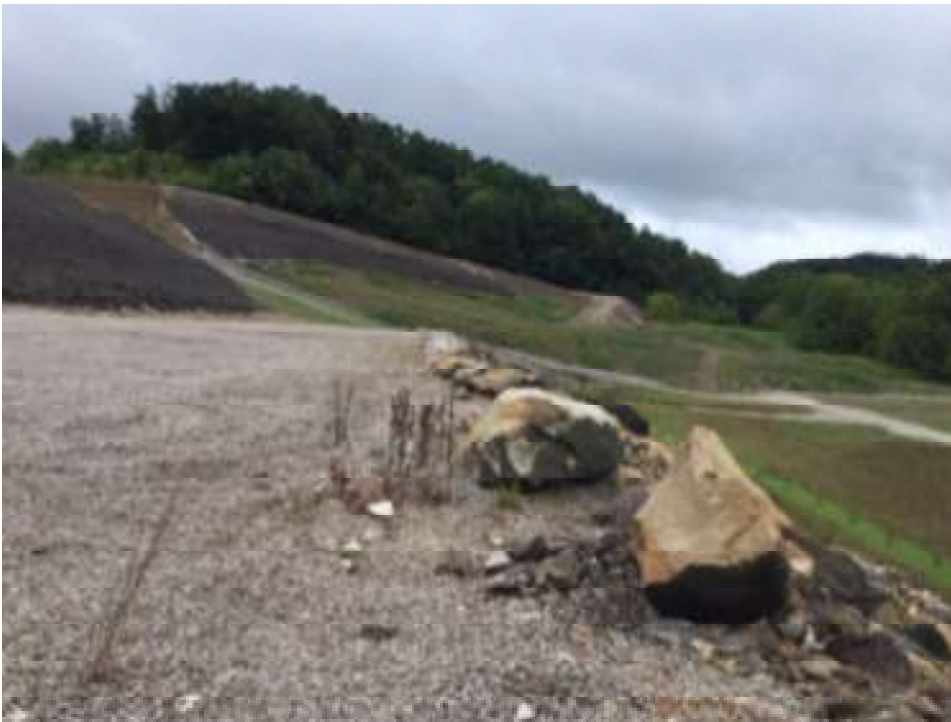
Photo #: 26

General condition of 590 buttress crest looking west.

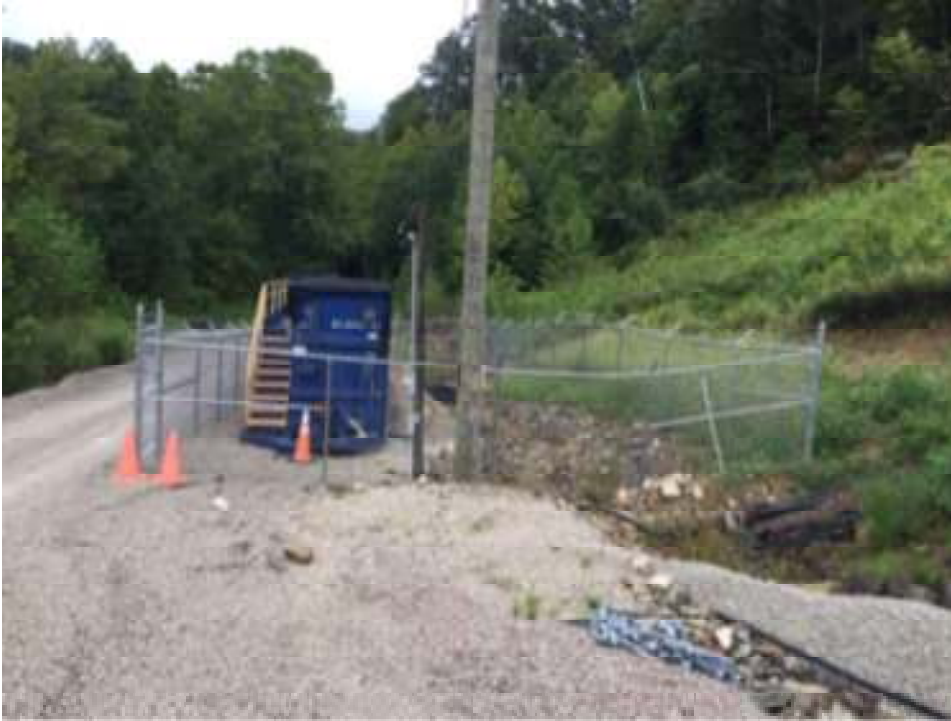
- 20) The seep collection system at the right downstream groin and the 590 berm appeared to be in good condition. This seep has historically had a red coloring and was pumped back to the main pool for discharge. A permanent treatment system has been installed and the discharge directed to flow to Outfall 018.

General condition of red water treatment system looking East

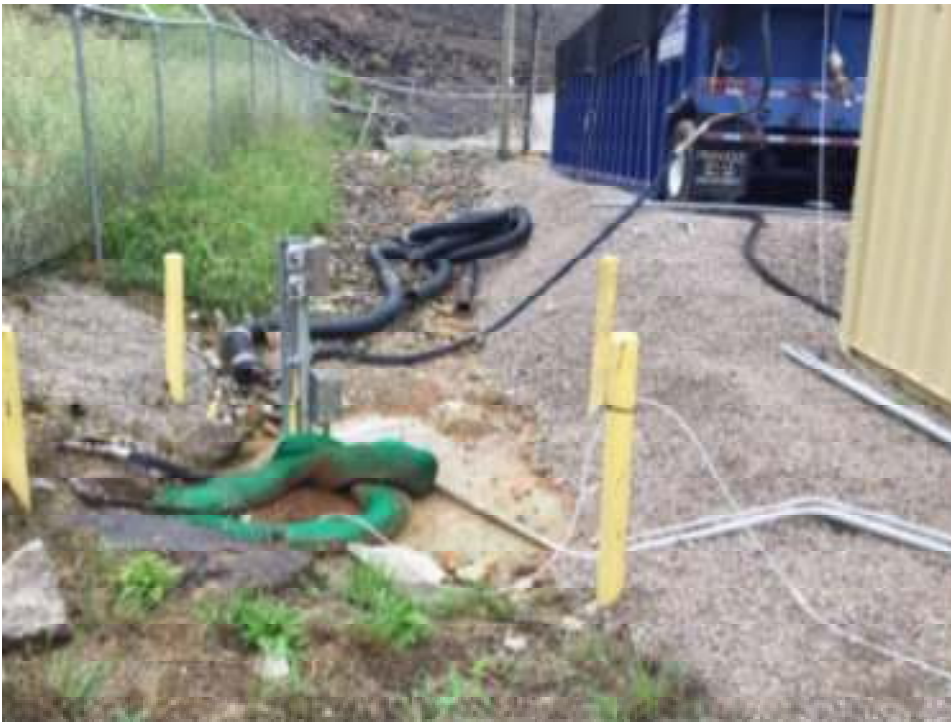
Photo #: 28

General condition of red water sump and drain channel. Area needs general housekeeping.

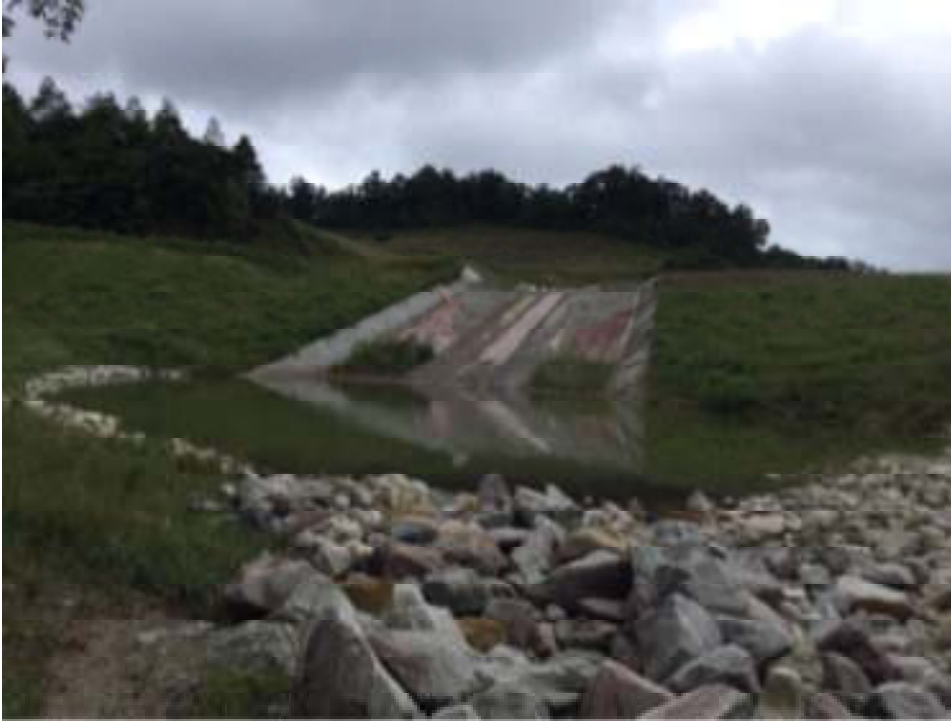
Photo #: 31

Notes: Looking southeast at Auxiliary spillway across plunge pool

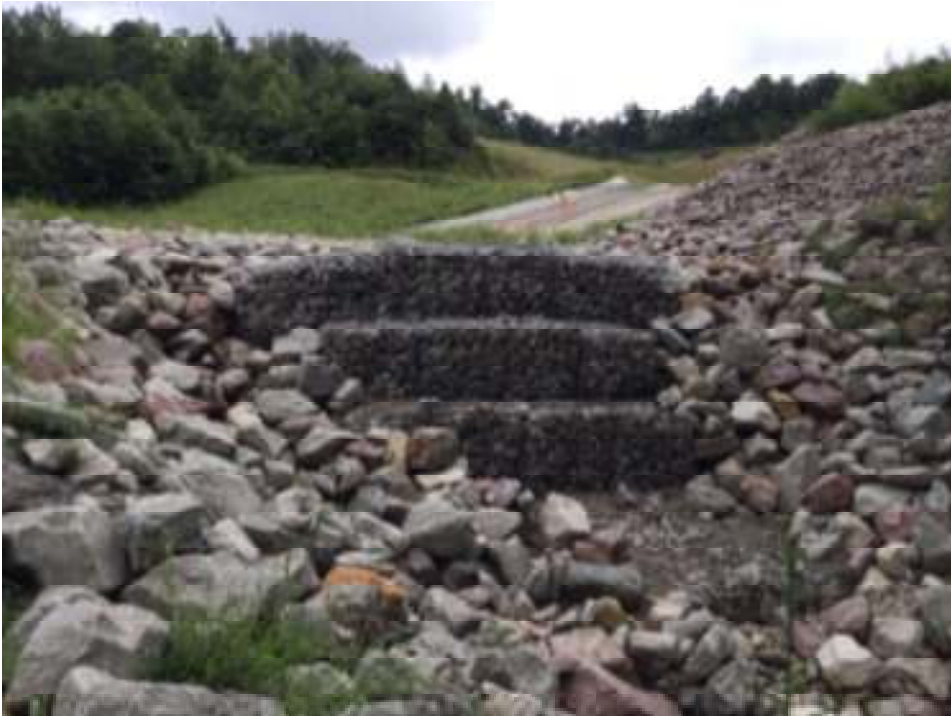
Photo #: 32

- 1) The articulated concrete block mat structure that forms the Auxiliary Spillway is in general condition.
- 2) Vegetation is already starting to appear in the open areas of the concrete blocks.
- 3) The undrain pipes are flowing but appear to be discharging discolored red water. Including the build-up of precipitate on the concrete.
- 4) The plunge pool and downstream area appears to be stable.

Notes: General condition of downstream side of Auxiliary spillway plunge pool discharge

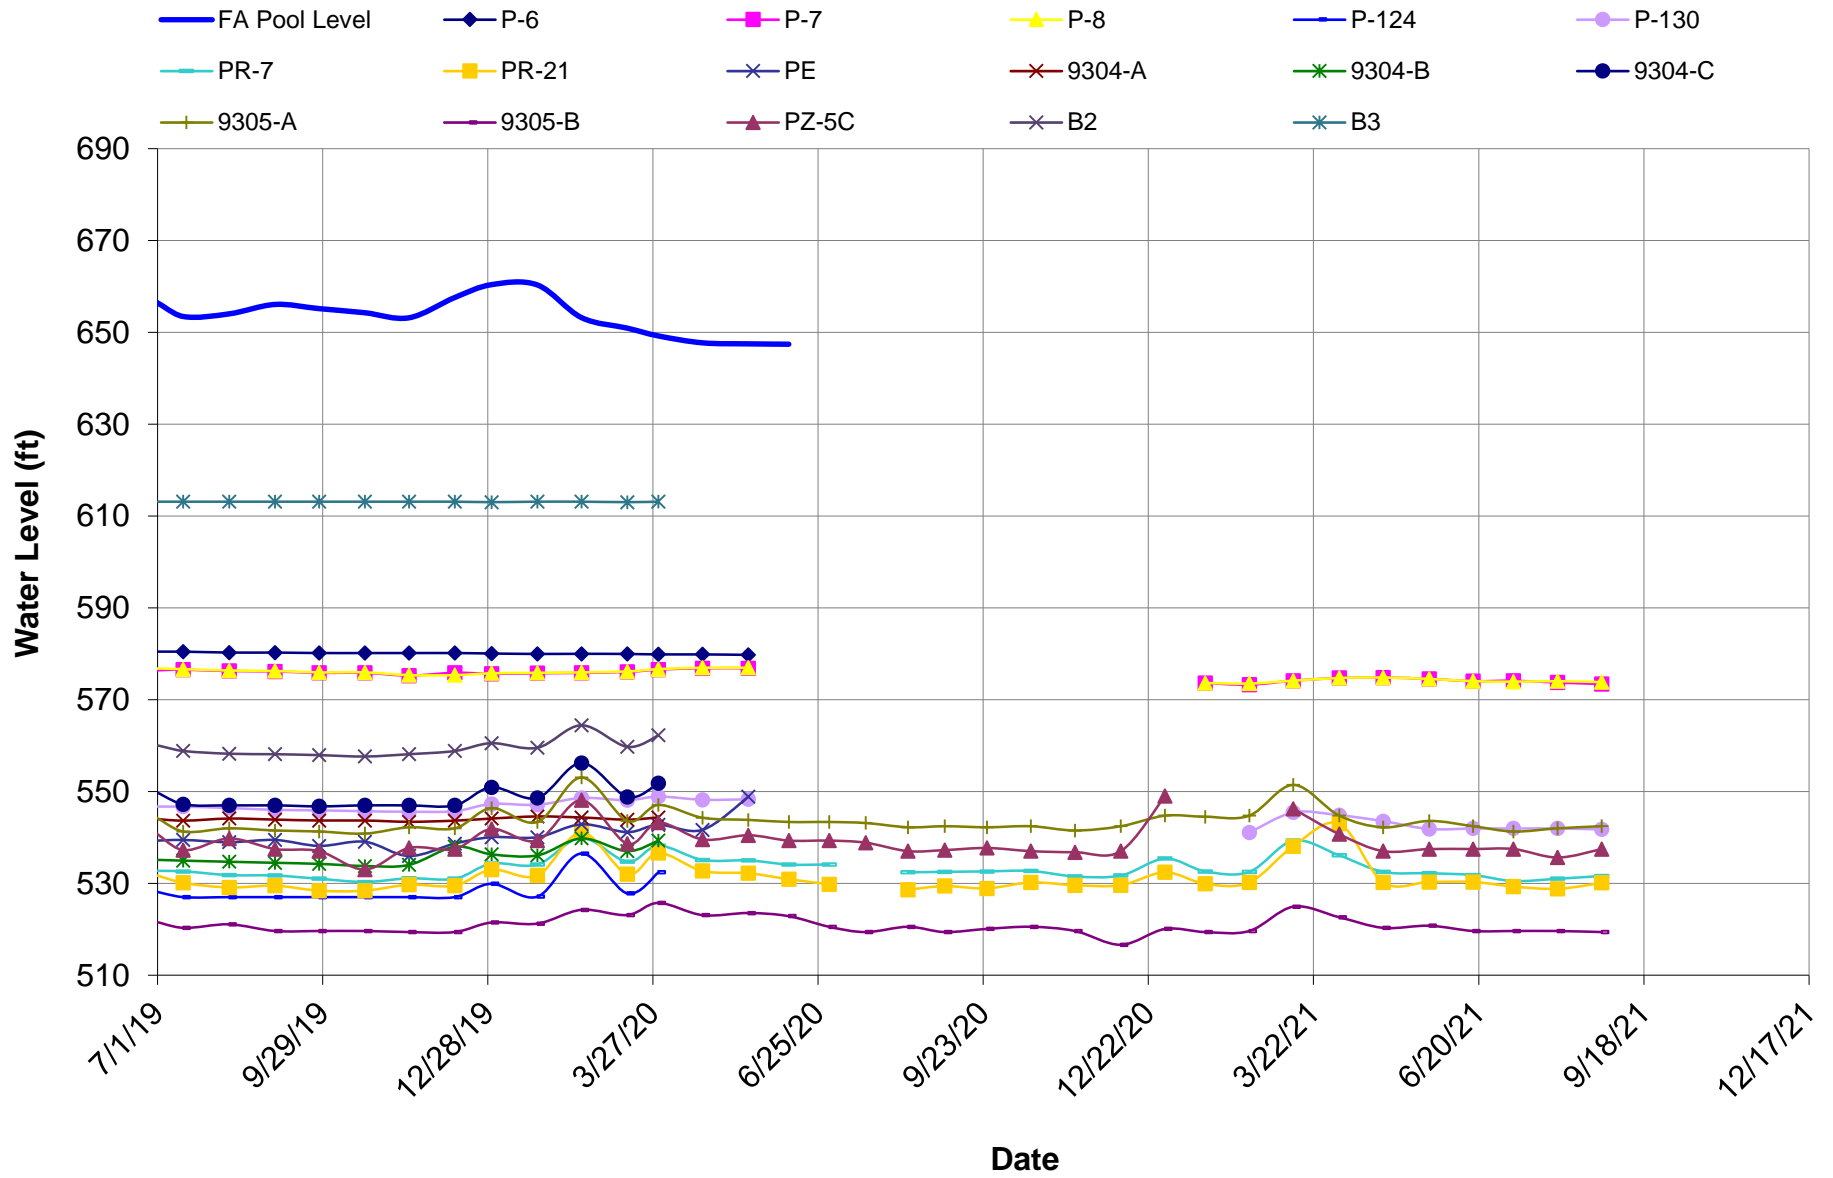
**Figure 4**  
**Big Sandy Plant - Fly Ash Pond**  
**Active Piezometer Water Levels**

Piezometers readings have generally stabilized since the last inspection after trending lower between the 2019 and 2020 inspections likely related to the lowering of the pool behind the dam. The common maximum reading for several piezometers of 3/11/21 corresponds to a high water event on Blaine Creek and the Big Sandy River. Figure 4 showing the piezometer readings is included in Attachment C. As noted in the previous inspection report nine Piezometers were closed and no longer monitored as part of the lowering of the main dam. Additionally, several of the piezometers were inaccessible during construction and the top of casings were lowered as part of construction.
