# **2021 Annual Dam and Dike Inspection Report**

**Clinch River Ash Pond 1A/1B**

**Clinch River Plant**  
**Ash Pond 1A/1B Dam**  
**Annual Engineering Inspection Report**  
**Document Number: GERS-21-071**

**Inspection Date: October 27, 2021**

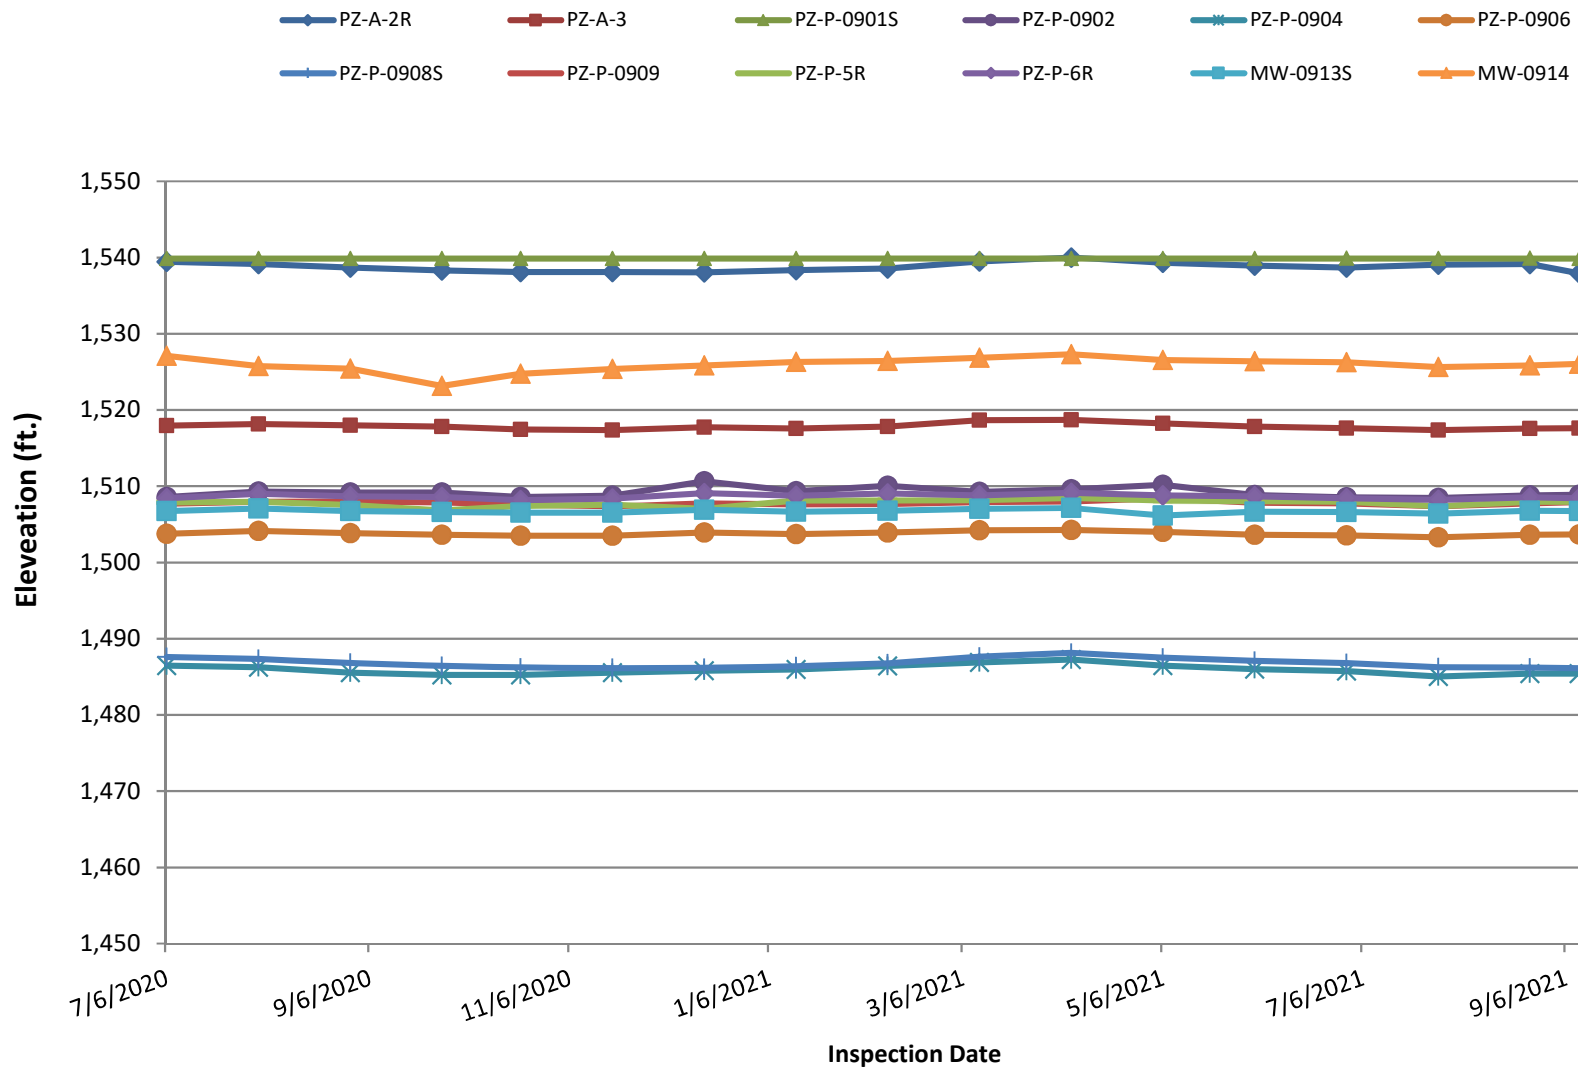
FIGURE 3: Pond 1 Piezometer Readings

In general, the piezometer data indicates no significant changes in the phreatic surface in the embankments. As a result of the pond closure project, several of the piezometers have been abandoned. The table below identifies the piezometers that remain and includes the maximum value/date recorded since the last inspection. Piezometers which are representative of specific cross sections through the dam have been plotted and shown in Appendix B. Piezometers that are shaded in the table below are located along the toe of the dike.

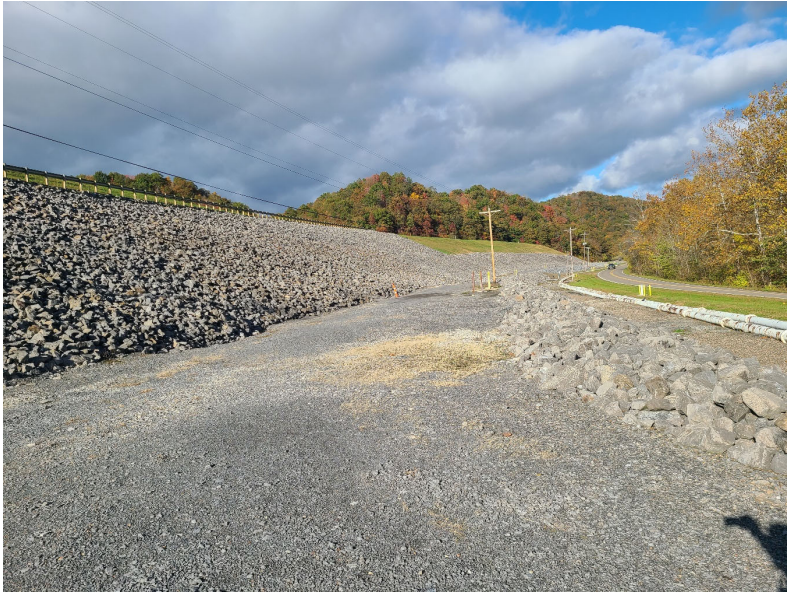
1. In general, there were no signs of slope instabilities, uncontrolled seepage, or erosion of the downstream slopes of the dam. The slopes are covered with a combination of riprap and vegetation. Vegetation is adequate and was recently mowed before the inspection. The condition of the riprap appeared sound and there was no displacement of the riprap. [photos 1-4]

Photo #1 – exterior slopes of Ponds 1A and 1B

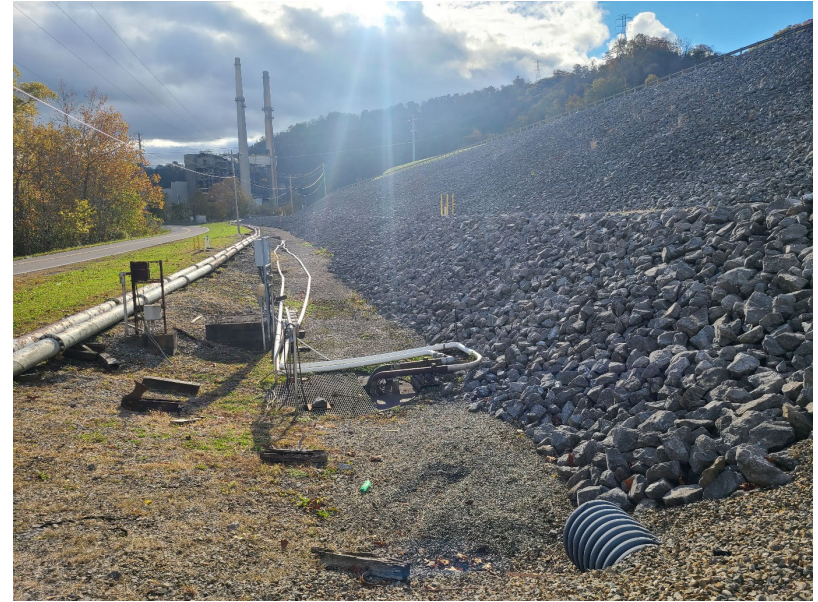
Photo #2 – exterior slopes near transition of 1A and 1B

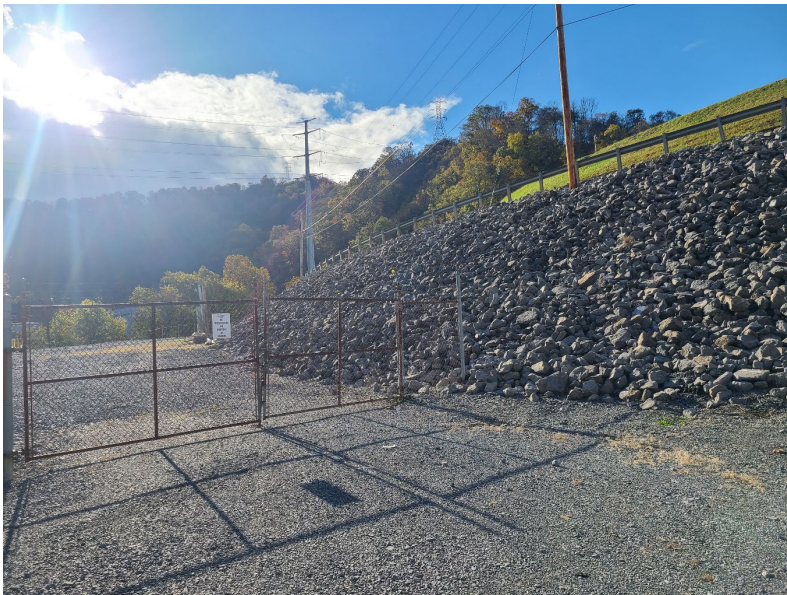
Photo #3 – exterior slope of Pond 1A

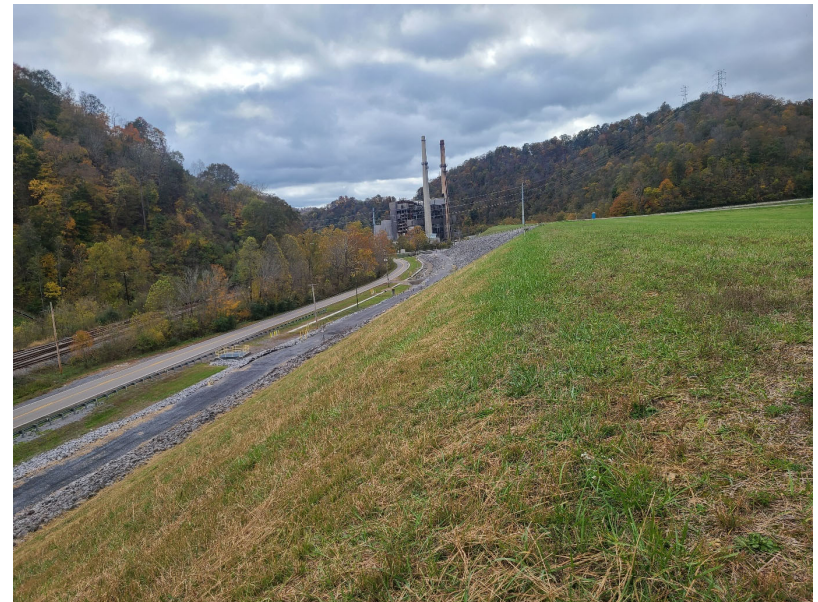
Photo #4 – grass cover on slopes of Pond 1B, above riprap

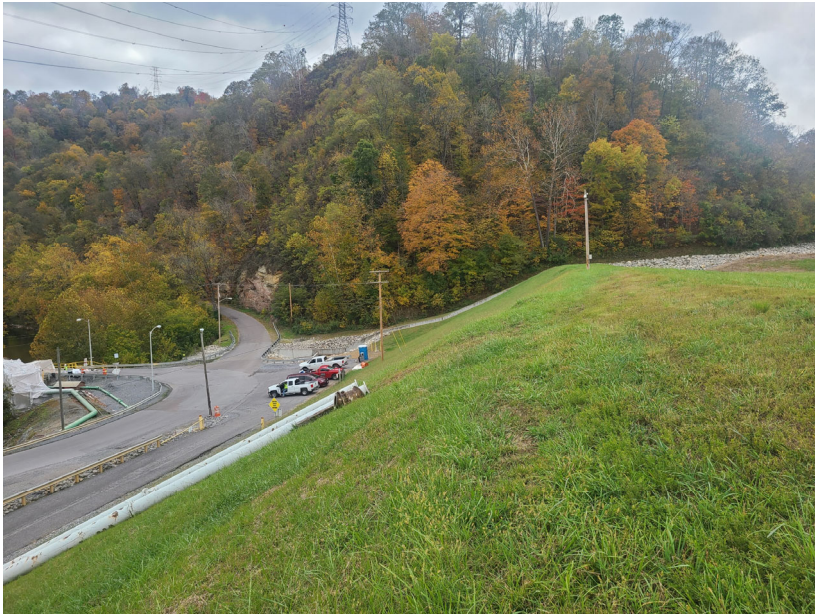
2. The slope of the most southern dike is all grassed and in good condition. There were no observed signs of instabilities, erosion or seepage [photo 5].

Photo #5 – exterior slope of south dike

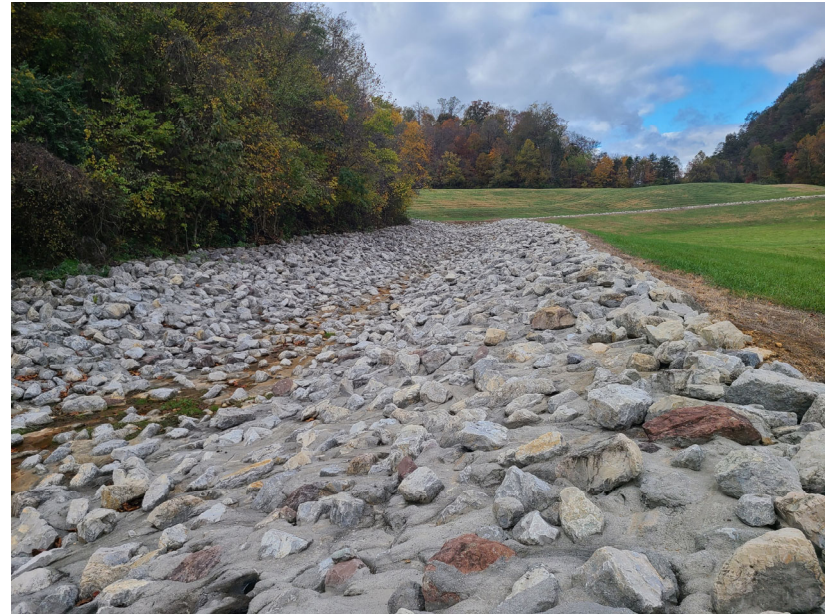
3. The Pond 1A diversion ditch along the right abutment was in good condition. The riprap lining was observed to be in good condition. The concrete downchute for the diversion ditch was also in good condition. [photos 6-7].

Photo #6 – Pond 1A diversion ditch

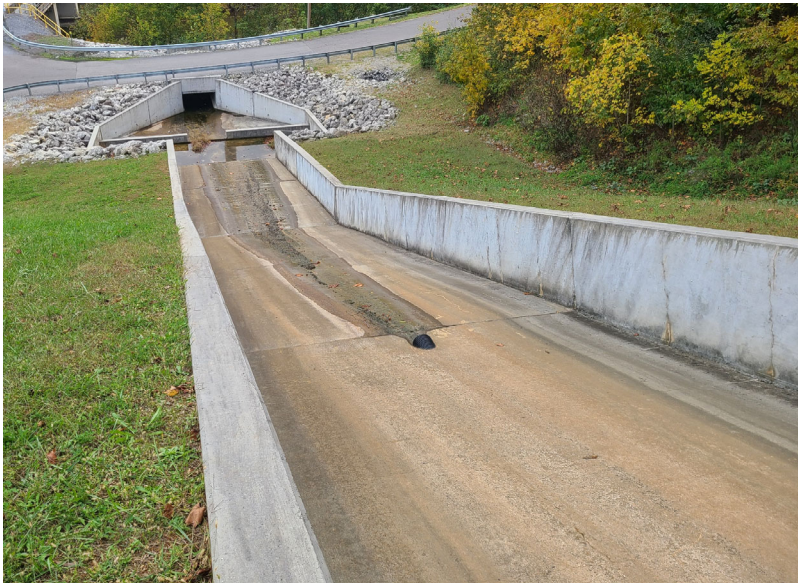
Photo #7 – concrete chute for Pond 1A diversion ditch

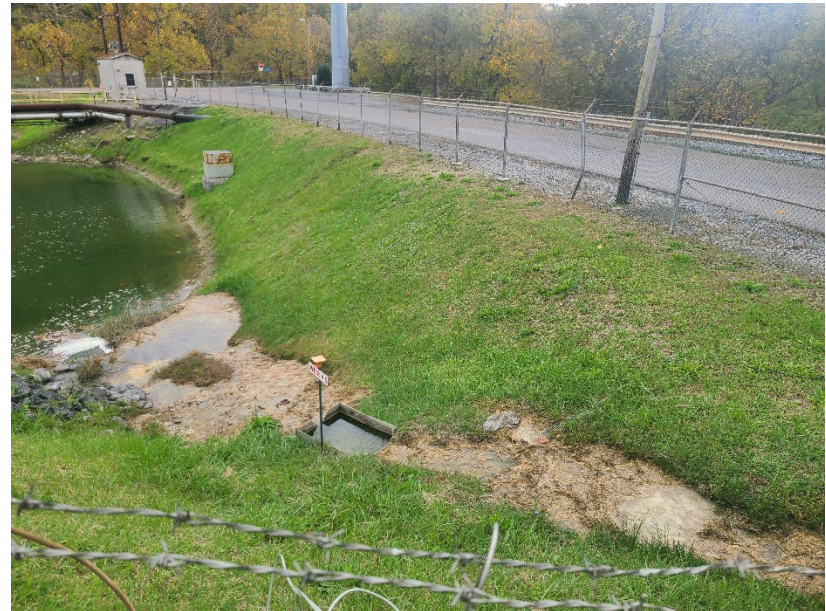
4. The seepage weirs at the reclaim pond were all discharging to some extent. All of the flow was clear. Weir 5 appeared to have the largest flowrate based on the field measurements [photo 8].

Photo #8 – seepage leading towards weir #5

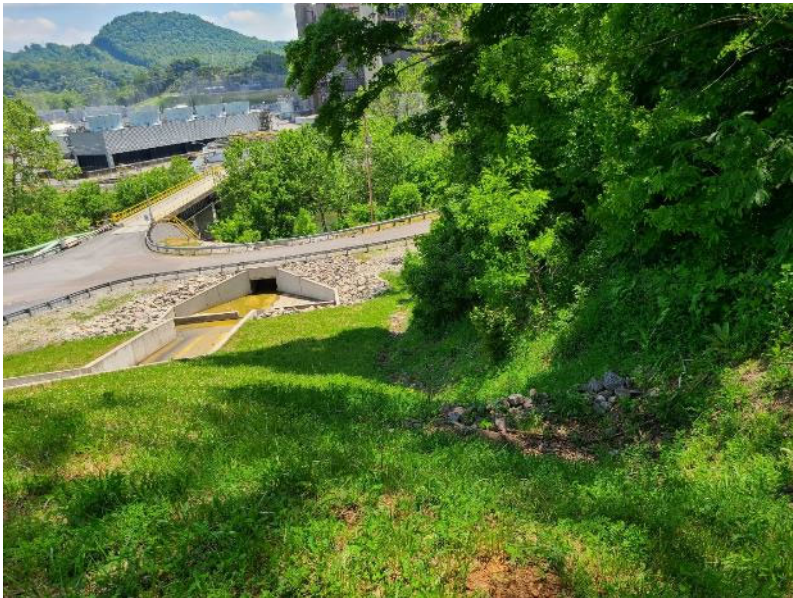
5. The right abutment area is cleared of brush within 25 feet of the dam embankment, except for a short section near the toe. [photo 9]
6. The seepage collection sump was operational at the time of the inspection. The majority of the seepage was flowing in from the left segment of the system. All of the flow appeared clear.

Photo #9 – right abutment, 25-ft clear zone

1. Maintain the vegetation within the regulatory 25-foot zone beyond the toe and abutments as required by VDCR Dam Safety.

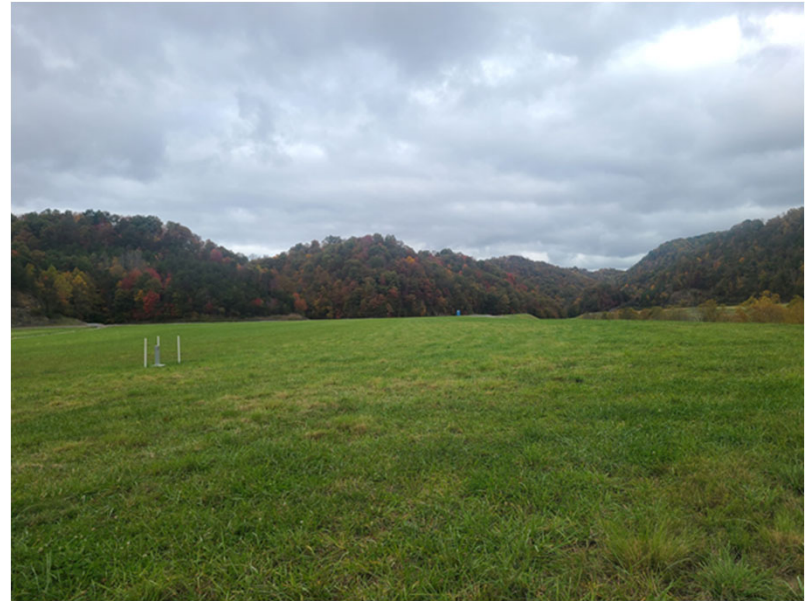
7. The surface area of the impoundment has been capped and covered. The vegetative growth is good over the entire surface. [photos 10-13]
8. Surface drainage appears adequate and there is no evidence of poor drainage at the inlet of the south swale into the east diversion ditch [photo 14]

Photo #10 – cap surface of Pond 1A

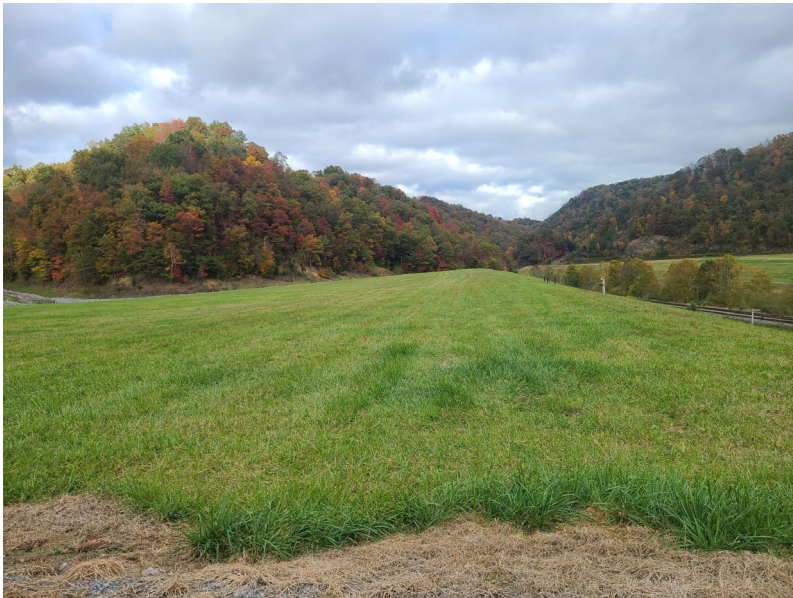
Photo #11 – cap surface of Pond 1B

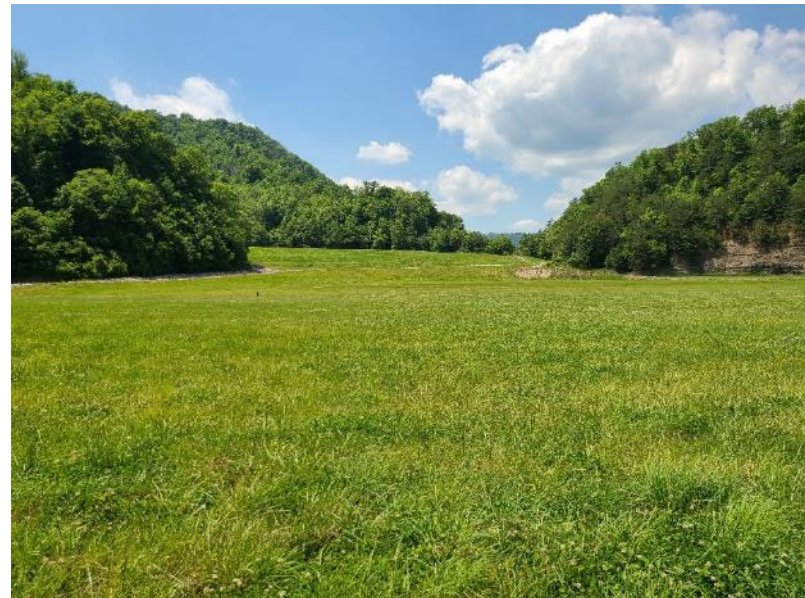
Photo #12 – cap surface of Pond 1A

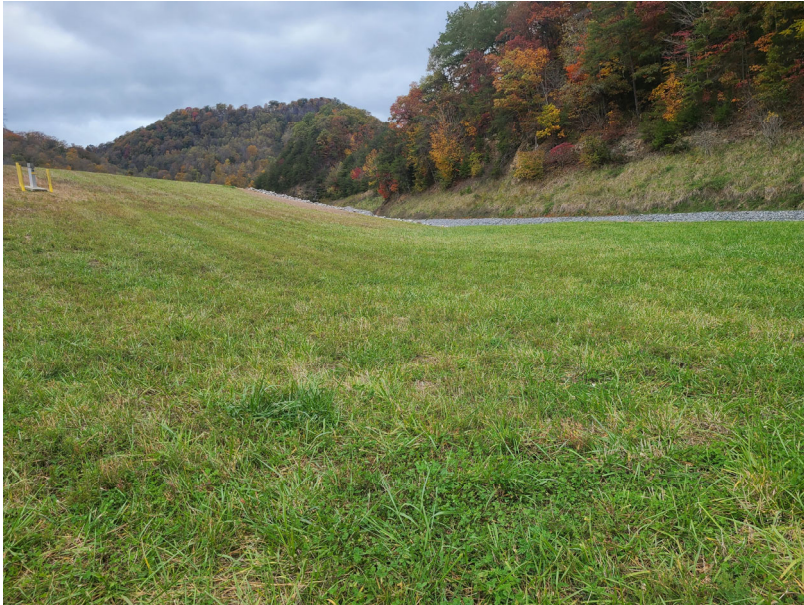
Photo #13 – cap surface of Pond 1B

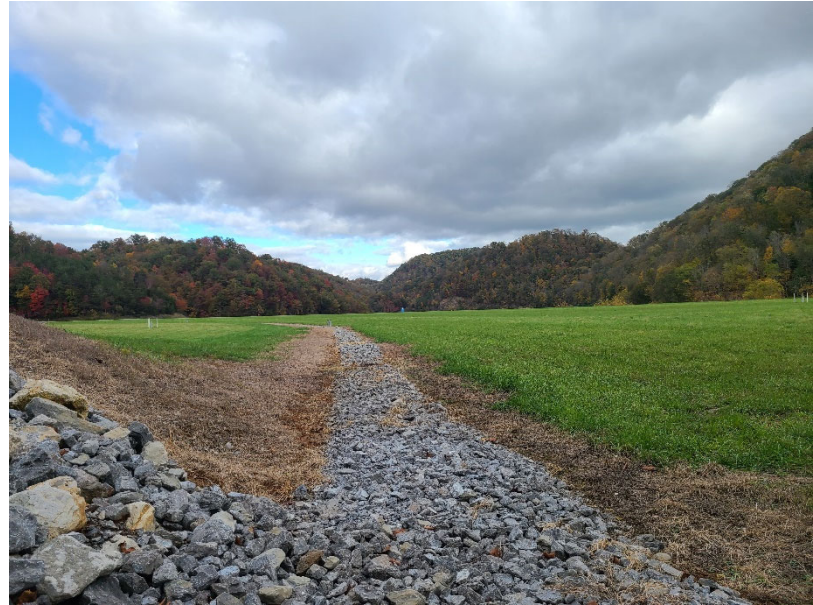
Photo #14 – drainage swale into Pond 1A diversion channel

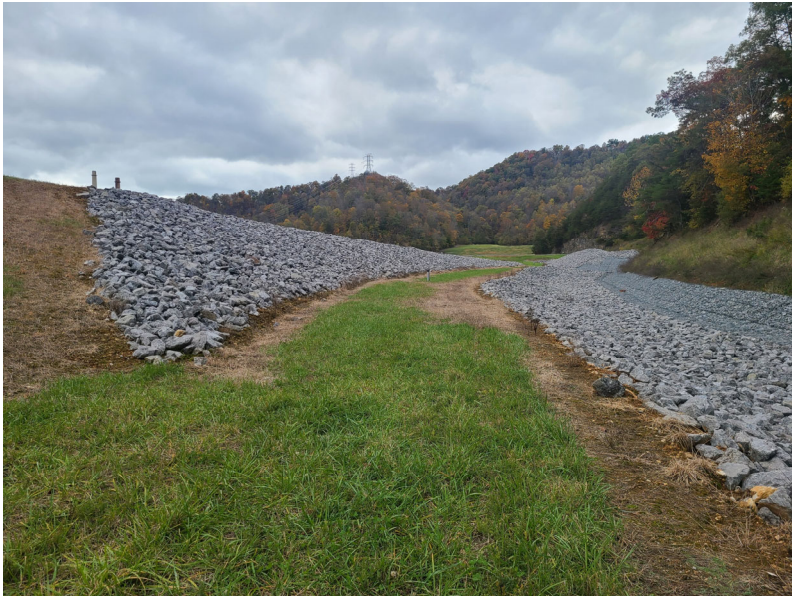
9. No erosion along any of the surface water drainage swales and ditches was observed.
10. Pond 1B diversion ditch system and collection basin appeared to be in good condition. No debris was observed in the collection basin [photos 15-16].

Photo #15 – Pond 1B diversion ditch

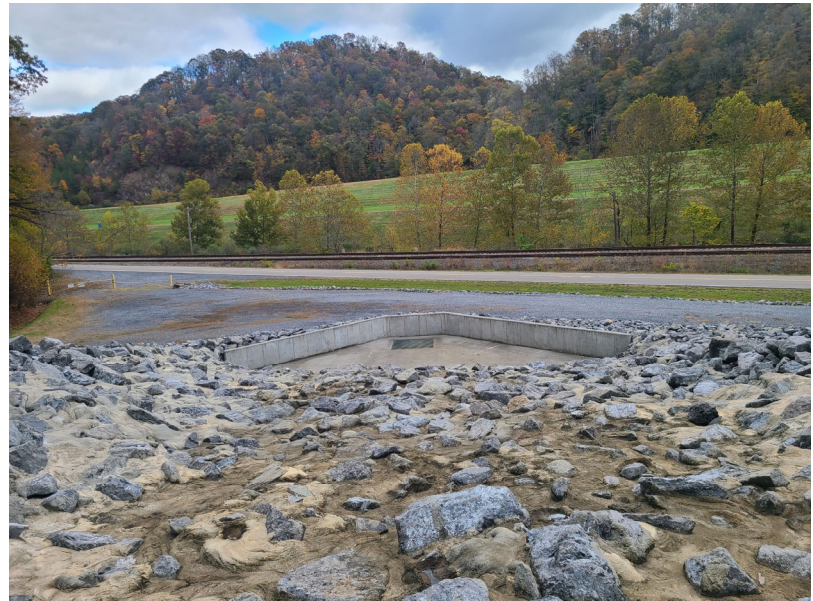
Photo #16 – collection basin at toe of Pond 1B diversion ditch

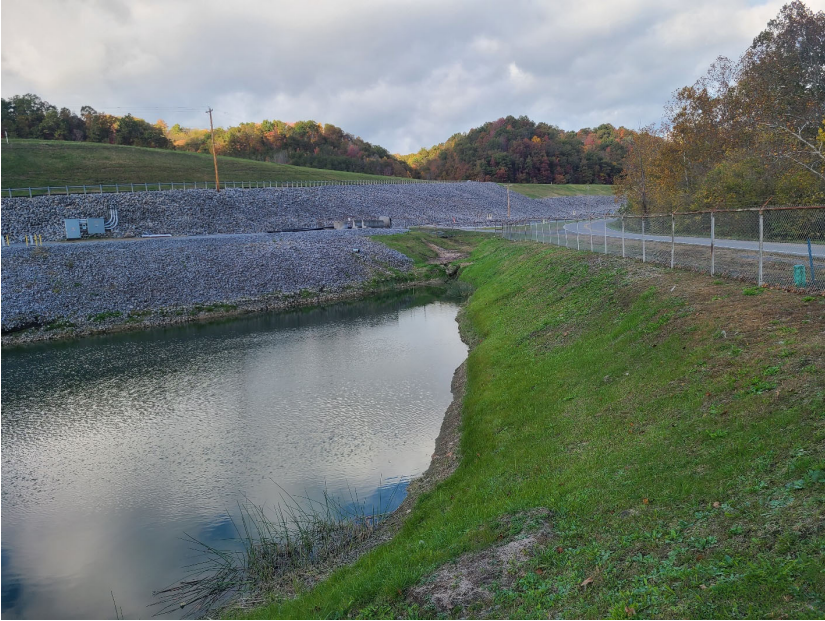
11. The interior slopes of the reclaim pond appeared stable and there was no displacement of the riprap cover or erosion of the grassed slopes [photo 17].

Photo #17 – reclaim pond interior slopes
