2021 Annual Landfill Inspection Report

FGD Stackout Area

**H.W. Pirkey Plant
Southwestern Electric Power Company
Hallsville, Texas**

Document ID: GERS-21-022

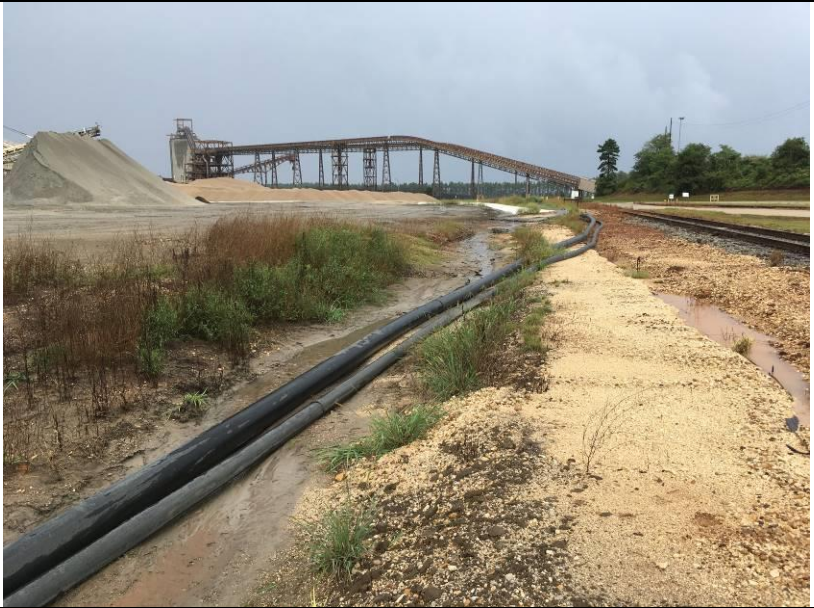
Photo # 1

View of the contact water drainage ditch located on the west side of Stackout Area.

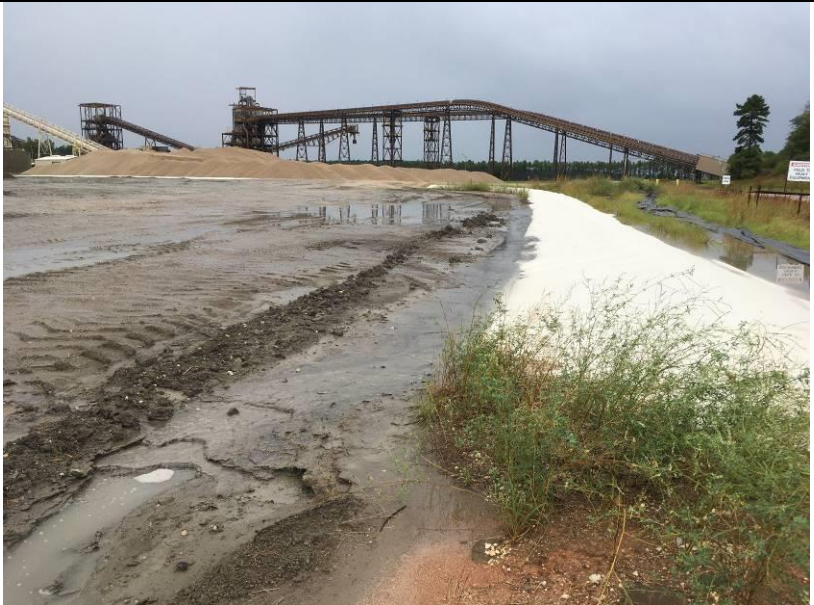
Photo # 2

1. The gravel berm with a geomembrane cover appeared to be in good condition. There was no evidence of holes, air/water pockets, or other signs of distress noted on the geomembrane.

View of the western gravel berm with a geomembrane cover facing south.

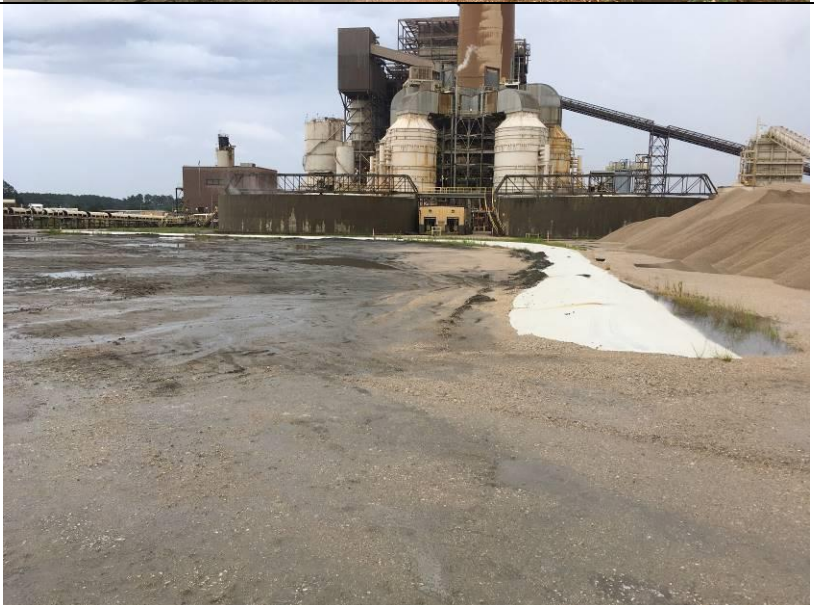
Photo # 3

View of the southern gravel berm with a geomembrane cover facing east.

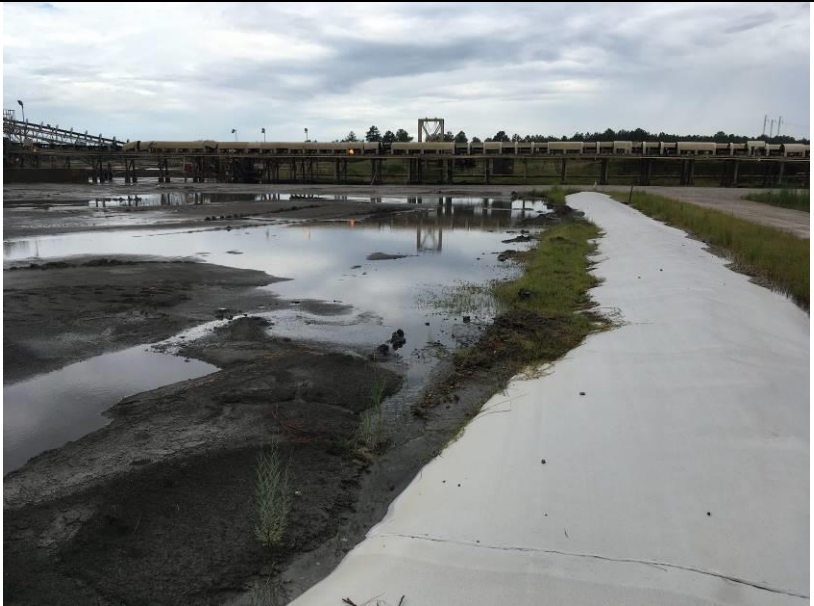
Photo # 4

2. A rain event of 1.51-inches occurred on 9/18/2021 in the early morning hours before the inspection resulting in several inches of standing water along the eastern gravel berm of the stackout area. Surface water from this area was flowing to a steel pipe culvert that conveys water underneath an access road located in the northeast corner of the pad. This culvert outlets onto a concrete slab with curb walls underneath the supports for the conveyor belt, which feeds the radial arm stacker. A section of these curb walls have been notched out to allow surface water runoff to drain to the drainage ditch that feeds the auxiliary surge pond.

View of the eastern gravel berm with a geomembrane cover facing north.

- 1) The area upstream of the culvert that drains the eastern perimeter ditch should be re-graded to maintain positive drainage to the culvert.
- 2) The rail road tie beam and wood debris lying up against the culvert of the of the north drainage ditch that direct runoff into the auxiliary surge pond should be removed.

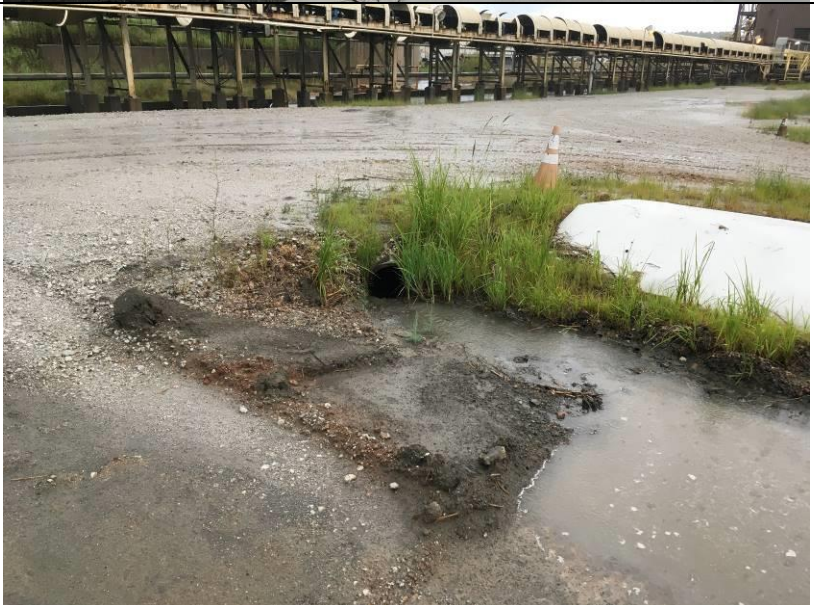
Photo # 5

View of the inlet culvert pipe that discharges water from the stackout area into the drainage ditch under the conveyor system.

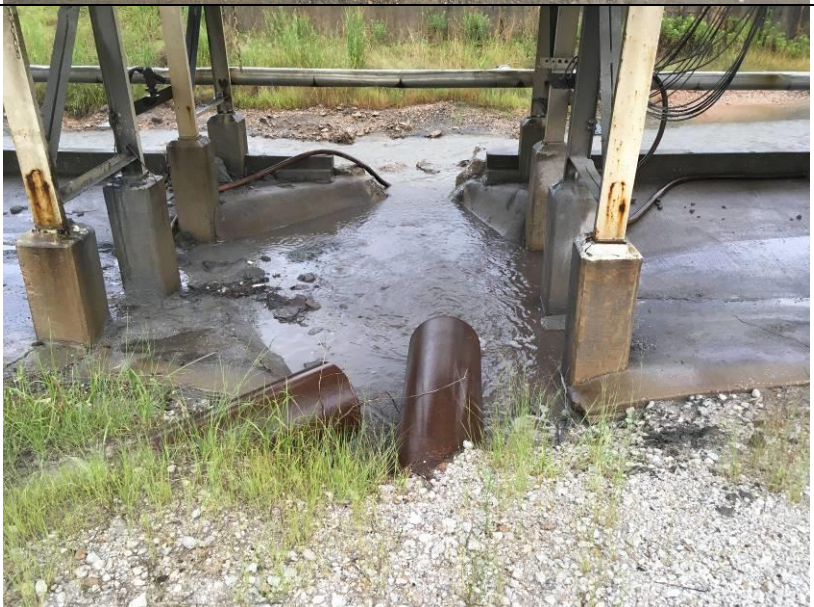
Photo # 6

View of the outlet area of the steel culverts under the conveyor system which feeds the radial arm stacker

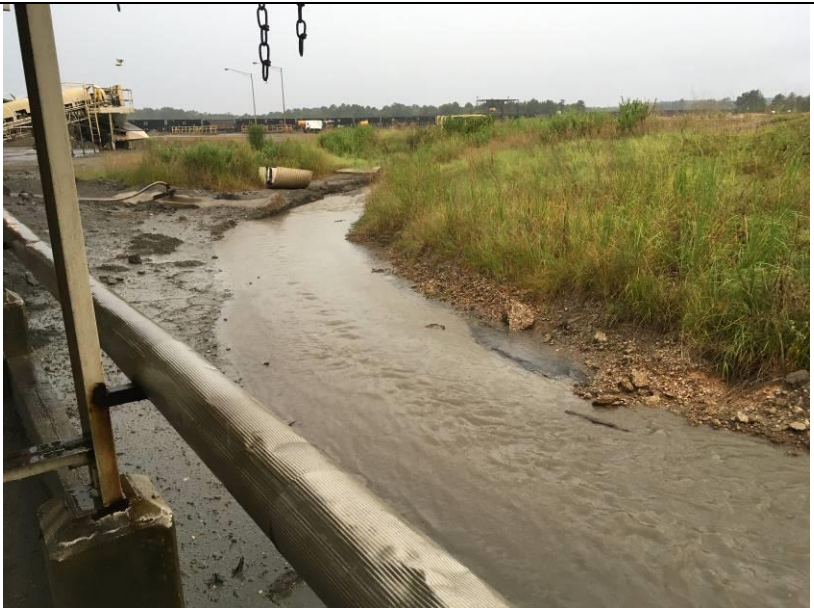
Photo # 7

View of the drainage ditch which is located under the conveyor system on the north side.

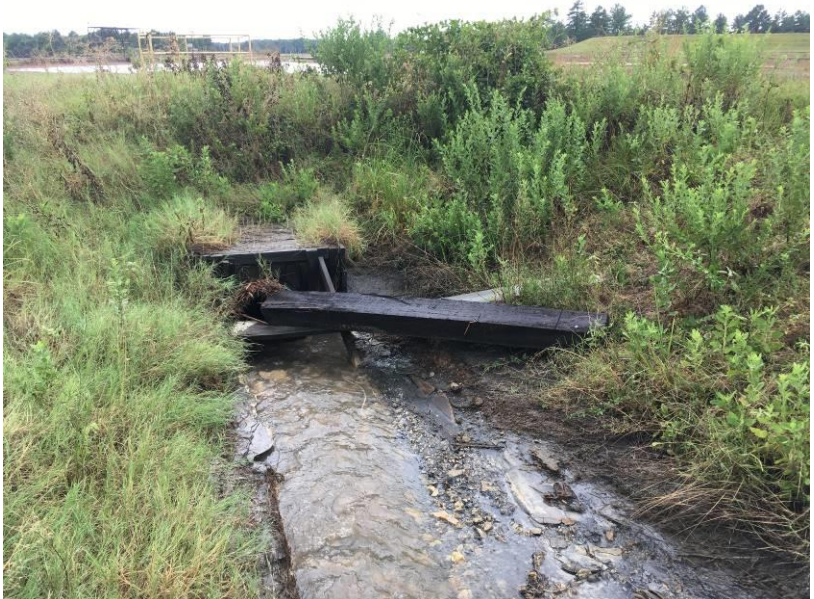
Photo # 8

3. An old rail road tie beam and other wood debris were observed at the end of the north drainage ditch and up against the culvert that directs runoff into the auxiliary surge pond. This culvert is downstream of the notch in the curb mentioned above.

View of the drainage ditch culvert which directs runoff into the auxiliary surge pond. This culvert is downstream of the notch in the curb shown in Photo #6

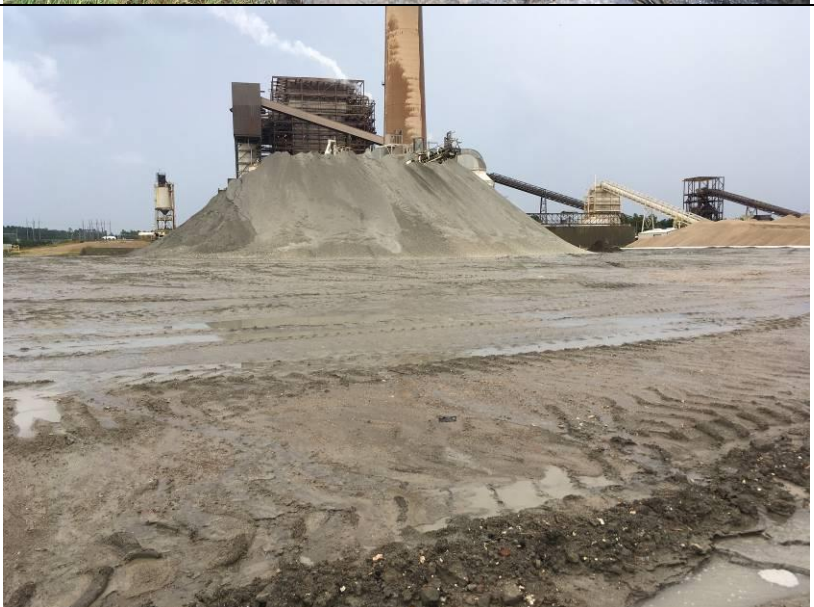
Photo # 9

View of the FGD Stackout Area with a pile of Gypsum on the pad.

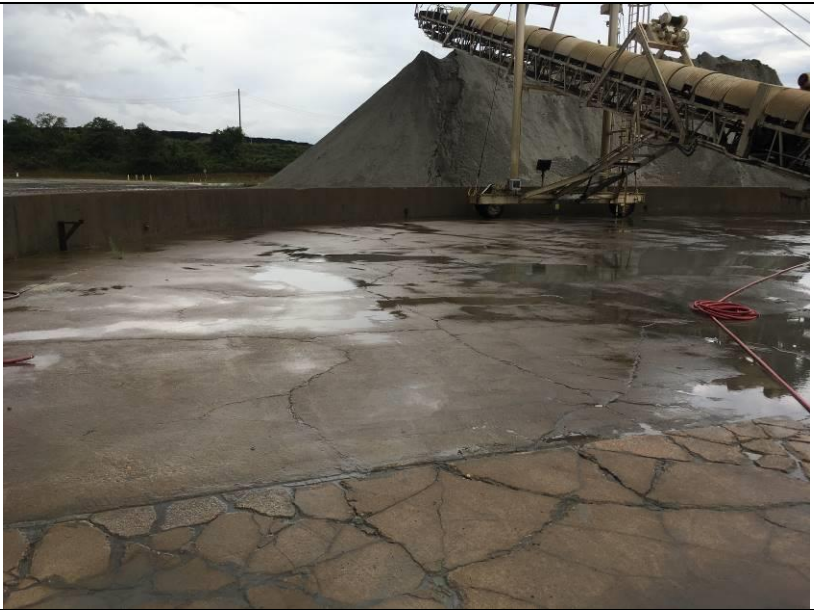
Photo # 10

View of the radial arm stacker that conveys gypsum to the stackout area.

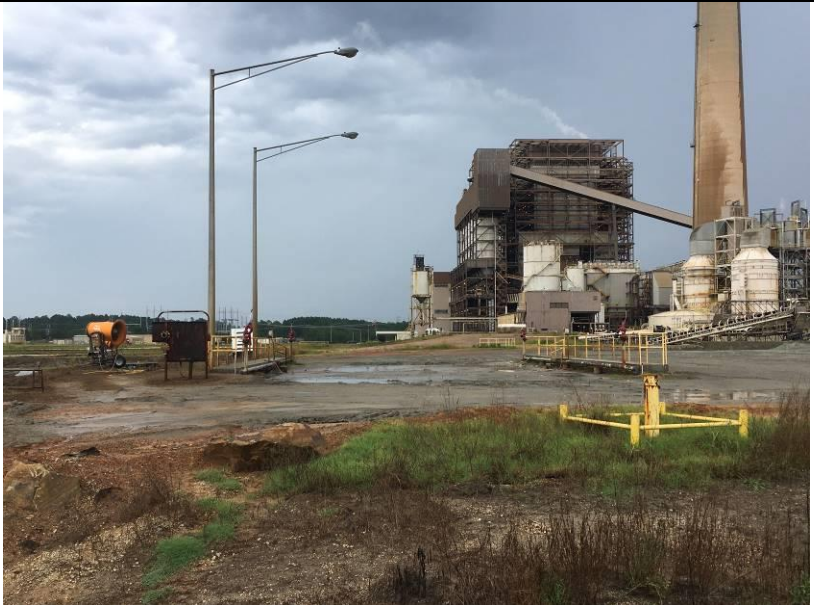
Photo # 11

View of the truck wash station to clean the dump trucks loading and hauling gypsum to the landfill.

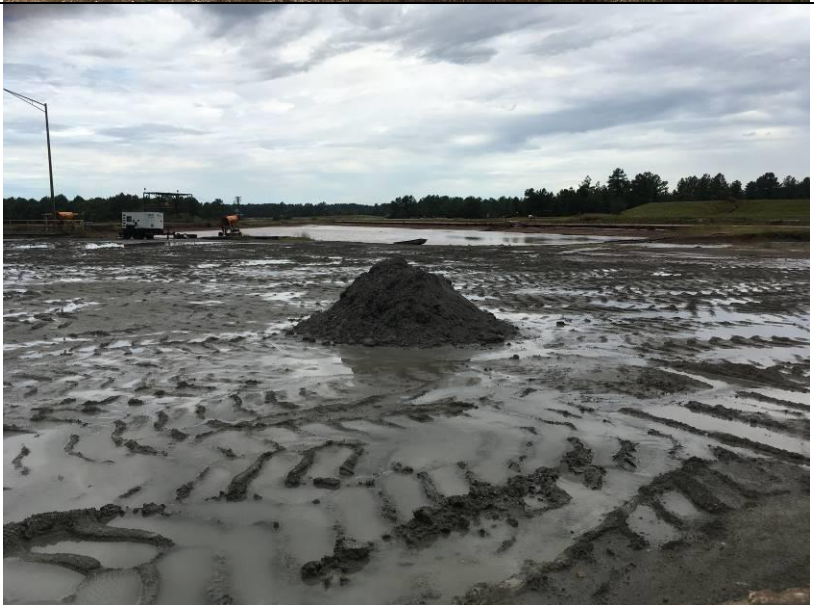
Photo # 12

View of the drainage area north of the stackout area that leads to the auxiliary surge pond.
