2021 Annual Landfill Inspection Report

**Rockport Plant
Indiana Michigan Power Company
Rockport, Indiana**

December 2021

Document ID: GERS-21-077

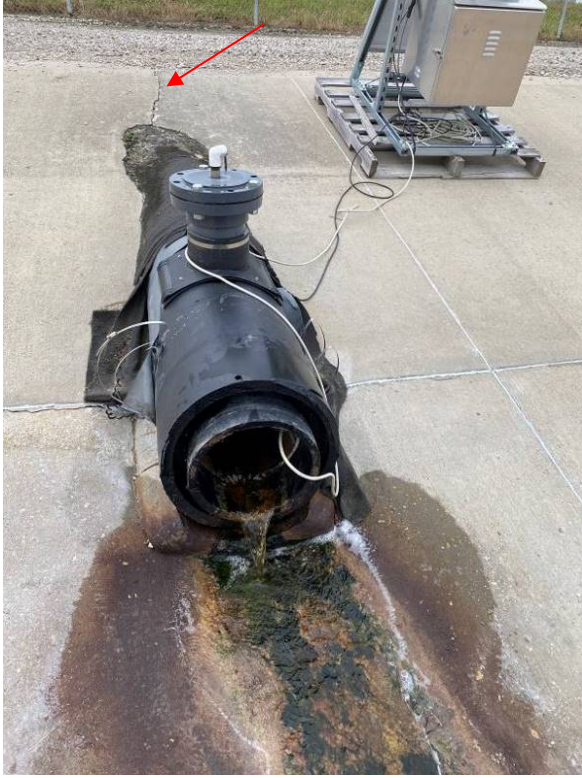
Photograph 1:

1. The North Pond was generally in good condition. At the time of the inspection both cells were filled and operating with about 8 feet of freeboard.
2. A small crack in the concrete liner of the West Pond was observed, and is located just above the leachate outlet pipes entering the pond from the south. There was about 3/8 inch vertical offset across this crack. (Photograph 1)

View of the leachate influent line at the west leachate pond. The crack in the concrete noted by the red arrow.

- 3) Improve the drainage patterns to direct contact water runoff towards the chimney drain on the north slope of Cell 3.
- 4) Repair the erosion rill and rodent burrow noted adjacent to the riprap channel located on the closed landfill.
- 5) Install a suitable sealant in the crack in the concrete lined section of the west pond, located above the leachate discharge pipe.
- 6) Consider improving drainage patterns in the area of standing water between the haul road and Cell 3.
- 7) Continue with plans to repair the leaking 8-inch-diameter steel discharge pipe at pond 002.

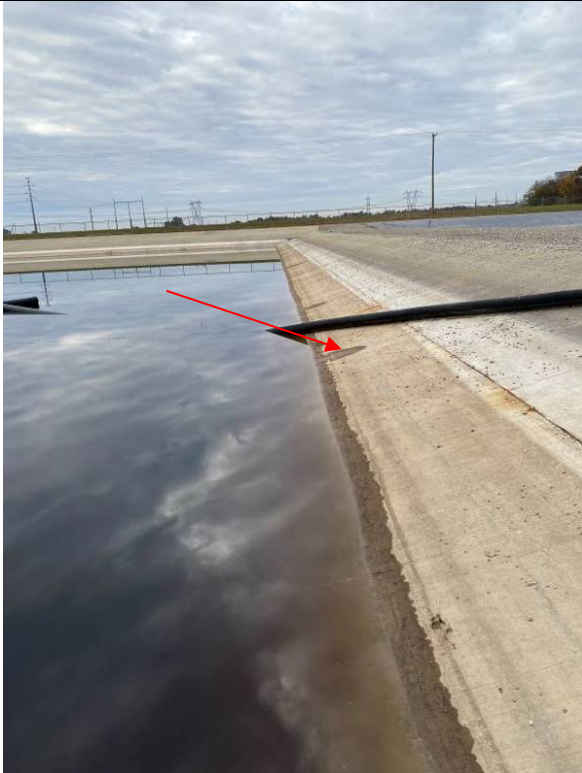
Photograph 2:

3. The West pond concrete lined portion was operating with about 6.5 feet of freeboard. The concrete lined section in general is in good condition with no signs of damage (except for small crack noted above). There was evidence of moisture wicking through the joints of the concrete lining. Since there is a LLDPE liner underneath the concrete, this is not an issue. (Photograph 2)

View of the west leachate pond. Notice the signs of moisture weeping through the joints of the protective concrete.

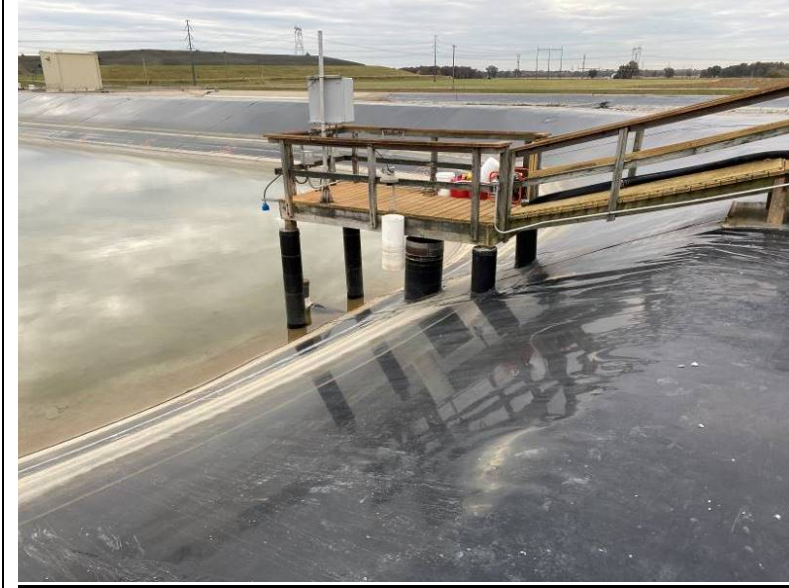
Photograph 3:

View of the discharge structure at leachate pond 002.

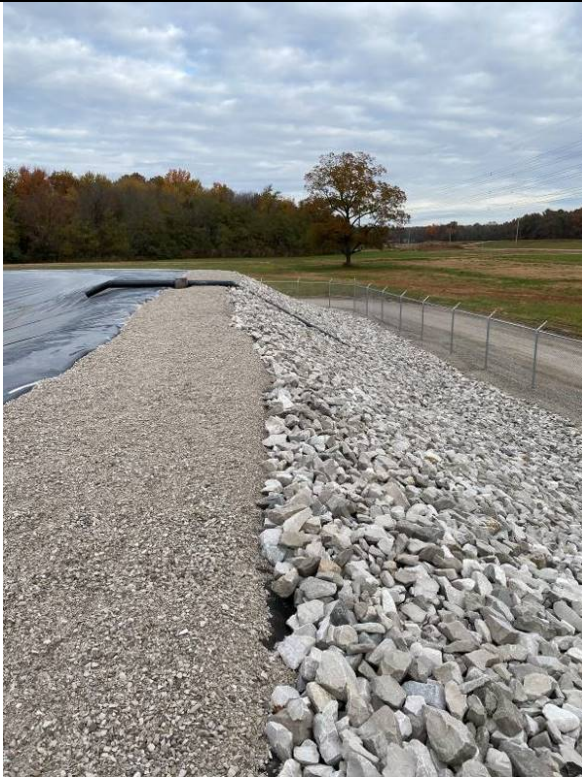
Photograph 4:

View of the new riprap slope protection at leachate pond 002.

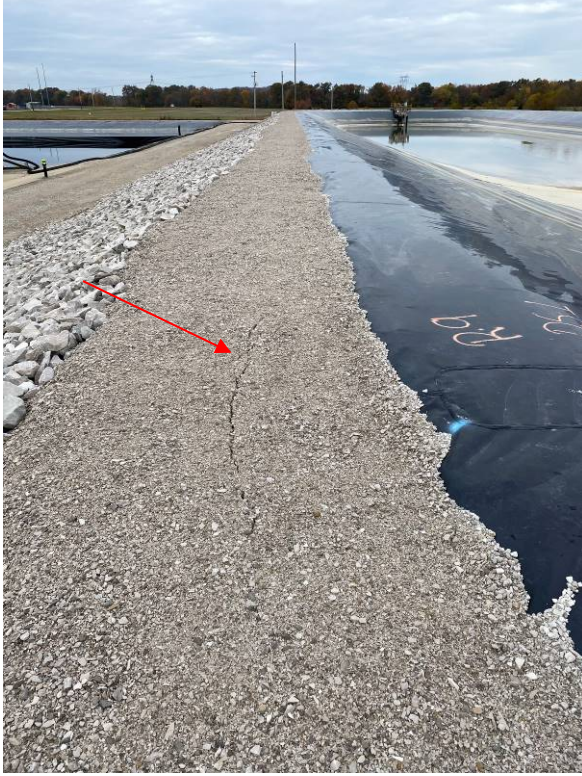
Photograph 5:

4. The 002 Pond was generally in good condition and operating with about 8 feet of freeboard. A new LLDPE liner has been installed in leachate pond 002. The exterior slopes of 002 Pond have been armored with riprap, and a new gravel wearing course added to the crest. There was minor cracking

observed along the anchor trench for the liner, believed to be from minor settlement of the anchor trench backfill. (Photograph 3 – 5)

View of the minor cracking observed along the surface of backfill in the anchor trench for the new liner at Pond 002.

- 1) Monitor the interim berm seepage repair area for any signs of seepage.
- 2) Monitor the anchor trench backfill for any additional cracking or settlement of the crest of pond 002.

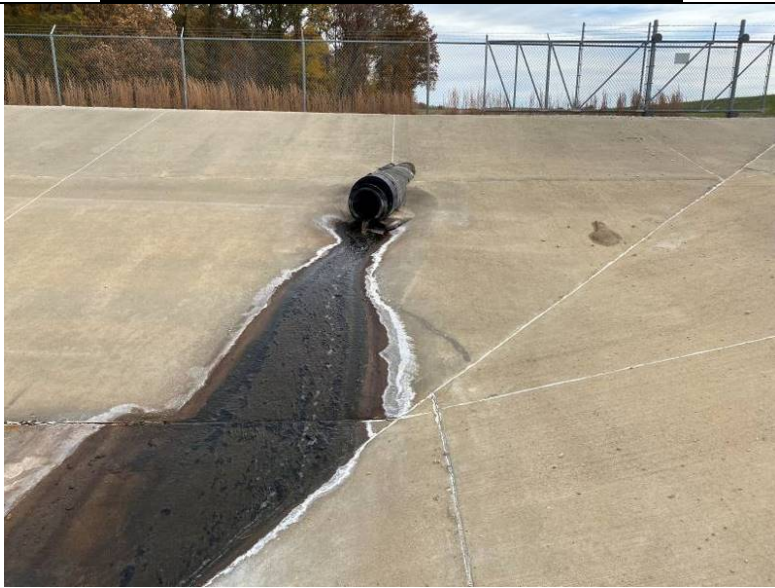
Photograph 6:

View of the leachate influent line at the north leachate pond.

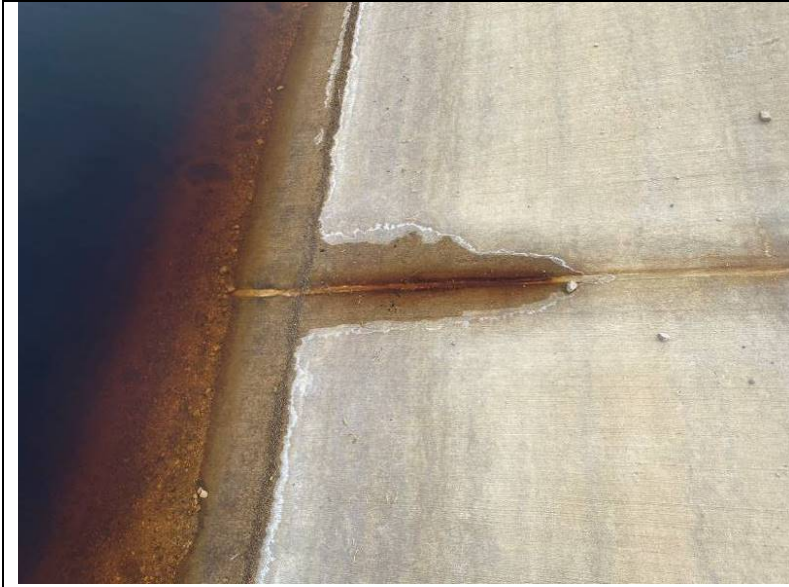
Photograph 7:

5. The concrete lined cell of the North Pond did not appear to have any signs of damage, cracks or spalling. There were no signs of blockage of the inlet and outlet piping. The fence surrounding the leachate pond was in good condition. There was evidence of moisture wicking through the joints of the concrete lining. Since there is a LLDPE liner underneath the concrete, this is not an issue. (Photograph 6-7)

View of moisture wicking through the joints of the protective concrete at the north leachate pond.

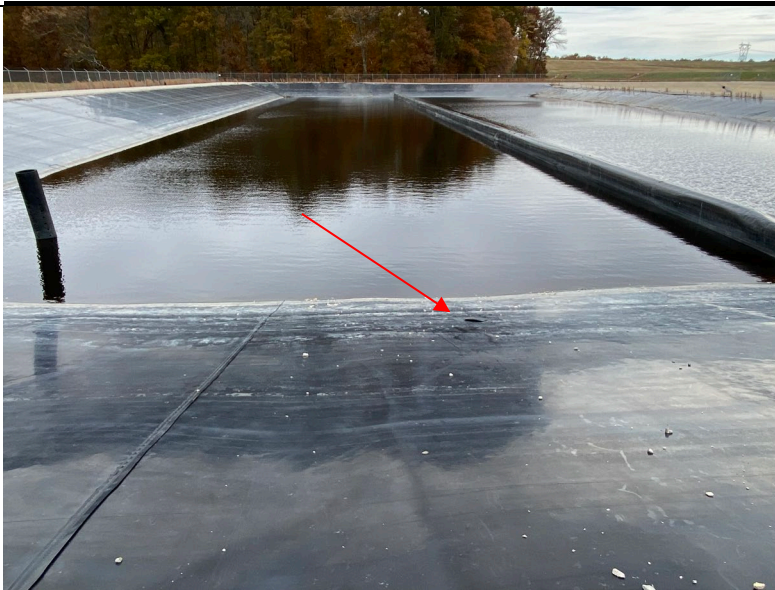
Photograph 8:

6. There was one area at the North Pond, close to the leachate sump, where a circular liner patch appeared to be separating from the liner. (Photograph 8-9)

View showing the north leachate pond. The red arrow shows location of the circular patch in Photograph 8.

- 1) Repair the peeling circular patch on the exposed liner in the north leachate pond.
- 2) Repair the erosion rill occurring at the edges of the rock check dam in Cell 1A

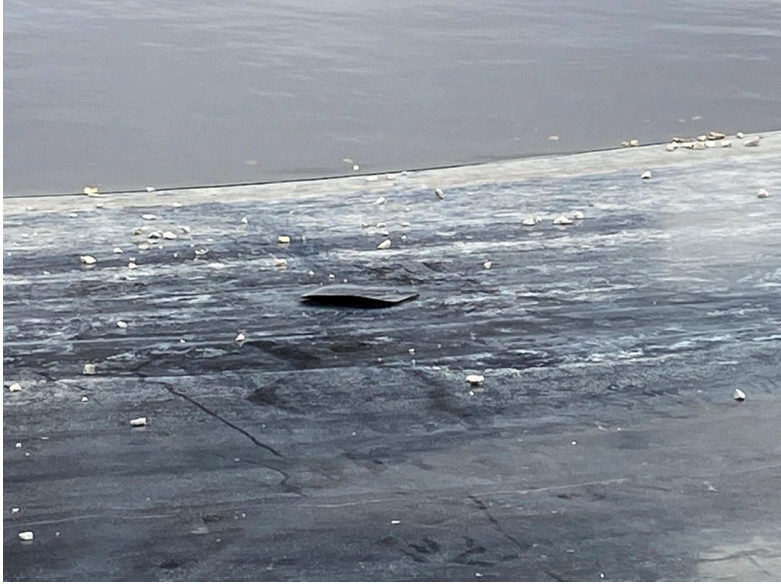
Photograph 9:

View of a circular patch on the north leachate pond that appears to be peeling.

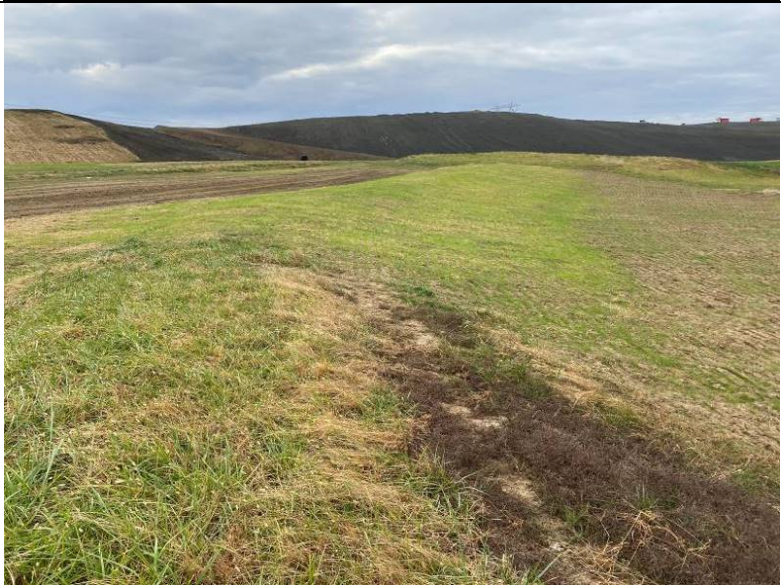
Photograph 10:

1. The inactive landfill cells 4B, 6 and 7 were in good condition. The vegetative cover was well established and in good condition.
2. Repairs to the intermediate berm were recently completed to address a leachate seepage deficiency. Grass cover was beginning to emerge. (Photograph 10).
3. A culvert underneath the haul road and discharging onto Cell 7 has been recently flushed out. Standing water was noted around the inlet of this culvert, between Cell 3 and the haul road. (Photograph 17-18)

A deficiency related to leachate seeping through the intermediate berm (Deficiency #12 on AEP's Deficiency Index) has been repaired and the deficiency is considered corrected by AEP Geotechnical Engineering. The overall corrective measure repair scheme consisted of geomembrane liner repair & seaming and the construction of an additional leachate collection pipe. Temporary measures were installed to collect leachate seepage and divert into the existing leachate collection system. The repair construction was completed in accordance with the landfill CQA/QC Manual.

View showing the interim berm in the area where the leachate seepage deficiency has been repaired and grass cover is establishing.

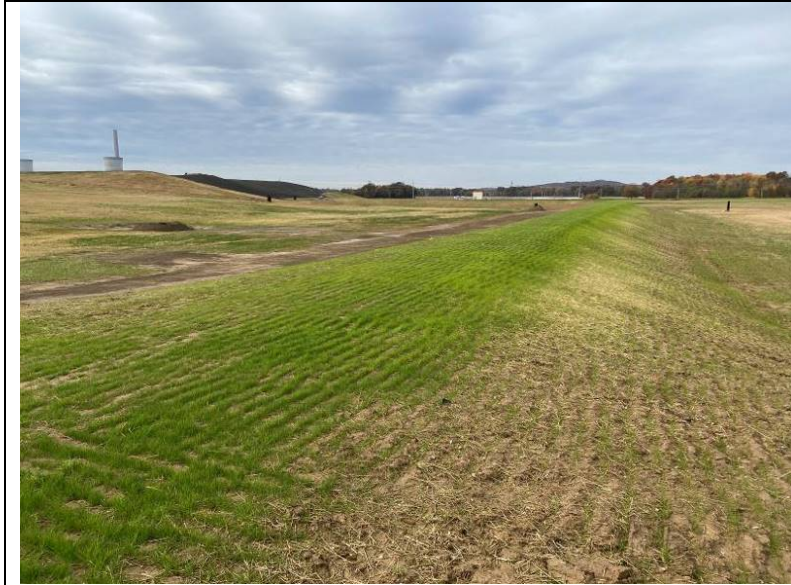
Photograph 11:

View showing the containment berm constructed in Cell 1A for future ash placement.

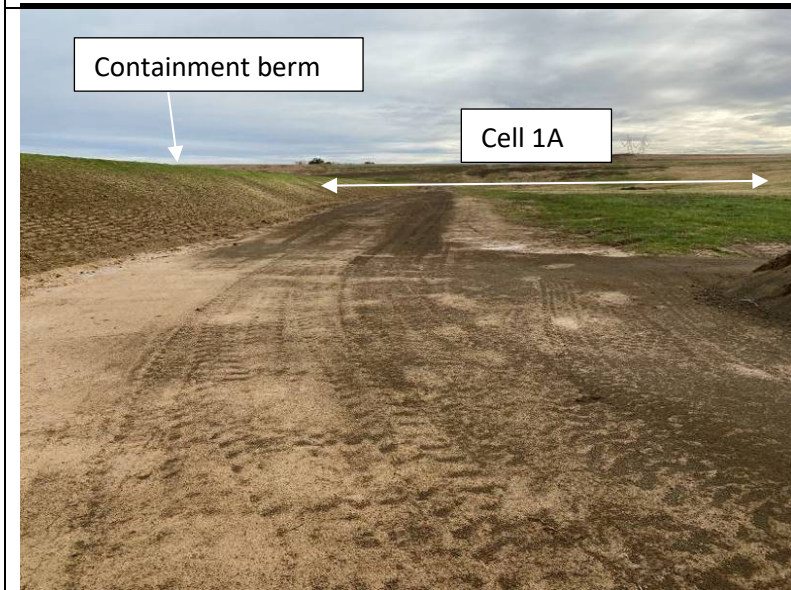
Photograph 12:

View showing the bottom ash placed on the waste side of the containment berm in Cell 1A.

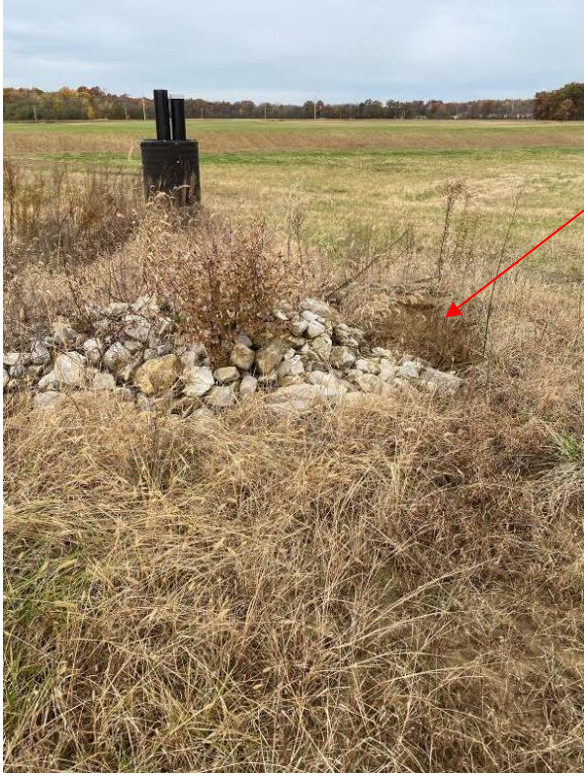
Photograph 13:

View of the erosion occurring at the edge of the rock check dam in Cell 1A.

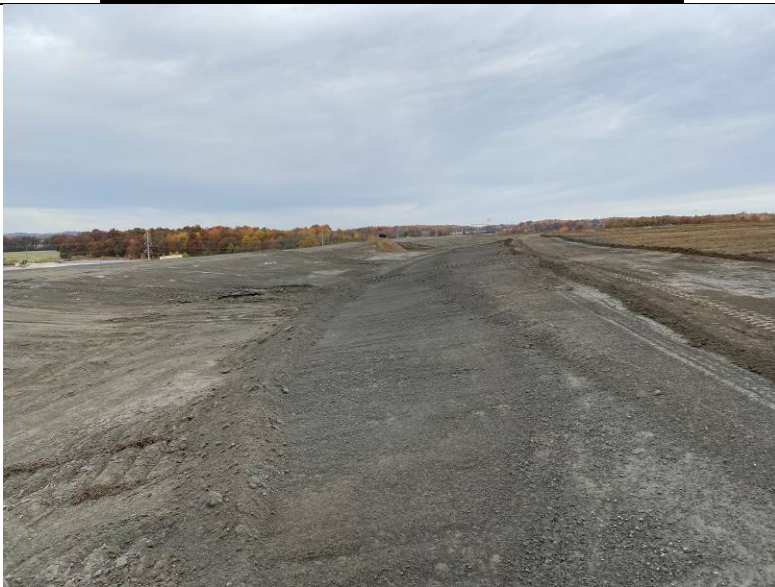
Photograph 14:

View of the active placement waste area.

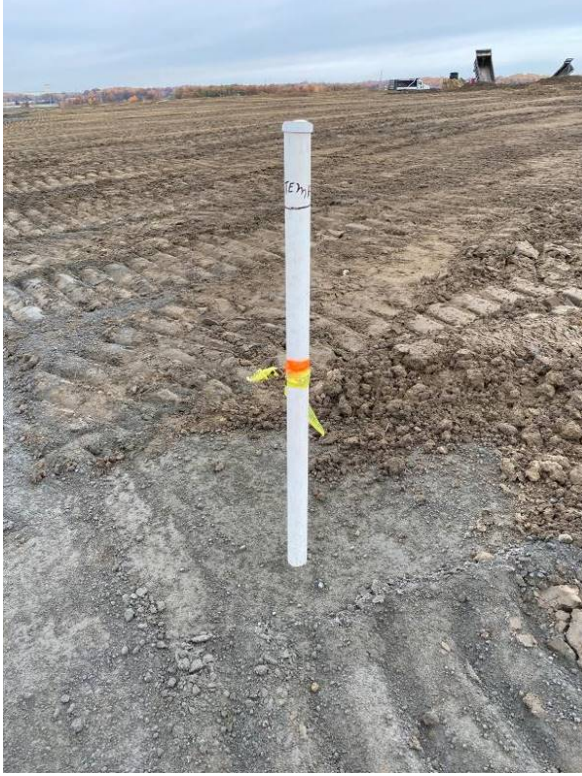
Photograph 15:

View showing survey stakes noted the elevation of permitted top of ash grades in Phase 1.

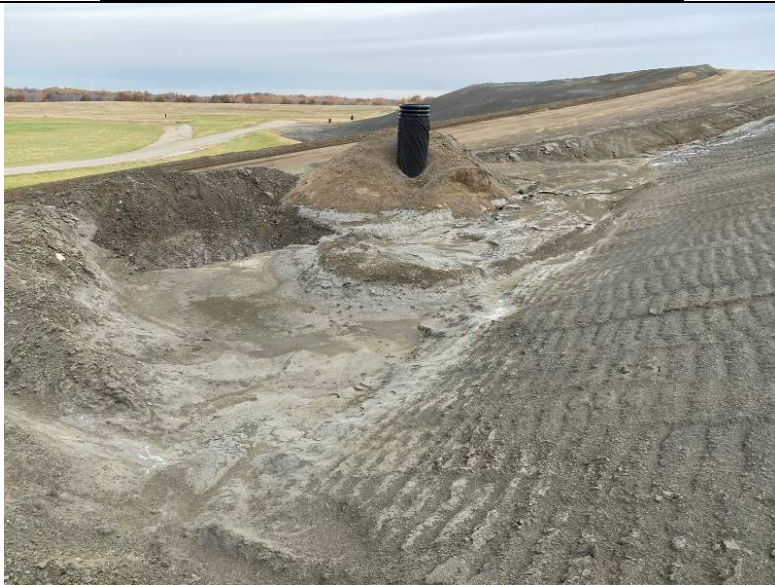
Photograph 16:

1. During the inspection, ash was being placed in the active disposal areas. Wet bottom ash from the cleanout of the East Bottom Ash Pond was drying out in areas of the active landfill. The chimney drains were functioning as designed and there was no pooling of water around the drains.
2. Grade stakes noting the permitted top of ash surface were observed in the active areas of the landfill. A minus 1-foot vertical offset was also marked on the grade stakes. (Photograph 15)
3. The ash surface leading to the chimney drain on the north slope of the active area should be graded to better direct runoff to the chimney drain pipe. (Photograph 16)

View showing a chimney drain on the north slope of Phase 1.

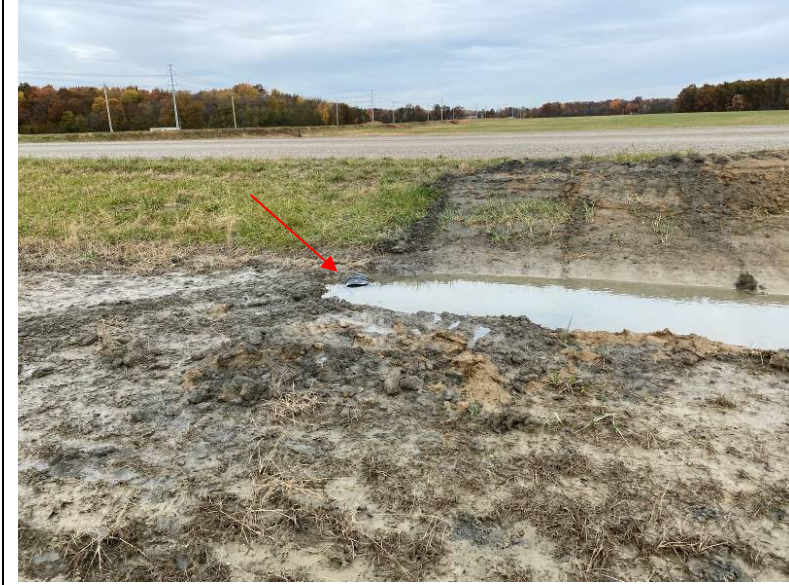
Photograph 17:

View of standing water upstream of the culvert into Cell 7. The crown of the culvert is a few inches above the water surface.

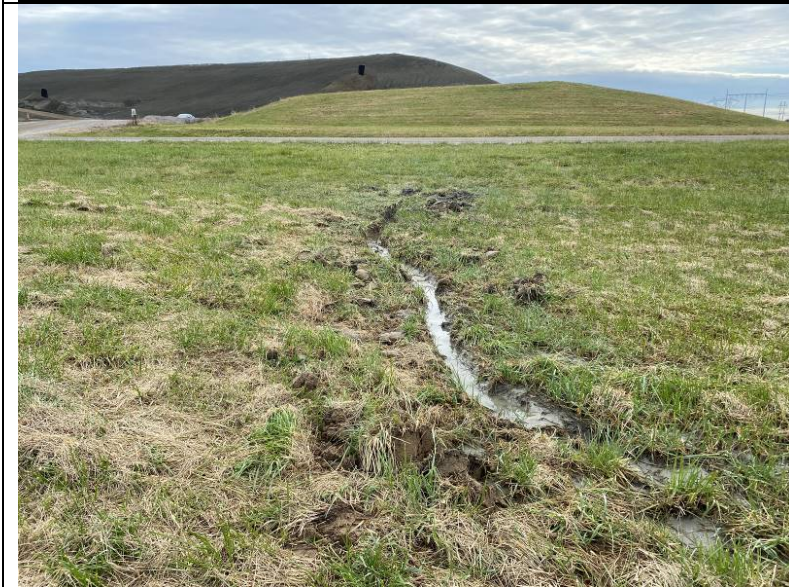
Photograph 18:

View of the outlet of the culvert shown in Photograph 17.

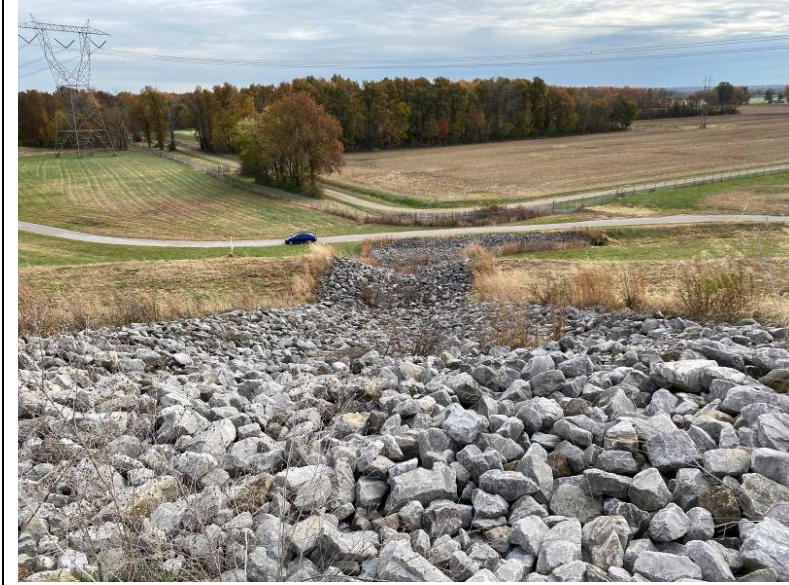
Photograph 19:

1. There was an area of erosion occurring on the northern edge of a riprap channel adjacent to the landfill access road. The erosion rill was about 2 feet deep. Rodent burrows were also found in this area.
2. The closed landfill area was observed to have a thick grass cover over the entire capped area that had recently been mowed. There were no signs of settlement, signs of movement or distress of the landfill area. The closed landfill area was in good condition and well maintained. (Photograph 19-20)

View of a riprap let down channel on the southeastern side of the closed landfill area.

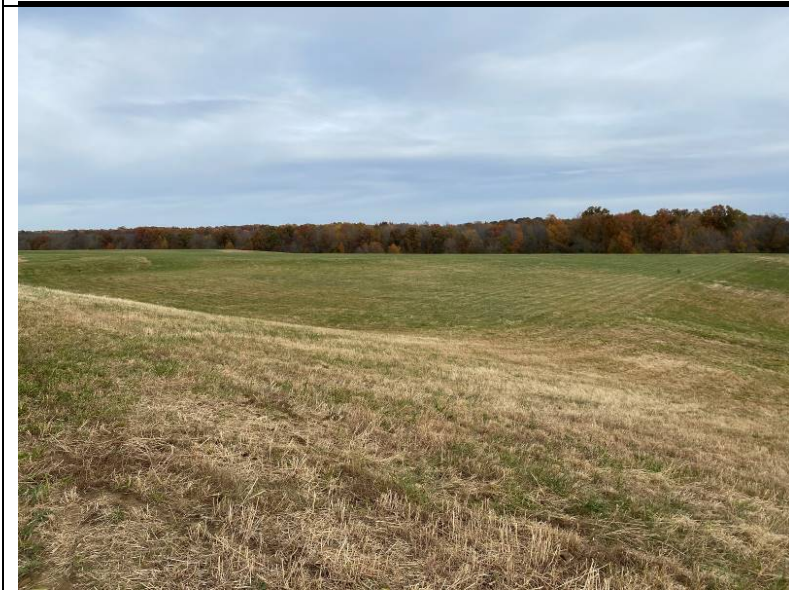
Photograph 20:

Typical view of the closed landfill area.
