2022 Annual Dam and Dike Inspection Report

Bottom Ash Pond Complex

**John E. Amos Plant
Appalachian Power Co.
Putnam County, West Virginia**

Document Number: GERS-22-046

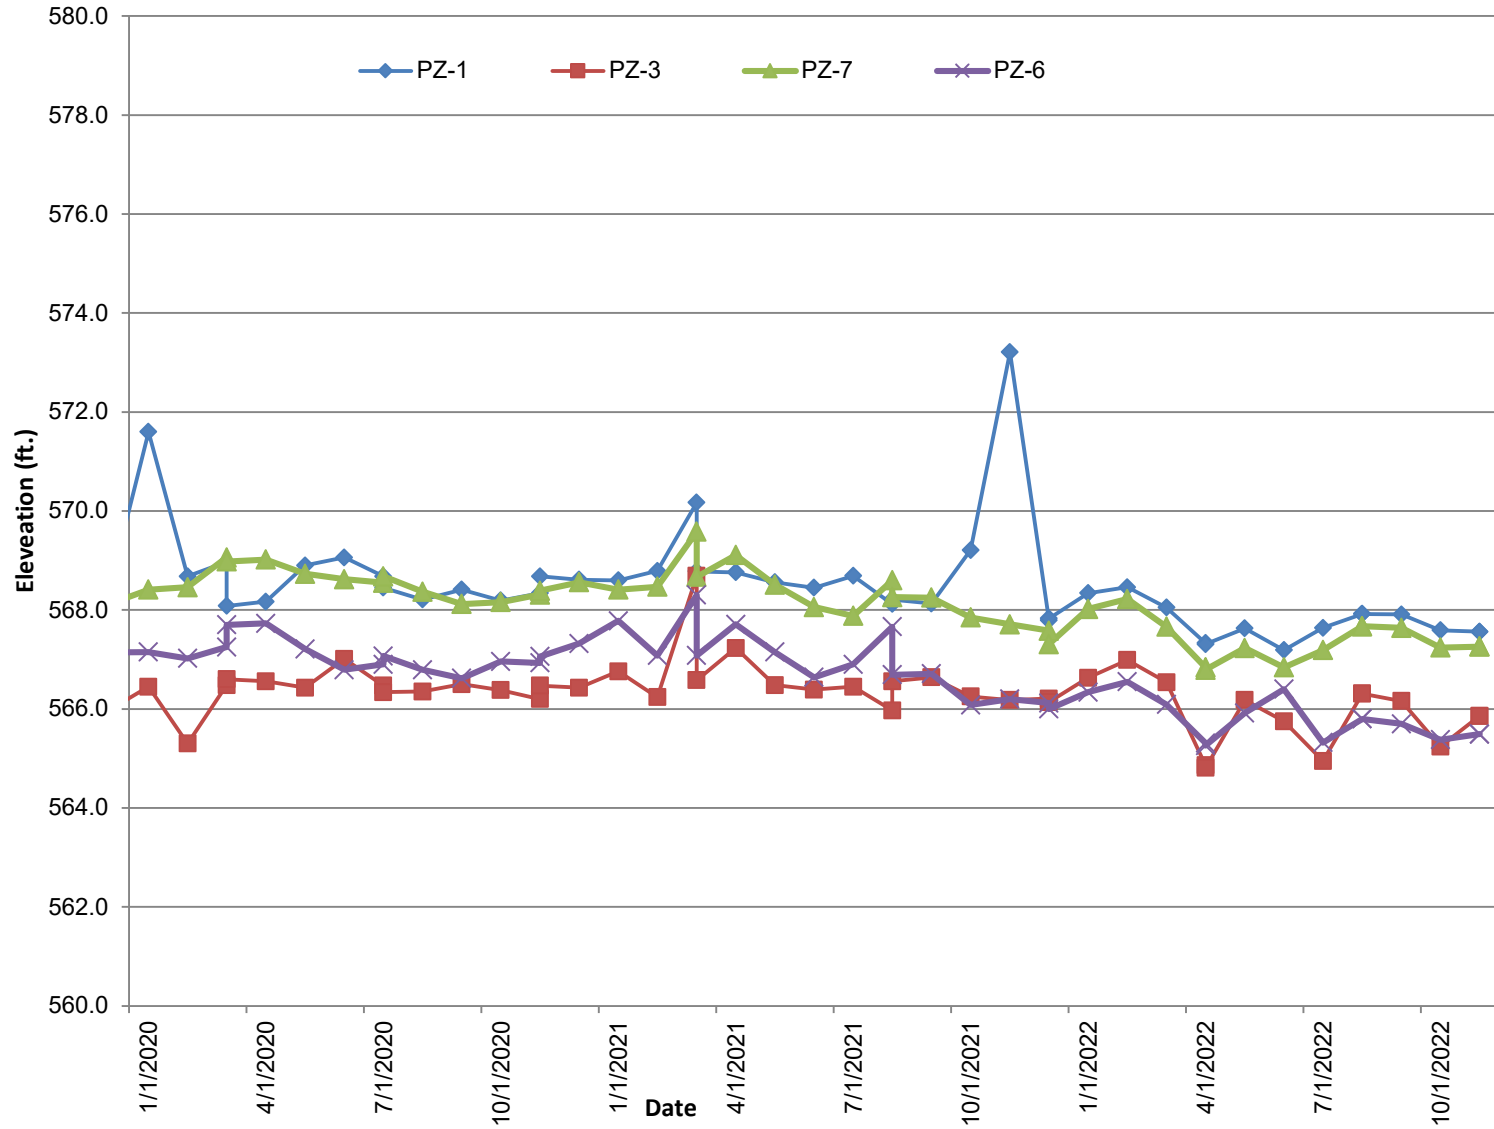
FIGURE 5
John E Amos Plant
Bottom Ash Pond
Piezometer Readings

The elevations of pond water levels and respective piezometer water levels have remained fairly constant with no adverse trends observed that would impair the structural stability of the perimeter dike. Piezometer hydrographs shown in Figure 5.

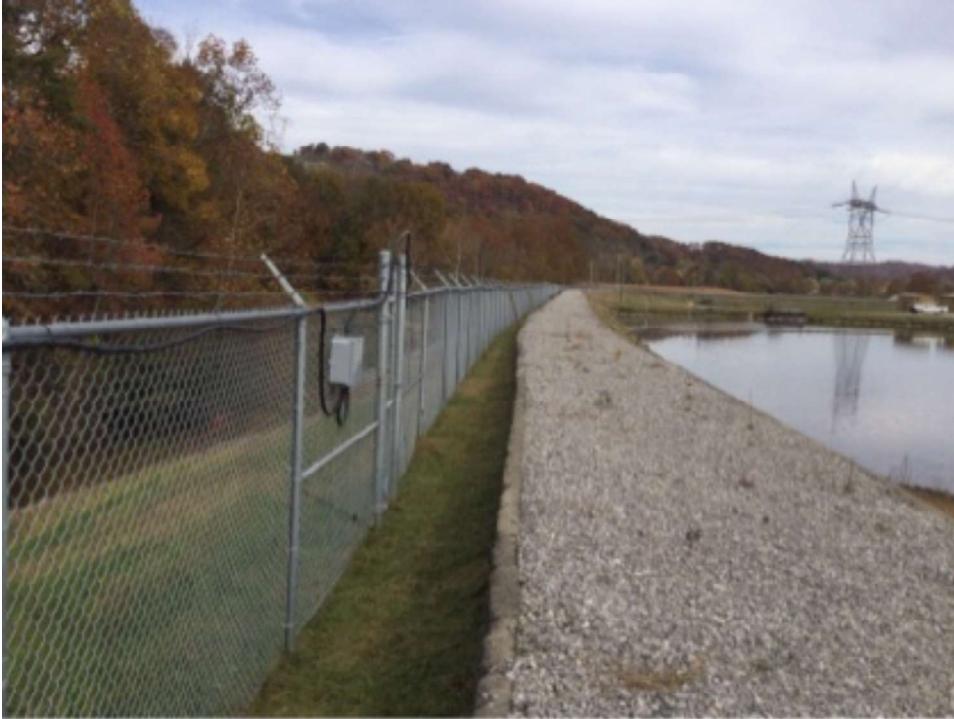
Notes: General condition of the exterior and crest of the stone wall along Main Dam along Reclaim Pond

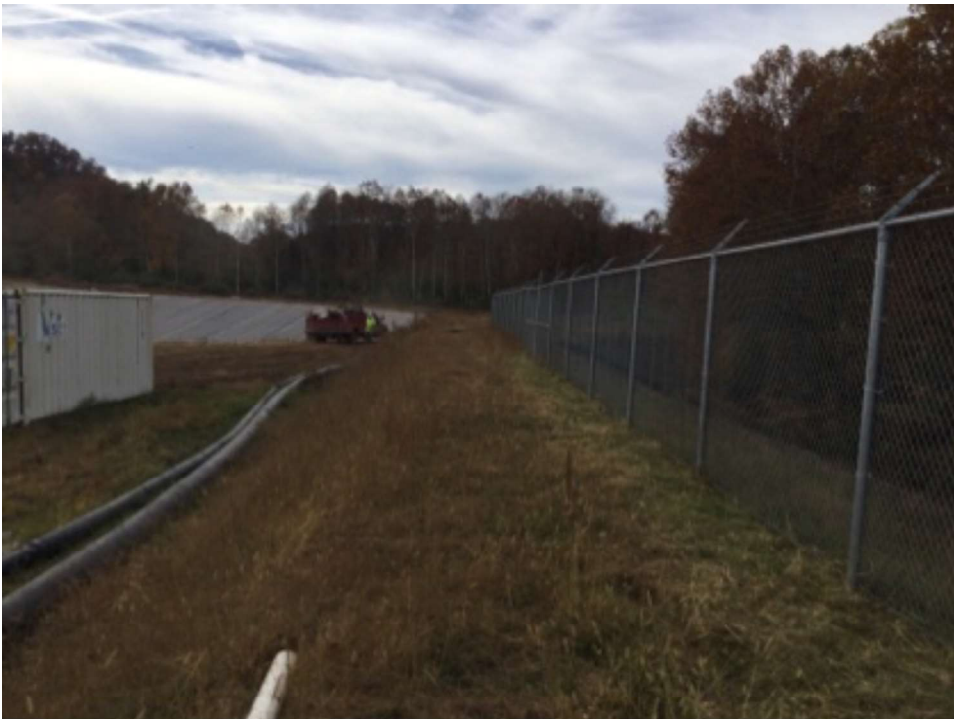
Notes: General condition of interior slope of Main Dam at Wastewater Pond (formally BAP 1B)

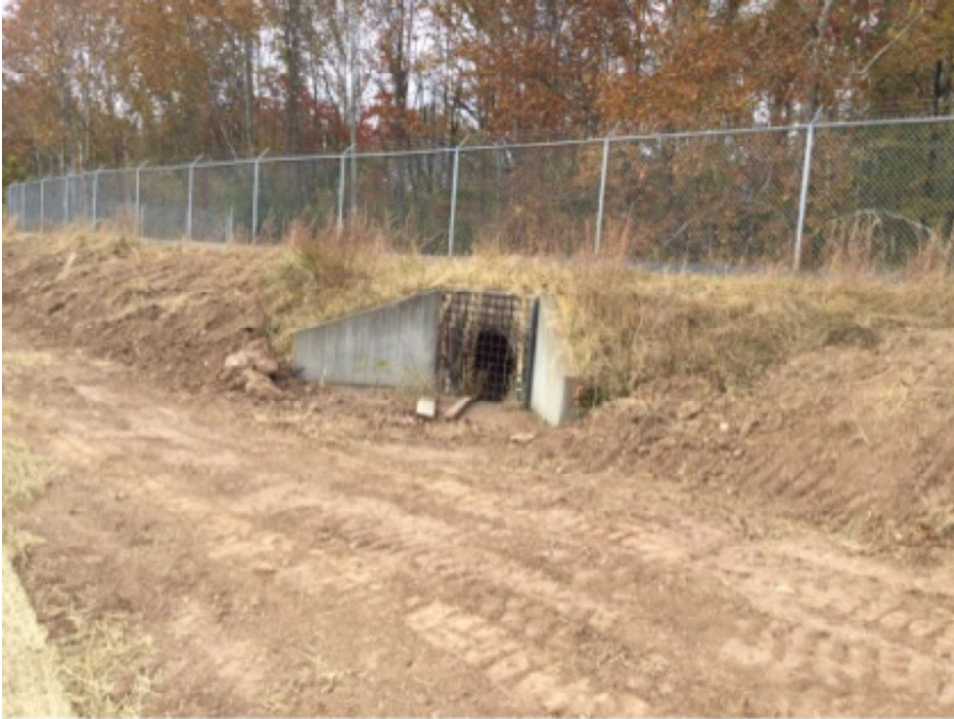
Notes: General condition of emergency spillway inlet at top of Wastewater Pond (formally BAP1B)

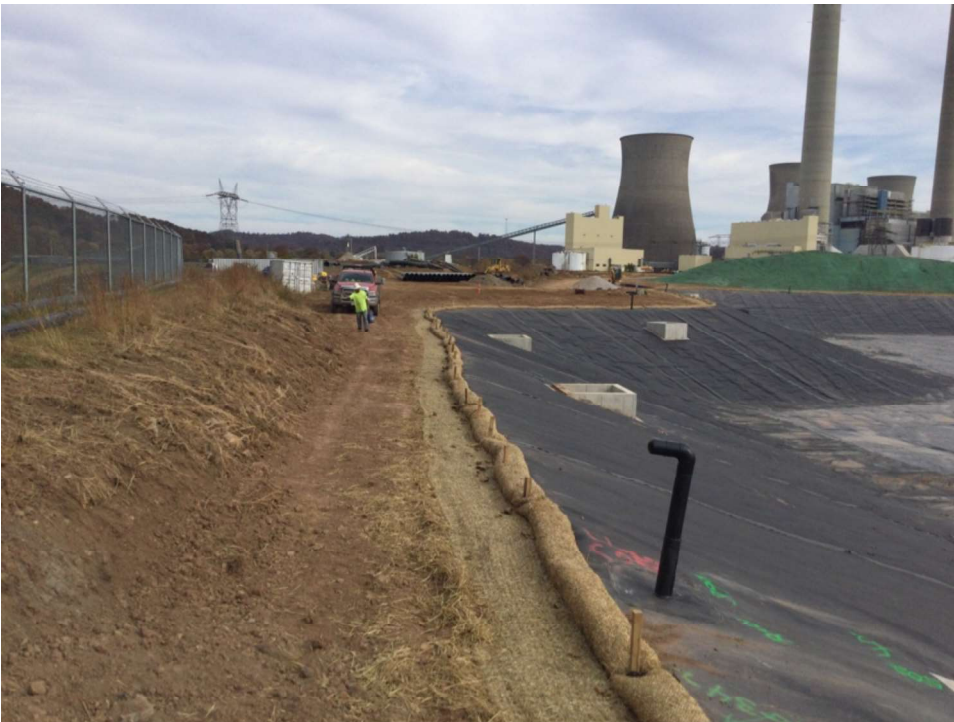
Notes: General condition of interior slope of Wastewater Pond (formally BAP 1B) along main dike

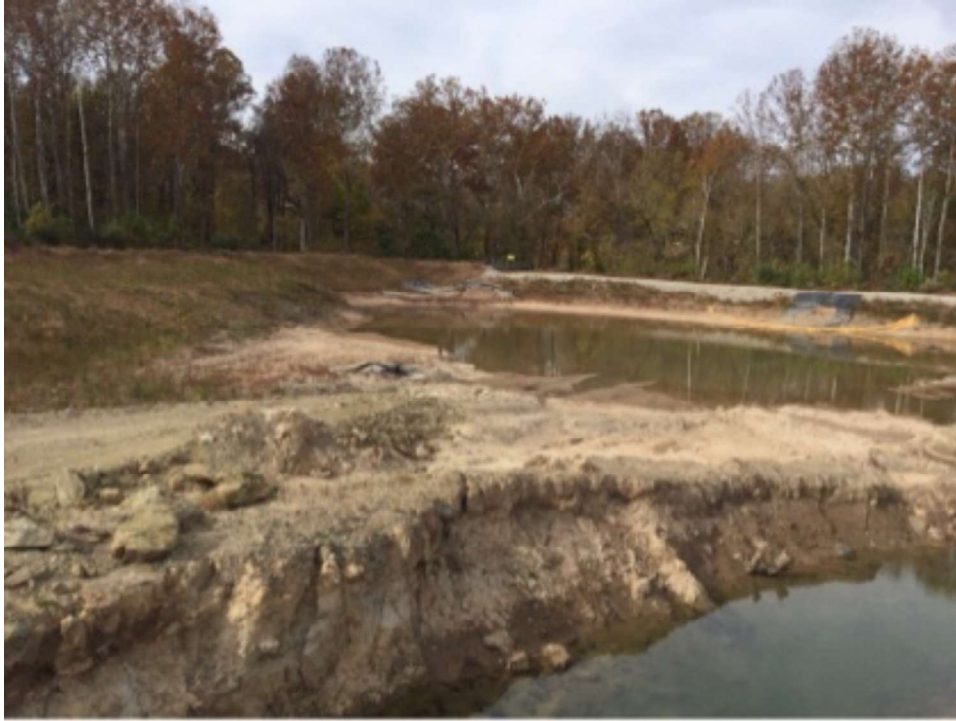
Photo #: 15

Notes: General condition of of the temporary stormwater pond at northwest corner. CCRs removed from area and area to be backfilled when storm water can be routed to wastewater pond

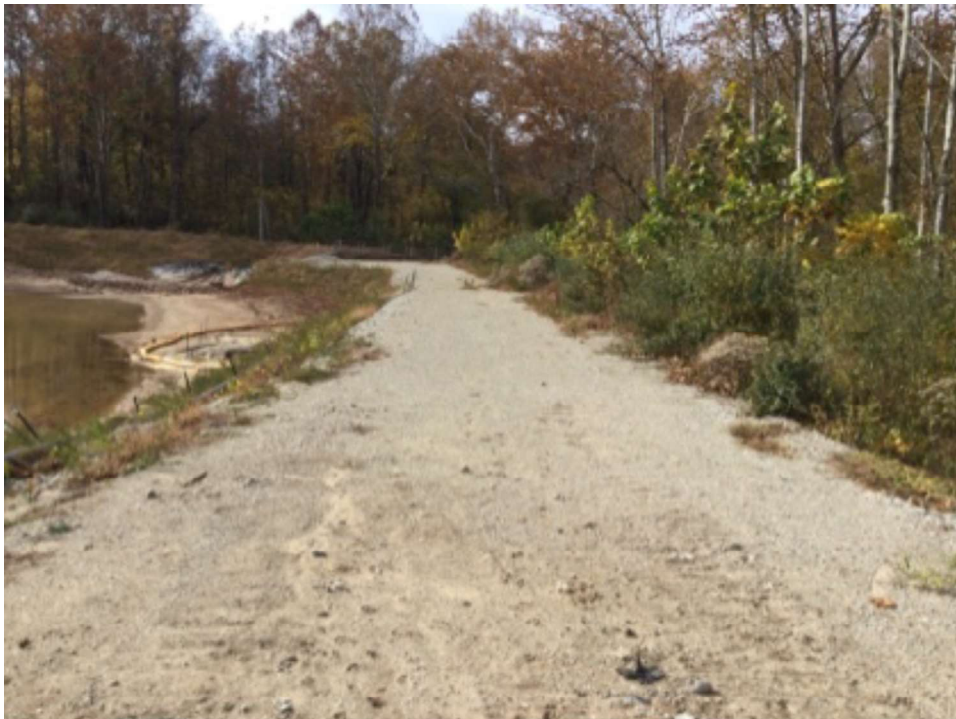
Photo #: 16

Notes: Crest of the historical dike at the northwest corner.

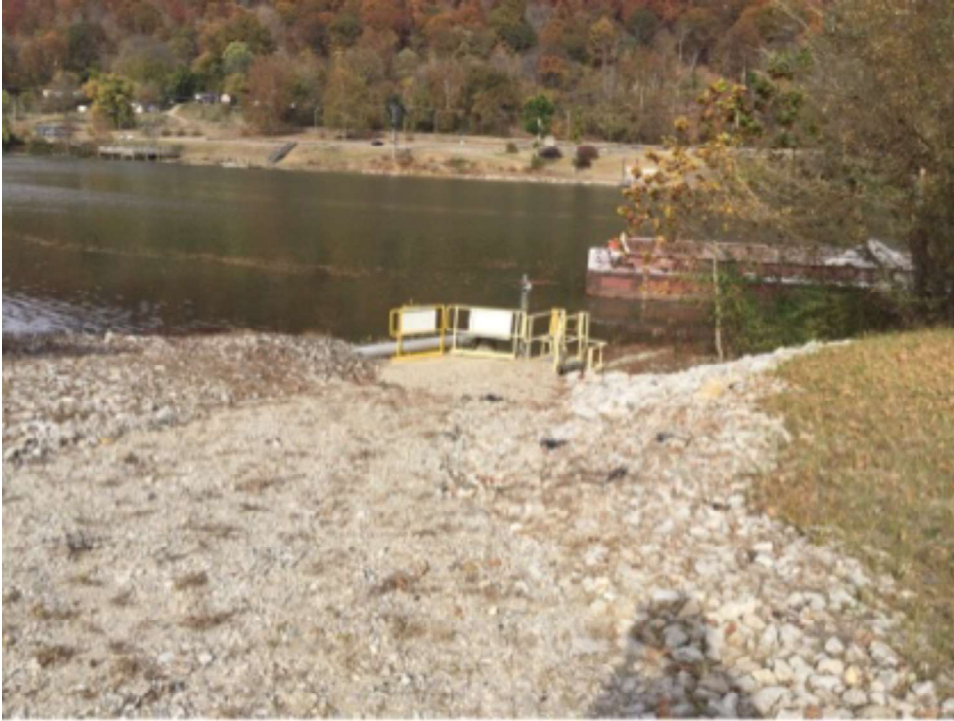
Photo #: 29

Notes: General condition of the approach to Outfall 003

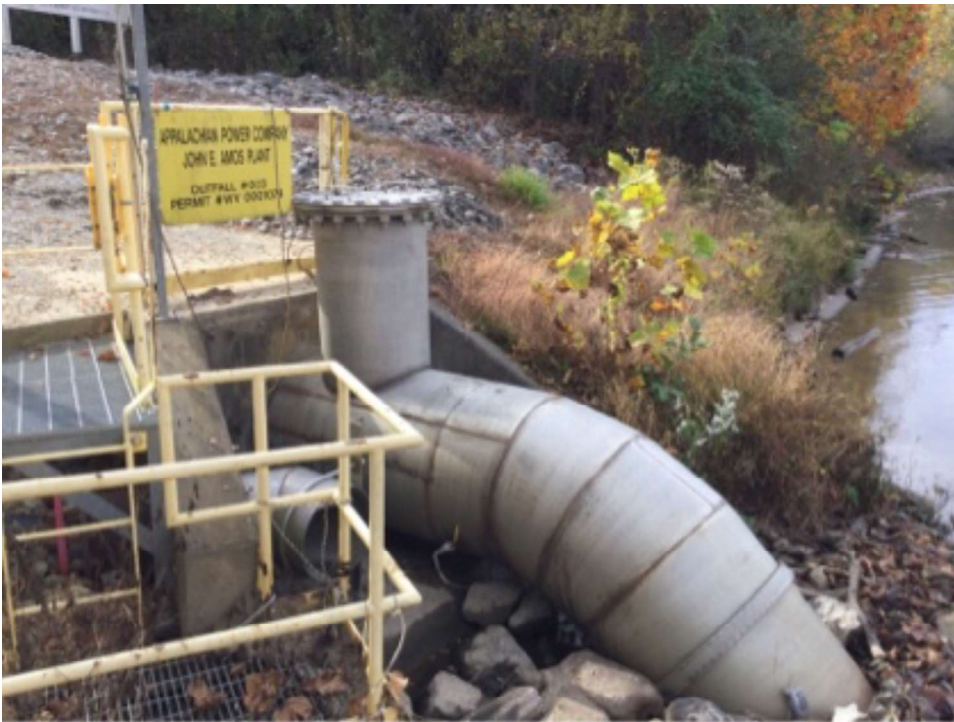
Photo #: 30

Notes: General condition of of Outfall 003 diffuser into the river
