2022 Annual Dam and Dike Inspection Report

Bottom Ash Pond Complex

Mitchell Plant

Document ID: GERS-22-012

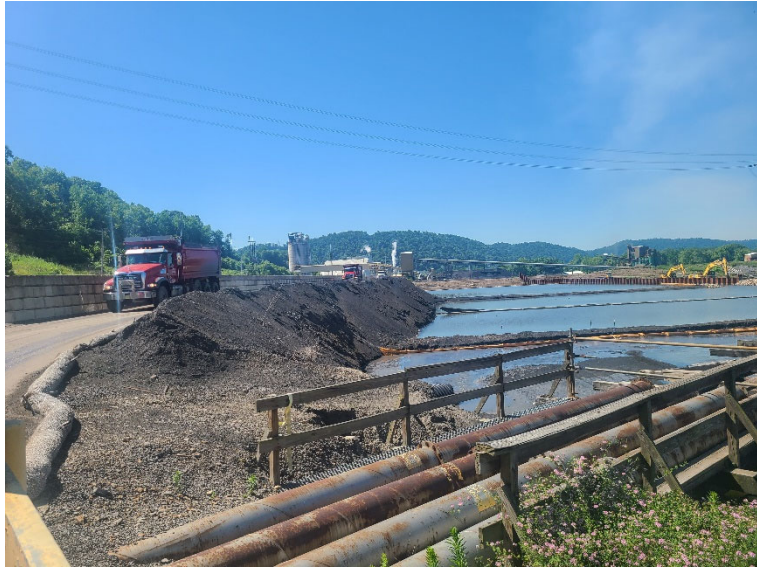
Photo No. 1

2. The east portion of the pond is used for dewatering and removal of sluiced bottom ash. The dewatering activities were not observed to impact the structure or stability of the dam and the impounding area of the pond appeared in good condition (Photos 1 through 6).

Observation 1: Construction Activities

Location: East inboard slope of the East section of Bottom Ash Pond looking south.

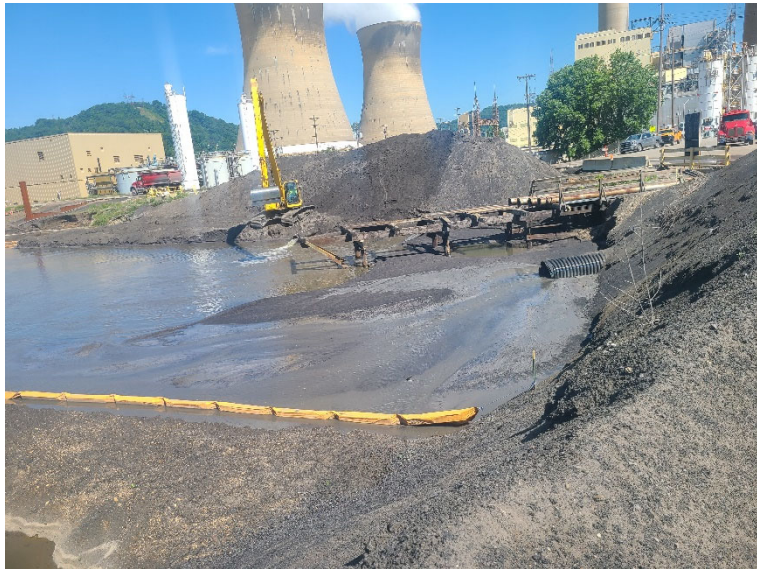
Photo No. 2

Observation 1: Construction Activities

Location: East inboard slope of the East section of Bottom Ash Pond looking north.

Bottom ash is being dredged

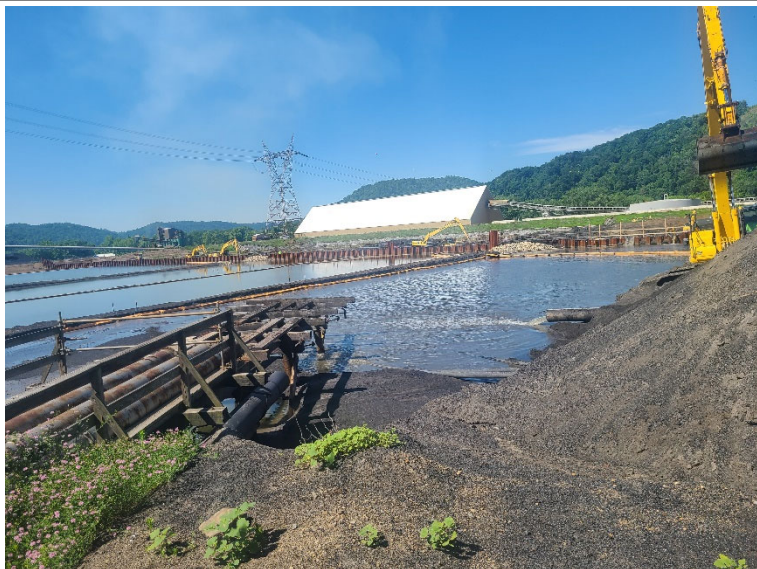
Photo No. 3

Observation 1: Construction Activities

Location: North inboard slope of the East section of Bottom Ash Pond looking west.

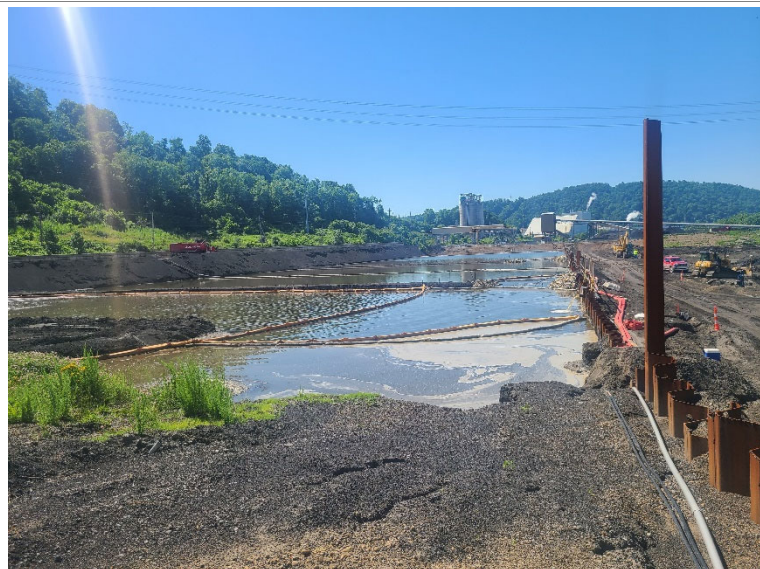
Photo No. 4

Observation 1: Construction Activities

Location: West inboard side of the East section of Bottom Ash Pond looking South.

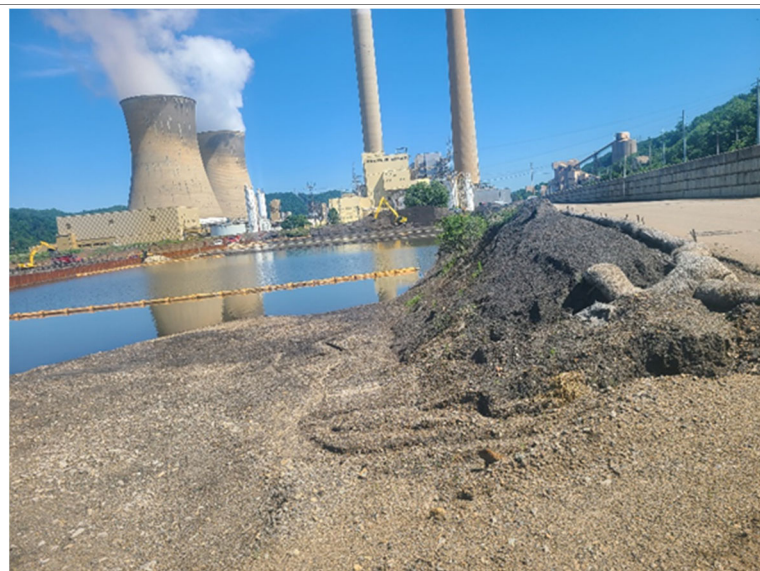
Photo No. 5

Observation 1: Construction Activities

Location: East inboard side of the East section of Bottom Ash Pond looking North.

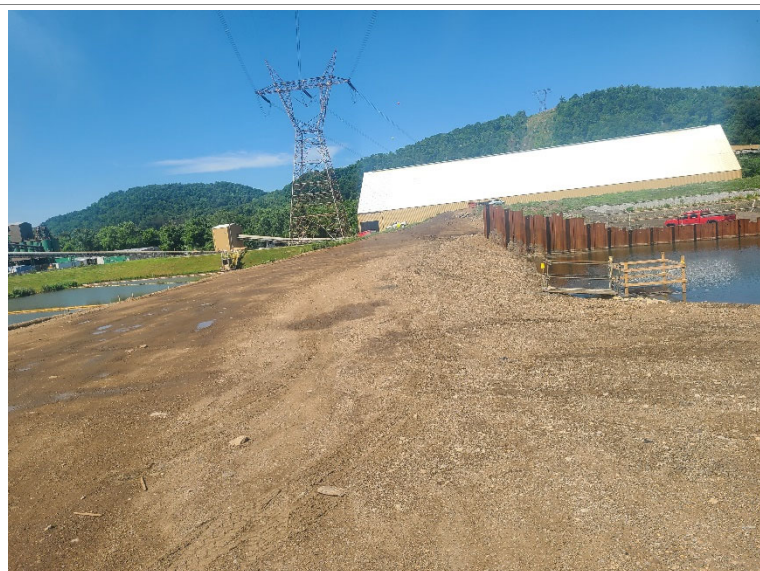
Photo No. 6

Observation 1: Construction Activities

Location: South inboard side of the East section of Bottom Ash Pond looking West.

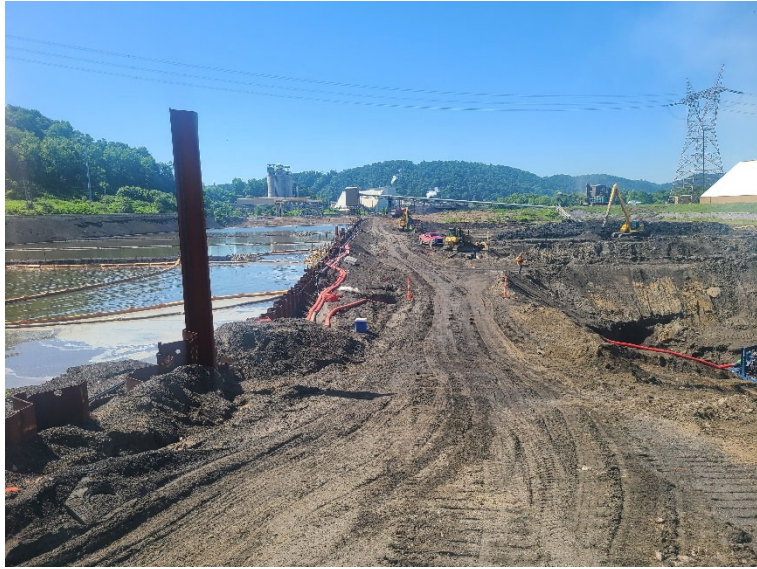
Photo No. 7

3. The west portion of the pond was dewatered and the bottom ash was being excavated to be transported to the onsite landfill (Photos 7 through 10).
4. There were no seepage or wet areas observed along the embankment.

Observation 2: Construction Activities

Location: West inboard side of the West section of Bottom Ash Pond looking South.

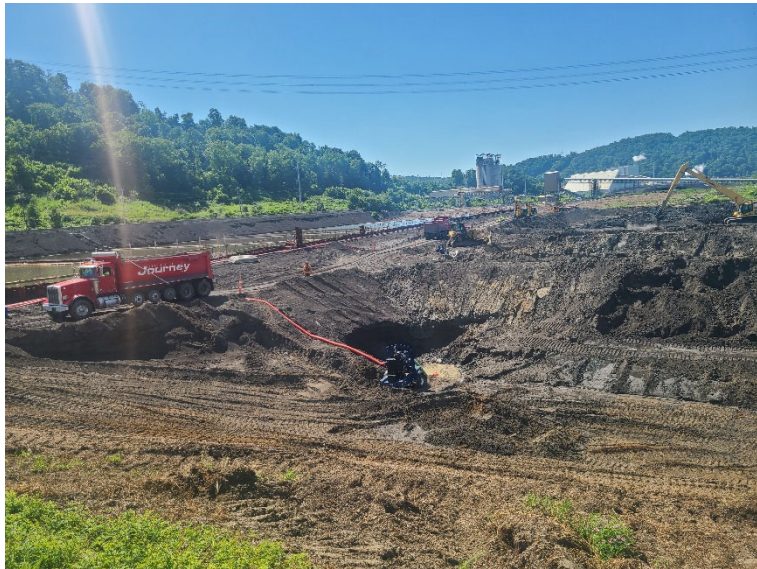
Photo No. 8

Observation 2: Construction Activities

Location: West section of Bottom Ash Pond looking South.

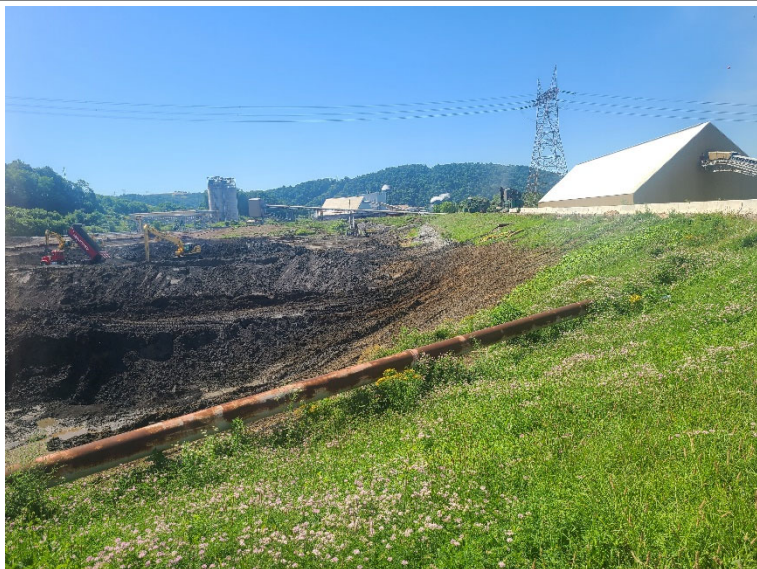
Photo No. 9

Observation 2: Construction Activities

Location: West inboard side of the West section of Bottom Ash Pond looking South.

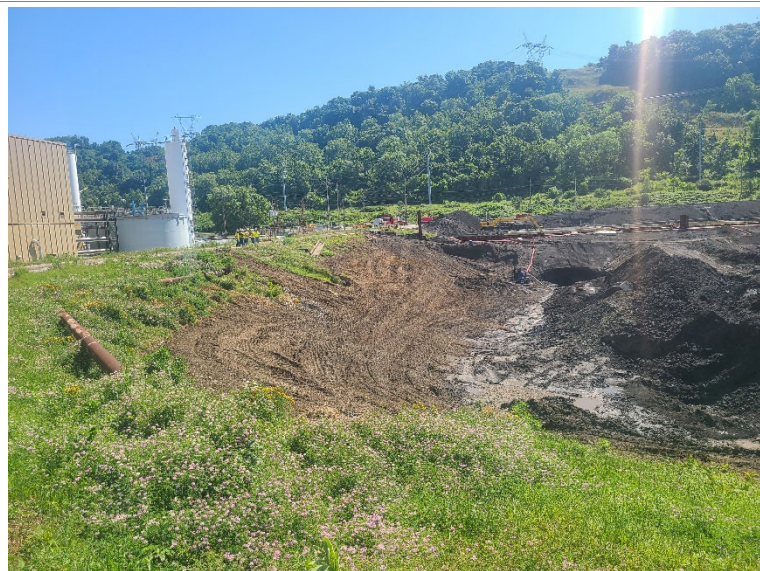
Photo No. 10

Observation 2: Construction Activities

Location: West inboard side of the West section of Bottom Ash Pond looking South.

Bottom Ash excavation

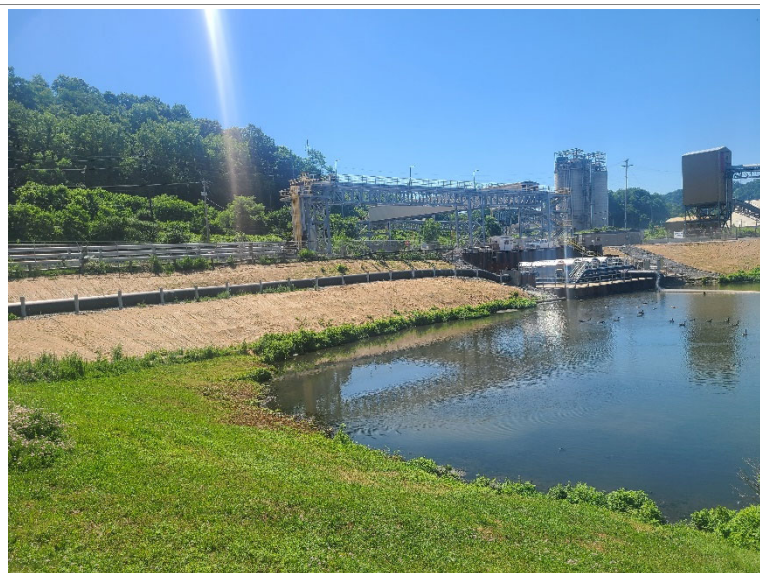
Photo No. 11

1. The Clear Water Pond was in good operating condition during the time of the inspection. Inflows from the East side of BAP enter the pond through the newly constructed temporary treatment system and the flow appeared to be unobstructed (Observation 3, Photos 11 through 13).

Observation 3: Construction Activities

Location: Clear Water Pond looking East.

Newly installed temporary water treatment Structure

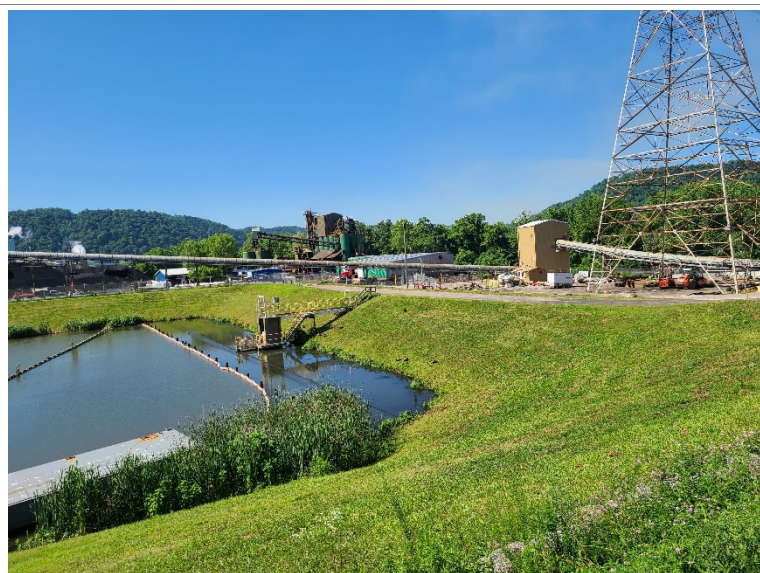
Photo No. 12

Observation 3: Operation Activities

Location: Clear Water Pond west Inboard dike.

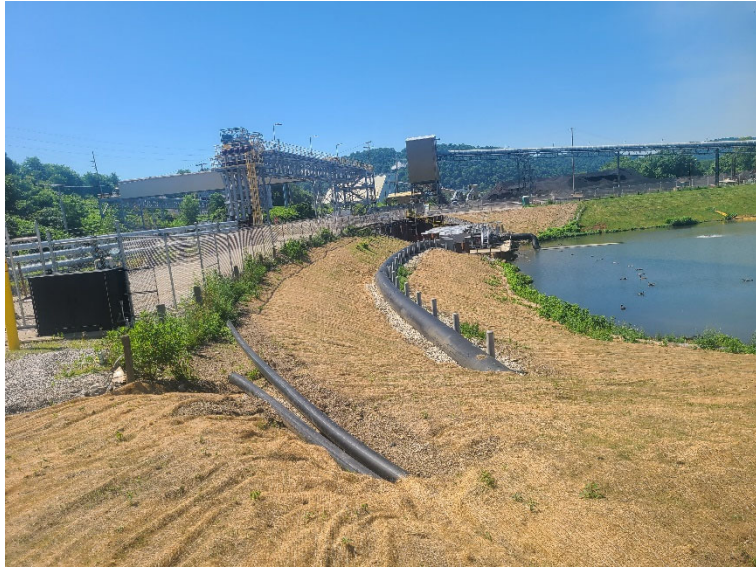
Photo No. 13

Observation 3: Construction Activities

Location: East inboard side of the Clear Water Pond looking South.

temporary treatment system

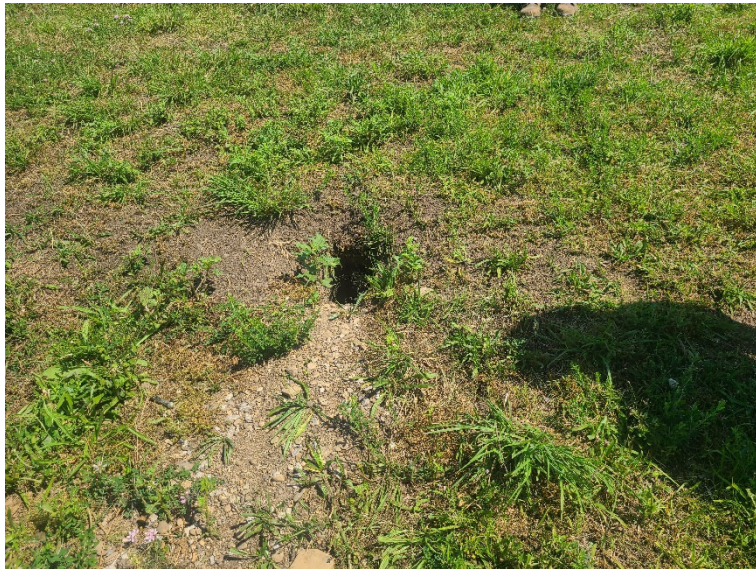
Photo No. 14

2. The interior slopes showed no signs of distress such as sloughing or bulges. The grass was recently mowed before the inspection. One animal burrow was observed during this inspection along the north and east interior dikes (Observation 4, Photo 14).

Observation 4: Animal Burrow.

Location: North inboard slope of Clear Water Pond

- 1) Repair animal burrows along the north and east interior dikes of the clear water pond (Observation 4).

Recommendations: Repair by filling in with soil.
