2022 Annual Landfill Inspection Report

Little Broad Run Landfill

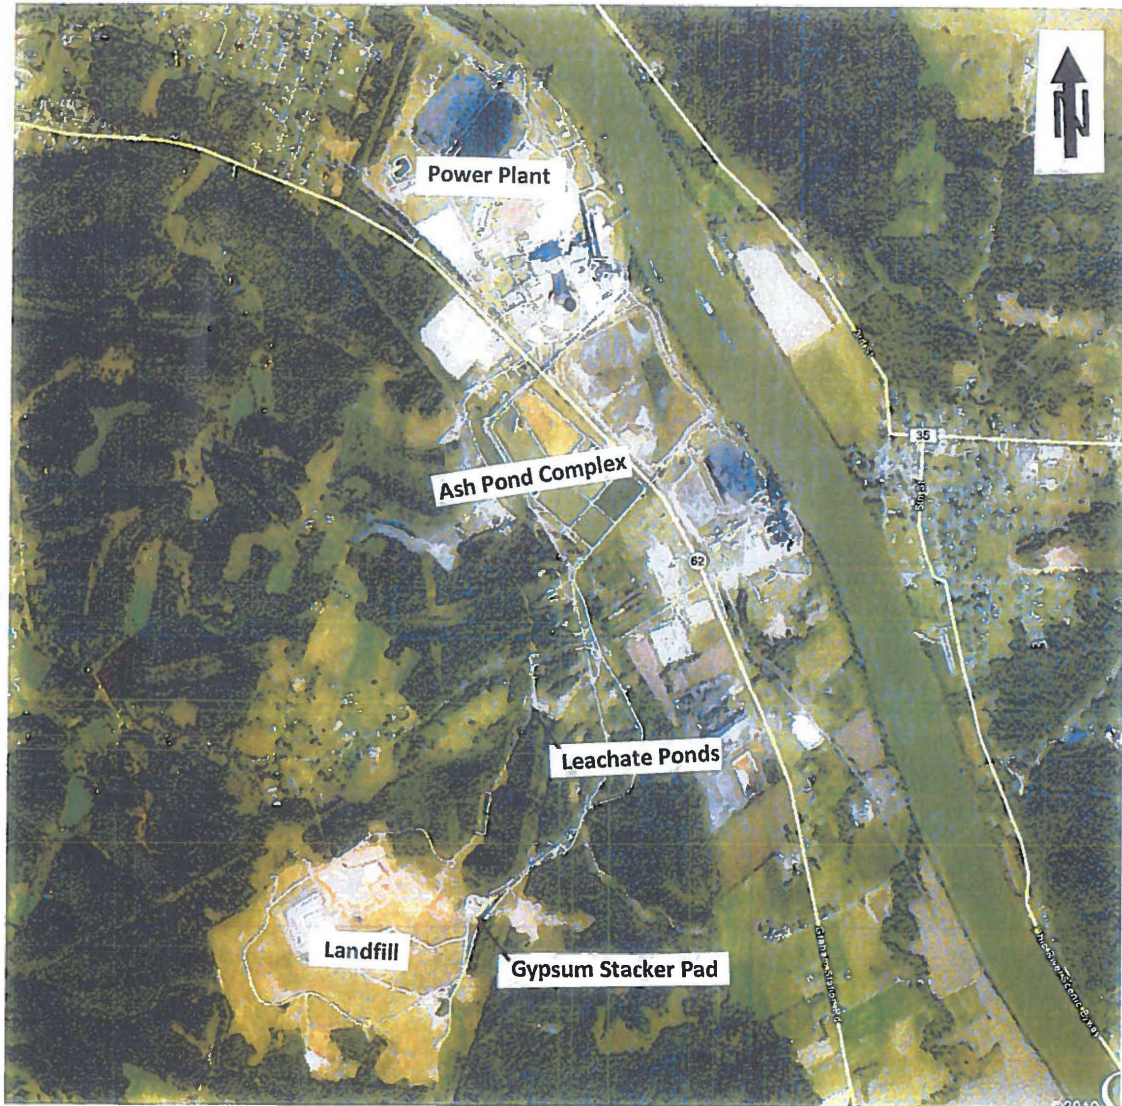
Figure 1 – Site Location Map
Little Broad Run Landfill-Mountaineer Plant

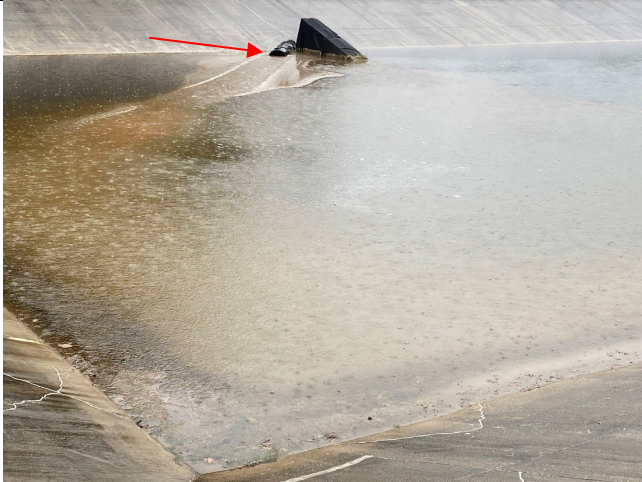
View of leachate collection pond #1

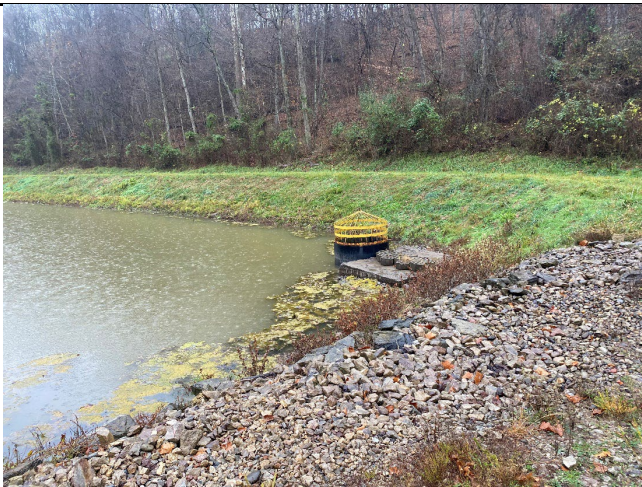
View of sediment accumulation in leachate collection pond #2. The influent line is noted by the red arrow.

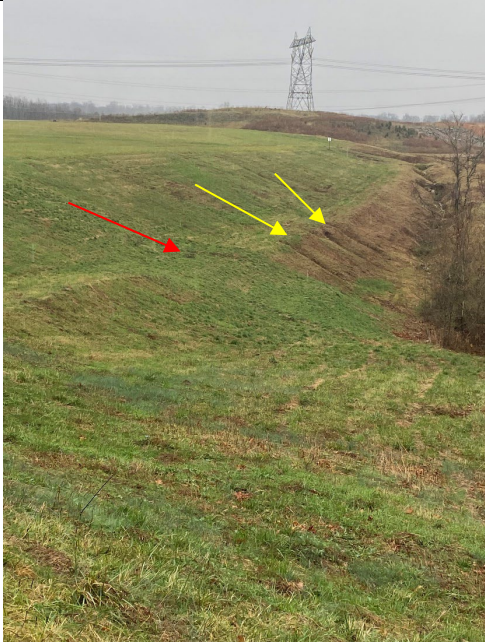
View of some bare soils on the outside of Area 3, adjacent to sump #2.

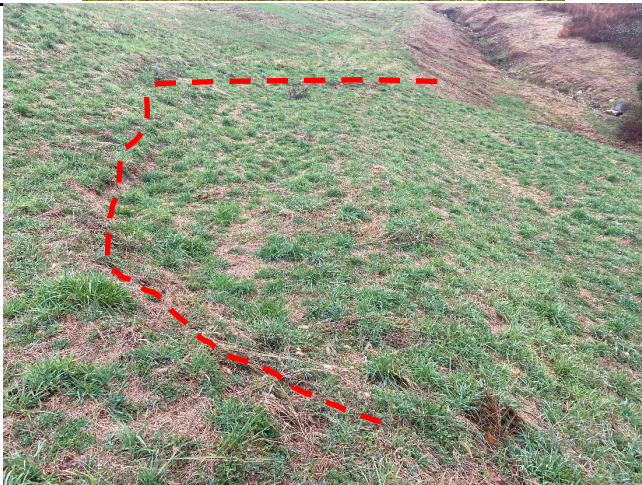
View of the outside slope of Area 1. Erosion rills are noted in yellow (photograph 16) and a shallow slip (photograph 15) noted in red.
