# 2023 Annual Landfill Inspection Report

**Mitchell Plant**

**Wheeling Power Company**

**Document ID: GERS-23-023**

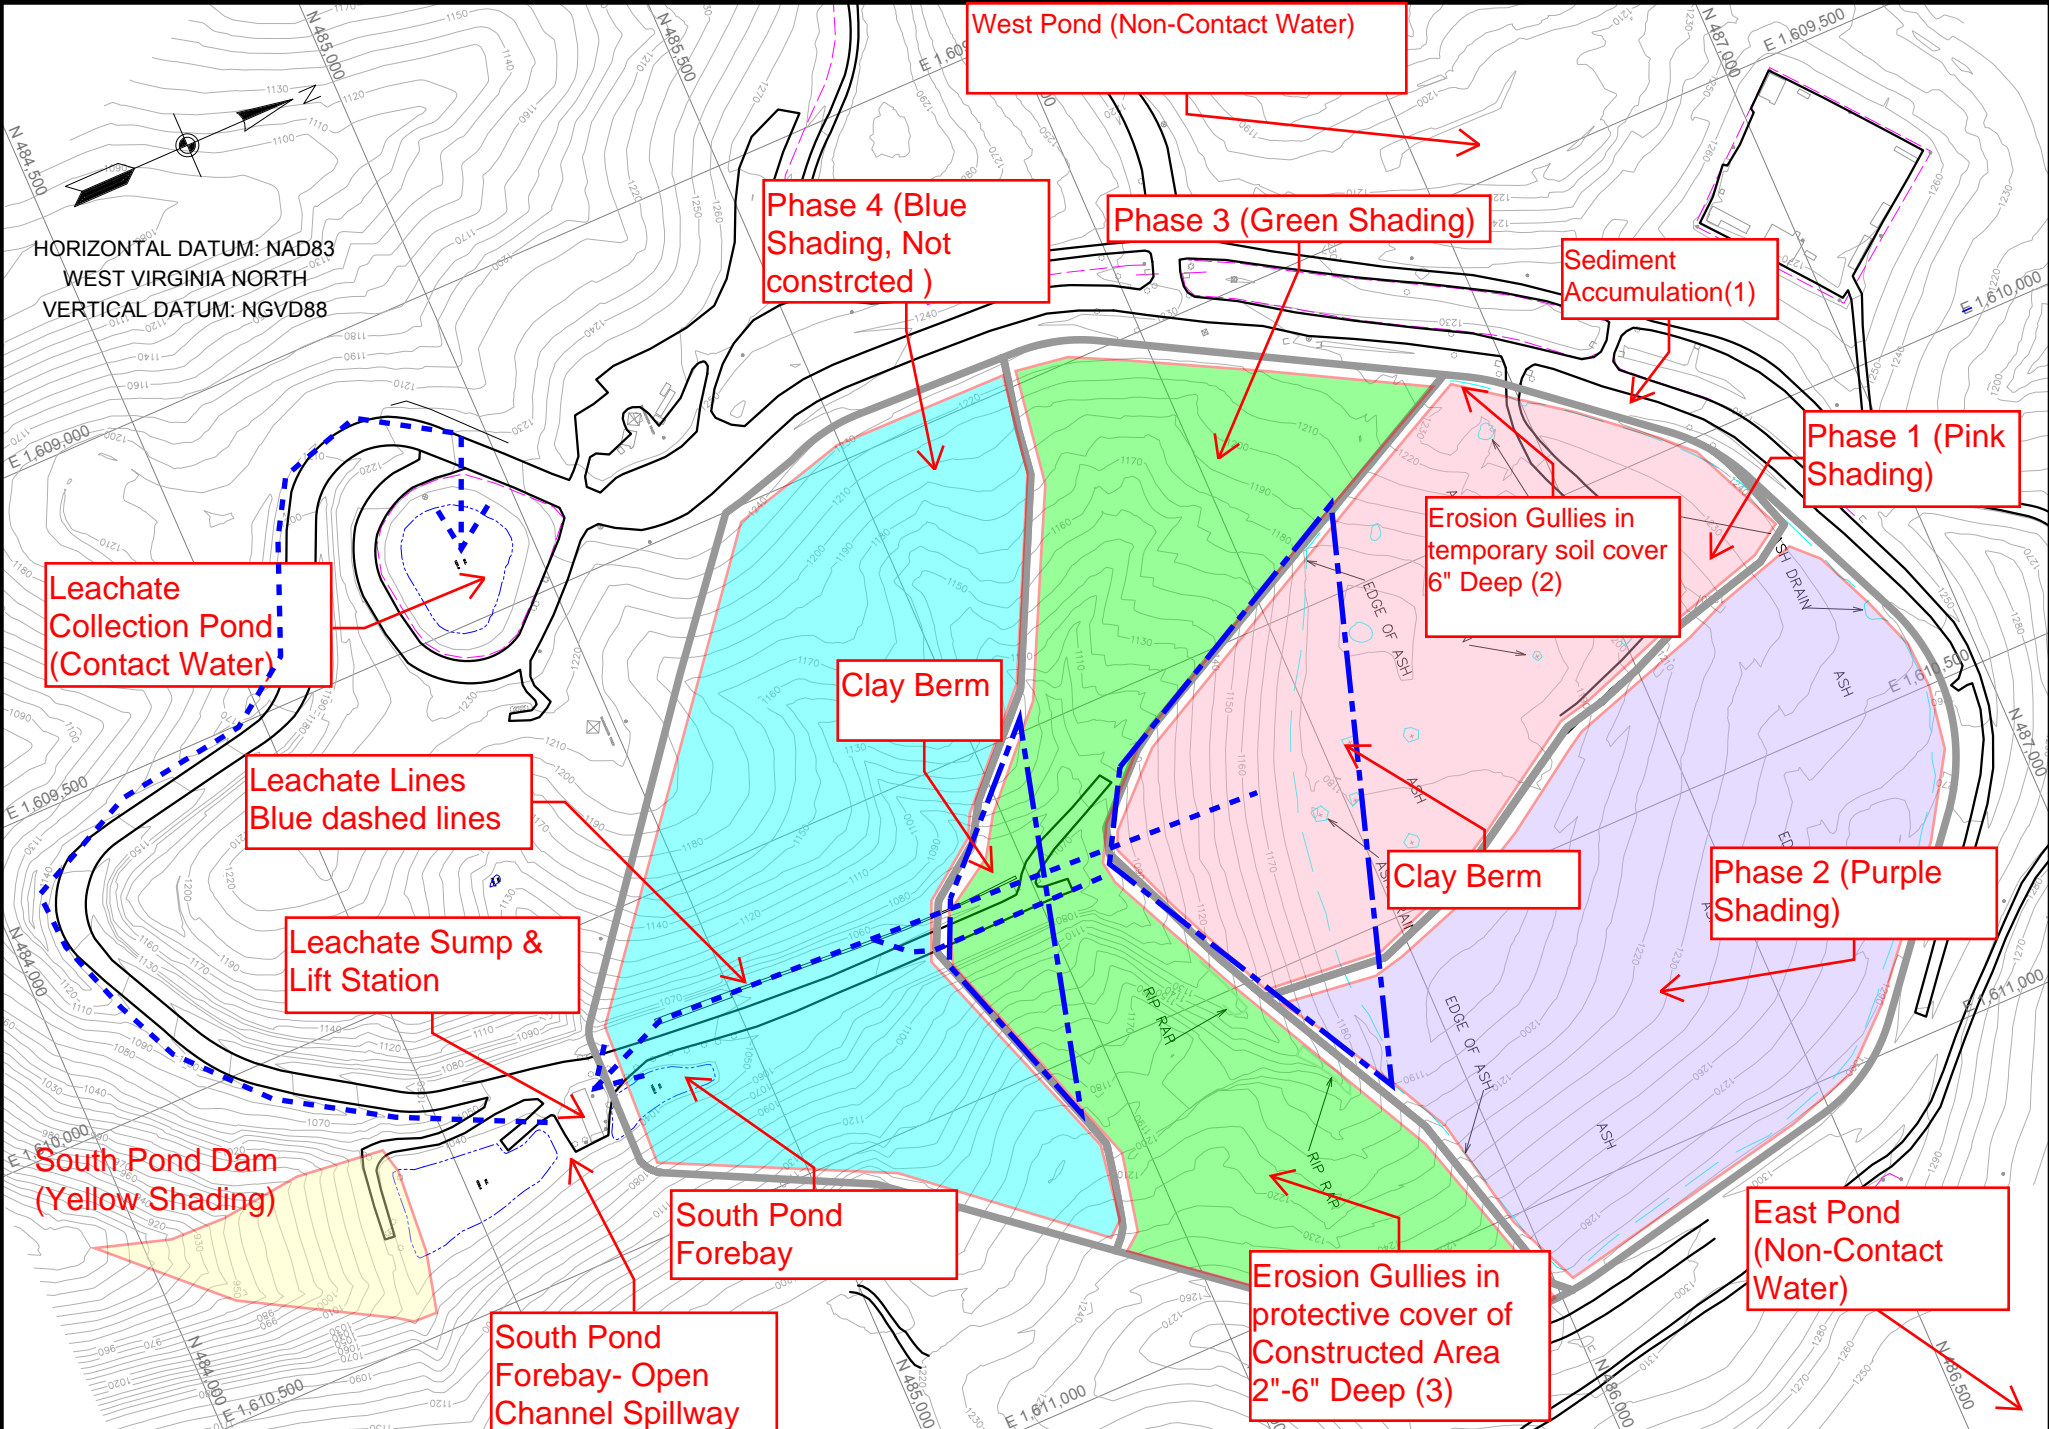
Landfill Inspection Location Map		
OHIO POWER COMPANY		
MITCHELL PLANT	WEST VIRGINIA	
LANDFILL		
FIGURE 1

Sediment Accumulation(1)

Erosion Gullies in temporary soil cover 6" Deep (2)

Erosion Gullies in protective cover of Constructed Area 2"-6" Deep (3)

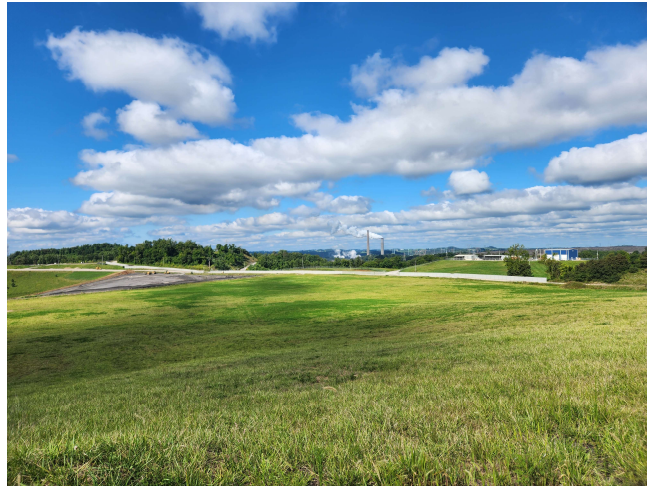
**Photo No. 1**

Observation 1: General Conditions:  
temporary soil cover

Location: Phase 1

Recommendations: N/A.

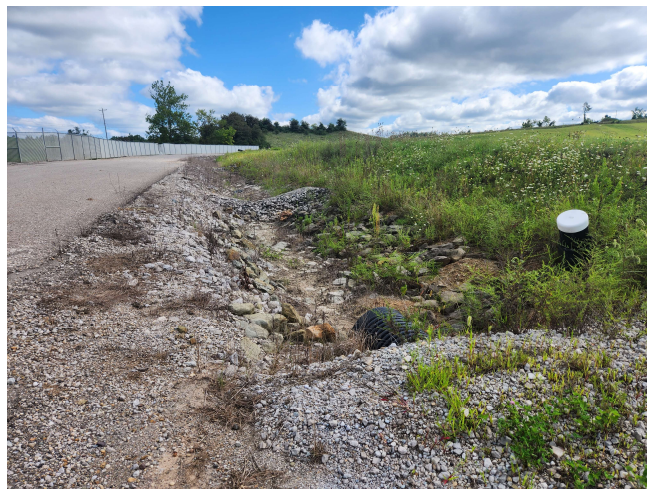
**Photo No. 2**

Observation 1: Minor Sediment  
Accumulation

Location: Outer Ditch Phase 1

1. Periodically remove the vegetation growing in the riprap-lined areas on the upstream slope and downstream toe area of the south pond dam.
2. Periodically dress the slope surface in order to minimize the erosion of the bottom ash protective cover.
3. Continue to perform routine maintenance on the leachate pump system components and remove any debris accumulation (leaf litter, sticks, etc.) as necessary for proper operation of the pumping system.
4. Clean sediments in outer ditch phase 1 area.
5. Fix Minor erosion in phase 1 area.

Recommendations: Clean ditch.

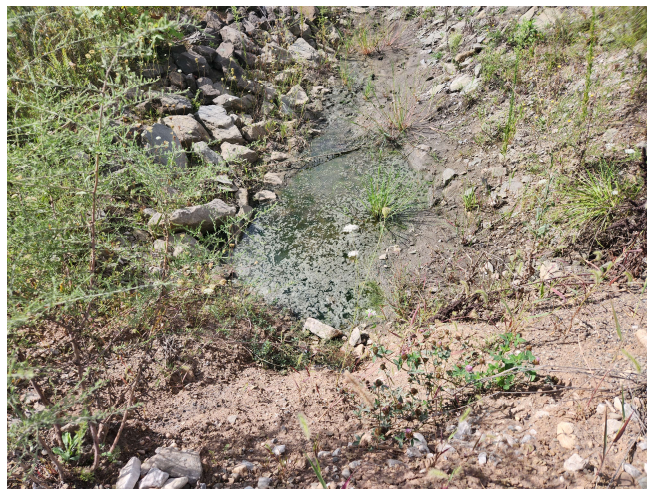
**Photo No. 3**

Observation 1: Minor Sediment  
Accumulation

Location: Outer Ditch Phase 1

Recommendations: Clean ditch.

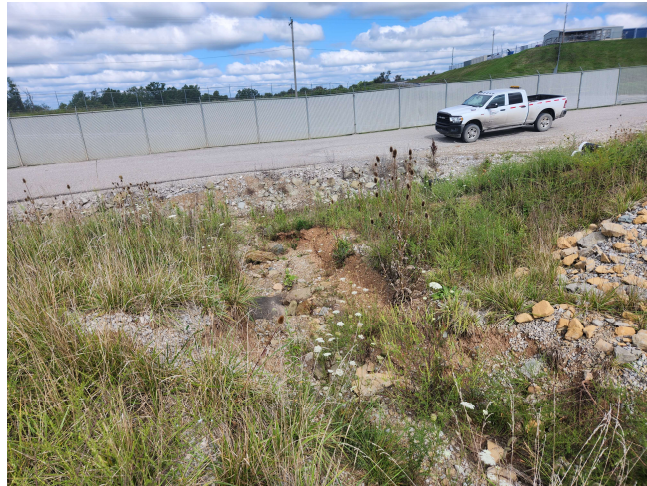
**Photo No. 4**

Observation 2: Minor Erosion in the temporary soil cover

Location Phase 1.

Recommendations: place and seed temporary soil cover.

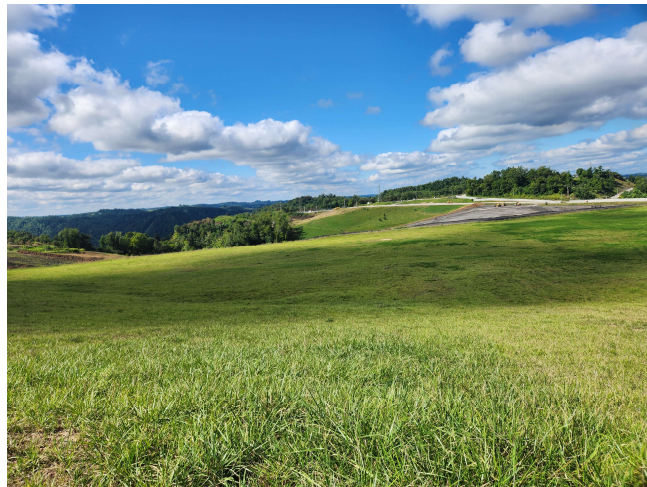
**Photo No. 5**

1. 6-inch-thick layer of the temporary cover was placed in the Phase 2 Area. The area is not actively receiving CCR material for disposal. There was no evidence of standing water, erosion, slope instabilities or uncontrolled seepage. (Photograph 5 and 6).

Observation 2: General Conditions: temporary soil cover

Location Phase 2.

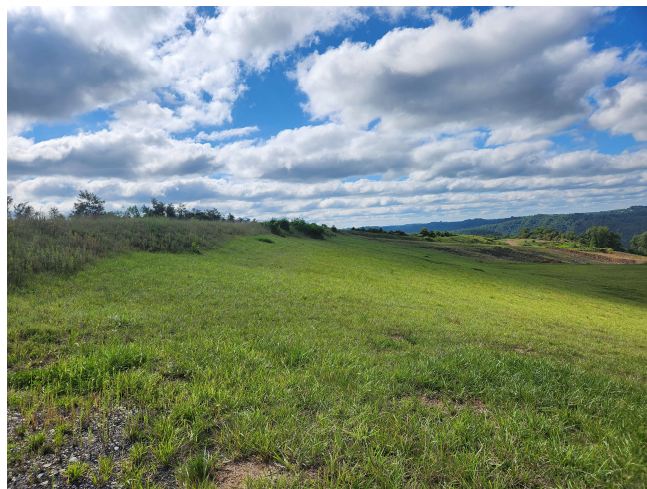
**Photo No. 6**

Observation 2: General Conditions: temporary soil cover

Location Phase 2.

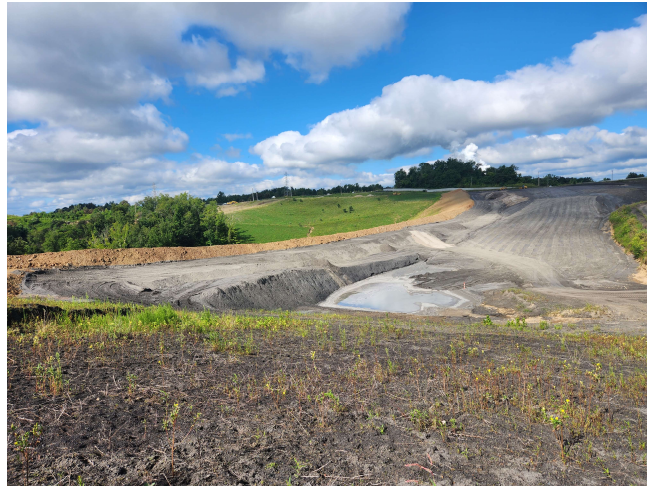
**Photo No. 7**

1. During the inspection, Phase 3 area was actively receiving CCR material for disposal. CCR material is dumped, spread out with a dozer and compacted with a smooth drummed roller. There was no evidence of standing water, slope instabilities or uncontrolled seepage. Few erosion gullies are present along the eastern slope and the western groin of the area within the protective bottom ash cover (Photographs 7 through 11).

Observation 3: General Conditions: Fly ash placement in phase 3.

Location: Floor area of Phase 3.

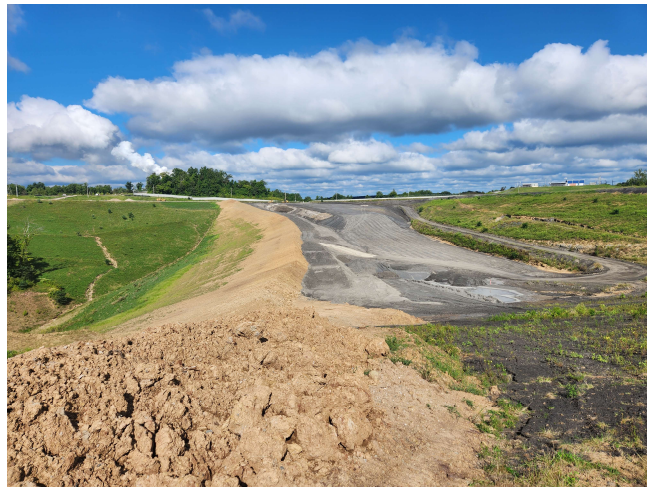
**Photo No. 8**

Observation 3: General Conditions

Location: left edge of east inboard slope of Phase 3 looking West.

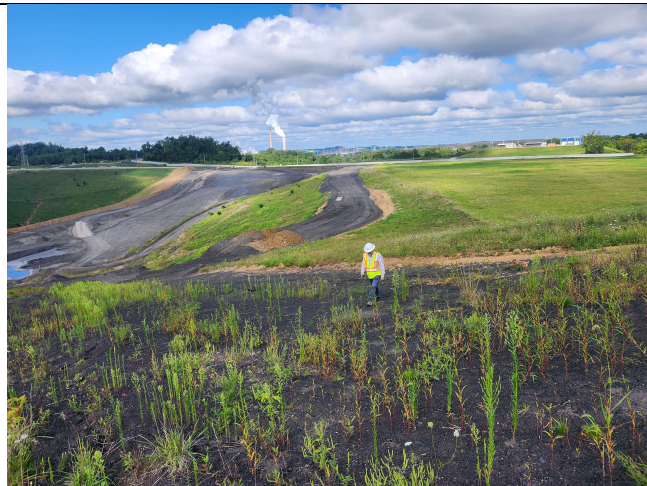
**Photo No. 9**

Observation 3: General Conditions

Location: Right edge of east inboard slope of Phase 3.

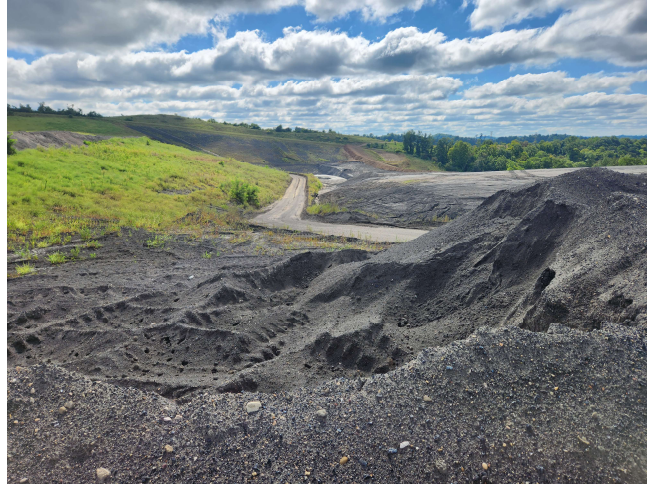
**Photo No. 10**

Observation 3: General Conditions:

Location: left edge of west inboard slope of Phase 3

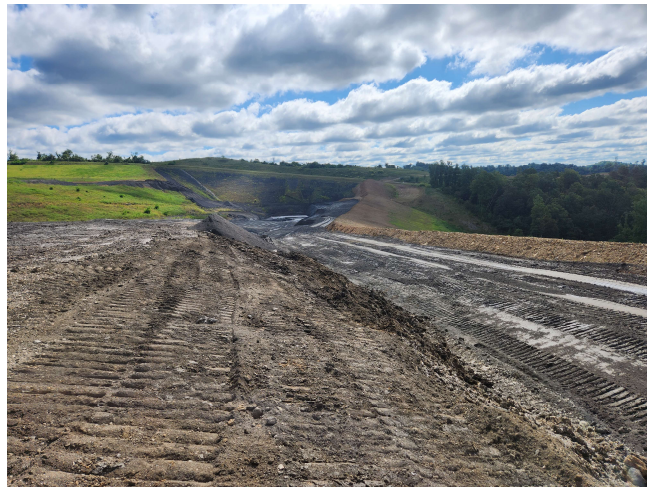
**Photo No. 11**

Observation 3: General Conditions:

Location: Right of east inboard slope of Phase 3.

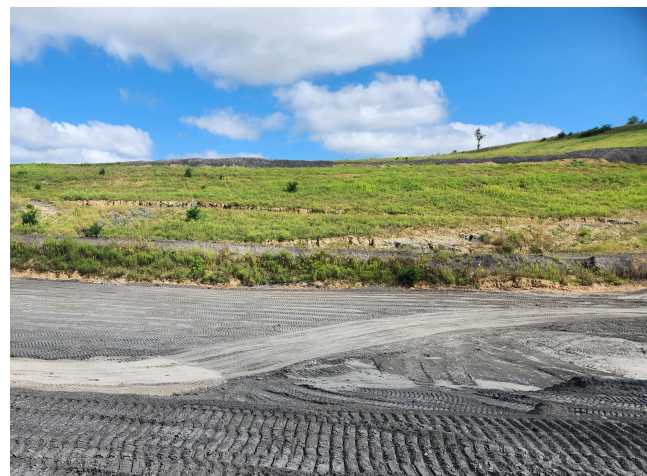
**Photo No. 12**

1. At the time of inspection, the clay berm south of phases 1 and 2 was recently mowed with good established grass cover. At some areas, the clay from phases 1 and 2 clay berm was harvested to be used in constructing the phase 3 Berm (photograph 12 and 13).
2. There was no evidence of uncontrolled leachate, slope instability or ponding water on the clay berms area.

Observation 4: Clay Berm

Location: Phase 1&2.

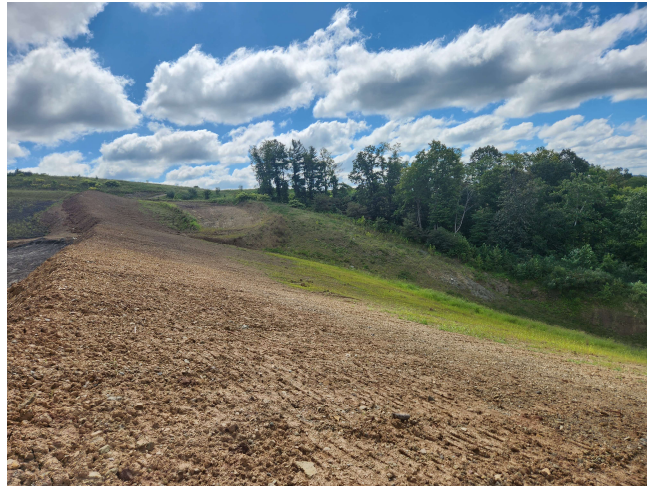
**Photo No. 13**

Observation 4: Clay Berm.

Location: Phase 3.
