2023 Annual Landfill Inspection Report

Little Broad Run Landfill

**Mountaineer Plant
New Haven, West Virginia**

Date of Inspection: August 29, 2023

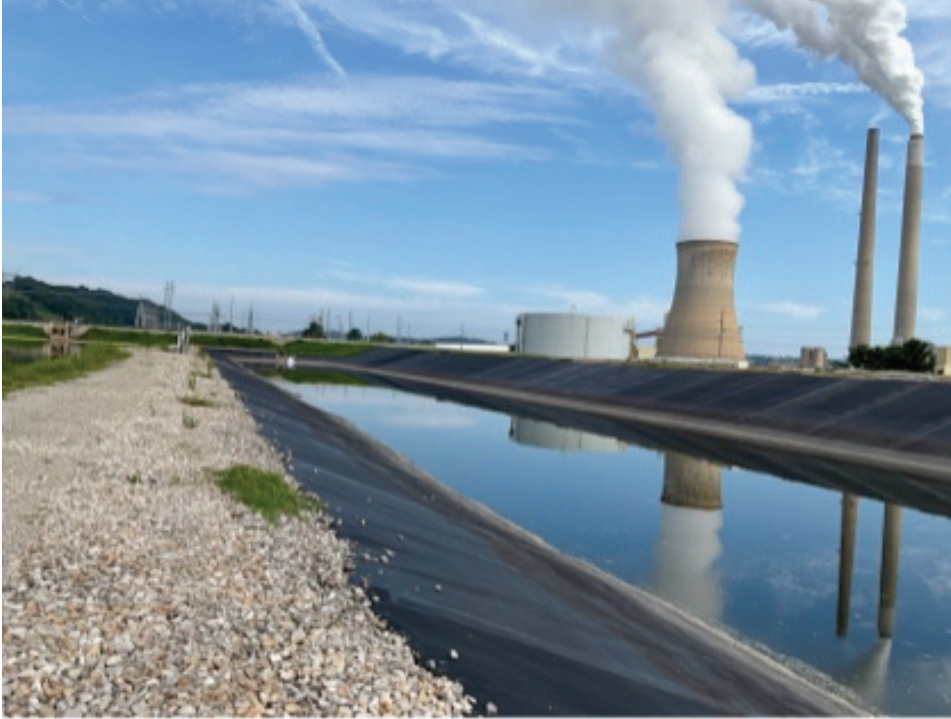
1

1. The leachate ponds discharge into the leachate surge pond located at the pond complex. The two discharge HDPE pipes (8" and 16" in diameter) are located on the west dike of the pond appeared in good functional condition. The exposed geomembrane liner of the leachate surge pond appeared in good condition, with no signs of tears, punctures or other damage.

General condition of
Leachate Surge Pond.

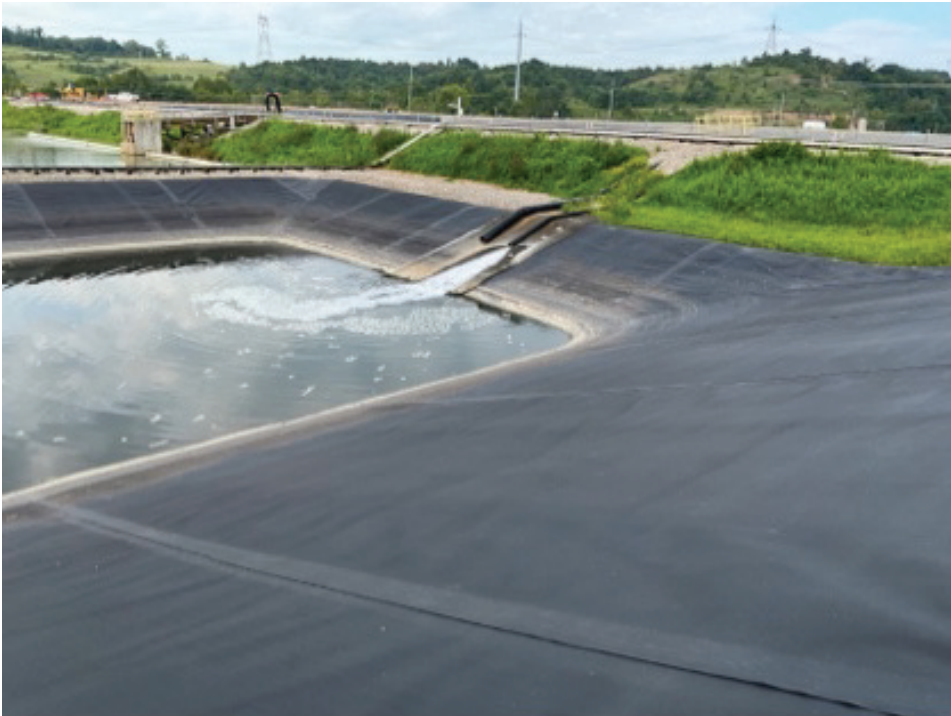
2

Leachate discharge into
Leachate Surge Pond

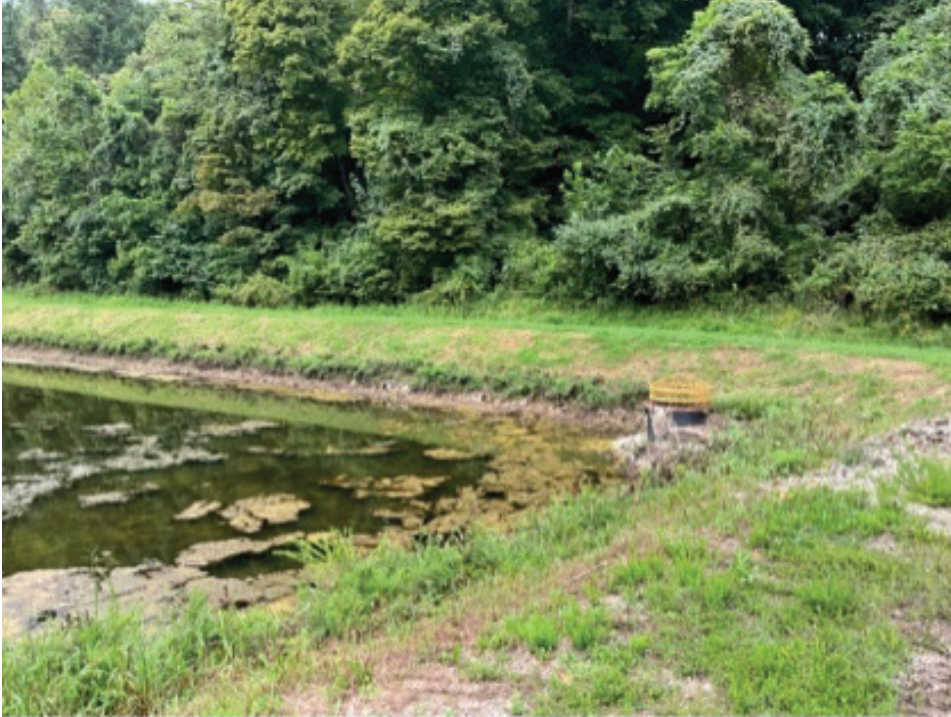
5

5. The ground water interceptor drain outlets were observed to be flowing free and clear of any obstructions.
6. Landfill Area 7 sediment pond appeared to be functioning as designed and in satisfactory condition. Spillways were observed to be unobstructed and in satisfactory condition.

Area 7 Sediment Pond
outfall

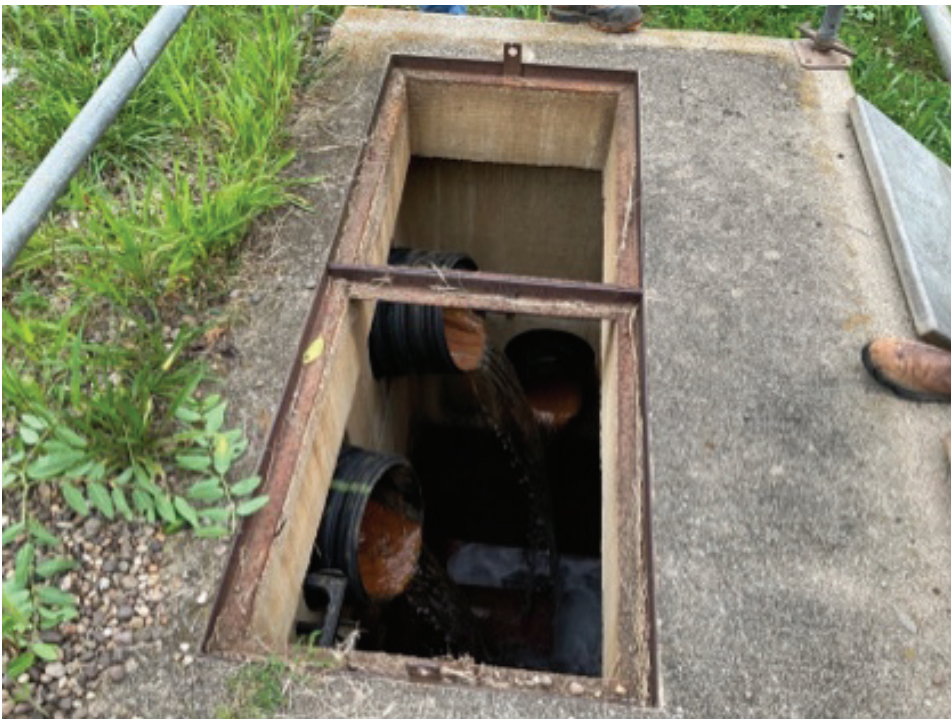
6

4. The leachate collection system of the landfill is collected in a manhole at the east side of the landfill. The leachate pipes were observed to be flowing and free of any obstructions. Some minor iron-stained sediments were accumulating at the outlet in the manhole, but this did not appear to restrict the flows.

Leachate collection
sump. Leachate drain
lines combine and drain
to the leachate ponds.

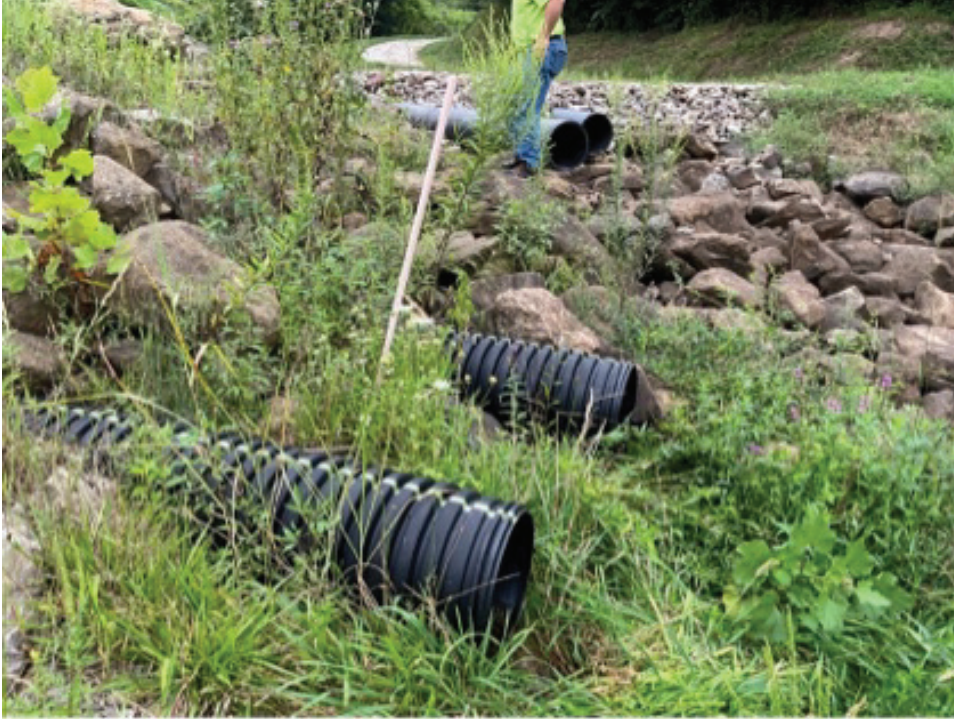
Notes: Groundwater underdrain from areas 4, 6, and 7 discharge into area 7 sediment pond.

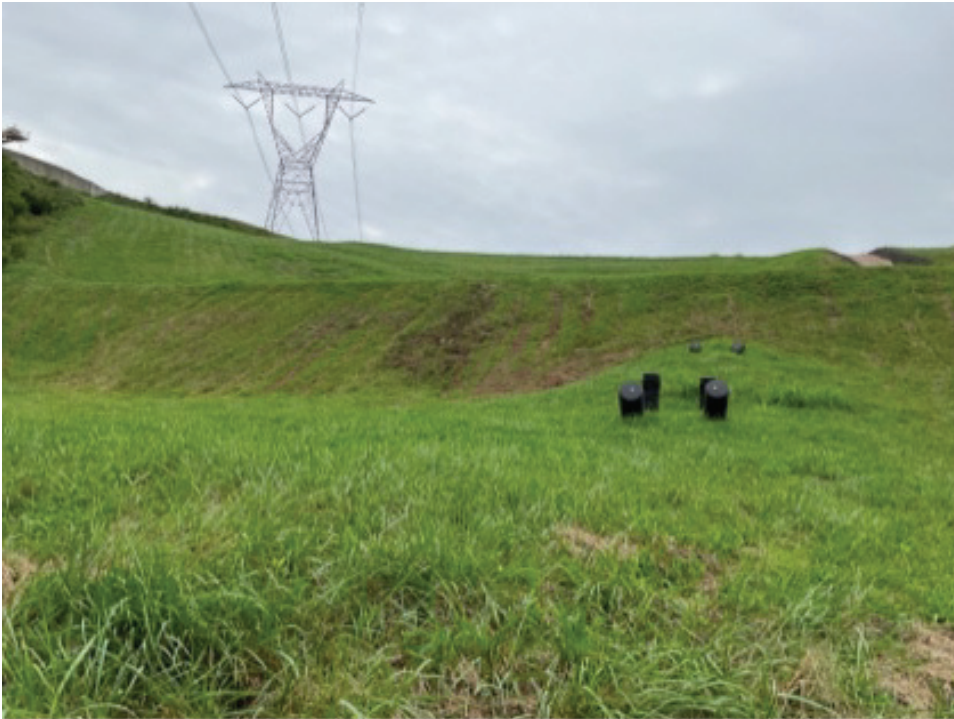
Notes: General condition of exterior toe of Area 7 final cover

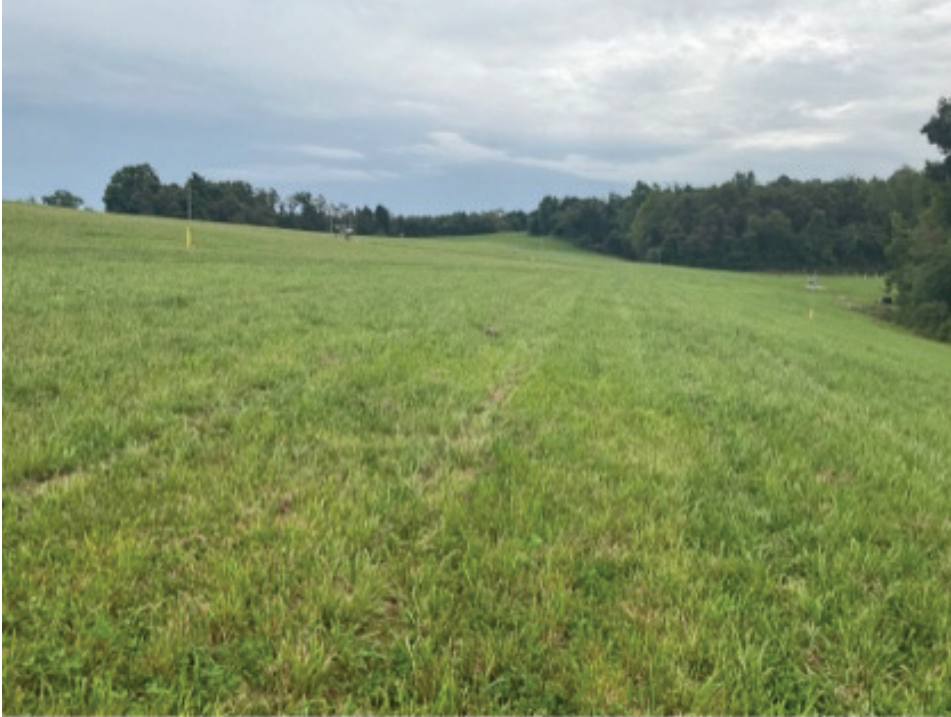
15

General condition of Area 3 final cover.

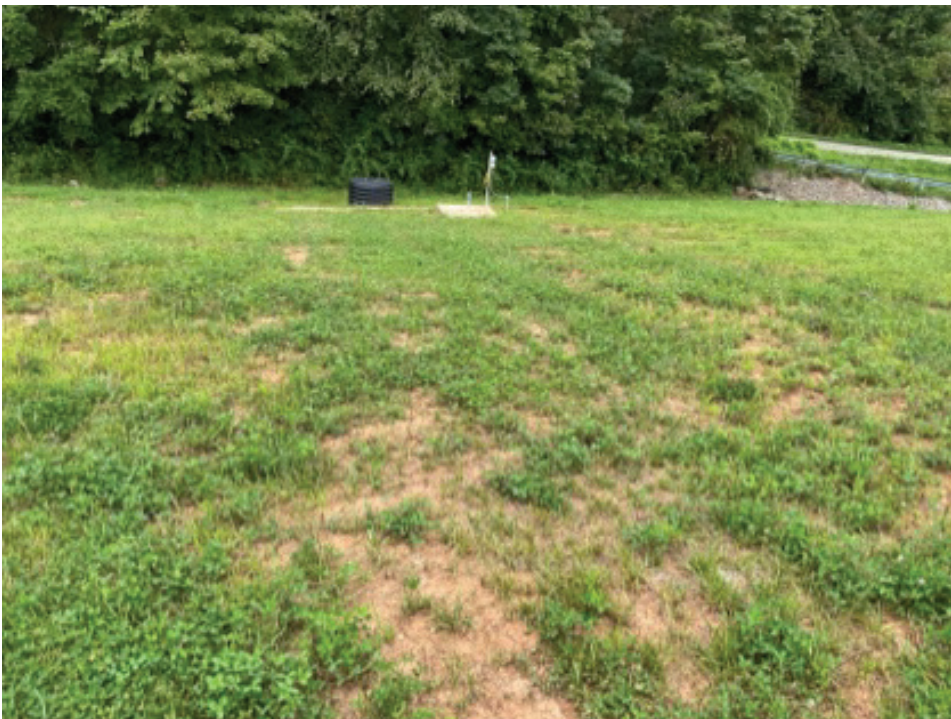
16

10. Landfill Area 5 and the perimeter access road were in satisfactory and stable condition with controlled vegetation.
 11. Overall, Area 3 appeared in satisfactory and stable condition with good vegetative cover and the perimeter ditches around Area 3 were in satisfactory and functioning condition with no standing water. The area of bare soils upslope from sump #2 noted during the 2022 inspection is mostly vegetated.

Area 3 area above toe drain sump #2 that was identified in 2022 as needing seeded.

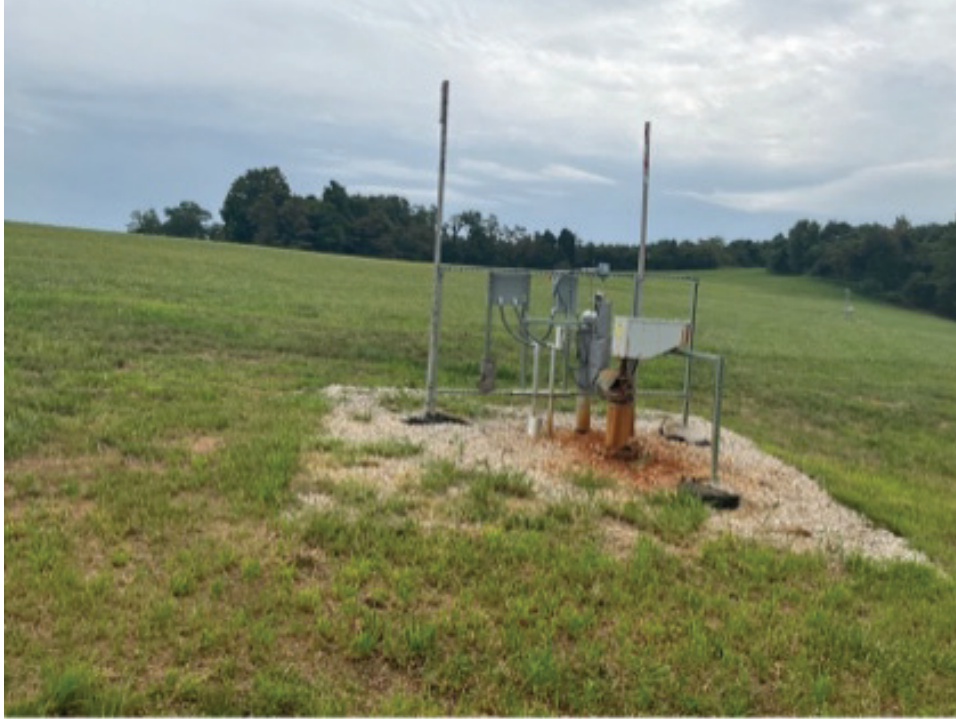
13. The 10 dewatering wells installed in Area 3 in 2022 to address the ongoing deficiency pertaining to leachate buildup were generally operational with no issues noted. The dewatering wells discharge to a frac-tank with secondary containment. A few of the dewatering wells need to have seals replaced.

Notes: Typical Area 3 dewatering well (#4)

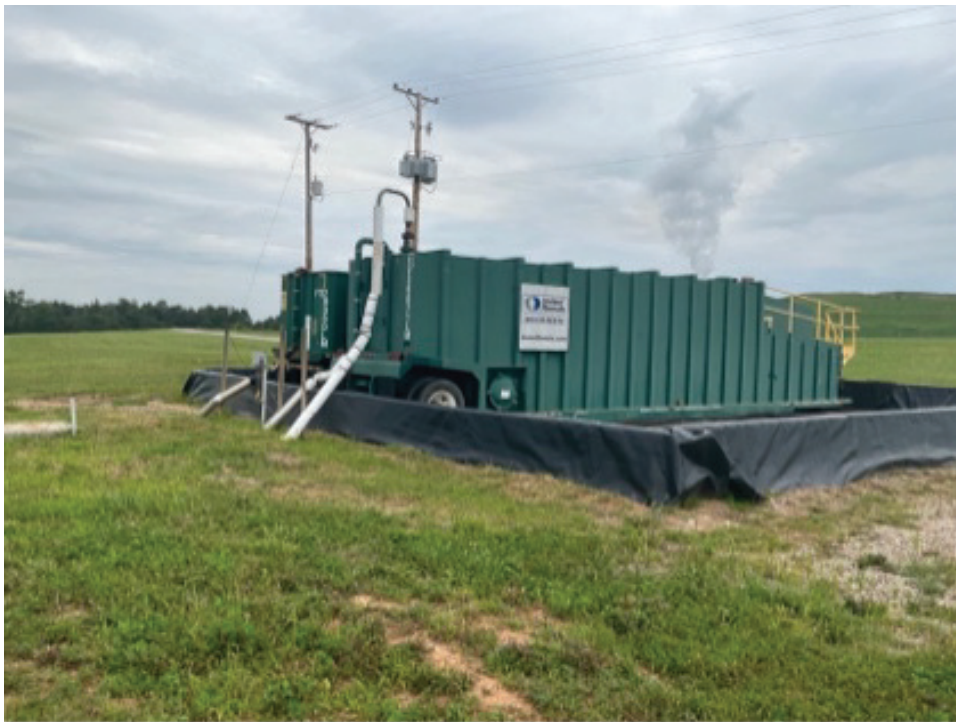
Notes: General condition of FRAC tanks used for leachate storage and secondary containment for dewatering wells.

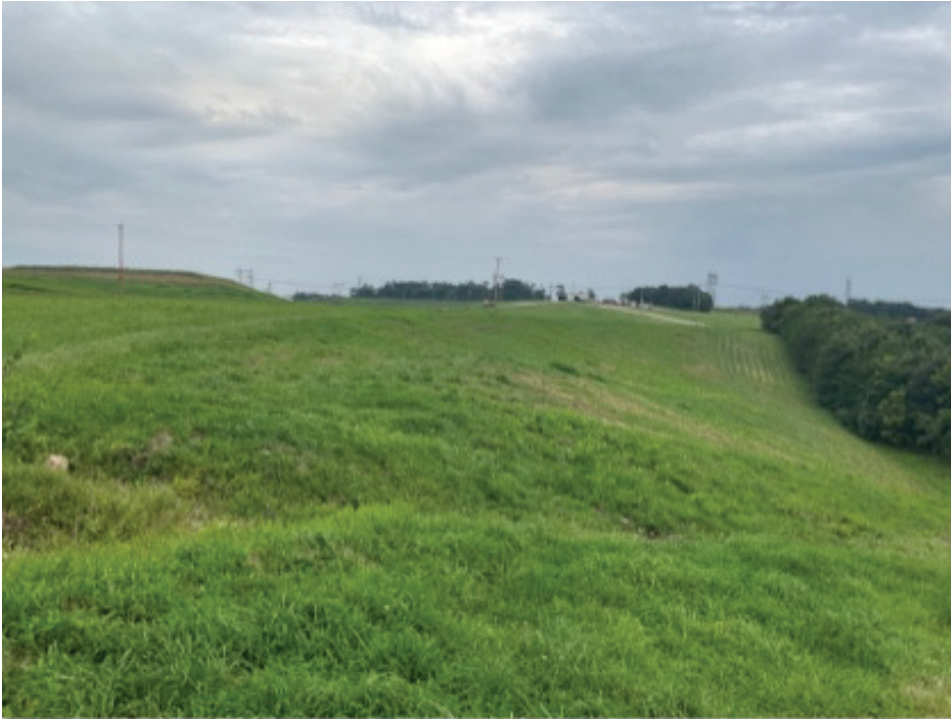
19

General condition of Area 2 exterior slope lower portion earthen berm

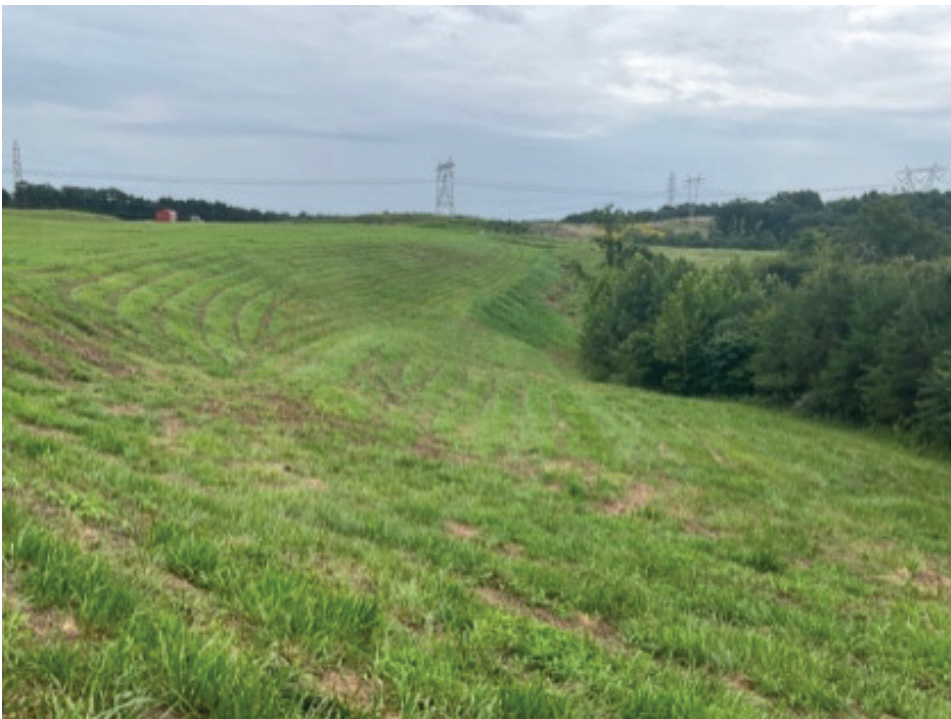
20

15. Landfill Area 1 appeared in satisfactory and stable condition. A minor slip located on the outside earthen berm of Area 1 that was repaired in years in 2019 appears to be stable with no apparent change in the scarp or depression from previous inspections. There were no signs of seepage observed along the toe in this area. Erosion gullies on the southern slope of the earthen perimeter berm continue to appear stable, as noted in 2022.

General condition of Area 1 exterior slope.
