2023 ANNUAL DAM AND DIKE INSPECTION REPORT

BOTTOM ASH PONDS

**PIRKEY POWER PLANT
HALLSVILLE, TEXAS**

Dam & Dike Inspection Report (CCR - Bottom Ash Ponds)

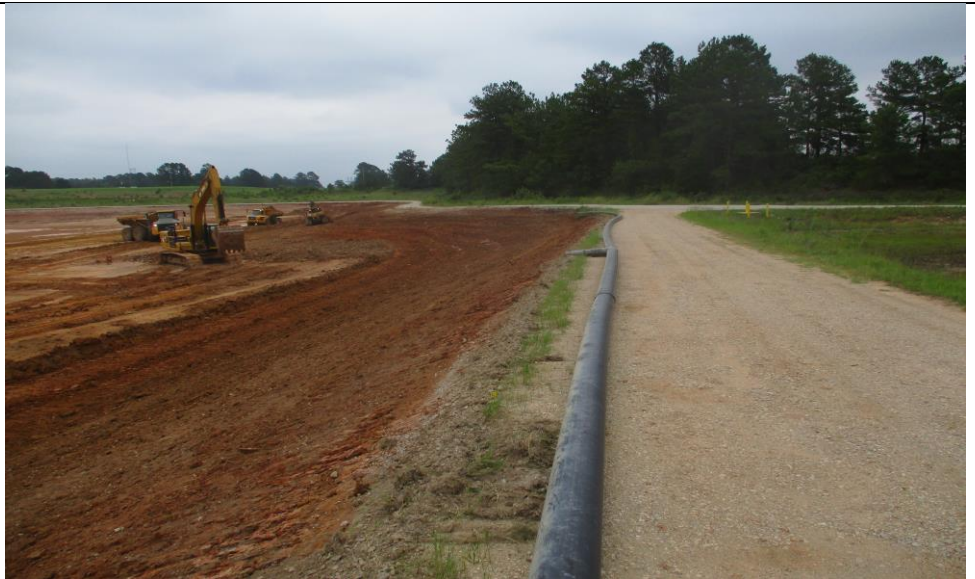
1. Photographs No. 1-3 illustrates the south upstream slope, and crest. The south side appeared in good condition without any signs of settlement, misalignment and cracking observed. An area of the embankment to the west was cutout for the closure-by-removal activities (Photograph No. 3).

Photograph No. 1
The upstream of the south dike (looking east).

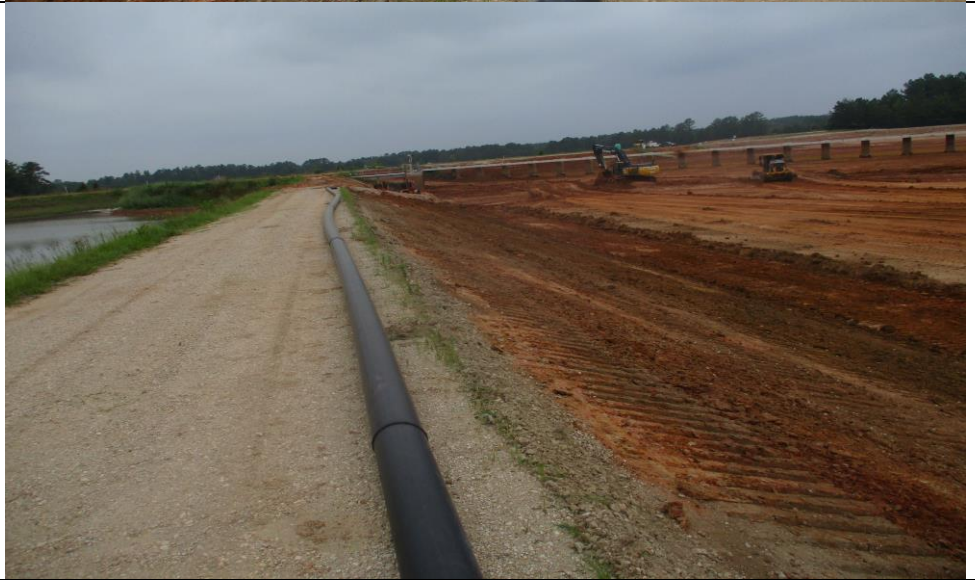
Photograph No. 2
View of the south dike crest and upstream slope (looking west).

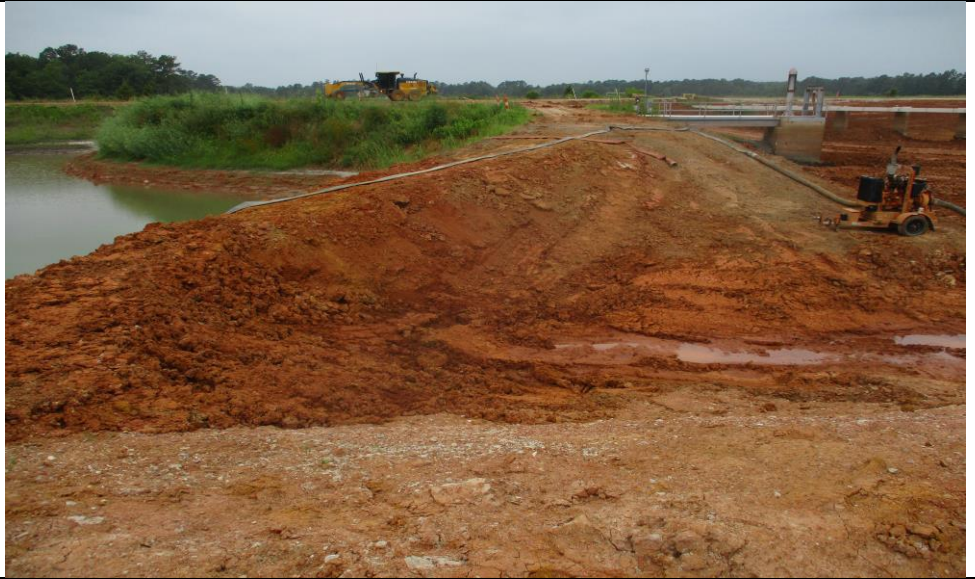
Photograph No. 3
Portion of the dike excavated due to pond closure activities.

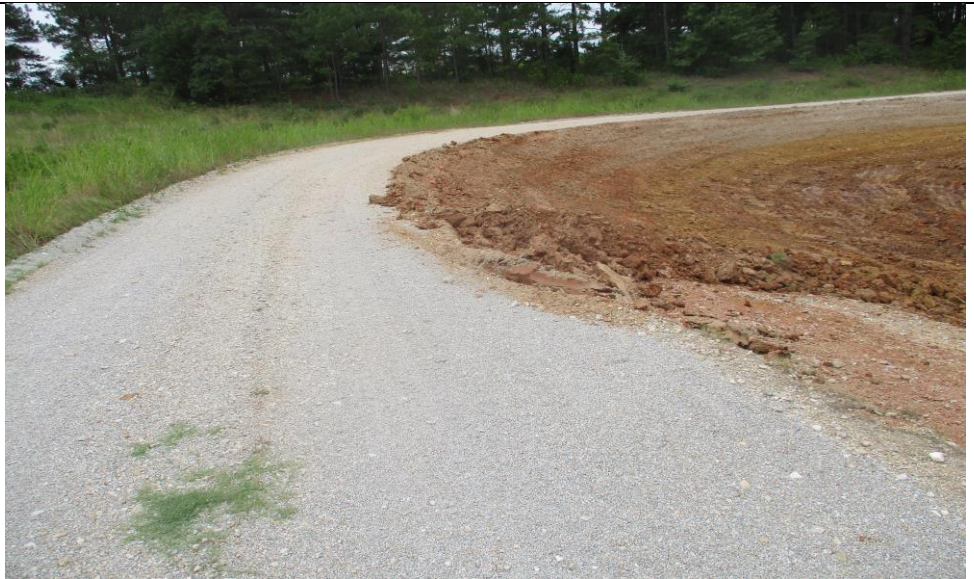
Photograph No. 4
View of typical north crest of the east pond.

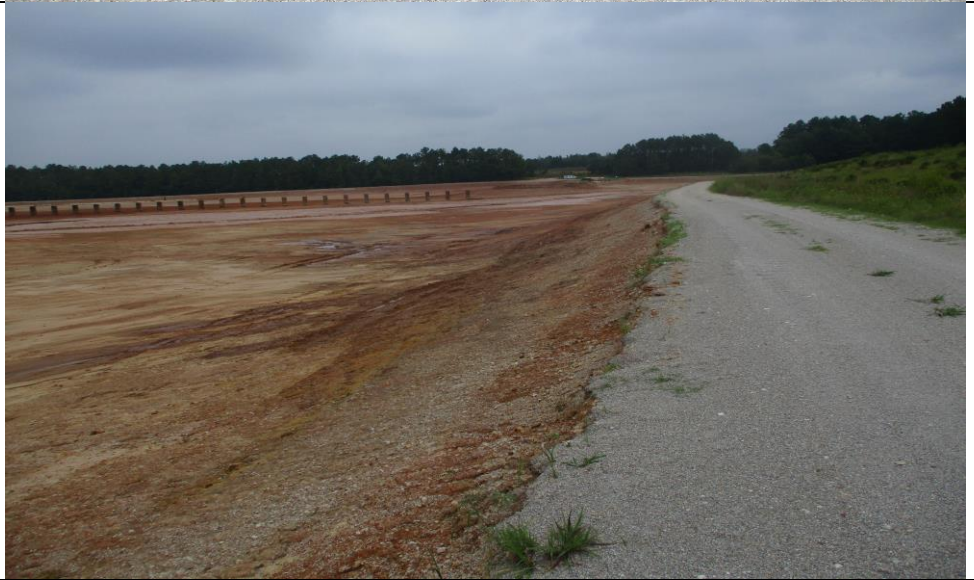
Photograph No. 5
Upstream slope and pond inside.

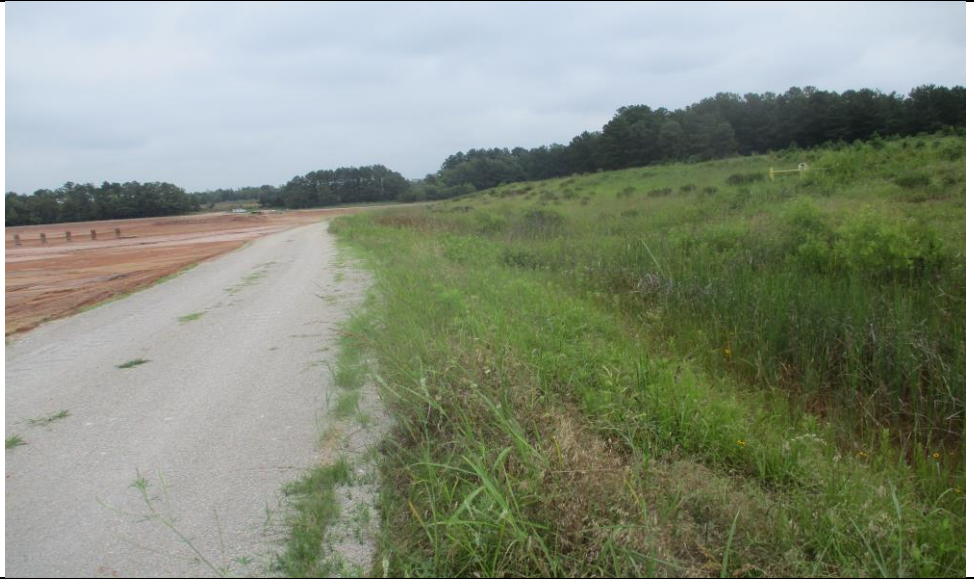
2. Photographs No. 6-9 illustrates typical condition of the upstream slope, crest, toe ditch, and interior of the pond. Overall, the north dike is in good and stable condition. A spot was noticed at the crest (Photograph No. 9) with minor rutting from truck traffic. There were no other signs of settlement, misalignment and cracking.

Photograph No. 6
View of the crest and toe ditch area.

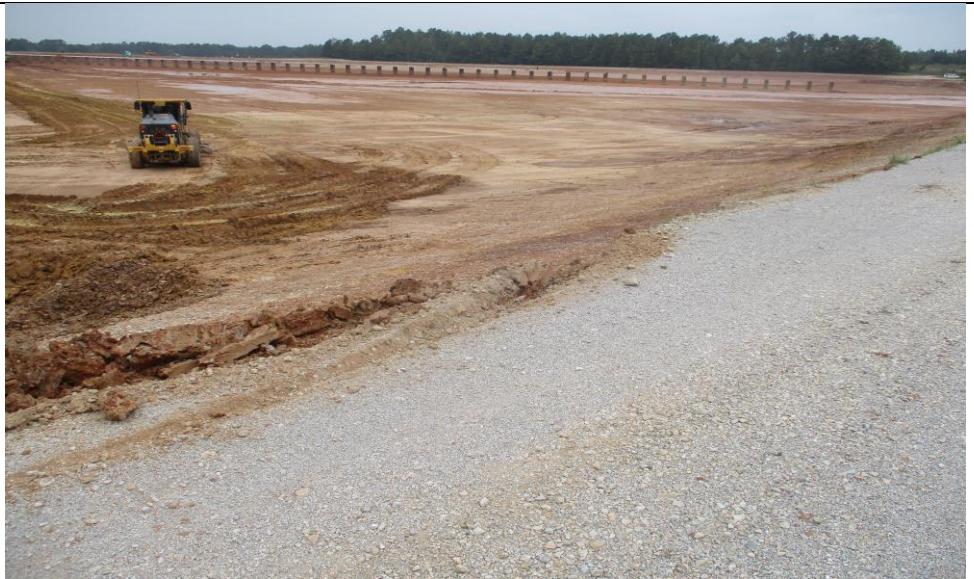
Photograph No. 7
Pond closure work in progress.

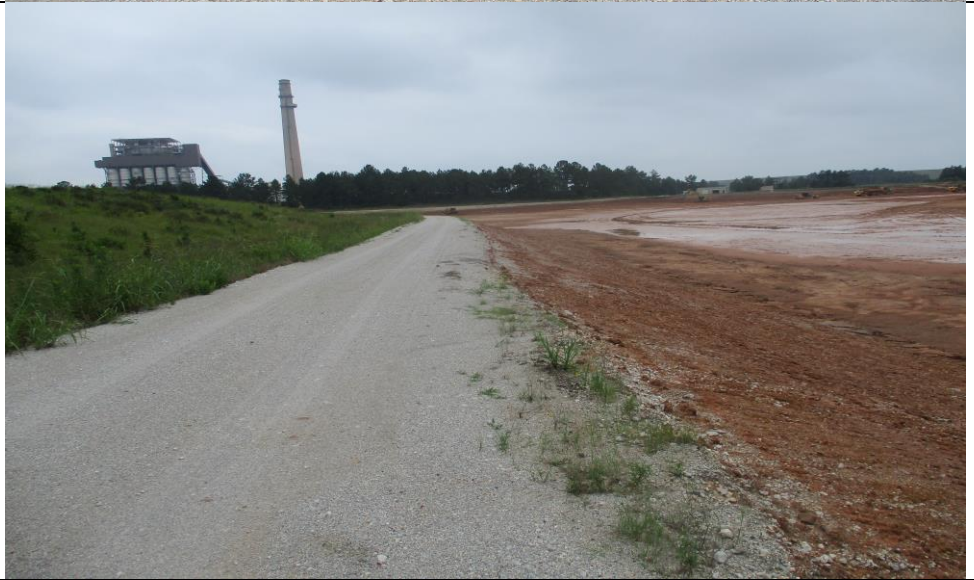
Photograph No. 8
Typical view of the crest.

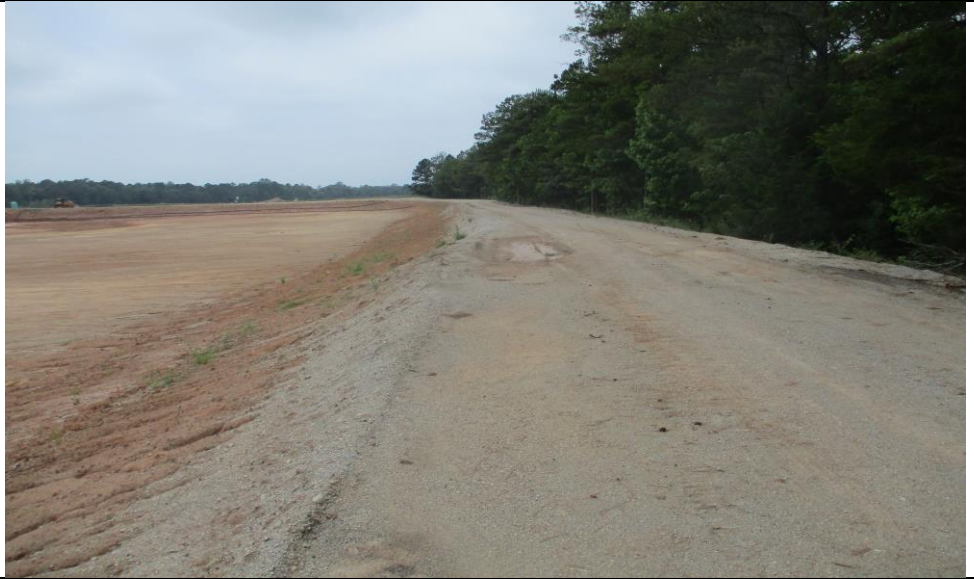
Photograph No. 9
Minor rutting at the crest.

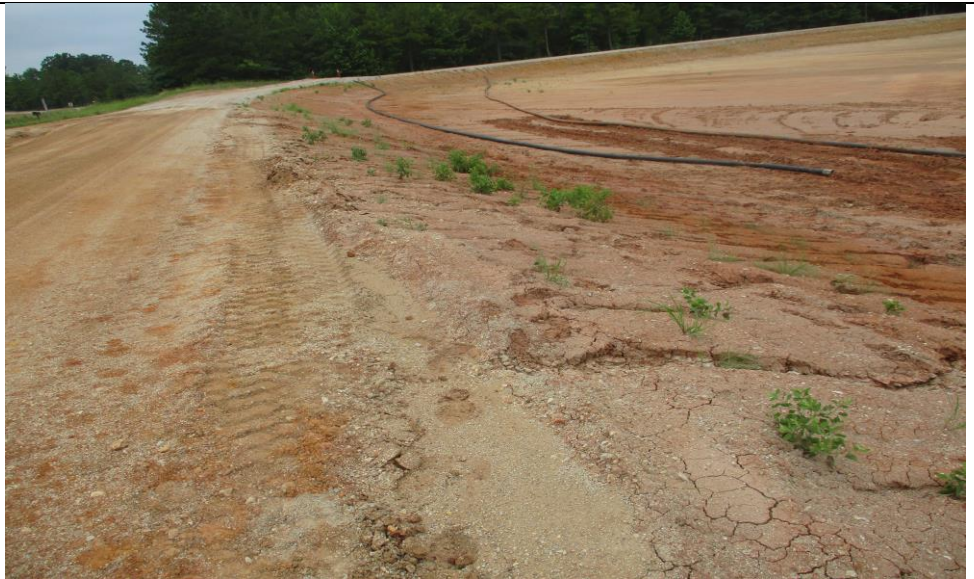
3. Photographs No. 10 shows the general condition of the interior slopes of the west dike of the bottom ash pond. The slope and crest appeared in satisfactory and stable condition. There were some minor erosion gullies on the interior slope but no significant signs of settlement, misalignment, or sloughing.

Photograph No. 10
The west dike between the ash ponds (looking north).

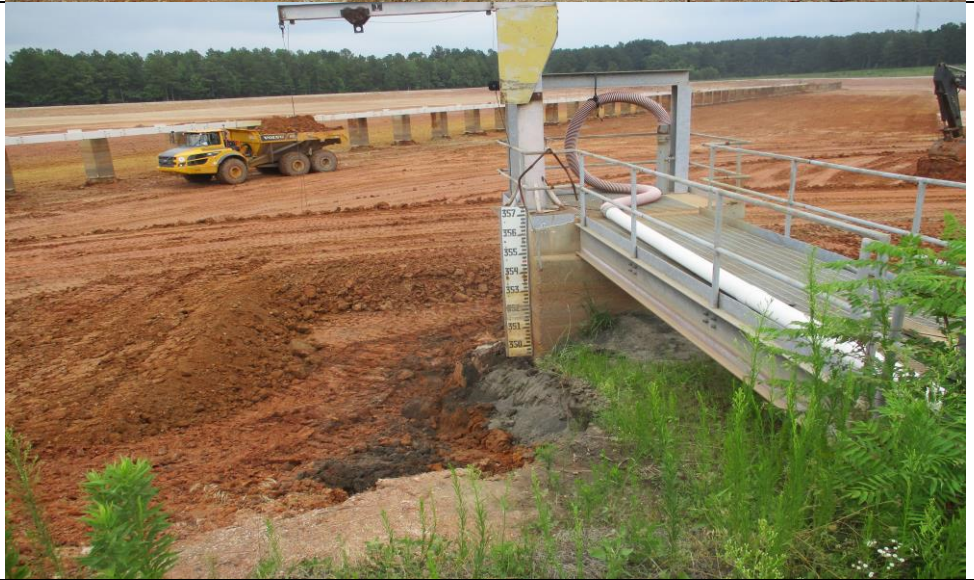
4. The overflow discharge structure was not functioning at the time inspection due to pond closure work, but the walkway, railings, metal decking, and visible concrete were found to be in satisfactory condition (Photograph No. 11)

Photograph No. 11
Overflow discharge structure.

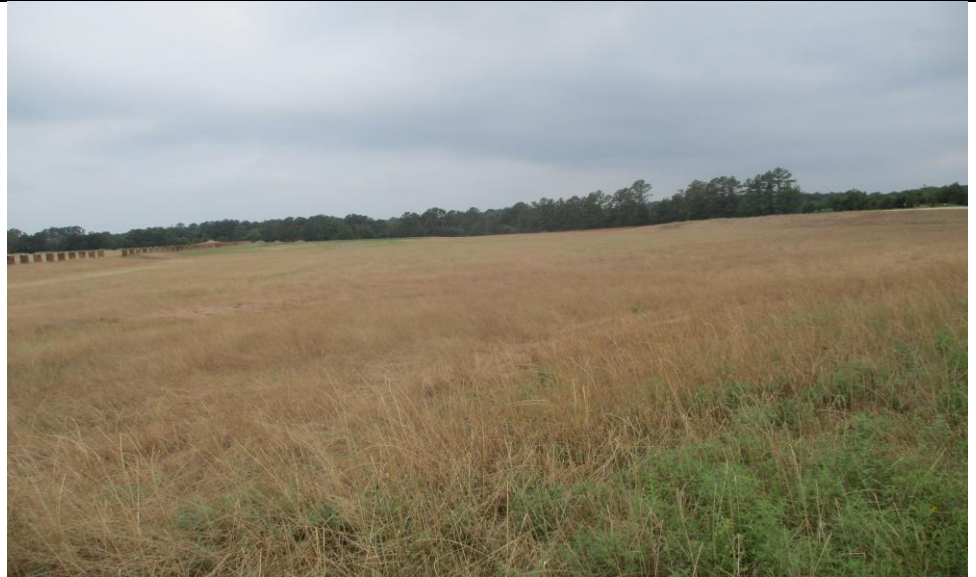
The West Bottom Ash Pond is currently out of service and is being closed by removal. Photographs No. 12 and 13 illustrate overall view of the pond interior close area. In general, the crest, interior and exterior slopes of the dike appear to be in satisfactory and stable condition. No significant change to the exterior slope was noted from the previous inspection. The only significant change that has occurred is the excavation and removal of a part of the southern berm as a part of the closure by removal activities. No significant settlement or misalignment was observed. Seeps were not observed during the inspection. No animal burrows were observed

Photograph No. 12
Interior of the closed West
Bottom Ash Pond.

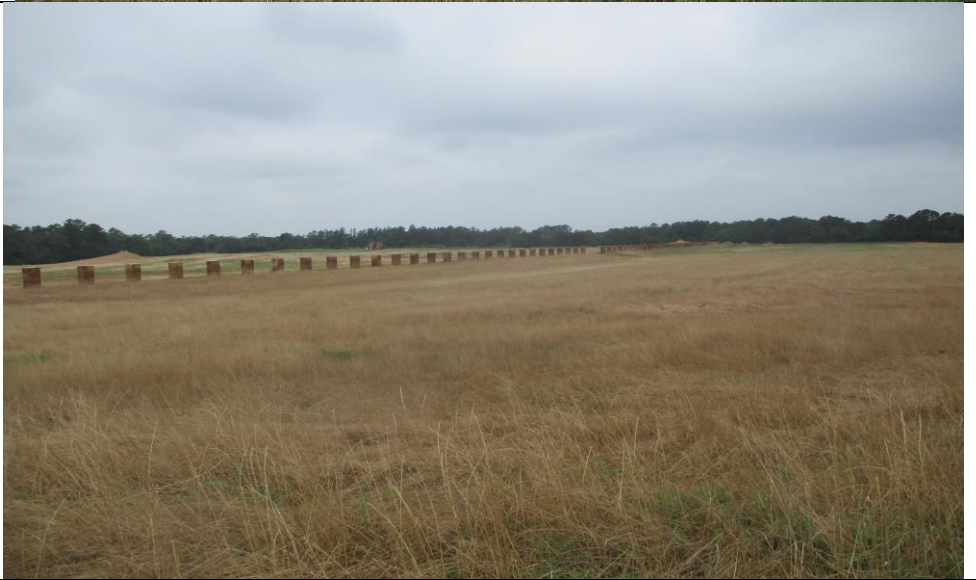
Photograph No. 13
Another view of the closed
West Bottom Ash Pond.

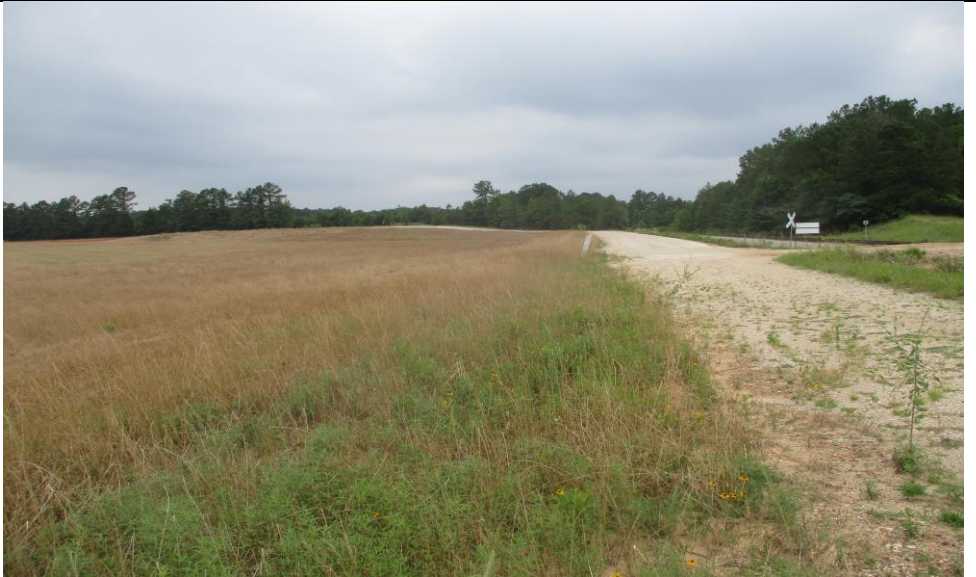
during the inspection. Photographs No. 14-18 illustrate good condition of the supporting dike, slopes, and crest.

Photograph No. 14
East dike (looking north).

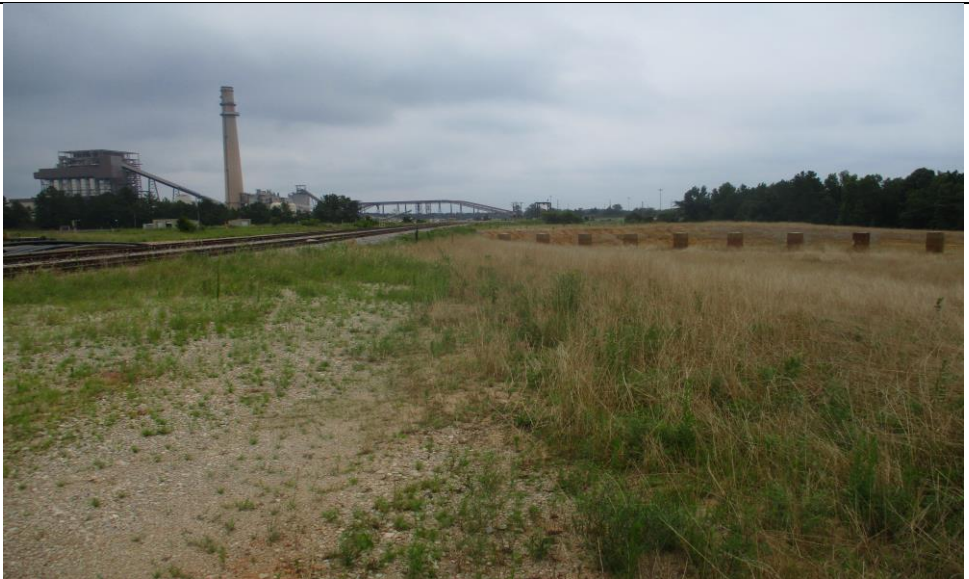
Photograph No. 15
East dike (looking south).

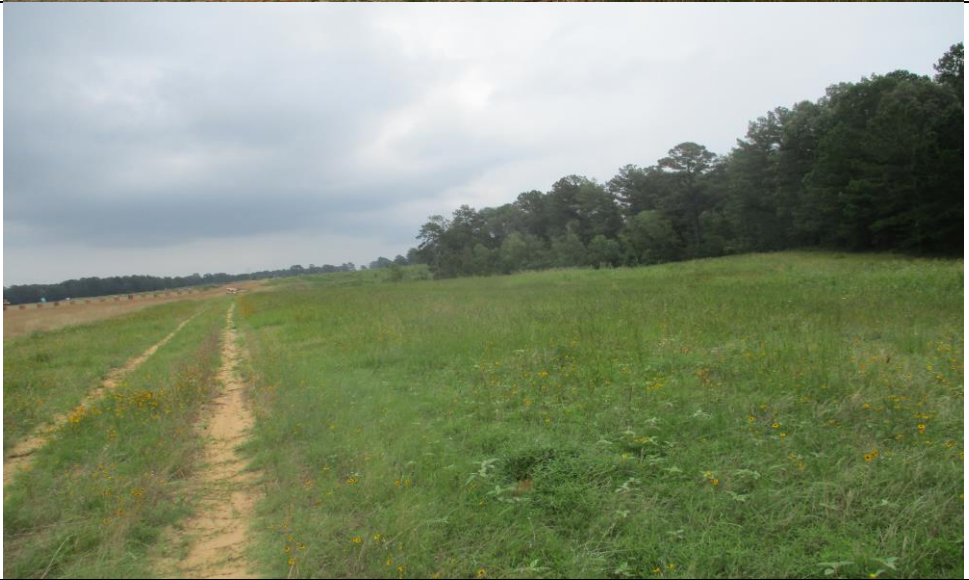
Photograph No. 16
Typical view of the south dike of the upstream slope.

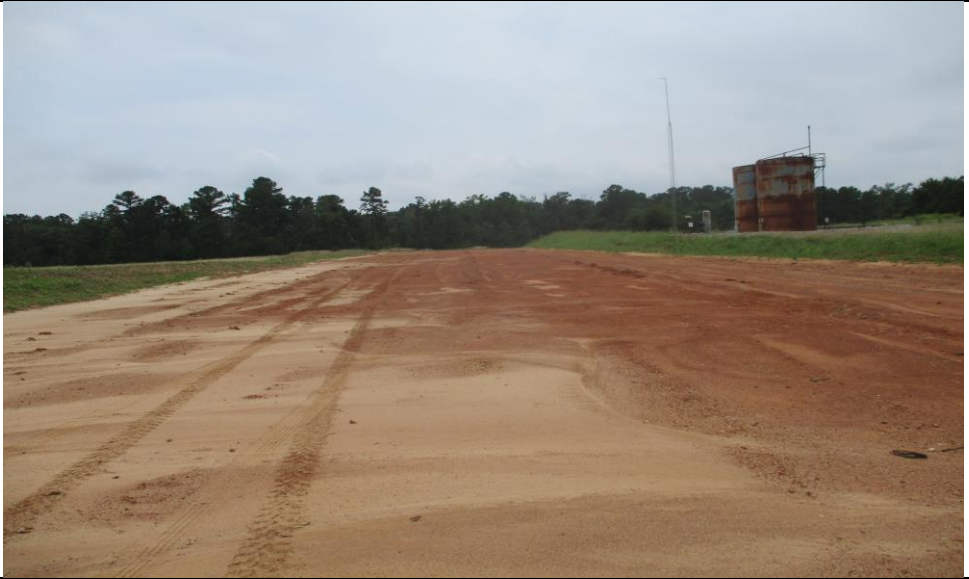
Photograph No. 17
Typical view of the west dike.

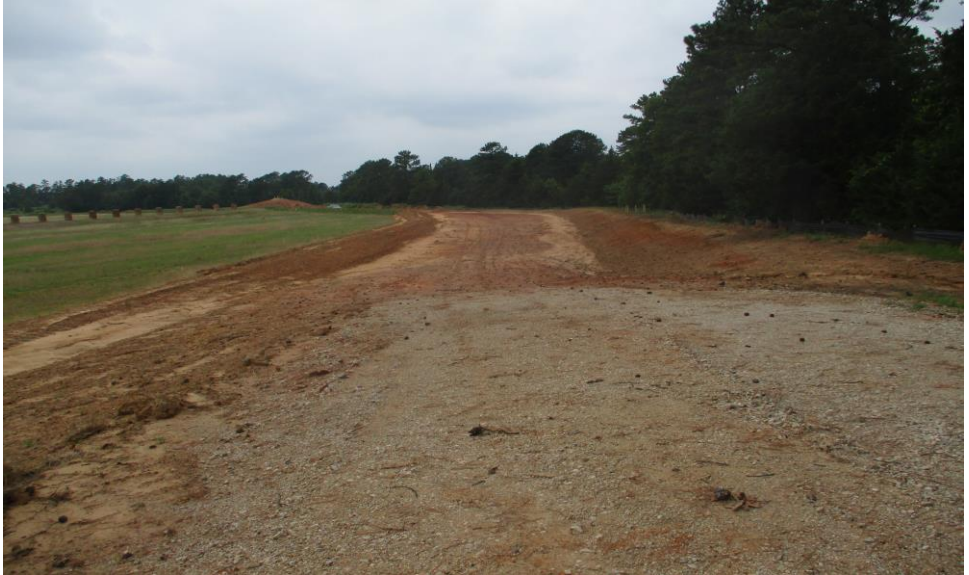
Photograph No. 18
Typical view of the north dike.

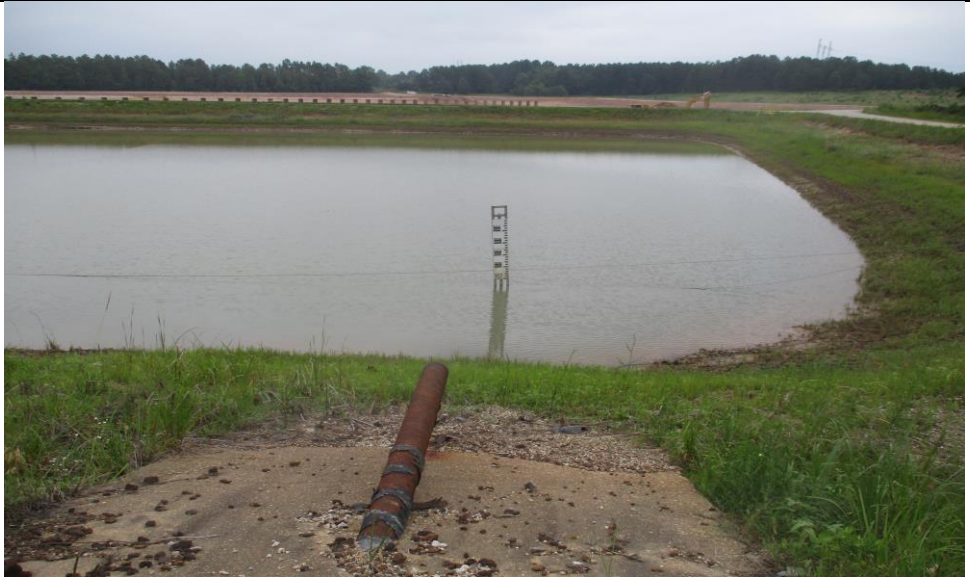
Secondary Bottom Ash Pond is located in the southwest corner of the EBAP. Overall condition of this pond is illustrated in Photographs No. 19-22. The pond appeared in good and stable, and functional condition.

Photograph No. 19
View of the secondary bottom ash pond (looking north).

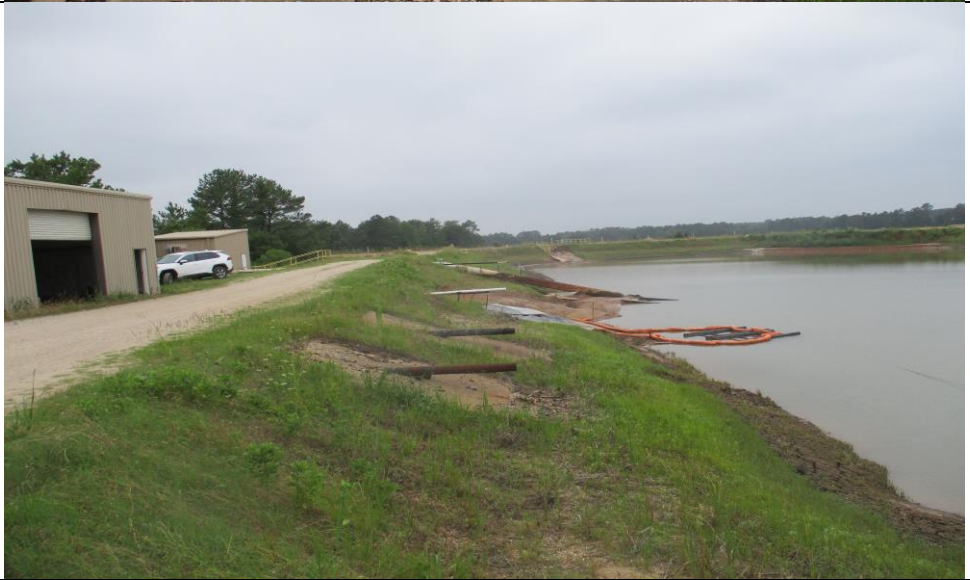
Photograph No. 20
South dike of the pond (looking west).

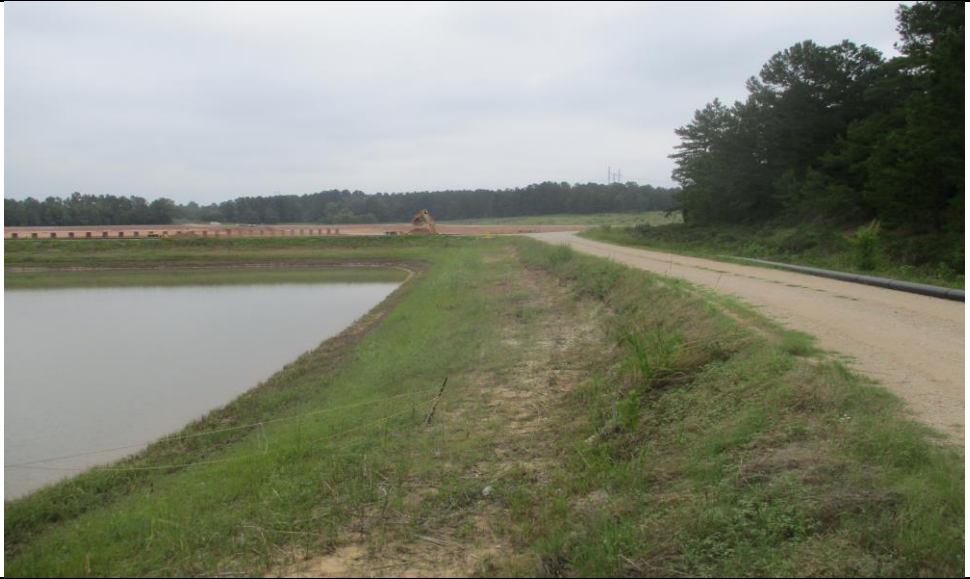
Photograph No. 21
East dike of the pond (looking north).

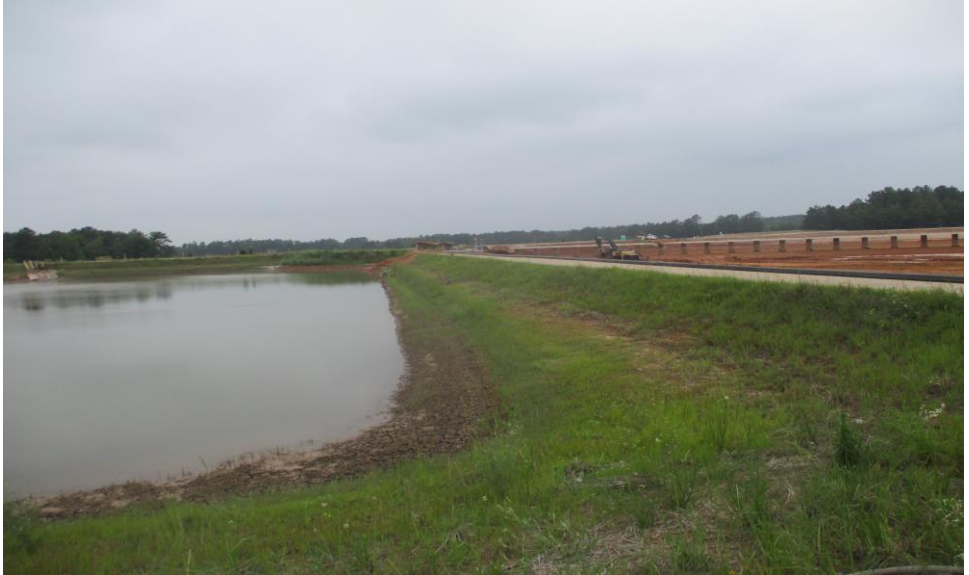
Photograph No. 22
North dike of the pond.22

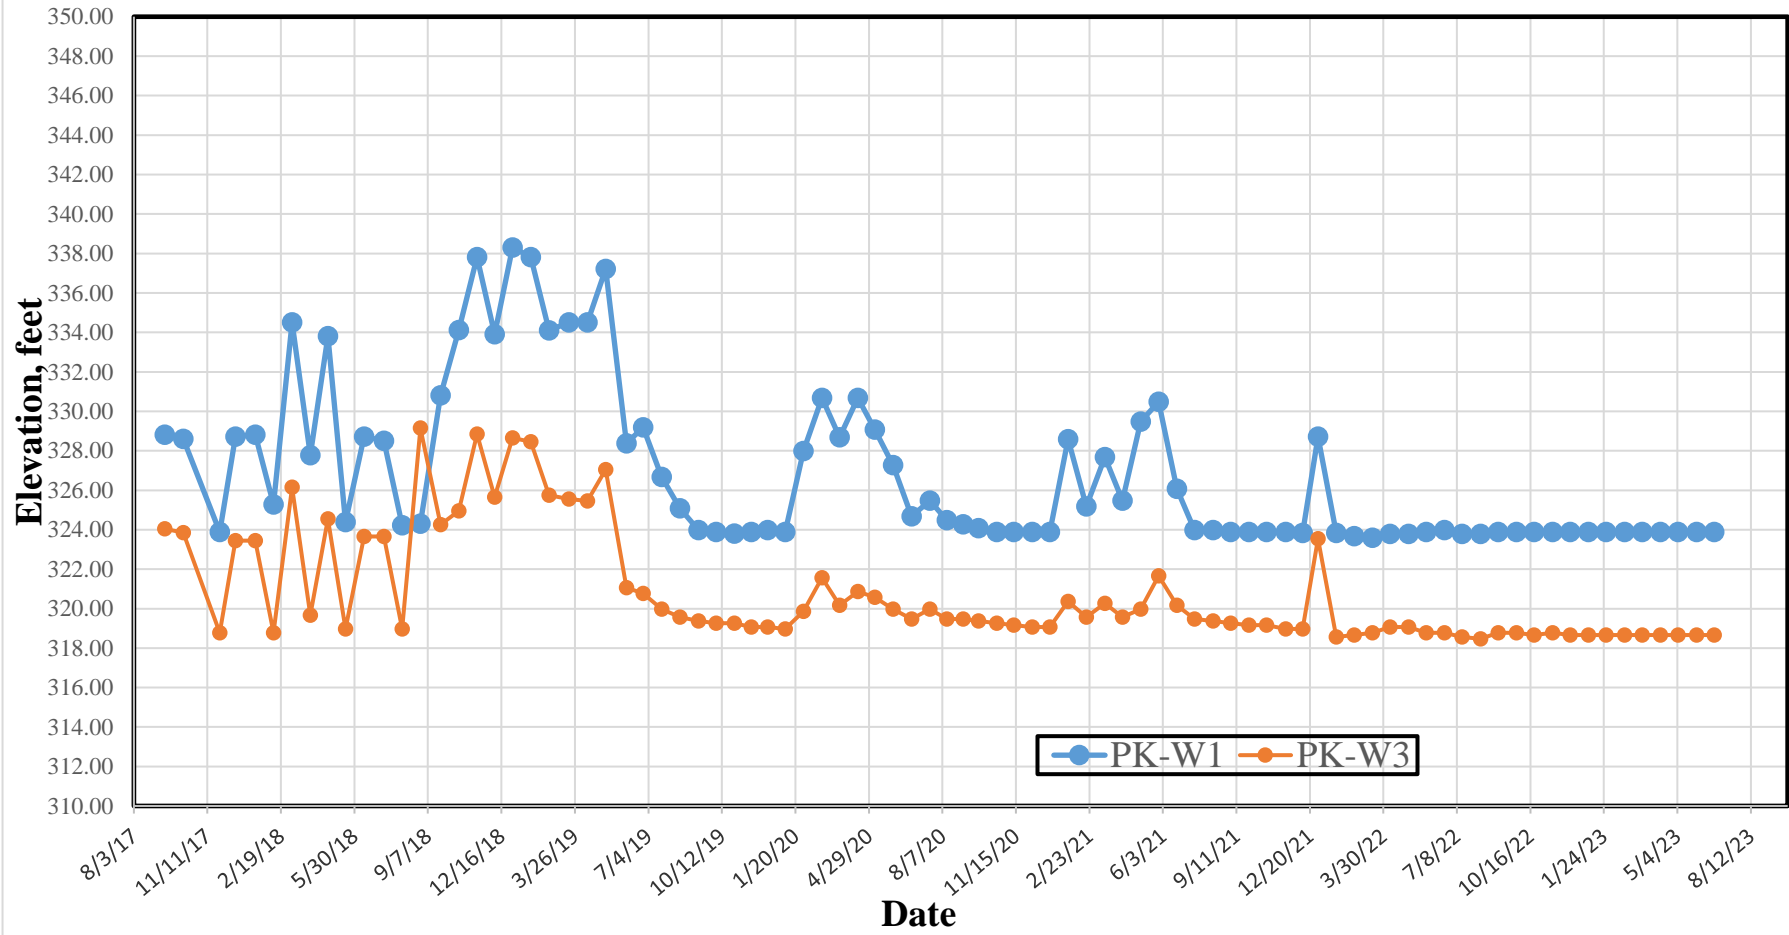
Figure 4 - Water Elevation Piezometric Historical Data

Historical piezometric water elevation data is provided in Figure 4. The maximum levels measured since the last inspection of the West Bottom Ash Pond are reported below. Because of the closure and not standing water in the ponds, the readings in the piezometers W-1 and W-3 are constantly same as expected.

Pond Name	Crest Elevation (msl)	Boring/Piezometer	Min/Max/Present WSEL (msl)
WBAP	357.0	PK-W1	323.88/323.88/323.88
WBAP	357.0	PK-W3	318.67/318.77/318.67
