Bottom Ash Pond Complex 2024 Annual Dam and Dike Inspection Report

John E. Amos Plant, Putnum County, West Virginia

October 16, 2024

AEP Document ID: GEVR-24-021

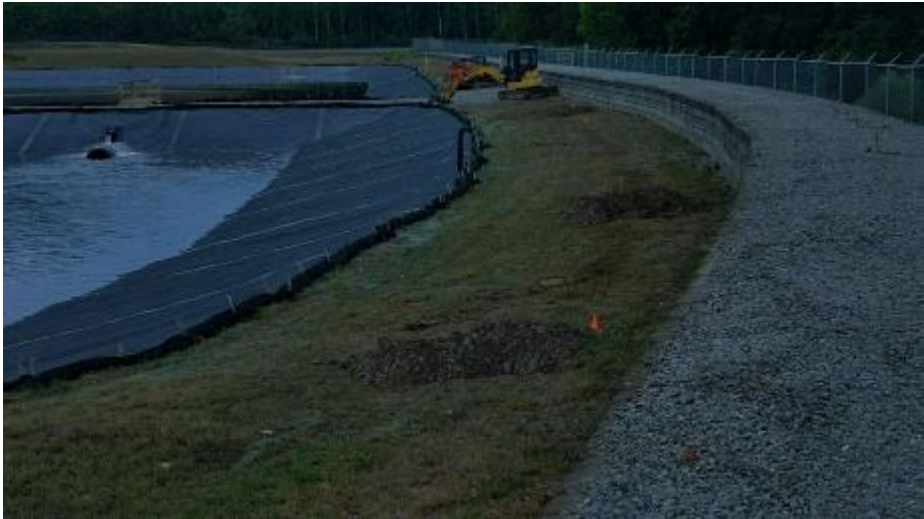
| PHOTOGRAPH NO: 1 | DATE: July 22, 2024 8:58 AM | LATITUDE: 38.47928453 | LONGITUDE: -81.82864491 |

- The stone wall along the crest of the Main Dam along the Clearwater and Reclaim Ponds appeared in good condition. Photographs No. 1 and No. 2.
- The downstream slope of the Main Dam was observed to be in good condition. No significant settlement, misalignment, erosion, or seepage were observed. Vegetation was maintained to 12-inches or less as shown in Photographs No. 4 and No. 7.

| DESCRIPTION: Clearwater Pond. Main Dam Crest of stone wall – looking West. General Photo, Typical Conditions. | | | |

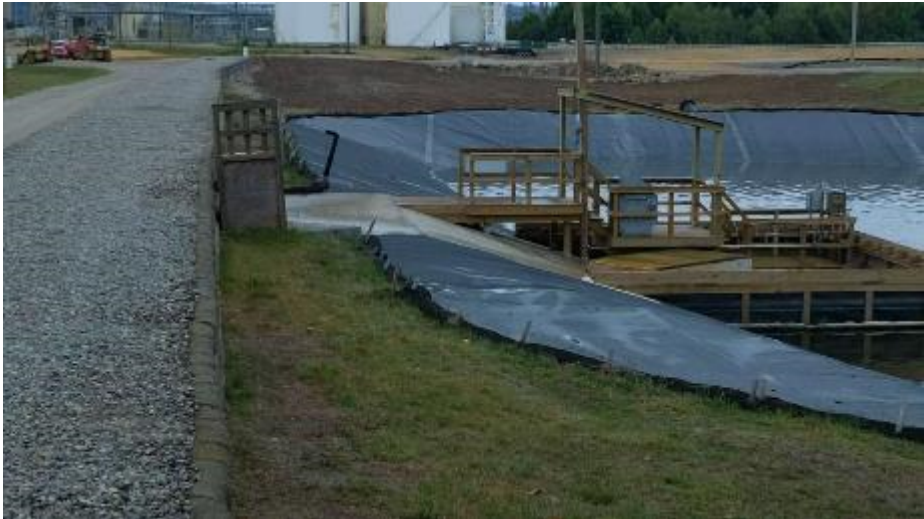
| PHOTOGRAPH NO: 2 | DATE: July 22, 2024 9:02 AM | LATITUDE: 38.47996583 | LONGITUDE: -81.82898953 |

- The primary decant structure in the Clearwater Pond has been reconstructed and in operation as shown in Photographs No. 2.

| DESCRIPTION: Clearwater Pond, top of stone wall – Looking South. Ground Cover, Typical Conditions. | | | |

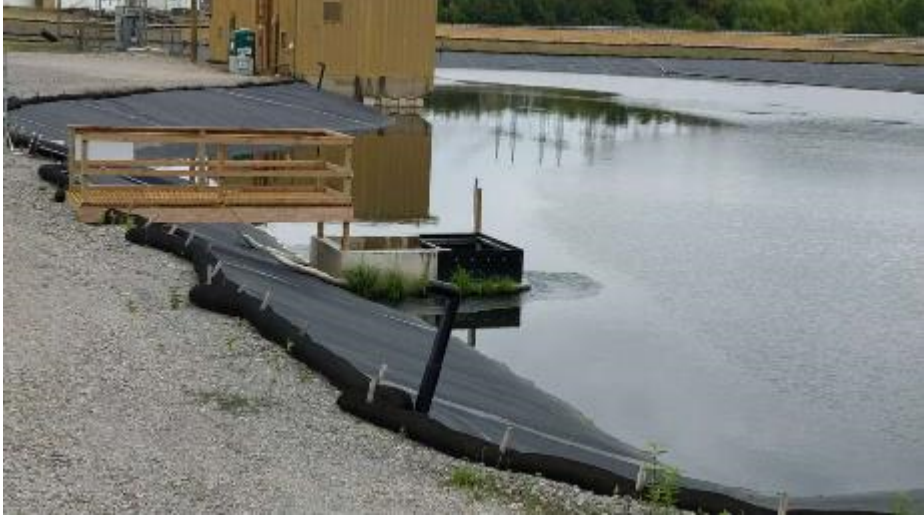
| PHOTOGRAPH NO: 3 | DATE: July 22, 2024 9:06 AM | LATITUDE: 38.47967904 | LONGITUDE: -81.82987244 |

- The inboard slope of the Main Dam was in good condition. There were no visual signs of misalignment, settlement, or sloughing that would indicate any instability within the dike as shown in Photograph No 3.

| DESCRIPTION: Reclaim Pond. Crest and Upstream Slope of splitter dike with Clearwater Pond. General Photo, Typical Conditions. | | | |

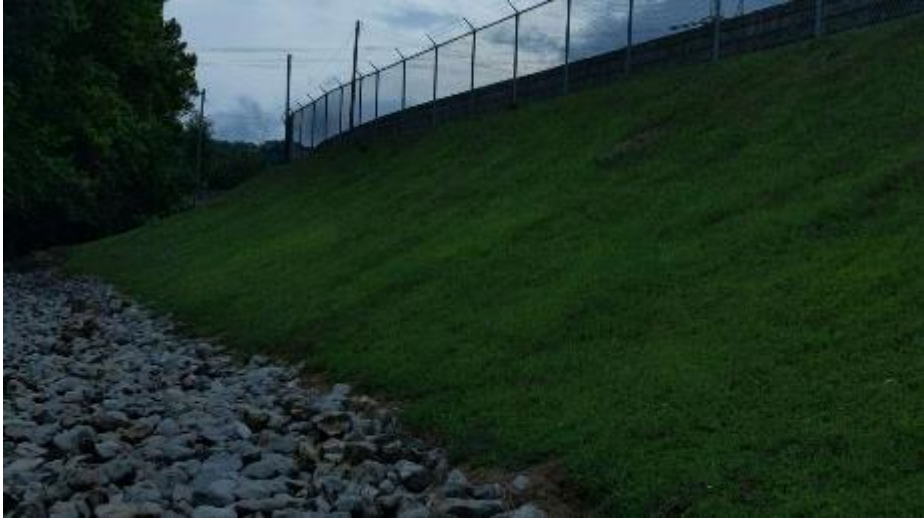
| PHOTOGRAPH NO: 4 | DATE: July 22, 2024 9:09 AM | LATITUDE: 38.47976373 | LONGITUDE: -81.83010007 |

| DESCRIPTION: Downstream Slope of Main Dam below Reclaim Pond – Looking East. General Photo, Typical Vegetation. | | | |

- Continue to maintain the vegetation on the upstream and downstream side slopes to a height of 12-inches or less.
- Some woody vegetation was observed growing in the riprap at the toe of the Main Dam and along Bills Creek. Continue to maintain the woody vegetation to 12-inches or less.

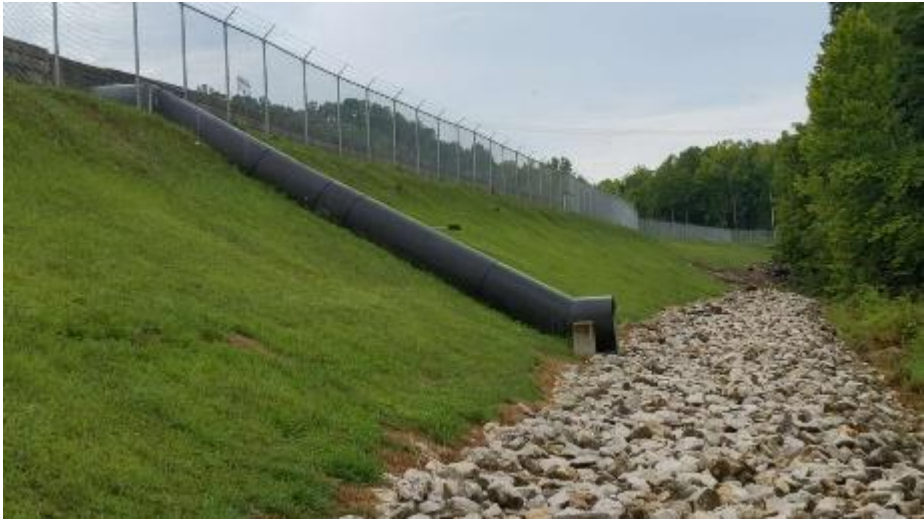
| PHOTOGRAPH NO: 5 | DATE: July 22, 2024 9:10 AM | LATITUDE: 38.47977008 | LONGITUDE: -81.83010162 |

- The Reclaim Pond 36-inch diameter HDPE emergency overflow pipe was observed to be in good condition from the block wall and no erosion was noted along the pipe. The outlet to the 36-inch diameter overflow pipe was free of vegetation and could flow unobstructed to Bills Creek as shown in Photograph No. 5 and Photograph No. 6.

| PHOTOGRAPH NO: 5 | DATE: July 22, 2024 9:10 AM | LATITUDE: 38.47977008 | LONGITUDE: -81.83010162 |
|--|--|--|---|
| <p>DESCRIPTION:</p> <p>Downstream slope below reclaim pond. Looking West, Typical Conditions, Note Emergency Spillway Pipe.</p> | | | |

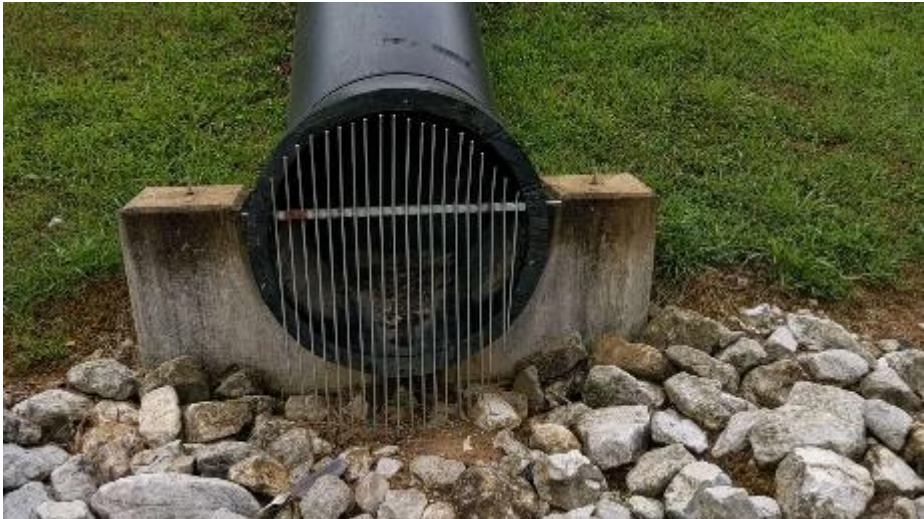
| PHOTOGRAPH NO: 5 | DATE: July 22, 2024 9:10 AM | LATITUDE: 38.47977008 | LONGITUDE: -81.83010162 |
|--|--|--|---|
| PHOTOGRAPH NO: 6 | DATE: July 22, 2024 9:13 AM | LATITUDE: 38.47964545 | LONGITUDE: -81.83038621 |

| PHOTOGRAPH NO: 5 | DATE: July 22, 2024 9:10 AM | LATITUDE: 38.47977008 | LONGITUDE: -81.83010162 |
|--|--|--|---|
| <p>DESCRIPTION:</p> <p>Reclaim Pond. Toe of downstream slope / drainage feature. Typical Conditions. Note Animal Guard Grate.</p> | | | |

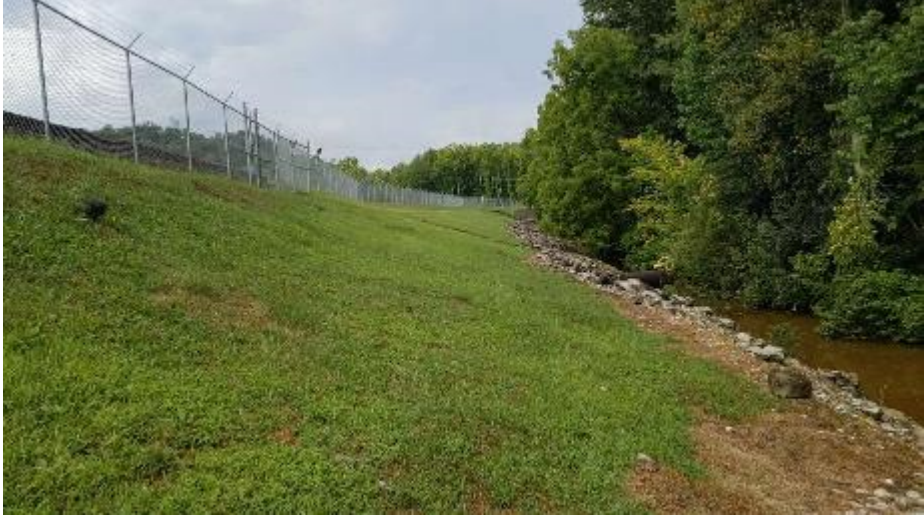
| PHOTOGRAPH NO: 7 | DATE: July 22, 2024 9:19 AM | LATITUDE: 38.47924457 | LONGITUDE: -81.8312832 |

- The riprap revetment on the downstream toe of the Main Dam appeared in good condition. Woody vegetation continues to exist along the toe area and Bills Creek but is being maintained as shown in Photograph No. 7

| DESCRIPTION: Downstream Slope of Main Dam. Looking West between Wastewater and Reclaim Ponds. General Photo, Typical Vegetation. | | | |

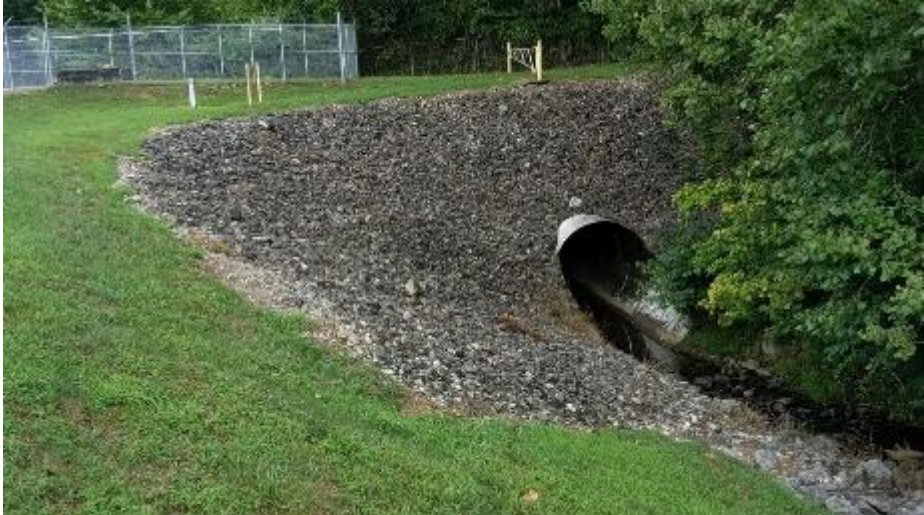
| PHOTOGRAPH NO: 8 | DATE: July 22, 2024 9:26 AM | LATITUDE: 38.47859683 | LONGITUDE: -81.83293785 |

| DESCRIPTION: Wastewater Pond. Drainage feature at Toe of Dam. General Photo, Typical Conditions. | | | |

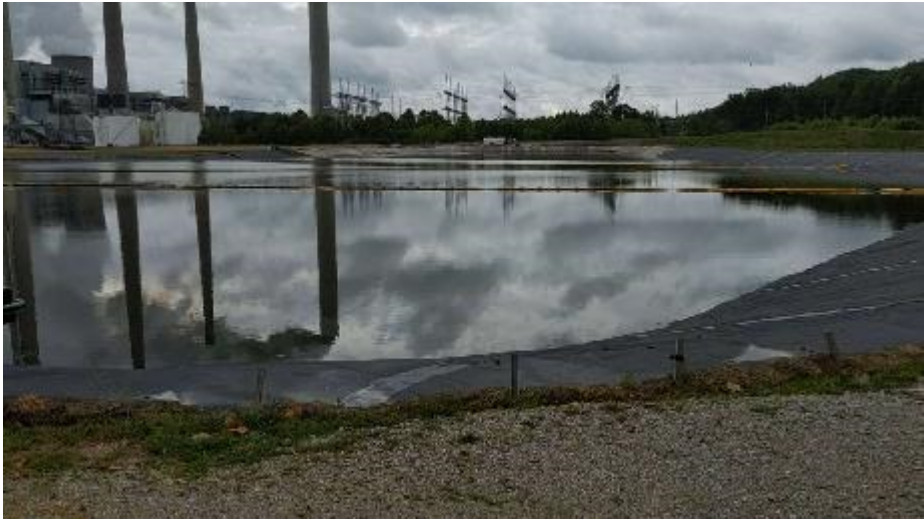
| PHOTOGRAPH NO: 9 | DATE: July 22, 2024 9:31 AM | LATITUDE: 38.47846469 | LONGITUDE: -81.83352687 |

- The geosynthetic liners on the interior slopes appeared in good condition as shown in Photograph No. 9.
- The Bottom Ash Pond Complex outfall structures were observed to be in good condition with no obstructions observed.

| DESCRIPTION: Wastewater Pond. Looking South. General Photo, Typical Conditions. | | | |

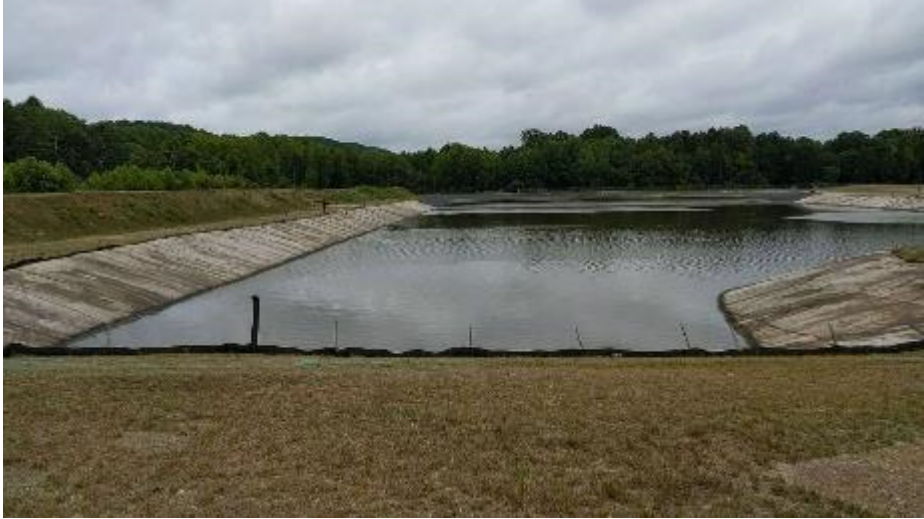
| PHOTOGRAPH NO: 10 | DATE: July 22, 2024 9:42 AM | LATITUDE: 38.47528644 | LONGITUDE: -81.83139549 |

| DESCRIPTION: Upstream Slope of Wastewater Pond. Note Synthetic Liner and Fabriform Protective Cover in the Forebay Area for Non-CCR solids management. | | | |

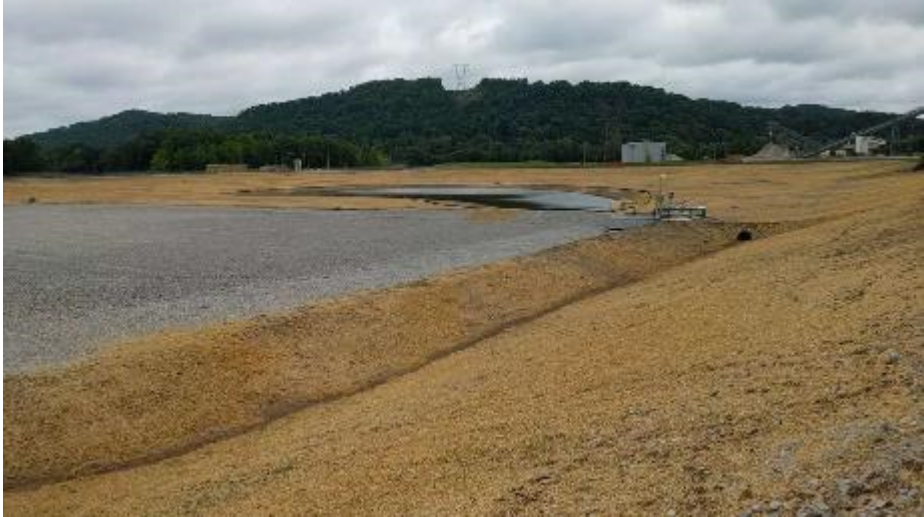
| PHOTOGRAPH No: 11 | DATE: July 22, 2024 9:47 AM | LATITUDE: 38.47569159 | LONGITUDE: -81.83038223 |

| <p>DESCRIPTION:</p> <p>Ash Pond 1A, Storm Drainage Collection Area.</p> <p>Additional Context:</p> <p>Former Bottom Ash Pond 1A (Closed by CCR Removal). Area repurposed to control stormwater and small lined area used to treat process water solids from the wastewater pond.</p> | | | |

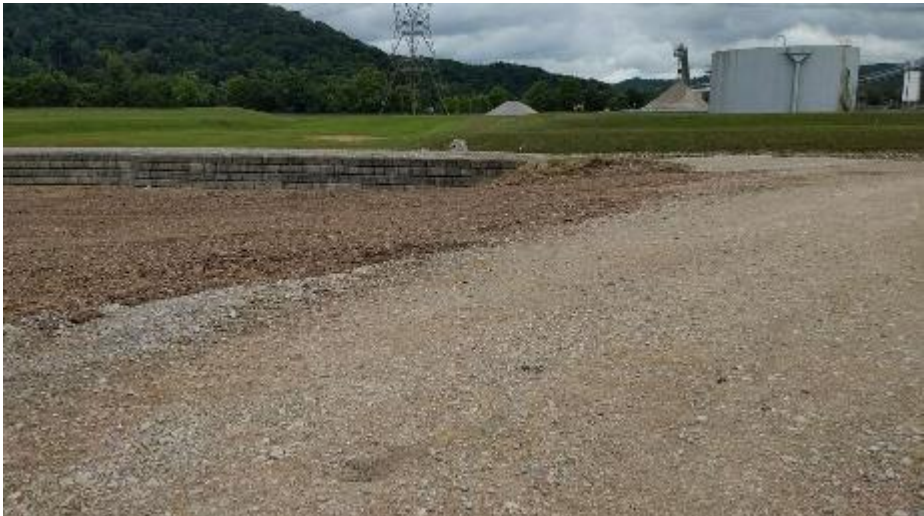
| PHOTOGRAPH No: 12 | DATE: July 22, 2024 10:03 AM | LATITUDE: 38.47859003 | LONGITUDE: -81.82870174 |

- The South Dike (former BAP 1A/Reclaim splitter dike) has been raised as part of the repurposing of the Reclaim Pond. The Reclaim Pond slope is in good condition with vegetation starting to appear. The crest generally appears in good condition as shown in Photograph No. 12.

| <p>DESCRIPTION:</p> <p>Clearwater Pond. Inboard Dike. General Photo, Monitor Conditions.</p> <p>Area noted in 2023 for maintenance related to construction project which has been completed.</p> | | | |

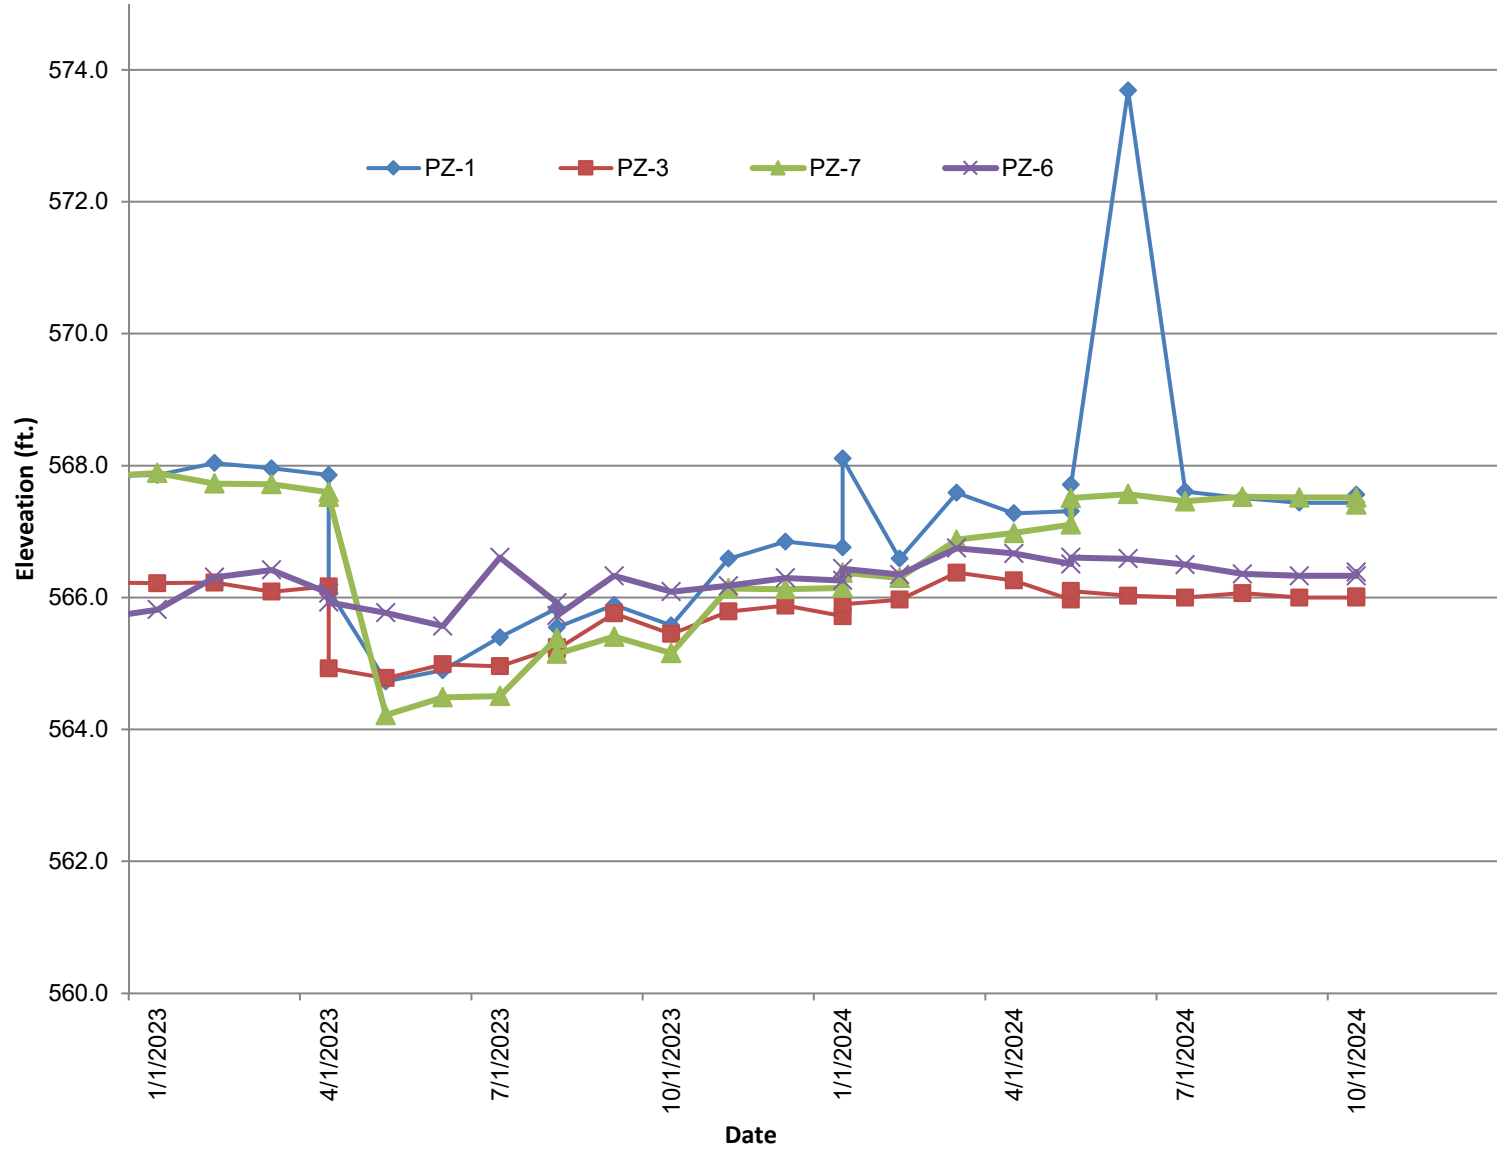
Amos Plant Bottom Ash Complex Piezometer Readings

The location of the instrumentation is shown on Figure 3 – Site Plan. The piezometer readings generally exhibited minor fluctuations month to month during 2024. It should be noted that the elevation of PZ-1 rose approximately 6-feet from May to June in 2024, but trended back to normal elevations near elevation 567.5 in July 2024. A graph of the piezometer readings is provided in Appendix B – Instrumentation Data. The maximum recorded readings of each instrument for past two annual inspections are shown in the table below.

The elevations of pond water levels have varied as ponds during the closure and repurposing project. The piezometer water levels have generally remained constant with no adverse trends observed that would impair the structural stability of the perimeter dike.
