Amos FGD Landfill 2024 Annual Landfill Inspection Report

John E. Amos Plant, Putnum County, West Virginia

October 16, 2024

AEP Document ID: GEVR-24-022

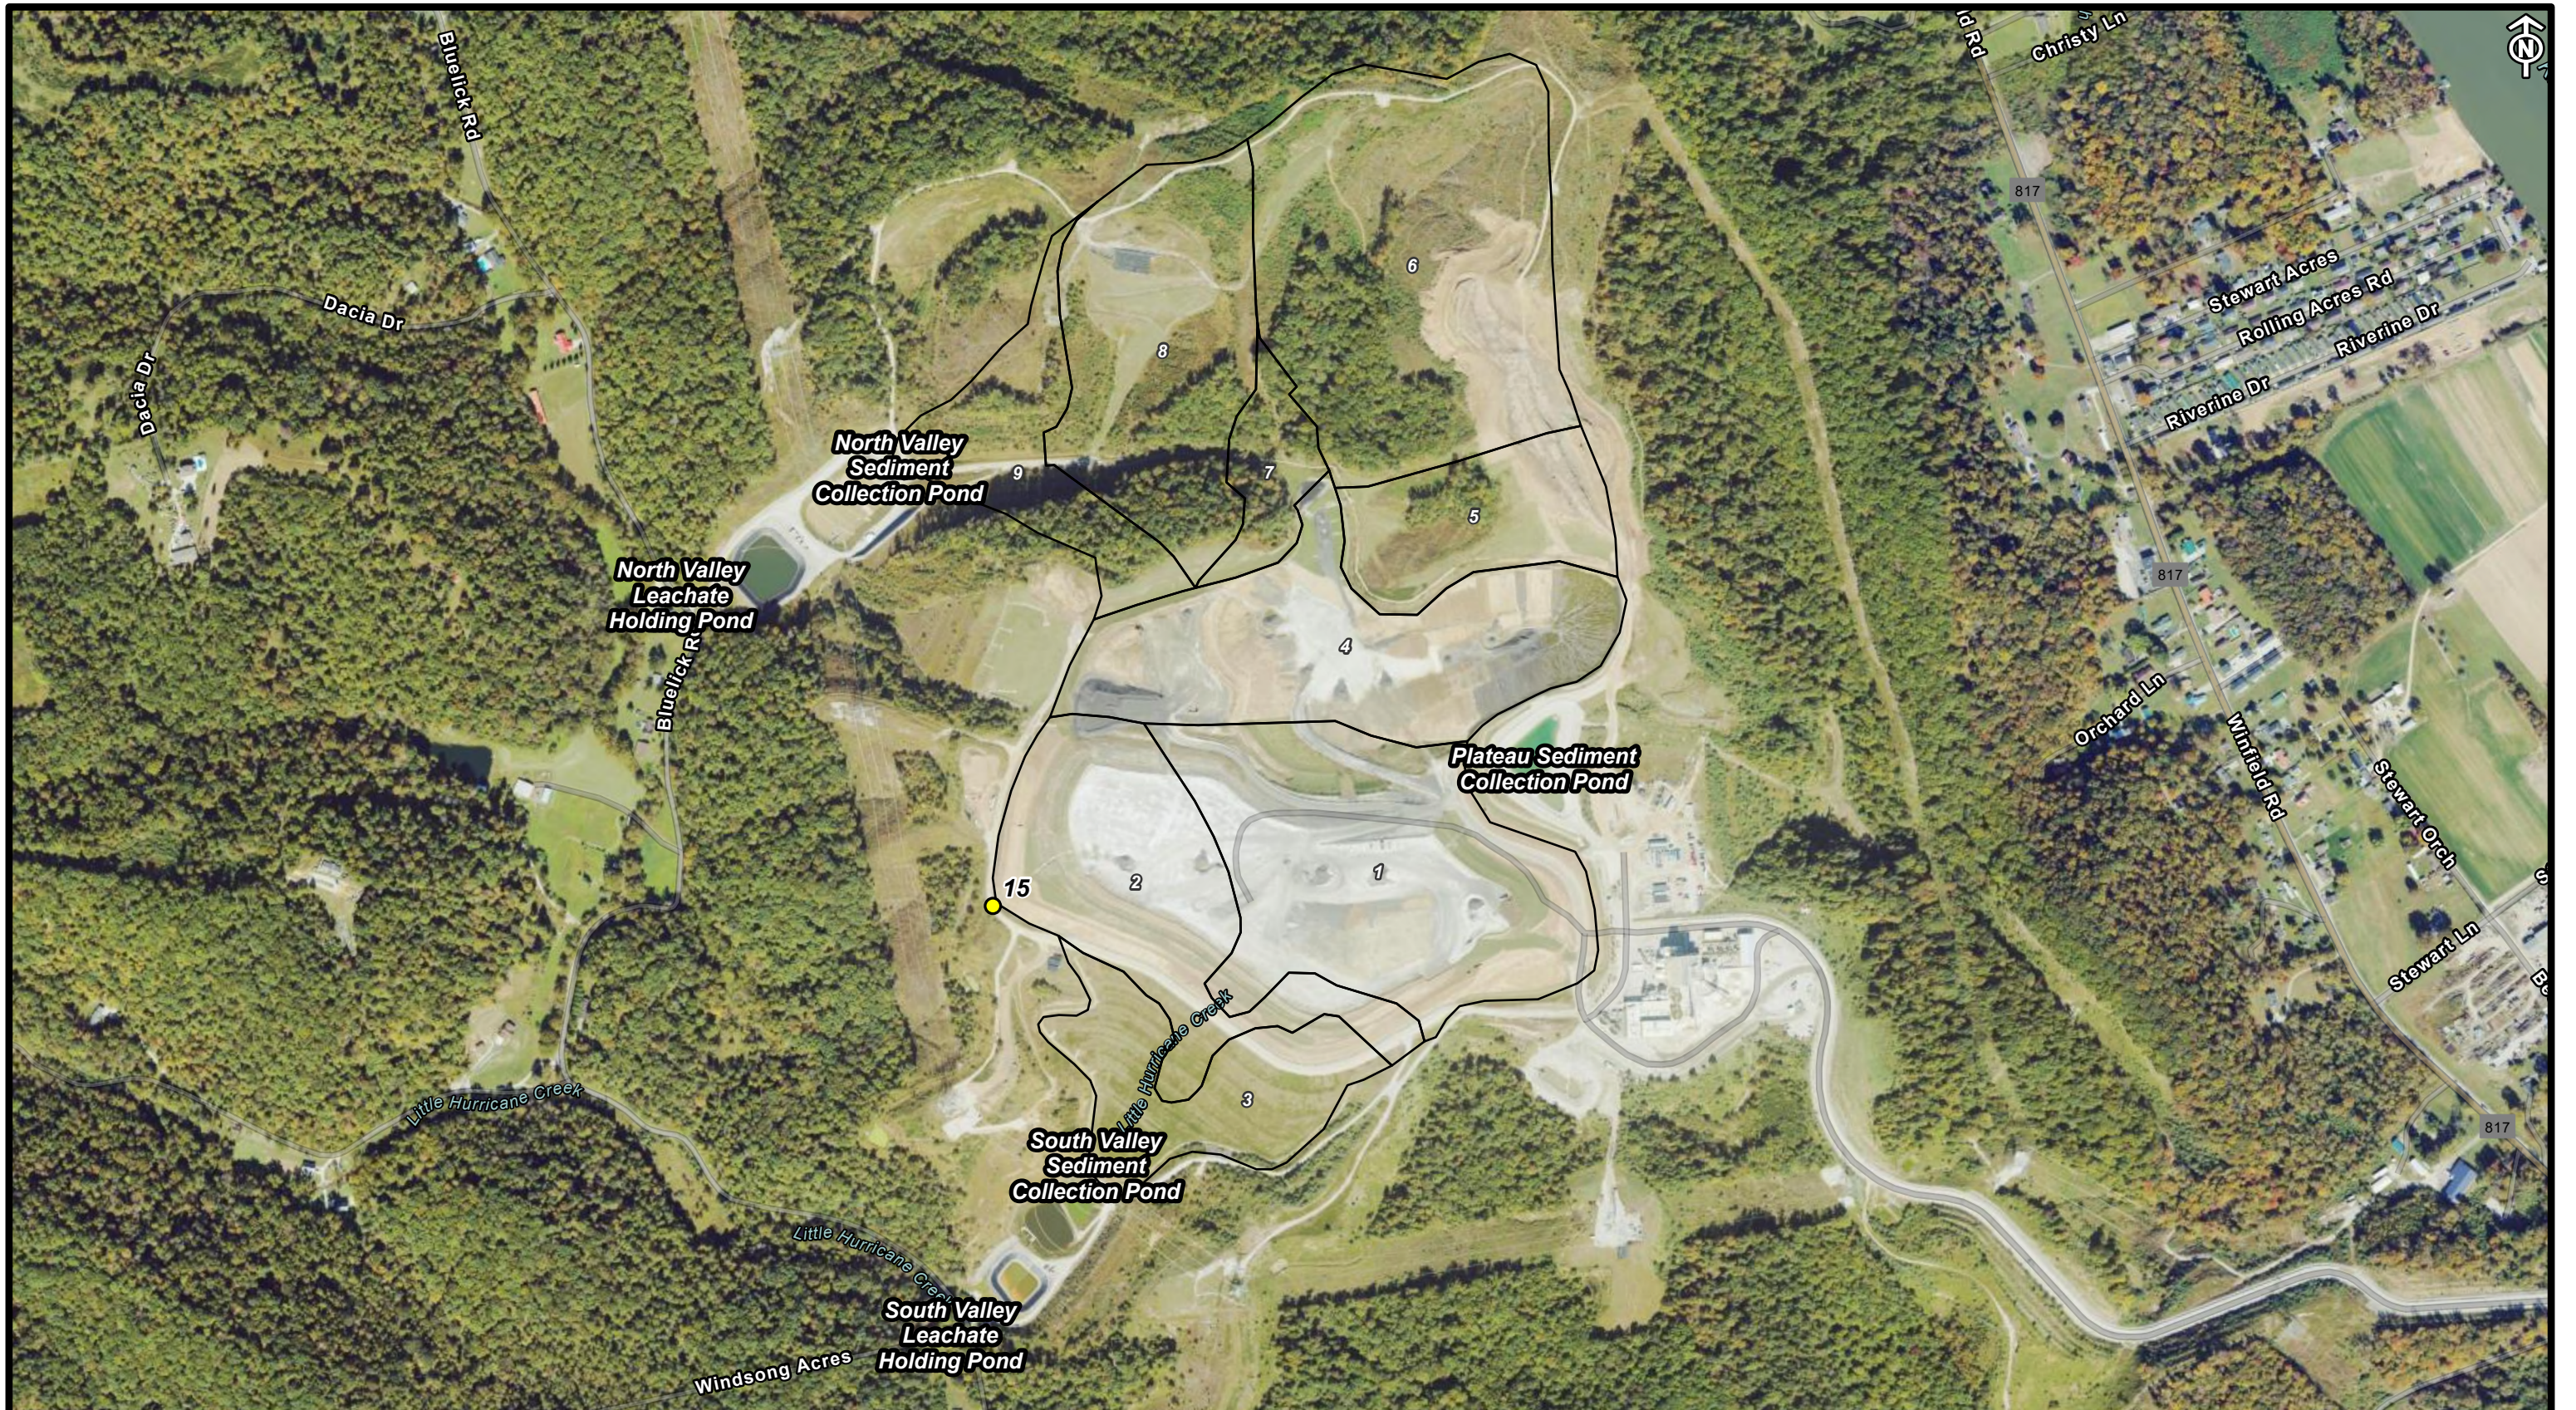
ITEMS TO BE MONITORED

1. Item 15 – Minor erosion observed in sequence 2 drainage feature. The minor erosion should be monitored and addressed before the erosion becomes significant.

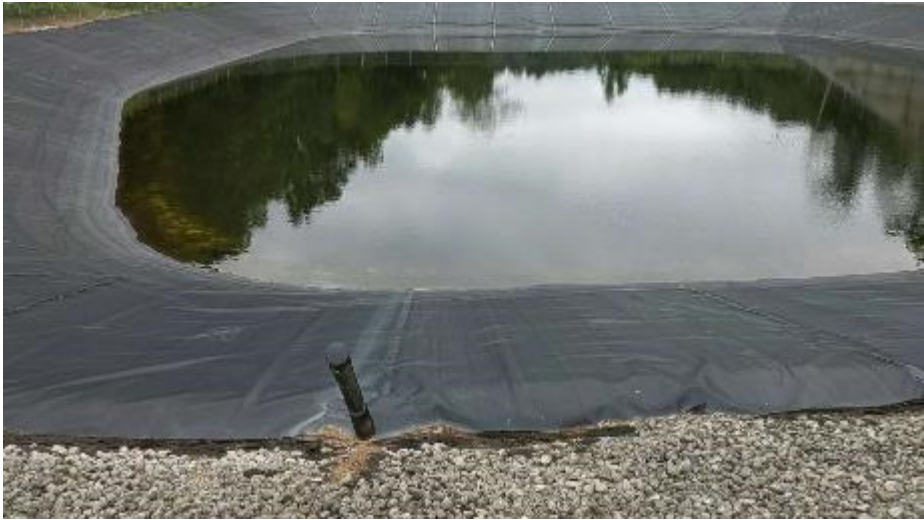
1. The North Valley Leachate holding pond was in good condition. The exposed membrane was in good condition and the pond was being operated with adequate freeboard as shown in Photograph 1 and 2.

PHOTOGRAPH NO: 1	DATE: July 22, 2024 11:49 AM	LATITUDE: 38.48671886	LONGITUDE: -81.86113655
DIRECTION: 130	SITE LOCATION: PUTNAM COUNTY, WEST VIRGINIA		
DESCRIPTION: North Valley Leachate Holding Pond. Upstream Slope – Looking West. General Photo, Typical Conditions.

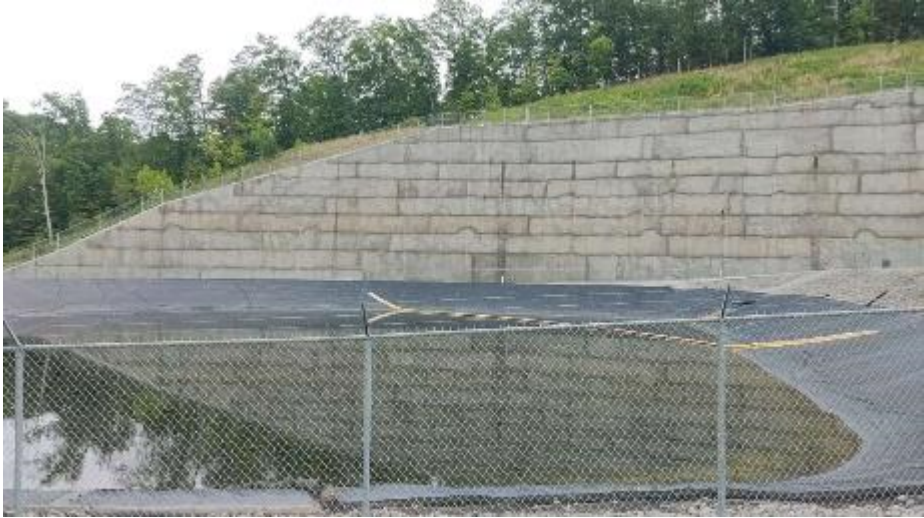
PHOTO BY: GEI CONSULTANTS, INC.			
PHOTOGRAPH NO: 2	DATE: July 22, 2024 11:53 AM	LATITUDE: 38.48649933	LONGITUDE: -81.86126069
DIRECTION: 229	SITE LOCATION: PUTNAM COUNTY, WEST VIRGINIA		
DESCRIPTION: North Valley Leachate Holding Pond. North soil nail wall – Looking Northwest. General Photo, Typical Conditions.

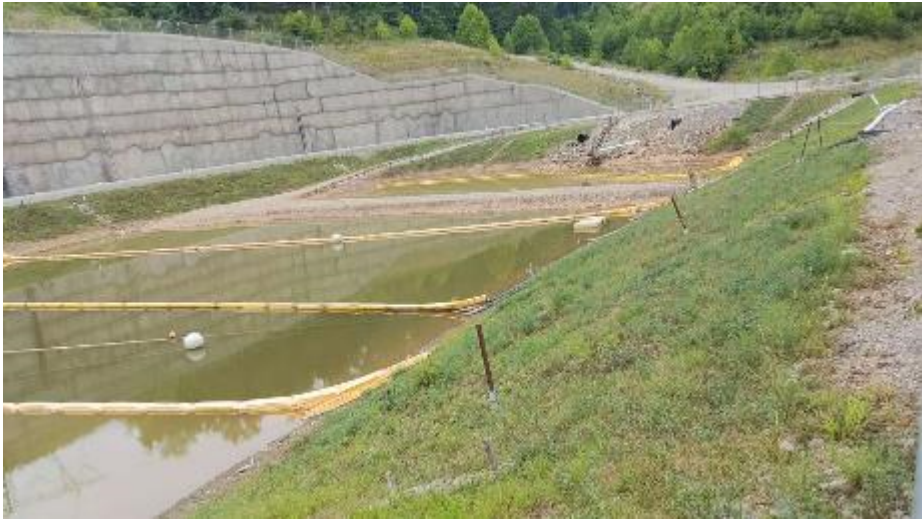
2. The North Valley Sediment Collection Pond was in good condition. The upstream slope vegetation was healthy and maintained to less than 12-inches. The drainage structures were not blocked with debris and no erosion was observed at the outlets of the structures. The turbidity curtains were properly staked and seemed to be functioning as they were designed as shown in Photograph 3.

PHOTOGRAPH NO: 3	DATE: July 22, 2024 11:56 AM	LATITUDE: 38.48692397	LONGITUDE: -81.86060406
DIRECTION: 265	SITE LOCATION: PUTNAM COUNTY, WEST VIRGINIA		
DESCRIPTION: North Valley Sediment Collection Pond. Upstream slope – Looking North. General Photo, Typical Conditions.

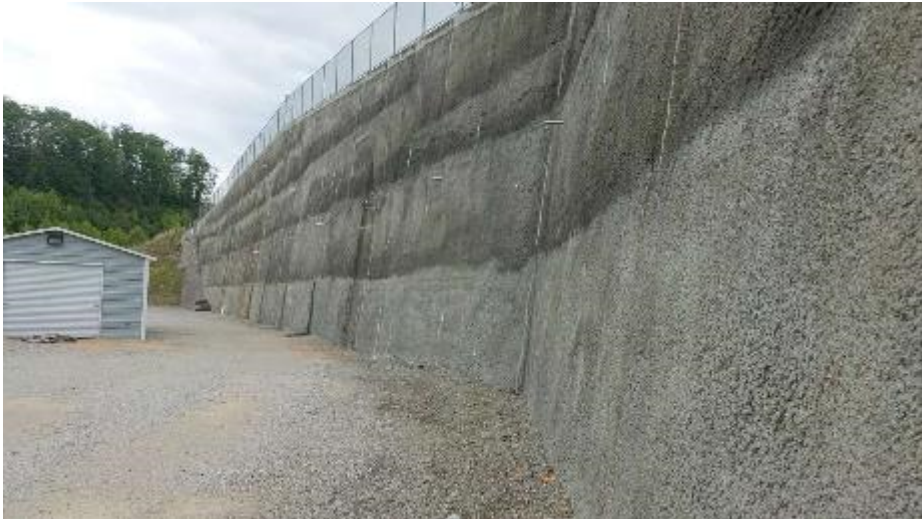
3. The soil nail wall along the northern and southern limits of the North Valley Sediment Collection Pond was in good condition with proper alignment as shown in Photographs 4 and 5.

PHOTO BY: GEI CONSULTANTS, INC.			
PHOTOGRAPH NO: 4	DATE: July 22, 2024 11:57 AM	LATITUDE: 38.48678938	LONGITUDE: -81.86054629
DIRECTION: 352	SITE LOCATION: PUTNAM COUNTY, WEST VIRGINIA		
DESCRIPTION: North Valley Sediment Collection Pond. South soil nail wall in north valley pond complex – Looking East. General Photo, Typical Conditions.

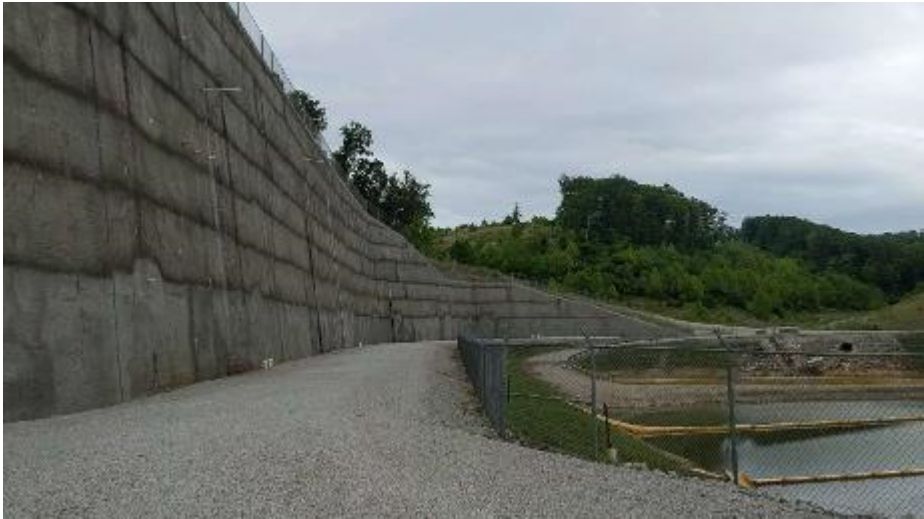
PHOTOGRAPH NO: 5	DATE: July 22, 2024 12:00 PM	LATITUDE: 38.48733888	LONGITUDE: -81.86138961
DIRECTION: 335	SITE LOCATION: PUTNAM COUNTY, WEST VIRGINIA		
DESCRIPTION: North Valley Sediment Collection Pond. North soil nail wall in north valley pond complex – looking East. General Photo, Typical Conditions.

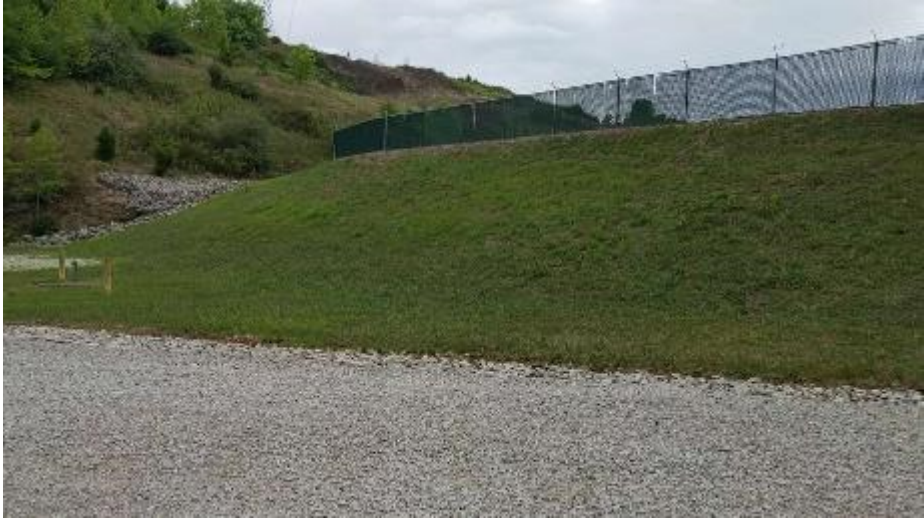
4. The South Valley Leachate holding pond was in good condition. The downstream slope vegetation was well maintained, and the exposed membrane was in good condition as shown in Photographs 6, 7, and 8.

PHOTO BY: GEI CONSULTANTS, INC.			
PHOTOGRAPH NO: 6	DATE: July 22, 2024 12:07 PM	LATITUDE: 38.47804669	LONGITUDE: -81.85920197
DIRECTION: 299	SITE LOCATION: PUTNAM COUNTY, WEST VIRGINIA		
DESCRIPTION: South Valley Leachate Holding Pond. Downstream slope of embankment. General Photo, Typical Conditions.

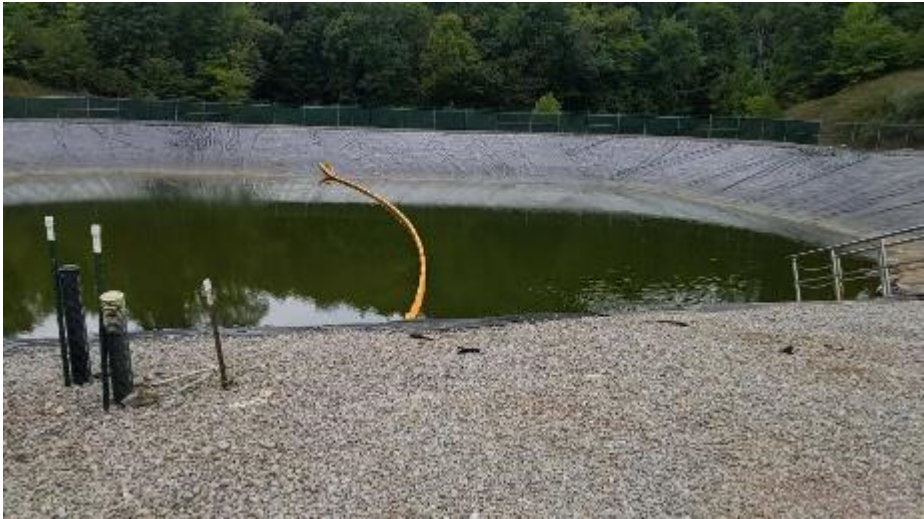
PHOTOGRAPH NO: 7	DATE: July 22, 2024 12:09 PM	LATITUDE: 38.4787987	LONGITUDE: -81.85839207
DIRECTION: 152		SITE LOCATION: PUTNAM COUNTY, WEST VIRGINIA	
DESCRIPTION: South Valley Leachate Holding Pond. Upstream Slope – Looking Southeast. General Photo, Typical Conditions.

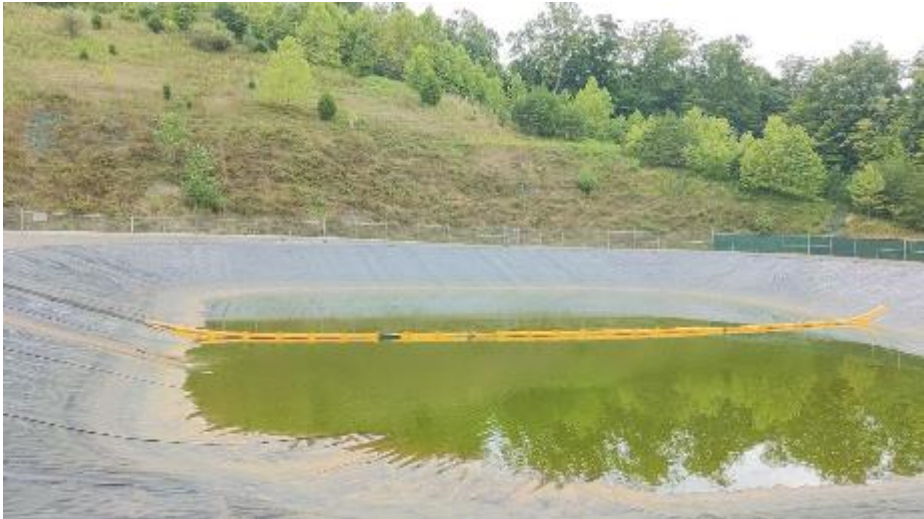
PHOTO BY: GEI CONSULTANTS, INC.			
PHOTOGRAPH NO: 8	DATE: July 22, 2024 12:11 PM	LATITUDE: 38.47878293	LONGITUDE: -81.85888616
DIRECTION: 72		SITE LOCATION: PUTNAM COUNTY, WEST VIRGINIA	
DESCRIPTION: South Valley Leachate Holding Pond. East area, Upstream Slope – Looking South. General Photo, Typical Conditions.

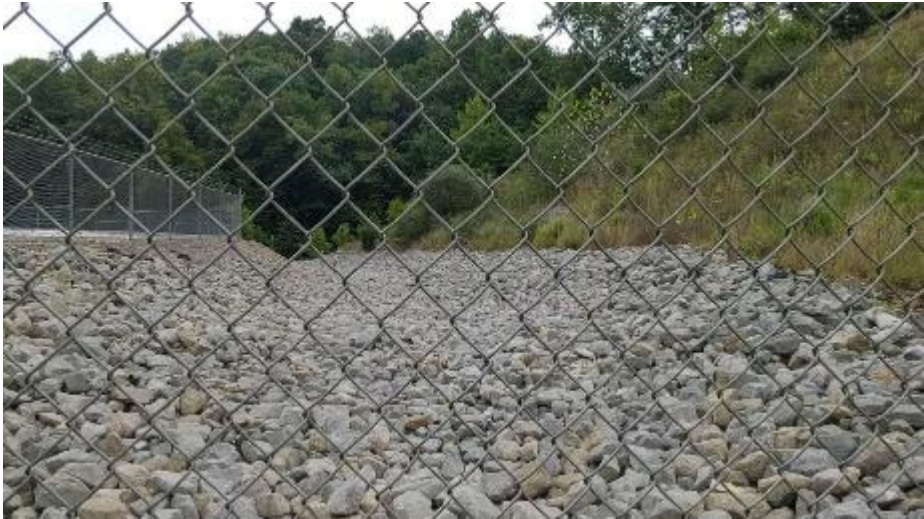
PHOTOGRAPH NO: 9	DATE: July 22, 2024 12:13 PM	LATITUDE: 38.47896307	LONGITUDE: -81.85877818
DIRECTION: 166	SITE LOCATION: PUTNAM COUNTY, WEST VIRGINIA		
DESCRIPTION: South Valley Sediment Collection Pond. Emergency Spillway Channel. General Photo, Typical Conditions.

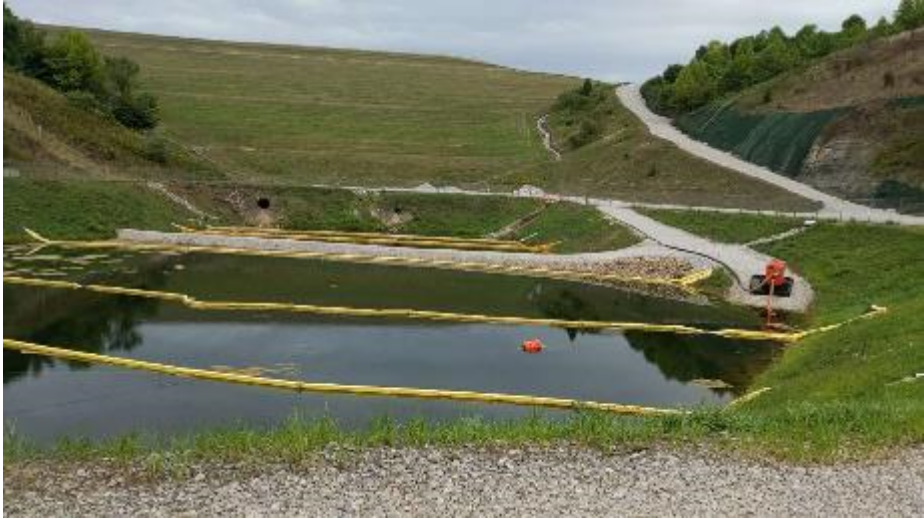
5. The South Valley Sediment Collection Pond was in good condition. The upstream slope vegetation was healthy and maintained to less than 12-inches. The drainage structures were not blocked with debris. The turbidity curtains were properly staked and seemed to be functioning as they were designed as shown in Photographs 10 and 11.

PHOTO BY: GEI CONSULTANTS, INC.			
PHOTOGRAPH NO: 10	DATE: July 22, 2024 12:14 PM	LATITUDE: 38.47874526	LONGITUDE: -81.85855176
DIRECTION: 333	SITE LOCATION: PUTNAM COUNTY, WEST VIRGINIA		
DESCRIPTION: South Valley Sediment Collection Pond. Upstream Slope – looking Northeast. General Photo, Typical Conditions.

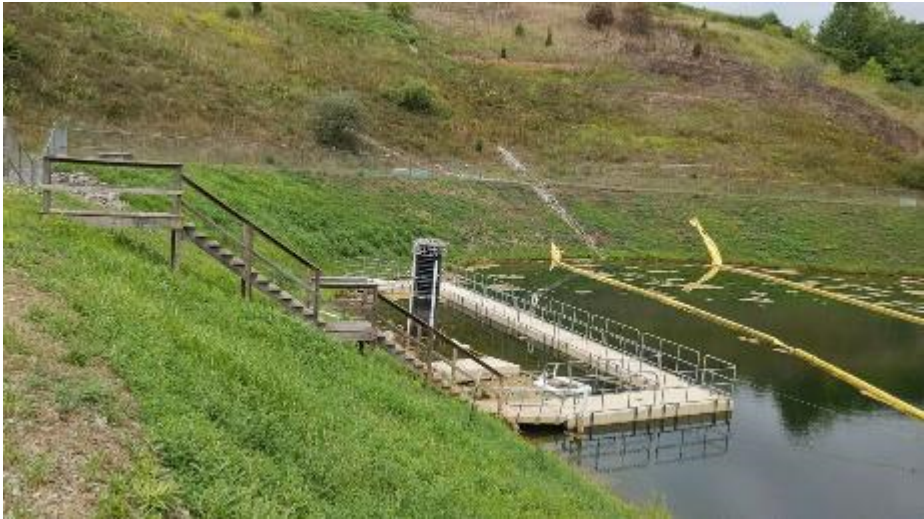
PHOTOGRAPH No: 11	DATE: July 22, 2024 12:16 PM	LATITUDE: 38.47874399	LONGITUDE: -81.85849955
DIRECTION: 263	SITE LOCATION: PUTNAM COUNTY, WEST VIRGINIA		
DESCRIPTION: South Valley Sediment Collection Pond. Decant Structure, Interior of Pond. General Photo, Typical Conditions.

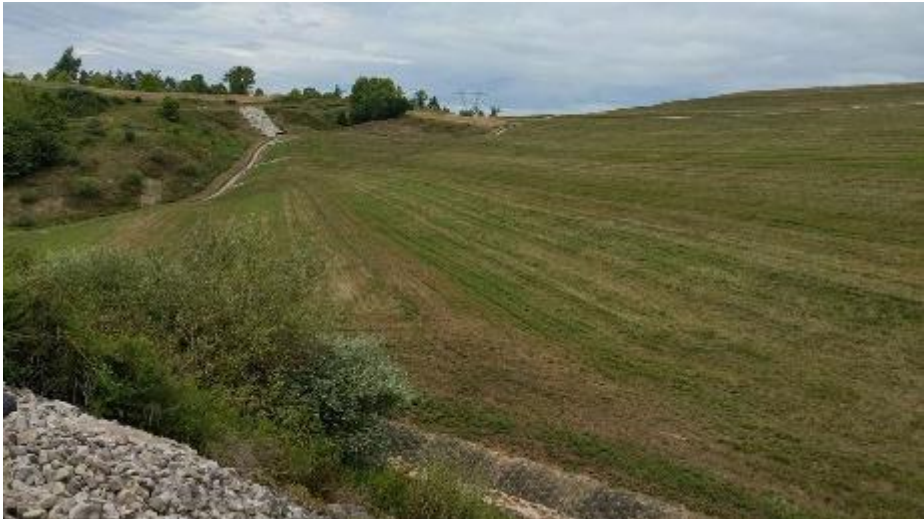
6. The landfill vegetated cover was in good condition and well maintained as shown in photograph 12, 13, and 14.
7. The landfill cover drainage features are in satisfactory condition. We should note that some minor erosion was observed in Sequence 2 as shown in Photograph 15. The minor erosion should be monitored and addressed before the erosion becomes significant. Other landfill drainage features were in good condition and functioning as designed as shown in Photograph 13, 14, and 22.

PHOTO BY: GEI CONSULTANTS, INC.			
PHOTOGRAPH No: 12	DATE: July 22, 2024 12:21 PM	LATITUDE: 38.47979685	LONGITUDE: -81.85565021
DIRECTION: 247	SITE LOCATION: PUTNAM COUNTY, WEST VIRGINIA		
DESCRIPTION: Sequence 3. Final Cover. General Photo, Typical Conditions.

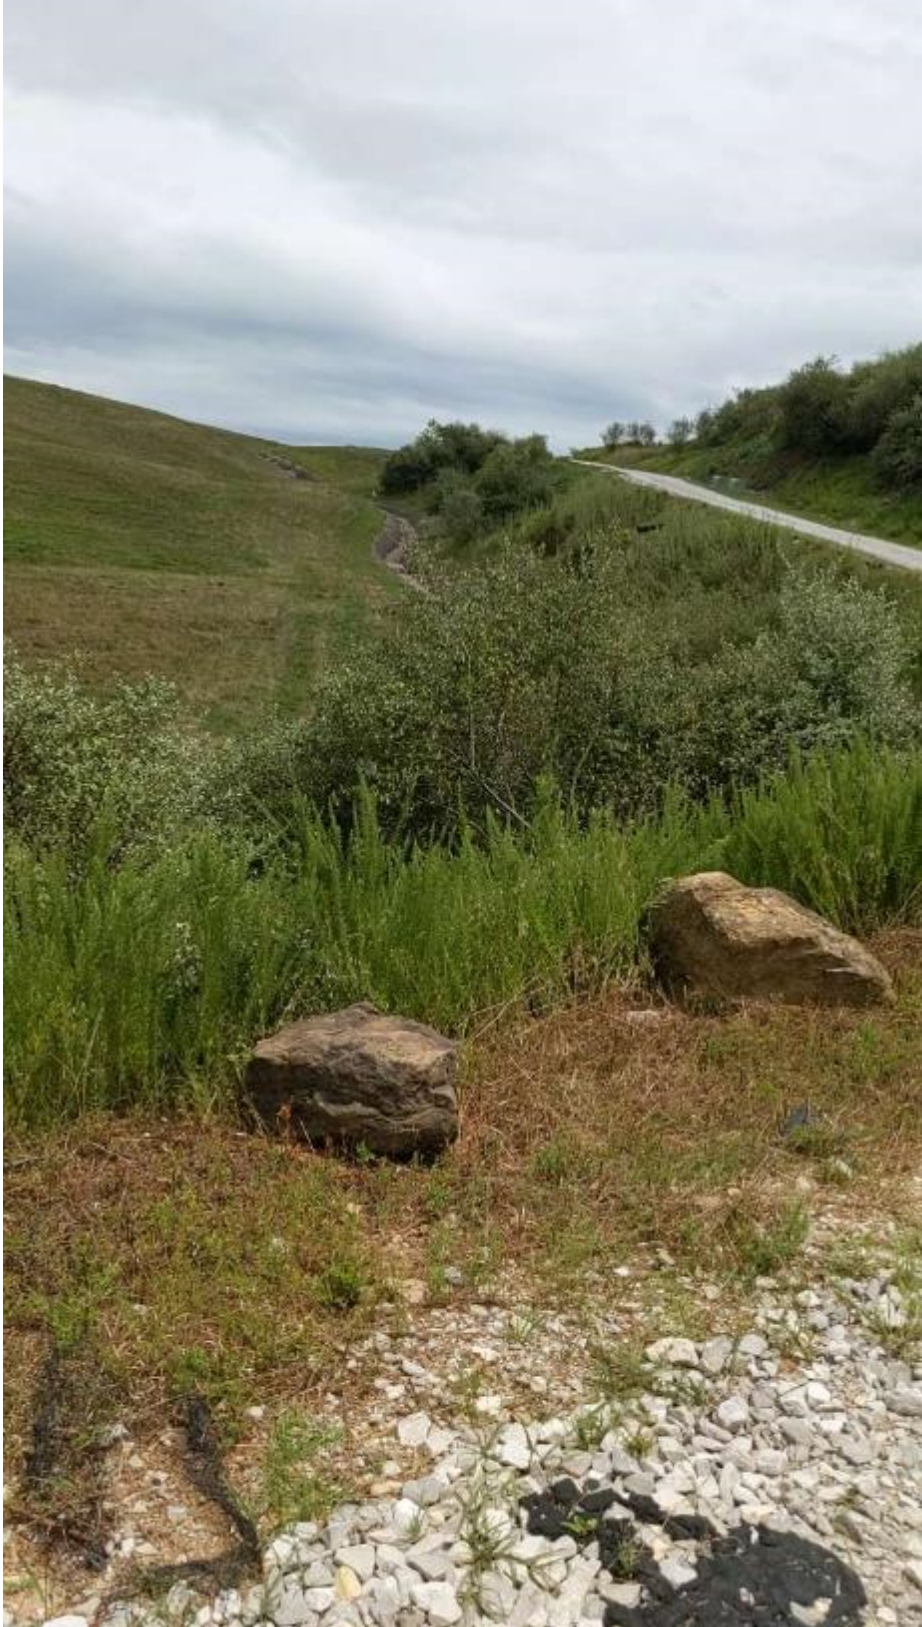
PHOTOGRAPH No: 13	DATE: July 22, 2024 12:24 PM	LATITUDE: 38.47950271	LONGITUDE: -81.85509303
DIRECTION: 42	SITE LOCATION: PUTNAM COUNTY, WEST VIRGINIA		
DESCRIPTION: Sequence 3. Perimeter Ditch. General Photo, Typical Conditions.

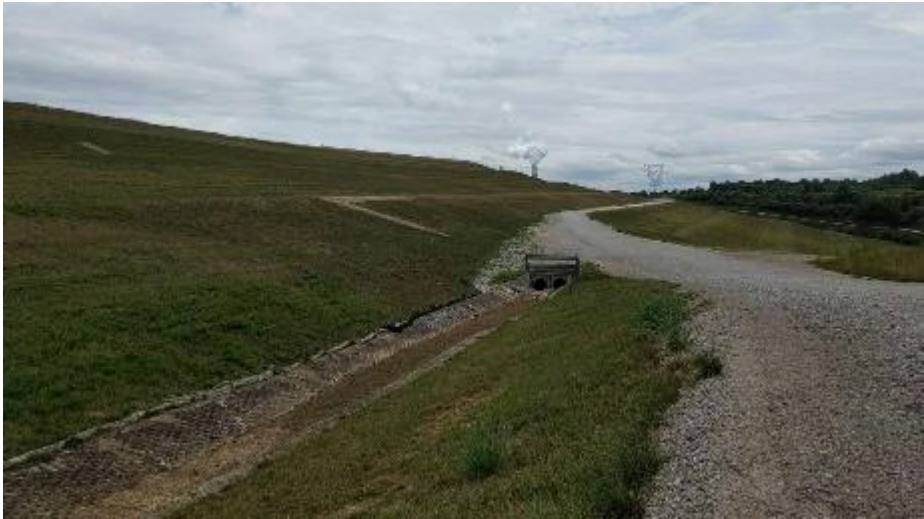
PHOTOGRAPH No: 14	DATE: July 22, 2024 12:30 PM	LATITUDE: 38.48260011	LONGITUDE: -81.85868002
DIRECTION: 29	SITE LOCATION: PUTNAM COUNTY, WEST VIRGINIA		
DESCRIPTION: Sequence 2. Interim Cover, down to 950 bench. Final Cover below 950 bench.

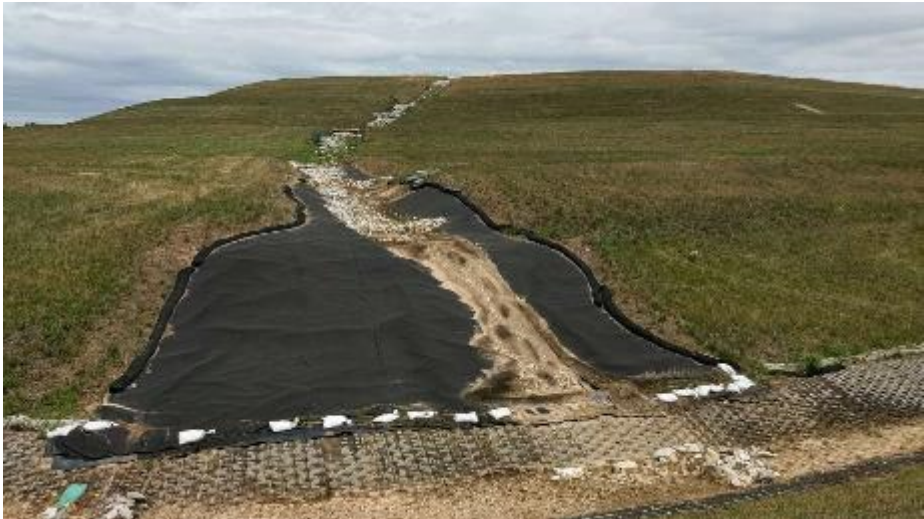
PHOTO BY: GEI CONSULTANTS, INC.			
PHOTOGRAPH No: 15	DATE: July 22, 2024 12:33 PM	LATITUDE: 38.48271702	LONGITUDE: -81.85881576
DIRECTION: 342	SITE LOCATION: PUTNAM COUNTY, WEST VIRGINIA		
DESCRIPTION: Sequence 2. Drainage Feature. General Photo, Monitor Conditions.

1. Continue routine mowing of final and temporary covers to ensure proper vegetative growth.
2. Address issues like minor animal burrows and minor erosion rills before they become significant.
3. Continue to check site culverts, ditches, outfall structures for debris/blockages to allow the site stormwater to flow as it was designed.

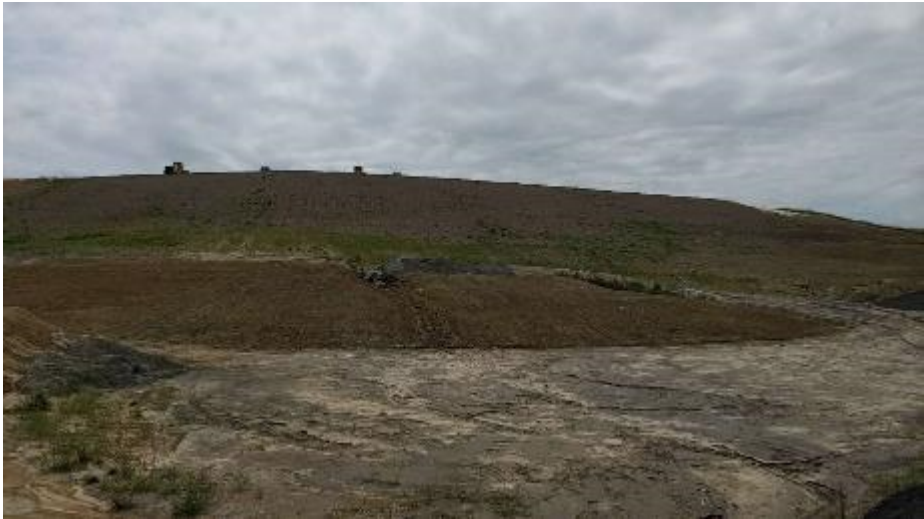
PHOTOGRAPH No: 16	DATE: July 22, 2024 12:38 PM	LATITUDE: 38.48507772	LONGITUDE: -81.85514404
DIRECTION: 120	SITE LOCATION: PUTNAM COUNTY, WEST VIRGINIA		
DESCRIPTION: Sequence 2. Interim Cover – Looking South from Sequence 4. General Photo, Typical Conditions.

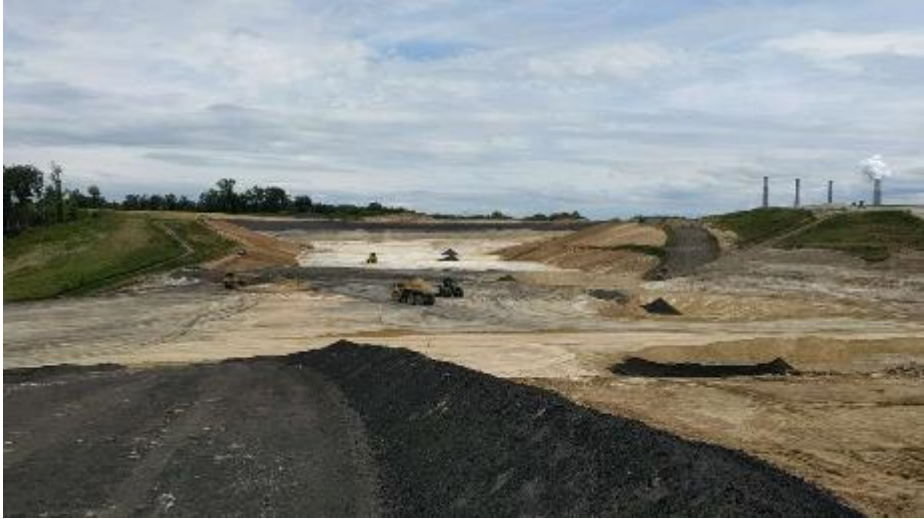
8. The active areas of the landfill were in satisfactory condition with functioning chimney drains as shown in Photographs 17, 18, 19, and 21.
9. The Plateau Stormwater Runoff Pond was in good condition. The upstream slopes show no signs of erosion and the outlet structure was free of debris as shown in Photograph 20.

PHOTO BY: GEI CONSULTANTS, INC.			
PHOTOGRAPH No: 17	DATE: July 22, 2024 12:39 PM	LATITUDE: 38.48513934	LONGITUDE: -81.85523918
DIRECTION: 24	SITE LOCATION: PUTNAM COUNTY, WEST VIRGINIA		
DESCRIPTION: Sequence 4. Active Material Placement. General Photo, Typical Conditions.

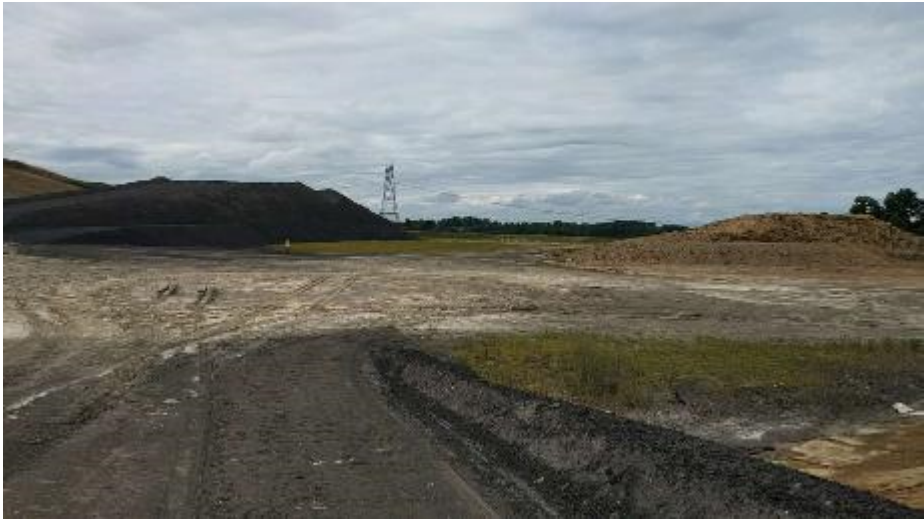
PHOTOGRAPH No: 18	DATE: July 22, 2024 12:41 PM	LATITUDE: 38.48518156	LONGITUDE: -81.85538021
DIRECTION: 195	SITE LOCATION: PUTNAM COUNTY, WEST VIRGINIA		
DESCRIPTION: Sequence 4. Bottom Ash Stock Piles. General Photo, Typical Conditions.

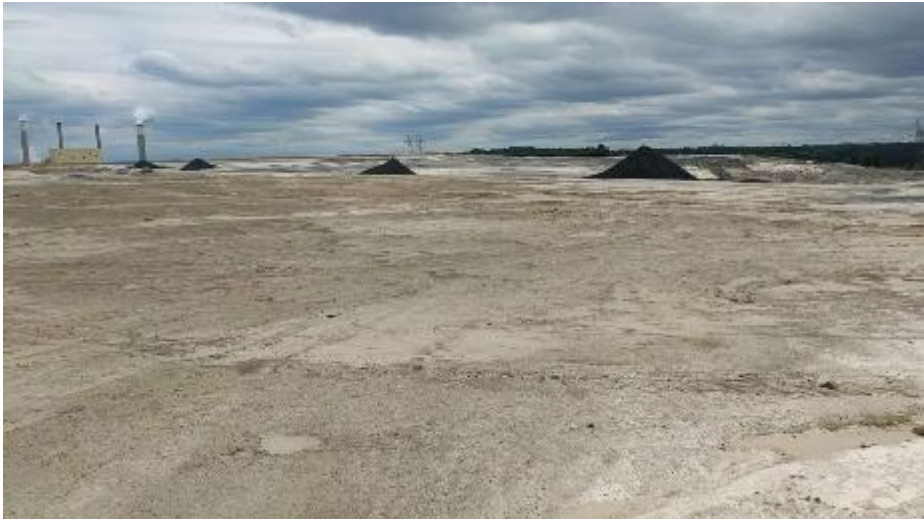
PHOTO BY: GEI CONSULTANTS, INC.			
PHOTOGRAPH No: 19	DATE: July 22, 2024 12:53 PM	LATITUDE: 38.48391043	LONGITUDE: -81.85686828
DIRECTION: 54	SITE LOCATION: PUTNAM COUNTY, WEST VIRGINIA		
DESCRIPTION: Sequence 1, 2 and 3 Active Areas. Note Chimney Drains, Typical Conditions.

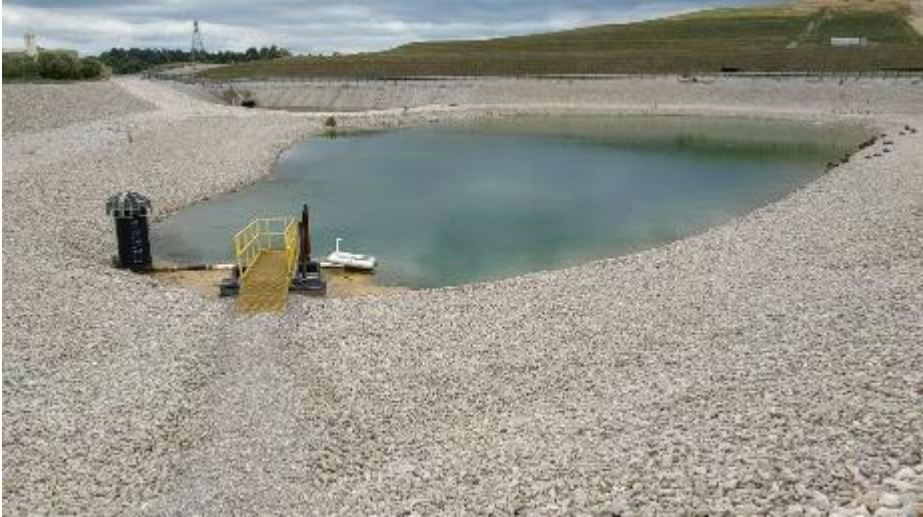
PHOTOGRAPH No: 20	DATE: July 22, 2024 1:02 PM	LATITUDE: 38.48469649	LONGITUDE: -81.85056109
DIRECTION: 104	SITE LOCATION: PUTNAM COUNTY, WEST VIRGINIA		
DESCRIPTION: Plateau Stormwater Runoff Pond. General Photo, Typical Conditions.

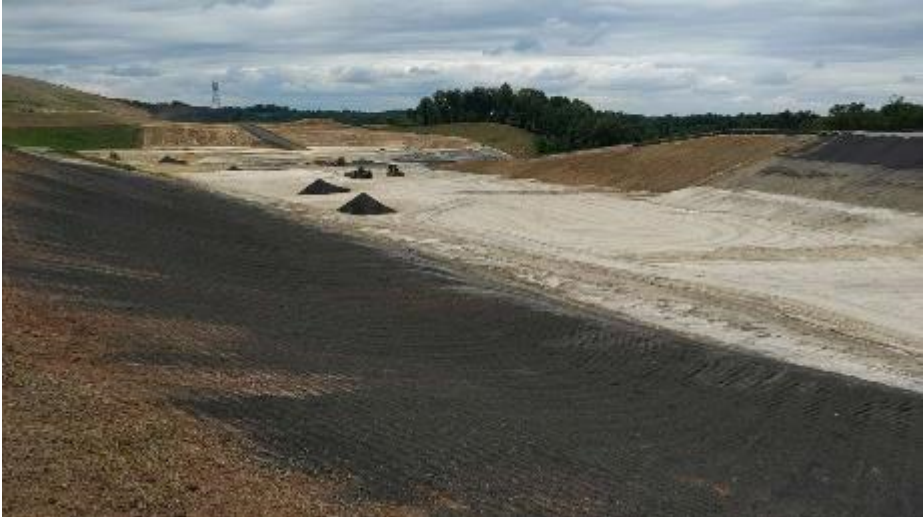
PHOTO BY: GEI CONSULTANTS, INC.			
PHOTOGRAPH No: 21	DATE: July 22, 2024 1:04 PM	LATITUDE: 38.48487849	LONGITUDE: -81.85051422
DIRECTION: 209	SITE LOCATION: PUTNAM COUNTY, WEST VIRGINIA		
DESCRIPTION: Sequence 4. Active Area – Looking West. Typical Conditions.
