## CCR Landfill 2024 Annual CCR Landfill Inspection Report

Flint Creek Plant, Gentry, Arkansas

December 12, 2024  
Project 2305686  
AEP Document ID: GEVR-24-038

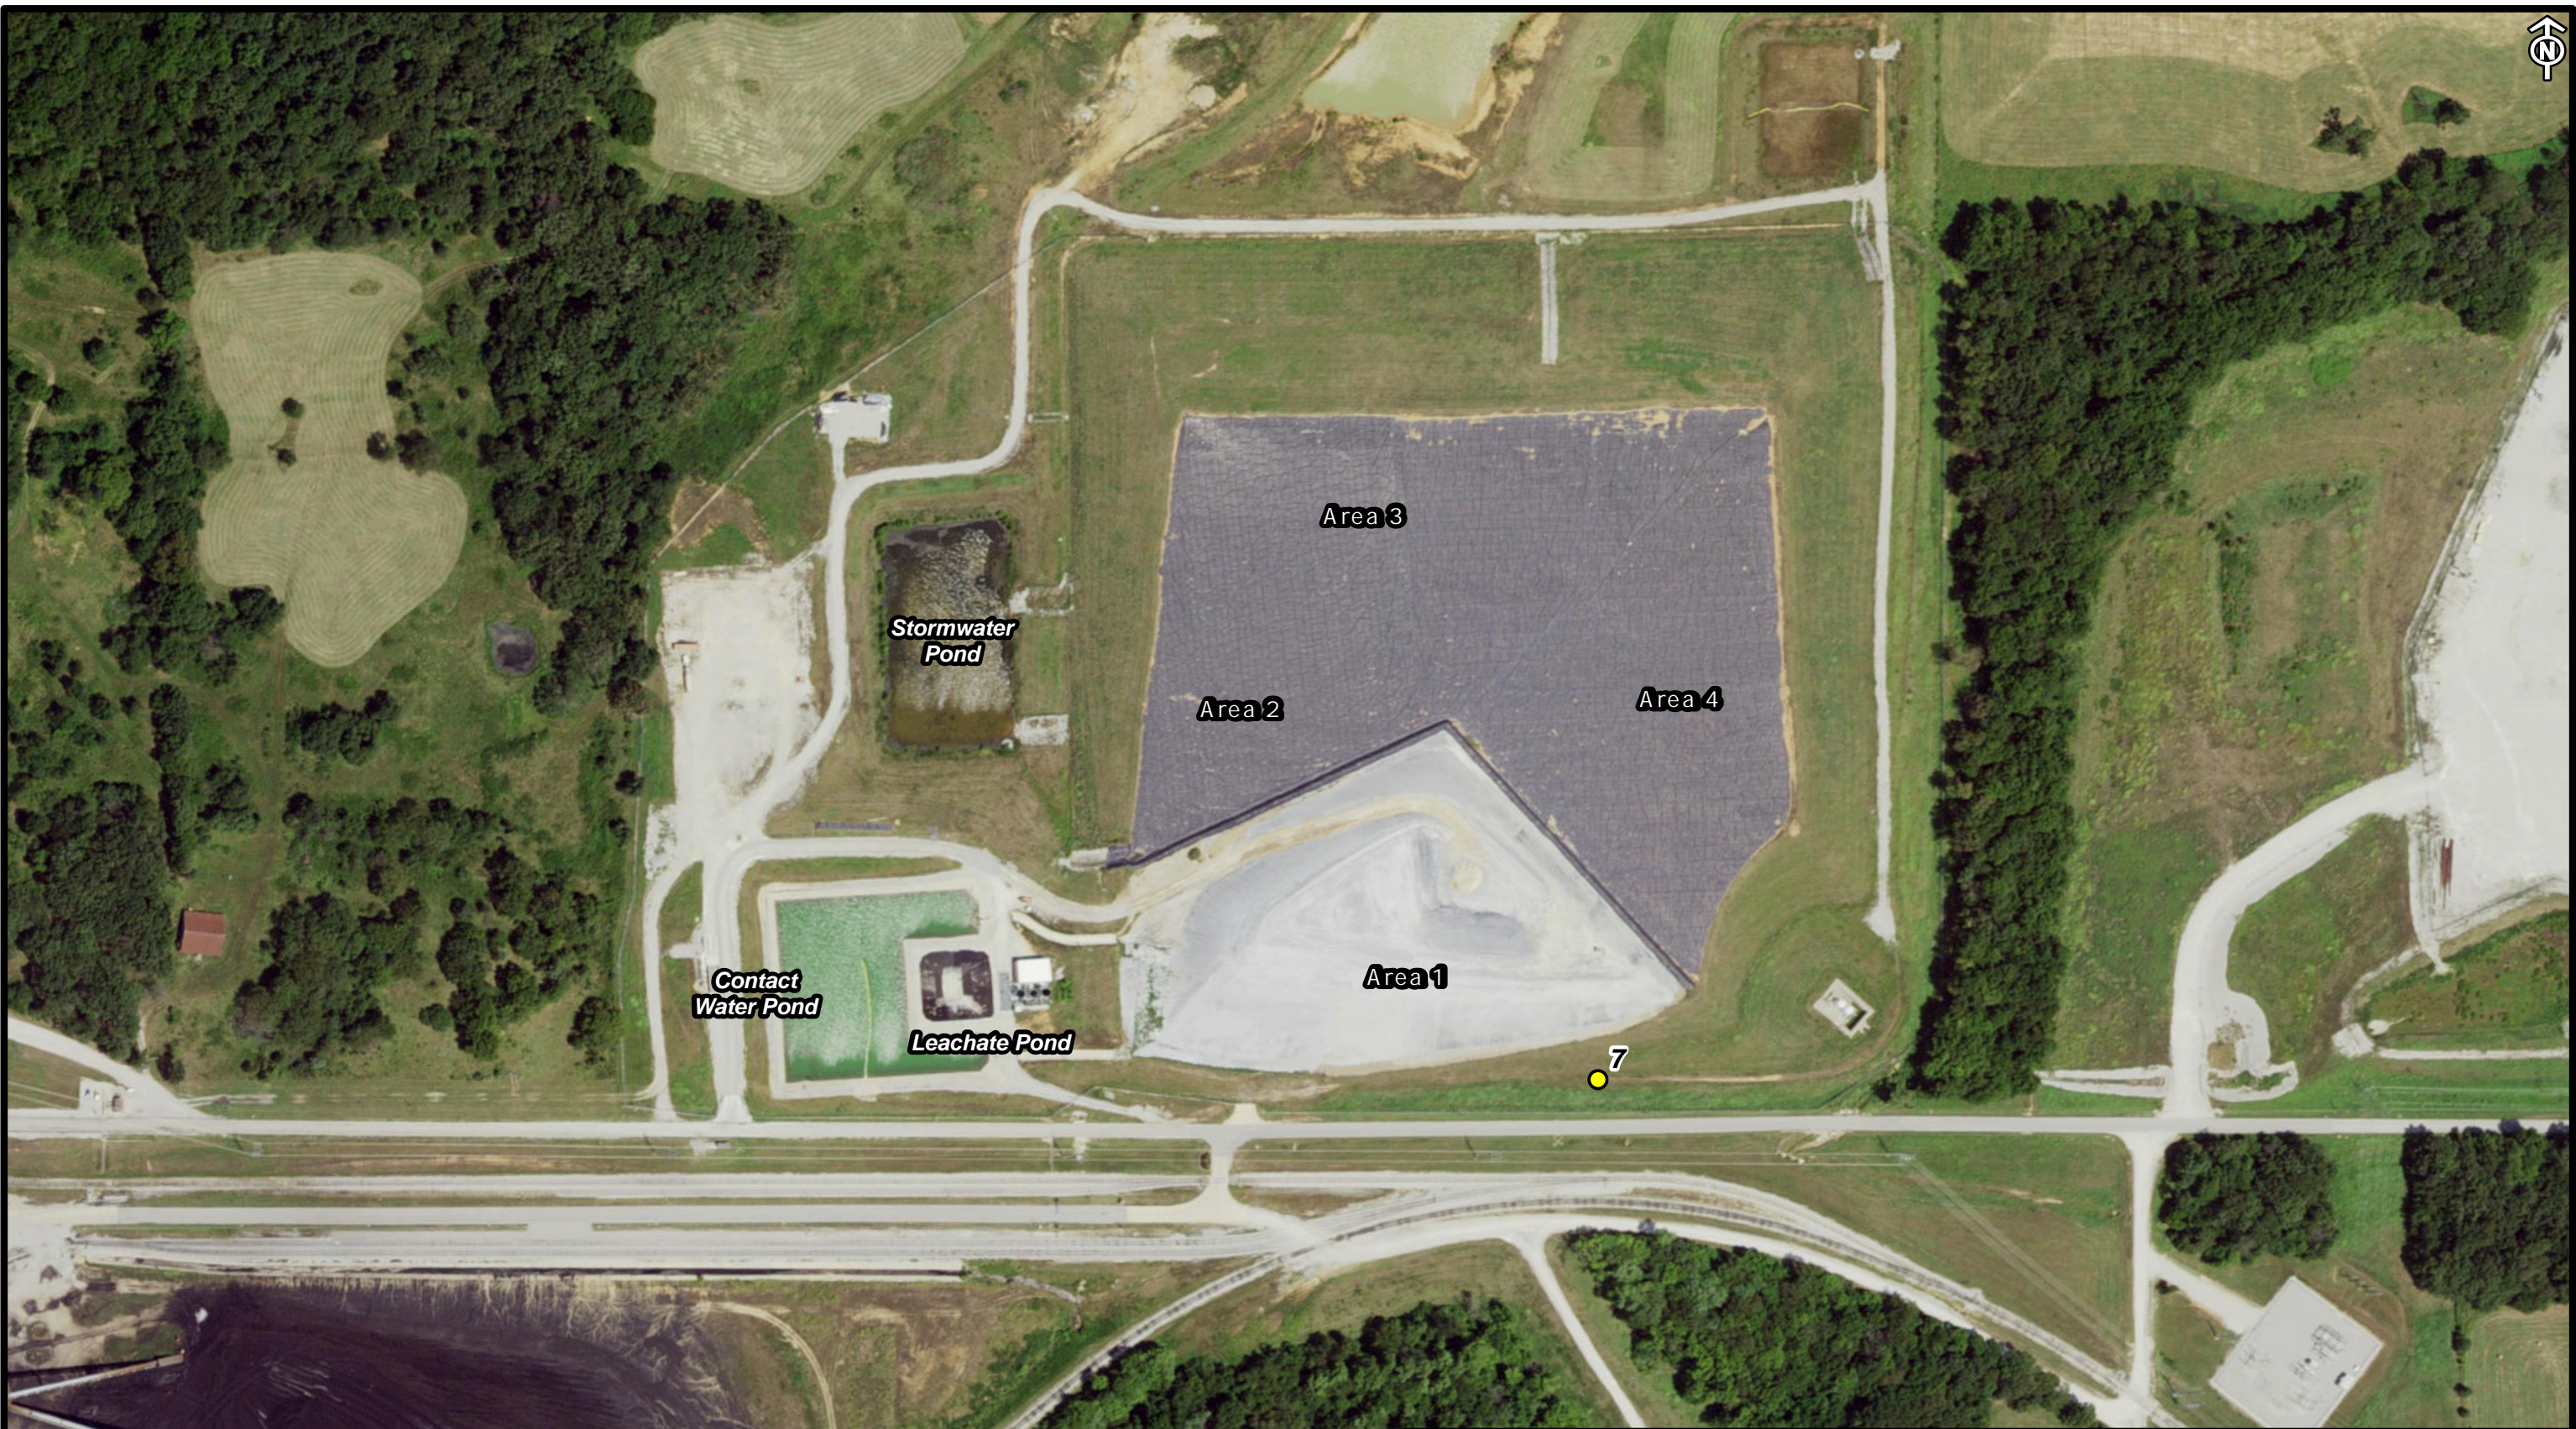
ITEMS TO BE MONITORED

- Item 7 – Monitor the potential longitudinal crack on the southern slope. For reference, its length was measured to be 25-feet during the annual inspection.

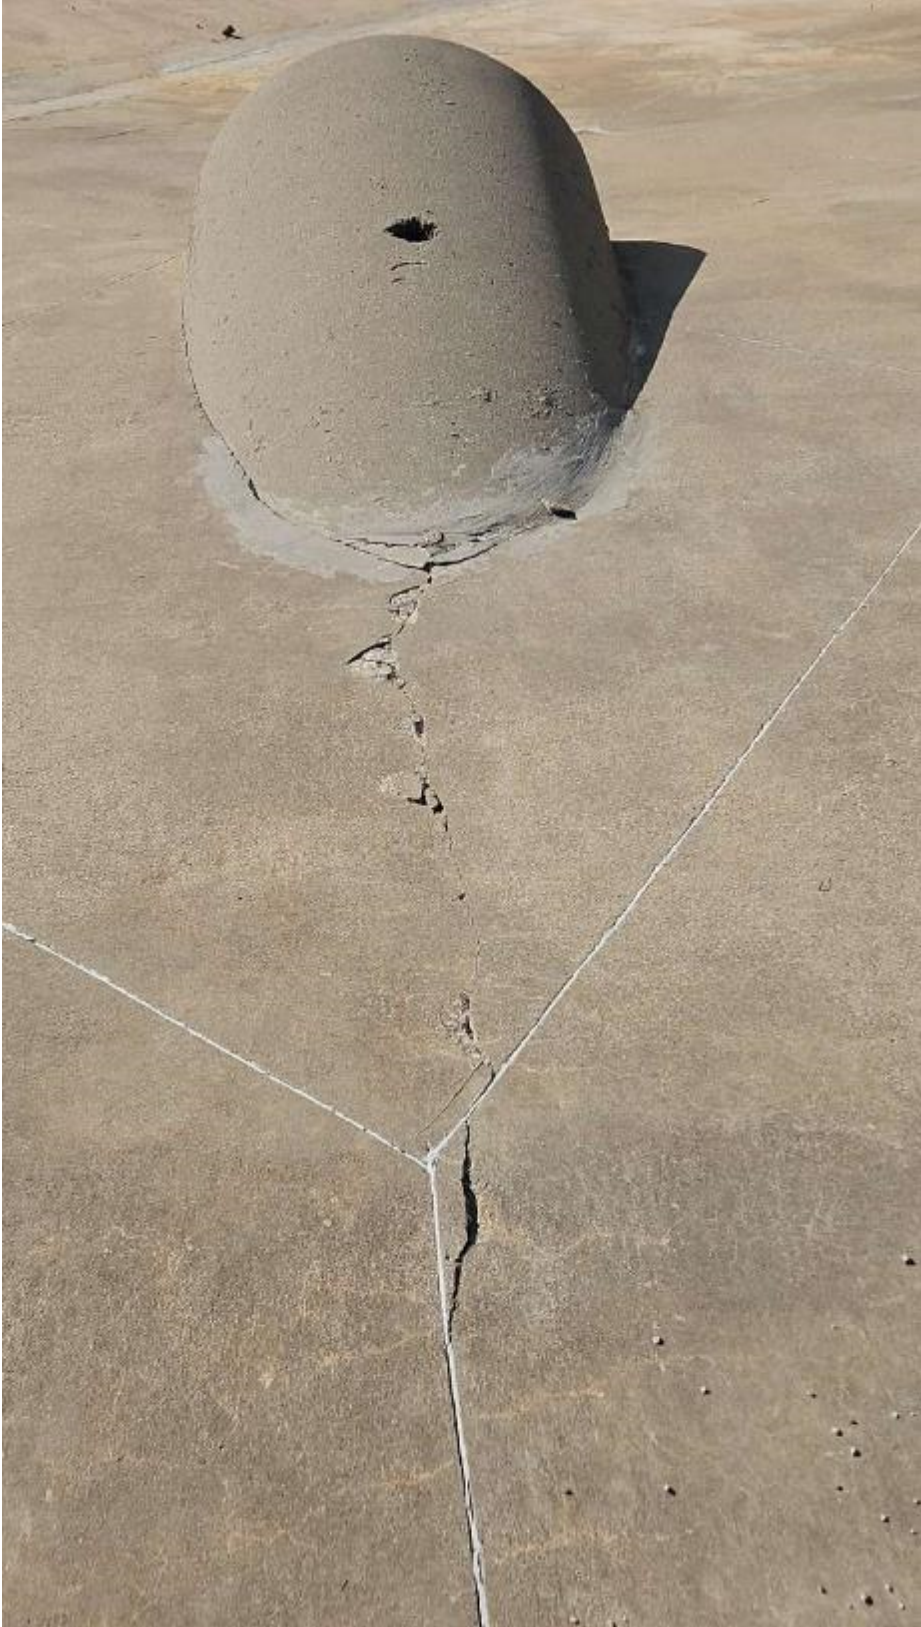
The leachate / contact water pond is generally in good condition as shown in Photograph No. 2 and No. 3. Some minor concrete cracking was observed as shown in Photograph No. 1 and No. 4 and should be sealed/addressed with polyurethane sealant like Sonolastic NP1 or equivalent.

PHOTOGRAPH NO: 1	DATE: November 7, 2024 1:50 PM	LATITUDE: 36.25797743	LONGITUDE: -94.51715092
DIRECTION: 273°		SITE LOCATION: GENTRY, ARKANSAS	
<b>DESCRIPTION:</b>  Leachate Pond. Inlet Pipe. Address concrete cracks, with polyurethane sealant such Sonolastic NP1.

- Item 1 – Address/seal the concrete cracking with polyurethane sealant, such as Sonolastic NP1.

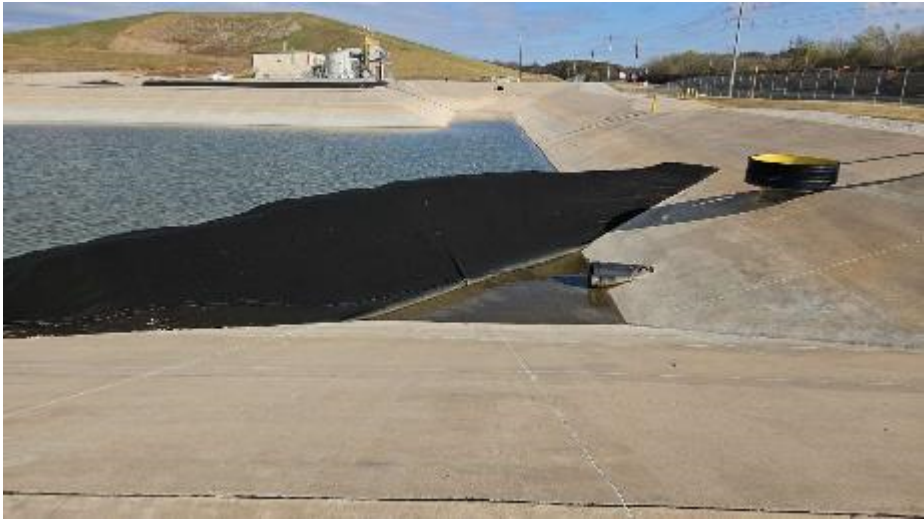
<b>PHOTOGRAPH NO: 2</b>	<b>DATE:</b> November 7, 2024 1:56 PM	<b>LATITUDE:</b> 36.25752052	<b>LONGITUDE:</b> -94.51788854
<b>DIRECTION:</b> 356°		<b>SITE LOCATION:</b> GENTRY, ARKANSAS	
<b>DESCRIPTION:</b>  Contact Water Pond. General Photo, Typical Conditions.

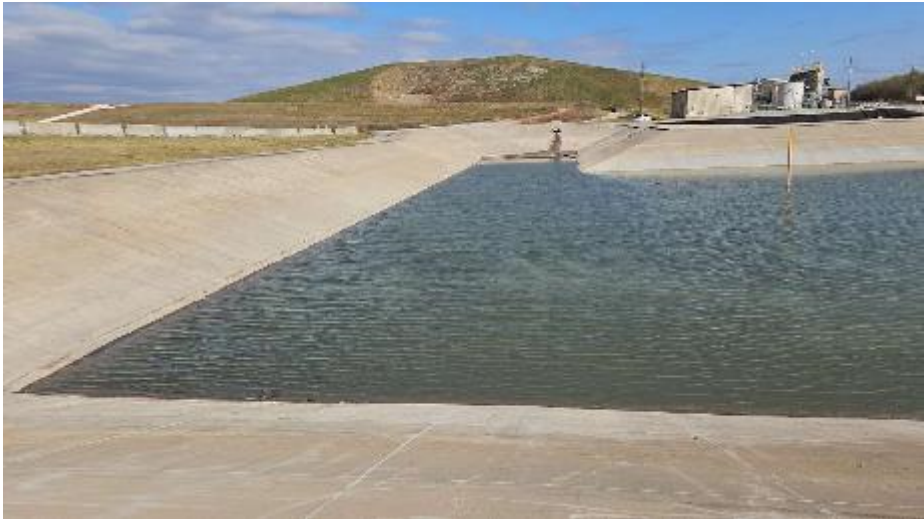
<b>PHOTO BY:</b>  GEI CONSULTANTS, INC.			
<b>PHOTOGRAPH NO: 3</b>	<b>DATE:</b> November 7, 2024 1:59 PM	<b>LATITUDE:</b> 36.25806131	<b>LONGITUDE:</b> -94.5178897
<b>DIRECTION:</b> 349°		<b>SITE LOCATION:</b> GENTRY, ARKANSAS	
<b>DESCRIPTION:</b>  Contact Water Pond. General Photo, Typical Conditions.

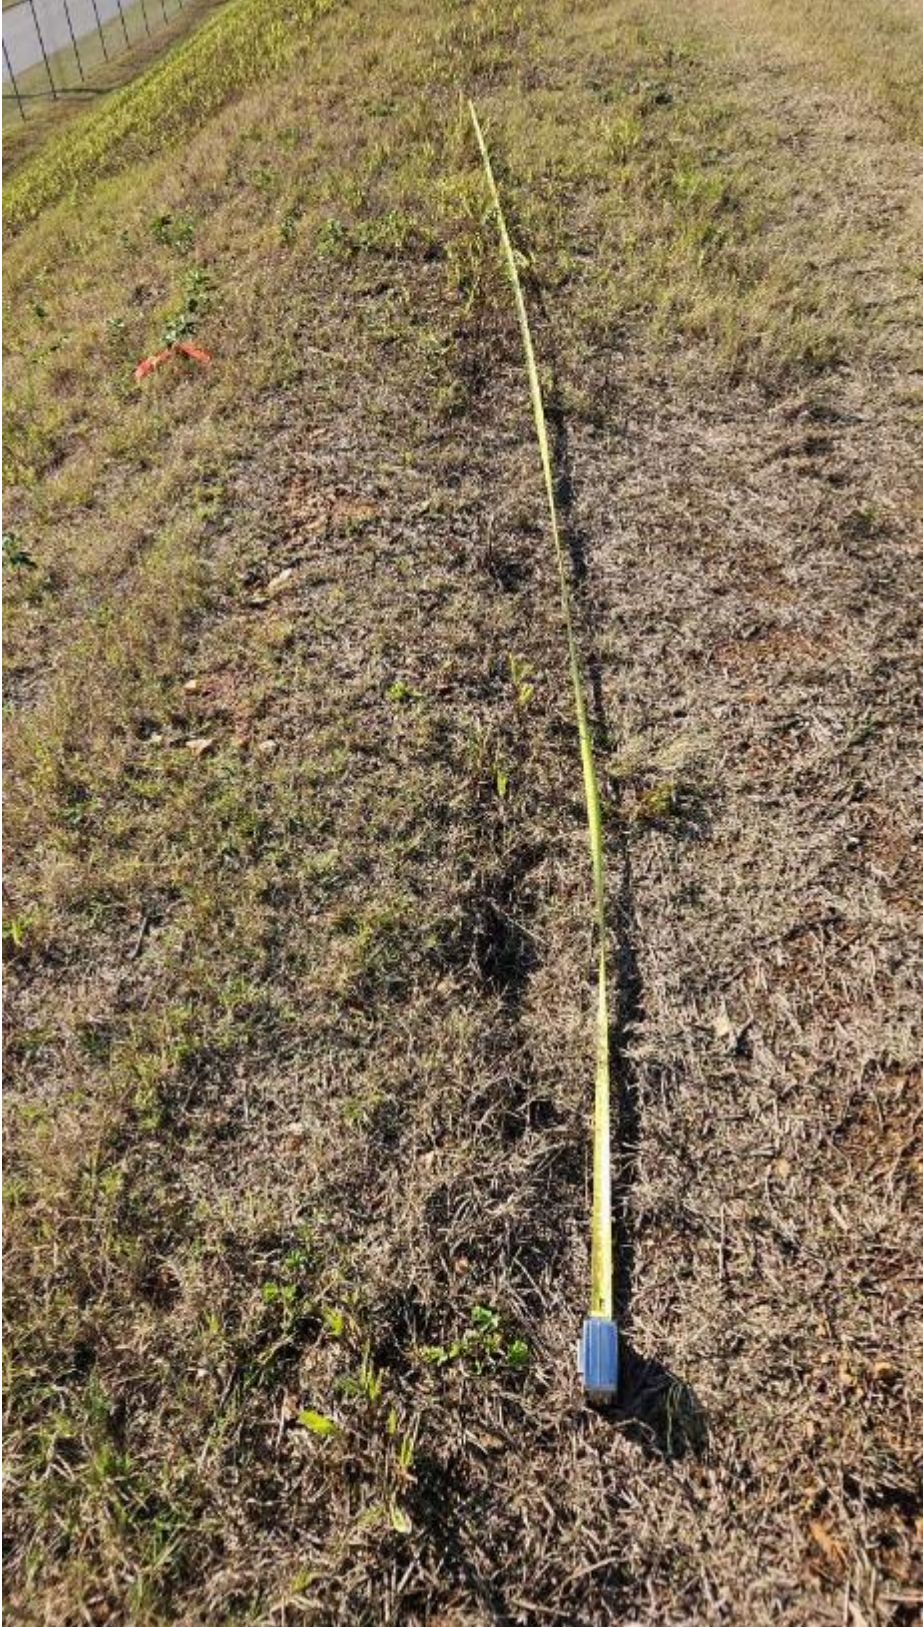
The landfill is functioning as intended. One potential lateral crack was observed on the southern slope and should be monitored for additional movement as shown in Photograph No. 7. No other conditions were observed that may be disrupting to the safe operation of the landfill.

PHOTOGRAPH NO: 7	DATE: November 7, 2024 2:12 PM	LATITUDE: 36.25733493	LONGITUDE: -94.51373109
DIRECTION: 273°		SITE LOCATION: GENTRY, ARKANSAS	
<b>DESCRIPTION:</b>  Landfill Downstream Slope. Potential lateral crack, approx 25 ft long, along the edge of the berm, approximately 75 ft east of B5. Stable at the time of the inspection. Monitor Conditions.

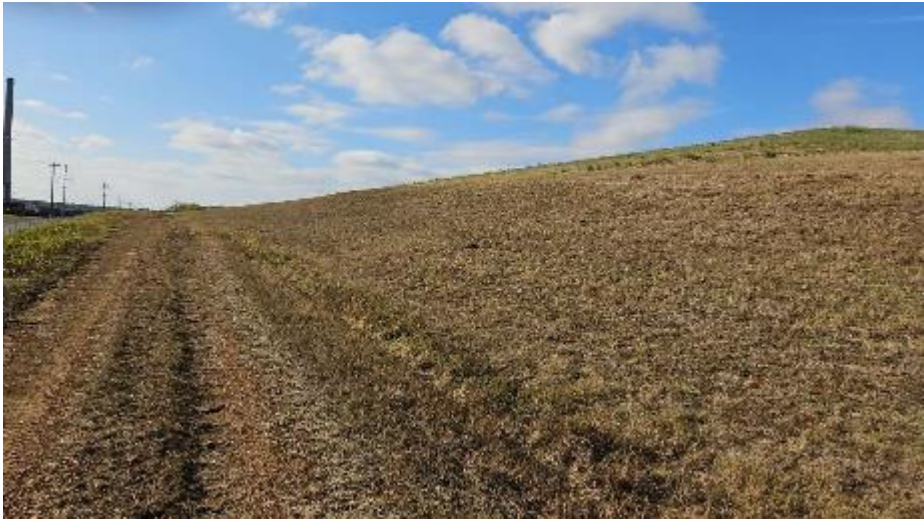
<b>PHOTOGRAPH NO: 8</b>	<b>DATE:</b> November 7, 2024 2:18 PM	<b>LATITUDE:</b> 36.2573239	<b>LONGITUDE:</b> -94.513038
<b>DIRECTION:</b> 209°		<b>SITE LOCATION:</b> GENTRY, ARKANSAS	
<b>DESCRIPTION:</b>  Landfill Downstream Slope. General Photo, Typical Conditions.

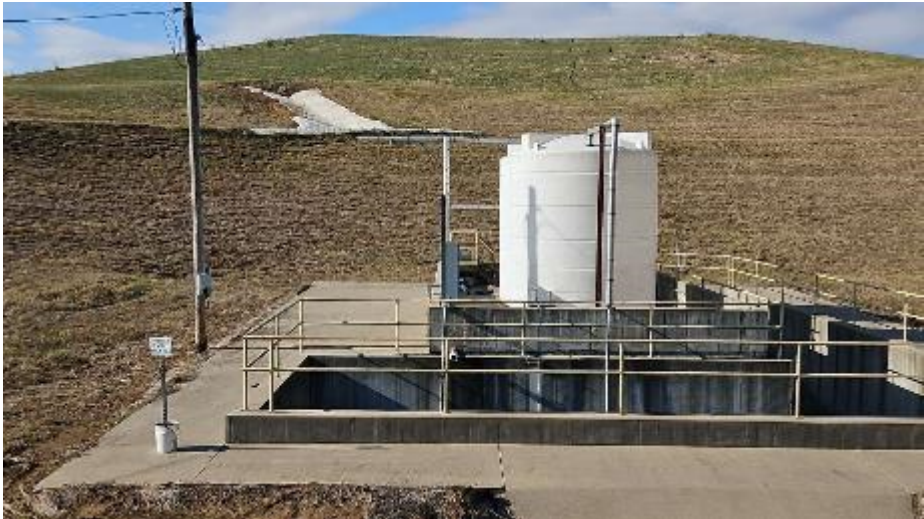
<b>PHOTO BY:</b>  GEI CONSULTANTS, INC.			
<b>PHOTOGRAPH NO: 9</b>	<b>DATE:</b> November 7, 2024 2:20 PM	<b>LATITUDE:</b> 36.25743271	<b>LONGITUDE:</b> -94.51230031
<b>DIRECTION:</b> 219°		<b>SITE LOCATION:</b> GENTRY, ARKANSAS	
<b>DESCRIPTION:</b>  Landfill Downstream Slope / Drainage Feature. General Photo, Typical Conditions.

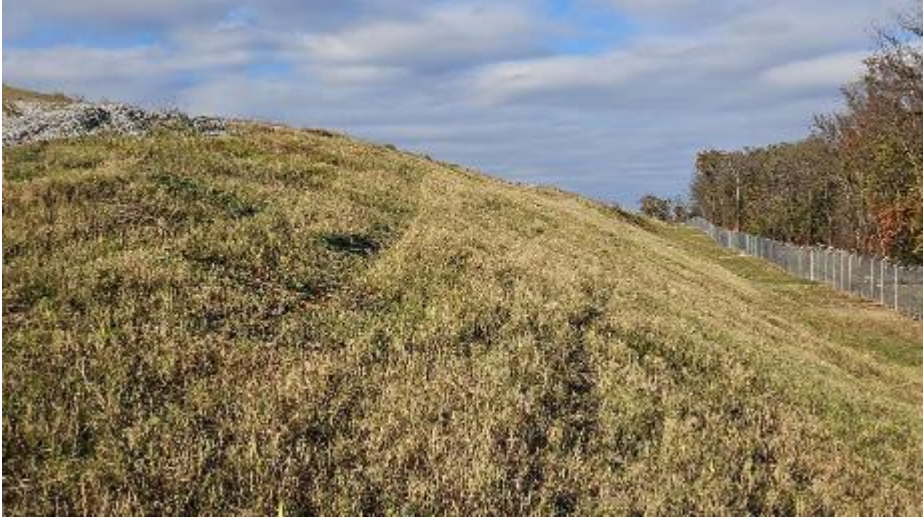
<b>PHOTOGRAPH No: 10</b>	<b>DATE:</b> November 7, 2024 2:26 PM	<b>LATITUDE:</b> 36.25779879	<b>LONGITUDE:</b> -94.51211408
<b>DIRECTION:</b> 262°	<b>SITE LOCATION:</b> GENTRY, ARKANSAS		
<b>DESCRIPTION:</b>  Landfill Interim Cover. General Photo, Typical Conditions.

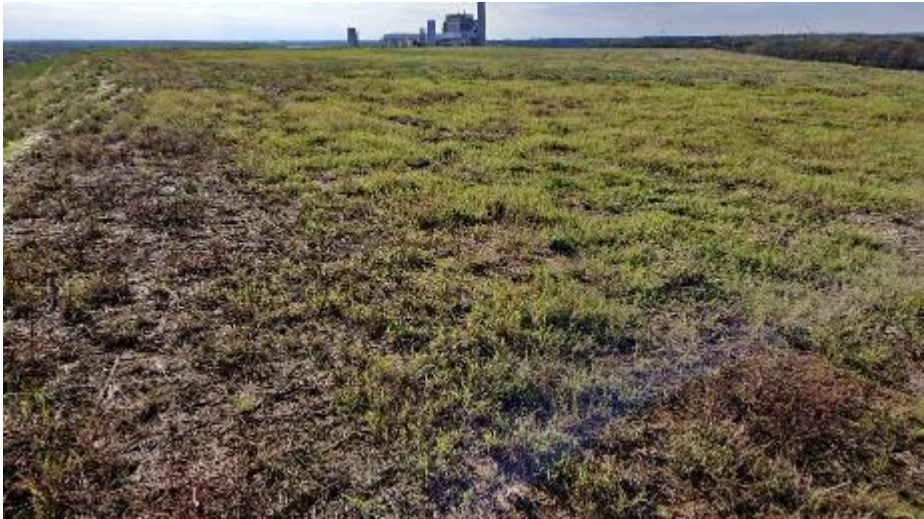
<b>PHOTOGRAPH No: 12</b>	<b>DATE:</b> November 7, 2024 2:37 PM	<b>LATITUDE:</b> 36.25865816	<b>LONGITUDE:</b> -94.51332411
<b>DIRECTION:</b> 161°	<b>SITE LOCATION:</b> GENTRY, ARKANSAS		
<b>DESCRIPTION:</b>  Landfill Crest. Interim Cover. General Photo, Typical Conditions.

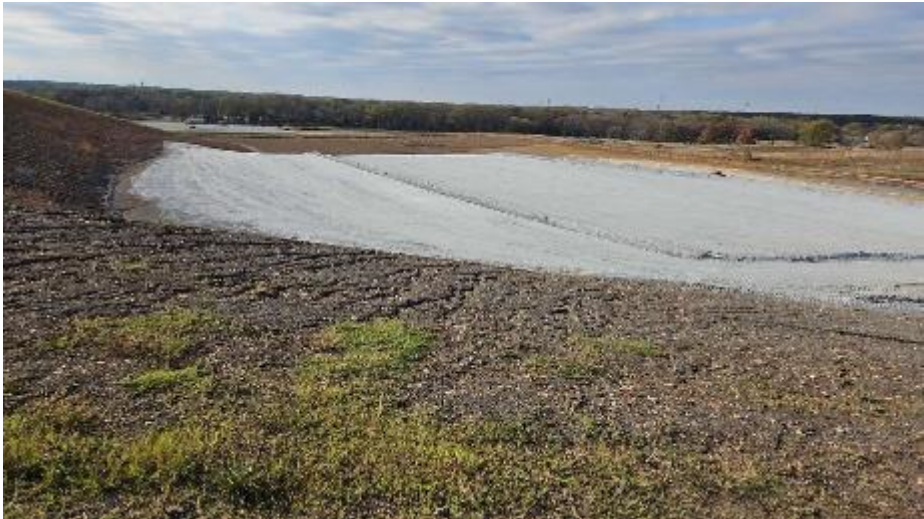
<b>PHOTO BY:</b>  GEI CONSULTANTS, INC.			
<b>PHOTOGRAPH No: 13</b>	<b>DATE:</b> November 7, 2024 2:40 PM	<b>LATITUDE:</b> 36.25912305	<b>LONGITUDE:</b> -94.51315677
<b>DIRECTION:</b> 200°	<b>SITE LOCATION:</b> GENTRY, ARKANSAS		
<b>DESCRIPTION:</b>  Landfill Active Area. General Photo, Typical Conditions.

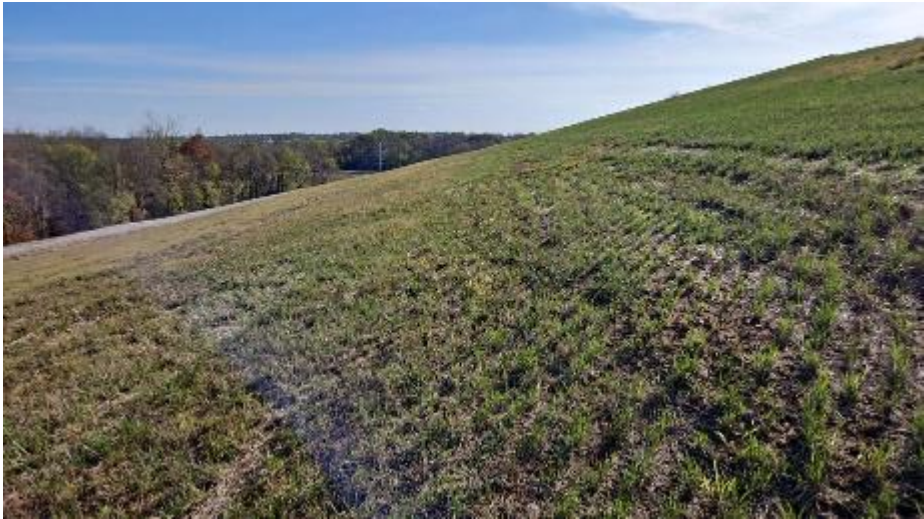
<b>PHOTOGRAPH No: 14</b>	<b>DATE:</b> November 7, 2024 2:44 PM	<b>LATITUDE:</b> 36.25948009	<b>LONGITUDE:</b> -94.51268775
<b>DIRECTION:</b> 87°		<b>SITE LOCATION:</b> GENTRY, ARKANSAS	
<b>DESCRIPTION:</b>  Landfill Downstream Slope. General Photo, Typical Conditions.

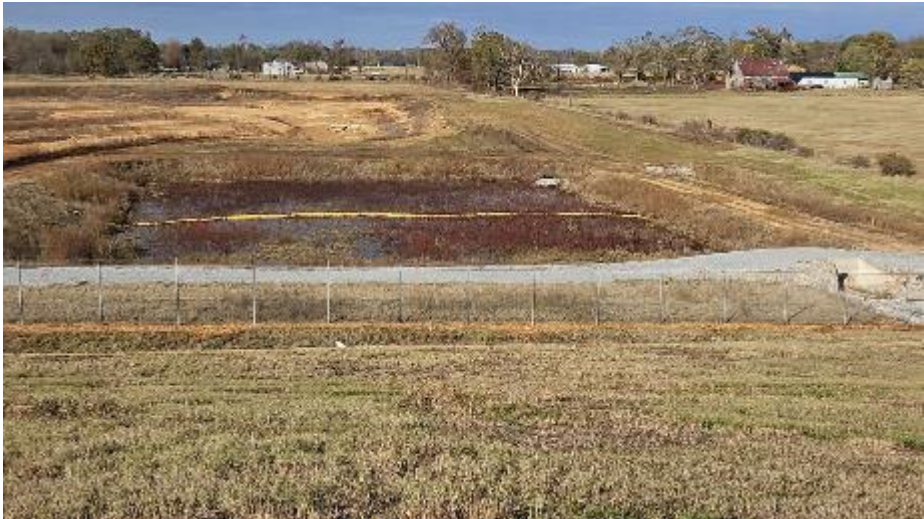
<b>PHOTO BY:</b>  GEI CONSULTANTS, INC.			
<b>PHOTOGRAPH No: 15</b>	<b>DATE:</b> November 7, 2024 2:47 PM	<b>LATITUDE:</b> 36.26037419	<b>LONGITUDE:</b> -94.5126738
<b>DIRECTION:</b> 284°		<b>SITE LOCATION:</b> GENTRY, ARKANSAS	
<b>DESCRIPTION:</b>  Stormwater Pond. General Photo, Typical Conditions.

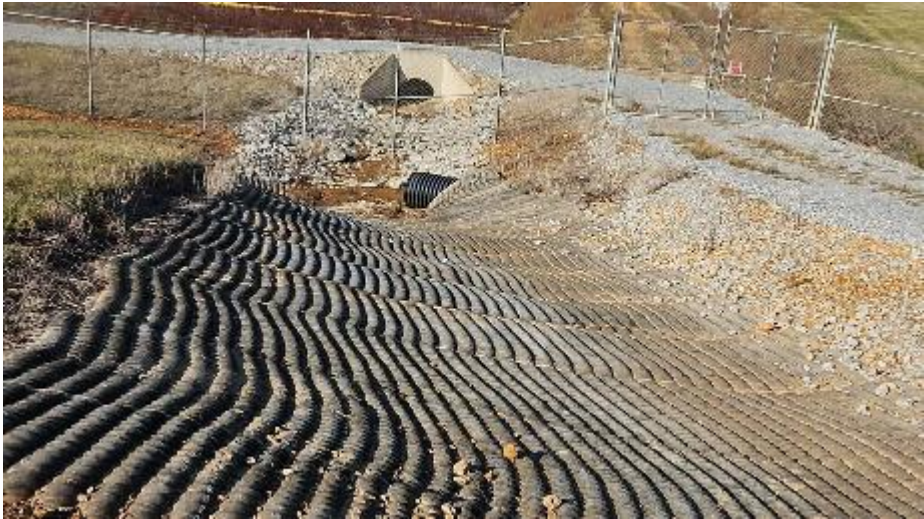
PHOTOGRAPH No: 16	DATE: November 7, 2024 2:49 PM	LATITUDE: 36.26055028	LONGITUDE: -94.51220734
DIRECTION: 267°	SITE LOCATION: GENTRY, ARKANSAS		
<b>DESCRIPTION:</b>  Stormwater Pond. Inlet Works / Stormwater Features, Letdown Channel. General Photo, Typical Conditions. No debris / blockages observed.

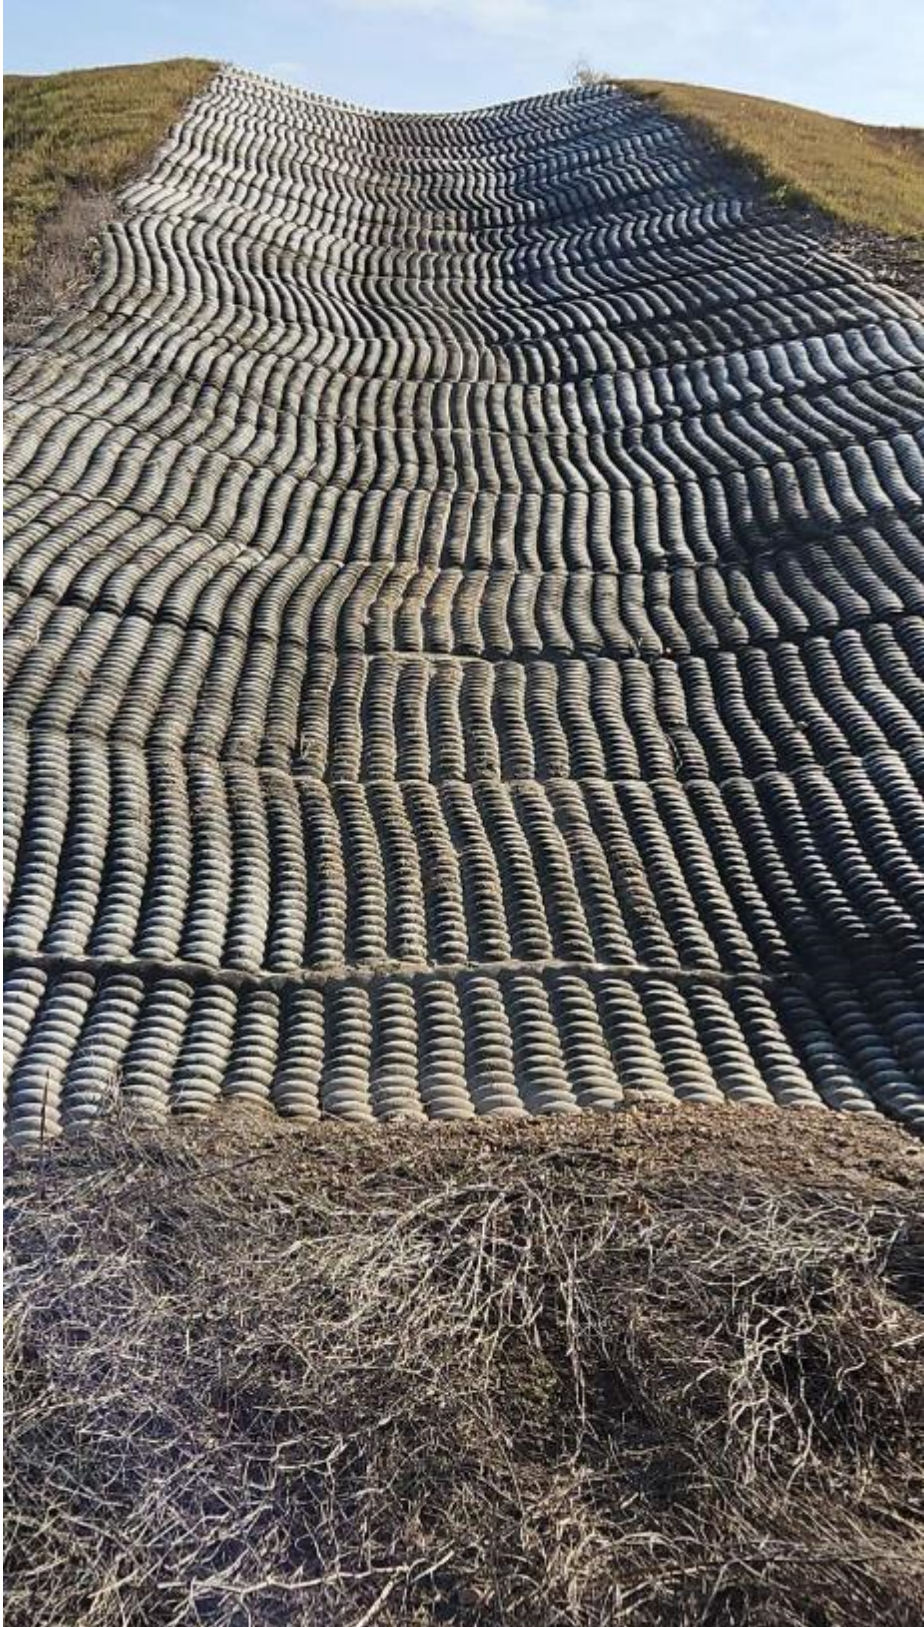
PHOTOGRAPH No: 17	DATE: November 7, 2024 2:55 PM	LATITUDE: 36.26076979	LONGITUDE: -94.51385411
DIRECTION: 179°		SITE LOCATION: GENTRY, ARKANSAS	
<b>DESCRIPTION:</b>  Landfill Downstream Slope / Drainage feature. Fabri-form Letdown Channel. General Photo, Typical Conditions.

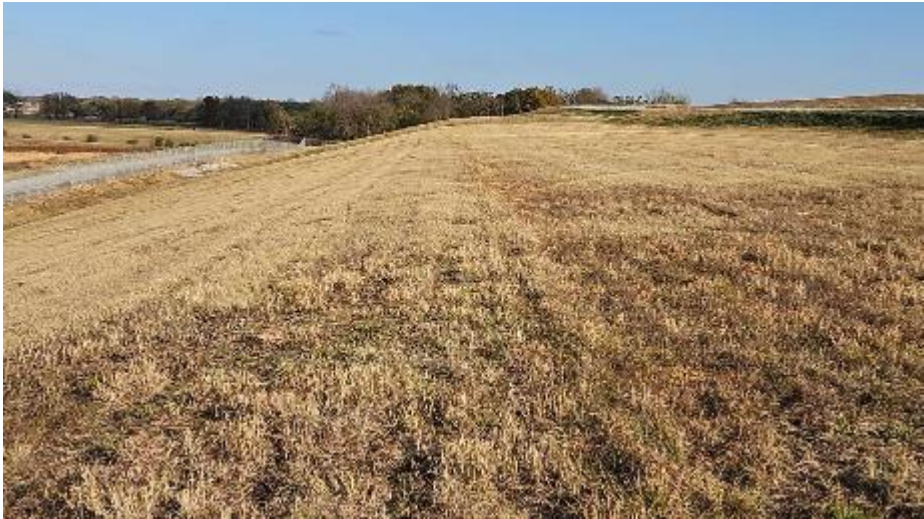
<b>PHOTOGRAPH No: 18</b>	<b>DATE:</b> November 7, 2024 3:04 PM	<b>LATITUDE:</b> 36.26049399	<b>LONGITUDE:</b> -94.51555491
<b>DIRECTION:</b> 2°		<b>SITE LOCATION:</b> GENTRY, ARKANSAS	
<b>DESCRIPTION:</b>  Landfill Downstream Slope. General Photo, Typical Conditions.

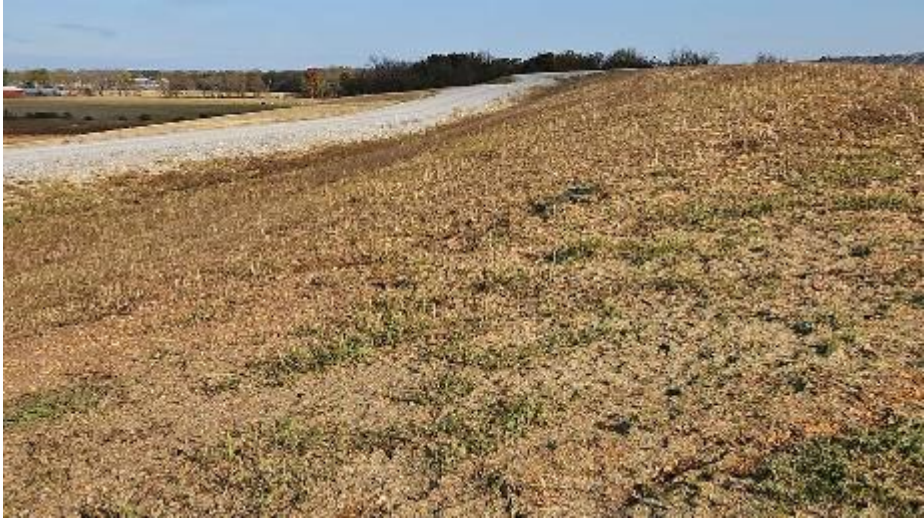
<b>PHOTO BY:</b>  GEI CONSULTANTS, INC.			
<b>PHOTOGRAPH No: 19</b>	<b>DATE:</b> November 7, 2024 3:07 PM	<b>LATITUDE:</b> 36.26012417	<b>LONGITUDE:</b> -94.51577145
<b>DIRECTION:</b> 356°		<b>SITE LOCATION:</b> GENTRY, ARKANSAS	
<b>DESCRIPTION:</b>  Landfill Downstream Slope. General Photo, Typical Conditions.

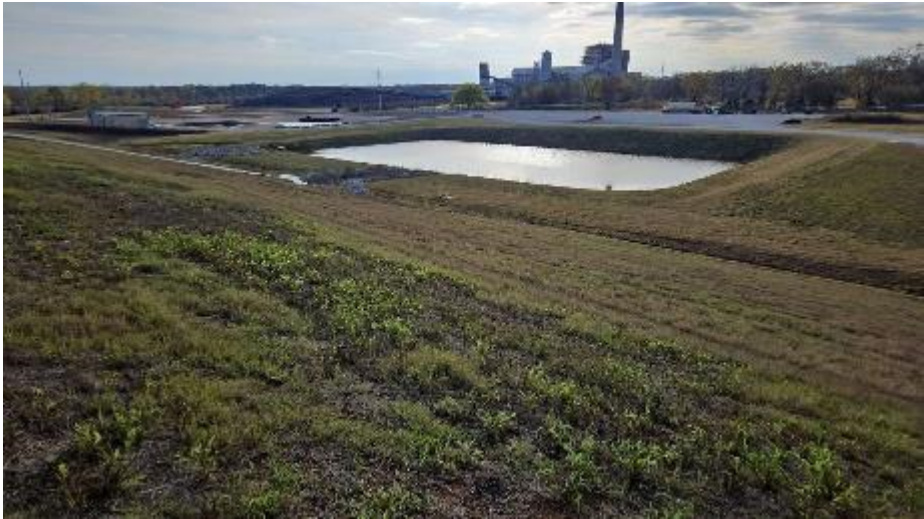
<b>PHOTOGRAPH No: 20</b>	<b>DATE:</b> November 7, 2024 3:09 PM	<b>LATITUDE:</b> 36.26011998	<b>LONGITUDE:</b> -94.51577381
<b>DIRECTION:</b> 131°	<b>SITE LOCATION:</b> GENTRY, ARKANSAS		
<b>DESCRIPTION:</b>  Stormwater Pond. General Photo, Typical Conditions.

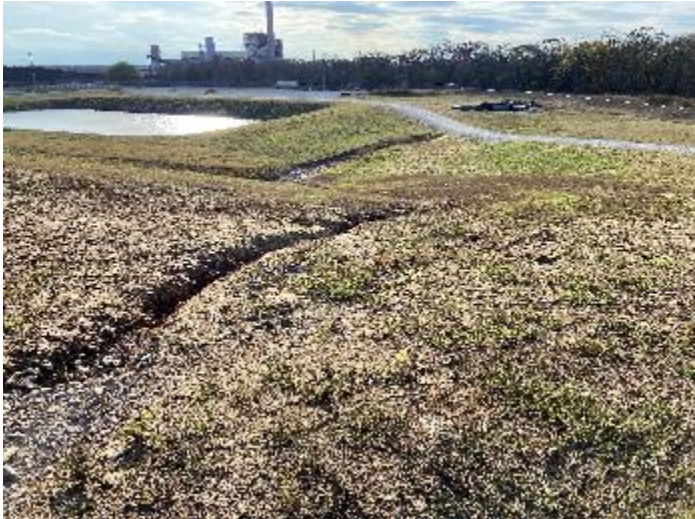
<b>PHOTO BY:</b>  GEI CONSULTANTS, INC.			
<b>PHOTOGRAPH No: 21</b>	<b>DATE:</b> November 7, 2024	<b>LATITUDE:</b> NA	<b>LONGITUDE:</b> NA
<b>DIRECTION:</b> NA	<b>SITE LOCATION:</b> GENTRY, ARKANSAS		
<b>DESCRIPTION:</b>  Landfill Downstream Slope. Address minor erosion.

- Item 4 – Address/seal the concrete cracking with polyurethane sealant, such as Sonolastic NP1.
- Item 11 – Address the minor erosion rills before they become significant.
- Item 21 – Address the minor erosion rills before they become significant.
- Item 23 – Address the minor erosion rills before they become significant.
- Item 24 – Address the minor erosion rills before they become significant.

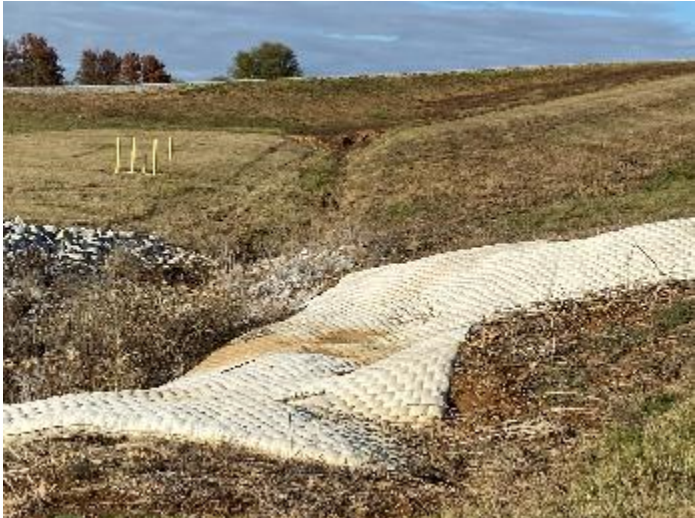
<b>PHOTOGRAPH No: 25</b>	<b>DATE:</b> November 7, 2024	<b>LATITUDE:</b> NA	<b>LONGITUDE:</b> NA
<b>DIRECTION:</b> NA	<b>SITE LOCATION:</b> GENTRY, ARKANSAS		
<b>DESCRIPTION:</b>  Landfill Stormwater Feature / Fabriform down chute. General Photo, Typical Conditions.
