Primary Bottom Ash Pond 2024 Annual Dam and Dike Inspection Report

Flint Creek Plant, Gentry, Arkansas

December 12, 2024
Project 2305686
AEP Document ID: GEVR-24-040

Primary Bottom Ash Pond Flint Creek Power Plant AEP Document ID: GEVR-24-040

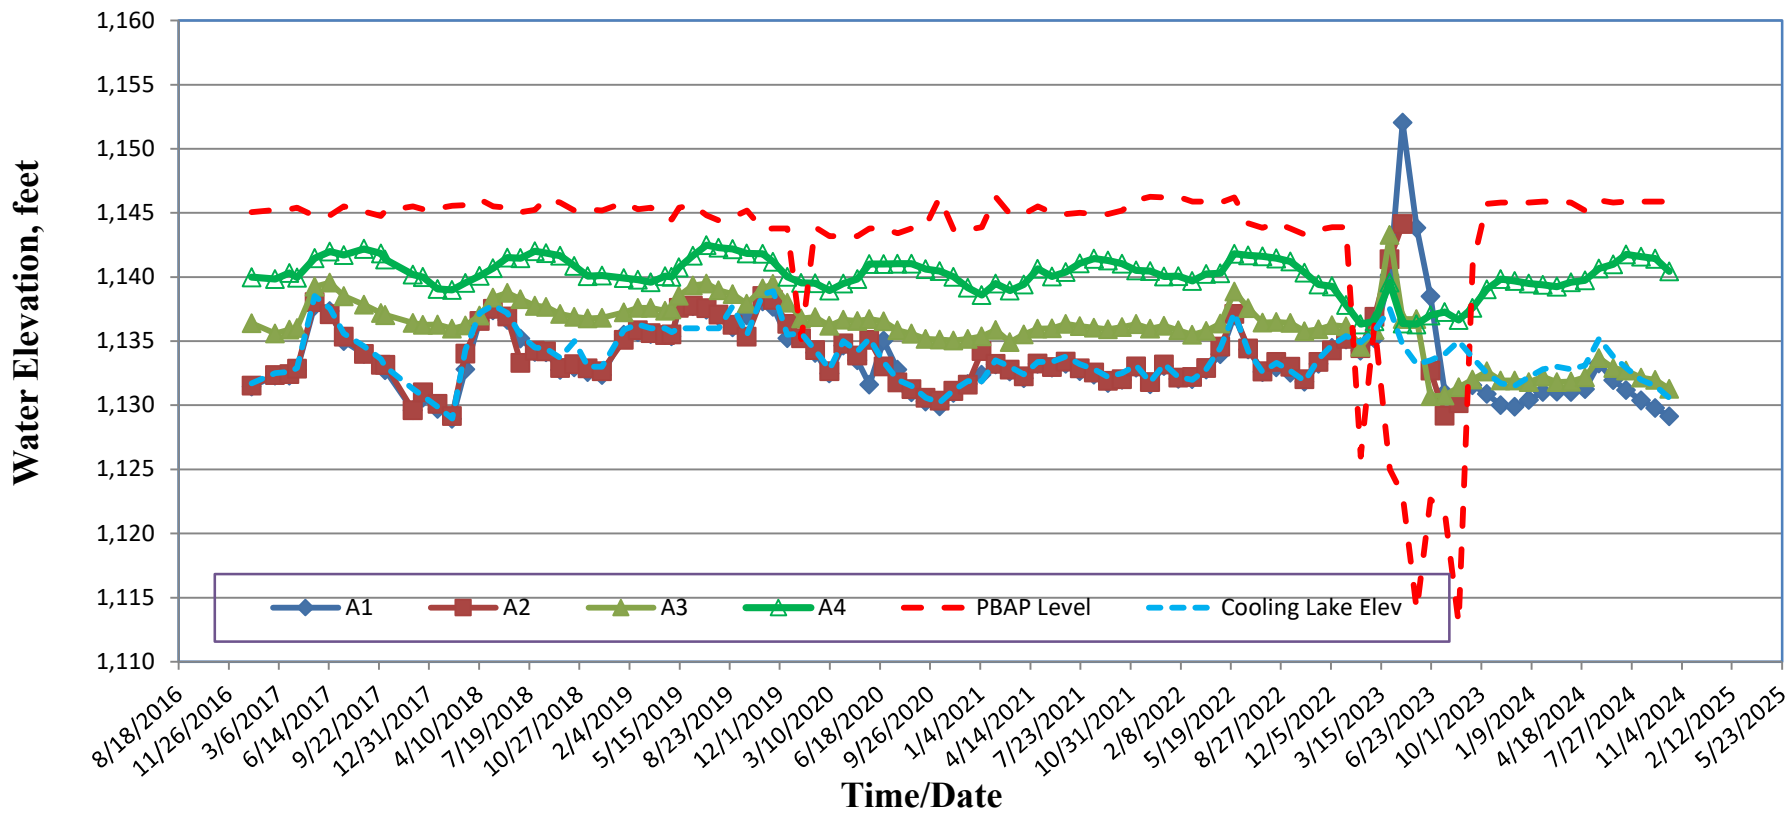
Flint Creek PBAP Piezometer Data

There are four piezometers located along the crest of the dam as shown on Figure 3 – Site Plan. A review of readings since the last inspection and historical readings indicate the levels are consistent and respond to the fluctuation of the cooling lake level. The piezometers are more influenced by the level of the cooling lake than the elevation of the Primary Bottom Ash Pond. A spike was noticed in Piezometers A1-A3 in April 2023 and A4 in August 2023. Piezometers A1-A3 were damaged by construction equipment and were replaced in June 2023. Typically, the trend in the historical data between the piezometer reading, lake level, and pond levels are consistent. The maximum piezometer readings for the last two annual inspections are provided below in Table 1. The instrumentation data of the piezometer readings over the past several years is provided in Appendix A – Instrumentation Data.

Notes: The readings in 2024 are generally consistent with the readings in 2022 when the Primary Bottom Ash Pond was operating at normal conditions. See Appendix A for graph of Piezometer Data.

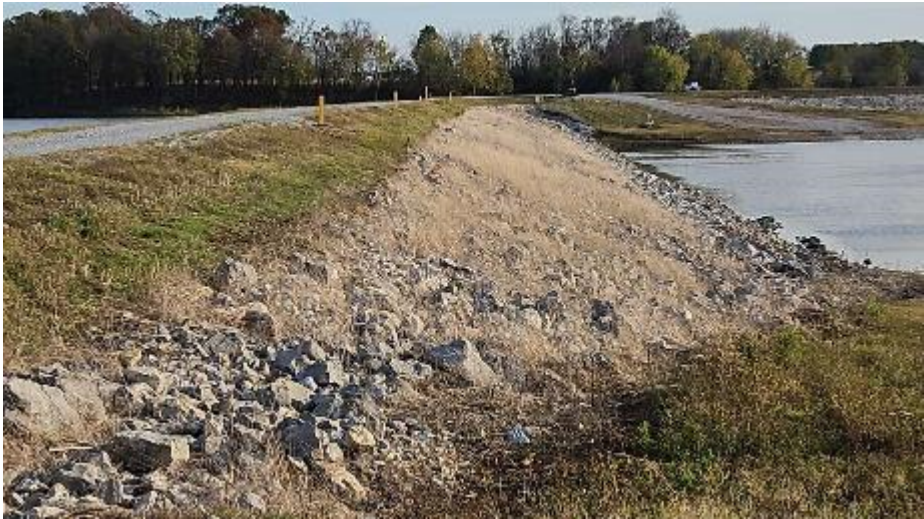
The downstream slope of the dam is in good condition. The riprap is compact and the vegetation is being maintained to 12-inches or less as shown in Photographs No. 1, No. 3, and No. 4.

PHOTOGRAPH NO: 1	DATE: November 7, 2024 3:41 PM	LATITUDE: 36.25748981	LONGITUDE: -94.52105441
DIRECTION: 77°		SITE LOCATION: GENTRY, ARKANSAS	
DESCRIPTION: Primary Bottom Ash Pond Downstream Slope of Dam. Ground Cover, Typical Conditions.

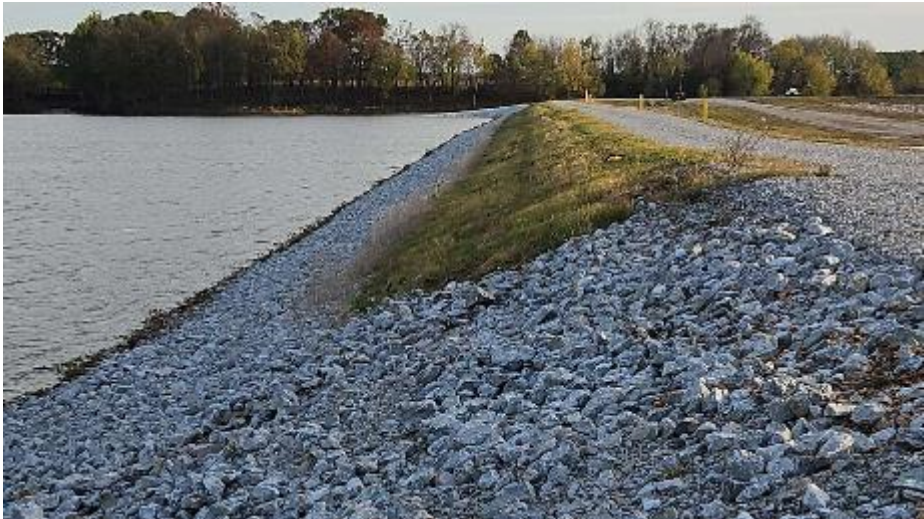
The upstream slope of the dam is in good condition. The riprap is compact and the vegetation is being maintained to 12-inches or less as shown in Photographs No. 2, No. 5, and No. 10.

PHOTO BY: GEI CONSULTANTS, INC.			
PHOTOGRAPH NO: 2	DATE: November 7, 2024 3:49 PM	LATITUDE: 36.25337997	LONGITUDE: -94.52473016
DIRECTION: 64°		SITE LOCATION: GENTRY, ARKANSAS	
DESCRIPTION: Primary Bottom Ash Pond. Upstream Slope of Dam. General Photo, Typical Conditions. Appr. water level 1145.9 ft msl.

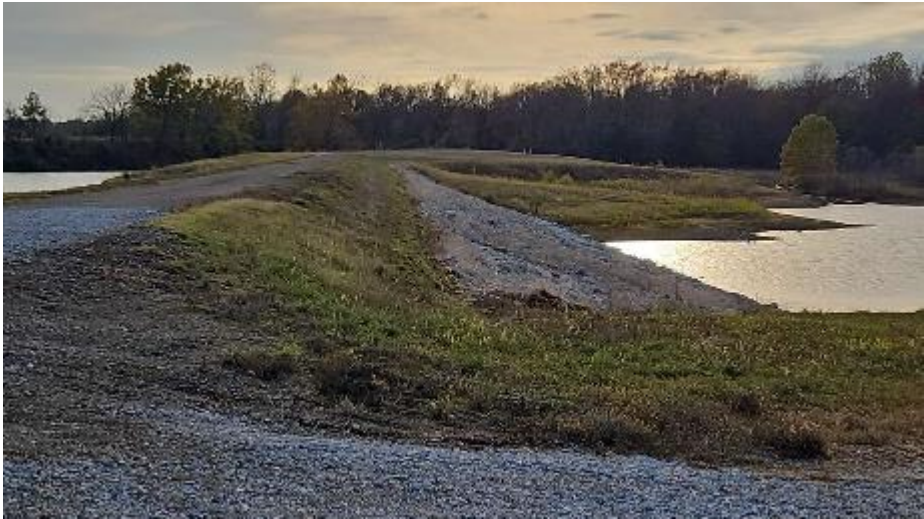
PHOTOGRAPH NO: 3	DATE: November 7, 2024 3:55 PM	LATITUDE: 36.25083427	LONGITUDE: -94.52396495
DIRECTION: 139°		SITE LOCATION: GENTRY, ARKANSAS	
DESCRIPTION: Clearwater Pond. Downstream Slope of Dam. General Photo, Typical Conditions.

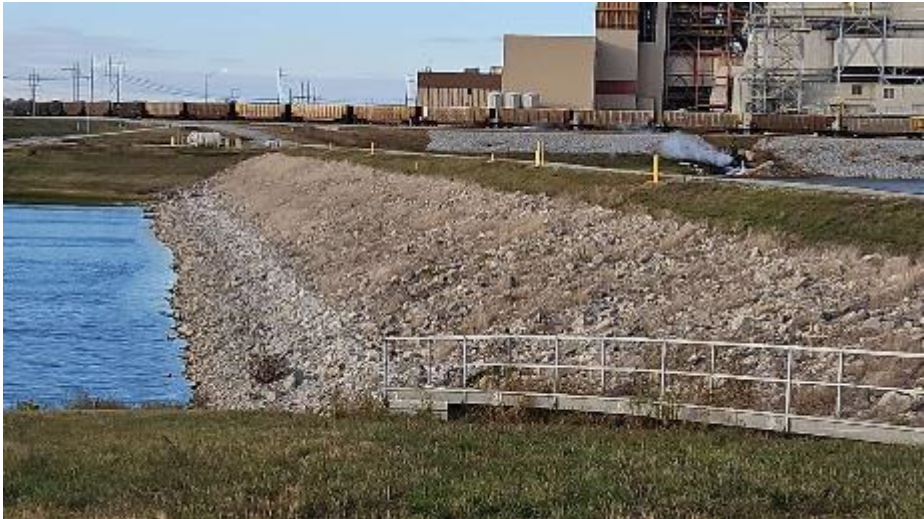
PHOTO BY: GEI CONSULTANTS, INC.			
PHOTOGRAPH NO: 4	DATE: November 7, 2024 3:57 PM	LATITUDE: 36.25082681	LONGITUDE: -94.52395919
DIRECTION: 262°		SITE LOCATION: GENTRY, ARKANSAS	
DESCRIPTION: Primary Bottom Ash Pond. Downstream Slope of Dam. General Photo, Typical Conditions.

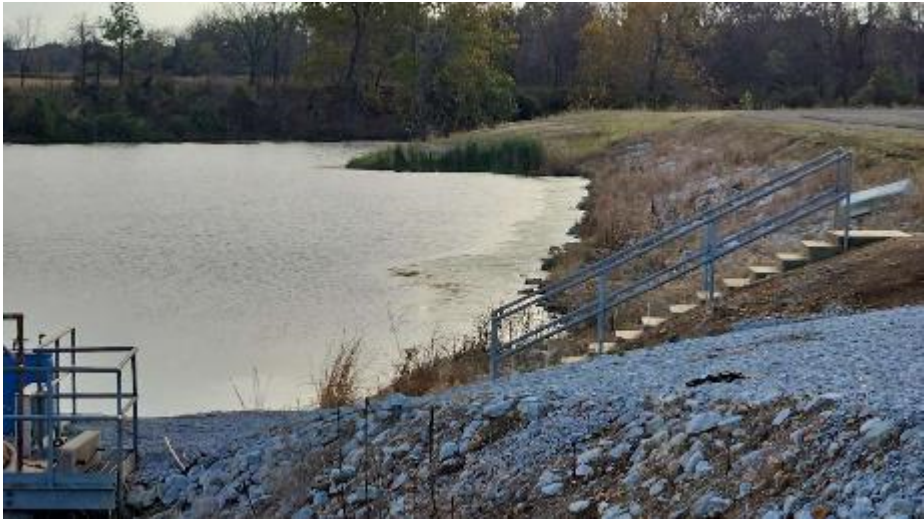
PHOTOGRAPH NO: 5	DATE: November 7, 2024 3:58 PM	LATITUDE: 36.25072779	LONGITUDE: -94.52379574
DIRECTION: 131°		SITE LOCATION: GENTRY, ARKANSAS	
DESCRIPTION: Clearwater Pond. Upstream Slope of Dam. General Photo, Typical Conditions.

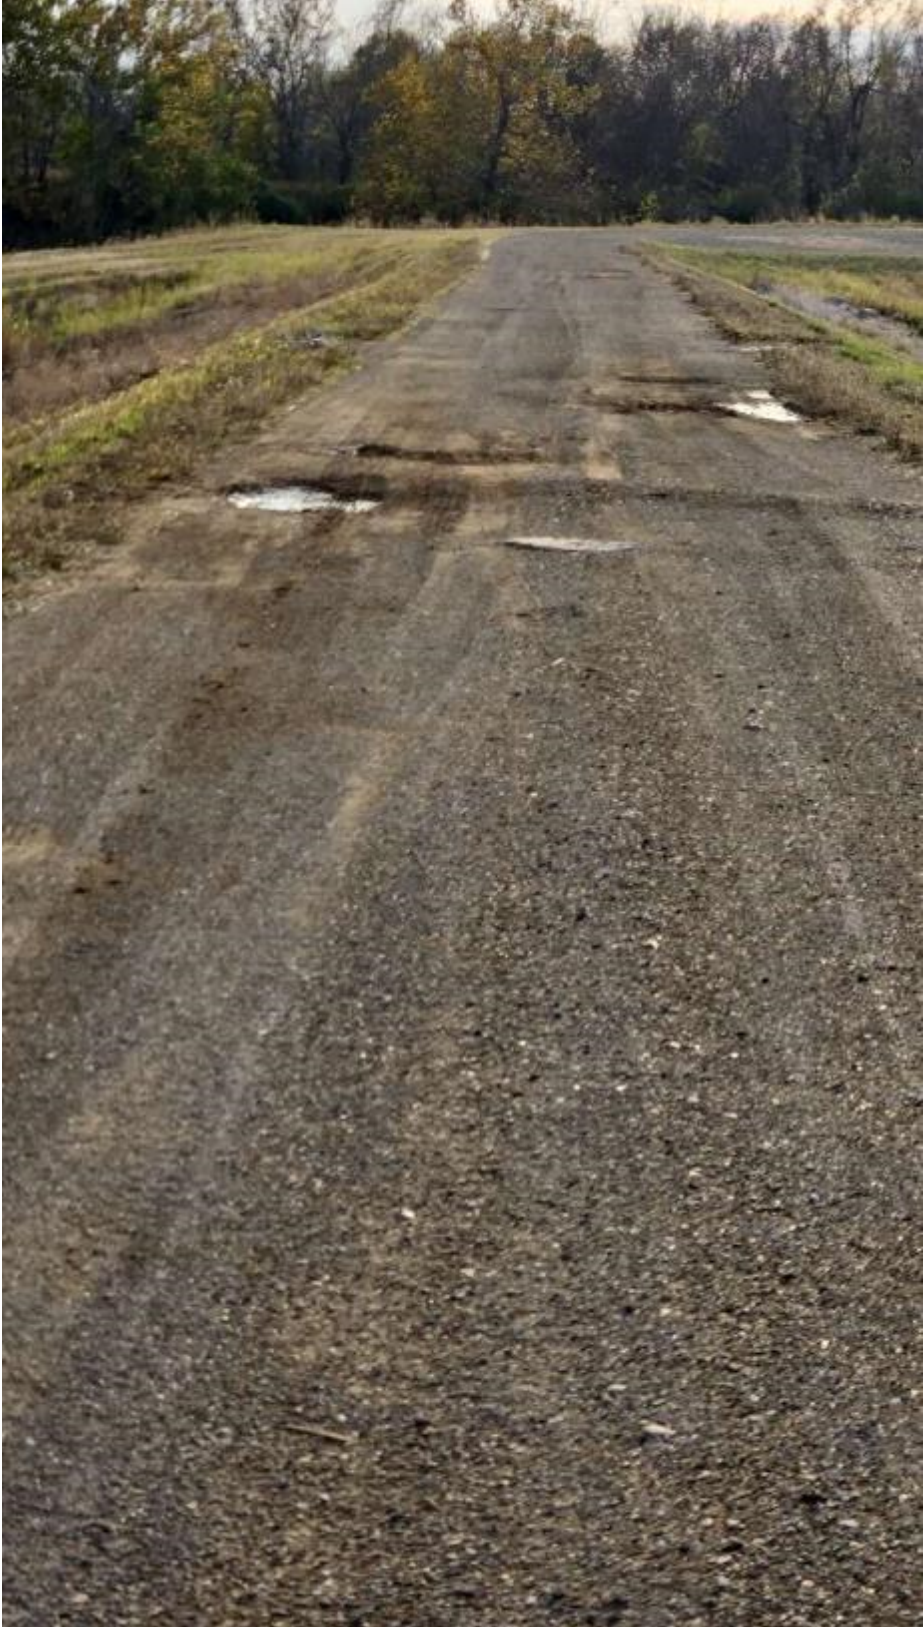
The crests for the Primary Bottom Ash Pond and the adjacent Clearwater Pond were generally in good condition, but minor rutting and potholes were observed in an isolated area on the Clearwater Pond Crest and should be addressed as shown in Photograph No. 7.

PHOTOGRAPH NO: 7	DATE: November 7, 2024 4:03 PM	LATITUDE: 36.25026084	LONGITUDE: -94.52465175
DIRECTION: 216°		SITE LOCATION: GENTRY, ARKANSAS	
DESCRIPTION: Clearwater Pond Crest. Address road surface

- Item No. 7 – Address the pavement rutting/potholes on the Clearwater Pond Crest.

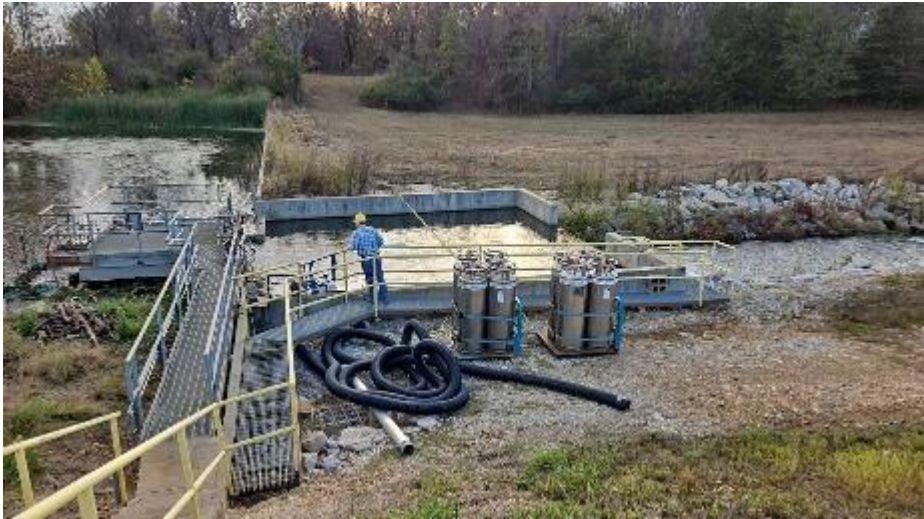
The spillway structures for the Primary Bottom Ash Pond and the adjacent Clearwater Pond are in good condition. No debris or blockages were observed that could restrict design flows as shown in Photographs No. 6 (Primary Bottom Ash Pond) and No. 8 (Clearwater Pond).

PHOTOGRAPH NO: 8	DATE: November 7, 2024 4:06 PM	LATITUDE: 36.2494558	LONGITUDE: -94.52619861
DIRECTION: 138°		SITE LOCATION: GENTRY, ARKANSAS	
DESCRIPTION: Clearwater Pond Spillway. General Photo, Typical Conditions. Approximate water elevation 1143.1 ft msl.

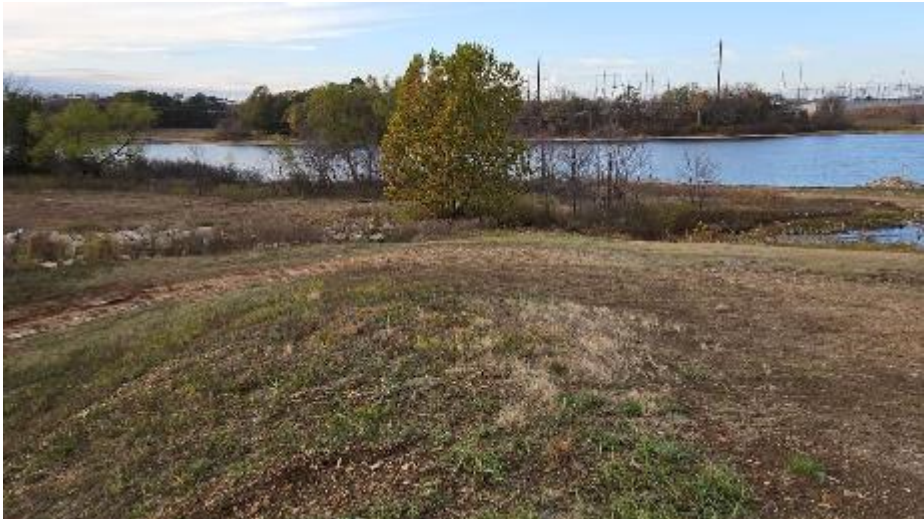
The Clearwater Pond tail race channel was in good condition. The vegetation was maintained to 12-inches or less and no debris or blockages were observed that could restrict design flows as shown in Photograph No. 9.

PHOTO BY: GEI CONSULTANTS, INC.			
PHOTOGRAPH NO: 9	DATE: November 7, 2024 4:12 PM	LATITUDE: 36.24946108	LONGITUDE: -94.52621235
DIRECTION: 237°		SITE LOCATION: GENTRY, ARKANSAS	
DESCRIPTION: Clearwater Pond Tail Race Channel. General Photo, Typical Conditions.

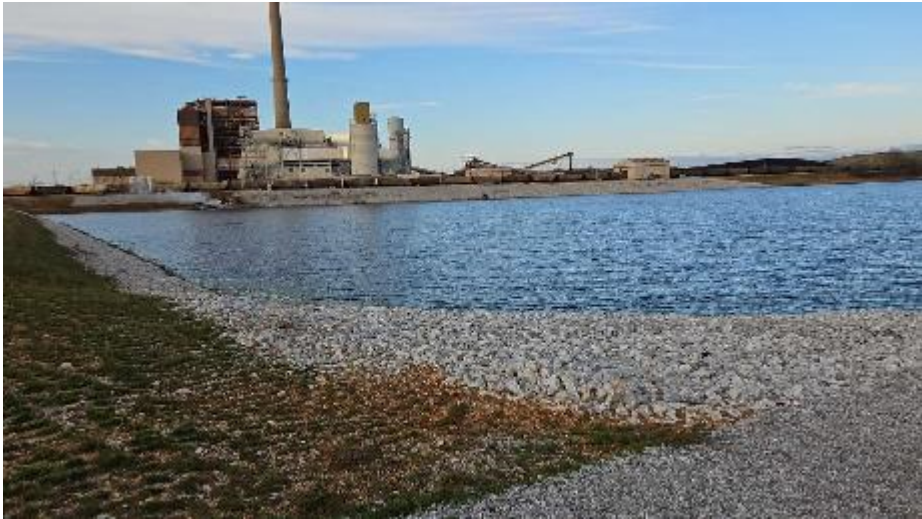
PHOTOGRAPH No: 10	DATE: November 7, 2024 4:18 PM	LATITUDE: 36.25084588	LONGITUDE: -94.52368697
DIRECTION: 283°	SITE LOCATION: GENTRY, ARKANSAS		
DESCRIPTION: Primary Bottom Ash Pond. Upstream Slope of Dam. General Photo, Typical Conditions.
