Bottom Ash Complex 2024 Annual Dam and Dike Inspection Report

Mitchell Plant, Marshall County, West Virginia

October 28, 2024

AEP Document ID: GEVR-24-030

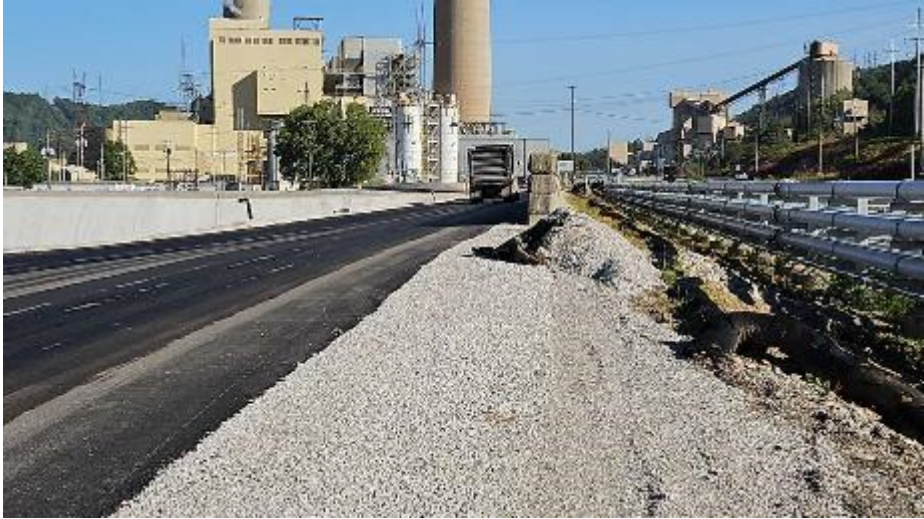
1. The East Bottom Ash Pond was in good condition. The upstream slope Fabriform lining was in good condition as shown in Photograph No. 1. The East Bottom Ash Pond East Crest was in good condition and recently paved with asphalt as shown in Photograph No. 2. The East Bottom Ash Pond downstream slope was also well vegetated on the south end as shown in Photograph No. 3.

PHOTO BY: GEI CONSULTANTS, INC.			
PHOTOGRAPH NO: 2	DATE: September 4, 2024 8:29 AM	LATITUDE: 39.82432968	LONGITUDE: -80.81412916
DIRECTION: 284°	SITE LOCATION: MARSHALL COUNTY, WEST VIRGINIA		
DESCRIPTION: East Bottom Ash Pond. Downstream Slope. Note Asphalt Surface on Crest of Eastern Dike.

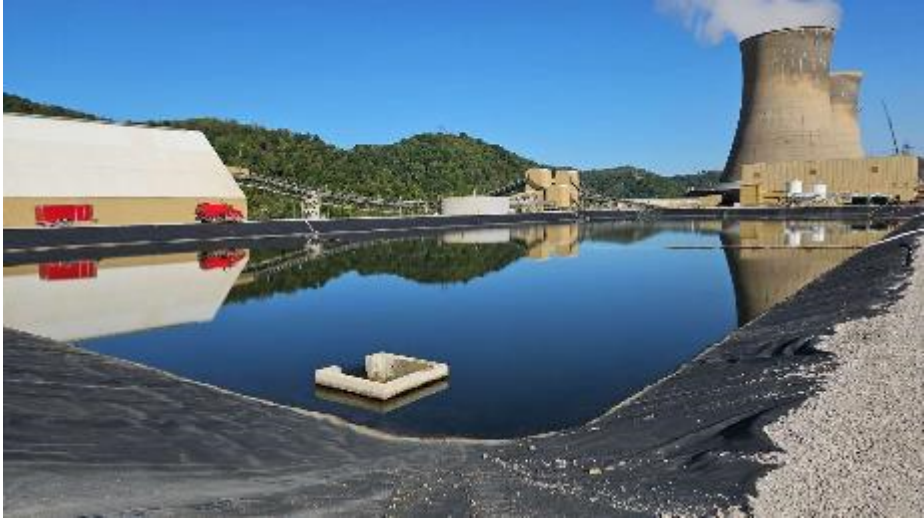
2. The West Bottom Ash Pond was in good condition. The upstream slope geomembrane lining was in good condition as shown in Photograph No. 4. The West Bottom Ash Pond Crest was paved with gravel and in good condition as shown in Photograph No. 5, No. 7, and No. 8. The West Bottom Ash Pond downstream slope was well vegetated but had some areas that should be maintained to 12-inches or less as shown in Photograph No. 5, No. 6, and No. 9. Two railroad ties were identified in the crest that should be removed and regraded as well.

PHOTO BY: GEI CONSULTANTS, INC.			
PHOTOGRAPH NO: 4	DATE: September 4, 2024 8:34 AM	LATITUDE: 39.8241844	LONGITUDE: -80.81510526
DIRECTION: 221°		SITE LOCATION: MARSHALL COUNTY, WEST VIRGINIA	
DESCRIPTION: West Bottom Ash Pond. Upstream Slope. Exposed Liner in good condition.

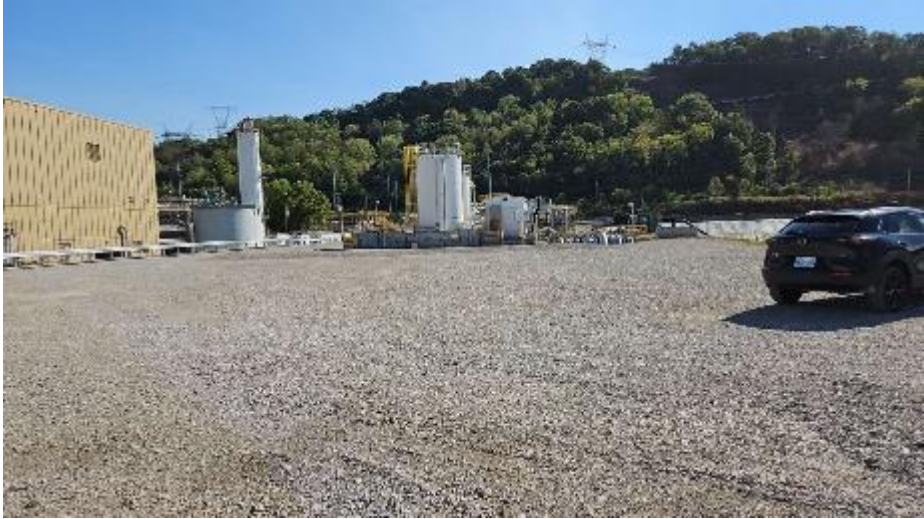
PHOTO BY: GEI CONSULTANTS, INC.			
PHOTOGRAPH NO: 8	DATE: September 4, 2024 8:59 AM	LATITUDE: 39.82565721	LONGITUDE: -80.81668722
DIRECTION: 354°	SITE LOCATION: MARSHALL COUNTY, WEST VIRGINIA		
DESCRIPTION: Crest of Northern Perimeter Dam. Typical Conditions.

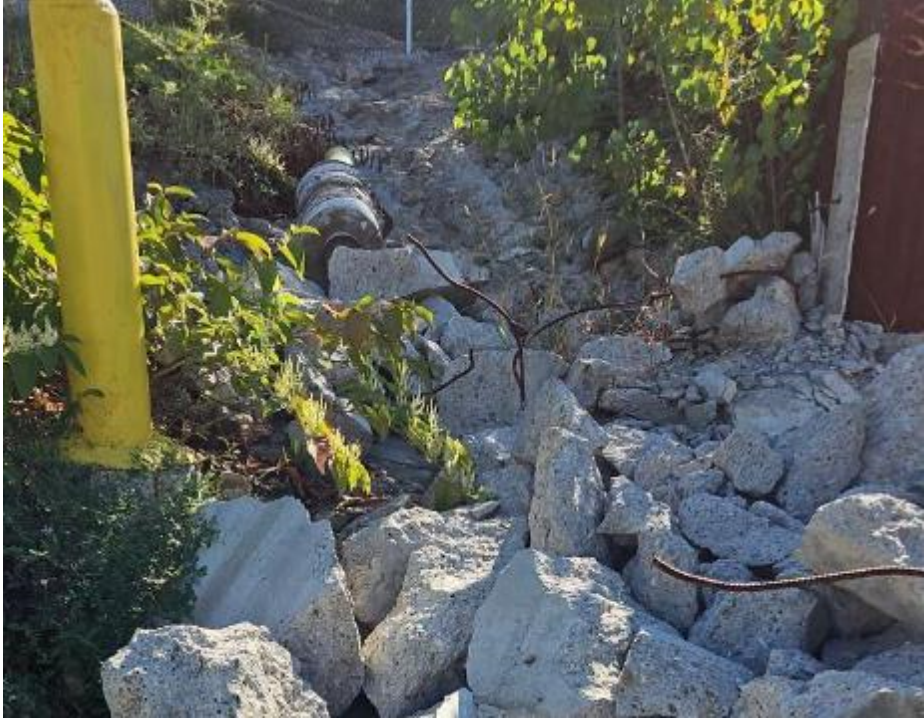
PHOTOGRAPH No: 11	DATE: September 4, 2024 9:21 AM	LATITUDE: 39.82364514	LONGITUDE: -80.81427256
DIRECTION: 113°	SITE LOCATION: MARSHALL COUNTY, WEST VIRGINIA		
DESCRIPTION: Clear Water Pond. Upstream slope. Stabilized area of erosion.

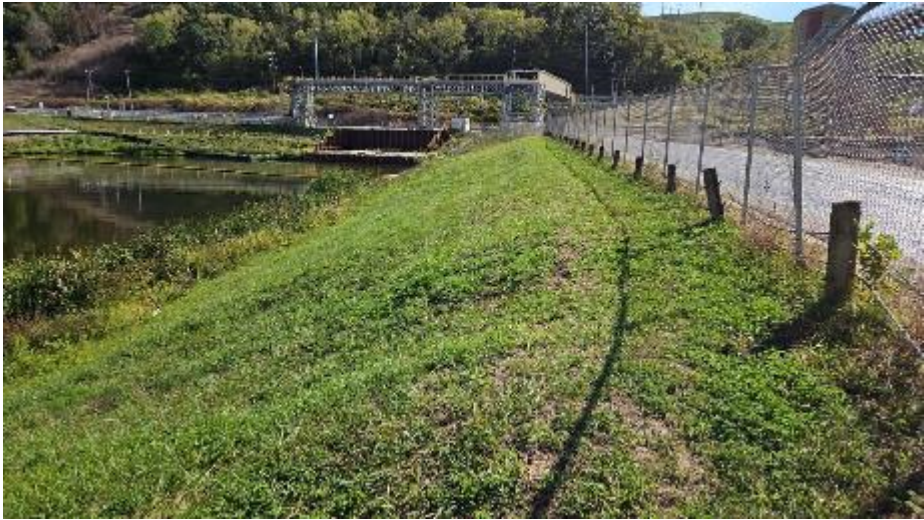
1. The Clear Water Pond was in good condition. The vegetation on the upstream slope was in good condition and maintained to 12-inches or less as shown in Photograph No. 10, No. 12, and No. 13. The Clear Water Pond Crest was paved with gravel and observed in good condition. The Clear Water Pond Outlet/Drainage features were in good condition with no obstructions as shown in Photograph No. 14 and No. 15.

PHOTO BY: GEI CONSULTANTS, INC.			
PHOTOGRAPH No: 12	DATE: September 4, 2024 9:33 AM	LATITUDE: 39.82301954	LONGITUDE: -80.81548728
DIRECTION: 4°	SITE LOCATION: MARSHALL COUNTY, WEST VIRGINIA		
DESCRIPTION: Clear Water Pond. Upstream Slope. General Photo, Typical Conditions.

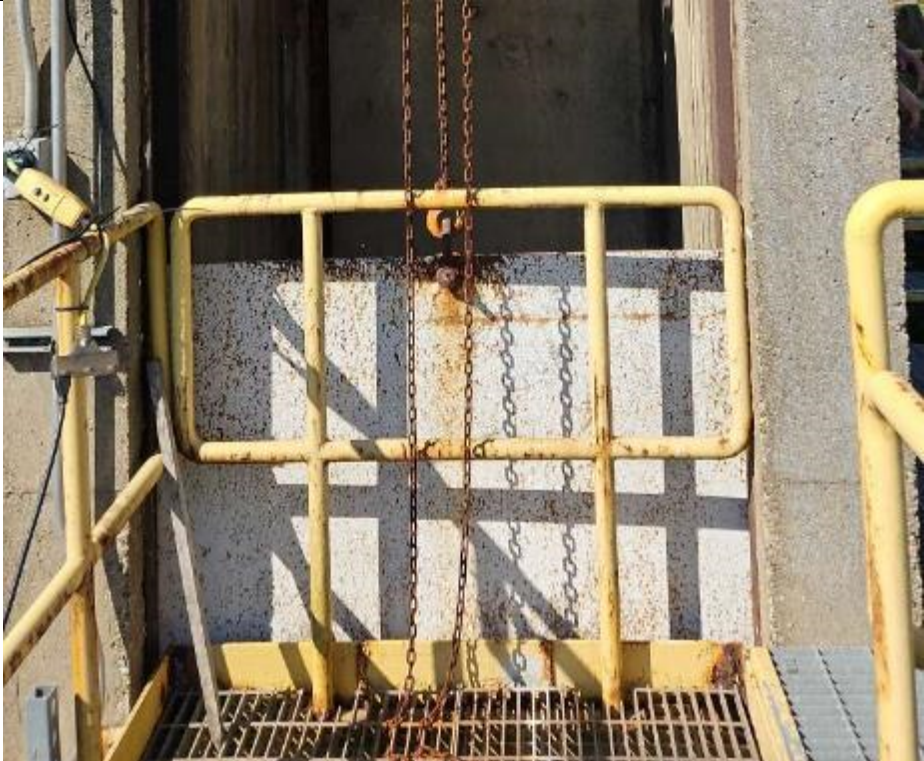
PHOTO BY: GEI CONSULTANTS, INC.			
PHOTOGRAPH No: 14	DATE: September 4, 2024 9:39 AM	LATITUDE: 39.82346205	LONGITUDE: -80.81554678
DIRECTION: 11°		SITE LOCATION: MARSHALL COUNTY, WEST VIRGINIA	
DESCRIPTION: Clear Water Pond. Decant Structure / Control Mechanism. Water Elevation ~ 662.0

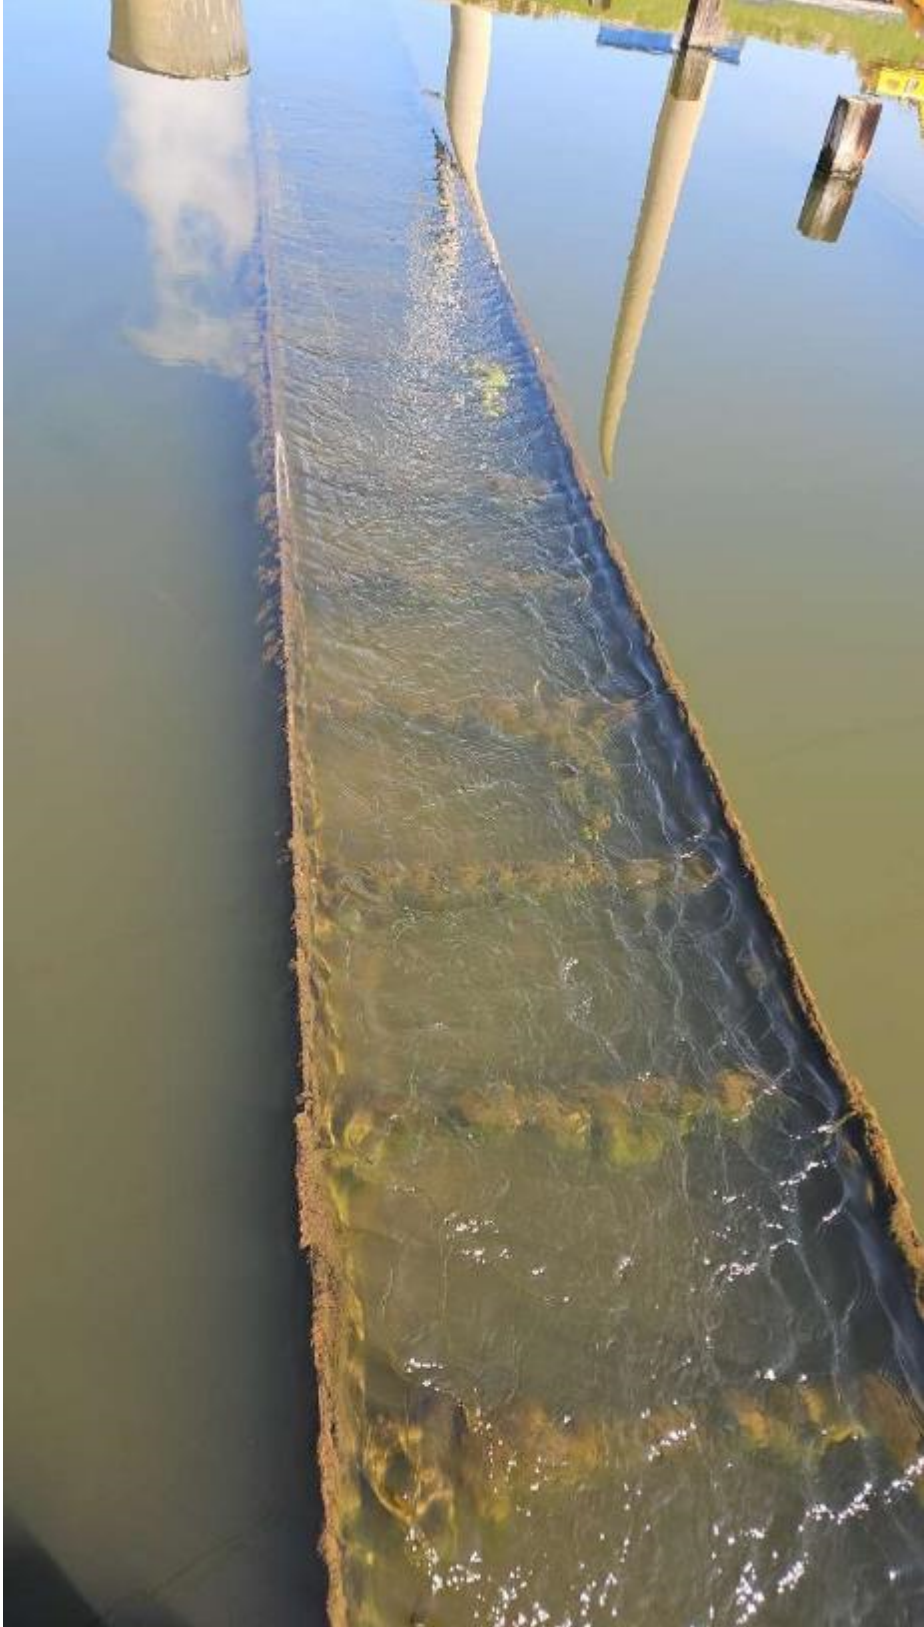
PHOTOGRAPH No: 15	DATE: September 4, 2024 9:42 AM	LATITUDE: 39.82346754	LONGITUDE: -80.81555916
DIRECTION: 30°	SITE LOCATION: MARSHALL COUNTY, WEST VIRGINIA		
DESCRIPTION: Clear Water Pond. Outlet Structure. General Photo. Typical conditions
