Mitchell Landfill
2024 Annual Landfill Inspection
Report

Mitchell Plant, Moundsville, West Virginia

October 28, 2024

AEP Document ID: GEVR-24-028

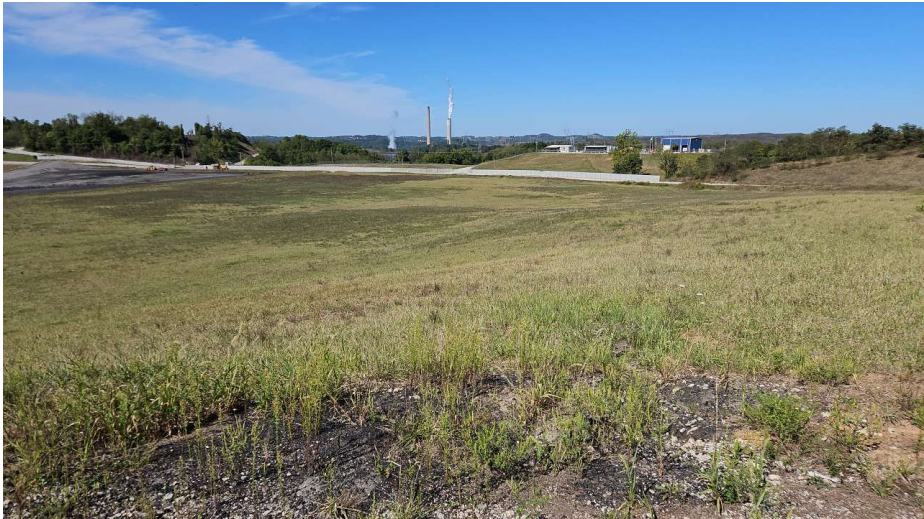
1. The temporary cover on Phase 1 and Phase 2 is satisfactory. The vegetation is maintained to 12-inches or less and there was no ponding water as shown in Photograph 1 and Photograph 2. Some minor erosion was observed on the adjacent sideslopes and should be addressed before it becomes significant as shown in Photograph 5 and Photograph 6.

PHOTOGRAPH NO: 1	DATE: September 4, 2024 10:19 AM	LATITUDE: 39.82897222	LONGITUDE: -80.77307299
DIRECTION: 183°	SITE LOCATION: MARSHALL COUNTY, WEST VIRGINIA		
DESCRIPTION: Mitchell Landfill. Interim Cover. General Photo, Typical Conditions.

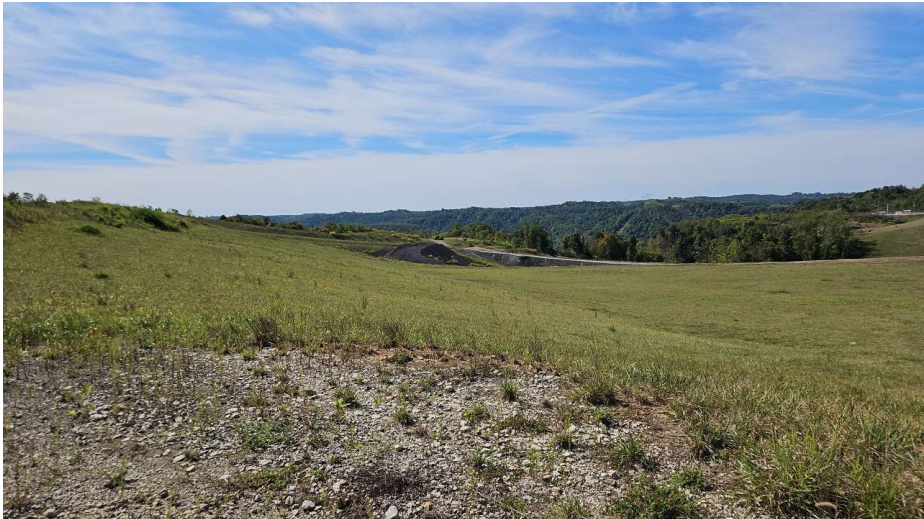
PHOTO BY: GEI CONSULTANTS, INC.			
PHOTOGRAPH NO: 2	DATE: September 4, 2024 10:21 AM	LATITUDE: 39.82896264	LONGITUDE: -80.77311781
DIRECTION: 105°	SITE LOCATION: MARSHALL COUNTY, WEST VIRGINIA		
DESCRIPTION: Mitchell Landfill. Interim Cover. Note Bottom Ash Stockpile to be used with Chimney Drains

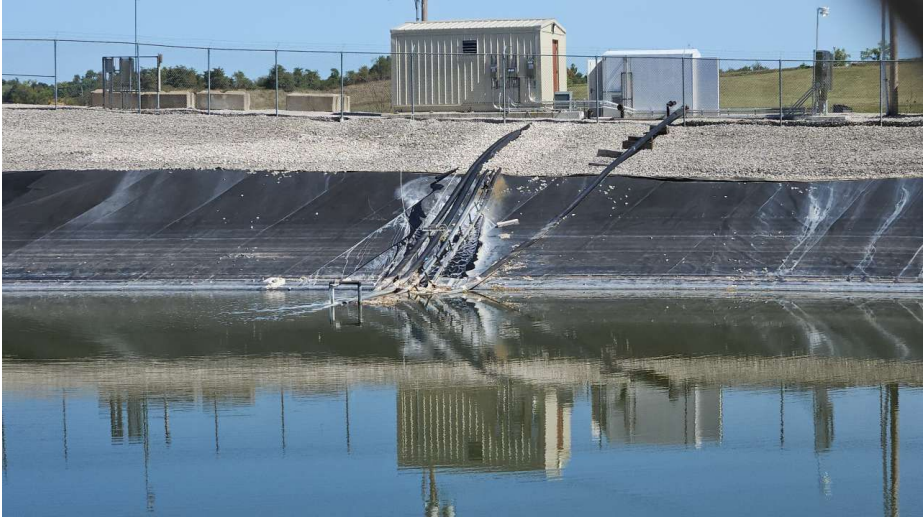
4. The leachate collection pond was in good condition and operating with at least 2-feet of freeboard. No rips or tears were observed in the exposed geomembrane as shown in photographs 7 and 8.

PHOTOGRAPH NO: 7	DATE: September 4, 2024 10:47 AM	LATITUDE: 39.82387545	LONGITUDE: -80.77862846
DIRECTION: 309°		SITE LOCATION: MARSHALL COUNTY, WEST VIRGINIA	
DESCRIPTION: Leachate Collection Pond. General Photo, Typical Conditions.

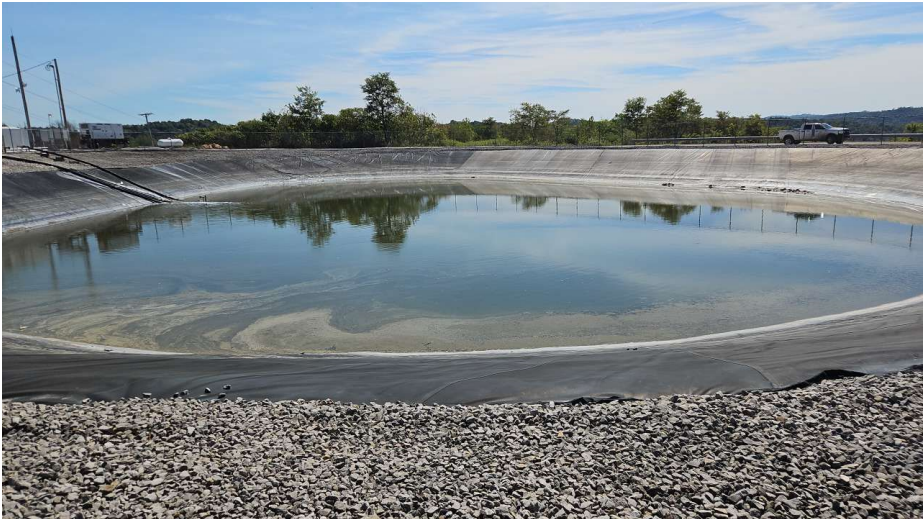
PHOTO BY: GEI CONSULTANTS, INC.			
PHOTOGRAPH NO: 8	DATE: September 4, 2024 10:51 AM	LATITUDE: 39.82443508	LONGITUDE: -80.77898141
DIRECTION: 18°		SITE LOCATION: MARSHALL COUNTY, WEST VIRGINIA	
DESCRIPTION: Leachate Collection Pond. Exposed geosynthetics in good condition.

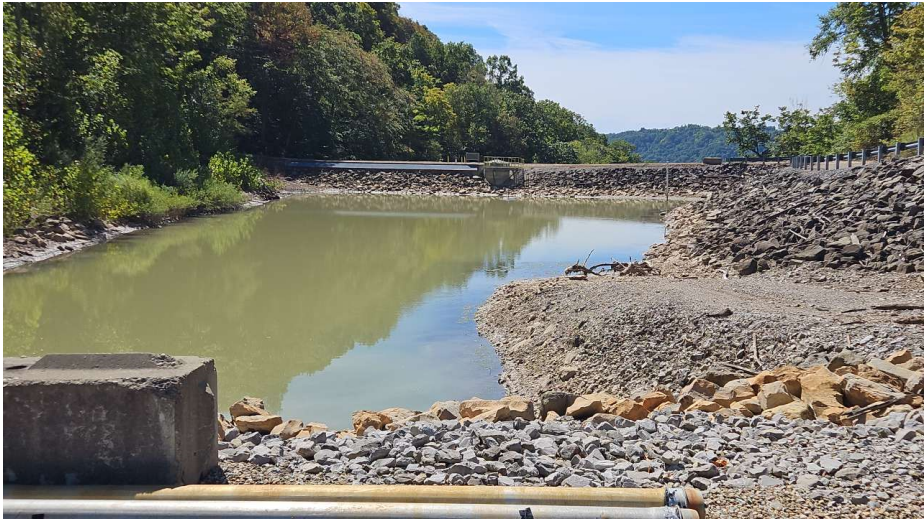
PHOTOGRAPH NO: 9	DATE: September 4, 2024 10:58 AM	LATITUDE: 39.82371128	LONGITUDE: -80.77551957
DIRECTION: 61°		SITE LOCATION: MARSHALL COUNTY, WEST VIRGINIA	
DESCRIPTION: South Pond. General Photo, Typical Conditions.

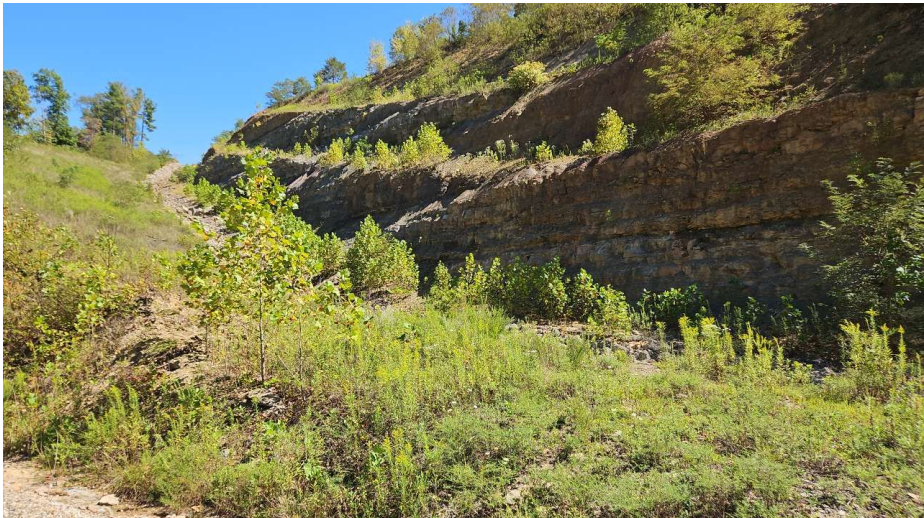
PHOTO BY: GEI CONSULTANTS, INC.			
PHOTOGRAPH NO: 10	DATE: September 4, 2024 11:00 AM	LATITUDE: 39.8236873	LONGITUDE: -80.77533555
DIRECTION: 343°		SITE LOCATION: MARSHALL COUNTY, WEST VIRGINIA	
DESCRIPTION: South Pond. Perimeter Ditch. General Photo, Typical Conditions. Note: The erosion identified is outside the active area, upstream of the stormwater pond, and is not affecting landfill operations.

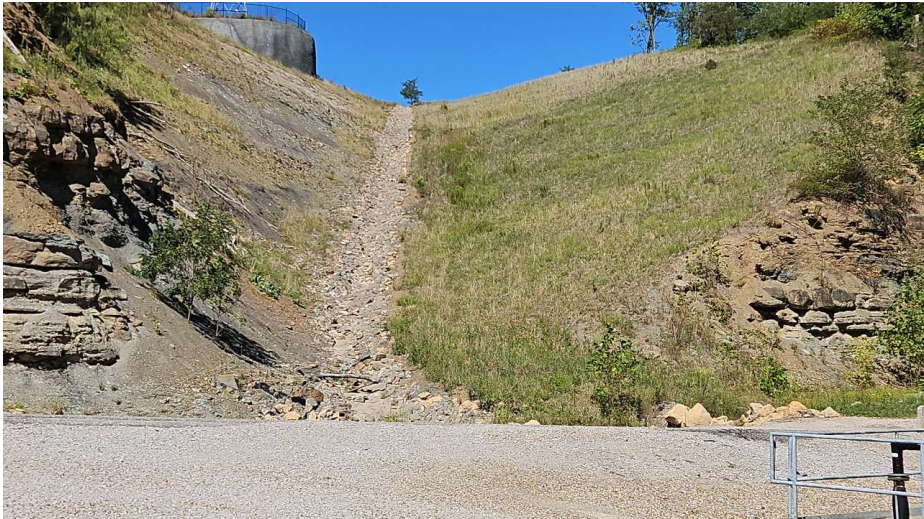
PHOTOGRAPH No: 11	DATE: September 4, 2024 11:02 AM	LATITUDE: 39.82370404	LONGITUDE: -80.775492
DIRECTION: 257°		SITE LOCATION: MARSHALL COUNTY, WEST VIRGINIA	
DESCRIPTION: South Pond. Letdown Channel. Typical Conditions.

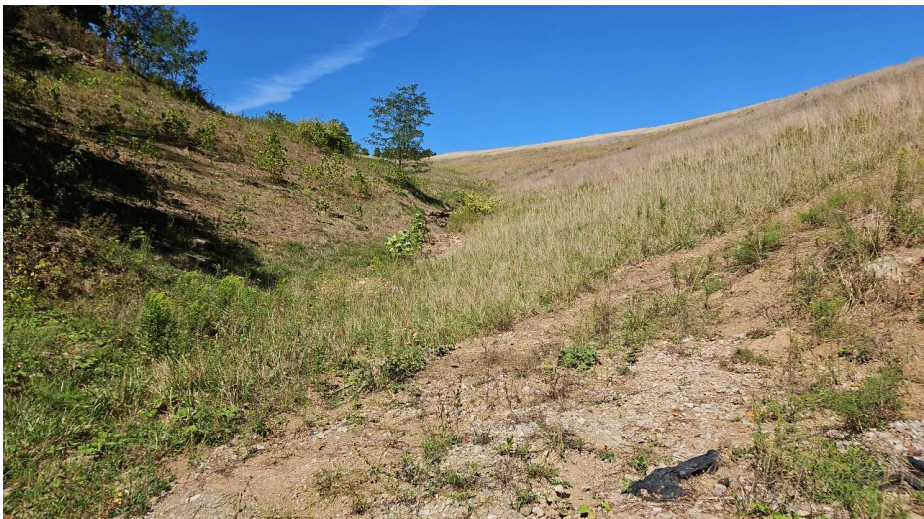
2. The Phase 3 active area is in satisfactory condition. The material is being placed in accordance with fill progression plan and chimney drains were functioning as they were designed as shown in Photographs 3 and 4. Minor erosion was observed in the Phase 3 western and eastern stormwater ditches and should be addressed before it becomes significant as shown in Photograph 12 and Photograph 13.

PHOTO BY: GEI CONSULTANTS, INC.			
PHOTOGRAPH No: 12	DATE: September 4, 2024 11:08 AM	LATITUDE: 39.82539658	LONGITUDE: -80.77565407
DIRECTION: 256°		SITE LOCATION: MARSHALL COUNTY, WEST VIRGINIA	
DESCRIPTION: Mitchell Landfill Western Stormwater Ditch. Address minor erosion before it becomes significant. Note: The erosion identified is outside the active area, upstream of the stormwater pond, and is not affecting landfill operations.

1. Item No. 5 and 6 – Address the minor erosion before it becomes significant. Consider re-evaluating this area and developing a drainage plan with ditches designed for the anticipated flow conditions.
2. Item No. 12 and 13 – Address the minor erosion before it becomes significant. Consider re-evaluating this area and developing a drainage plan with ditches designed for the anticipated flow conditions.

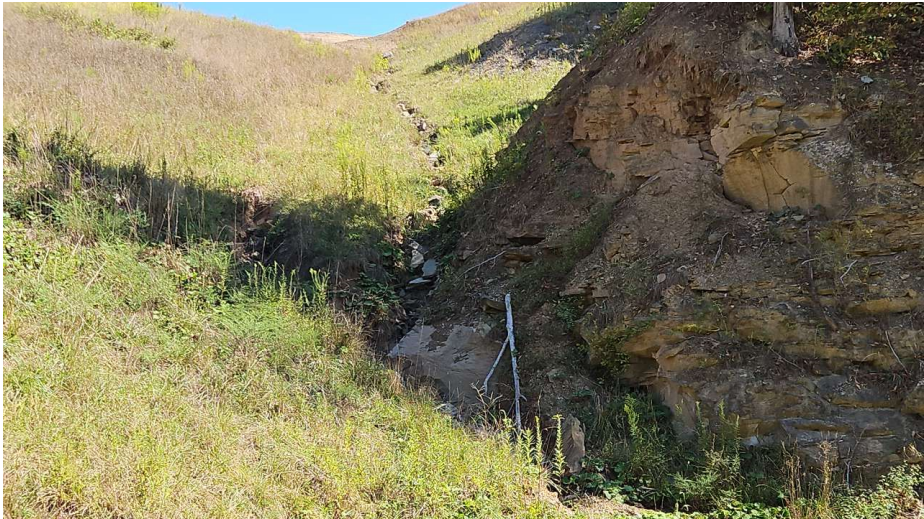
PHOTOGRAPH No: 13	DATE: September 4, 2024 11:10 AM	LATITUDE: 39.8253994	LONGITUDE: -80.77565845
DIRECTION: 355°	SITE LOCATION: MARSHALL COUNTY, WEST VIRGINIA		
DESCRIPTION: Mitchell Landfill Phase 3. Eastern Storm Runoff Perimeter Ditch. Address minor erosion before it becomes significant.

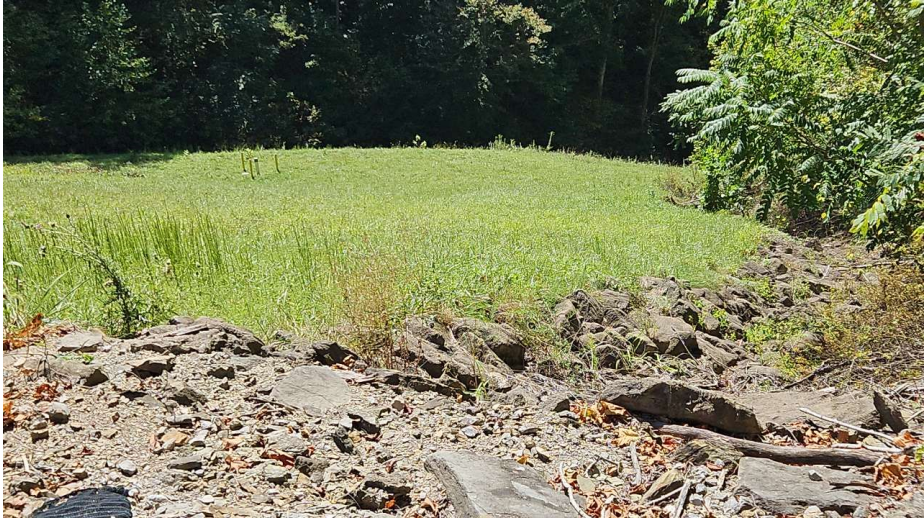
3. The upstream and downstream slopes of the South Pond were in satisfactory condition. The vegetation on the downstream slope was healthy and no erosion was observed as shown in Photograph 14. Some vegetation was observed in excess of 12-inches and should be maintained more frequently as shown in Photograph No. 15. The upstream slope was covered with riprap and the vegetation was generally maintained to less than 12-inches as shown in Photograph 9. The South Pond outlet structure was in good condition and the trash rack was free of obstructions as shown in Photograph 16. Vegetation in excess of 12-inches was observed into and adjacent to the south pond stormwater inlet channel, this vegetation should be maintained to 12-inches or less before it becomes larger and more difficult to maintain.

PHOTO BY: GEI CONSULTANTS, INC.			
PHOTOGRAPH No: 14	DATE: September 4, 2024 11:18 AM	LATITUDE: 39.82287466	LONGITUDE: -80.77569997
DIRECTION: 51°	SITE LOCATION: MARSHALL COUNTY, WEST VIRGINIA		
DESCRIPTION: South Pond Downstream Slope. Ground Cover, Typical Conditions.

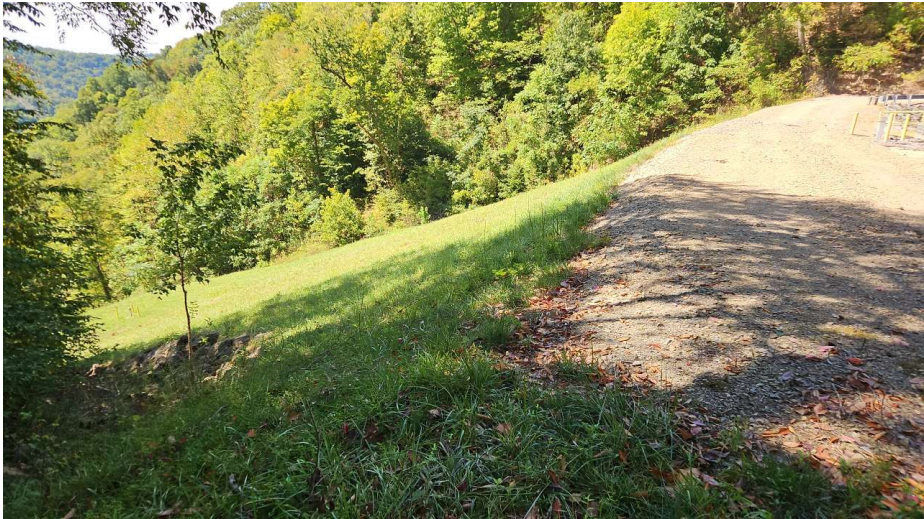
PHOTOGRAPH No: 15	DATE: September 4, 2024 11:21 AM	LATITUDE: 39.82280658	LONGITUDE: -80.77501144
DIRECTION: 179°		SITE LOCATION: MARSHALL COUNTY, WEST VIRGINIA	
DESCRIPTION: South Pond Downstream Slope. Address/Maintain Woody Vegetation to 12-inches or less.

3. Item No. 15 – Address/maintain the woody vegetation in excess of 12-inches on the downstream slope of the South Pond.
4. Item No. 17 – Address/maintain the woody vegetation in excess of 12-inches on the upstream channel of the South Pond.

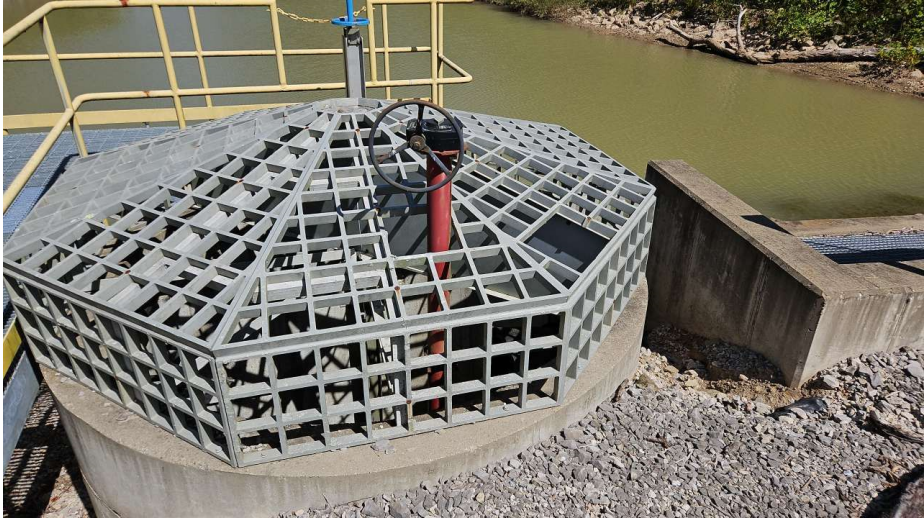
PHOTO BY: GEI CONSULTANTS, INC.			
PHOTOGRAPH No: 16	DATE: September 4, 2024 11:25 AM	LATITUDE: 39.82287374	LONGITUDE: -80.77532702
DIRECTION: 308°		SITE LOCATION: MARSHALL COUNTY, WEST VIRGINIA	
DESCRIPTION: South Pond. Decant Structure and Trash Rack working in good condition.

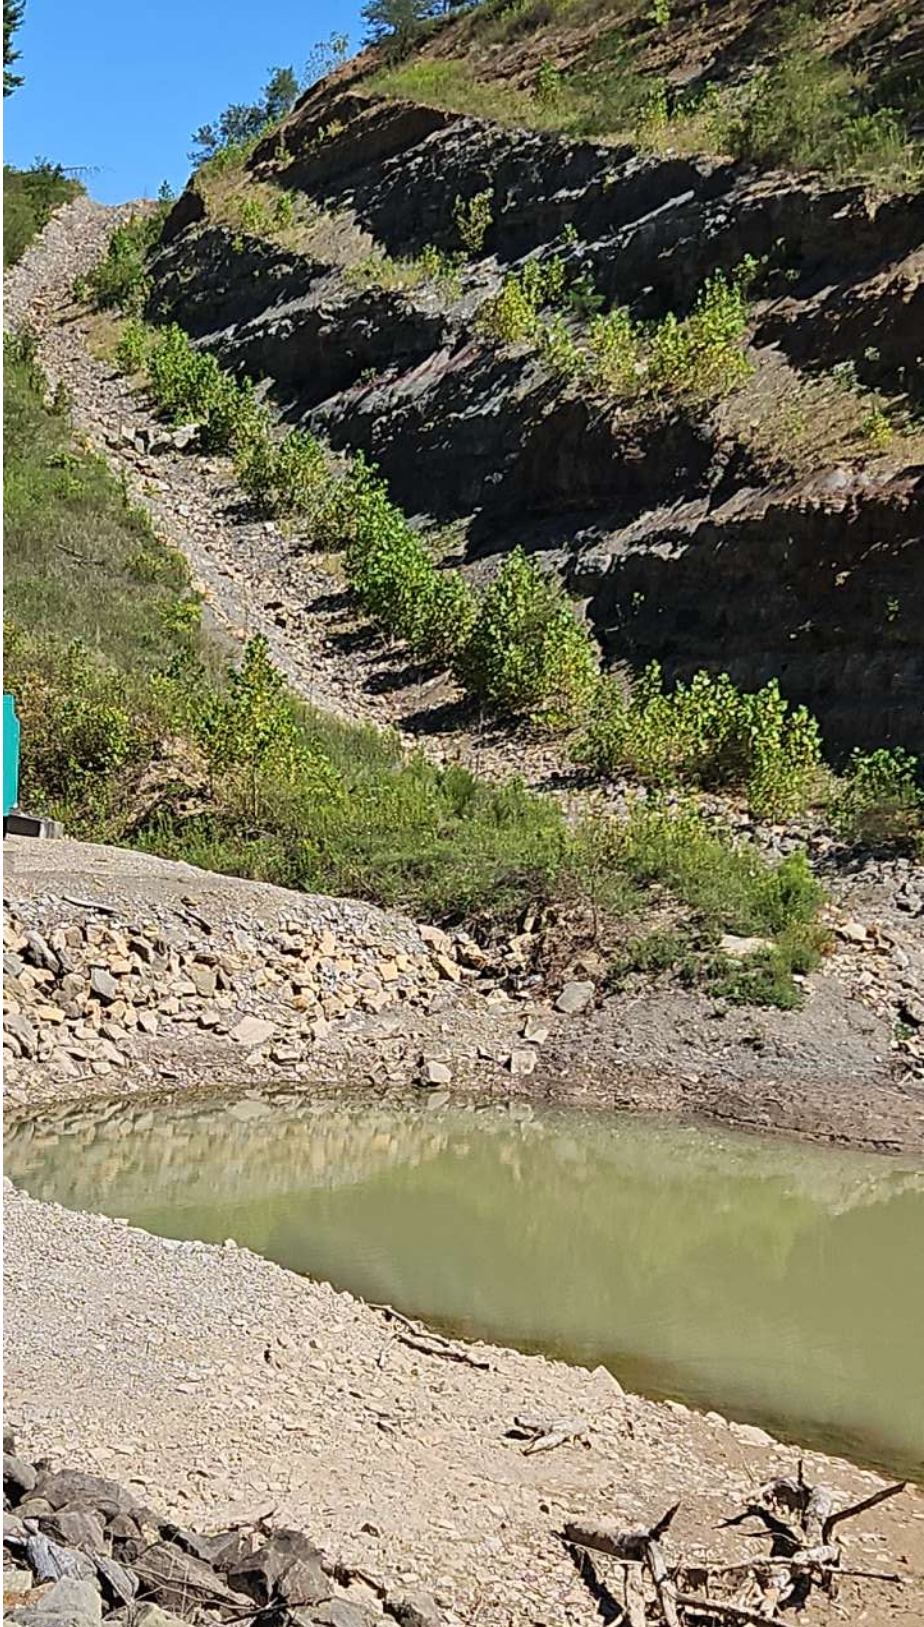
PHOTOGRAPH No: 17	DATE: September 4, 2024 11:28 AM	LATITUDE: 39.82337311	LONGITUDE: -80.77562926
DIRECTION: 16°		SITE LOCATION: MARSHALL COUNTY, WEST VIRGINIA	
<p>DESCRIPTION:</p> <p>South Pond. Storm Outlet Channel. Address/Maintain Woody Vegetation to 12-inches or less.</p> <p>Note: The erosion identified is outside the active area, upstream of the stormwater pond, and is not affecting landfill operations.</p>
