Settling Ponds 2024 Dam and Dike Inspection

Mountaineer Plant, Letart, West Virginia

AEP Document ID: GEVR-24-031

2024 Annual Inspection Report

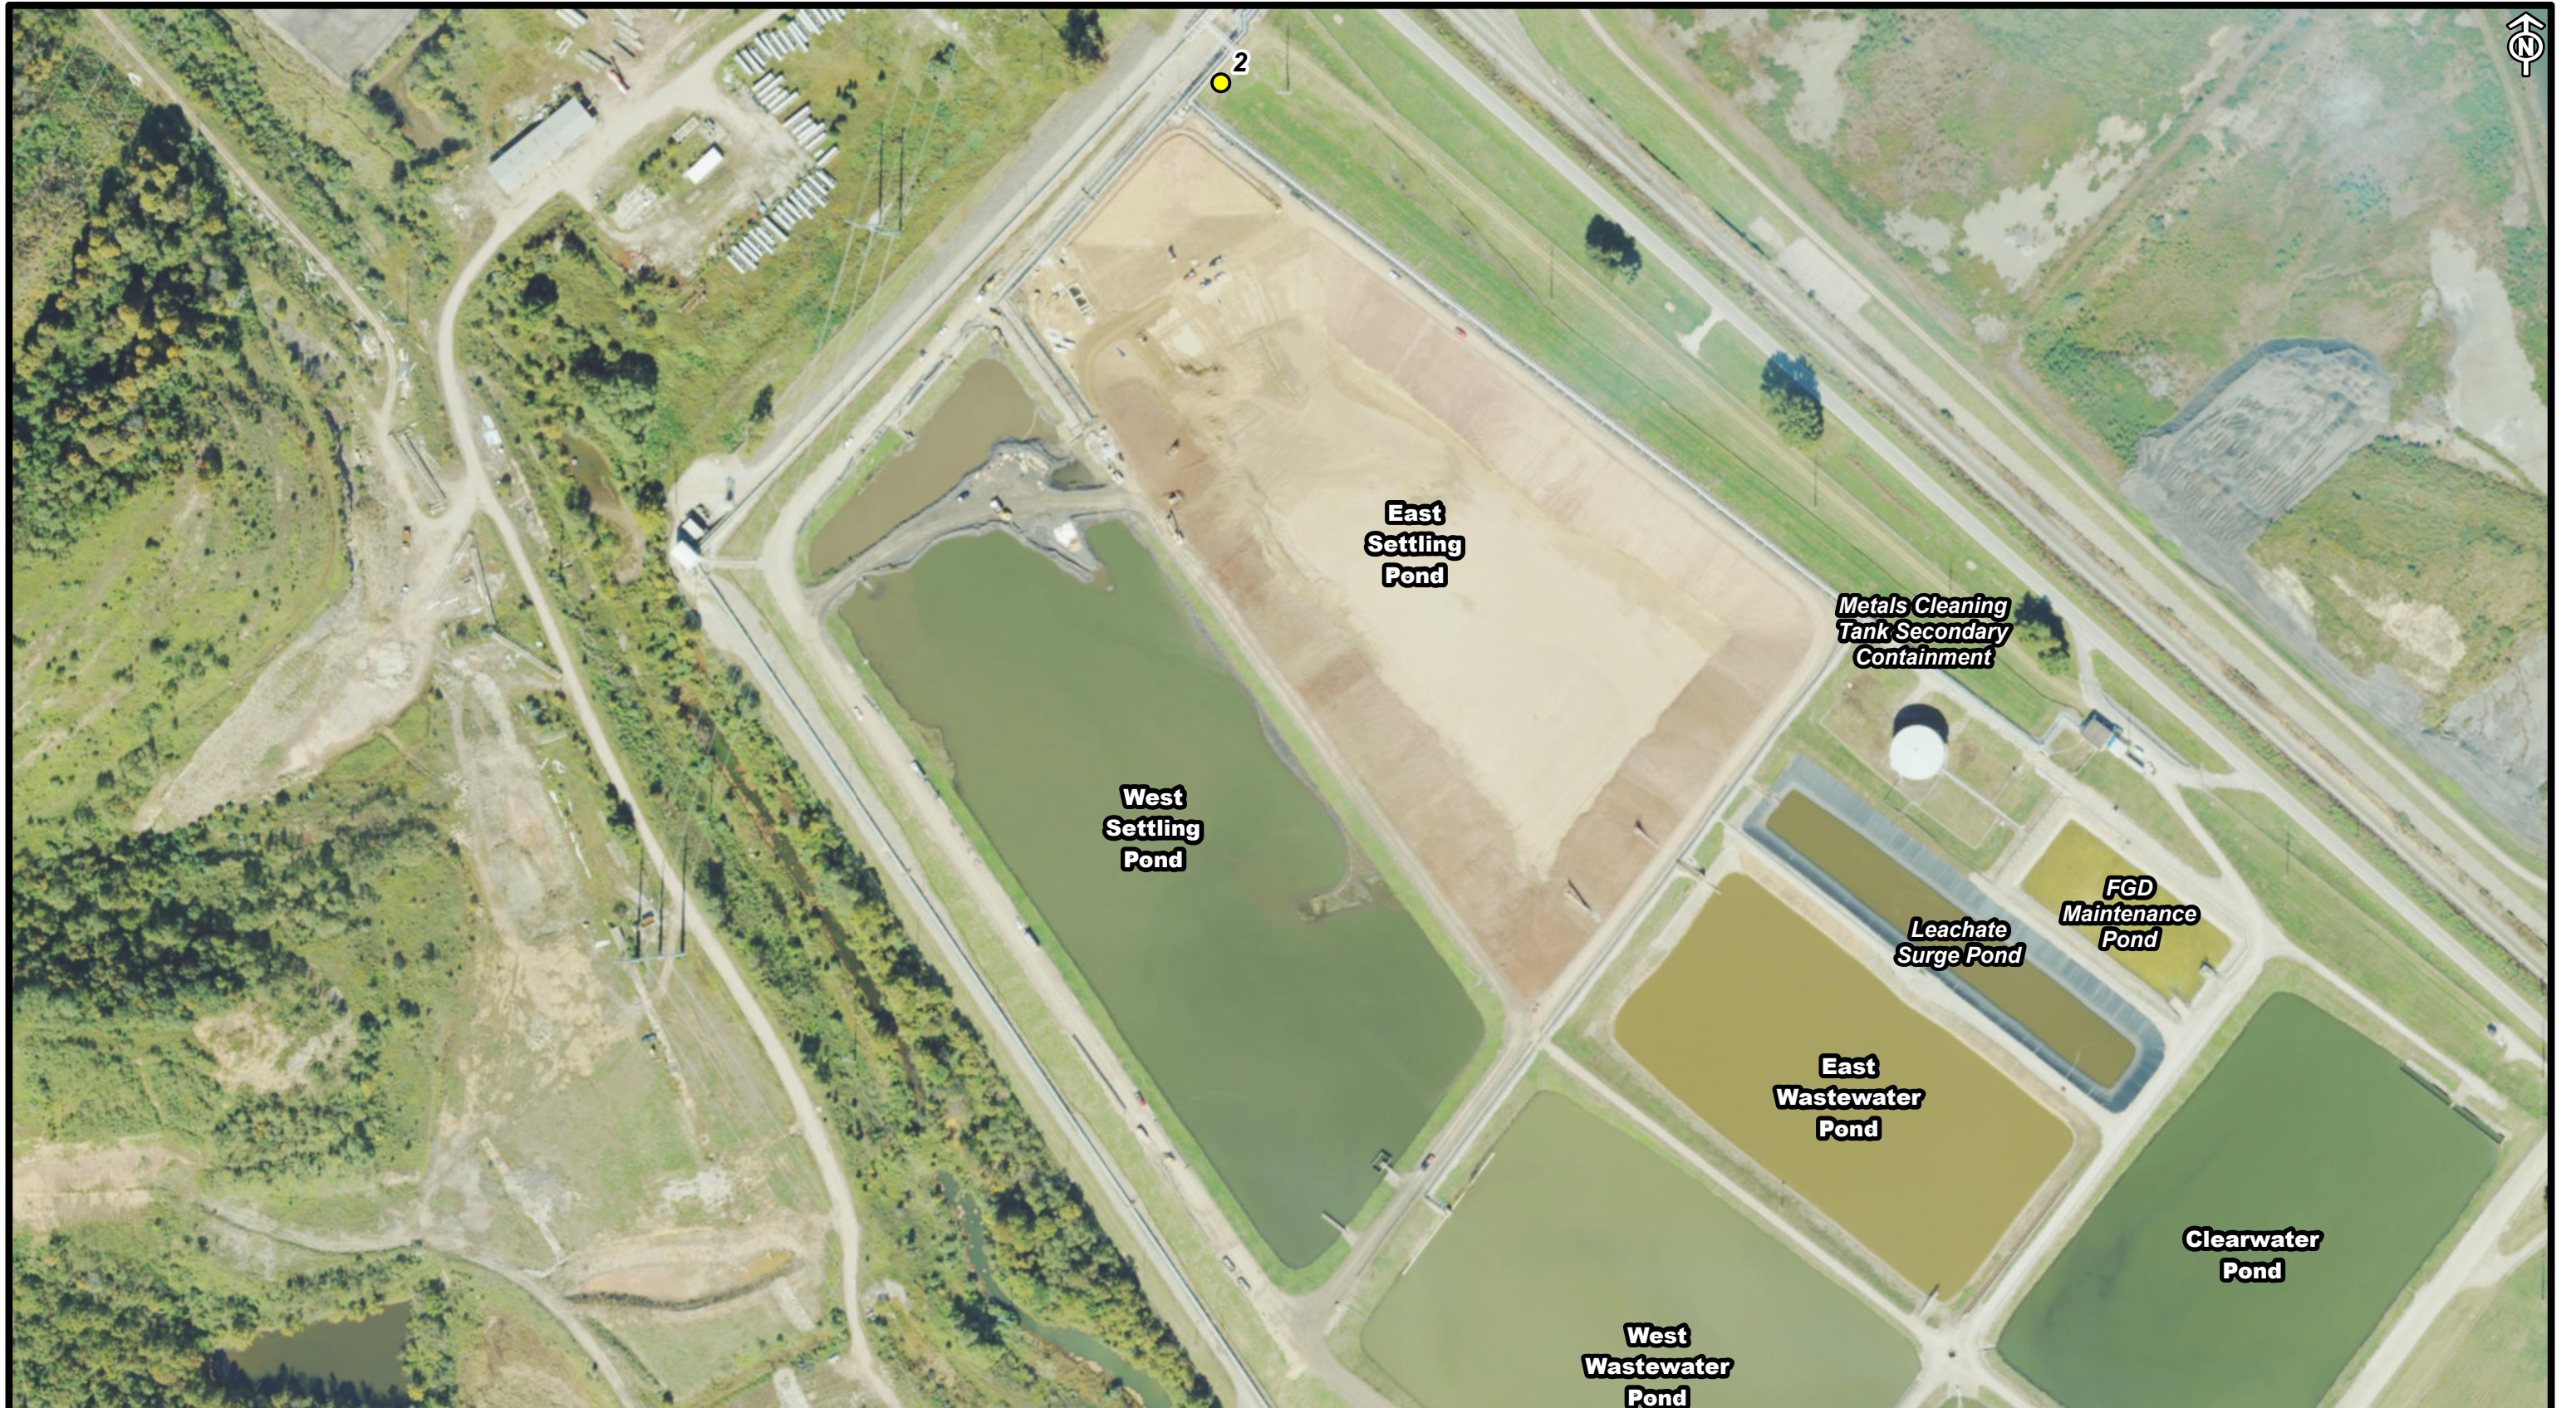
ITEMS TO BE MONITORED

- Item No. 2 – Monitor the downstream slope of the East Settling Pond. The toe of the slope was observed to be wet. If this is result of stormwater ponding this area, considering grading the area to promote positive drainage.
- Static groundwater elevations and pond pool elevations should continue to be graphed together.
 - Static water levels should continue to be measured on its current frequency for piezometers PZ-09-03, PZ-09-04, PZ-09-05.
 - The pond pool stages should be recorded the on a periodic basis with the piezometers.
- Monitor the dikes for movement, settlement, or changes in conditions.
- Monitor upstream and downstream embankment side slopes for animal burrows and seepage.

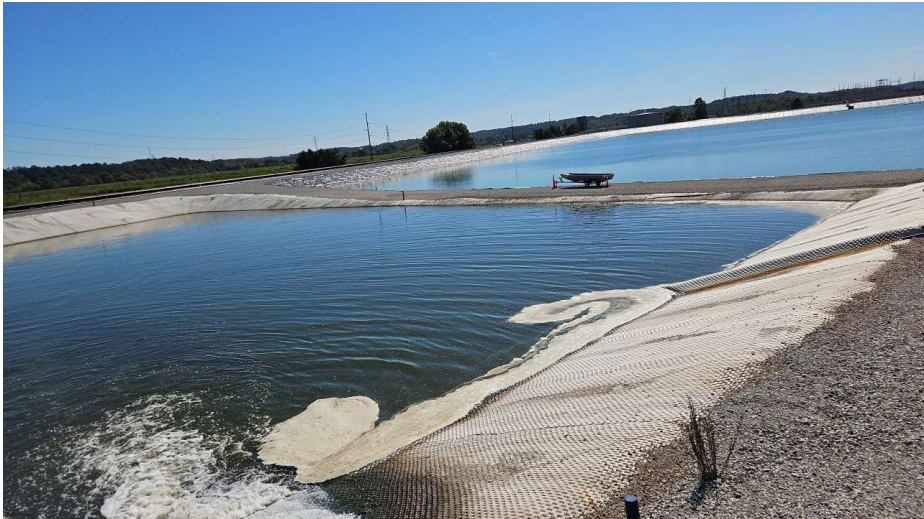
1. The East Settling Pond upstream slope was in good condition. The exposed Fabriform liner showed no signs of wear or distress as shown in Photograph No. 1.
2. The West Settling Pond upstream slope was in good condition. The exposed geomembrane liner showed no signs of wear or distress as shown in Photograph No. 3.
3. The West Settling Pond downstream slope was in good condition. The vegetation was healthy and maintained to 12-inches or less as shown in Photograph No. 4. No erosion or seepage was observed.
4. The East Settling Pond downstream slope was in satisfactory condition. The vegetation was healthy and maintained to 12-inches or less as shown in Photograph No. 5. A wet area was observed near the toe of the slope and should be monitored to determine if it is related to seepage or if it is due to stormwater drainage as shown in Photograph No. 2.

PHOTOGRAPH NO: 1	DATE: September 3, 2024 10:12 AM	LATITUDE: 38.97307164	LONGITUDE: -81.93882077
DIRECTION: 8°		SITE LOCATION: LETART, WEST VIRGINIA	
DESCRIPTION: Pyrite Pond. Upstream Slope. General Photo, Typical Conditions. Note Pyrite Forebay area with Fabriform over Geomembrane Liner.

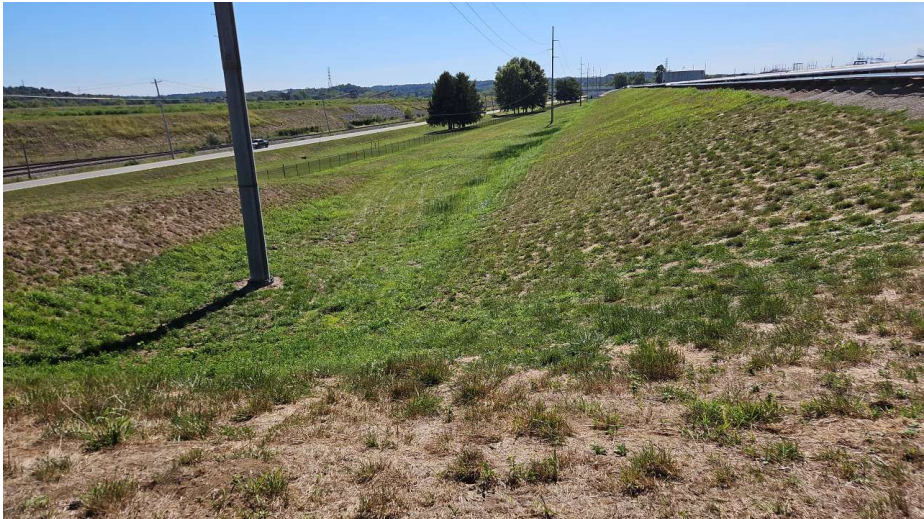
PHOTO BY: GEI CONSULTANTS, INC.			
PHOTOGRAPH NO: 2	DATE: September 3, 2024 10:18 AM	LATITUDE: 38.97370562	LONGITUDE: -81.93792839
DIRECTION: 30°		SITE LOCATION: LETART, WEST VIRGINIA	
DESCRIPTION: East Settling Pond. East area, Downstream Slope of Dam. Note Wet Area along Toe, Monitor Conditions, address as necessary.

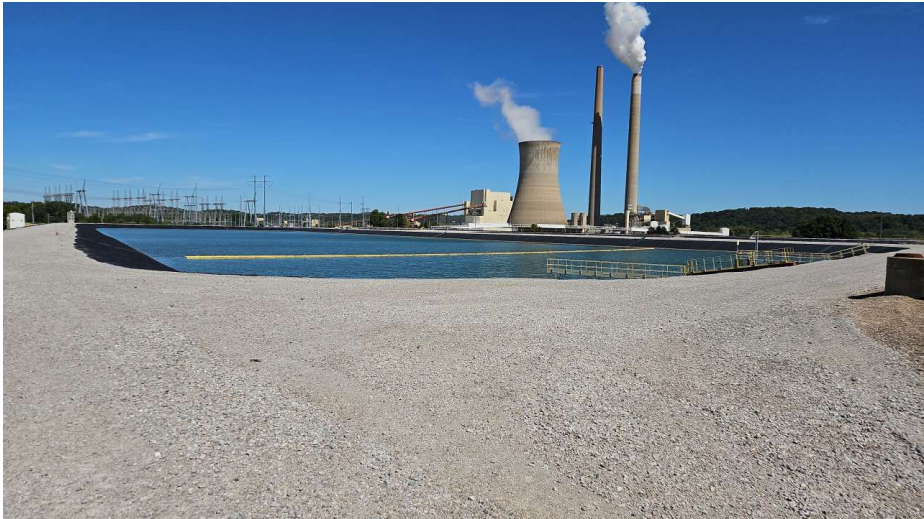
PHOTOGRAPH NO: 3	DATE: September 3, 2024 11:03 AM	LATITUDE: 38.9685064	LONGITUDE: -81.93783231
DIRECTION: 298°		SITE LOCATION: LETART, WEST VIRGINIA	
DESCRIPTION: West Settling Pond, Upstream Slope. General Photo, note Synthetic Liner.

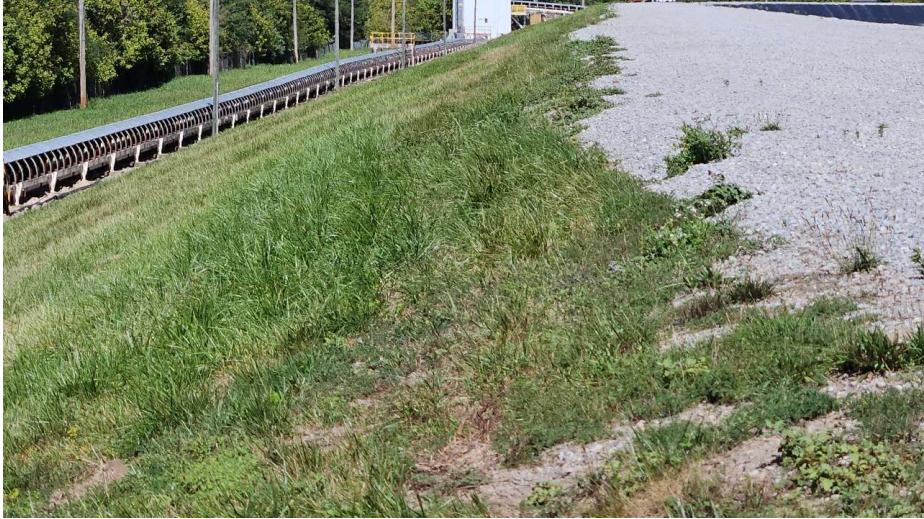
PHOTO BY: GEI CONSULTANTS, INC.			
PHOTOGRAPH NO: 4	DATE: September 3, 2024 11:05 AM	LATITUDE: 38.9685417	LONGITUDE: -81.9380304
DIRECTION: 268°		SITE LOCATION: LETART, WEST VIRGINIA	
DESCRIPTION: West Settling Pond. West area, Downstream Slope of Dam. General Photo, Typical Conditions.

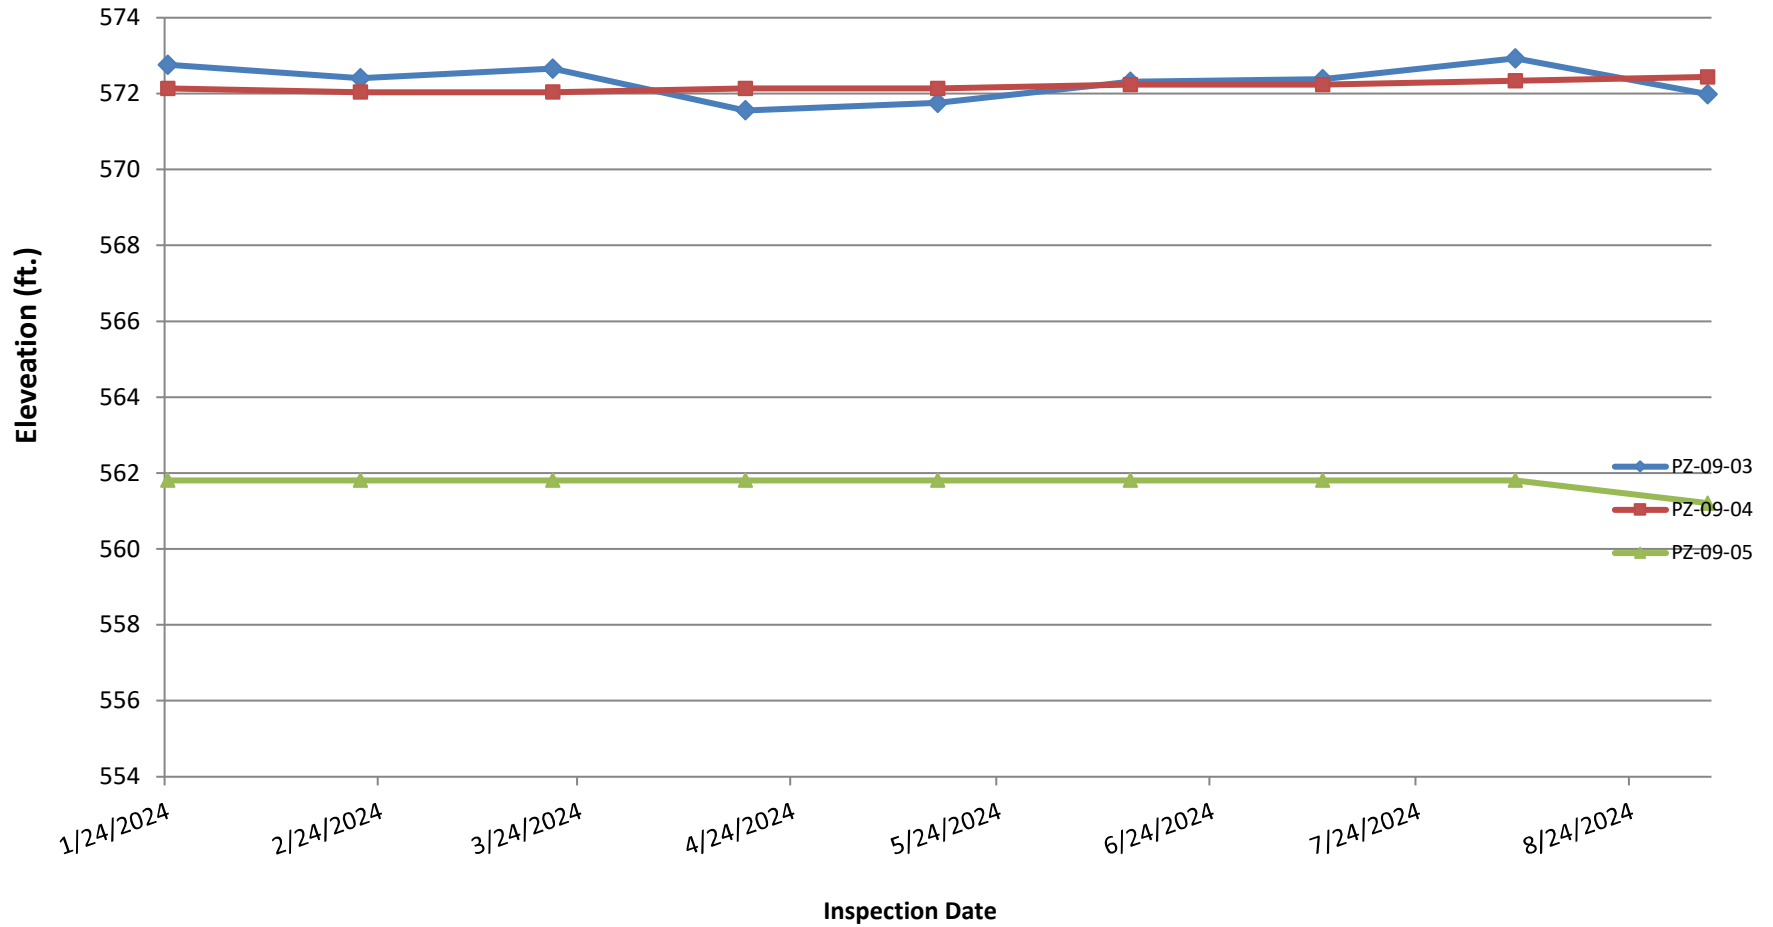
Mountaineer - 30 Day Piezometer Readings Wastewater Pond Complex Settling Ponds

Three standpipe piezometers exist around the Wastewater Pond Complex (includes the East and West Settling Ponds) as shown on Figure 3. Regular readings are recorded for each piezometer at a minimum 30-day interval. The piezometer readings exhibited minor fluctuations month to month during 2024, although it should be noted that PZ-09-03 was 7.1 feet lower than elevations recorded in 2023. PZ-09-03 was redeveloped in the fall of 2023 and generally has lower static groundwater elevations compared to its historical monitoring results. A graph of the 2024 piezometer readings are provided in Appendix B – Instrumentation Data.
