Little Broad Run Landfill 2024 Landfill Inspection

Mountaineer Plant, Letart, West Virginia

AEP Document ID: GEVR-24-032

2024 Annual Inspection Report

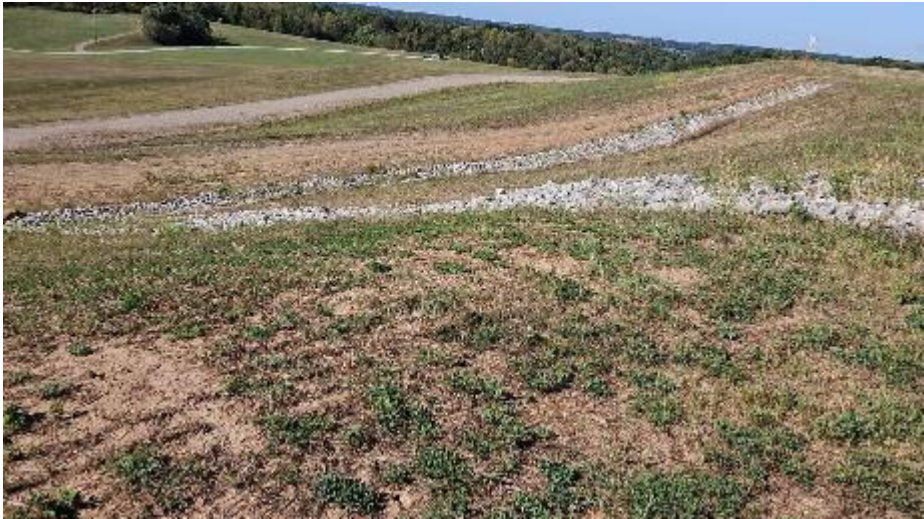
2. Areas where erosion was previously observed have been repaired/revegetated or lined with riprap as shown in Photograph No. 2 and Photograph No. 7, respectively.

PHOTOGRAPH NO: 7	DATE: September 3, 2024 8:57 AM	LATITUDE: 38.94851625	LONGITUDE: -81.94957212
DIRECTION: 125°	SITE LOCATION: LETART, WEST VIRGINIA		
DESCRIPTION: Little Broad Run Landfill. Downstream Slope of Final Cover. Erosion recently addressed. Note Stone Filled drainage channel

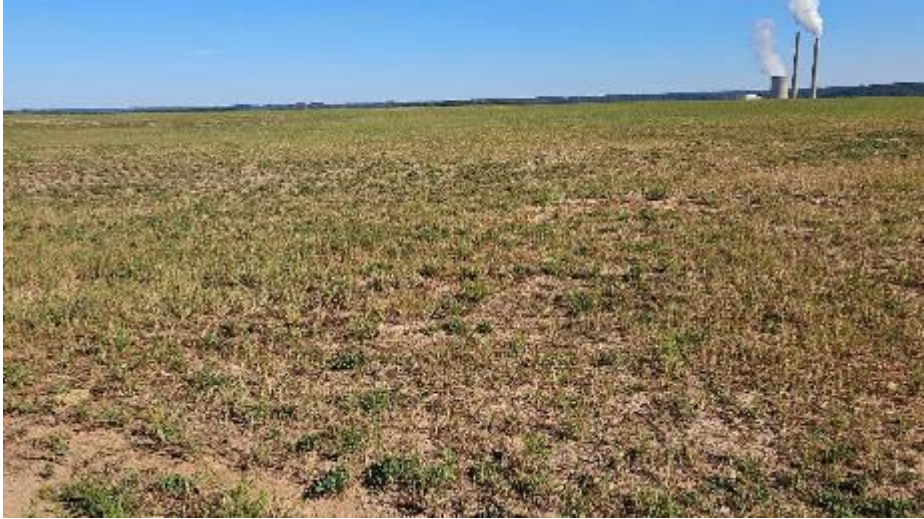
1. The top deck drainage is in good condition. The vegetation is healthy, maintained to 12-inches or less, and no erosion was observed as shown in Photograph No. 1, No. 3, No. 4, No. 5, No. 6, No. 8.

PHOTO BY: GEI CONSULTANTS, INC.			
PHOTOGRAPH NO: 8	DATE: September 3, 2024 9:00 AM	LATITUDE: 38.94853115	LONGITUDE: -81.94947699
DIRECTION: 287°	SITE LOCATION: LETART, WEST VIRGINIA		
DESCRIPTION: Little Broad Run Landfill. Top deck. General Photo, Typical Conditions.

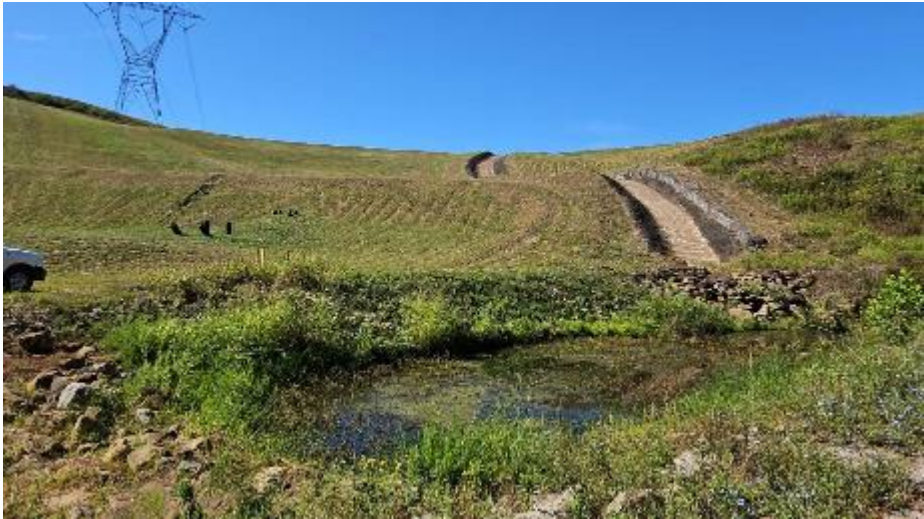
4. Landfill drainage features are in good condition. No blockages were observed, and vegetation was maintained to 12-inches or less in areas of channelized flow as shown in Photograph No. 11.

PHOTOGRAPH No: 11	DATE: September 3, 2024 9:29 AM	LATITUDE: 38.95159629	LONGITUDE: -81.94253812
DIRECTION: 322°		SITE LOCATION: LETART, WEST VIRGINIA	
DESCRIPTION: Little Broad Run Landfill. Riprap Drainage Feature. General Photo, Typical Conditions.

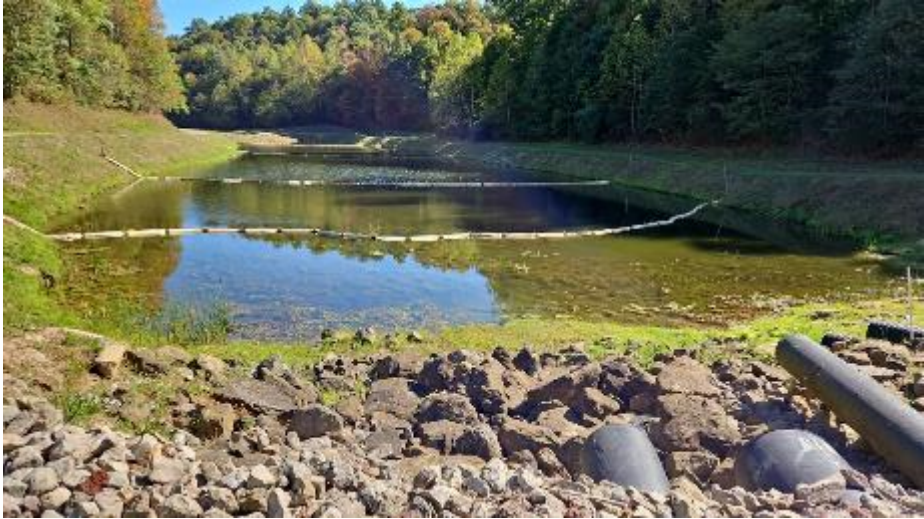
5. The landfill sediment ponds are in good condition. The inlet and outlet structures were free of obstructions and no erosion was observed. The turbidity curtains seemed to be installed per manufacturer recommendations and were functioning as designed. The ponds were operating with sufficient freeboard and do not need to be cleaned out as shown in Photograph No. 12, No. 13, No. 15, and No. 16.

PHOTO BY: GEI CONSULTANTS, INC.			
PHOTOGRAPH No: 12	DATE: September 3, 2024 9:33 AM	LATITUDE: 38.95177044	LONGITUDE: -81.9425098
DIRECTION: 349°		SITE LOCATION: LETART, WEST VIRGINIA	
DESCRIPTION: Little Broad Run Landfill. Sediment Ponds. Water level approximately 4 feet below landfill underdrain discharge pipe invert and stormwater discharge pipes

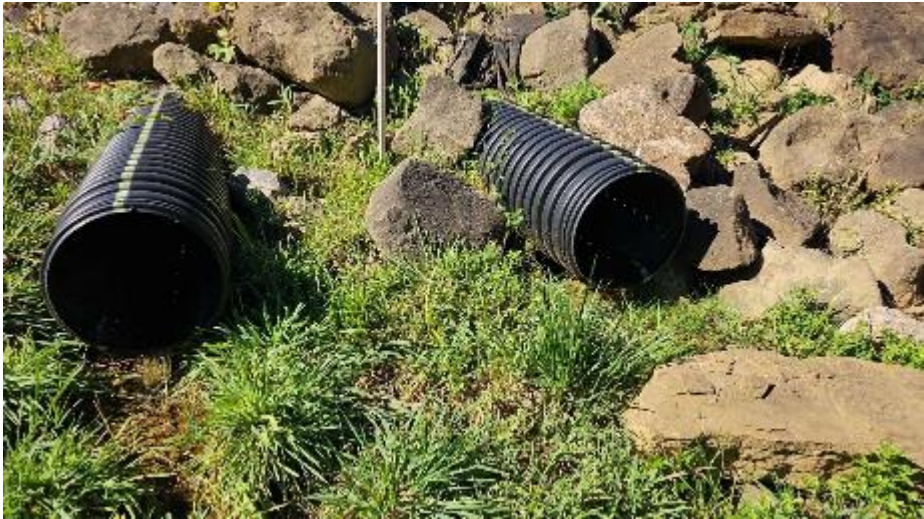
PHOTOGRAPH No: 13	DATE: September 3, 2024 9:37 AM	LATITUDE: 38.95175951	LONGITUDE: -81.94232611
DIRECTION: 147°		SITE LOCATION: LETART, WEST VIRGINIA	
DESCRIPTION: Little Broad Run Landfill. Sediment Ponds. Groundwater under drains. Approximate Drain flow (left) 20 oz in 4 seconds; (right) 20 oz in 23 seconds.

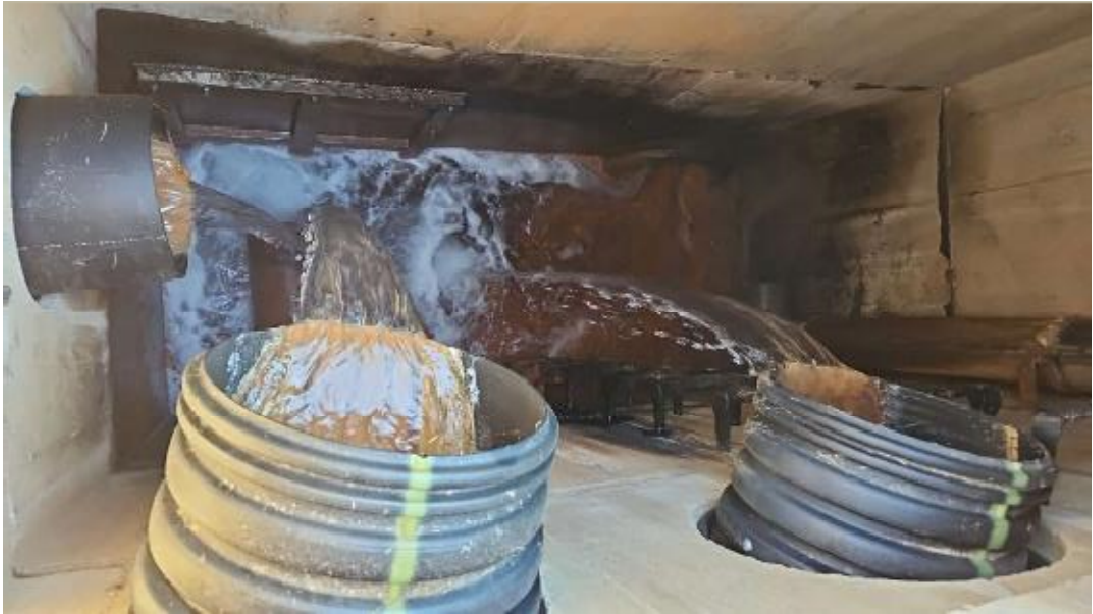
6. The leachate ponds are in satisfactory condition. The leachate collection vault was operating as designed as shown in Photograph No. 14. The leachate drainage structures are in good condition and free of obstructions as shown in Photograph No. 17 and No. 18. Some minor vegetation was observed in the concrete contraction joints. Please consider removing the vegetation in the contraction joints and sealing the joints with Sonolastic NP1 or equivalent polyurethane sealant.

PHOTO BY: GEI CONSULTANTS, INC.			
PHOTOGRAPH No: 14	DATE: September 3, 2024 9:44 AM	LATITUDE: 38.95160984	LONGITUDE: -81.9422238
DIRECTION: 337°		SITE LOCATION: LETART, WEST VIRGINIA	
DESCRIPTION: Leachate Collection Vault. General Photo, Typical Conditions.

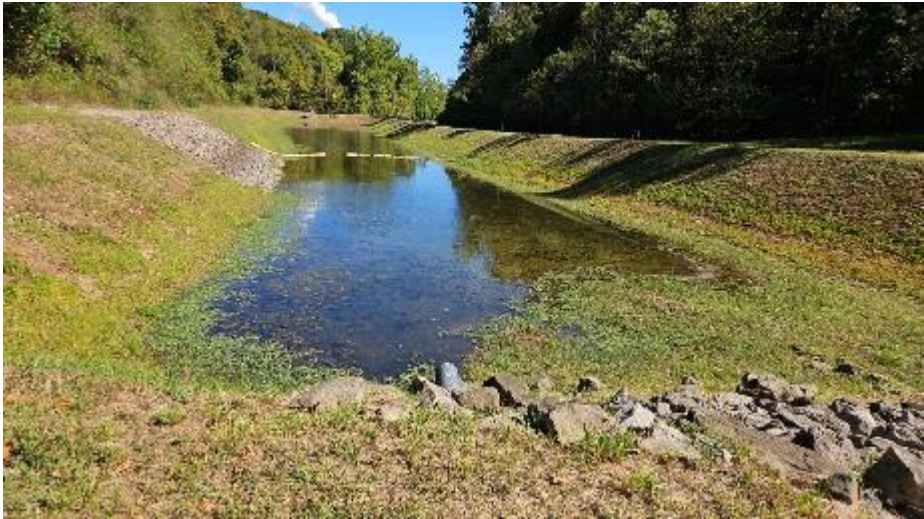
PHOTOGRAPH No: 15	DATE: September 3, 2024 9:49 AM	LATITUDE: 38.95306787	LONGITUDE: -81.94102703
DIRECTION: 312°	SITE LOCATION: LETART, WEST VIRGINIA		
DESCRIPTION: Landfill Sediment Ponds. Note: Riprap Stabilized Area of Former Slip. General Photo, Typical Conditions.

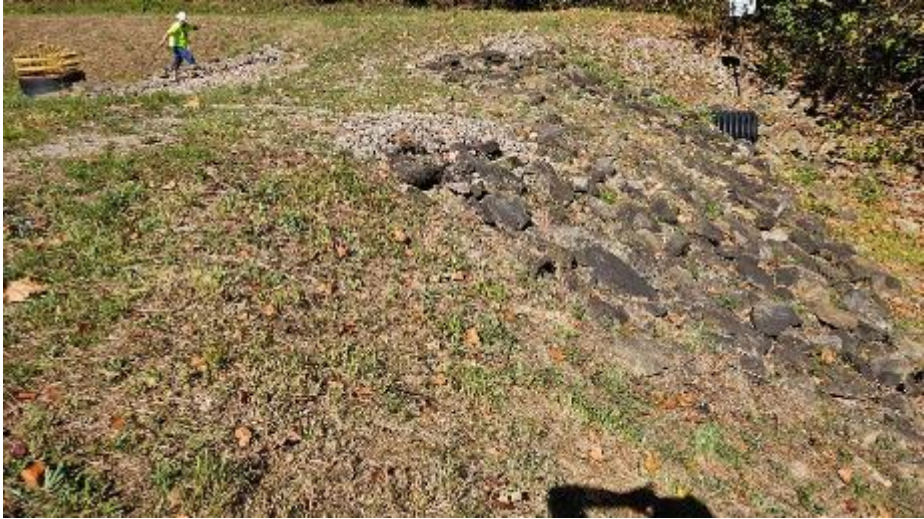
PHOTO BY: GEI CONSULTANTS, INC.			
PHOTOGRAPH No: 16	DATE: September 3, 2024 9:52 AM	LATITUDE: 38.95491906	LONGITUDE: -81.94048973
DIRECTION: 232°	SITE LOCATION: LETART, WEST VIRGINIA		
DESCRIPTION: Landfill Sediment Ponds. Outfall Structure and Downstream Slope. Riprap Ground Cover. General Photo, Typical Conditions. Water level approximately 5-feet below overflow pipe.

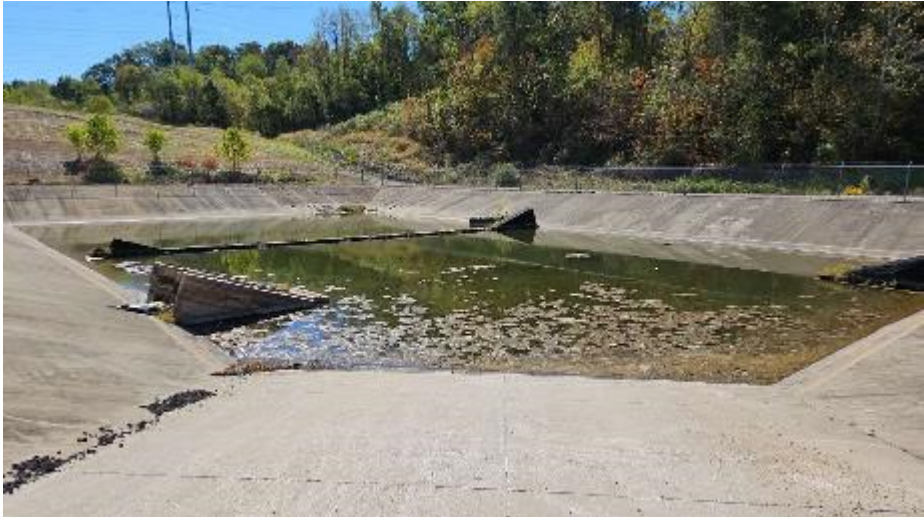
PHOTOGRAPH No: 17	DATE: September 3, 2024 9:59 AM	LATITUDE: 38.95911334	LONGITUDE: -81.93763447
DIRECTION: 5°	SITE LOCATION: LETART, WEST VIRGINIA		
DESCRIPTION: Leachate Ponds. Consider addressing any vegetation in the concrete joints during routine maintenance activities. Concrete joints could also be sealed with Sonolastic NP1 or equivalent Polyurethane Sealant.

1. Continue routine mowing of the temporary cover.
2. Address issues like minor animal burrows and minor erosion rills before they become significant.
3. Continue to check site drainage features such as culverts, ditches, and outfall structures for debris/blockages to allow the site stormwater to flow as it was designed.
4. Seal concrete joints with Sonolastic NP1 or equivalent polyurethane sealant.

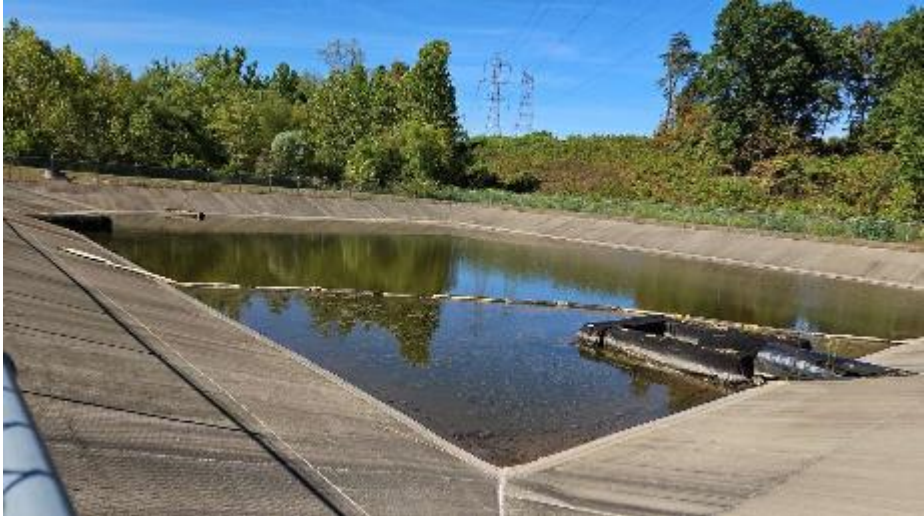
PHOTO BY: GEI CONSULTANTS, INC.			
PHOTOGRAPH No: 18	DATE: September 3, 2024 10:02 AM	LATITUDE: 38.95925553	LONGITUDE: -81.93773604
DIRECTION: 140°	SITE LOCATION: LETART, WEST VIRGINIA		
DESCRIPTION: Leachate Ponds. Leachate Collection System area, Stilling Basin. Concrete, Typical Conditions.
