Bottom Ash Pond 2024 Annual Dam and Dike Inspection Report

Northeastern Plant, Oologah, Oklahoma

Project 2305686

AEP Document ID: GEVR-24-036

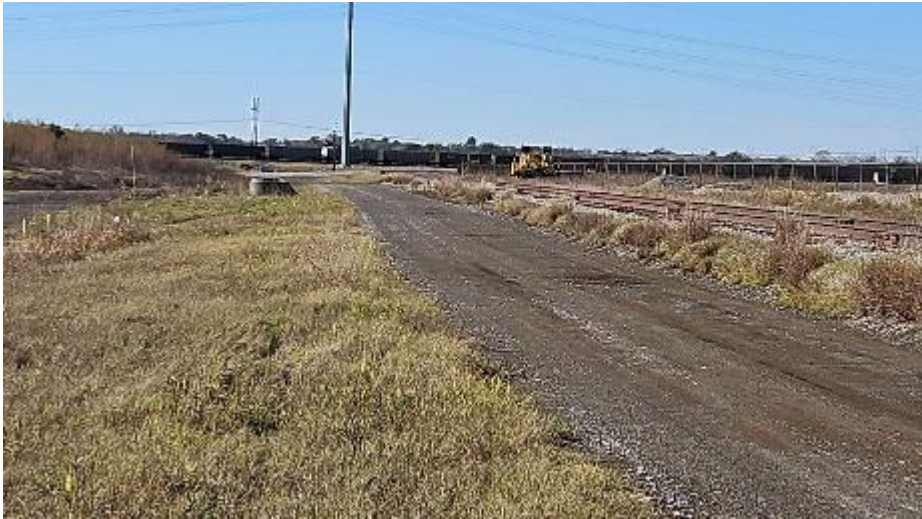
The Bottom Ash Pond Crest is in good condition. No cracks, ruts, potholes, or evidence of subsidence were observed on the areas paved with gravel or areas supporting the train tracks as shown on Photograph No. 1 and No. 10.

PHOTOGRAPH NO: 1	DATE: November 6, 2024 1:14 PM	LATITUDE: 36.42290196	LONGITUDE: -95.70246456
DIRECTION: 158°		SITE LOCATION: OOLOGAH, OKLAHOMA	
DESCRIPTION: Bottom Ash Pond North Crest. General Photo, Typical Conditions.

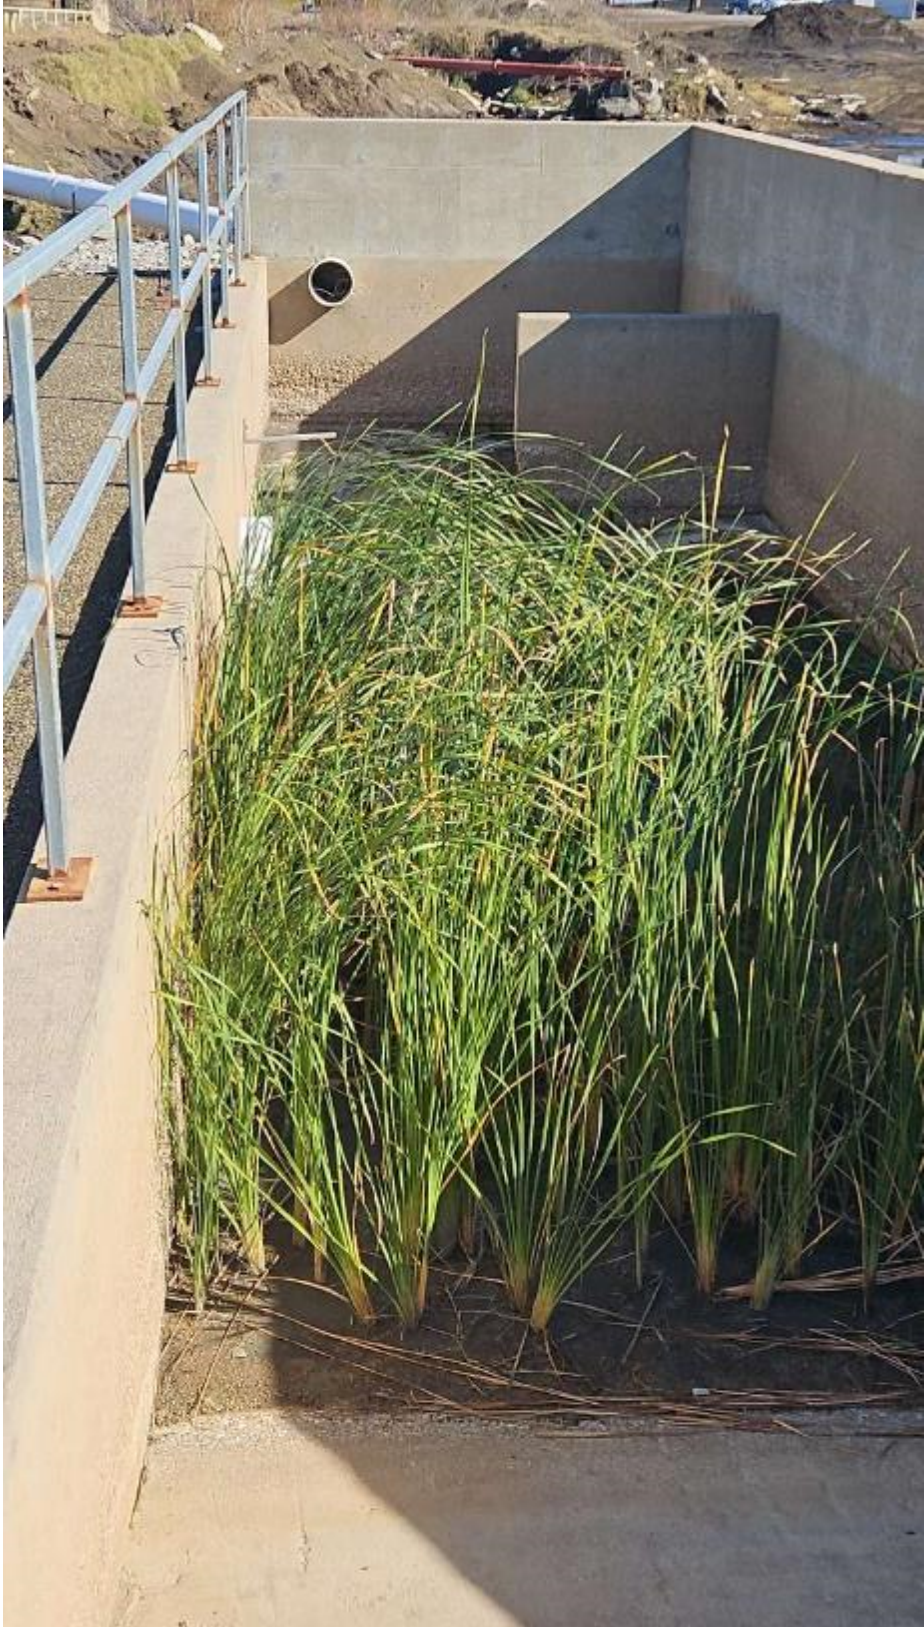
The Bottom Ash Pond Discharge Structure is in satisfactory condition. Vegetation and debris that could restrict flow was observed and should be addressed as shown in Photograph No. 2 and No. 3. Some concrete deterioration was also observed but does not need to be addressed as its understood that the unit is scheduled to be closed.

PHOTOGRAPH NO: 2	DATE: November 6, 2024 1:17 PM	LATITUDE: 36.42277726	LONGITUDE: -95.70328869
DIRECTION: 85°		SITE LOCATION: OOLOGAH, OKLAHOMA	
DESCRIPTION: Bottom Ash Pond Discharge Structure. Address vegetation restricting flow.

- Item 2 – Address/remove the vegetation growing in the discharge structure.
- Item 3 – Address/remove the minor blockage/debris in the discharge structure.
- Item 10 – Address/maintain the vegetation to 12-inches or less along the southern upstream slope.

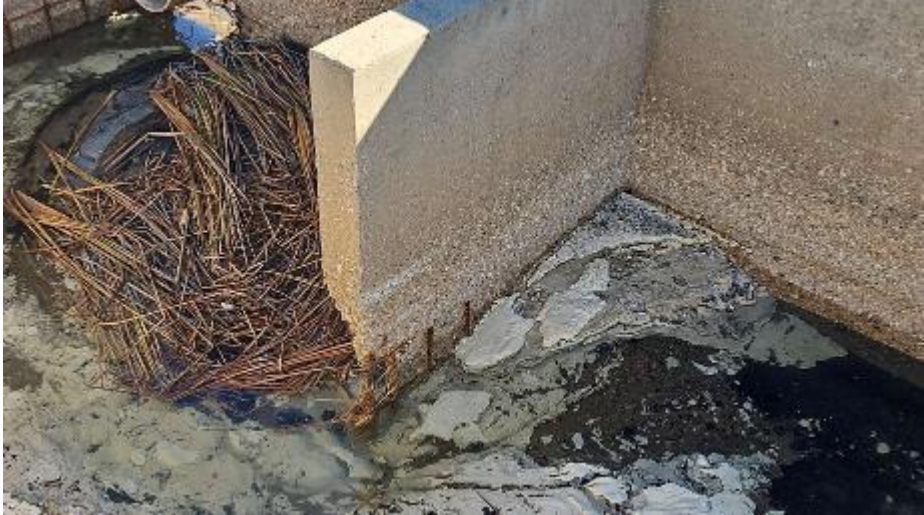
PHOTOGRAPH NO: 3	DATE: November 6, 2024 1:20 PM	LATITUDE: 36.42278701	LONGITUDE: -95.70316706
DIRECTION: 37°	SITE LOCATION: OOLOGAH, OKLAHOMA		
DESCRIPTION: Bottom Ash Pond Discharge Structure. Address debris blockage.

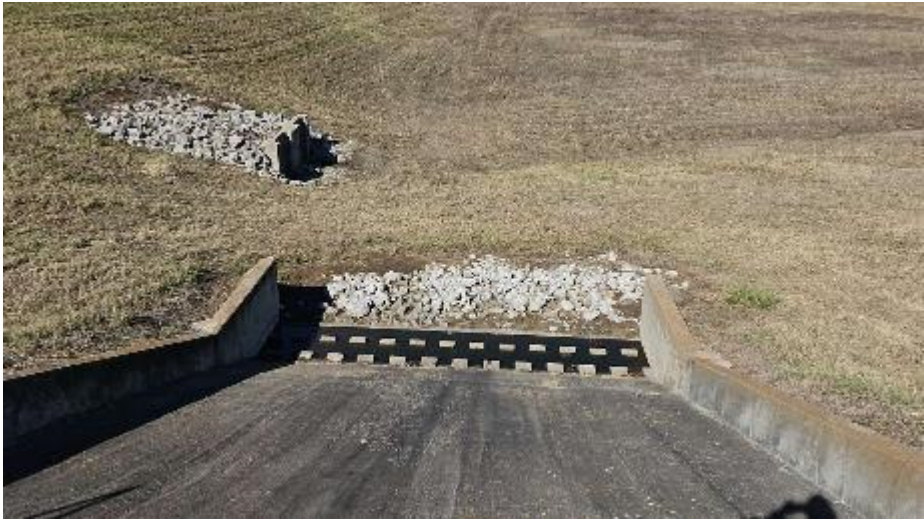
The Bottom Ash Pond Inlet Structure, Spillway, and Stilling Basin are in good condition with no erosion observed or debris that could restrict flow as shown in Photographs No. 4 through No. 7.

PHOTOGRAPH NO: 5	DATE: November 6, 2024 1:28 PM	LATITUDE: 36.4231809	LONGITUDE: -95.7087995
DIRECTION: 269°		SITE LOCATION: OOLOGAH, OKLAHOMA	
DESCRIPTION: Bottom Ash Pond, Downstream Slope of Spillway and Stilling Basin. Concrete, Typical Conditions.

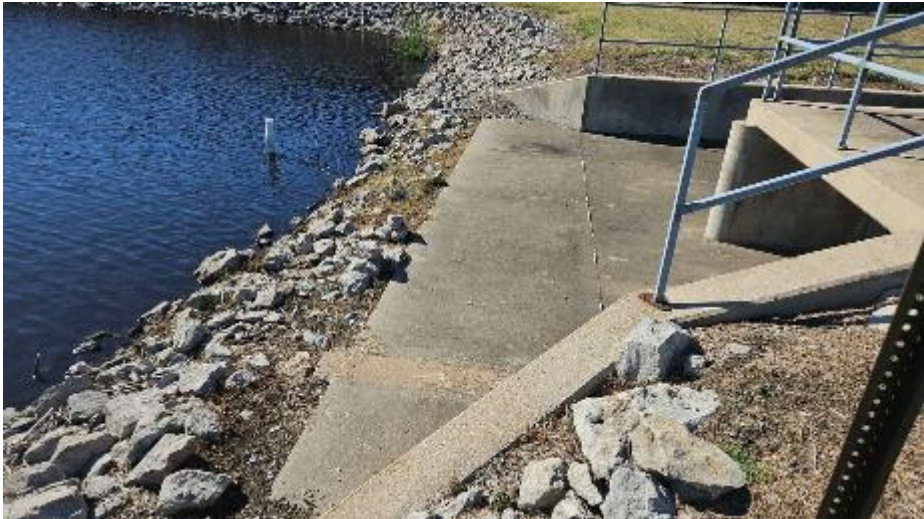
PHOTO BY: GEI CONSULTANTS, INC.			
PHOTOGRAPH NO: 6	DATE: November 6, 2024 1:29 PM	LATITUDE: 36.42318644	LONGITUDE: -95.70880561
DIRECTION: 186°		SITE LOCATION: OOLOGAH, OKLAHOMA	
DESCRIPTION: Bottom Ash Pond Upstream Slope of Spillway. General Photo, Typical Conditions.

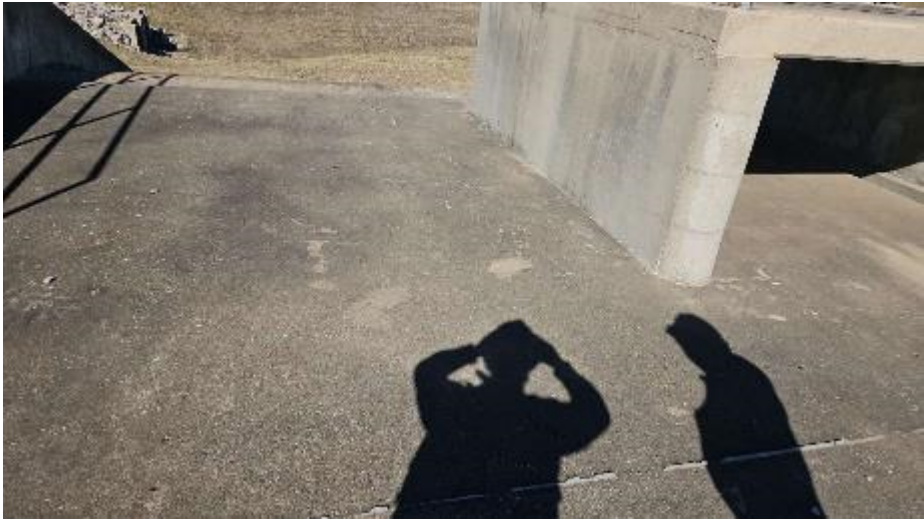
PHOTOGRAPH NO: 7	DATE: November 6, 2024 1:31 PM	LATITUDE: 36.42316916	LONGITUDE: -95.70880512
DIRECTION: 292°	SITE LOCATION: OOLOGAH, OKLAHOMA		
DESCRIPTION: Bottom Ash Pond Crest of Spillway. Concrete, Typical Conditions.

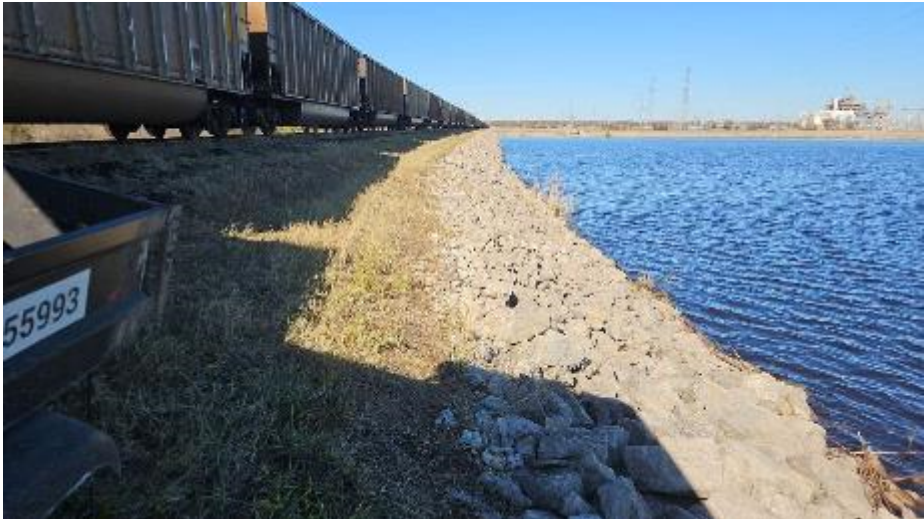
The Bottom Ash Pond Upstream Slope is in satisfactory condition. Generally, the upstream slope vegetation is healthy and maintained to 12-inches or less as shown in Photograph No. 8, No. 9, and No. 11. Vegetation along the southern upstream slope shown in Photograph No. 10 should be maintained to 12-inches or less. The riprap that exists along the upstream slope shoreline is compact and in good condition with no signs of erosion.

PHOTO BY: GEI CONSULTANTS, INC.			
PHOTOGRAPH NO: 8	DATE: November 6, 2024 1:36 PM	LATITUDE: 36.4214664	LONGITUDE: -95.70922242
DIRECTION: 279°	SITE LOCATION: OOLOGAH, OKLAHOMA		
DESCRIPTION: Bottom Ash Pond Upstream West Slope of Dam. General Photo, Typical Conditions.

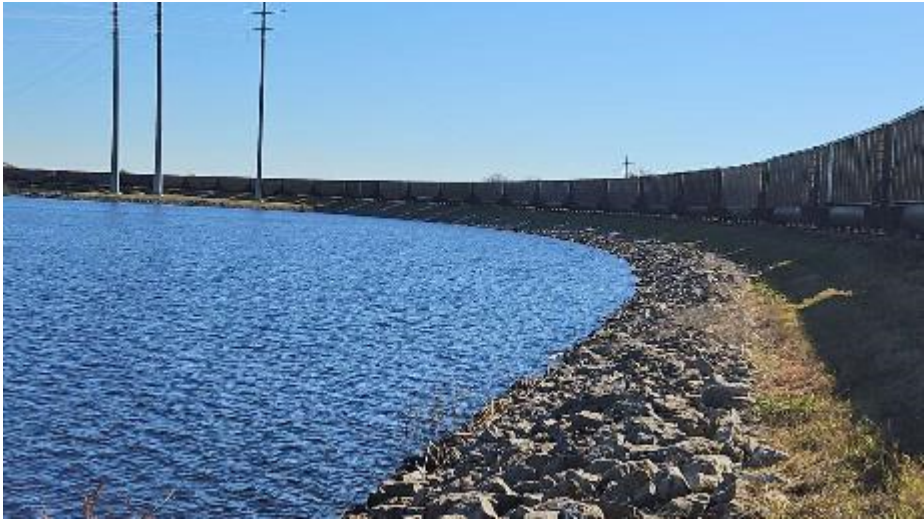
PHOTOGRAPH NO: 9	DATE: November 6, 2024 1:37 PM	LATITUDE: 36.42146564	LONGITUDE: -95.70922252
DIRECTION: 61°		SITE LOCATION: OOLOGAH, OKLAHOMA	
DESCRIPTION: Bottom Ash Pond Upstream Southwest Slope of Dam. General Photo, Typical Conditions.

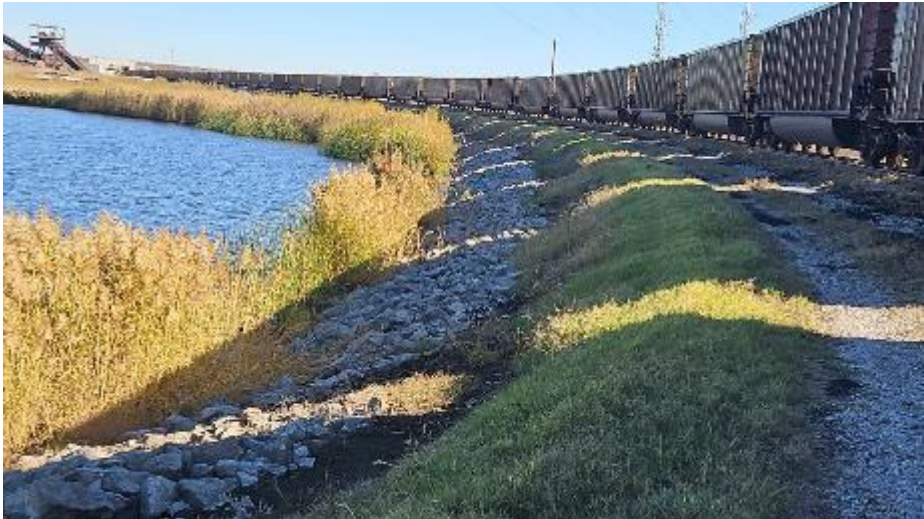
PHOTO BY: GEI CONSULTANTS, INC.			
PHOTOGRAPH NO: 10	DATE: November 6, 2024 1:38 PM	LATITUDE: 36.42143941	LONGITUDE: -95.70921718
DIRECTION: 5°		SITE LOCATION: OOLOGAH, OKLAHOMA	
DESCRIPTION: Bottom Ash Pond Upstream South Slope. Please address/maintain the vegetation to 12- inches or less along the shoreline.

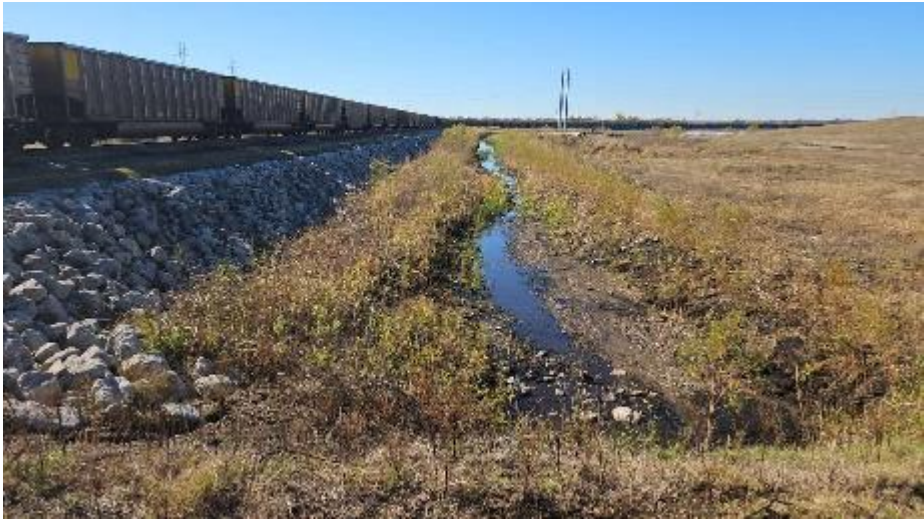
PHOTOGRAPH NO: 11	DATE: November 6, 2024 1:47 PM	LATITUDE: 36.41895859	LONGITUDE: -95.70732981
DIRECTION: 186°	SITE LOCATION: OOLOGAH, OKLAHOMA		
DESCRIPTION: Bottom Ash Pond Upstream South Slope of Dam. Inlet from Coal Yard Drainage. General Photo, Typical Conditions.

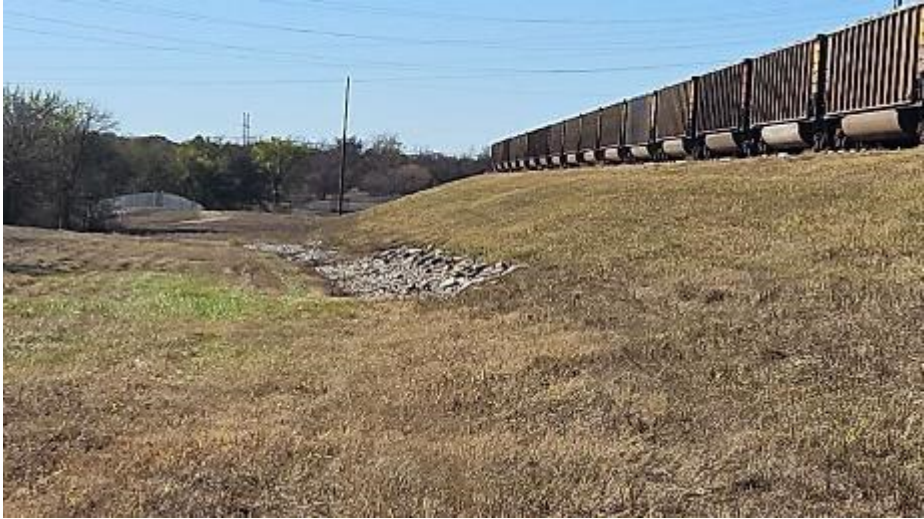
The Bottom Ash Pond Downstream Slope is in good condition. The vegetation is healthy and maintained to 12-inches or less as shown in Photograph No. 12, Photograph No. 13, and Photograph No. 14.

PHOTO BY: GEI CONSULTANTS, INC.			
PHOTOGRAPH NO: 12	DATE: November 6, 2024 1:58 PM	LATITUDE: 36.41835848	LONGITUDE: -95.70190474
DIRECTION: 189°	SITE LOCATION: OOLOGAH, OKLAHOMA		
DESCRIPTION: Bottom Ash Pond Downstream South Slope. General Photo, Typical Conditions.

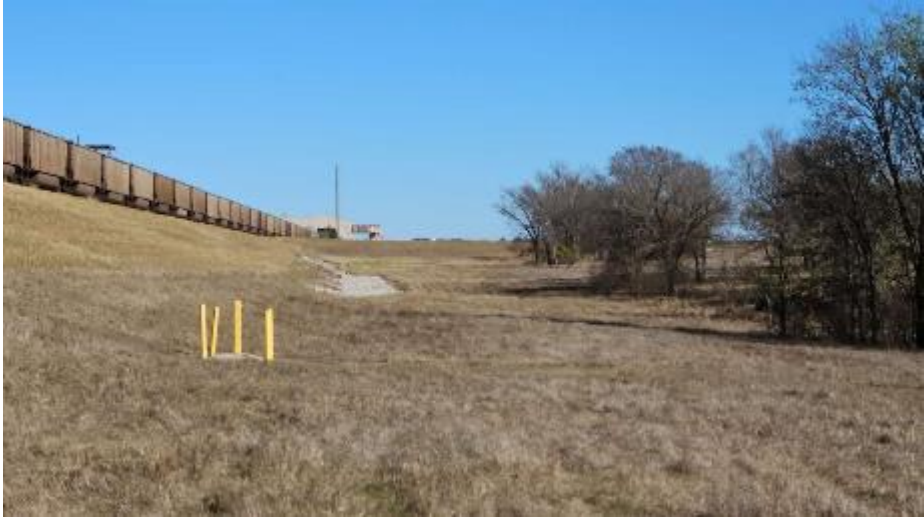
PHOTOGRAPH No: 13	DATE: November 6, 2024 2:03 PM	LATITUDE: 36.41825629	LONGITUDE: -95.70542427
DIRECTION: 353°		SITE LOCATION: OOLOGAH, OKLAHOMA	
DESCRIPTION: Bottom Ash Pond Downstream South Slope. This area was noted to be wet as a result of the 6-8 inches of precip that the site received in the week leading up to the inspection.

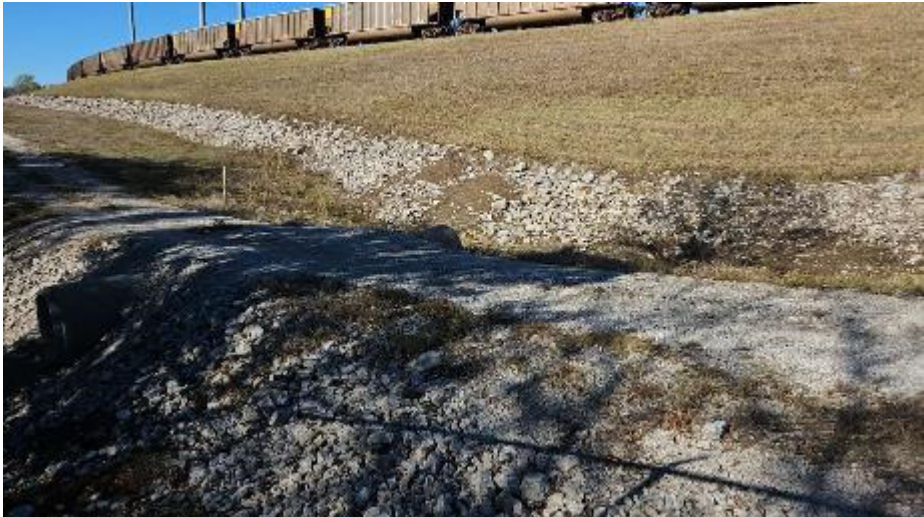
PHOTO BY: GEI CONSULTANTS, INC.			
PHOTOGRAPH No: 14	DATE: November 6, 2024 2:05 PM	LATITUDE: 36.41813652	LONGITUDE: -95.70621592
DIRECTION: 316°		SITE LOCATION: OOLOGAH, OKLAHOMA	
DESCRIPTION: Bottom Ash Pond Downstream Southwest Slope at the highest cross-section. General Photo, Typical Conditions.

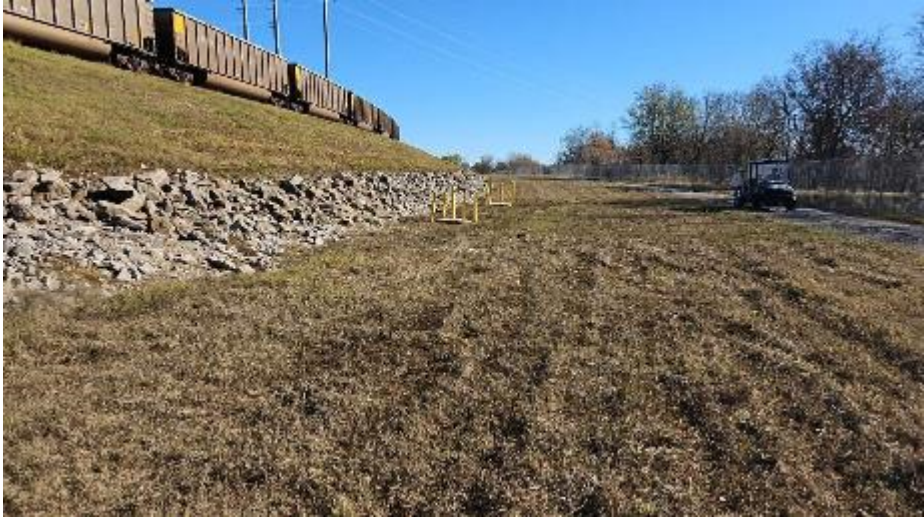
The Bottom Ash Pond Downstream Toe of Slope is satisfactory. The southwest and west downstream toe of slope areas were saturated given 6-8 inches of rain that the site received prior to the annual site inspection. Equipment should stay off these areas while ground conditions are soft. See Photograph No. 15 and No. 16.

PHOTOGRAPH No: 15	DATE: November 6, 2024 2:11 PM	LATITUDE: 36.42000128	LONGITUDE: -95.70902604
DIRECTION: 33°	SITE LOCATION: OOLOGAH, OKLAHOMA		
<p>DESCRIPTION:</p> <p>Bottom Ash Pond Downstream Southwest Slope of Dam. General Photo, Typical Conditions.</p> <p>This area was noted to be wet as a result of the 6-8 inches of precip that the site received in the week leading up to the inspection.</p>

The southern and western downstream toe of slope should be monitored for saturated conditions. No maintenance equipment should operate on the soft saturated subgrade.

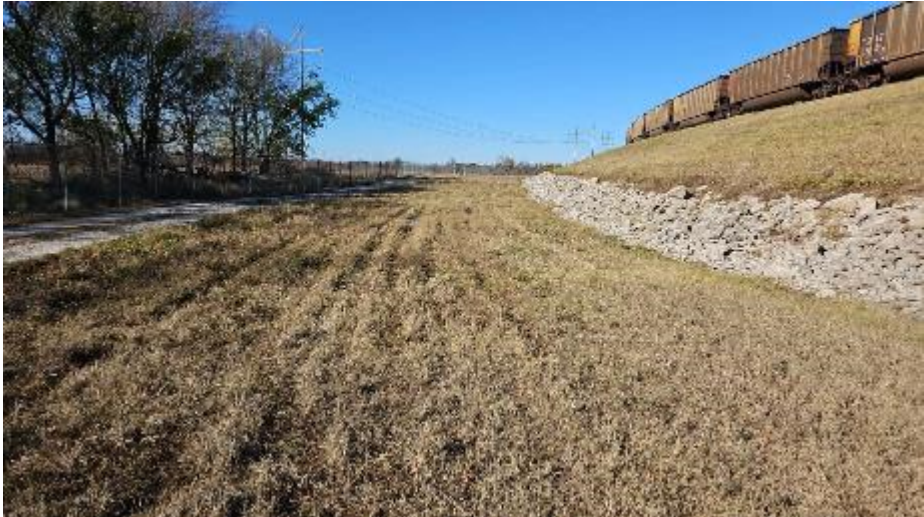
<p>PHOTO BY:</p> <p>GEI CONSULTANTS, INC.</p>			
PHOTOGRAPH No: 16	DATE: November 6, 2024 2:12 PM	LATITUDE: 36.42009846	LONGITUDE: -95.70909419
DIRECTION: 254°	SITE LOCATION: OOLOGAH, OKLAHOMA		
<p>DESCRIPTION:</p> <p>Bottom Ash Pond Downstream West Slope of Dam. General Photo, Typical Conditions.</p> <p>This area was noted to be wet as a result of the 6-8 inches of precip that the site received in the week leading up to the inspection.</p>
