Bottom Ash Ponds 2024 Annual Dam and Dike Inspection Report

H.W. Pirkey Power Plant, Hallsville, Texas

July 8, 2024

AEP Document ID: GEVR-24-001

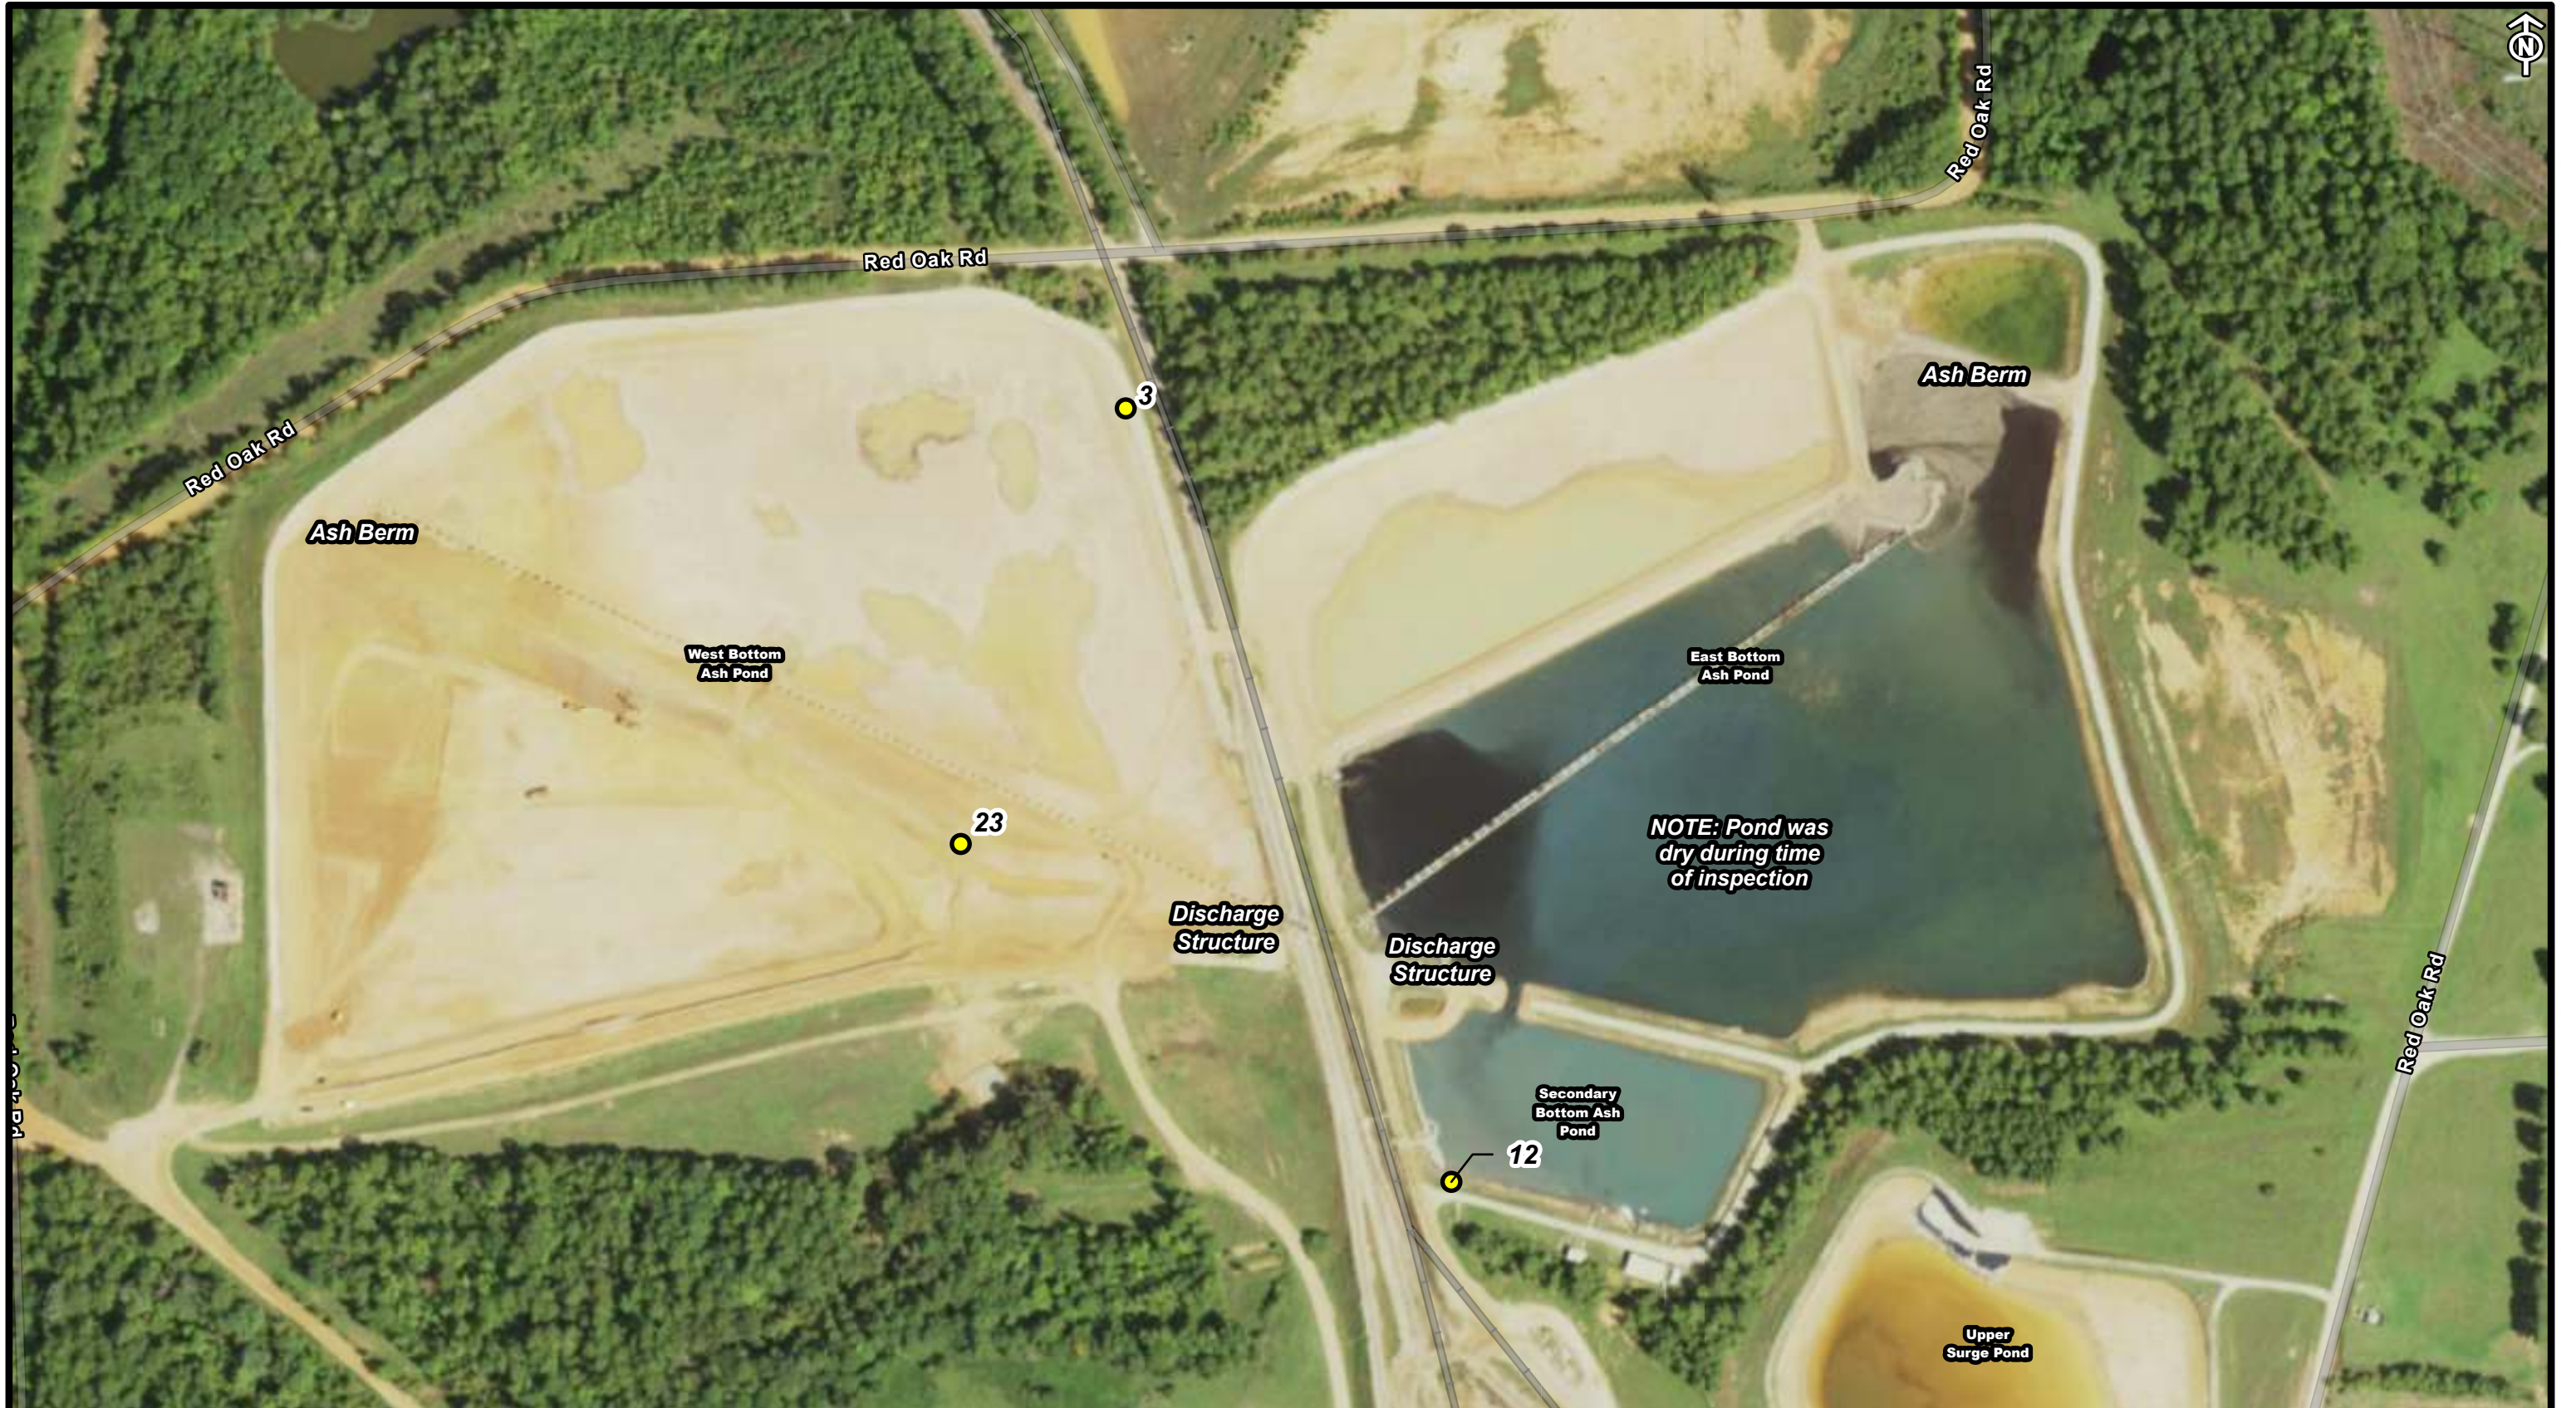
ITEMS TO BE MONITORED

- Item 3 – Monitor the rut for concentrated flow and additional erosion. Address as needed.
- Item 12 – Monitor the area for vegetation establishment / erosion. Address as needed.
- Item 23 – Monitor culvert outlet for build up of sediment. Address as needed.

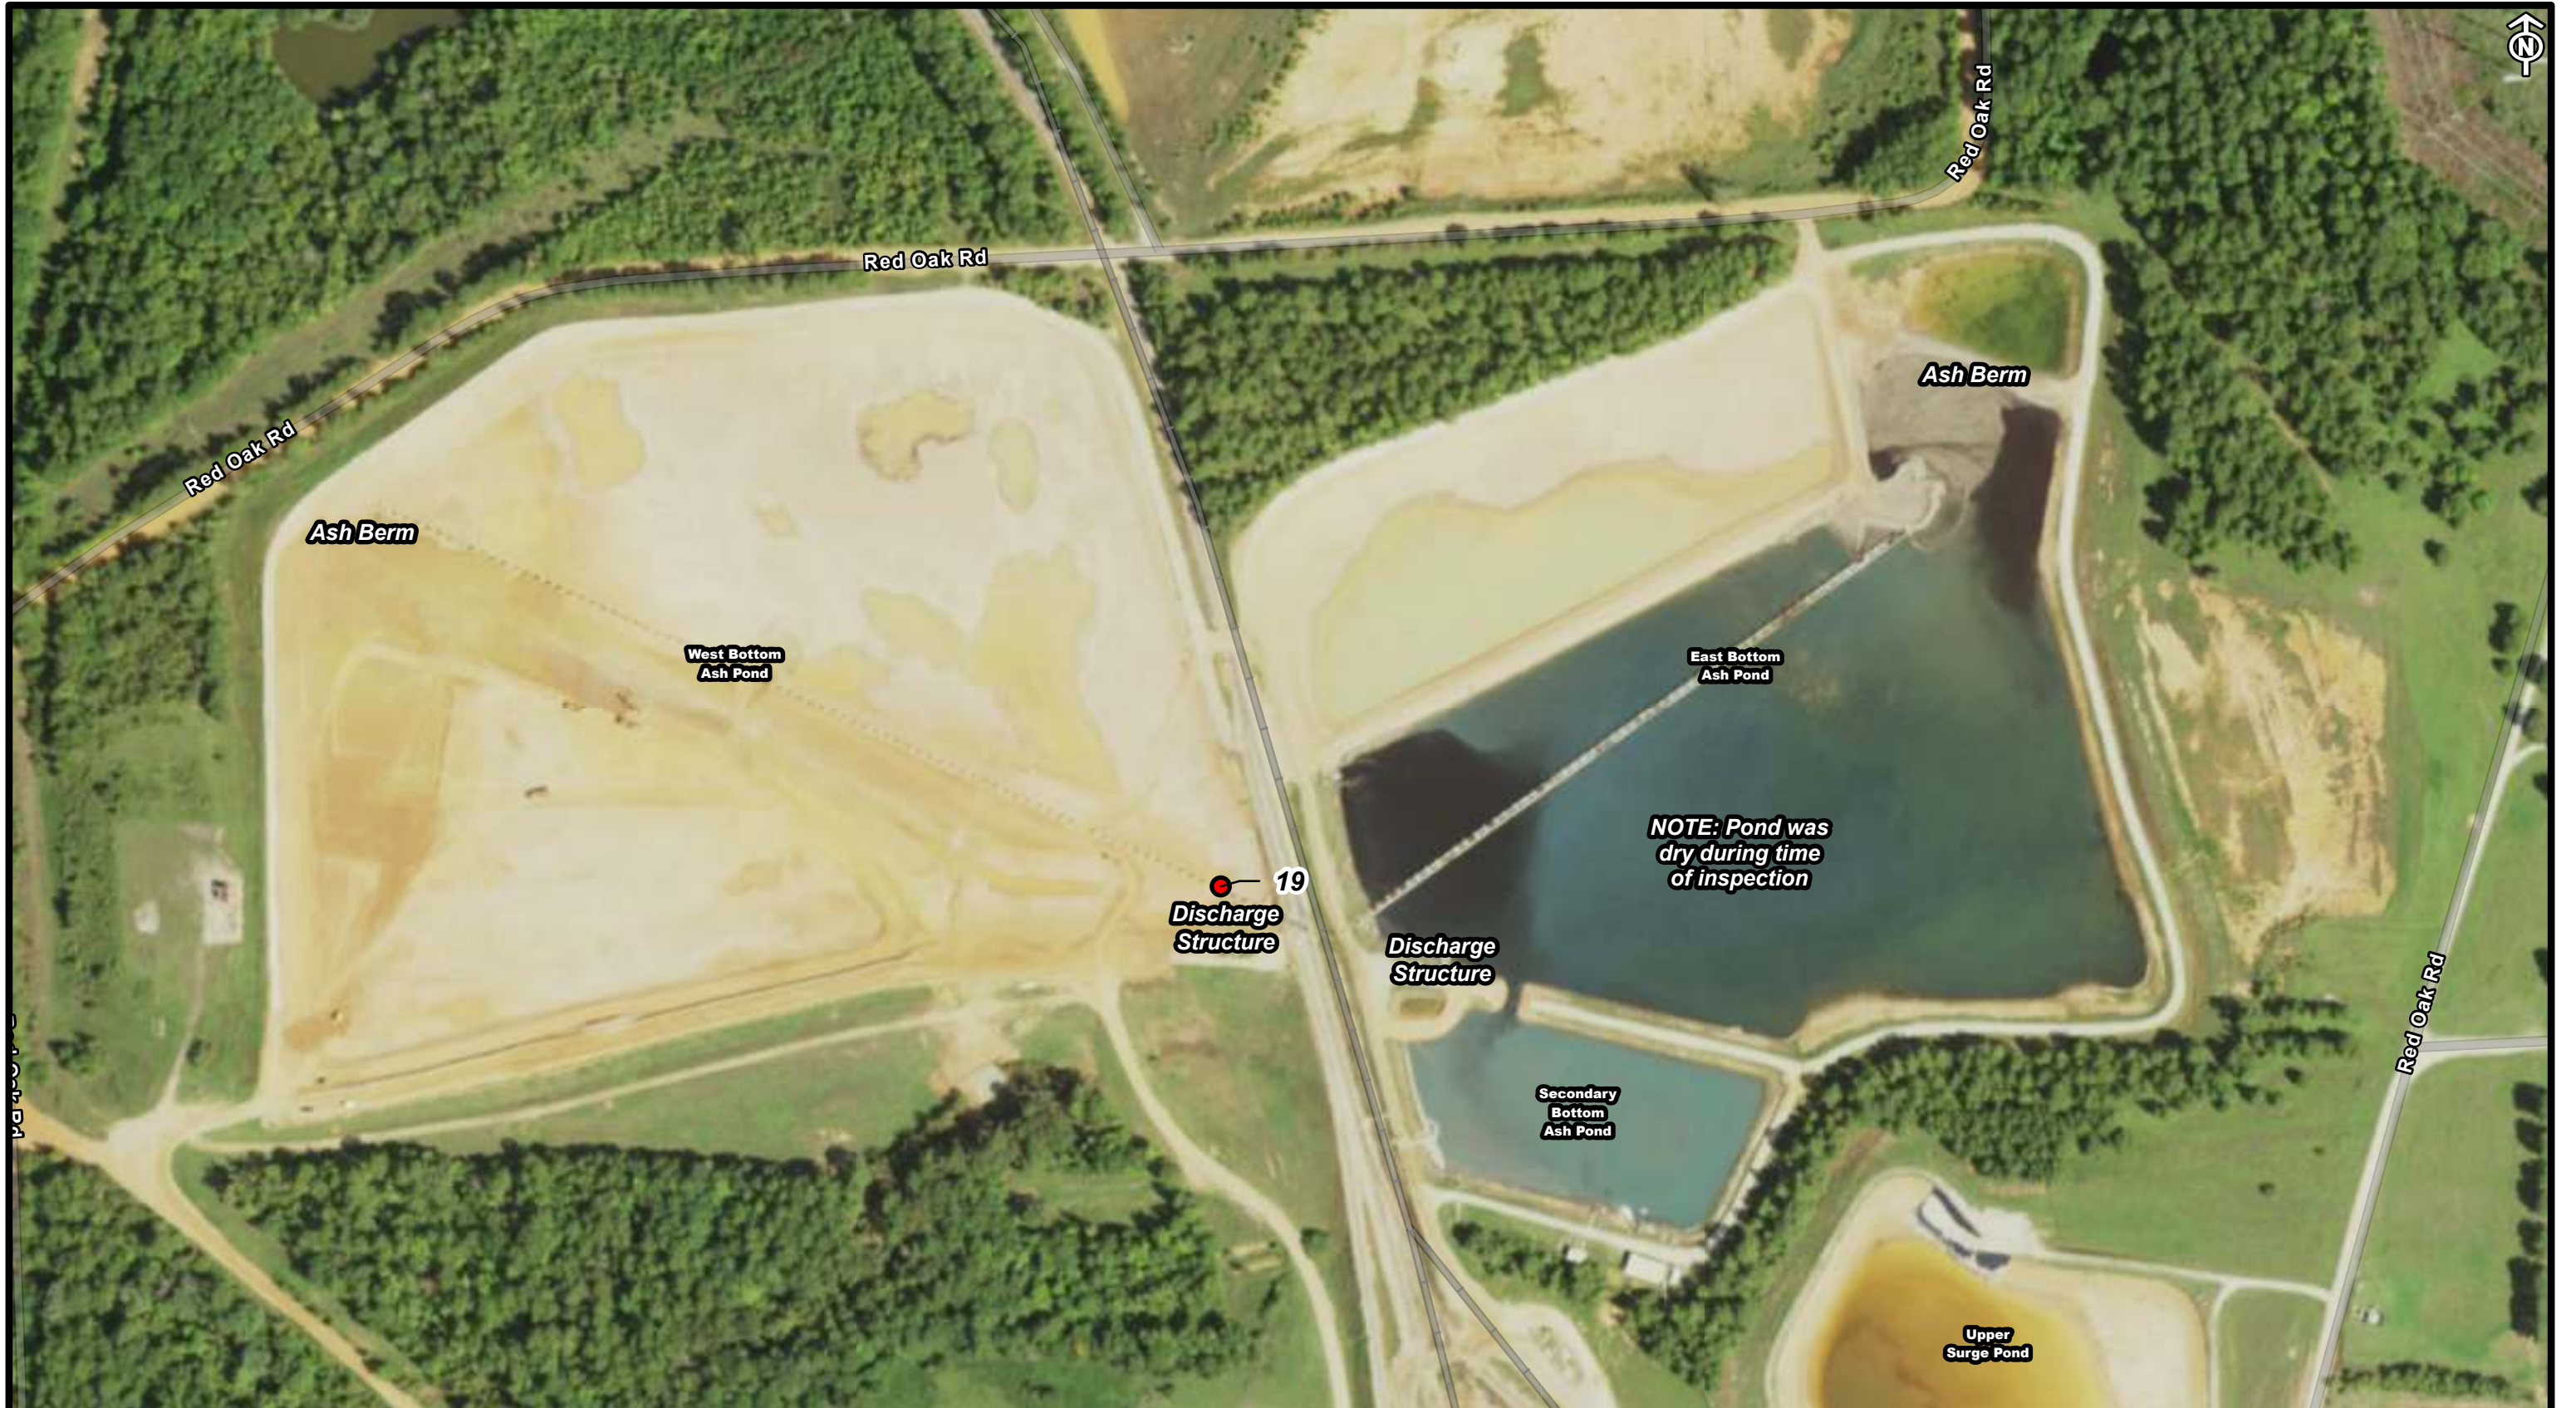
ITEMS TO BE ADDRESSED

- Item 19 – Significant Erosion to be addressed. Vegetation sparse. Regrade area and re-establish vegetation.

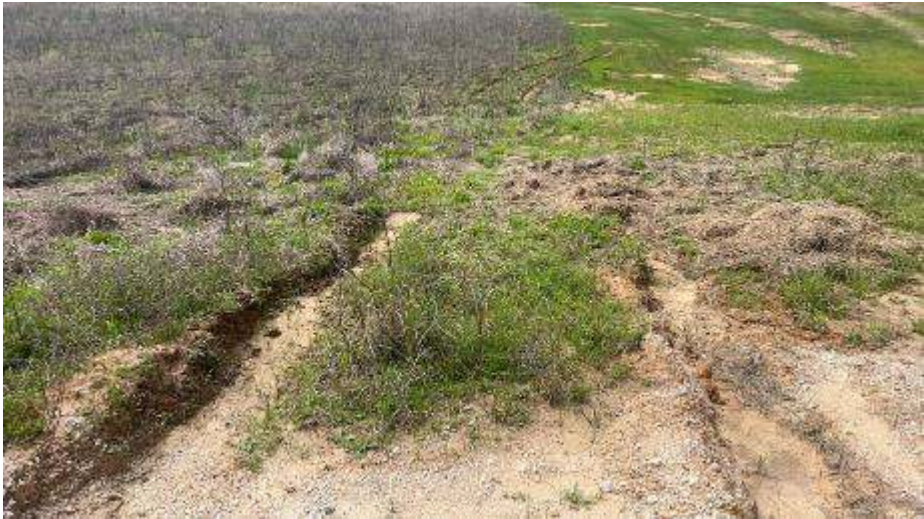
PHOTOGRAPH NO: 3	DATE: March 20, 2024 2:53 PM	LATITUDE: 32.4684570721057	LONGITUDE: -94.4897581711097
SITE LOCATION: HALLSVILLE, TEXAS			
DESCRIPTION: East area, Crest. Looking West. Ruts, Monitor Conditions.

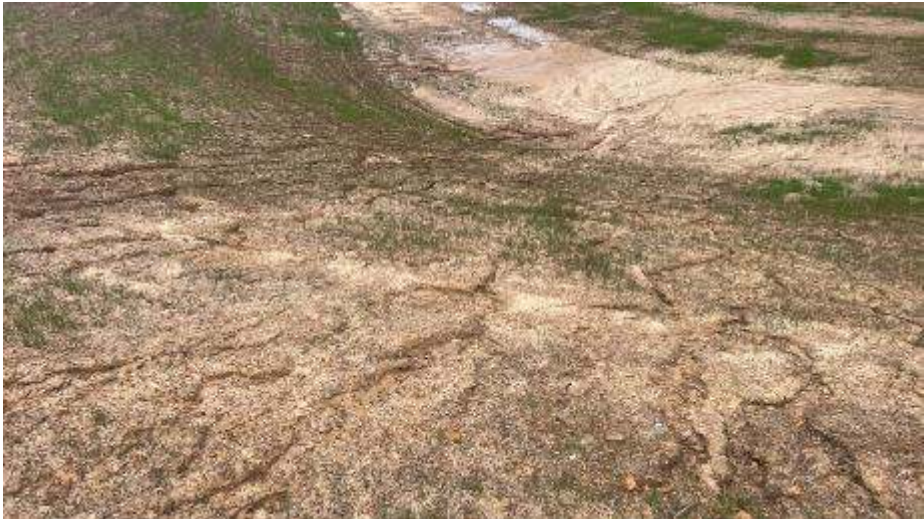
PHOTO BY: GEI CONSULTANTS, INC.			
PHOTOGRAPH No: 12	DATE: March 20, 2024 2:22 PM	LATITUDE: 32.4652087361673	LONGITUDE: -94.488314509223
SITE LOCATION: HALLSVILLE, TEXAS			
DESCRIPTION: South area, Upstream Slope. Looking Northeast. Minor Erosion, Monitor Conditions.

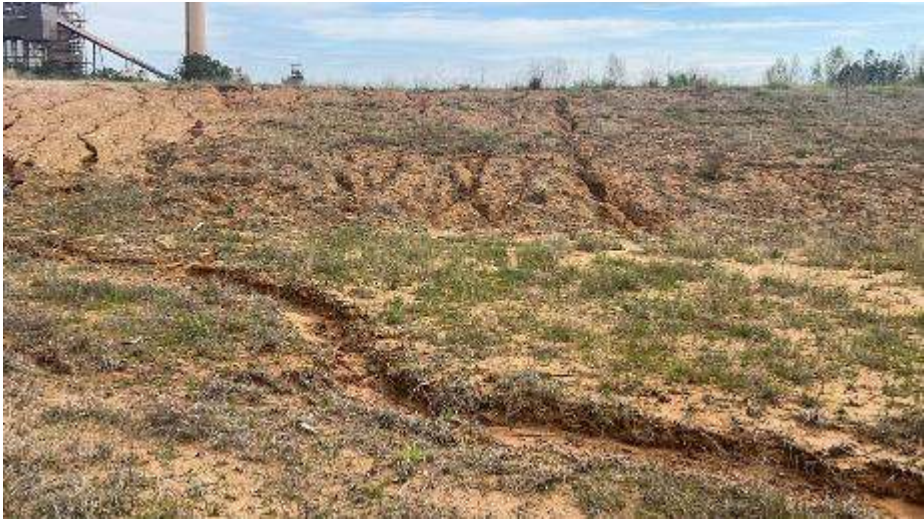
PHOTOGRAPH No: 19	DATE: March 20, 2024 3:02 PM	LATITUDE: 32.4664663179631	LONGITUDE: -94.4893840783756
SITE LOCATION: HALLSVILLE, TEXAS			
DESCRIPTION: South area, Upstream Slope. Looking Southeast. Major Erosion, please Repair.

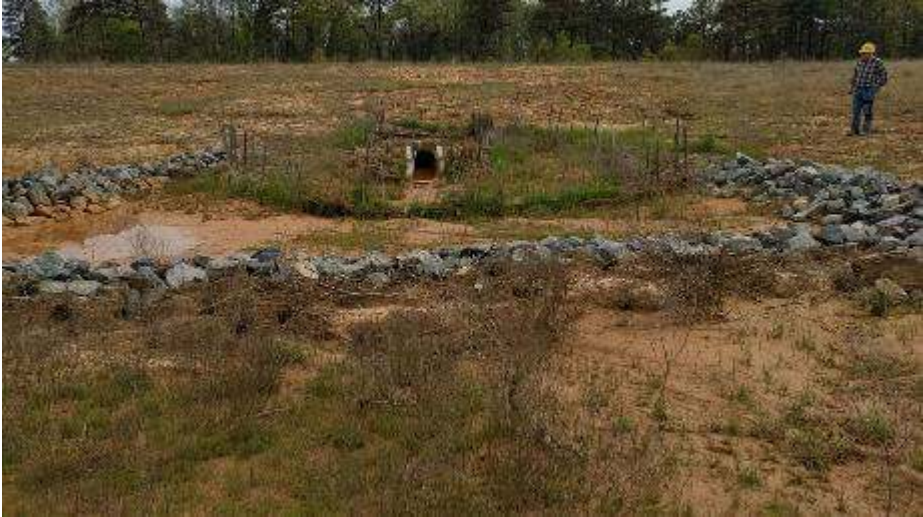
PHOTOGRAPH No: 23	DATE: March 20, 2024 3:09 PM	LATITUDE: 32.46668275	LONGITUDE: -94.49064368
SITE LOCATION: HALLSVILLE, TEXAS			
DESCRIPTION: Outlet Works area, 24" storm Drain Feature. Looking South. Monitor Conditions.
