## CCR Landfill and Leachate Collection 2024 Annual Inspection Report

Rockport Plant, Rockport, Indiana

September 3, 2024

AEP Document ID: GEVR-24-013

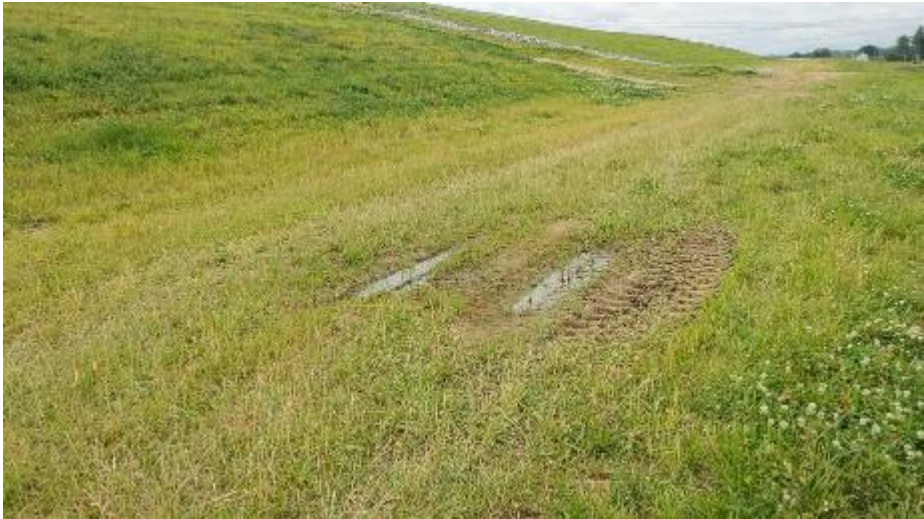
1. The perimeter ditches to the West and South were in good condition with no signs of erosion or blockage. Some isolated areas with ponding water and rutting were identified as items to be monitored or addressed (Photo No. 3, No. 5, and No. 6).

<b>PHOTOGRAPH NO: 3</b>	<b>DATE:</b> June 5, 2024 9:48 AM	<b>LATITUDE:</b> 37.94390696	<b>LONGITUDE:</b> -87.01760605
<b>DIRECTION:</b> Southeast	<b>SITE LOCATION:</b> ROCKPORT, INDIANA		
<b>DESCRIPTION:</b>  CCR Landfill, side slope and toe of slope. Looking Southeast. Ponding water, soft area, ruts. Monitor area and if water continues to pond, consider regrading the area to maintain positive drainage.

Item 3 – Monitor the soft spots and rutting along the toe of slope on the western edge of Cell 3. If ponding water and rutting continues to be observed, consider regrading the area to improve/maintain positive drainage.

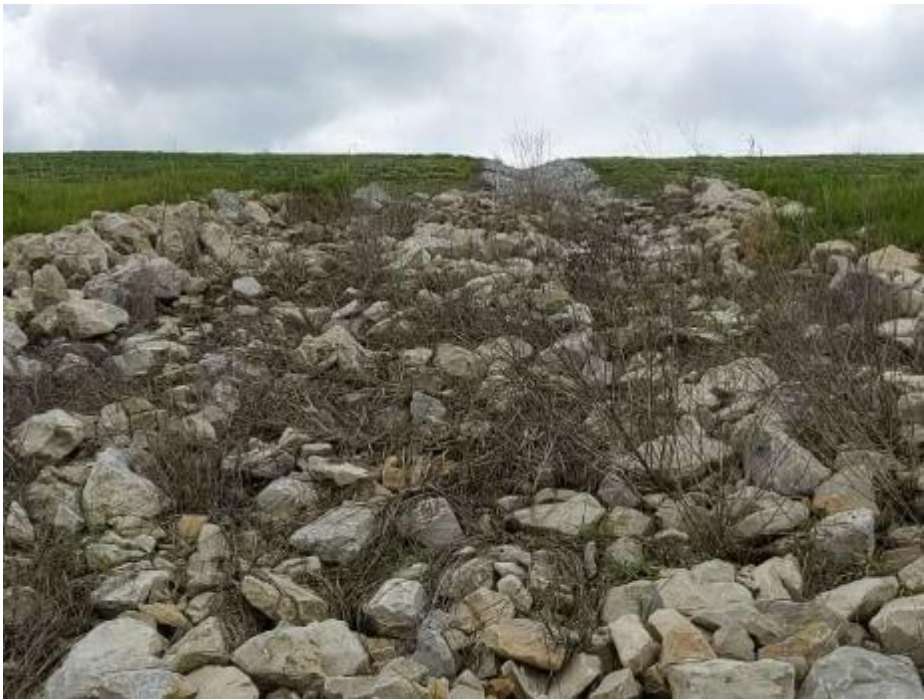
<b>PHOTO BY:</b>  GEI CONSULTANTS, INC.			
<b>PHOTOGRAPH NO: 4</b>	<b>DATE:</b> June 5, 2024 9:52 AM	<b>LATITUDE:</b> 37.94347597	<b>LONGITUDE:</b> -87.01781265
<b>DIRECTION:</b> East	<b>SITE LOCATION:</b> ROCKPORT, INDIANA		
<b>DESCRIPTION:</b>  CCR Landfill, Riprap down-chute stormwater feature Looking East. Typical Conditions.

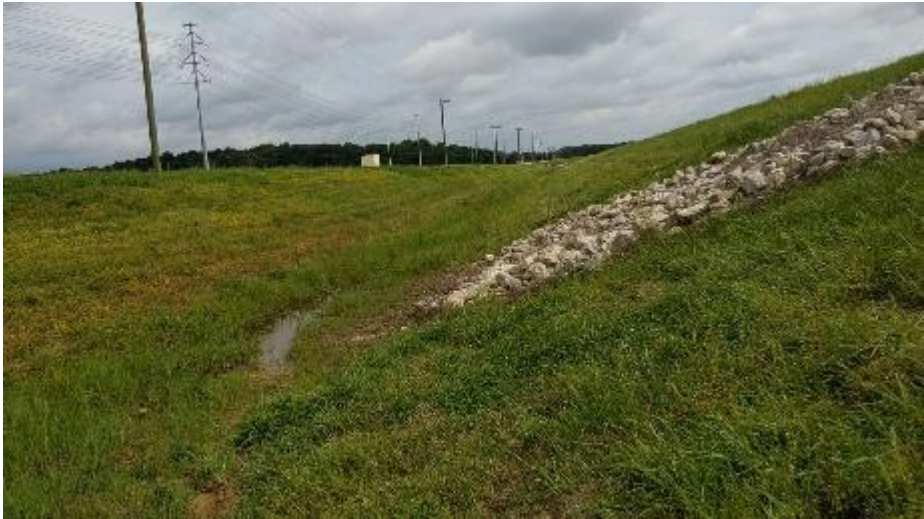
<b>PHOTOGRAPH NO: 5</b>	<b>DATE:</b> June 5, 2024 9:58 AM	<b>LATITUDE:</b> 37.94223329	<b>LONGITUDE:</b> -87.01765469
<b>DIRECTION:</b> Northwest	<b>SITE LOCATION:</b> ROCKPORT, INDIANA		
<b>DESCRIPTION:</b>  CCR Landfill, Toe of slope, perimeter ditch. Looking northwest. Note ponding water in ditch.

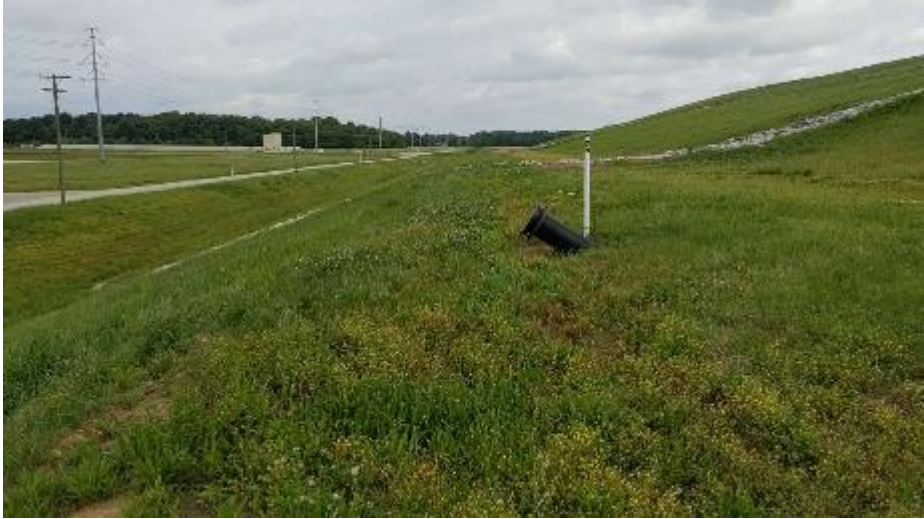
1. Cells 1A, 1B, 2 and 3 were generally in good condition. The vegetative cover was well established and controlled with mowing (Photo No. 1, No. 6., No. 24 and No. 25). Stormwater features (riprap down-chutes and culverts) were unobstructed (Photos No. 4, No. 5, No. 10, No. 11, and No. 12). Isolated wet areas with minor rutting (Photo No. 3 and No. 5), an isolated area of significant erosion (Photo No. 9), and an isolated area of stressed vegetation were identified as items to be monitored or addressed.
2. The chimney drains appear to be functioning as designed.

<b>PHOTO BY:</b>  GEI CONSULTANTS, INC.			
<b>PHOTOGRAPH NO: 6</b>	<b>DATE:</b> June 5, 2024 10:02 AM	<b>LATITUDE:</b> 37.94192859	<b>LONGITUDE:</b> -87.01765655
<b>DIRECTION:</b> North	<b>SITE LOCATION:</b> ROCKPORT, INDIANA		
<b>DESCRIPTION:</b>  CCR Landfill, toe of slope and side slope riser. General photo with perennial grass.

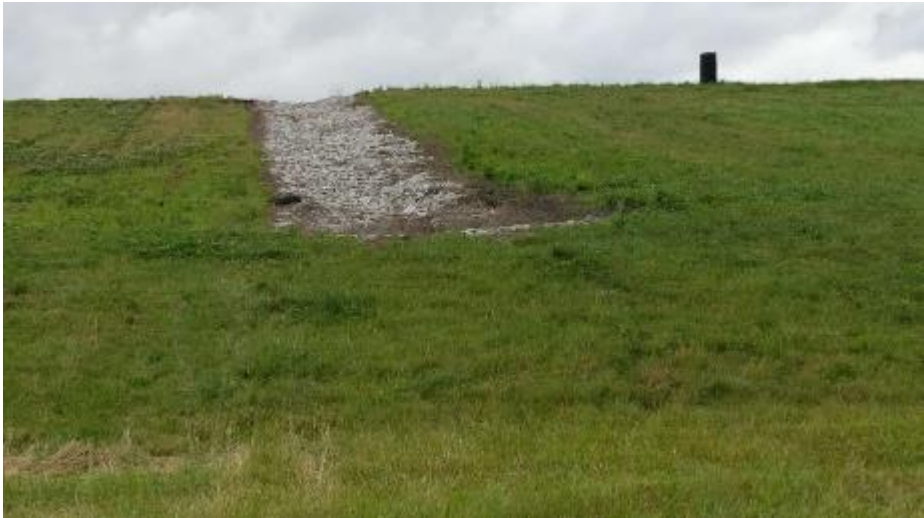
<b>PHOTOGRAPH NO: 9</b>	<b>DATE:</b> June 5, 2024 10:13 AM	<b>LATITUDE:</b> 37.94211513	<b>LONGITUDE:</b> -87.01561064
<b>DIRECTION:</b> North	<b>SITE LOCATION:</b> ROCKPORT, INDIANA		
<b>DESCRIPTION:</b>  CCR Landfill, Sideslope. Looking North. Significant Erosion, Please address.	 		
<b>PHOTO BY:</b>  GEI CONSULTANTS, INC.			
<b>PHOTOGRAPH NO: 10</b>	<b>DATE:</b> June 5, 2024 10:21 AM	<b>LATITUDE:</b> 37.94259693	<b>LONGITUDE:</b> -87.01438508
<b>DIRECTION:</b> North	<b>SITE LOCATION:</b> ROCKPORT, INDIANA		
<b>DESCRIPTION:</b>  CCR Landfill, Sideslope of Interim Cover. Looking North. Note Stormwater Runoff Drainage Channel and Chimney Drain.

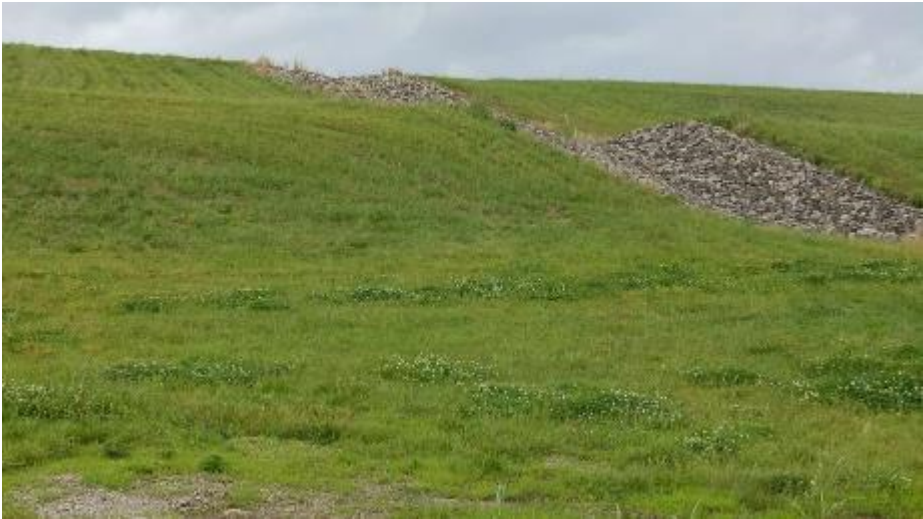
<b>PHOTOGRAPH No: 11</b>	<b>DATE:</b> June 5, 2024 10:29 AM	<b>LATITUDE:</b> 37.9431306	<b>LONGITUDE:</b> -87.01247514
<b>DIRECTION:</b> North		<b>SITE LOCATION:</b> ROCKPORT, INDIANA	
<b>DESCRIPTION:</b>  CCR Landfill, Sideslope of Interim Cover. Looking North. General Photo, Typical Conditions.

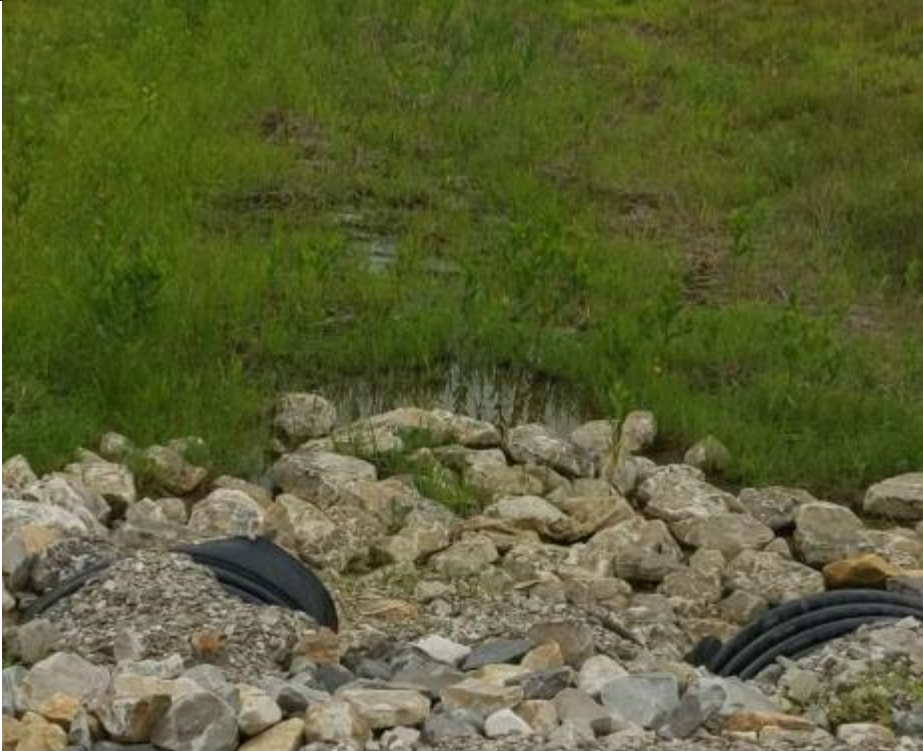
<b>PHOTO BY:</b>  GEI CONSULTANTS, INC.			
<b>PHOTOGRAPH No: 12</b>	<b>DATE:</b> June 5, 2024 10:30 AM	<b>LATITUDE:</b> 37.94312281	<b>LONGITUDE:</b> -87.01245894
<b>DIRECTION:</b> West		<b>SITE LOCATION:</b> ROCKPORT, INDIANA	
<b>DESCRIPTION:</b>  CCR Landfill. Perimeter Ditch. Looking West. Note unobstructed culverts. Typical Conditions.

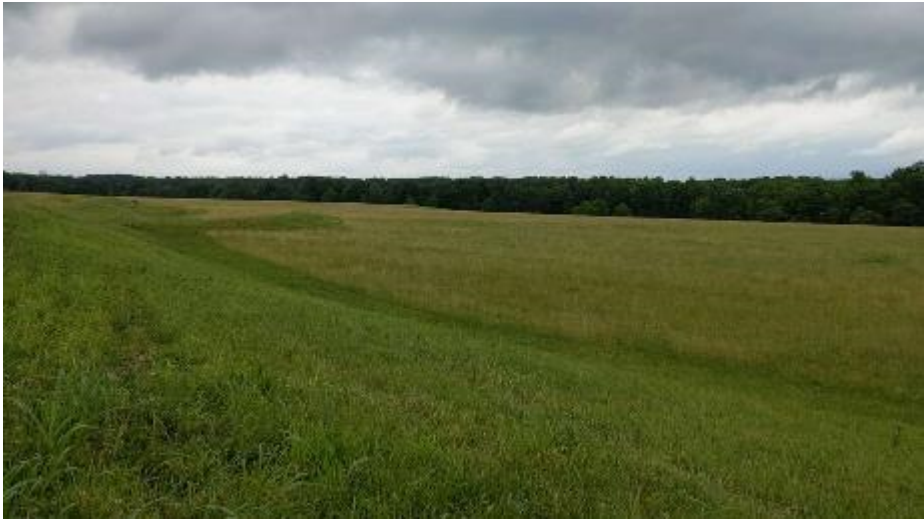
1. The Closed Landfill (Type II Liner) was in good condition. The vegetative cover was well established, controlled with mowing, and in good condition with no apparent signs of erosion or seepage (Photo No. 15 and No. 20).

<b>PHOTOGRAPH No: 15</b>	<b>DATE:</b> June 5, 2024 10:50 AM	<b>LATITUDE:</b> 37.94594271	<b>LONGITUDE:</b> -87.00970562
<b>DIRECTION:</b> Northeast	<b>SITE LOCATION:</b> ROCKPORT, INDIANA		
<b>DESCRIPTION:</b>  CCR Landfill. Final Vegetation Cover of Closed Landfill. Looking Northeast. General Photo, Typical Conditions.

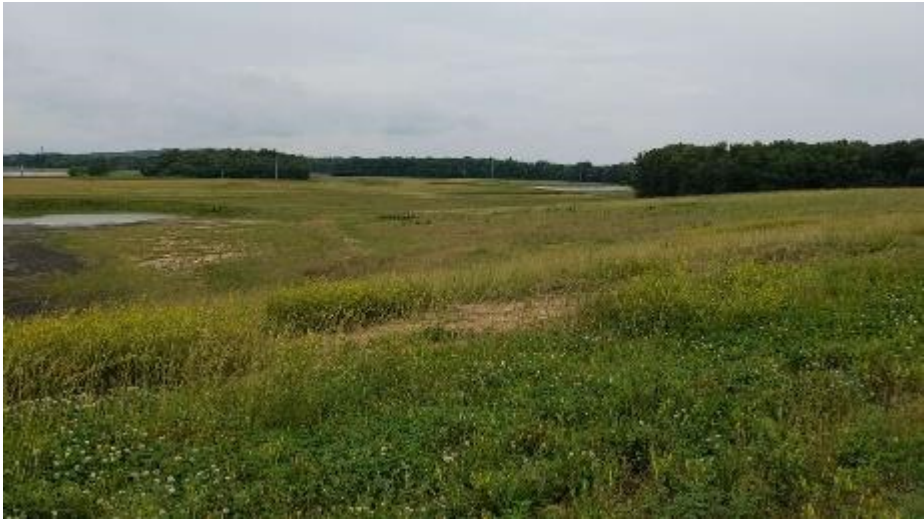
<b>PHOTOGRAPH No: 19</b>	<b>DATE:</b> June 5, 2024 11:06 AM	<b>LATITUDE:</b> 37.94866145	<b>LONGITUDE:</b> -87.01044452
<b>DIRECTION:</b> Southeast	<b>SITE LOCATION:</b> ROCKPORT, INDIANA		
<b>DESCRIPTION:</b>  CCR Landfill Crest - Looking Southeast. Note transition between active and inactive area. Typical Condition of Interim Cover.

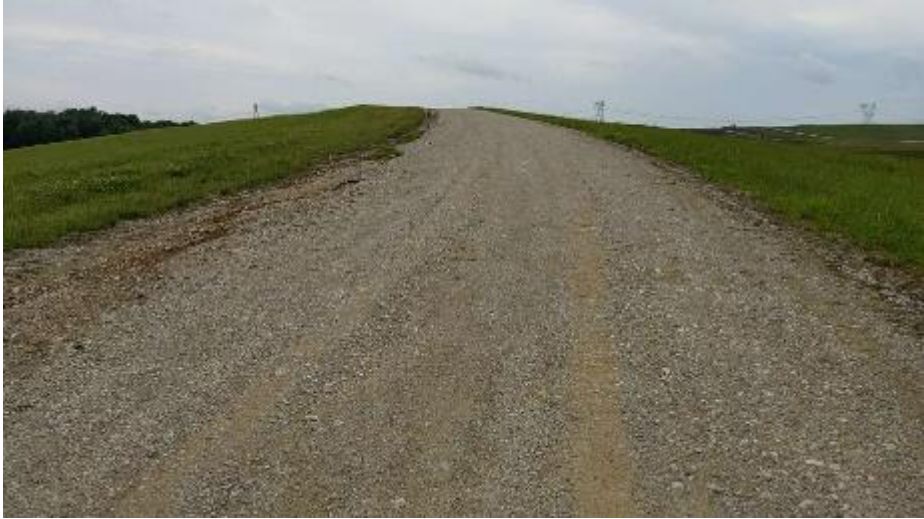
<b>PHOTO BY:</b>  GEI CONSULTANTS, INC.			
<b>PHOTOGRAPH No: 20</b>	<b>DATE:</b> June 5, 2024 11:21 AM	<b>LATITUDE:</b> 37.95252886	<b>LONGITUDE:</b> -87.01219039
<b>DIRECTION:</b> South	<b>SITE LOCATION:</b> ROCKPORT, INDIANA		
<b>DESCRIPTION:</b>  CCR Landfill. North end of closed area. Looking South. Note Access Road and Vegetated Final Cover.

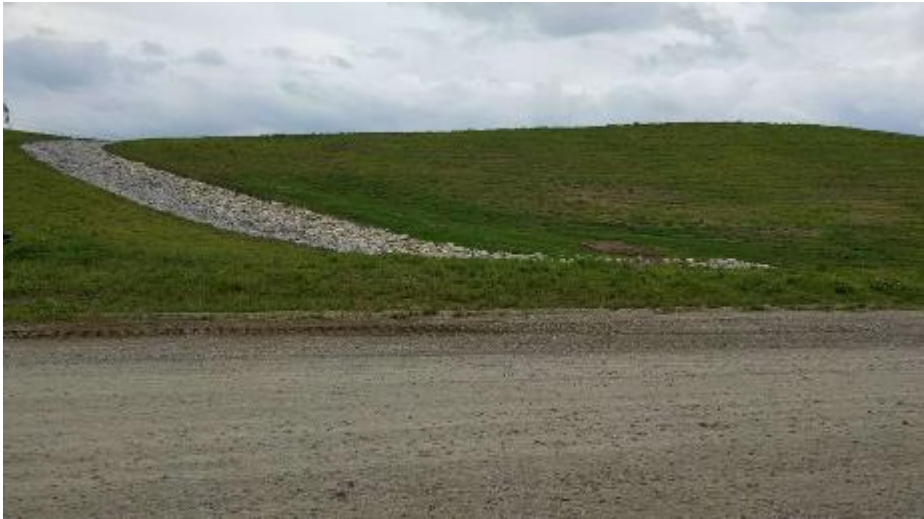
<b>PHOTOGRAPH No: 23</b>	<b>DATE:</b> June 5, 2024 11:46 AM	<b>LATITUDE:</b> 37.94606461	<b>LONGITUDE:</b> -87.0138681
<b>DIRECTION:</b> South	<b>SITE LOCATION:</b> ROCKPORT, INDIANA		
<b>DESCRIPTION:</b>  CCR Landfill. Downstream Slope of Interim Cover. Looking South. General Photo, Typical Conditions. Note Stormwater Riprap Channel.

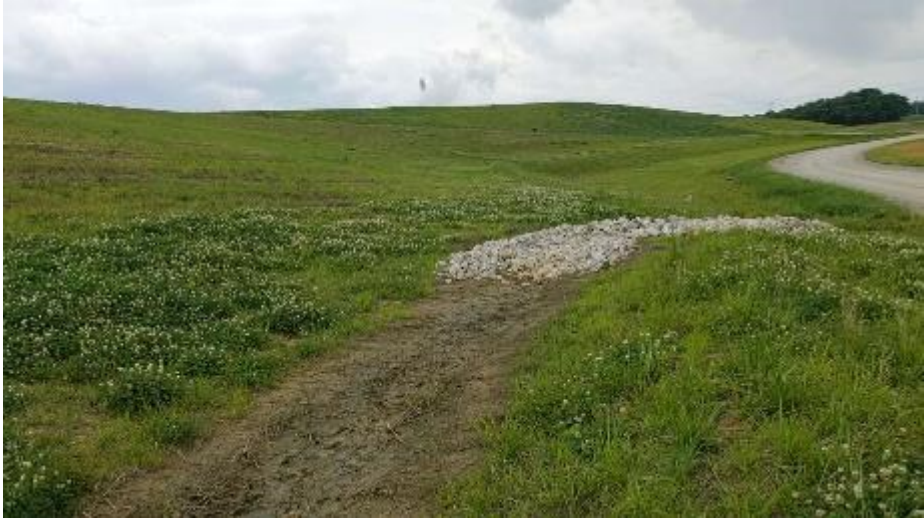
<b>PHOTO BY:</b>  GEI CONSULTANTS, INC.			
<b>PHOTOGRAPH No: 24</b>	<b>DATE:</b> June 5, 2024 11:50 AM	<b>LATITUDE:</b> 37.94558571	<b>LONGITUDE:</b> -87.01448928
<b>DIRECTION:</b> Southwest	<b>SITE LOCATION:</b> ROCKPORT, INDIANA		
<b>DESCRIPTION:</b>  CCR Landfill, Downstream Slope. Looking Southwest. General Photo, Typical Conditions.

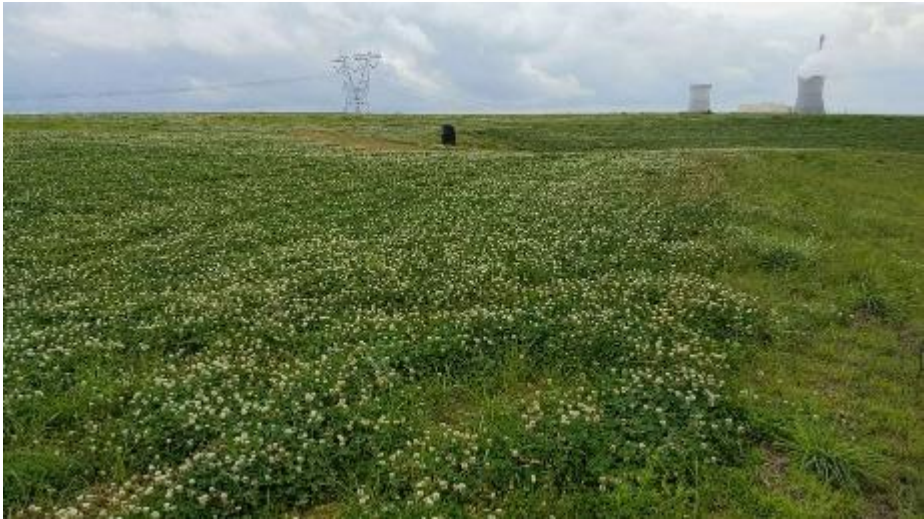
<b>PHOTOGRAPH No: 25</b>	<b>DATE:</b> June 5, 2024 11:53 AM	<b>LATITUDE:</b> 37.9449139	<b>LONGITUDE:</b> -87.01440767
<b>DIRECTION:</b> South	<b>SITE LOCATION:</b> ROCKPORT, INDIANA		
<b>DESCRIPTION:</b>  CCR Landfill, Crest. Note Interim Vegetation Cover. Looking South. General Photo, Typical Conditions.

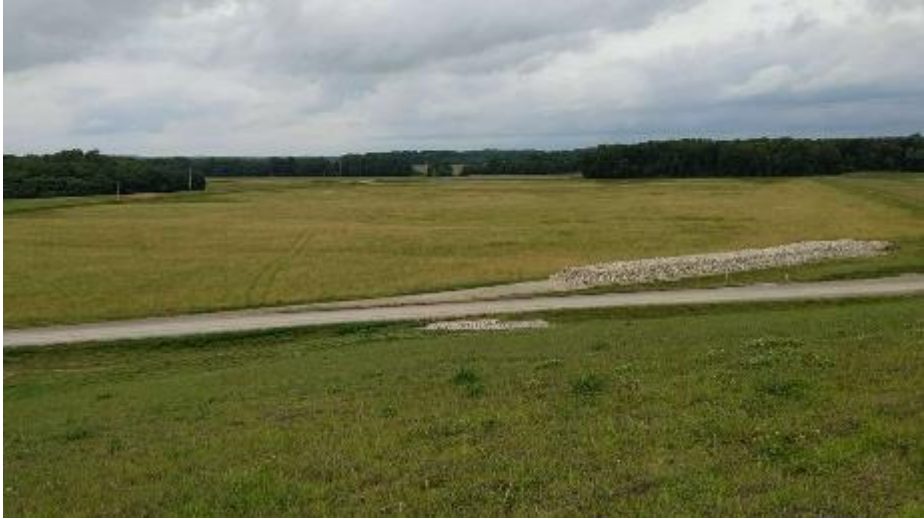
1. The inactive landfill cells 4B, 6, and 7 were in good condition. The vegetative cover was well established and in good condition with no apparent signs of erosion or seepage (Photo No. 22 and No. 26).

<b>PHOTO BY:</b>  GEI CONSULTANTS, INC.			
<b>PHOTOGRAPH No: 26</b>	<b>DATE:</b> June 5, 2024 11:55 AM	<b>LATITUDE:</b> 37.94493011	<b>LONGITUDE:</b> -87.01441943
<b>DIRECTION:</b> North	<b>SITE LOCATION:</b> ROCKPORT, INDIANA		
<b>DESCRIPTION:</b>  CCR Landfill, Inactive Cells 4A, 6, and 7. Looking North. General Photo, Typical Conditions. Note North Leachate Collection Pond in background.

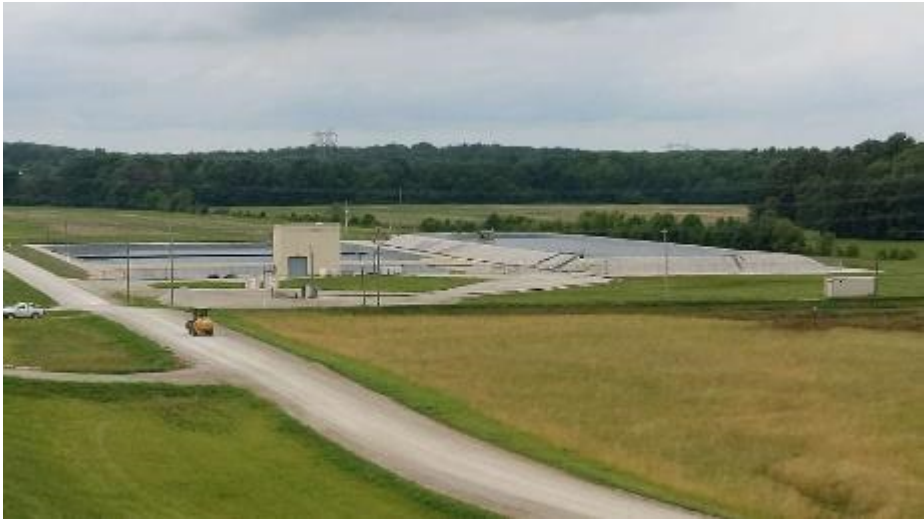
<b>PHOTOGRAPH No: 27</b>	<b>DATE:</b> June 5, 2024 11:57 AM	<b>LATITUDE:</b> 37.94491849	<b>LONGITUDE:</b> -87.01445681
<b>DIRECTION:</b> West	<b>SITE LOCATION:</b> ROCKPORT, INDIANA		
<b>DESCRIPTION:</b>  West Leachate Collection Pond and Leachate 002 Pond. Looking West. General Photo, Typical Conditions.

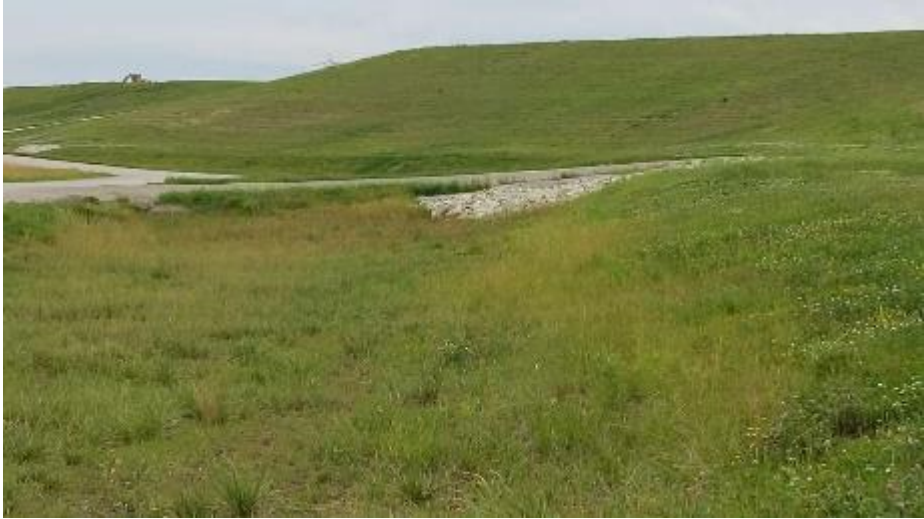
<b>PHOTO BY:</b>  GEI CONSULTANTS, INC.			
<b>PHOTOGRAPH No: 28</b>	<b>DATE:</b> June 5, 2024 12:05 PM	<b>LATITUDE:</b> 37.94507664	<b>LONGITUDE:</b> -87.01760554
<b>DIRECTION:</b> East	<b>SITE LOCATION:</b> ROCKPORT, INDIANA		
<b>DESCRIPTION:</b>  CCR Landfill Perimeter Ditch. Note Rirap Channel. Looking East. General Photo, Typical Conditions.

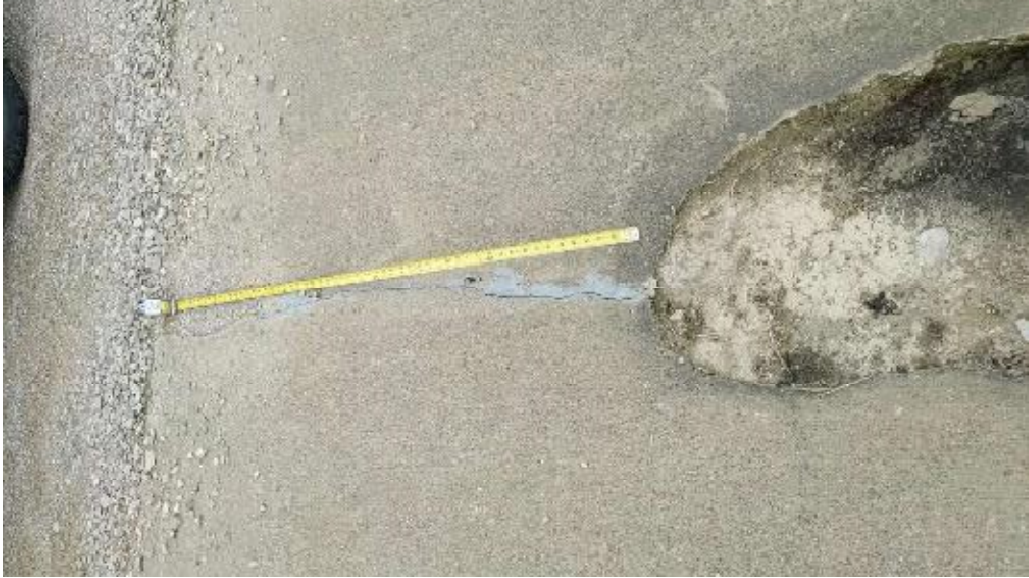
1. The small crack in the concrete liner of the West Pond previously reported was located just above the leachate outlet pipes entering the pond from the south. Photo No. 29 – Please monitor and consider routing the existing concrete crack to a width of ¼ - ½ of an inch and caulking it with MasterSeal NP1 to reduce concrete weathering.
2. The West Pond is generally in good condition with no signs of damage (except for small crack noted above).
3. The LLDPE lined portion of the West Pond appeared to be in good condition.

<b>PHOTOGRAPH No: 29</b>	<b>DATE:</b> June 5, 2024 12:11 PM	<b>LATITUDE:</b> 37.94542309	<b>LONGITUDE:</b> -87.01922367
<b>DIRECTION:</b> NA	<b>SITE LOCATION:</b> ROCKPORT, INDIANA		
<b>DESCRIPTION:</b>  West Pond, Upstream Slope. Monitor area and apply MasterSeal NP1 or equivalent caulk reduce weathering. 1/2" of vertical differential, 1/8" width.

Item 29 – Monitor Leachate Ponds for concrete cracks and address as needed with elastomeric caulking materials such as MasterSeal NP1 or equivalent.

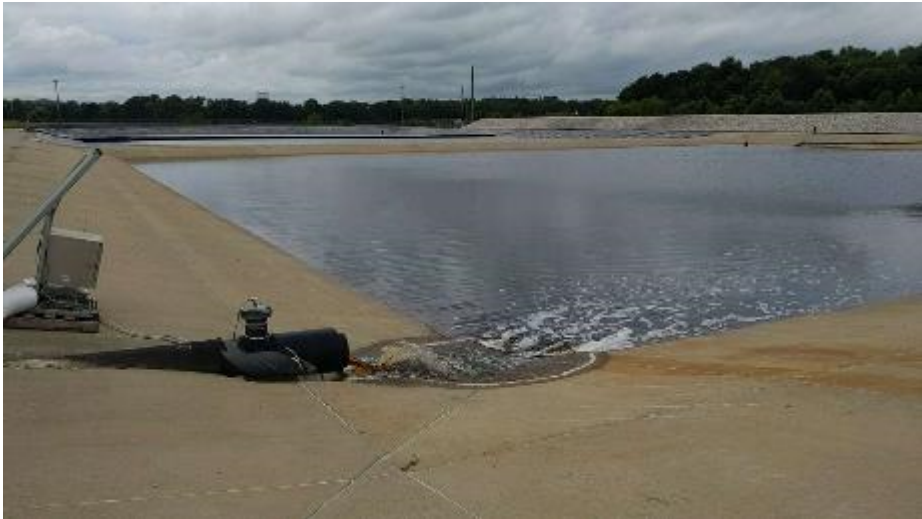
<b>PHOTO BY:</b>  GEI CONSULTANTS, INC.			
<b>PHOTOGRAPH No: 30</b>	<b>DATE:</b> June 5, 2024 12:19 PM	<b>LATITUDE:</b> 37.9454007	<b>LONGITUDE:</b> -87.01919551
<b>DIRECTION:</b> West	<b>SITE LOCATION:</b> ROCKPORT, INDIANA		
<b>DESCRIPTION:</b>  West Pond. Looking West. General Photo, Typical Conditions.

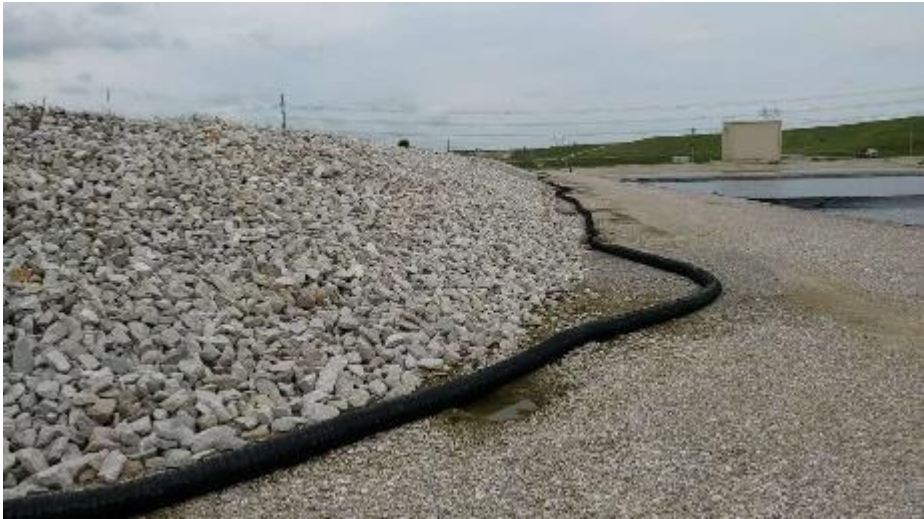
6. The downstream slopes of Leachate Pond 002 appeared in good condition. The downstream slopes seem to be stable and the riprap revetment has prevented erosion and woody vegetation establishment (Photos No. 31, No. 33 and No. 34).

<b>PHOTOGRAPH No: 31</b>	<b>DATE:</b> June 5, 2024 12:25 PM	<b>LATITUDE:</b> 37.94621767	<b>LONGITUDE:</b> -87.0211064
<b>DIRECTION:</b> East	<b>SITE LOCATION:</b> ROCKPORT, INDIANA		
<b>DESCRIPTION:</b>  West Pond/ 002 Leachate Pond. Downstream Slope of 002 Pond. Looking East. Ground Cover Riprap, Typical Conditions.

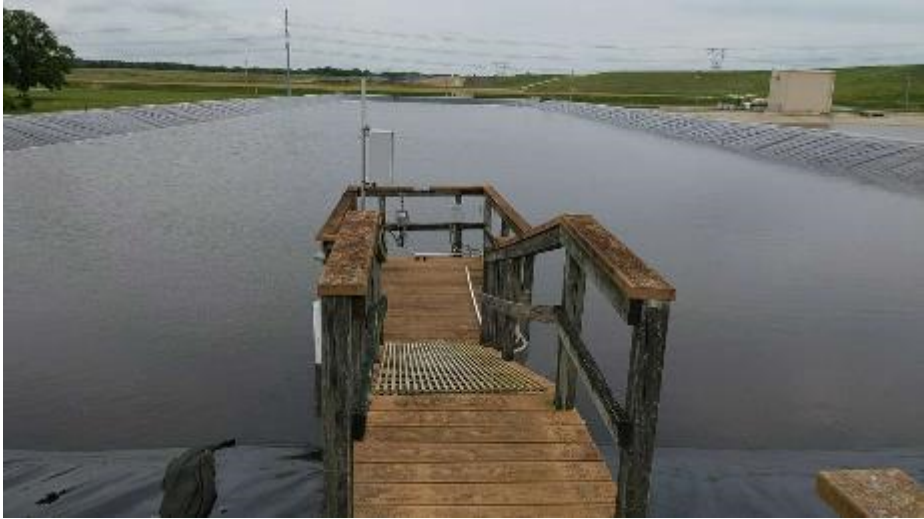
- c. West leachate pond (west bay) – 392.80
5. The LLDPE liner in Leachate Pond 002 appeared to be in good condition. Water elevation reported at 27-inches below the deck of the walkway (Photo No. 32).

<b>PHOTO BY:</b>  GEI CONSULTANTS, INC.			
<b>PHOTOGRAPH No: 32</b>	<b>DATE:</b> June 5, 2024 12:27 PM	<b>LATITUDE:</b> 37.94644407	<b>LONGITUDE:</b> -87.02103577
<b>DIRECTION:</b> East	<b>SITE LOCATION:</b> ROCKPORT, INDIANA		
<b>DESCRIPTION:</b>  002 Leachate Pond, Looking East. Note LLDPE Liner. Typical Conditions. Water level 27-inches.

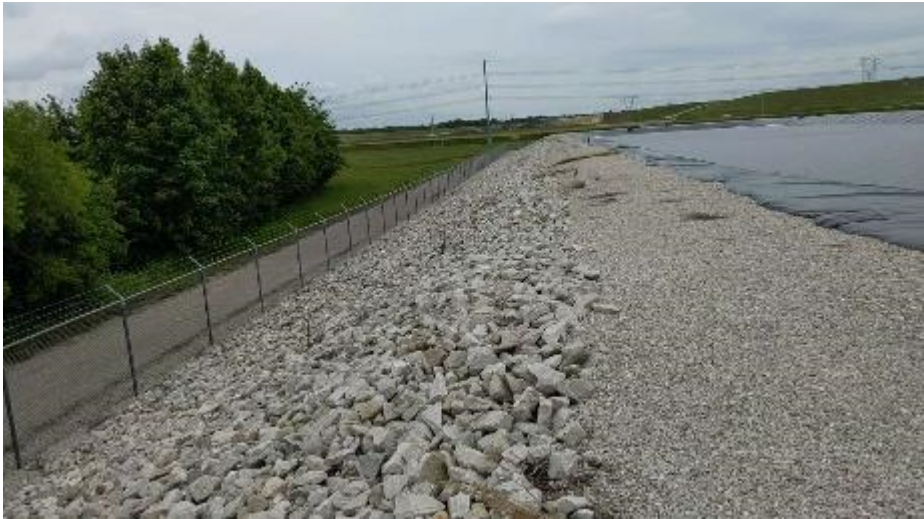
<b>PHOTOGRAPH No: 33</b>	<b>DATE:</b> June 5, 2024 12:32 PM	<b>LATITUDE:</b> 37.94666752	<b>LONGITUDE:</b> -87.02099548
<b>DIRECTION:</b> East	<b>SITE LOCATION:</b> ROCKPORT, INDIANA		
<b>DESCRIPTION:</b>  002 Leachate Pond. Downstream Slope Northern Dike. Looking East. Riprap Cover, Typical Conditions.

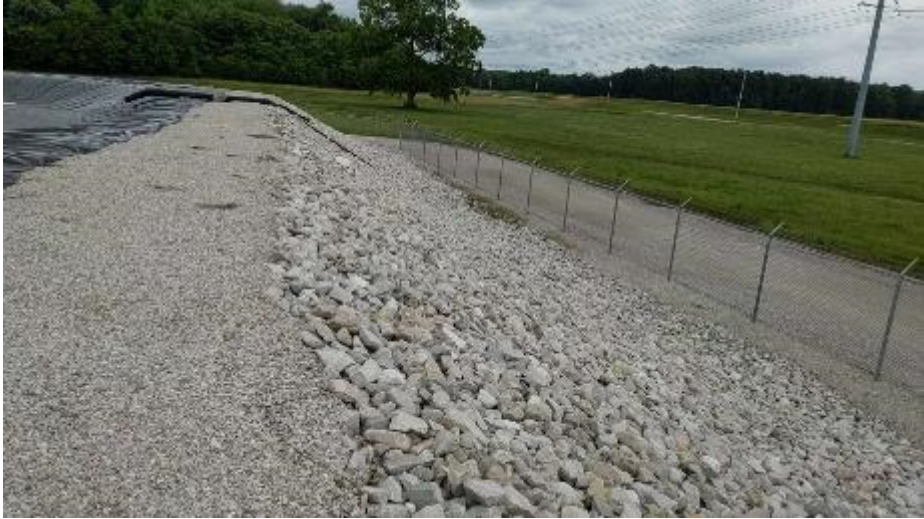
<b>PHOTO BY:</b>  GEI CONSULTANTS, INC.			
<b>PHOTOGRAPH No: 34</b>	<b>DATE:</b> June 5, 2024 12:37 PM	<b>LATITUDE:</b> 37.94632874	<b>LONGITUDE:</b> -87.01928192
<b>DIRECTION:</b> North	<b>SITE LOCATION:</b> ROCKPORT, INDIANA		
<b>DESCRIPTION:</b>  002 Leachate Pond, Downstream Slope Eastern Dike. Looking North. Riprap Cover. Typical Conditions.

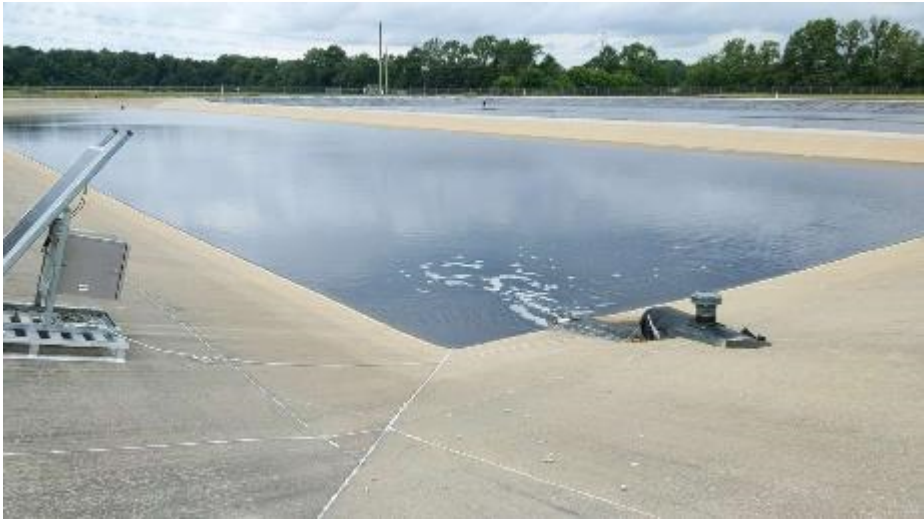
7. The North Pond was generally in good condition (Photo No. 35)
8. At the time of the inspection the water levels in the north pond were as follows:
  - o North pond (concrete bay) – 391.00

PHOTOGRAPH No: 35	DATE: June 5, 2024 12:49 PM	LATITUDE: 37.95050284	LONGITUDE: -87.01618019
DIRECTION: Northwest	SITE LOCATION: ROCKPORT, INDIANA		
DESCRIPTION:  North Pond, Looking Northwest. General Photo, Typical Conditions.
