East and West Bottom Ash Ponds 2024 Annual Dam and Dike Inspection Report

Rockport Plant, Rockport, Indiana

September 3, 2024

AEP Document ID: GEVR-24 016

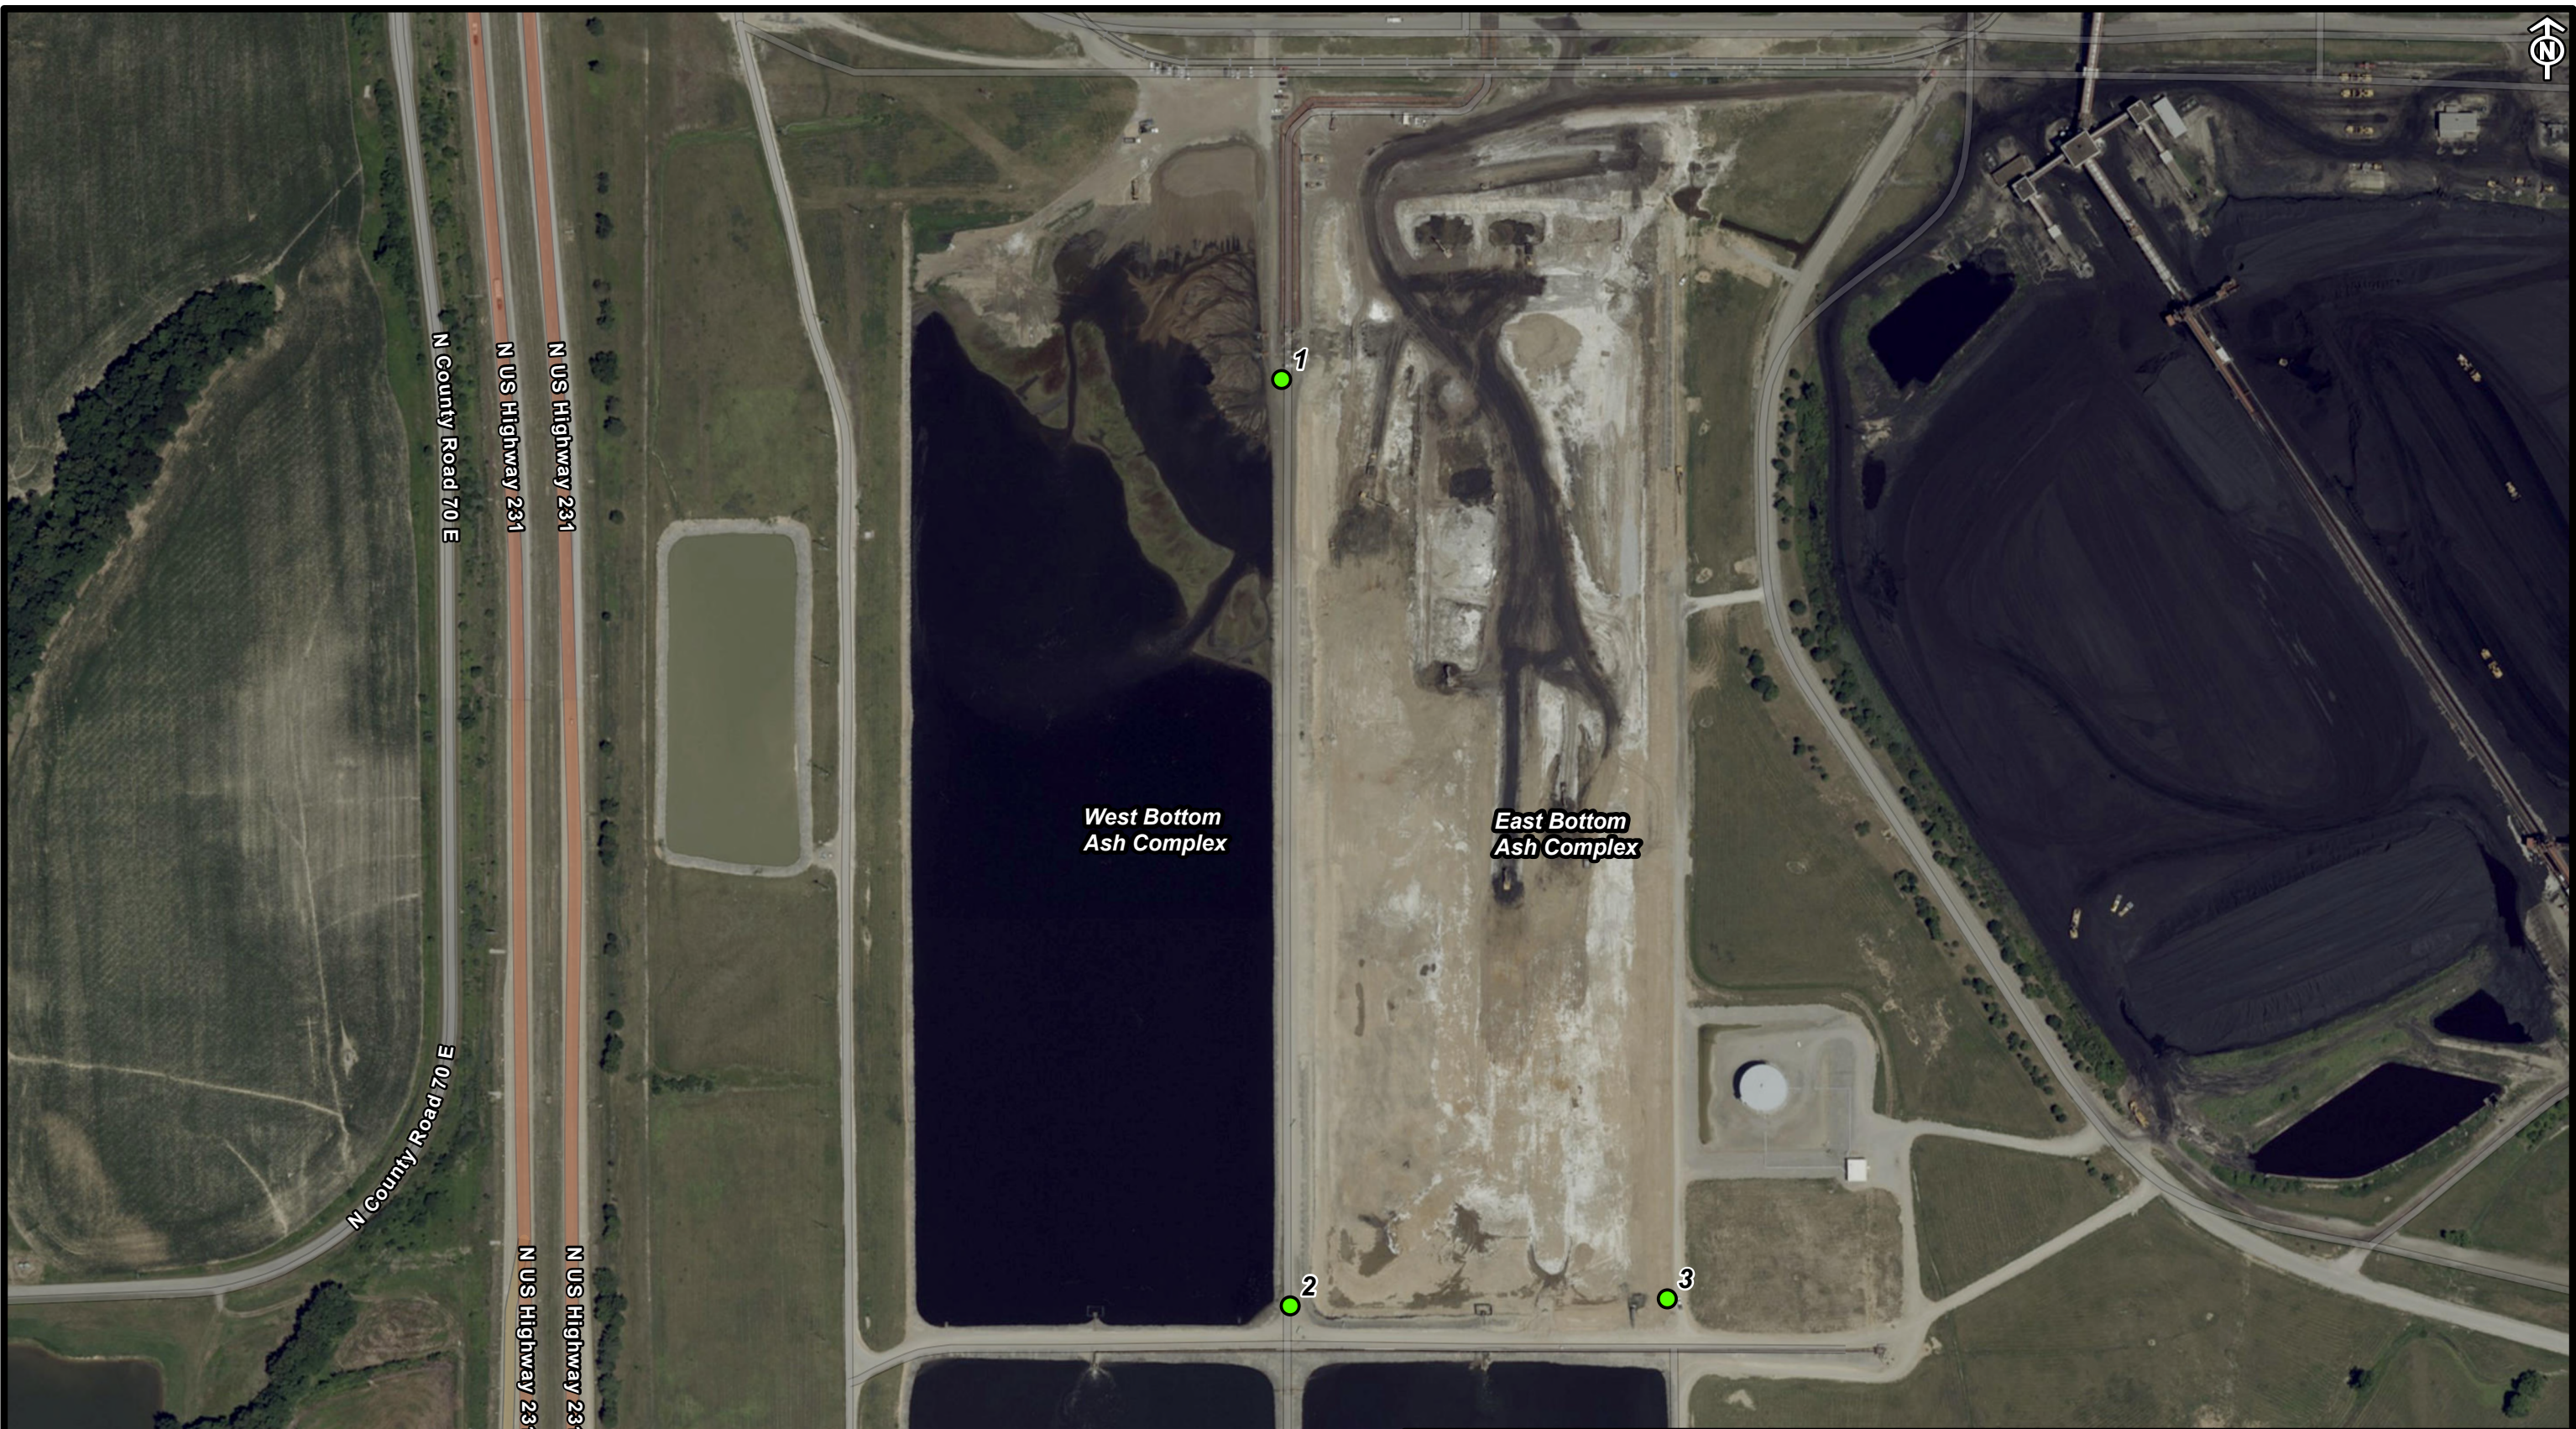
SITE PLAN

Overall, these units are in good condition. The impoundments are functioning as intended with no signs of potential structural weakness or conditions, which would disrupt the safe operation of the impoundments. Details of the visual inspection are presented below. Photographs taken during the inspection are included in Appendix A - Photolog. Each photograph that was captured during the inspection was tagged as either a general site observation, as an item to be monitored, or as an item to be addressed. The site observations are presented on Figure 3 – Site Plan. It should be noted that the inspection did not identify any items to be monitored or addressed.

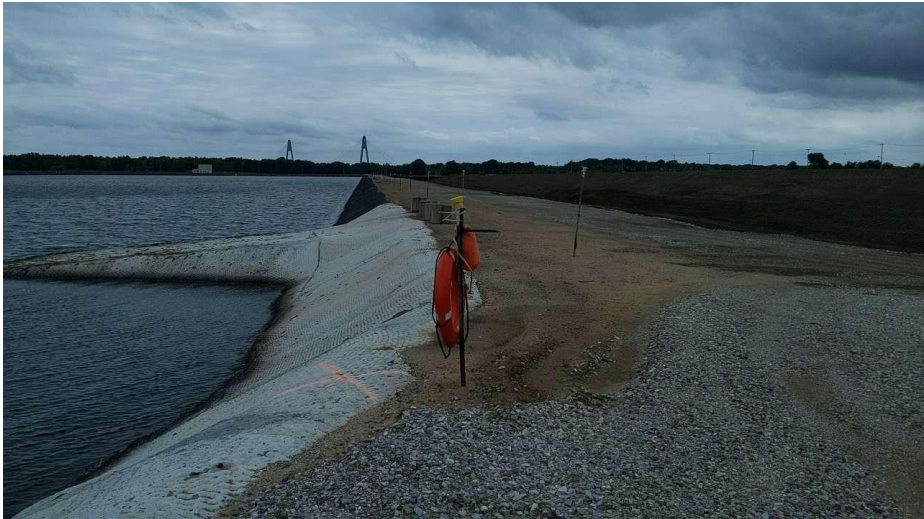
PHOTOGRAPH NO: 1	DATE: June 5, 2024 1:17 PM	LATITUDE: 37.9015863	LONGITUDE: -87.0978508
DIRECTION: South	SITE LOCATION: ROCKPORT, INDIANA		
DESCRIPTION: West area of East pond, Upstream Slope of Inboard Dike. Looking South. General Photo, Typical Conditions. Note Stockpiling of Material as Closure by removal of West Pond is implemented.

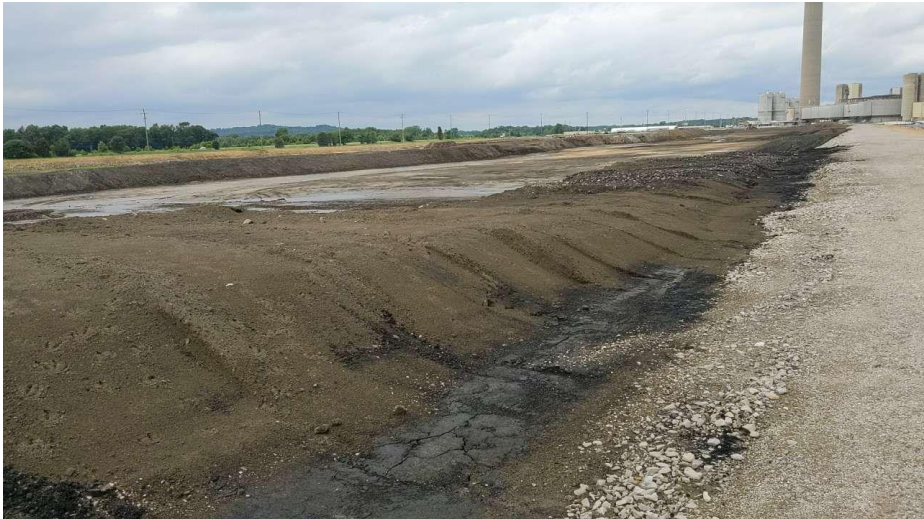
The West Bottom Ash Pond is inactive. It is currently de-watered and being closed by removal as shown in Photograph No. 2. The pond contents were placed in rows to facilitate drying before hauling and placement at the existing landfill.

PHOTO BY: GEI CONSULTANTS, INC.			
PHOTOGRAPH NO: 2	DATE: June 5, 2024 1:28 PM	LATITUDE: 37.8990752	LONGITUDE: -87.1034664
DIRECTION: North	SITE LOCATION: ROCKPORT, INDIANA		
DESCRIPTION: West Pond being closed by Removal. Looking North. General Photo, Typical Conditions. No Poned Water at time of inspection.

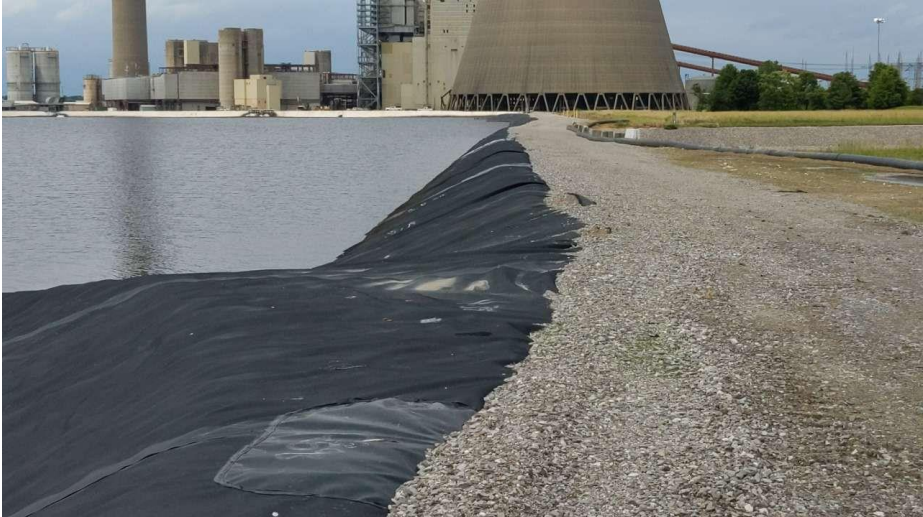
PHOTOGRAPH NO: 3	DATE: June 5, 2024 2:12 PM	LATITUDE: 37.9162358	LONGITUDE: -87.03412719
DIRECTION: North	SITE LOCATION: ROCKPORT, INDIANA		
DESCRIPTION: Upstream Slope of East Bottom Ash Pond, Eastern Dike. Looking North. Synthetic Cover, Typical Conditions.
