## CCR Landfill 2024 Annual Landfill Inspection Report

Turk Power Plant, Fulton, Arkansas

September 4, 2024  
Project 2305686  
AEP Document ID: GEVR-24-009

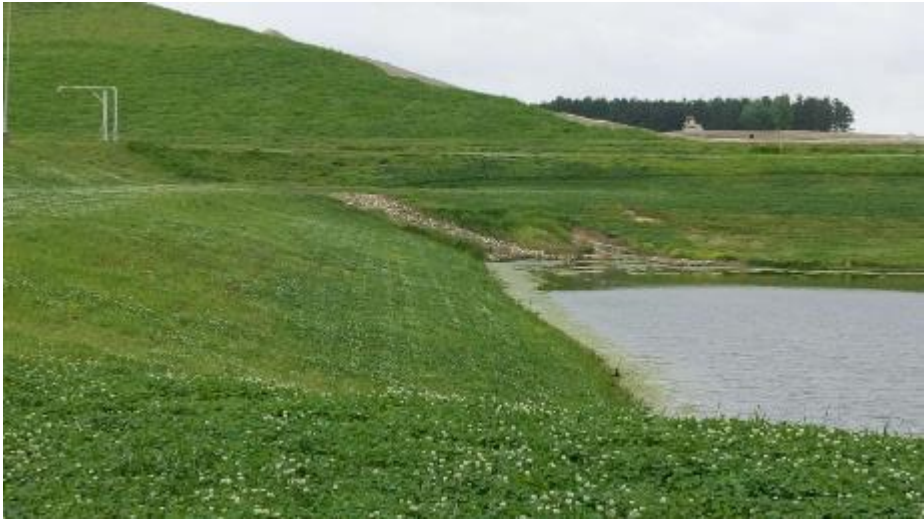
PHOTOGRAPH NO: 1	DATE: April 16, 2024 11:26 AM	LATITUDE: 33.64002692	LONGITUDE: -93.81118298
<b>SITE LOCATION:</b> TURK POWER PLANT, FULTON ARKANSAS			
<p><b>DESCRIPTION:</b></p> <p>Leachate Collection Pond, East Inboard Dike. Looking South. Note Drain Inlet Structure and Stabilized Erosion Feature.</p>

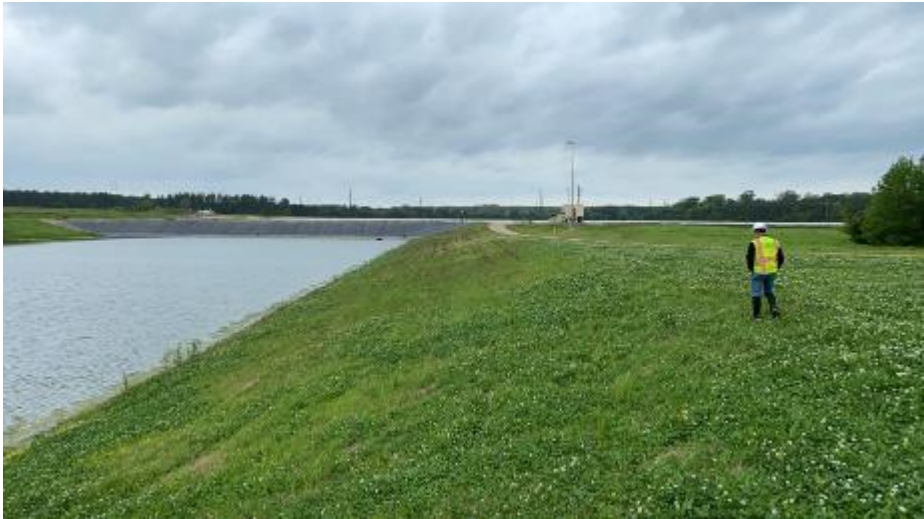
<b>PHOTOGRAPH NO: 3</b>	<b>DATE:</b> April 16, 2024 11:33 AM	<b>LATITUDE:</b> 33.6399127205441	<b>LONGITUDE:</b> -93.8111546504707
<b>SITE LOCATION:</b> TURK POWER PLANT, FULTON ARKANSAS			
<b>DESCRIPTION:</b>  Leachate Pond Inboard Dike. Looking West. General Photo, Typical Conditions.

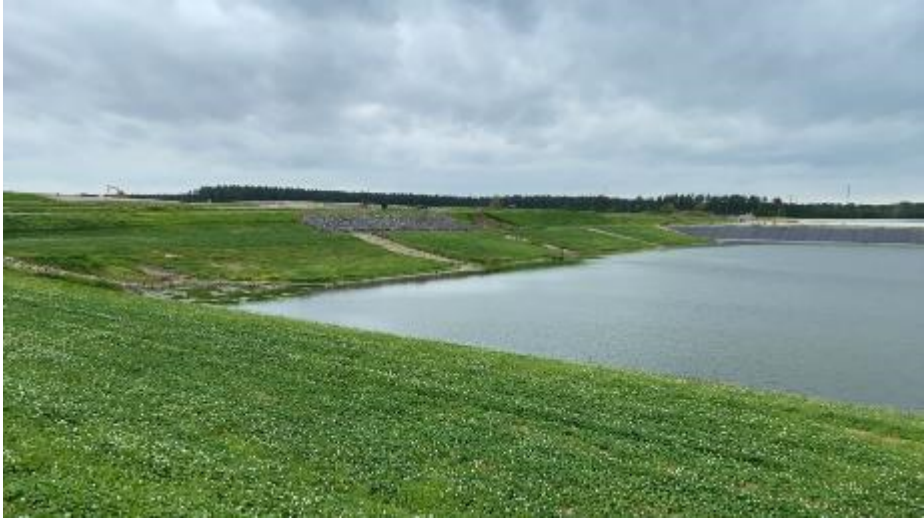
<b>PHOTO BY:</b>  GEI CONSULTANTS, INC.			
<b>PHOTOGRAPH NO: 4</b>	<b>DATE:</b> April 16, 2024 11:27 AM	<b>LATITUDE:</b> 33.6395458617488	<b>LONGITUDE:</b> -93.8109142007398
<b>SITE LOCATION:</b> TURK POWER PLANT, FULTON ARKANSAS			
<b>DESCRIPTION:</b>  Leachate Pond Inboard Dike, Letdown Channel. Looking Southwest at southern inboard slope. General Photo, Typical conditions.

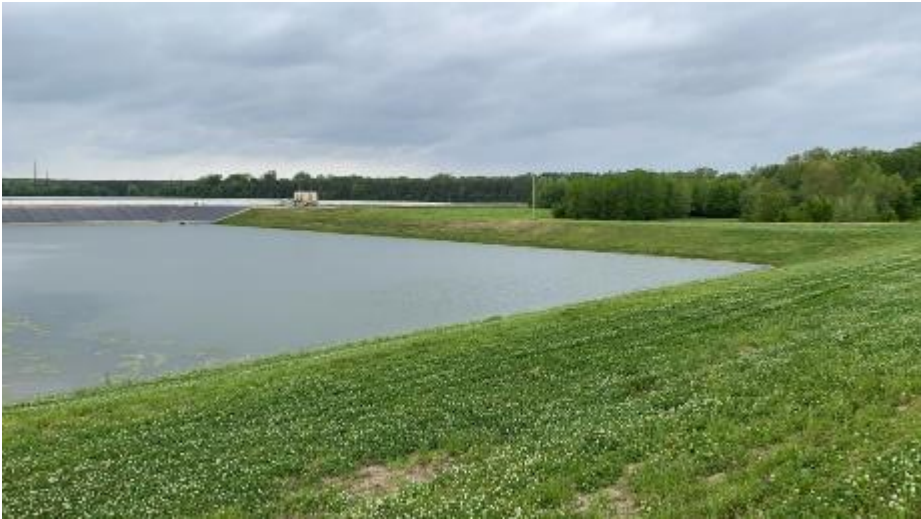
<b>PHOTOGRAPH NO: 5</b>	<b>DATE:</b> April 16, 2024 11:25 AM	<b>LATITUDE:</b> 33.6389422473519	<b>LONGITUDE:</b> -93.8108976308474
<b>SITE LOCATION:</b> TURK POWER PLANT, FULTON ARKANSAS			
<b>DESCRIPTION:</b>  Leachate Pond Inboard Dike. Looking Northwest. General Photo, Typical Conditions.

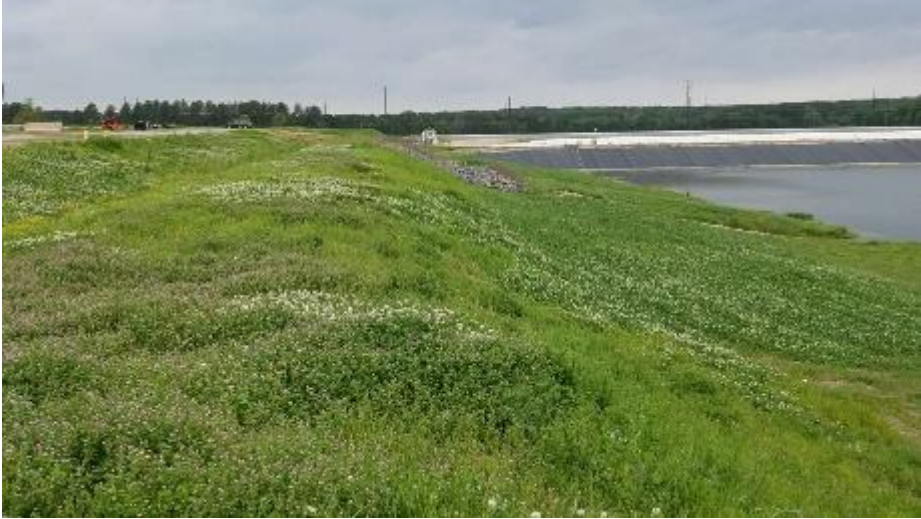
<b>PHOTO BY:</b>  GEI CONSULTANTS, INC.			
<b>PHOTOGRAPH NO: 6</b>	<b>DATE:</b> April 16, 2024 11:22 AM	<b>LATITUDE:</b> 33.63871724	<b>LONGITUDE:</b> -93.81099782
<b>SITE LOCATION:</b> TURK POWER PLANT, FULTON ARKANSAS			
<b>DESCRIPTION:</b>  Leachate Collection Pond on right, Crest of non-contact stormwater dike. Looking West. General Photo, Typical Conditions.

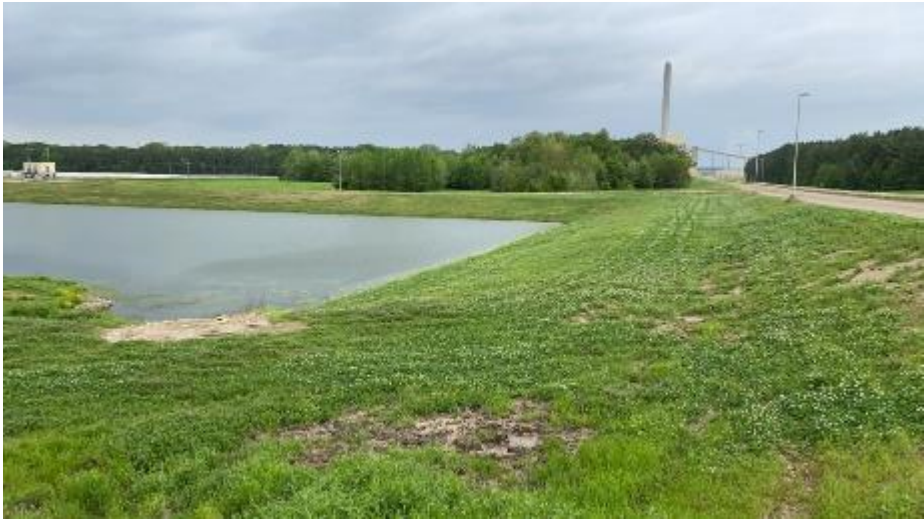
<b>PHOTOGRAPH NO: 7</b>	<b>DATE:</b> April 16, 2024 11:23 AM	<b>LATITUDE:</b> 33.6386989001598	<b>LONGITUDE:</b> -93.8109894616125
<b>SITE LOCATION:</b> TURK POWER PLANT, FULTON ARKANSAS			
<b>DESCRIPTION:</b>  Leachate Pond, Inboard Dike. Looking North. General Photo, Typical Conditions.

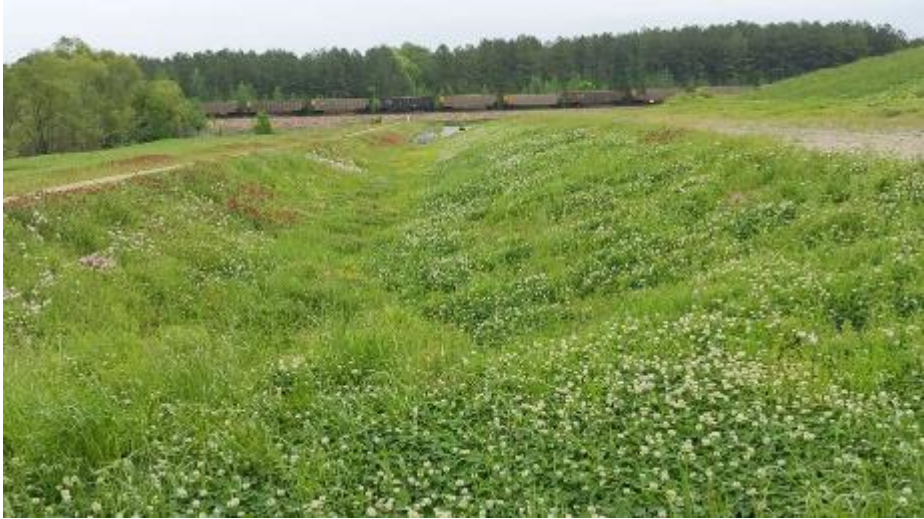
<b>PHOTO BY:</b>  GEI CONSULTANTS, INC.			
<b>PHOTOGRAPH NO: 8</b>	<b>DATE:</b> April 16, 2024 11:17 AM	<b>LATITUDE:</b> 33.6386436	<b>LONGITUDE:</b> -93.81066069
<b>SITE LOCATION:</b> TURK POWER PLANT, FULTON ARKANSAS			
<b>DESCRIPTION:</b>  North Landfill Perimeter Drainage Ditch. Looking East.

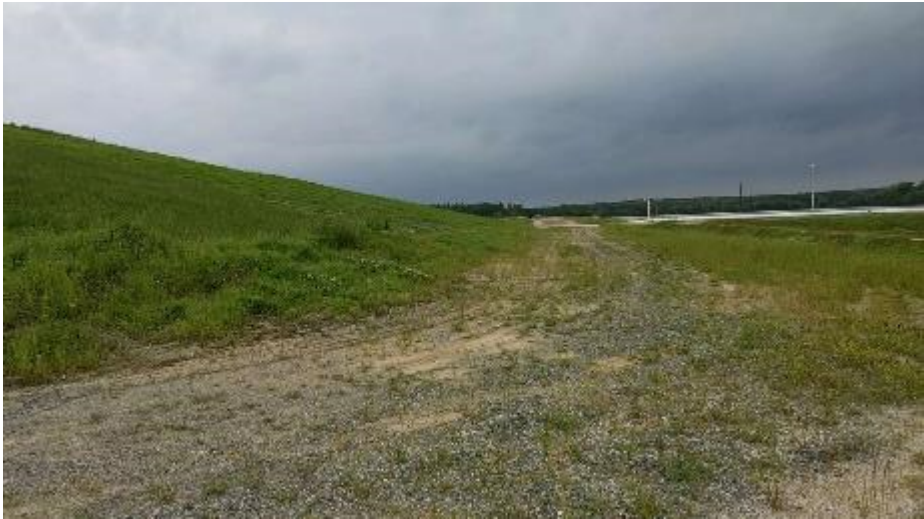
<b>PHOTOGRAPH No: 11</b>	<b>DATE:</b> April 16, 2024 11:14 AM	<b>LATITUDE:</b> 33.6385225	<b>LONGITUDE:</b> -93.80937129
<b>SITE LOCATION:</b> TURK POWER PLANT, FULTON ARKANSAS			
<b>DESCRIPTION:</b>  North Landfill Cell 1 Area, Downstream Slope of Outboard Dike. Looking West. General Photo, Typical Conditions.

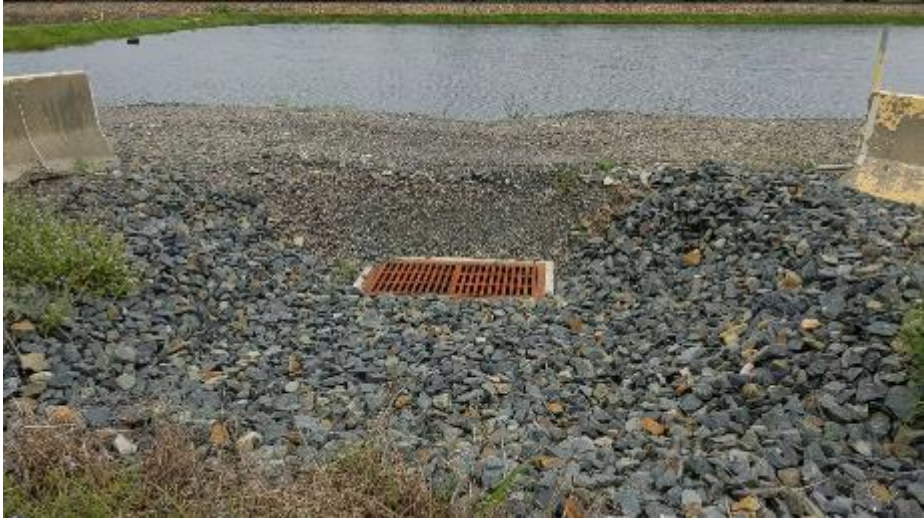
<b>PHOTO BY:</b>  GEI CONSULTANTS, INC.			
<b>PHOTOGRAPH No: 12</b>	<b>DATE:</b> April 16, 2024 11:08 AM	<b>LATITUDE:</b> 33.6382989	<b>LONGITUDE:</b> -93.80943161
<b>SITE LOCATION:</b> TURK POWER PLANT, FULTON ARKANSAS			
<b>DESCRIPTION:</b>  Drainage Structure, Cell 1 Outboard Slope Perimeter Ditch Drain. Looking East. Typical Conditions.

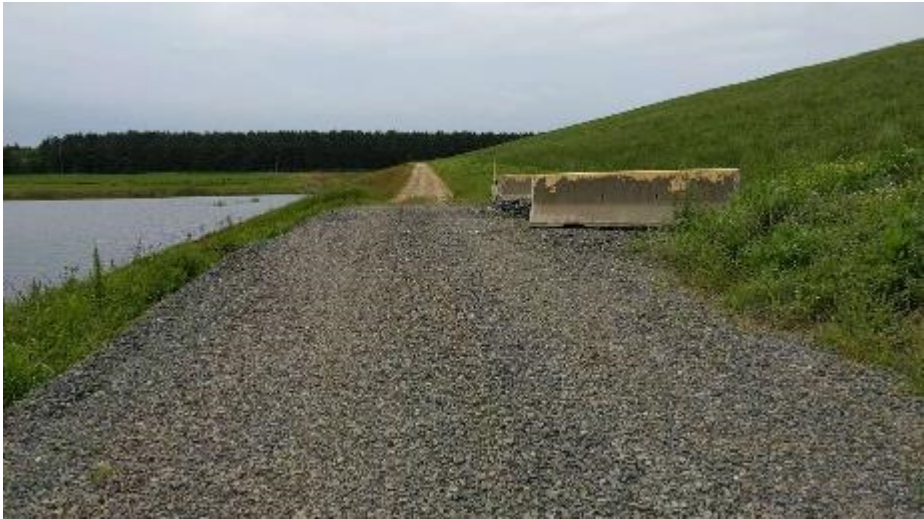
<b>PHOTOGRAPH No: 13</b>	<b>DATE:</b> April 16, 2024 11:12 AM	<b>LATITUDE:</b> 33.63829704	<b>LONGITUDE:</b> -93.80934964
<b>SITE LOCATION:</b> TURK POWER PLANT, FULTON ARKANSAS			
<b>DESCRIPTION:</b>  East Landfill Cell 1 Area, Access Road Berm of Outboard Dike. Looking South. General Photo, Typical Conditions.

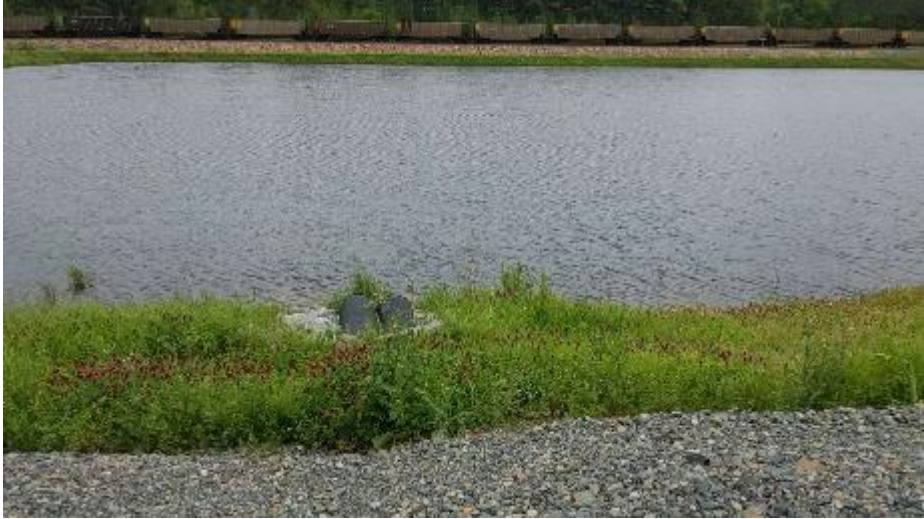
<b>PHOTO BY:</b>  GEI CONSULTANTS, INC.			
<b>PHOTOGRAPH No: 14</b>	<b>DATE:</b> April 16, 2024 11:11 AM	<b>LATITUDE:</b> 33.63826364	<b>LONGITUDE:</b> -93.80935559
<b>SITE LOCATION:</b> TURK POWER PLANT, FULTON ARKANSAS			
<b>DESCRIPTION:</b>  Outlet Works, Cell 1 Outboard Slope, Stormwater Pond. Looking East. General Photo, Typical Conditions.

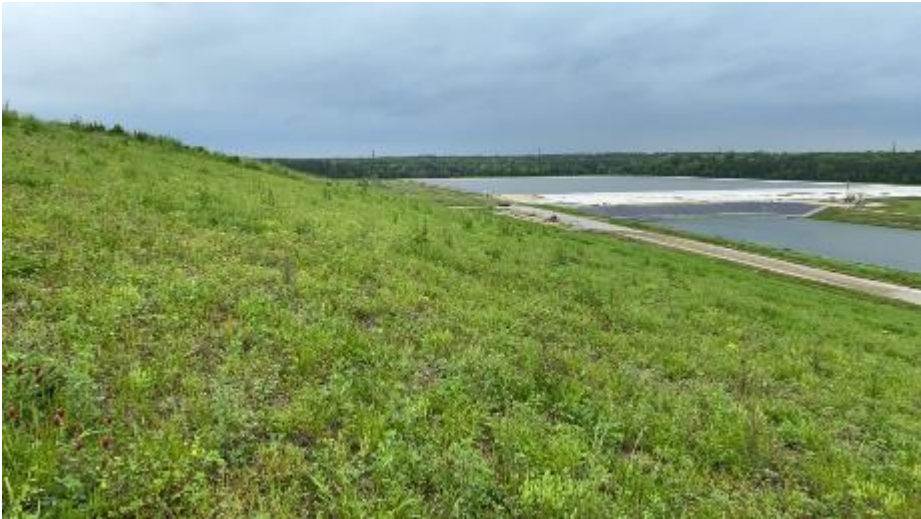
<b>PHOTOGRAPH No: 15</b>	<b>DATE:</b> April 16, 2024 11:10 AM	<b>LATITUDE:</b> 33.6377281184557	<b>LONGITUDE:</b> -93.8101482033263
<b>SITE LOCATION:</b> TURK POWER PLANT, FULTON ARKANSAS			
<b>DESCRIPTION:</b>  North Landfill Cell 1 Area, Top of Slope - Interim Cover. Looking Northwest. General Photo, Typical Conditions.

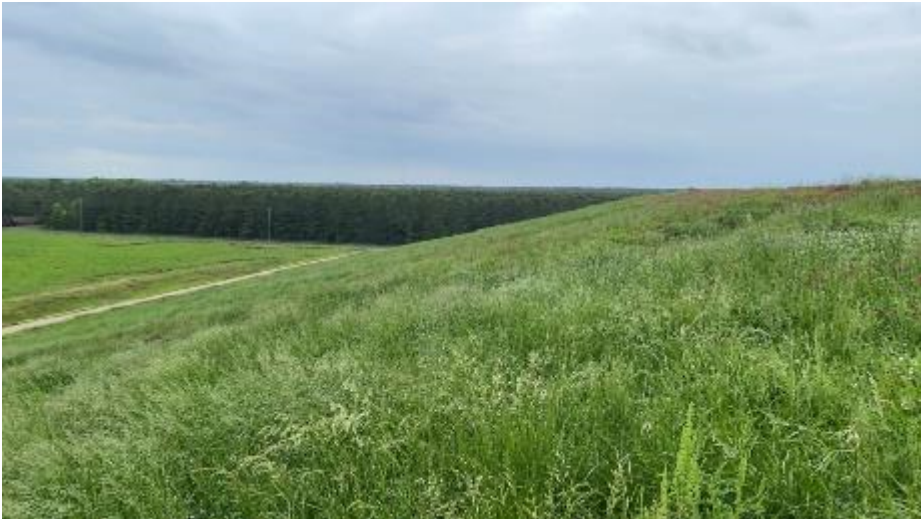
<b>PHOTO BY:</b>  GEI CONSULTANTS, INC.			
<b>PHOTOGRAPH No: 16</b>	<b>DATE:</b> April 16, 2024 11:07 AM	<b>LATITUDE:</b> 33.6374504554906	<b>LONGITUDE:</b> -93.8101856616144
<b>SITE LOCATION:</b> TURK POWER PLANT, FULTON ARKANSAS			
<b>DESCRIPTION:</b>  East area, Downstream Slope Interim Cover. Looking Southeast. General Photo, Typical Conditions.

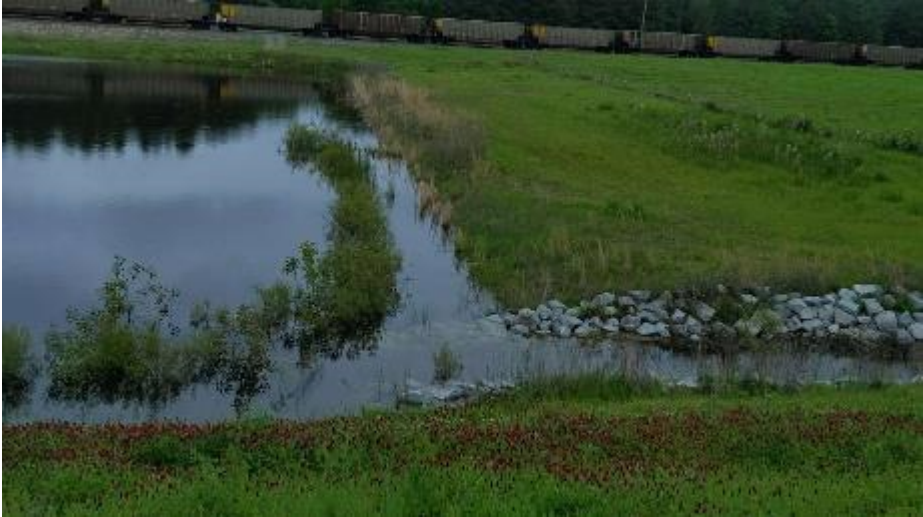
<b>PHOTOGRAPH No: 17</b>	<b>DATE:</b> April 16, 2024 11:04 AM	<b>LATITUDE:</b> 33.63715648	<b>LONGITUDE:</b> -93.80930497
<b>SITE LOCATION:</b> TURK POWER PLANT, FULTON ARKANSAS			
<b>DESCRIPTION:</b>  Inside Southwest corner of Stormwater Pond. Looking East. General Photo, Typical Conditions.

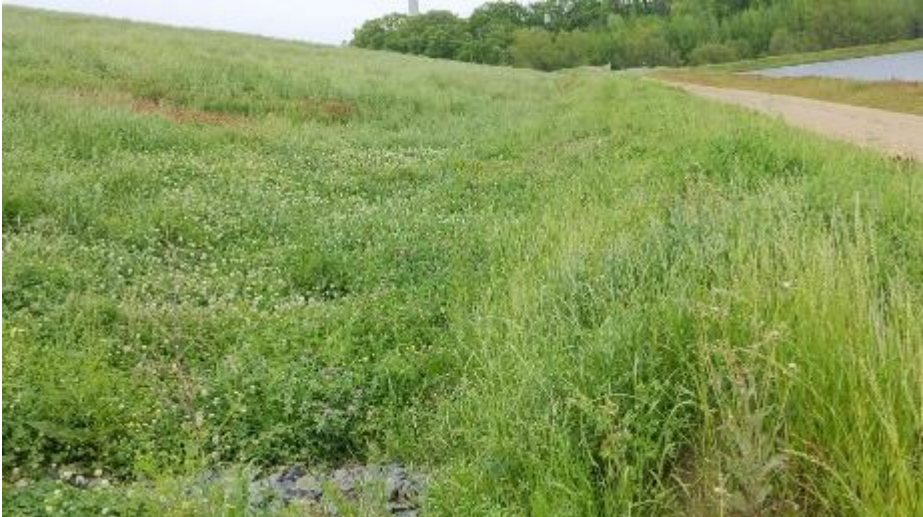
<b>PHOTO BY:</b>  GEI CONSULTANTS, INC.			
<b>PHOTOGRAPH No: 18</b>	<b>DATE:</b> April 16, 2024 11:01 AM	<b>LATITUDE:</b> 33.63706414	<b>LONGITUDE:</b> -93.80939137
<b>SITE LOCATION:</b> TURK POWER PLANT, FULTON ARKANSAS			
<b>DESCRIPTION:</b>  East Landfill Cell 1 Area, Toe of Interim Cover Slope. Looking North. Check Dam and Silt Build Up. Please Address Toe Ditch Obstructed Flow.

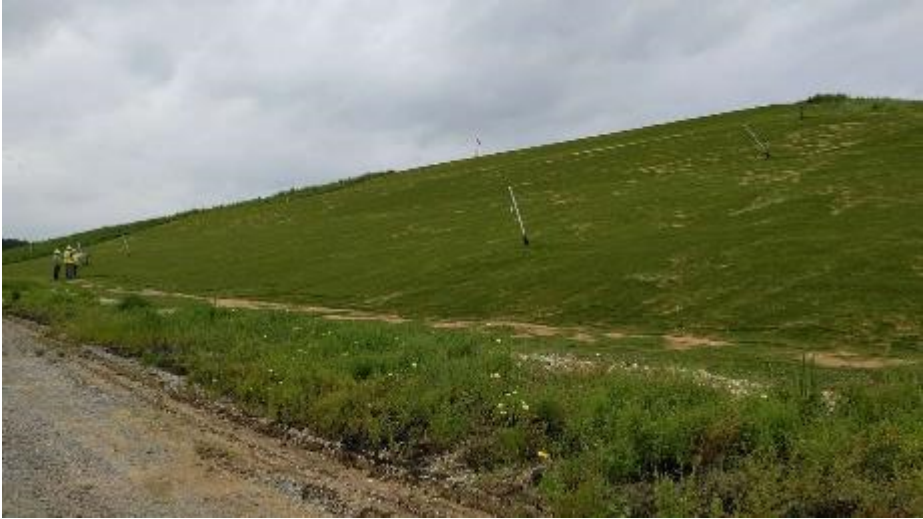
<b>PHOTOGRAPH No: 19</b>	<b>DATE:</b> April 16, 2024 10:46 AM	<b>LATITUDE:</b> 33.63588562	<b>LONGITUDE:</b> -93.8093574
<b>SITE LOCATION:</b> TURK POWER PLANT, FULTON ARKANSAS			
<b>DESCRIPTION:</b>  South Landfill Cell 1 Area, Downstream Slope of Perimeter Berm. Looking Southwest. General Photo, Typical Conditions.	 		
<b>PHOTO BY:</b>  GEI CONSULTANTS, INC.			
<b>PHOTOGRAPH No: 20</b>	<b>DATE:</b> April 16, 2024 10:45 AM	<b>LATITUDE:</b> 33.6358175	<b>LONGITUDE:</b> -93.80955839
<b>SITE LOCATION:</b> TURK POWER PLANT, FULTON ARKANSAS			
<b>DESCRIPTION:</b>  South Landfill Cell 1 Area, Toe of Slope, Closure Turf Test Pad. Looking West. General Photo, Typical Conditions.

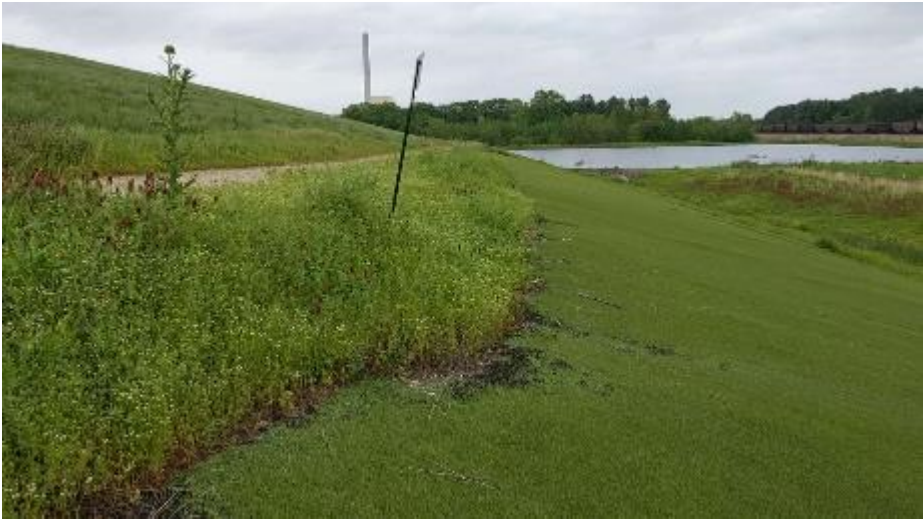
<b>PHOTOGRAPH No: 21</b>	<b>DATE:</b> April 16, 2024 10:48 AM	<b>LATITUDE:</b> 33.63620245	<b>LONGITUDE:</b> -93.8097932
<b>SITE LOCATION:</b> TURK POWER PLANT, FULTON ARKANSAS			
<b>DESCRIPTION:</b>  South Landfill Cell 1 Area, Slope of Landfill and Perimeter Berm. Looking Northeast. General Photo, Typical Conditions.

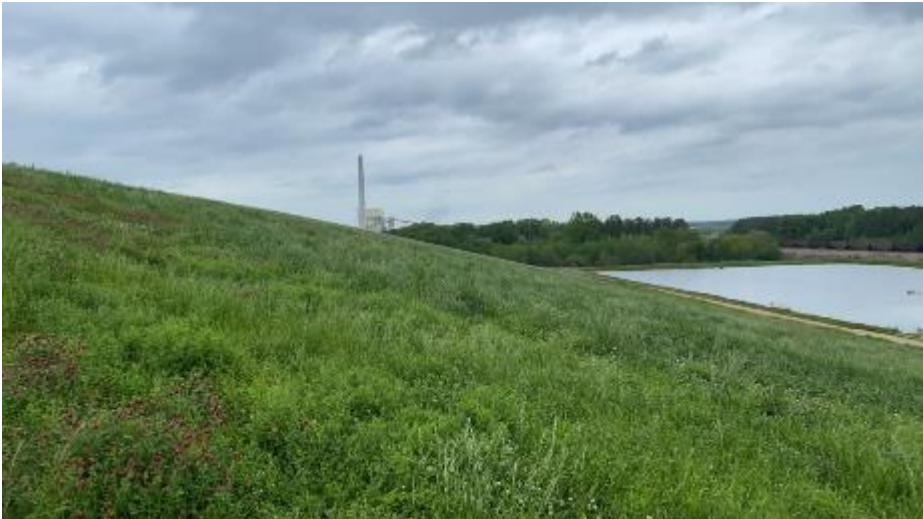
<b>PHOTO BY:</b>  GEI CONSULTANTS, INC.			
<b>PHOTOGRAPH No: 22</b>	<b>DATE:</b> April 16, 2024 10:50 AM	<b>LATITUDE:</b> 33.6362127624876	<b>LONGITUDE:</b> -93.8098006815265
<b>SITE LOCATION:</b> TURK POWER PLANT, FULTON ARKANSAS			
<b>DESCRIPTION:</b>  South Landfill Cell 1 Area, Interim Cover on Slope. Looking North. General Photo, Typical Conditions.

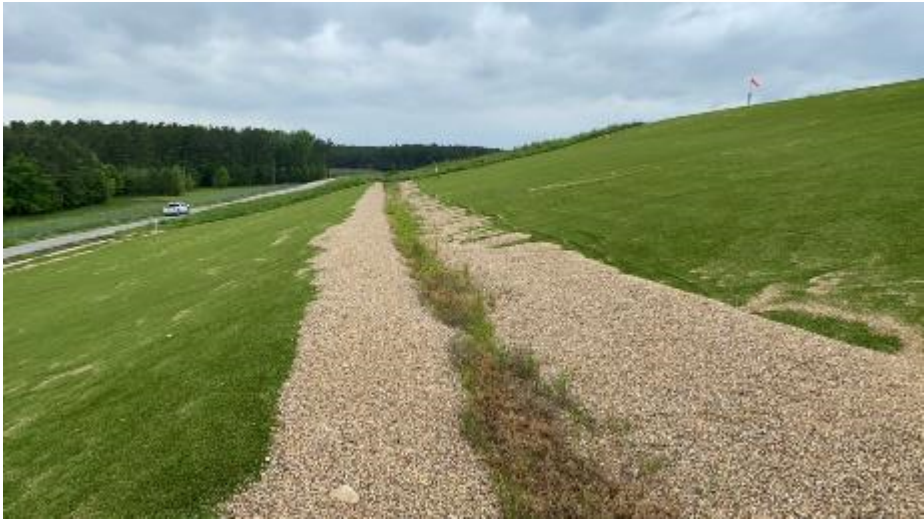
<b>PHOTOGRAPH No: 23</b>	<b>DATE:</b> April 16, 2024 10:48 AM	<b>LATITUDE:</b> 33.6361134314961	<b>LONGITUDE:</b> -93.8100407232091
<b>SITE LOCATION:</b> TURK POWER PLANT, FULTON ARKANSAS			
<b>DESCRIPTION:</b>  South Landfill Cell 1 Area, Closureturf Test Pad. Looking Southwest. General Photo, Typical Conditions.

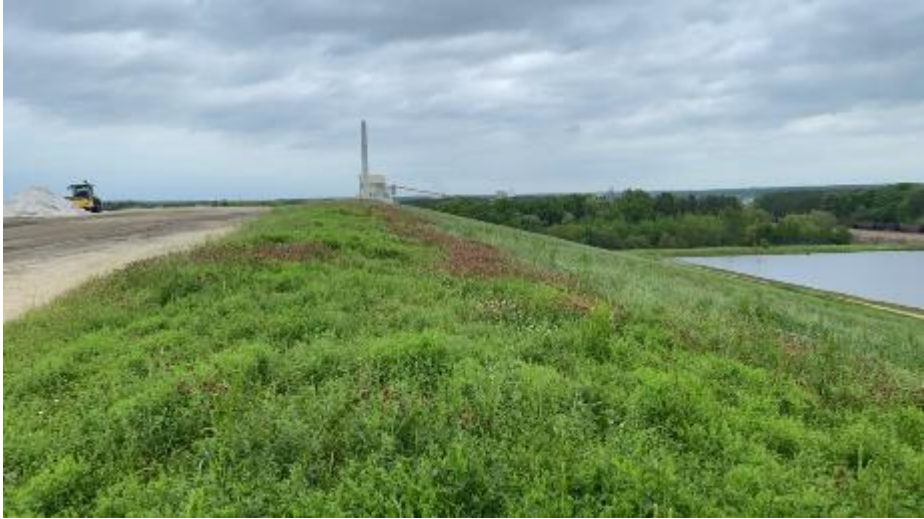
<b>PHOTO BY:</b>  GEI CONSULTANTS, INC.			
<b>PHOTOGRAPH No: 24</b>	<b>DATE:</b> April 16, 2024 10:56 AM	<b>LATITUDE:</b> 33.6363873252407	<b>LONGITUDE:</b> -93.8101502728039
<b>SITE LOCATION:</b> TURK POWER PLANT, FULTON ARKANSAS			
<b>DESCRIPTION:</b>  South Landfill Cell 1 Area, Landfill Crest. Looking North. Ground Cover, Typical Conditions.

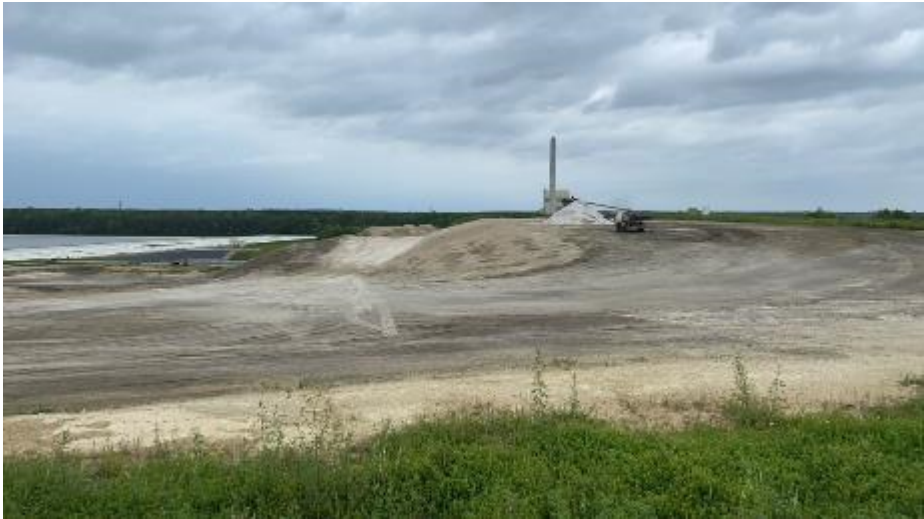
<b>PHOTOGRAPH No: 25</b>	<b>DATE:</b> April 16, 2024 10:58 AM	<b>LATITUDE:</b> 33.6362596195211	<b>LONGITUDE:</b> -93.810466298822
<b>SITE LOCATION:</b> TURK POWER PLANT, FULTON ARKANSAS			
<b>DESCRIPTION:</b>  South Landfill Cell 1 Area, Material Processing Landfill Crest Area. Looking North. General Photo, Typical Conditions.

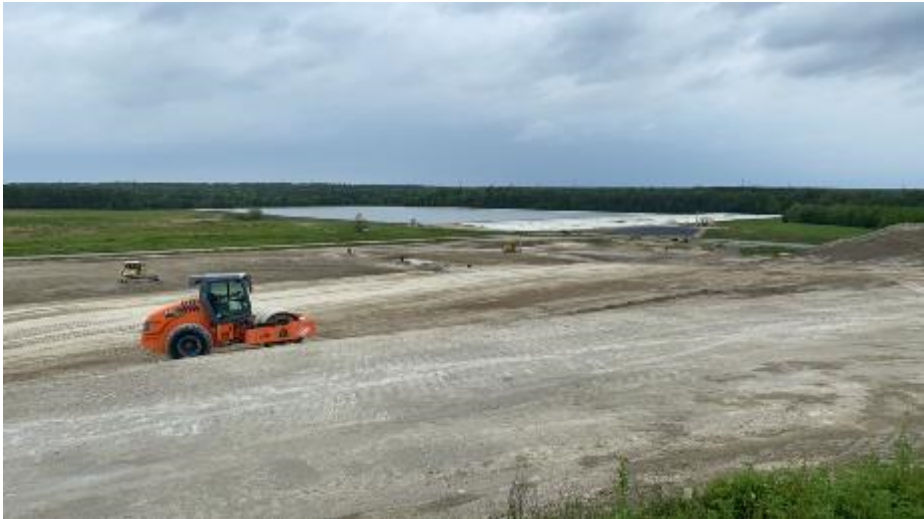
<b>PHOTO BY:</b>  GEI CONSULTANTS, INC.			
<b>PHOTOGRAPH No: 26</b>	<b>DATE:</b> April 16, 2024 11:00 AM	<b>LATITUDE:</b> 33.6361498757768	<b>LONGITUDE:</b> -93.8107605224506
<b>SITE LOCATION:</b> TURK POWER PLANT, FULTON ARKANSAS			
<b>DESCRIPTION:</b>  West Landfill Cell 1 Area, Material Processing Area. Looking West -Northwest. General Photo, Typical Conditions.

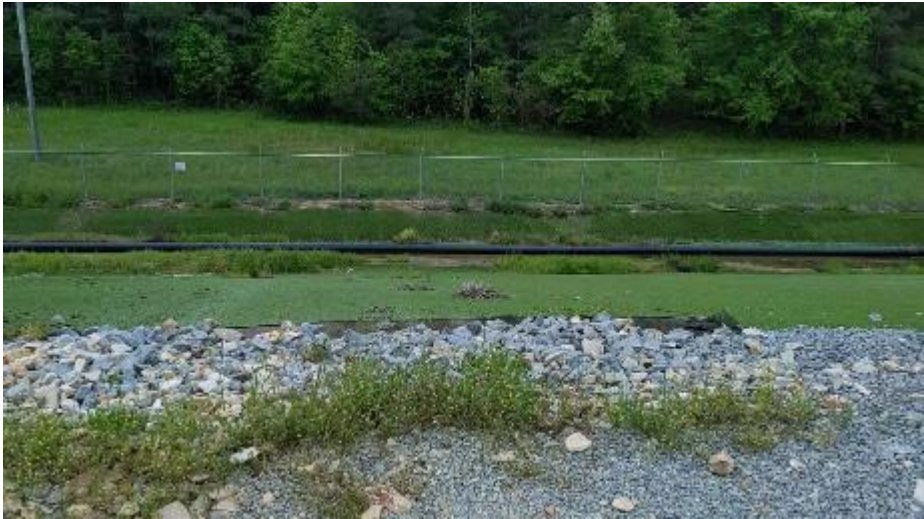
<b>PHOTOGRAPH No: 29</b>	<b>DATE:</b> April 16, 2024 10:28 AM	<b>LATITUDE:</b> 33.6355038	<b>LONGITUDE:</b> -93.81080271
<b>SITE LOCATION:</b> TURK POWER PLANT, FULTON ARKANSAS			
<b>DESCRIPTION:</b>  South Landfill Cell 1 Area, Downstream Slope of Perimeter Berm. Looking South. Drain Feature, Typical Conditions.

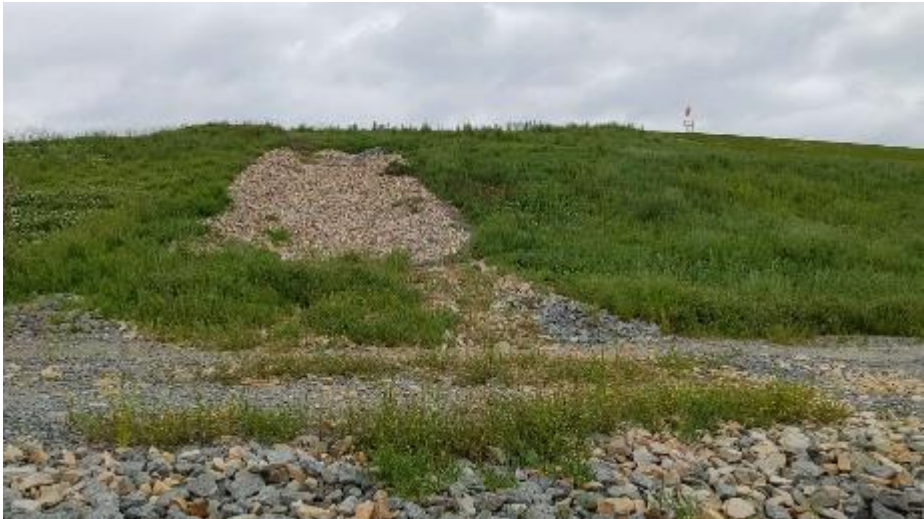
<b>PHOTO BY:</b>  GEI CONSULTANTS, INC.			
<b>PHOTOGRAPH No: 30</b>	<b>DATE:</b> April 16, 2024 10:26 AM	<b>LATITUDE:</b> 33.63545003	<b>LONGITUDE:</b> -93.8107797
<b>SITE LOCATION:</b> TURK POWER PLANT, FULTON ARKANSAS			
<b>DESCRIPTION:</b>  South Landfill Cell 1 Area, Landfill Stormwater Down chute, Looking North, Typical Conditions.

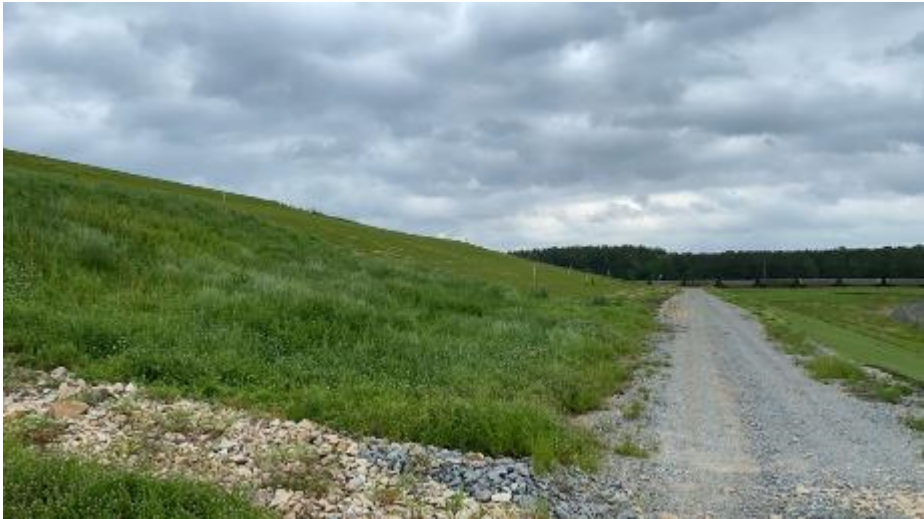
<b>PHOTOGRAPH No: 31</b>	<b>DATE:</b> April 16, 2024 10:26 AM	<b>LATITUDE:</b> 33.6354420249805	<b>LONGITUDE:</b> -93.8108409558186
<b>SITE LOCATION:</b> TURK POWER PLANT, FULTON ARKANSAS			
<b>DESCRIPTION:</b>  South Landfill Cell 1 Area, Landfill Slope and perimeter access road. Looking Northeast. General Photo, Typical Conditions.

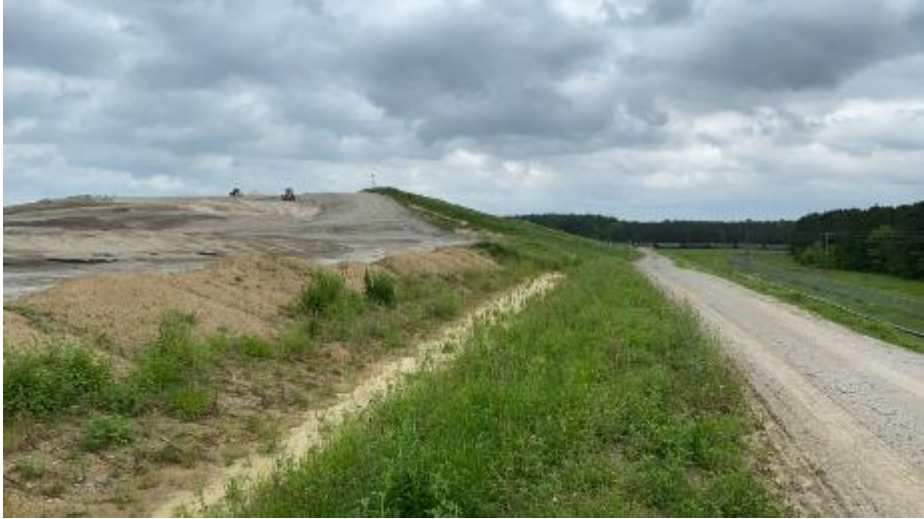
2. Cell 1 was in good and stable condition with no sign of instability, ponding water or significant erosion. The temporary access road to the west and landfill perimeter road to the south appeared in good condition. Photographs No. 24, No. 27, and No. 32 provide general conditions observed during the inspection.

<b>PHOTO BY:</b>  GEI CONSULTANTS, INC.			
<b>PHOTOGRAPH No: 32</b>	<b>DATE:</b> April 16, 2024 10:23 AM	<b>LATITUDE:</b> 33.6350148107474	<b>LONGITUDE:</b> -93.8121491172858
<b>SITE LOCATION:</b> TURK POWER PLANT, FULTON ARKANSAS			
<b>DESCRIPTION:</b>  South Landfill Cell 2 Area, Looking Northeast. General Photo, Typical Conditions.

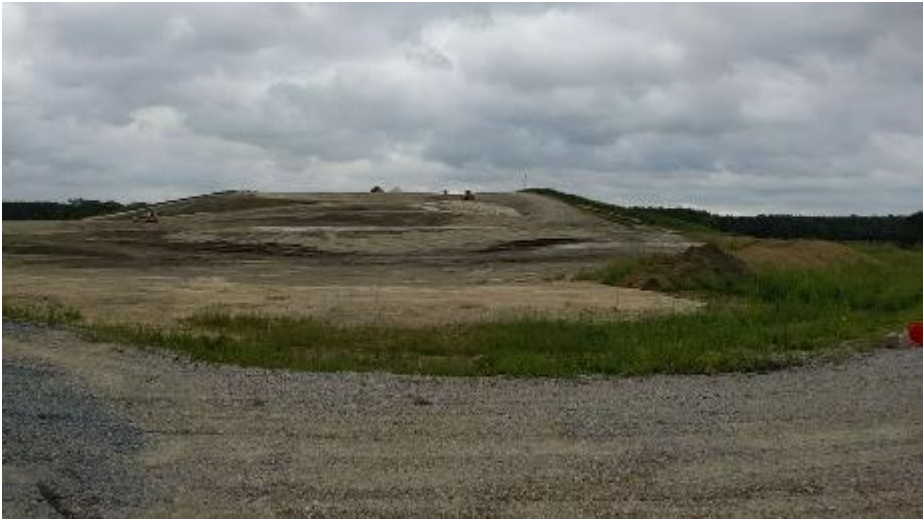
<b>PHOTOGRAPH No: 35</b>	<b>DATE:</b> April 16, 2024 10:11 AM	<b>LATITUDE:</b> 33.63497463	<b>LONGITUDE:</b> -93.8129043
<b>SITE LOCATION:</b> TURK POWER PLANT, FULTON ARKANSAS			
<b>DESCRIPTION:</b>  Inboard Slope of Active Cell 2. Looking North. General Photo, Typical Conditions.

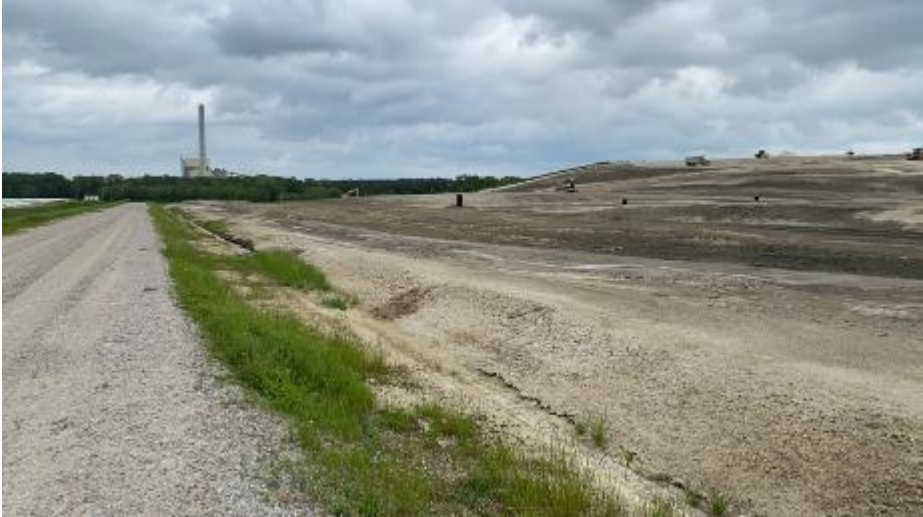
<b>PHOTOGRAPH No: 37</b>	<b>DATE:</b> April 16, 2024 10:08 AM	<b>LATITUDE:</b> 33.6352621487202	<b>LONGITUDE:</b> -93.8128571552294
<b>SITE LOCATION:</b> TURK POWER PLANT, FULTON ARKANSAS			
<b>DESCRIPTION:</b>  South Landfill Cell 2 Area, Perimeter Ditch. Looking North. General Photo, Typical Conditions.

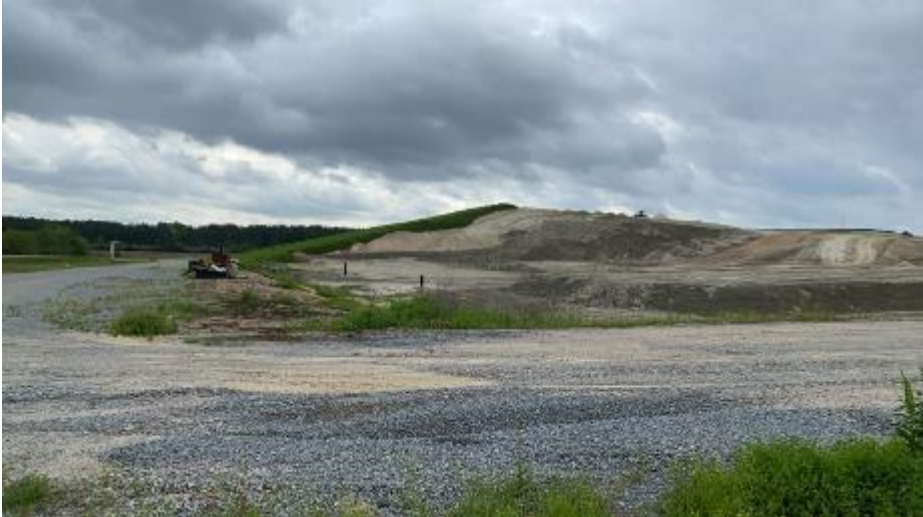
<b>PHOTO BY:</b>  GEI CONSULTANTS, INC.			
<b>PHOTOGRAPH No: 38</b>	<b>DATE:</b> April 16, 2024 9:59 AM	<b>LATITUDE:</b> 33.6384039419313	<b>LONGITUDE:</b> -93.8130426372581
<b>SITE LOCATION:</b> TURK POWER PLANT, FULTON ARKANSAS			
<b>DESCRIPTION:</b>  North Landfill Cell 2 Area. Looking East. Typical Conditions.

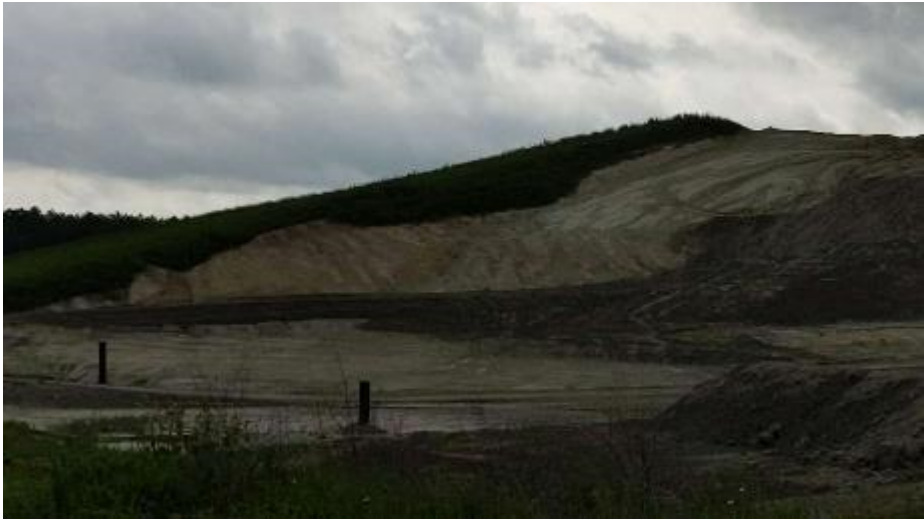
<p><b>PHOTOGRAPH No: 39</b></p>	<p><b>DATE:</b> April 16, 2024 9:57 AM</p>	<p><b>LATITUDE:</b> 33.63846696</p>	<p><b>LONGITUDE:</b> -93.81305696</p>
<p><b>SITE LOCATION:</b> TURK POWER PLANT, FULTON ARKANSAS</p>			
<p><b>DESCRIPTION:</b>  North Landfill Cell 2 Area, Inboard Slope. Cell 1 Outboard Slope with Interim Slope Cover. Looking Southeast, Note Length of Slope.</p>

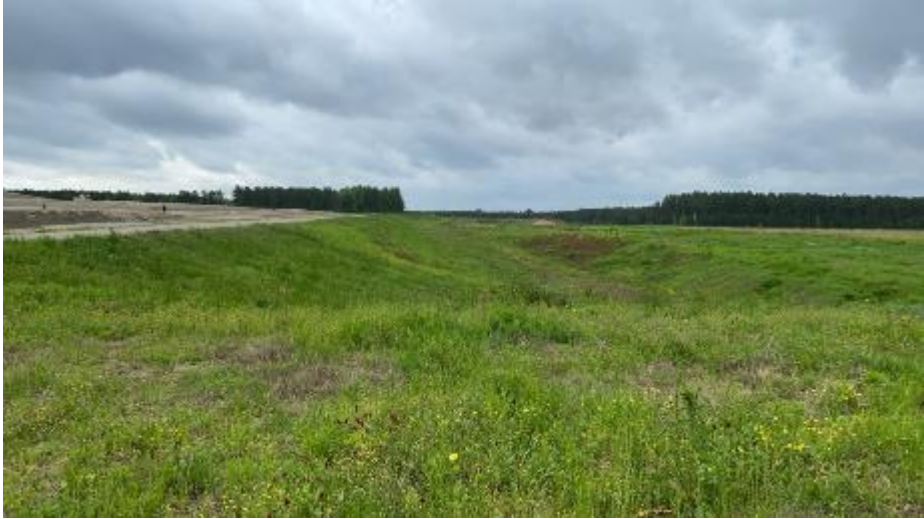
1. Overall condition of the CCR Landfill Cell 1 and Cell 2 was good. Photograph No. 40 was taken along the perimeter berm on the western side of the landfill. It also serves as the perimeter road in this section of the landfill. Cell 1 (Inactive) can be seen in the background of Photograph No. 39, while the Cell 2 (Active) is depicted in the foreground. Cell 2 CCR fill is nearly the elevation of the perimeter road as shown in Photograph No. 37 and No. 38. Active Cell 2 fill area appeared in good condition. No significant erosion or ponded water was observed.

<p><b>PHOTO BY:</b>  GEI CONSULTANTS, INC.</p>			
<p><b>PHOTOGRAPH No: 40</b></p>	<p><b>DATE:</b> April 16, 2024 9:55 AM</p>	<p><b>LATITUDE:</b> 33.638490748954</p>	<p><b>LONGITUDE:</b> -93.8130838177693</p>
<p><b>SITE LOCATION:</b> TURK POWER PLANT, FULTON ARKANSAS</p>			
<p><b>DESCRIPTION:</b>  North Landfill Cell 2 Area, Outboard Dike. Looking South. Ground Cover, Typical Conditions.</p>

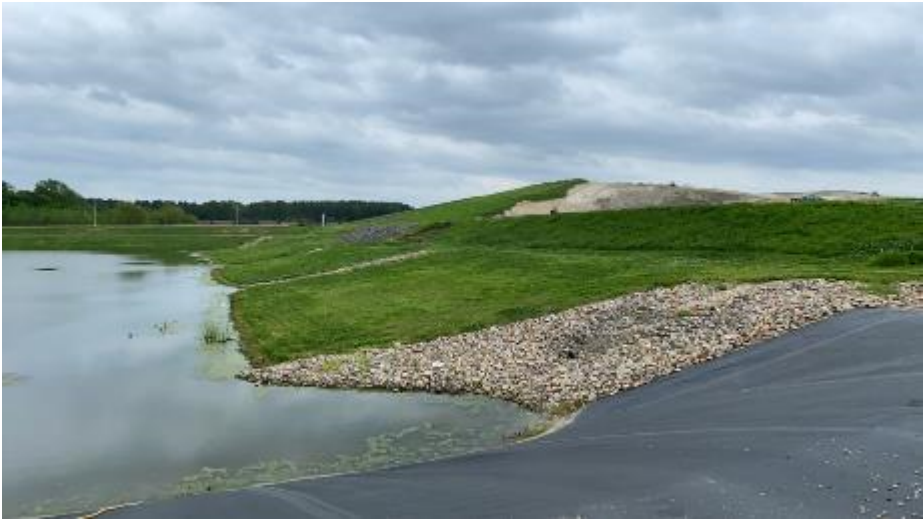
<b>PHOTOGRAPH No: 43</b>	<b>DATE:</b> April 16, 2024 11:48 AM	<b>LATITUDE:</b> 33.6391151642733	<b>LONGITUDE:</b> -93.8136579047572
<b>SITE LOCATION:</b> TURK POWER PLANT, FULTON ARKANSAS			
<b>DESCRIPTION:</b>  Leachate Pond, Southwest corner. Looking east. General photo, typical conditions

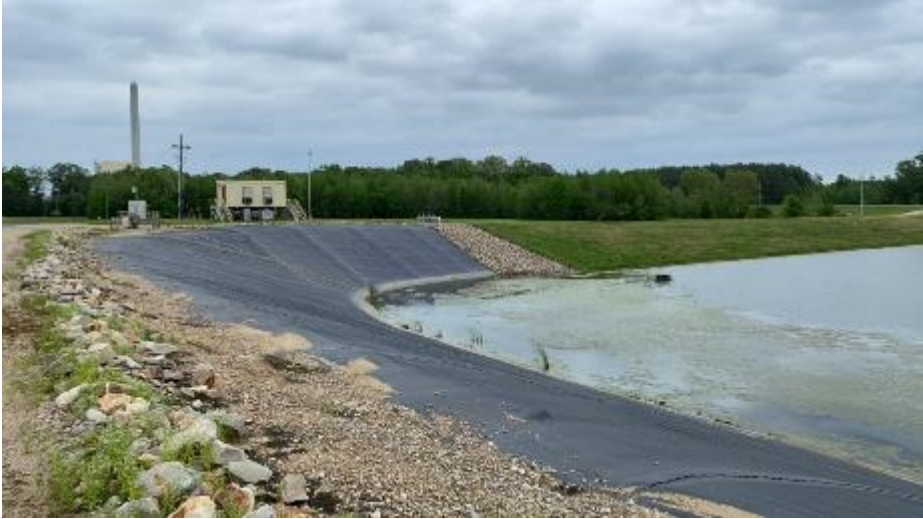
<b>PHOTO BY:</b>  GEI CONSULTANTS, INC.			
<b>PHOTOGRAPH No: 44</b>	<b>DATE:</b> April 16, 2024 11:47 AM	<b>LATITUDE:</b> 33.6393301484848	<b>LONGITUDE:</b> -93.8136179413534
<b>SITE LOCATION:</b> TURK POWER PLANT, FULTON ARKANSAS			
<b>DESCRIPTION:</b>  Synthetic Cover on Inboard Dike Leachate Pond. Looking North. General Photo, Typical Conditions.

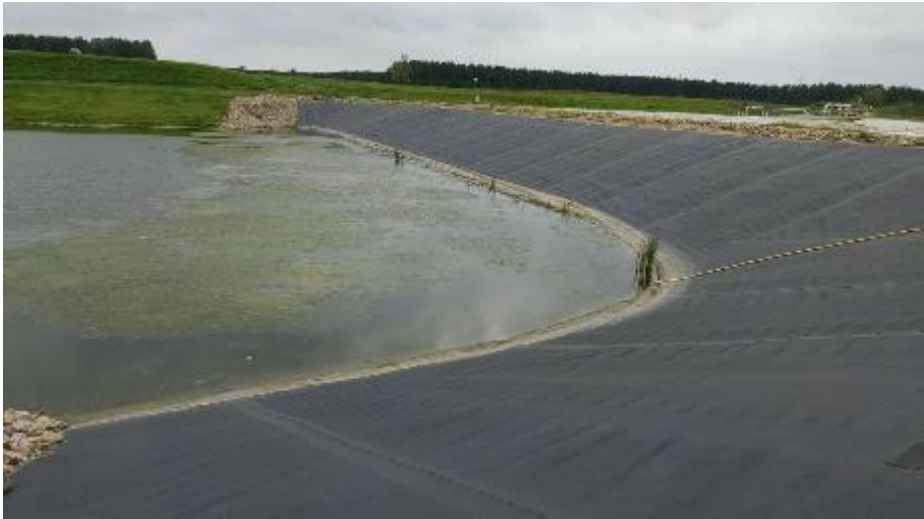
<b>PHOTOGRAPH No: 45</b>	<b>DATE:</b> April 16, 2024 11:40 AM	<b>LATITUDE:</b> 33.63996413	<b>LONGITUDE:</b> -93.81320783
<b>SITE LOCATION:</b> TURK POWER PLANT, FULTON ARKANSAS			
<b>DESCRIPTION:</b>  Leachate Pond Area, Looking South. General Photo, Typical Conditions. Note black sacrificial liner on top of primary liner.

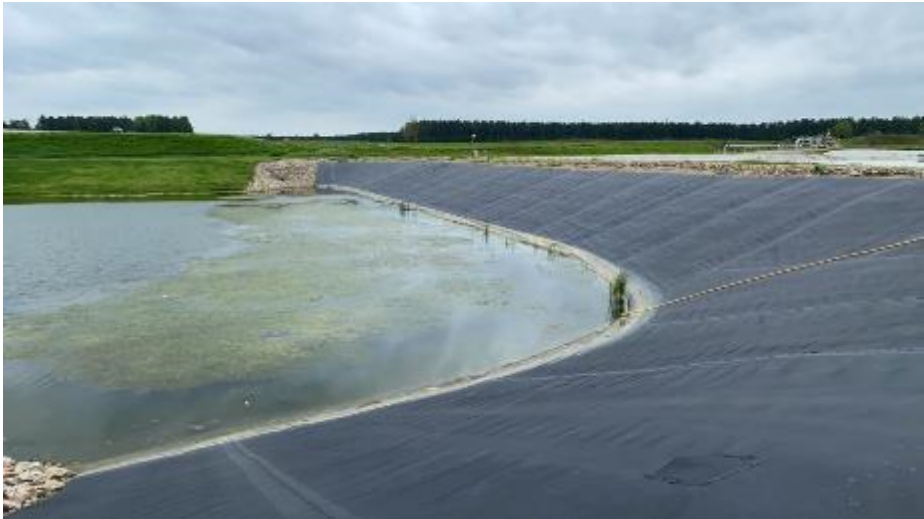
<b>PHOTO BY:</b>  GEI CONSULTANTS, INC.			
<b>PHOTOGRAPH No: 46</b>	<b>DATE:</b> April 16, 2024 11:40 AM	<b>LATITUDE:</b> 33.639963717438	<b>LONGITUDE:</b> -93.8131947961675
<b>SITE LOCATION:</b> TURK POWER PLANT, FULTON ARKANSAS			
<b>DESCRIPTION:</b>  Leachate Pond Area, Looking South. General Photo, Typical Conditions. Note black sacrificial liner on top of primary liner.

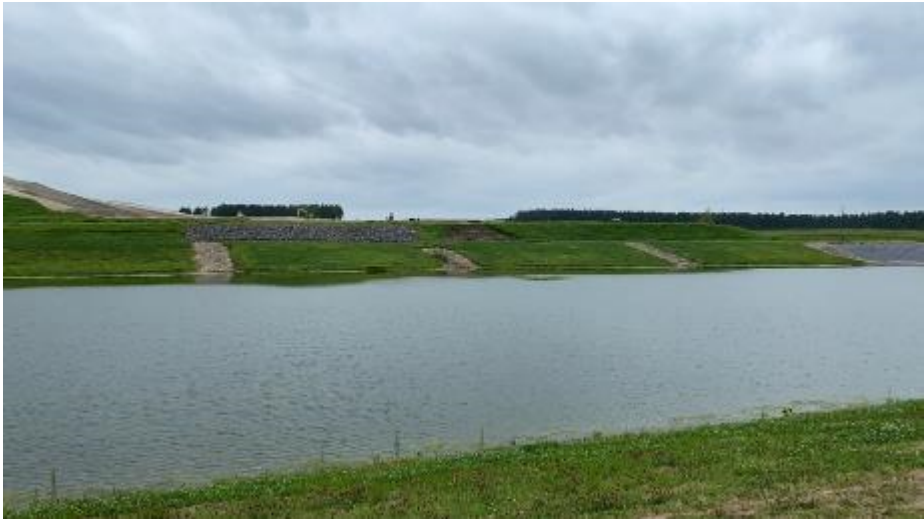
<b>PHOTOGRAPH No: 47</b>	<b>DATE:</b> April 16, 2024 11:35 AM	<b>LATITUDE:</b> 33.639937520843	<b>LONGITUDE:</b> -93.8118303231222
<b>SITE LOCATION:</b> TURK POWER PLANT, FULTON ARKANSAS			
<b>DESCRIPTION:</b>  Leachate Pond Area Looking South. General Photo, Typical Conditions.

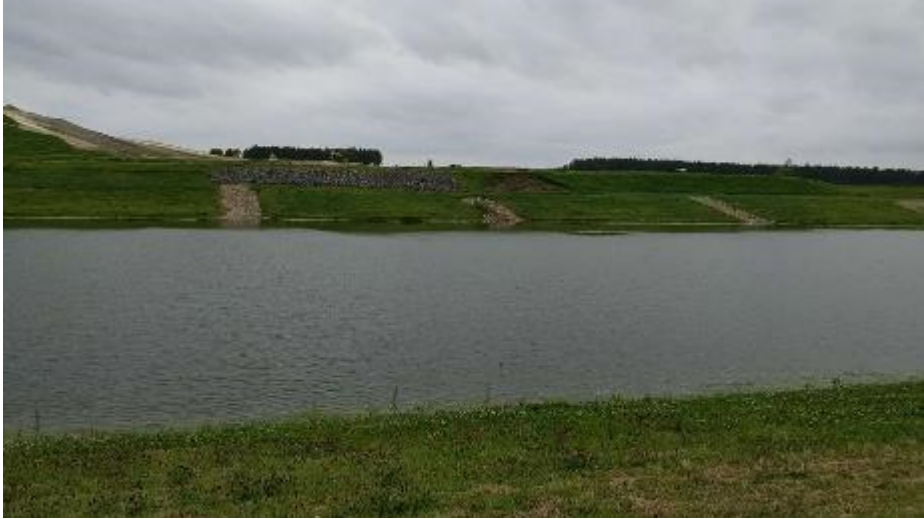
<b>PHOTO BY:</b>  GEI CONSULTANTS, INC.			
<b>PHOTOGRAPH No: 48</b>	<b>DATE:</b> April 16, 2024 11:36 AM	<b>LATITUDE:</b> 33.63994491	<b>LONGITUDE:</b> -93.81178737
<b>SITE LOCATION:</b> TURK POWER PLANT, FULTON ARKANSAS			
<b>DESCRIPTION:</b>  Leachate Pond Area Looking South. General Photo, Typical Conditions.
