## CCR Bottom Ash Storage Pond 2024 Annual Dam and Dike Inspection Report

Welsh Power Plant, Cason, Texas

AEP Document ID: GEVR-24-015

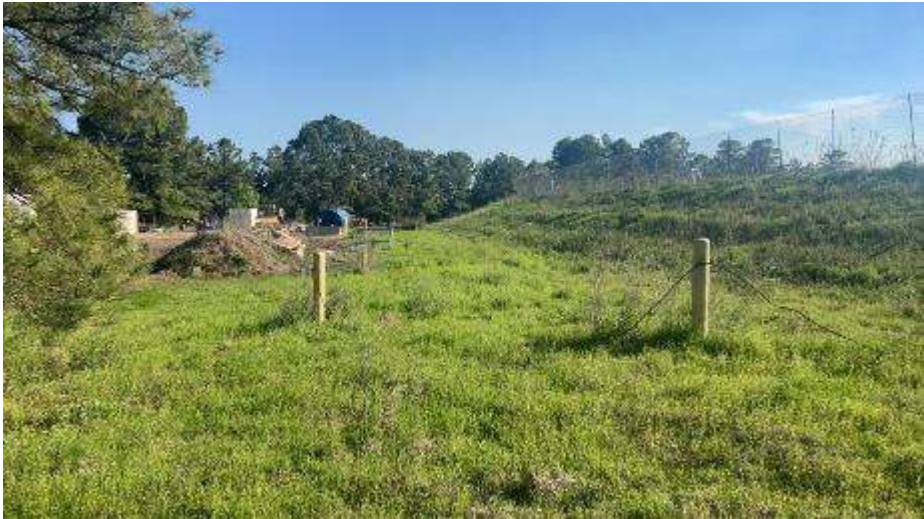
<b>PHOTOGRAPH NO: 3</b>	<b>DATE:</b> March 19, 2024 4:52 PM	<b>LATITUDE:</b> 33.0467098377658	<b>LONGITUDE:</b> -94.8426555044572
<b>DIRECTION:</b> South	<b>SITE LOCATION:</b> CASON, TEXAS		
<b>DESCRIPTION:</b>  Downstream Slope of Outboard Dike. Looking South. General Photo, Typical Conditions.

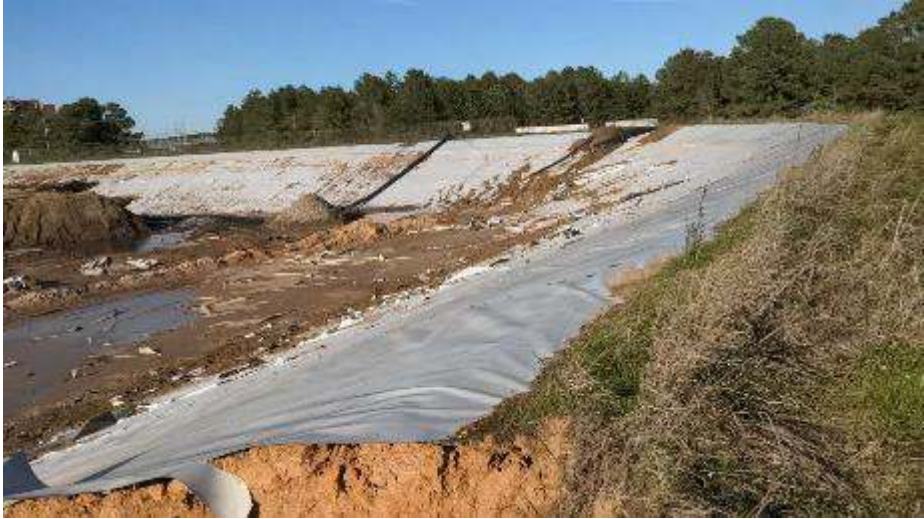
<b>PHOTO BY:</b>  GEI CONSULTANTS, INC.			
<b>PHOTOGRAPH NO: 4</b>	<b>DATE:</b> March 18, 2024 5:54 PM	<b>LATITUDE:</b> 33.04590577	<b>LONGITUDE:</b> -94.84264626
<b>DIRECTION:</b> East	<b>SITE LOCATION:</b> CASON, TEXAS		
<b>DESCRIPTION:</b>  Upstream Slope of Original Dam. Looking East. General Photo, Typical Conditions.

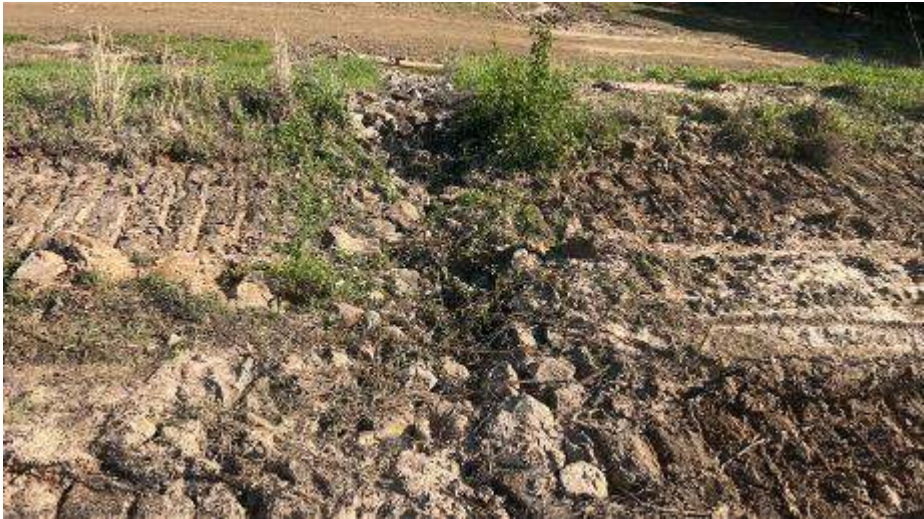
<b>PHOTOGRAPH NO: 5</b>	<b>DATE:</b> March 19, 2024 4:57 PM	<b>LATITUDE:</b> 33.0455077077291	<b>LONGITUDE:</b> -94.8427395124093
<b>DIRECTION:</b> South	<b>SITE LOCATION:</b> CASON, TEXAS		
<b>DESCRIPTION:</b>  Downstream Slope of Drainage Feature. Looking Southeast. Typical Conditions of Riprap.

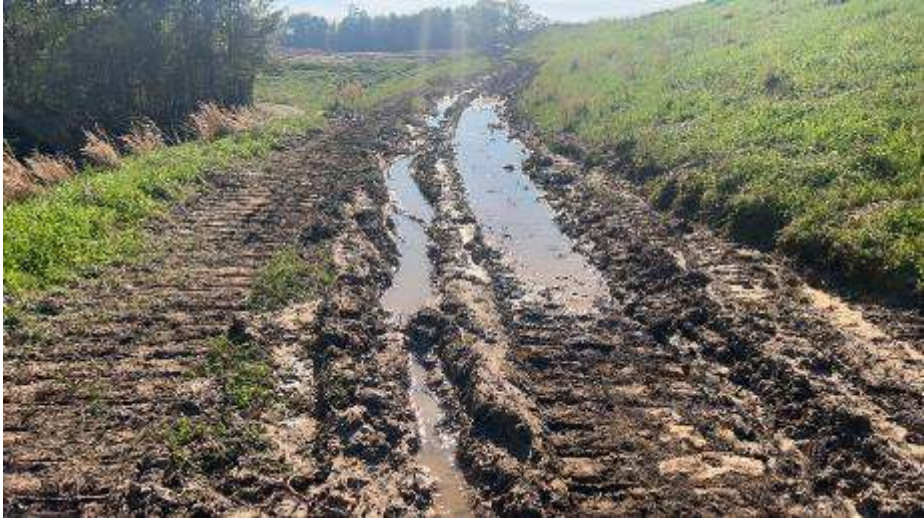
<b>PHOTO BY:</b>  GEI CONSULTANTS, INC.			
<b>PHOTOGRAPH NO: 6</b>	<b>DATE:</b> March 19, 2024 4:58 PM	<b>LATITUDE:</b> 33.0454897955821	<b>LONGITUDE:</b> -94.8428134103689
<b>DIRECTION:</b> West	<b>SITE LOCATION:</b> CASON, TEXAS		
<b>DESCRIPTION:</b>  Downstream Slope. Looking Southwest. General Photo, Typical Conditions.

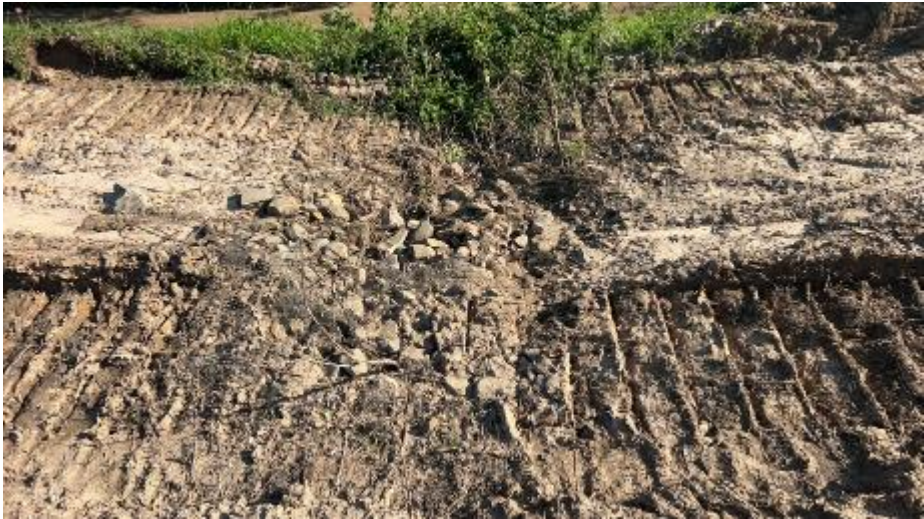
<b>PHOTOGRAPH NO: 7</b>	<b>DATE:</b> March 19, 2024 5:00 PM	<b>LATITUDE:</b> 33.0453527766715	<b>LONGITUDE:</b> -94.8433968572266
<b>DIRECTION:</b> Southeast	<b>SITE LOCATION:</b> CASON, TEXAS		
<b>DESCRIPTION:</b>  Downstream Slope, Drainage Feature. Looking Southeast. Riprap.

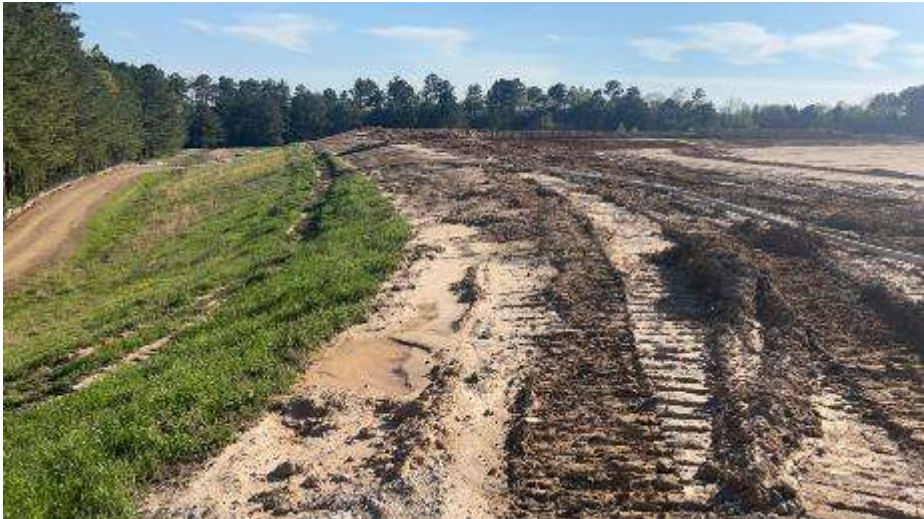
<b>PHOTO BY:</b>  GEI CONSULTANTS, INC.			
<b>PHOTOGRAPH NO: 8</b>	<b>DATE:</b> March 19, 2024 5:01 PM	<b>LATITUDE:</b> 33.0452812413131	<b>LONGITUDE:</b> -94.8435000353703
<b>DIRECTION:</b> South	<b>SITE LOCATION:</b> CASON, TEXAS		
<b>DESCRIPTION:</b>  East area, Crest and Downstream Slope. Looking South. General Photo, Typical Conditions.

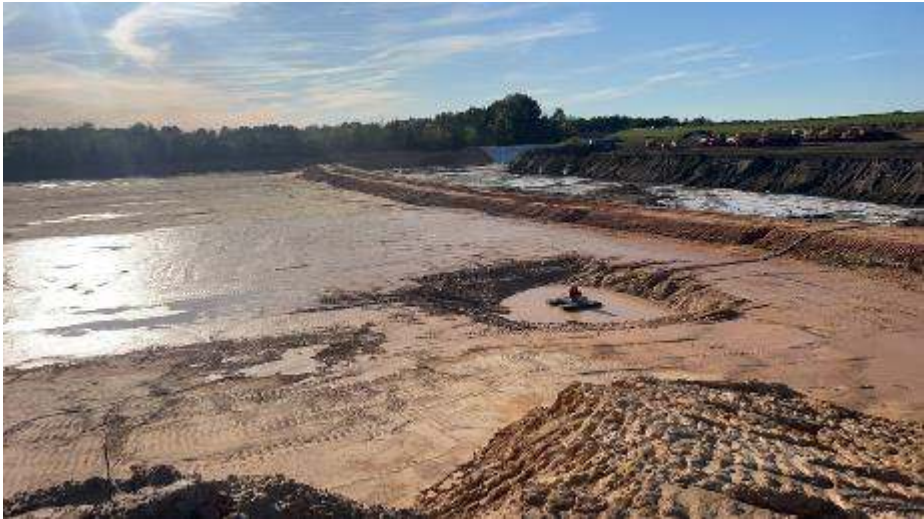
<b>PHOTOGRAPH NO: 9</b>	<b>DATE:</b> March 18, 2024 5:59 PM	<b>LATITUDE:</b> 33.0453224810753	<b>LONGITUDE:</b> -94.8437046776976
<b>DIRECTION:</b> West	<b>SITE LOCATION:</b> CASON, TEXAS		
<b>DESCRIPTION:</b>  South area, Crest. Looking West. Typical Conditions of Storage Pond.

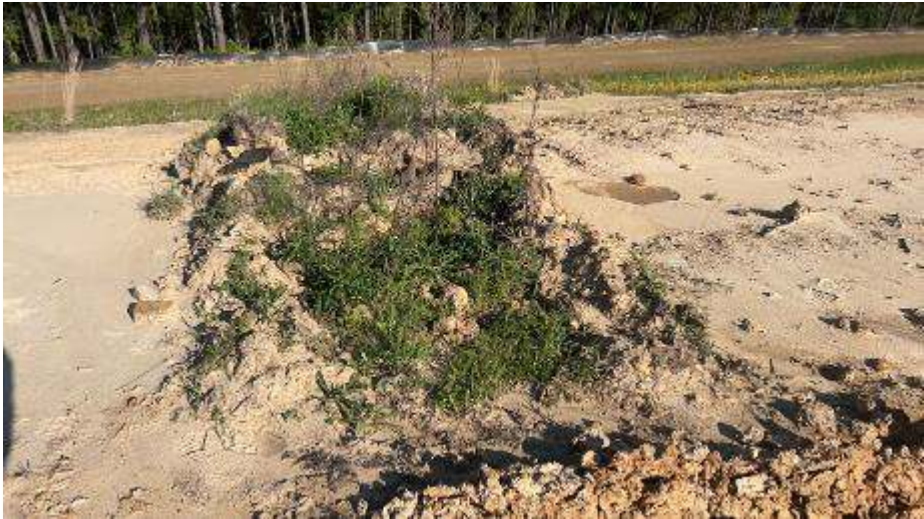
<b>PHOTOGRAPH NO: 11</b>	<b>DATE:</b> March 19, 2024 5:04 PM	<b>LATITUDE:</b> 33.0446721861726	<b>LONGITUDE:</b> -94.8437873177648
<b>DIRECTION:</b> East	<b>SITE LOCATION:</b> CASON, TEXAS		
<b>DESCRIPTION:</b>  East area, Crest of Drainage Feature. Looking East. Typical Riprap.

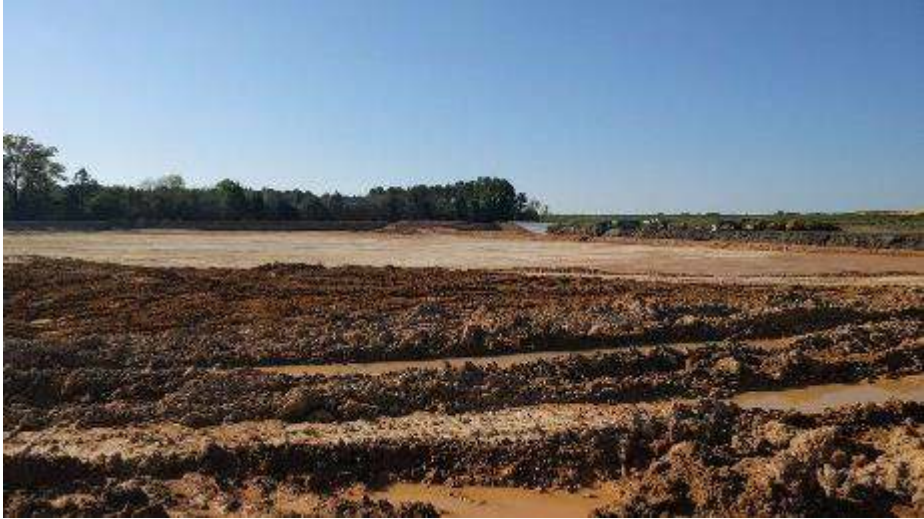
<b>PHOTO BY:</b>  GEI CONSULTANTS, INC.			
<b>PHOTOGRAPH NO: 12</b>	<b>DATE:</b> March 19, 2024 5:05 PM	<b>LATITUDE:</b> 33.04419355	<b>LONGITUDE:</b> -94.84388557
<b>DIRECTION:</b> North	<b>SITE LOCATION:</b> CASON, TEXAS		
<b>DESCRIPTION:</b>  South area, Upstream Slope of Inboard Dike. Looking North. Note area of Closure by Removal near Final Subgrade Elevation.

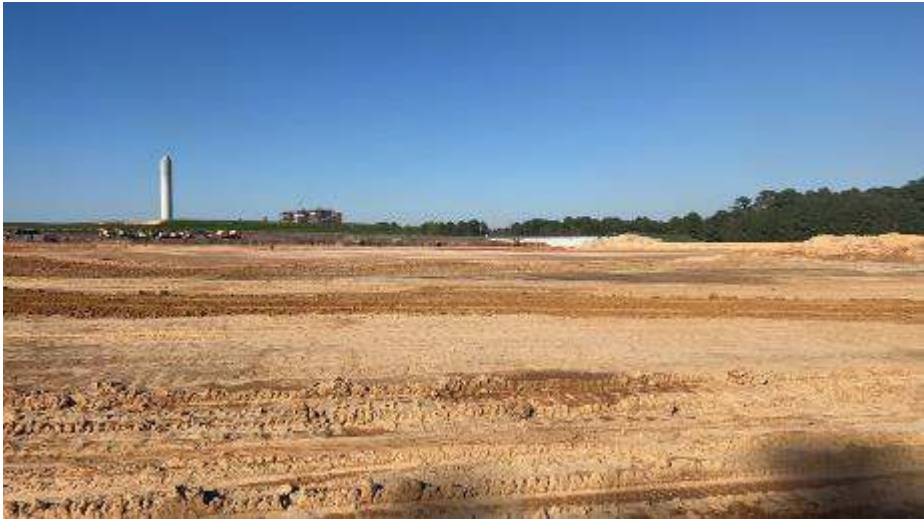
<b>PHOTOGRAPH No: 15</b>	<b>DATE:</b> March 19, 2024 5:13 PM	<b>LATITUDE:</b> 33.0438336473822	<b>LONGITUDE:</b> -94.8459234167427
<b>DIRECTION:</b> Northeast	<b>SITE LOCATION:</b> CASON, TEXAS		
<b>DESCRIPTION:</b>  South area, Toe. Looking Northeast. General Photo, Typical Conditions.

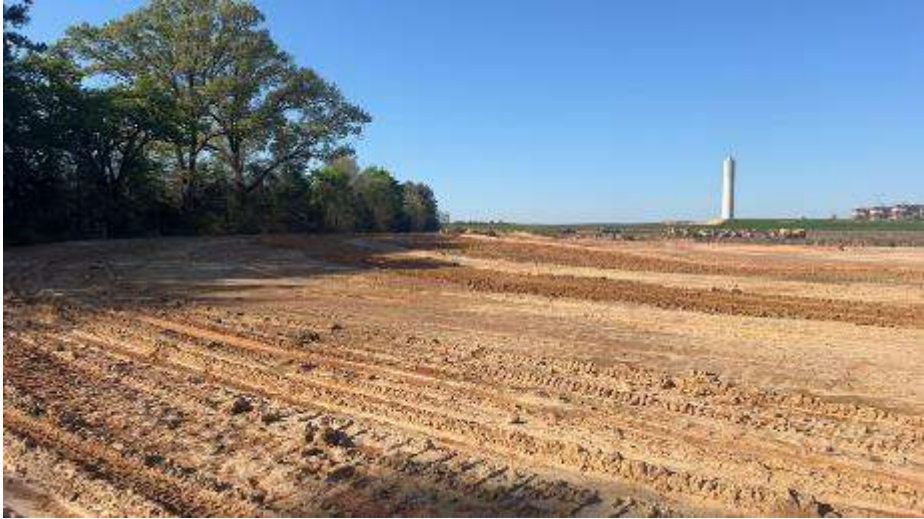
<b>PHOTO BY:</b>  GEI CONSULTANTS, INC.			
<b>PHOTOGRAPH No: 16</b>	<b>DATE:</b> March 19, 2024 5:14 PM	<b>LATITUDE:</b> 33.0438436247929	<b>LONGITUDE:</b> -94.8459236676379
<b>DIRECTION:</b> West	<b>SITE LOCATION:</b> CASON, TEXAS		
<b>DESCRIPTION:</b>  South area, Toe. Looking West. General Photo, Typical Conditions.

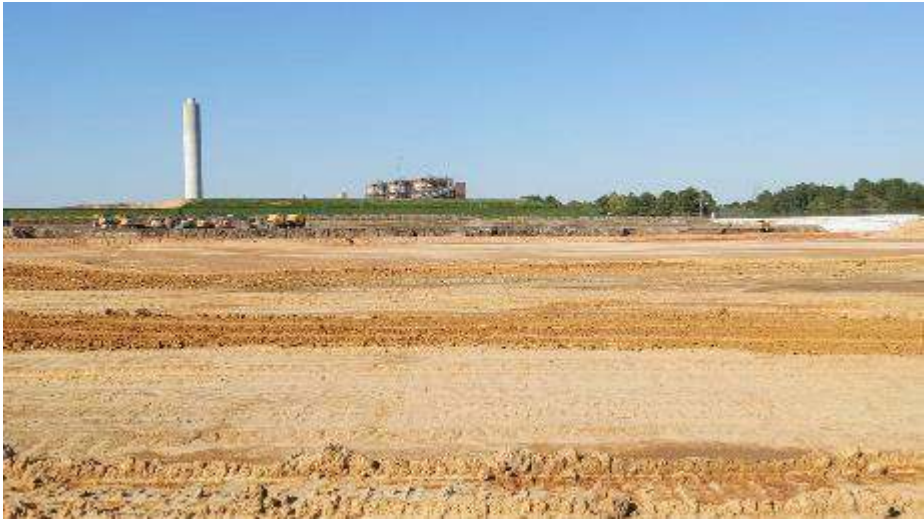
<b>PHOTOGRAPH No: 17</b>	<b>DATE:</b> March 19, 2024 5:13 PM	<b>LATITUDE:</b> 33.04386002	<b>LONGITUDE:</b> -94.84595354
<b>DIRECTION:</b> Northeast	<b>SITE LOCATION:</b> CASON, TEXAS		
<b>DESCRIPTION:</b>  South area, Outboard Dike. Looking Northeast into Active Pond Closure Area. Typical Conditions.

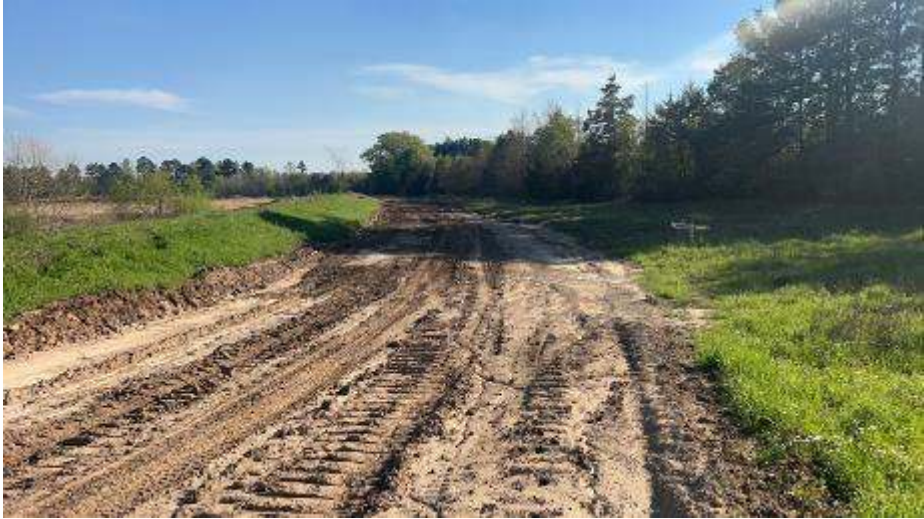
<b>PHOTO BY:</b>  GEI CONSULTANTS, INC.			
<b>PHOTOGRAPH No: 18</b>	<b>DATE:</b> March 19, 2024 5:21 PM	<b>LATITUDE:</b> 33.0468143055288	<b>LONGITUDE:</b> -94.8461336625621
<b>DIRECTION:</b> South	<b>SITE LOCATION:</b> CASON, TEXAS		
<b>DESCRIPTION:</b>  West area, Downstream Slope. Looking South. General Photo, Typical Conditions.
