Ash Landfill 2024 Annual CCR Landfill Inspection Report

Welsh Power Plant, Cason, Texas

August 13, 2024

AEP Document ID: GEVR-24-014

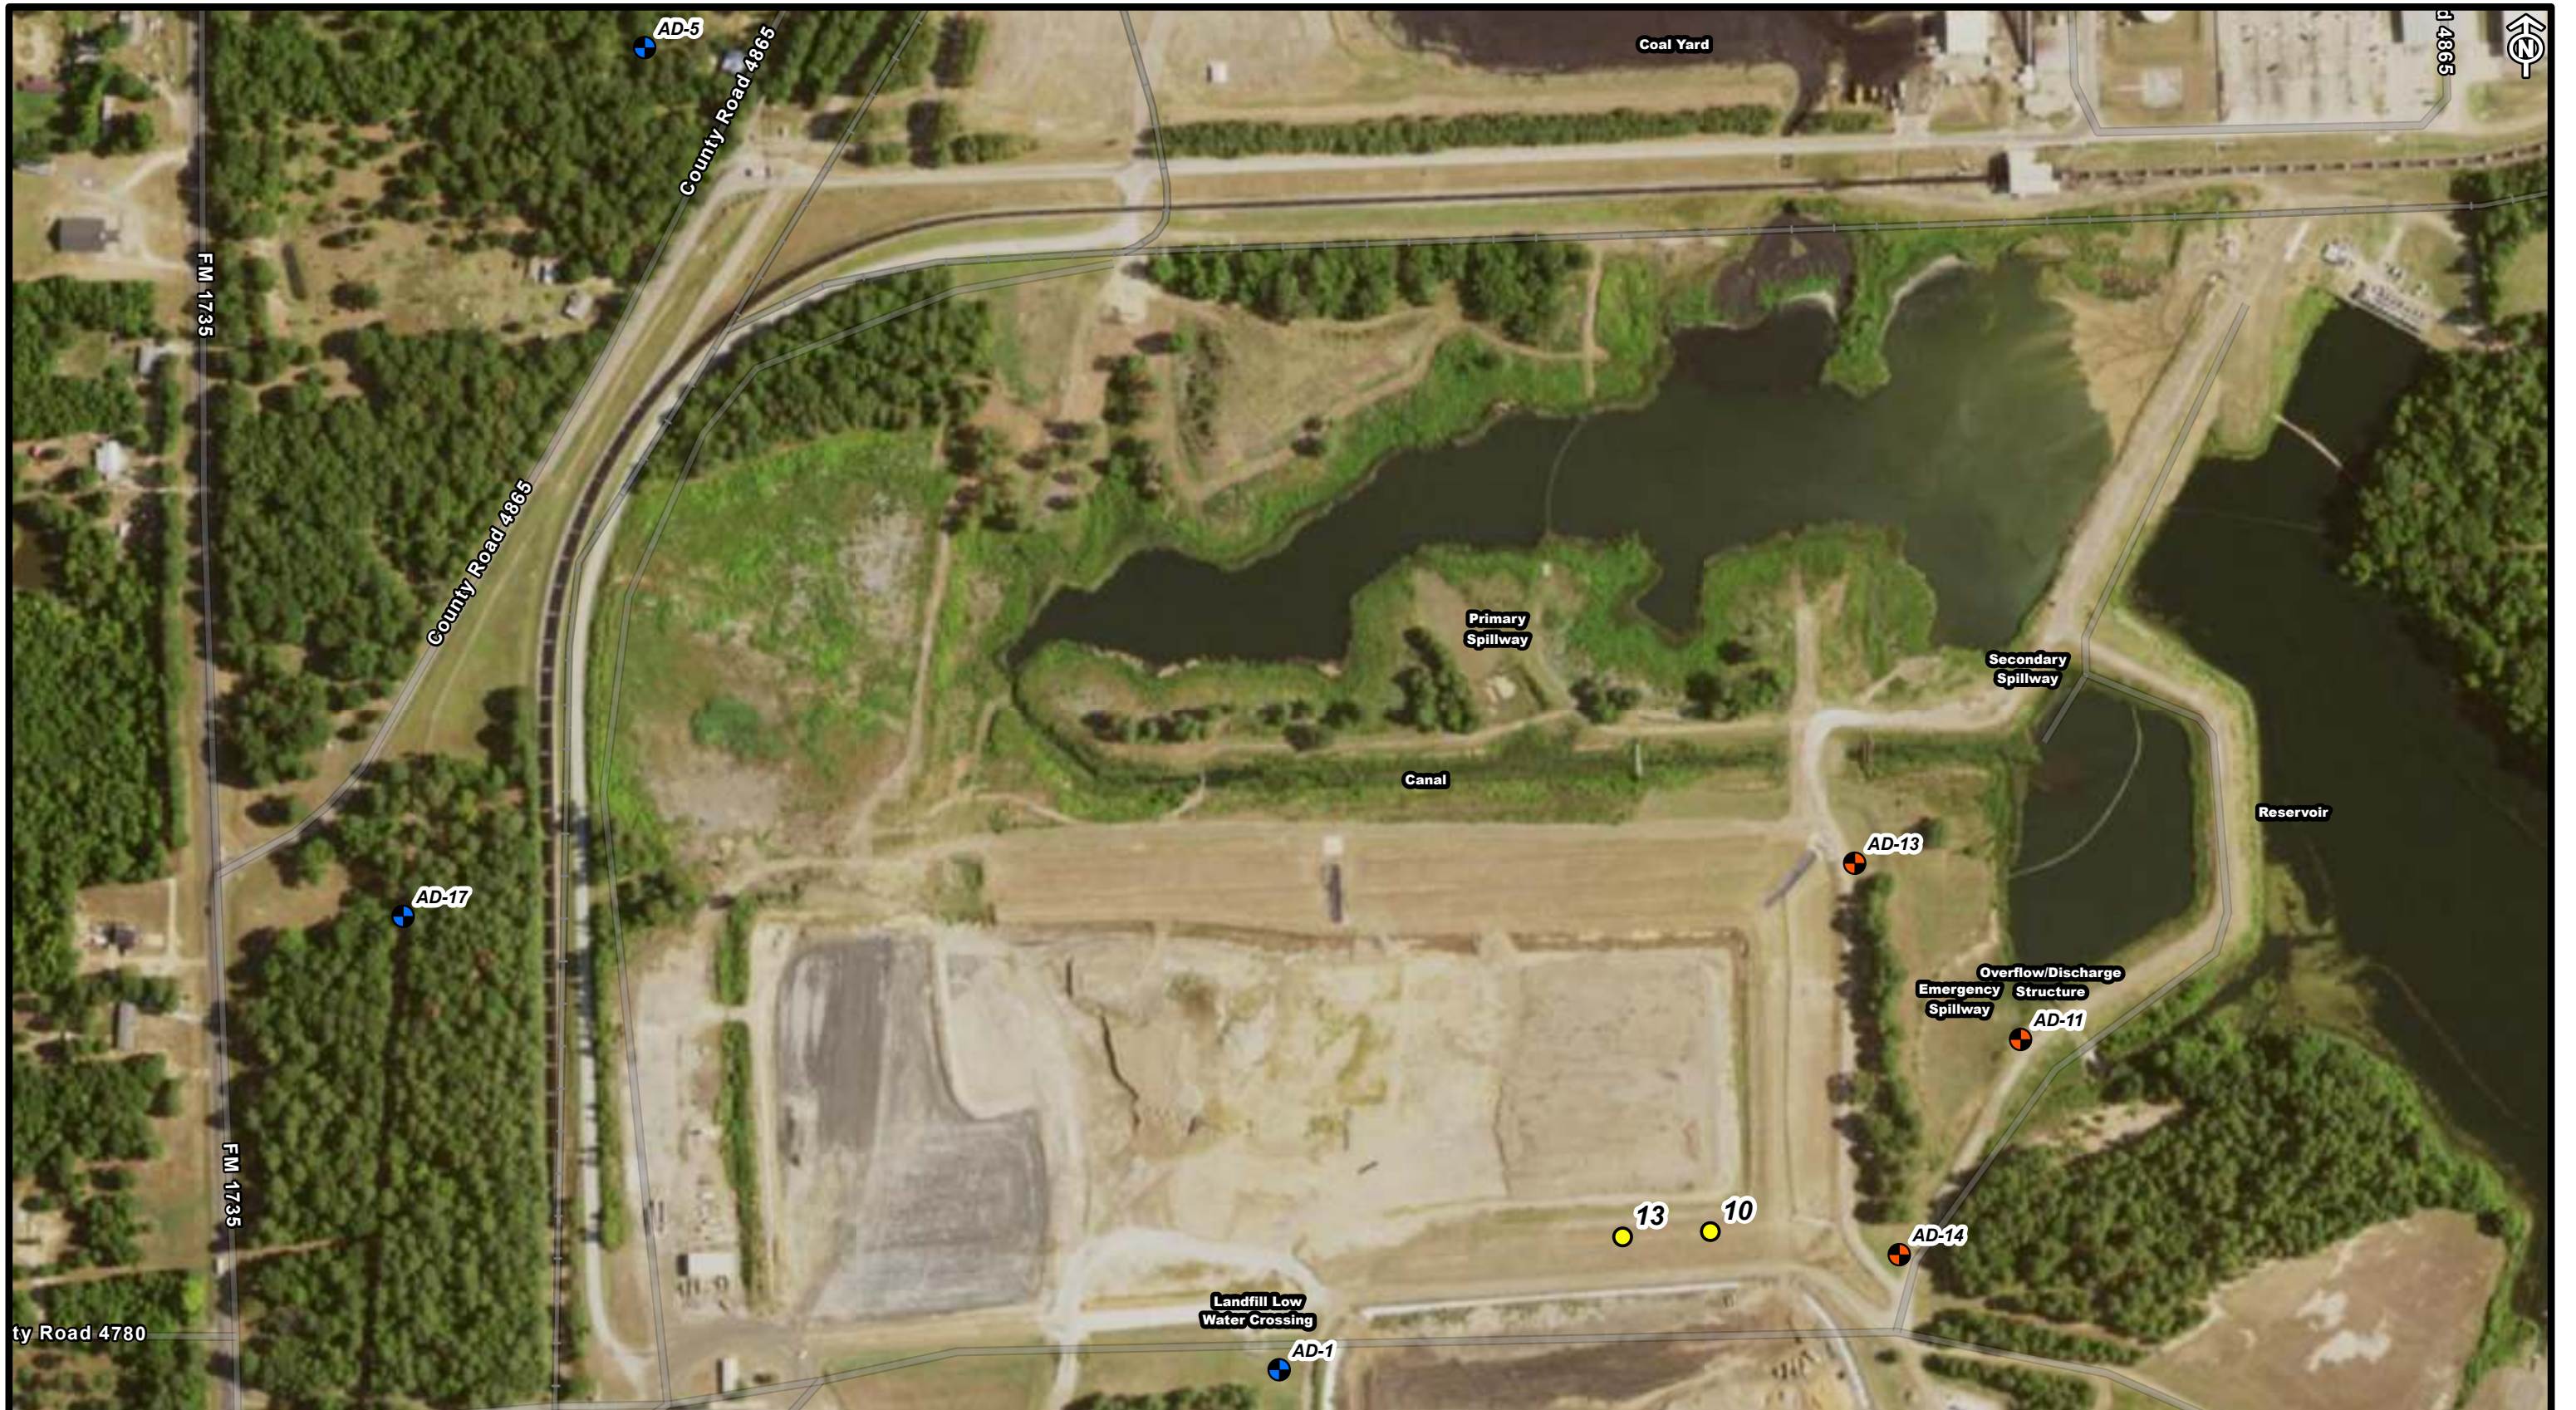
ITEMS TO BE MONITORED

- Leachate pumps should be monitored until the pumps resume to show normal readings related to the landfill leachate level. Alternately, operate the leachate pumps manually as needed.
- Item 10 – South face of the landfill slope. Monitor erosion, address as needed.
- Item 13 – South face of the landfill slope. Monitor animal activity, address as needed.

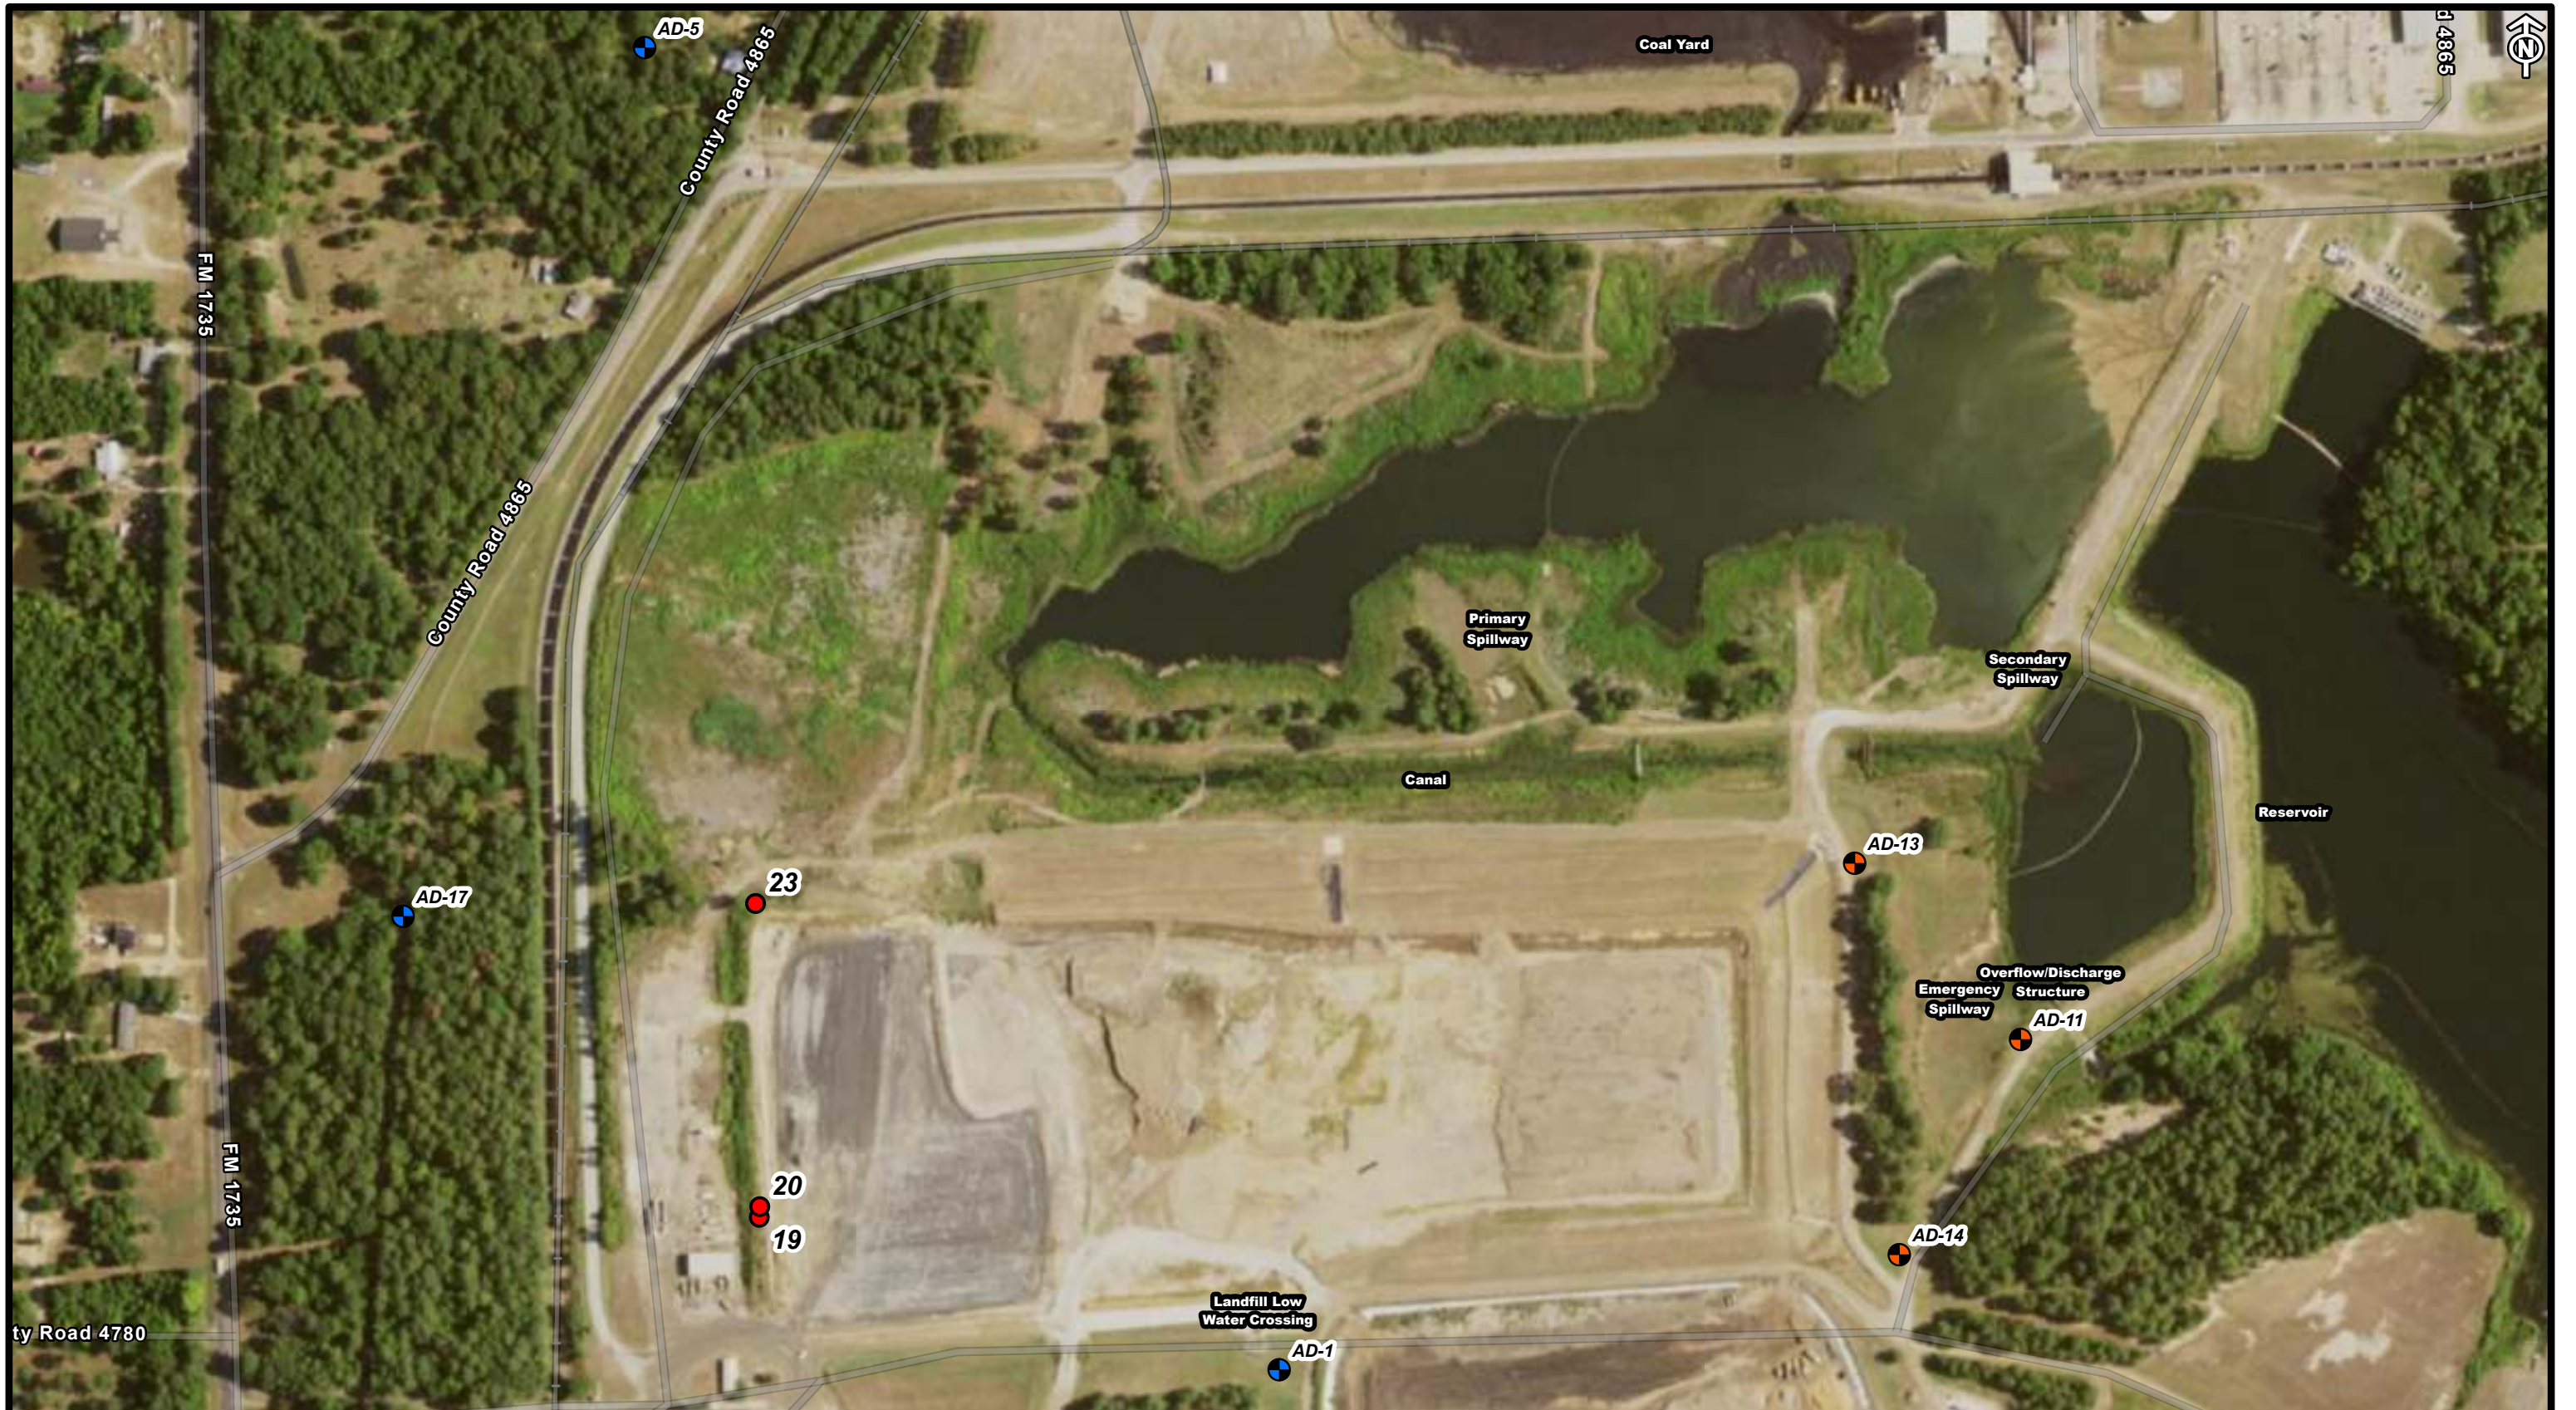
ITEMS TO BE ADDRESSED

- Item 19 – Address heavy vegetation along the western perimeter of the landfill.
- Item 20 – Address heavy vegetation along the western perimeter of the landfill.

- Item 23 – Address vegetation in the northwest corner of the landfill.

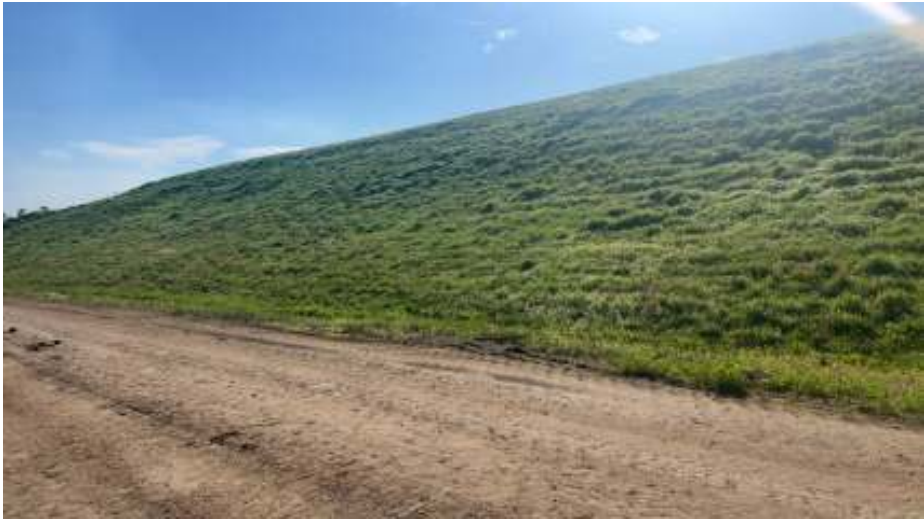
PHOTOGRAPH NO: 3	DATE: March 19, 2024 4:49 PM	LATITUDE: 33.0485136873554	LONGITUDE: -94.8427780390795
DIRECTION: West	SITE LOCATION: CASON, TEXAS		
DESCRIPTION: East area, Downstream Slope. Looking West. General Photo, Typical Conditions.

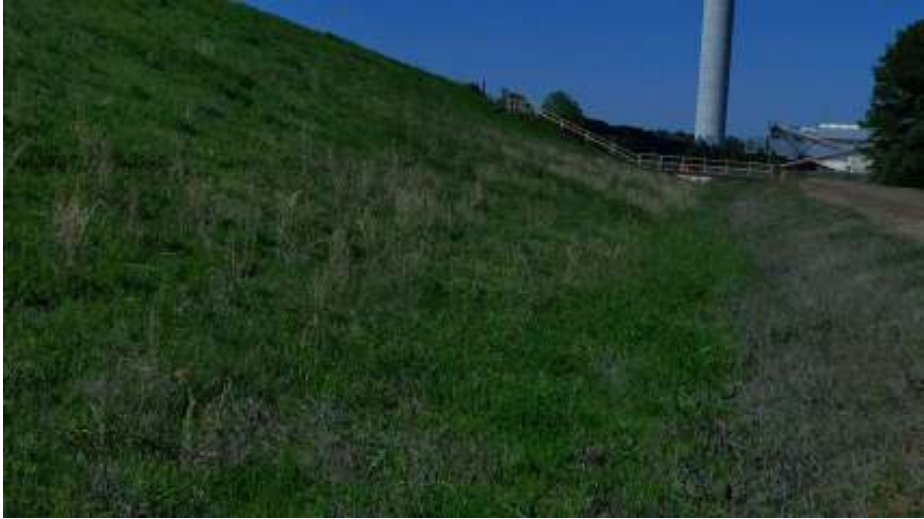
PHOTO BY: GEI CONSULTANTS, INC.			
PHOTOGRAPH NO: 4	DATE: March 19, 2024 3:33 PM	LATITUDE: 33.04752319	LONGITUDE: -94.84295892
DIRECTION: North	SITE LOCATION: CASON, TEXAS		
DESCRIPTION: East area, Downstream Slope of Outboard Dike. Note wet are at base of Toe.

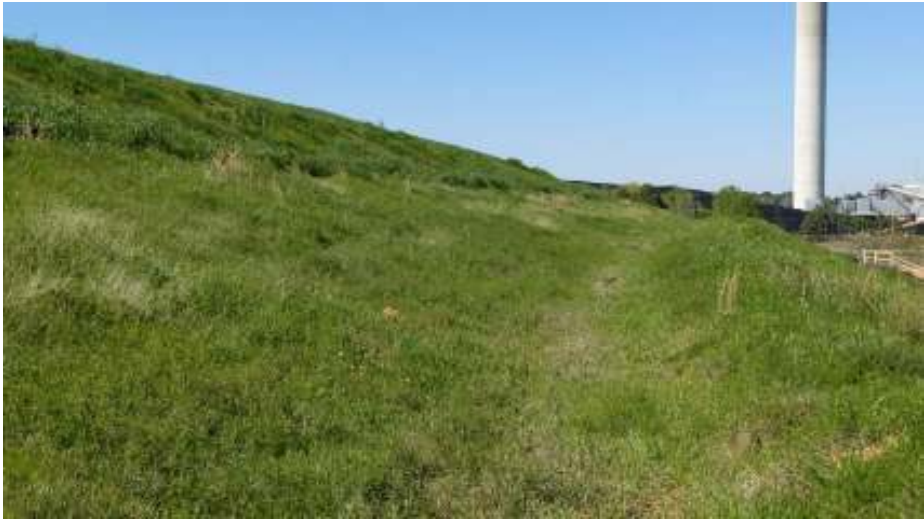
PHOTOGRAPH NO: 5	DATE: March 19, 2024 3:38 PM	LATITUDE: 33.04750493	LONGITUDE: -94.84318024
DIRECTION:	SITE LOCATION: CASON, TEXAS		
DESCRIPTION: East area, Downstream Slope of Outboard Dike. Looking North. Typical Conditions.

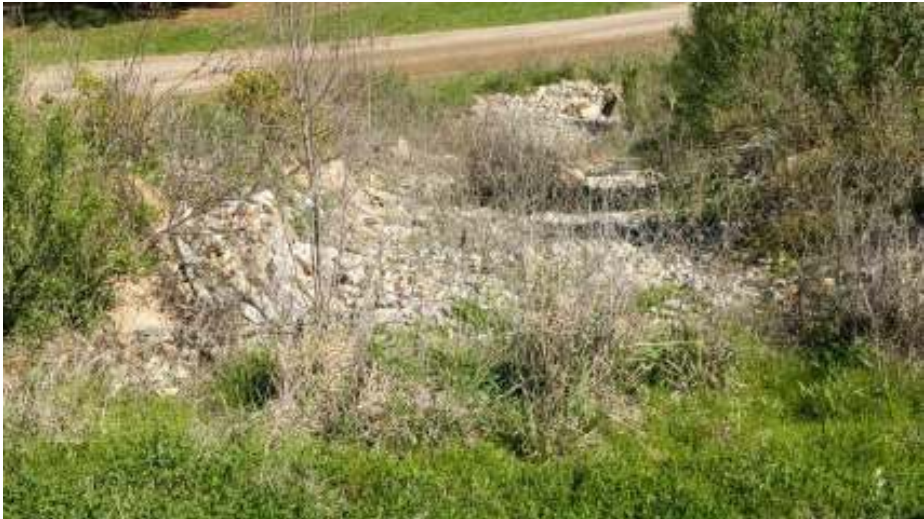
PHOTO BY: GEI CONSULTANTS, INC.			
PHOTOGRAPH NO: 6	DATE: March 19, 2024 3:39 PM	LATITUDE: 33.04740174	LONGITUDE: -94.84325309
DIRECTION: Southeast	SITE LOCATION: CASON, TEXAS		
DESCRIPTION: East area, Drainage Feature from Intermediate Bench to Toe. Looking Southeast. Typical Riprap.

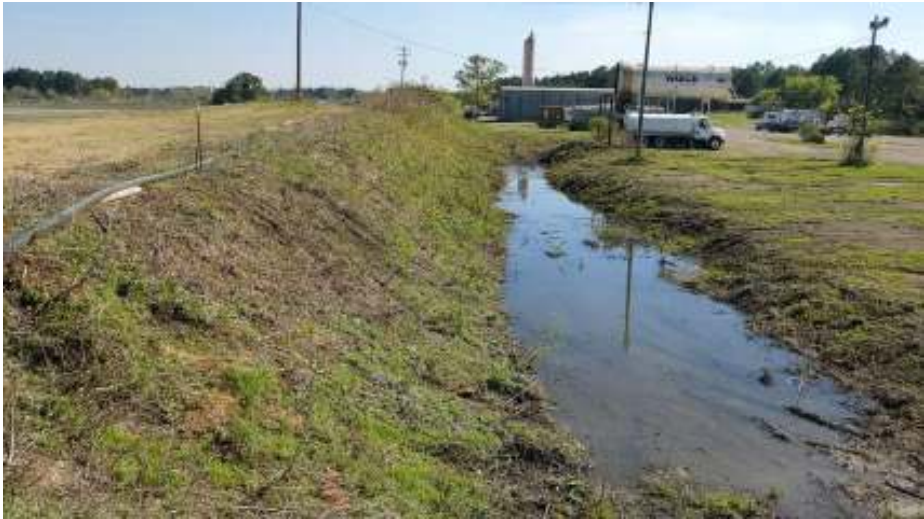
PHOTOGRAPH No: 21	DATE: March 19, 2024 4:13 PM	LATITUDE: 33.04855032	LONGITUDE: -94.84952324
DIRECTION: South	SITE LOCATION: CASON, TEXAS		
DESCRIPTION: West area, Downstream Slope of Outboard Dike. Looking South. Note Standing Water and Toe of Dike.

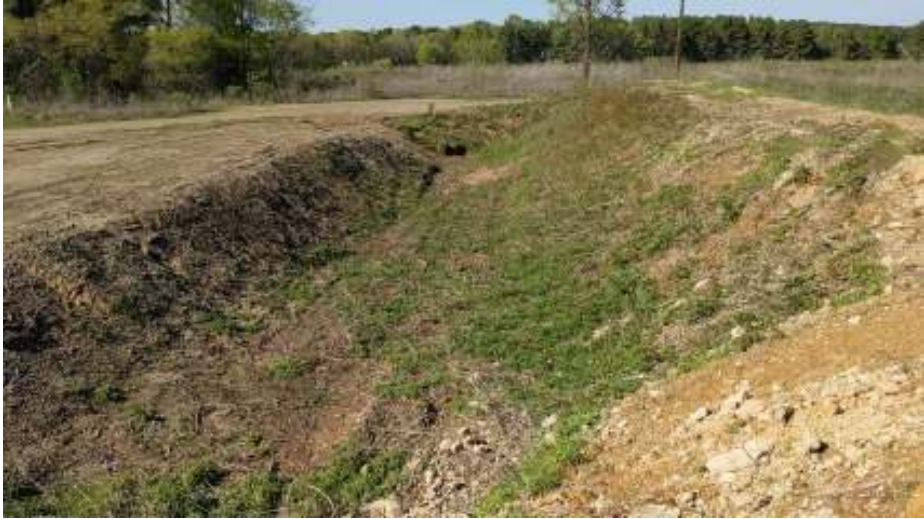
PHOTO BY: GEI CONSULTANTS, INC.			
PHOTOGRAPH No: 22	DATE: March 19, 2024 4:15 PM	LATITUDE: 33.04865543	LONGITUDE: -94.84964213
DIRECTION: North	SITE LOCATION: CASON, TEXAS		
DESCRIPTION: West area, Downstream Slope of Outboard Dike. Looking North. Note Drainage Culvert to Primary Ash pond.

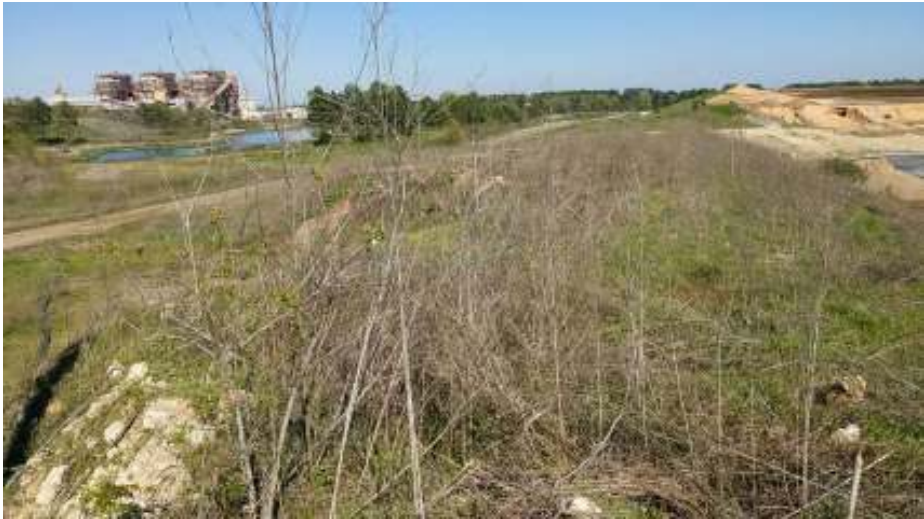
PHOTOGRAPH No: 23	DATE: March 19, 2024 4:18 PM	LATITUDE: 33.04916949	LONGITUDE: -94.8495
DIRECTION: East	SITE LOCATION: CASON, TEXAS		
DESCRIPTION: North Dike Northwest Corner, Downstream Slope of Outboard Dike. Looking East. Note Brush and Vegetation. Please Remove.

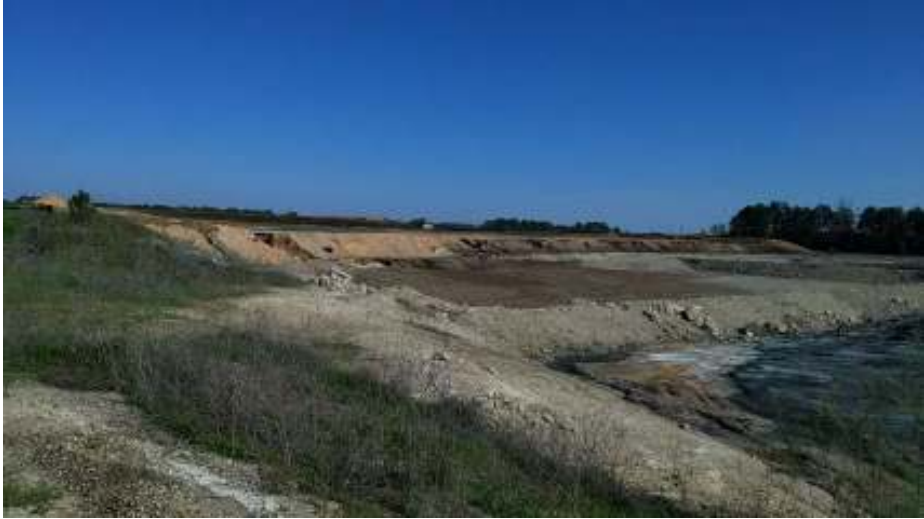
PHOTO BY: GEI CONSULTANTS, INC.			
PHOTOGRAPH No: 24	DATE: March 19, 2024 4:23 PM	LATITUDE: 33.04913614	LONGITUDE: -94.84862158
DIRECTION: Southeast	SITE LOCATION: CASON, TEXAS		
DESCRIPTION: North area, Active Placement Area. Looking Southeast.

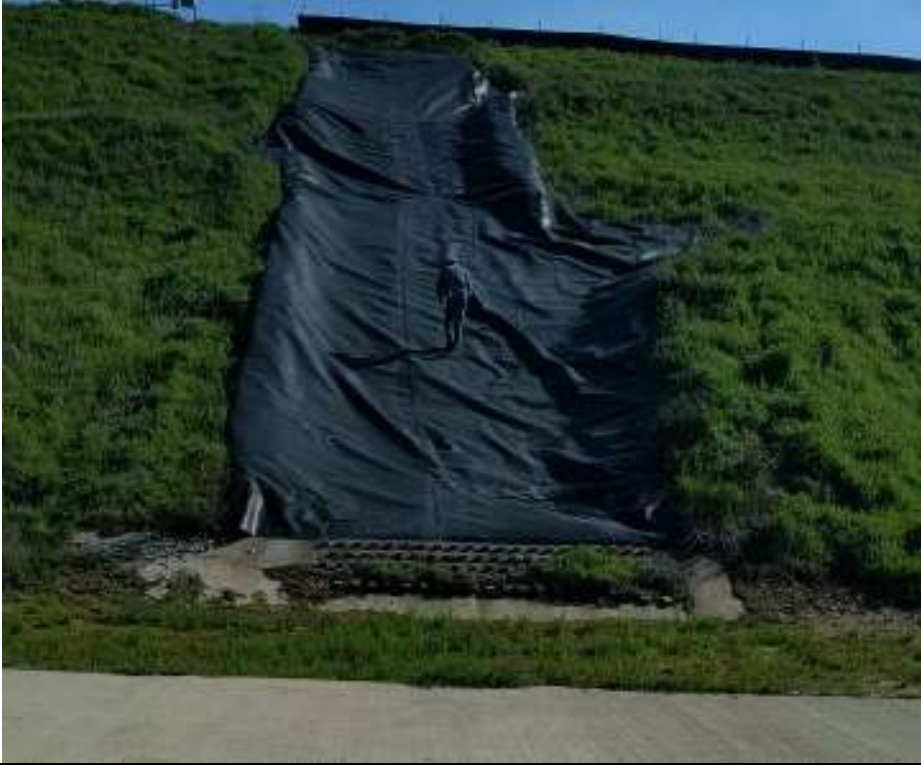
PHOTOGRAPH No: 27	DATE: March 19, 2024 4:34 PM	LATITUDE: 33.04945795	LONGITUDE: -94.8459425
DIRECTION:	SITE LOCATION: CASON, TEXAS		
DESCRIPTION: North area, Downstream Slope Drainage Feature. Note Synthetic Liner Cover.

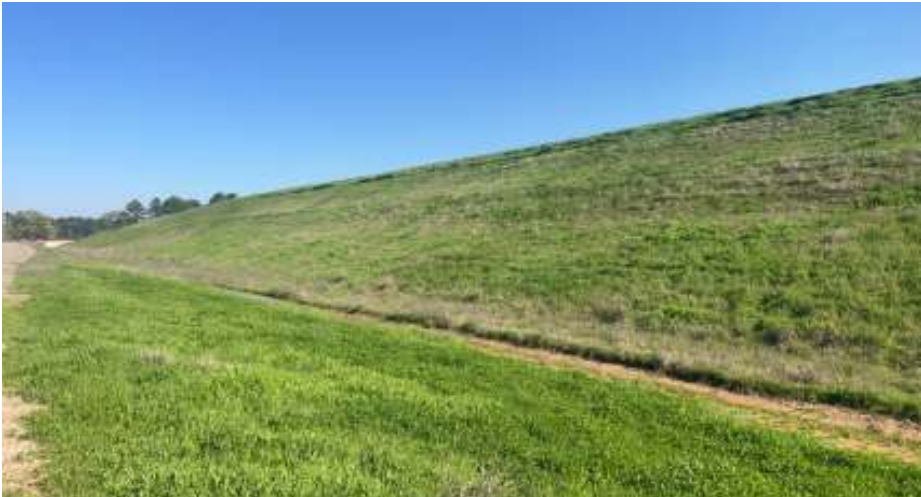
PHOTO BY: GEI CONSULTANTS, INC.			
PHOTOGRAPH No: 28	DATE: March 19, 2024 4:40 PM	LATITUDE: 33.0494484949398	LONGITUDE: -94.8458731475664
DIRECTION:	SITE LOCATION: CASON, TEXAS		
DESCRIPTION: North area, Downstream Slope and Toe. Looking Southeast. Typical Conditions.
