Primary Bottom Ash and Clearwater Pond 2024 Annual Dam and Dike Inspection Report

Welsh Power Plant, Cason, Texas

Project 2305686

AEP Document ID: GEVR-24-008

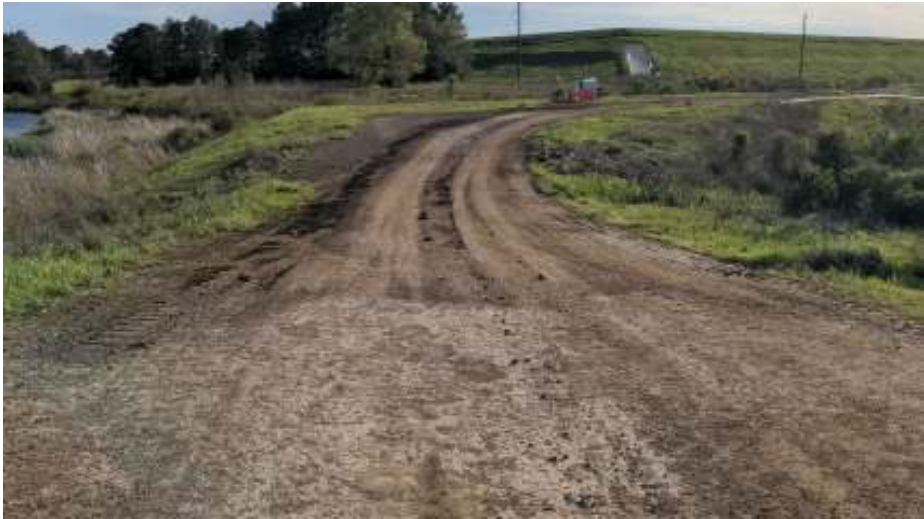
5. The primary emergency spillway is located towards the southeast section of the south dike. A concrete weir is located at the spillway was mostly buried in the ground. The primary emergency spillway appeared to be in satisfactory condition as shown in Photographs No. 19, No. 20, and No. 21. The secondary emergency spillway appeared in satisfactory condition as shown in Photographs No. 7 and No. 8.

PHOTOGRAPH NO: 7	DATE: March 18, 2024 5:39 PM	LATITUDE: 33.05033024	LONGITUDE: -94.84147485
DIRECTION: South	SITE LOCATION: CASON, TEXAS		
DESCRIPTION: Secondary Emergency Spillway area, Crest of dam, Looking South. Drainage Feature and Access Road.

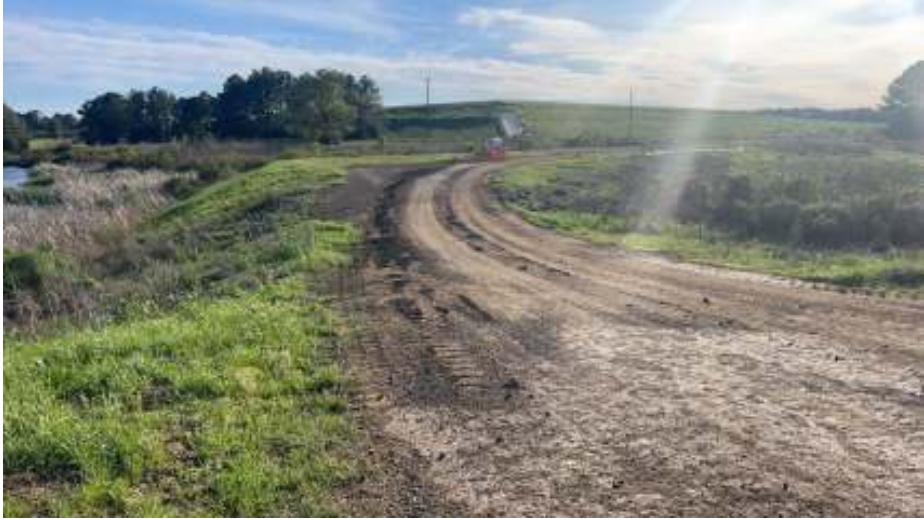
PHOTO BY: GEI CONSULTANTS, INC.			
PHOTOGRAPH NO: 8	DATE: March 18, 2024 5:40 PM	LATITUDE: 33.0503373890308	LONGITUDE: -94.841429415108
DIRECTION: South	SITE LOCATION: CASON, TEXAS		
DESCRIPTION: South area, Secondary Spillway. Looking South. General Photo, ruts to be addressed.

- Item 8 – Address vehicle ruts on the crest of the Primary Bottom Ash Pond secondary emergency spillway.
- Item 10 – Address vehicle ruts on the crest of the Clearwater Pond.

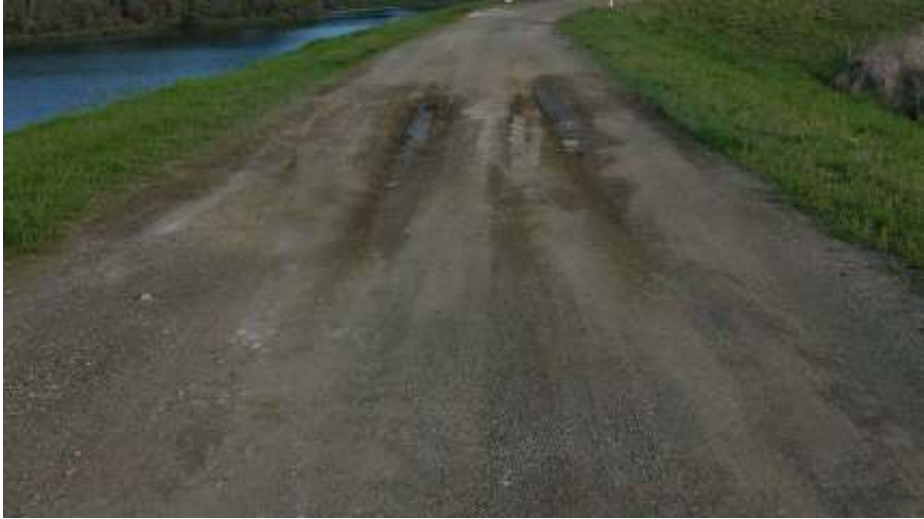
The crest of the east embankment was in good condition with no observed signs of misalignment, settlement, cracks, or significant deformation as shown in Photograph No. 16. There was an area with significant vehicular ruts on the crest of the northern dike as shown in Photograph No. 10.

PHOTOGRAPH NO: 9	DATE: March 19, 2024 5:56 PM	LATITUDE: 33.05015707	LONGITUDE: -94.84108904
DIRECTION:	SITE LOCATION: CASON, TEXAS		
DESCRIPTION: South area, Upstream Slope of Inboard Dike. Looking South. Typical Conditions.	 		
PHOTO BY: GEI CONSULTANTS, INC.			
PHOTOGRAPH NO: 10	DATE: March 19, 2024 5:57 PM	LATITUDE: 33.05017259	LONGITUDE: -94.8410859
DIRECTION: East	SITE LOCATION: CASON, TEXAS		
DESCRIPTION: North area, Crest of Original Dam. Looking East. Ruts to be addressed.

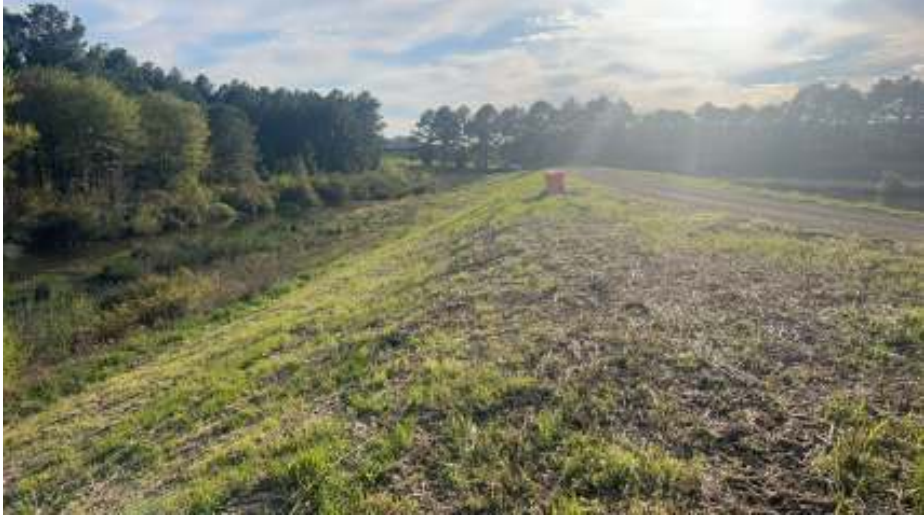
PHOTOGRAPH No: 13	DATE: March 19, 2024 5:51 PM	LATITUDE: 33.0488236164499	LONGITUDE: -94.8404323815391
DIRECTION: West	SITE LOCATION: CASON, TEXAS		
DESCRIPTION: South area, Crest. Looking West. General Photo, Typical Conditions.

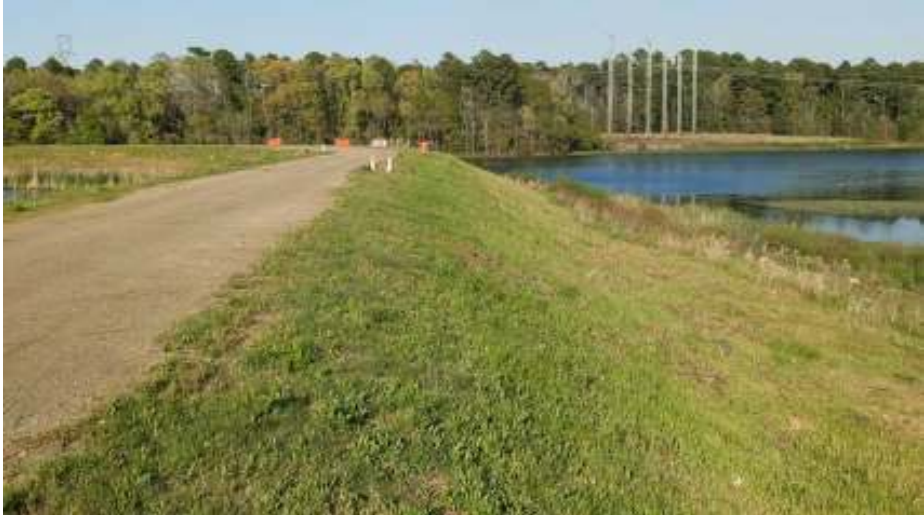
PHOTO BY: GEI CONSULTANTS, INC.			
PHOTOGRAPH No: 14	DATE: March 19, 2024 5:45 PM	LATITUDE: 33.04834439	LONGITUDE: -94.84147004
DIRECTION: East	SITE LOCATION: CASON, TEXAS		
DESCRIPTION: South area, Downstream Slope of Outboard Dike. Looking East. Typical Conditions.
