Landfill 2024 Annual Landfill Inspection Report

Northeastern Power Plant, Oologah, Oklahoma

December 2, 2024

Project 2305686

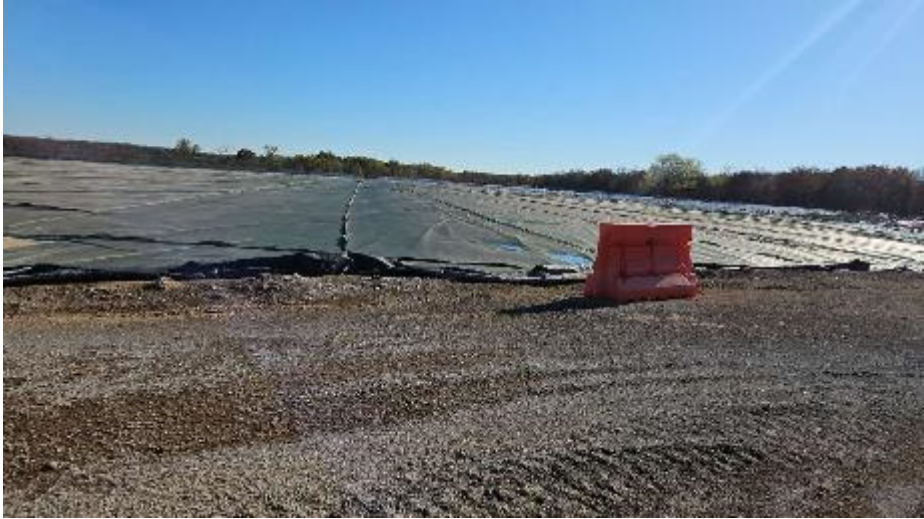
The landfill active area was being operated appropriately. Material is being placed and compacted systematically in lifts to allow contact stormwater to be collected, treated, and discharged as appropriate. During the inspection, the operators had recently watered haul roads, as shown in Photograph No. 1 to control fugitive dust generated from the landfill operations.

The landfill Wind Defender® interim covers are in good condition as shown in Photograph No. 2.

PHOTOGRAPH NO: 1	DATE: November 6, 2024 2:32 PM	LATITUDE: 36.41667306	LONGITUDE: -95.70003382
DIRECTION: 321°		SITE LOCATION: OOLOGAH, OKLAHOMA	
DESCRIPTION: Landfill Active Area. General Photo, Typical Conditions.	 		
PHOTO BY: GEI CONSULTANTS, INC.			
PHOTOGRAPH NO: 2	DATE: November 6, 2024 2:42 PM	LATITUDE: 36.41652501	LONGITUDE: -95.6997586
DIRECTION: 77°		SITE LOCATION: OOLOGAH, OKLAHOMA	
DESCRIPTION: Landfill Crest / Interim Cover. Photo shows installed rain flaps. General Photo, Typical Conditions.

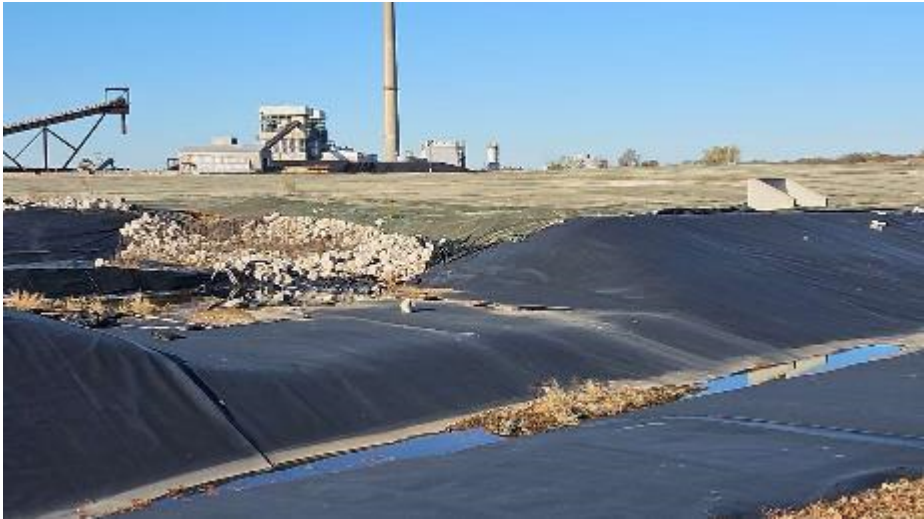
The landfill stormwater features are in satisfactory condition. Minor erosion was observed where one outfall channel meets with the landfill crest Wind Defender® interim cover as shown in Photograph No. 5. Additionally, the stormwater bypass ditch has minor blockage as shown in Photograph No. 8, near the splitter dike that exists between the leachate pond and the stormwater pond (Basin C). These observations are both minor but should be addressed. Other drainage features onsite were observed to be functioning as their design intended as shown in Photograph No. 7 and No. 10.

PHOTOGRAPH NO: 5	DATE: November 6, 2024 3:00 PM	LATITUDE: 36.4152248	LONGITUDE: -95.69742007
DIRECTION: 271°	SITE LOCATION: OOLOGAH, OKLAHOMA		
DESCRIPTION: Landfill Outlet Works / Drainage Feature. Address Minor Erosion and Geosynthetic Separation.

- Item 5 – Address the minor erosion where the Wind Defender® interim cover meets riprap outfall channel near the perimeter stormwater ditch.

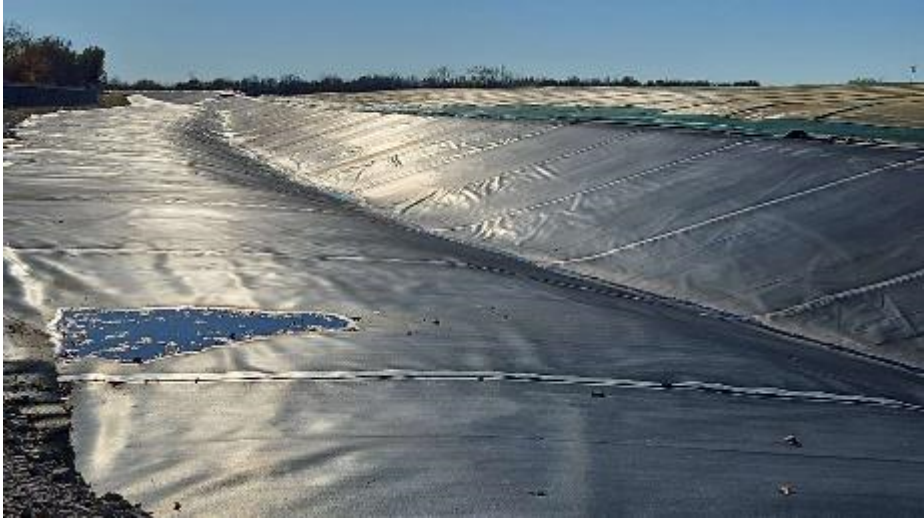
The landfill perimeter ditch is in good condition. Some areas of the perimeter ditches are lined with an exposed geomembrane – No rips, tears, holes, or deterioration was observed on the exposed liner shown in Photograph No. 4, No. 6 and No.7. Other portions of the perimeter ditches are vegetated. The vegetation in these ditches was healthy and well maintained as shown in Photograph No. 16.

PHOTO BY: GEI CONSULTANTS, INC.			
PHOTOGRAPH NO: 6	DATE: November 6, 2024 3:05 PM	LATITUDE: 36.41712689	LONGITUDE: -95.69521548
DIRECTION: 148°	SITE LOCATION: OOLOGAH, OKLAHOMA		
DESCRIPTION: Landfill East Perimeter Drainage. General Photo, Typical Conditions.

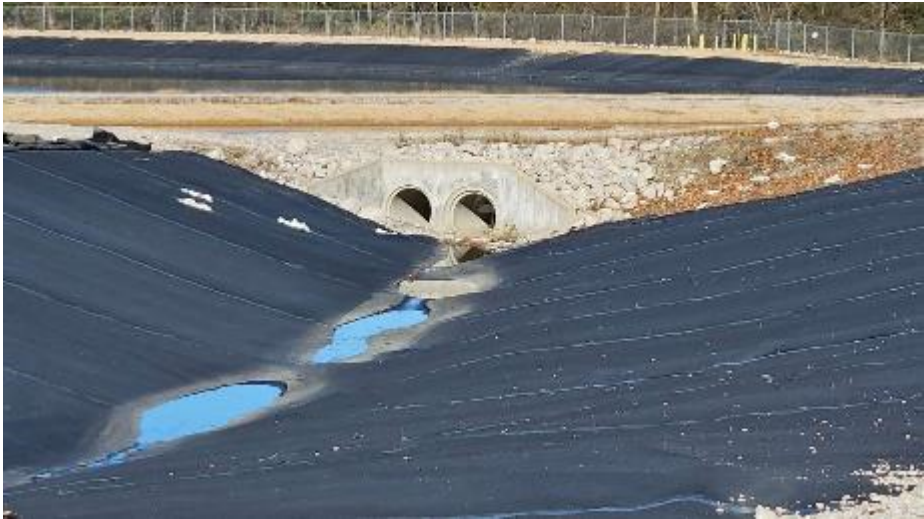
PHOTOGRAPH NO: 7	DATE: November 6, 2024 3:07 PM	LATITUDE: 36.41712554	LONGITUDE: -95.69517726
DIRECTION: 312°		SITE LOCATION: OOLOGAH, OKLAHOMA	
DESCRIPTION: Landfill Northeast Perimeter Drainage / South Outlet Culvert. General Photo, Typical Conditions.

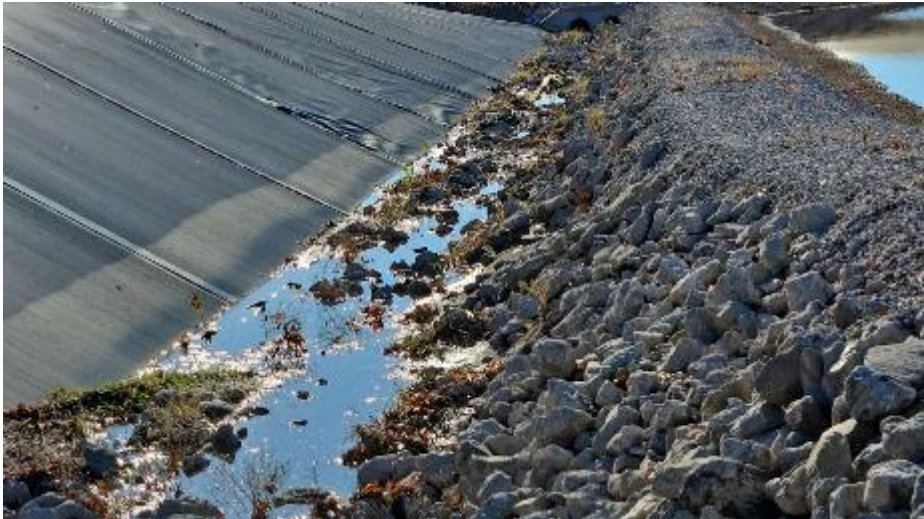
PHOTO BY: GEI CONSULTANTS, INC.			
PHOTOGRAPH NO: 8	DATE: November 6, 2024 3:11 PM	LATITUDE: 36.41814372	LONGITUDE: -95.6936075
DIRECTION: 156°		SITE LOCATION: OOLOGAH, OKLAHOMA	
DESCRIPTION: Landfill Leachate Impoundment. Perimeter Ditch, Address minor culvert debris / blockage.

- Item 8 – Address the minor culvert blockage that is backing up water along the splitter dike between the leachate collection pond and the stormwater runoff pond.

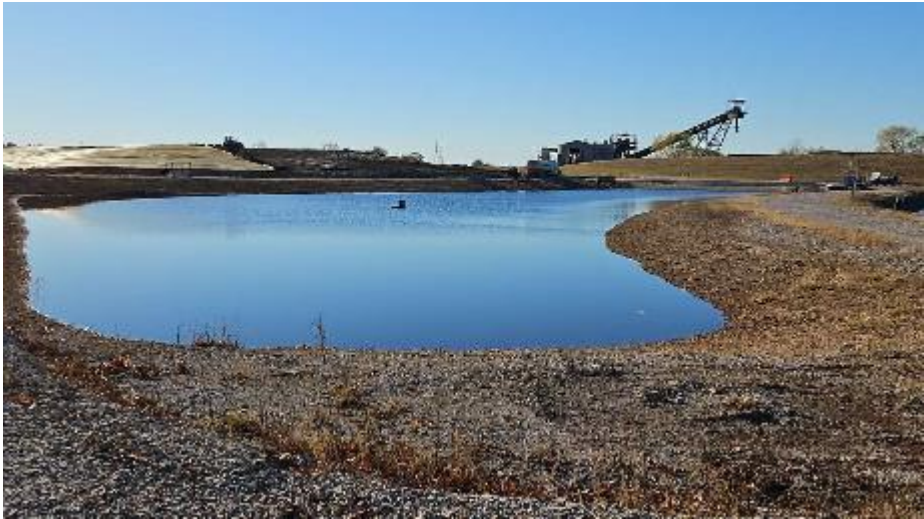
The landfill leachate pond is in good condition. The shoreline is well maintained with no observed erosion, overgrown vegetation, or debris that could block drainage features as shown in Photograph No. 9 and No. 11.

PHOTOGRAPH NO: 9	DATE: November 6, 2024 3:15 PM	LATITUDE: 36.41814322	LONGITUDE: -95.69361628
DIRECTION: 184°	SITE LOCATION: OOLOGAH, OKLAHOMA		
DESCRIPTION: Landfill Leachate Impoundment. General Photo, Typical Conditions.

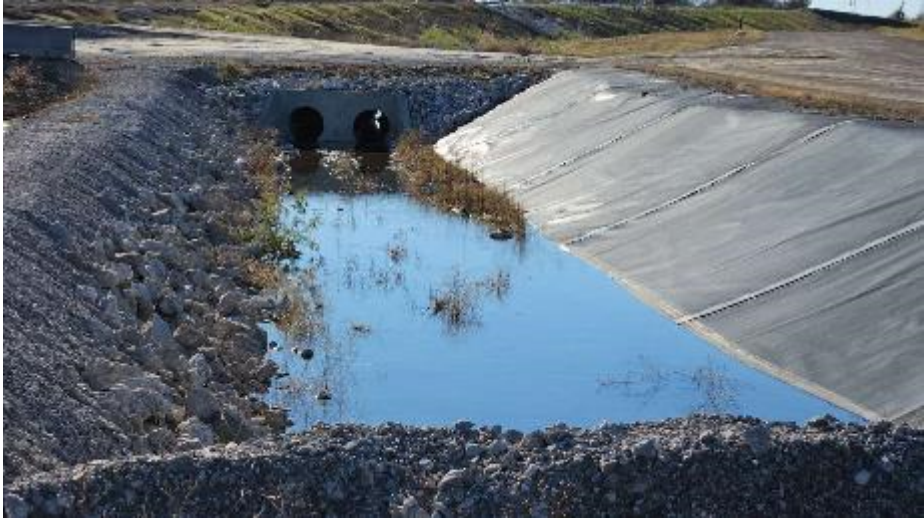
PHOTO BY: GEI CONSULTANTS, INC.			
PHOTOGRAPH NO: 10	DATE: November 6, 2024 3:20 PM	LATITUDE: 36.41855375	LONGITUDE: -95.69497984
DIRECTION: 165°	SITE LOCATION: OOLOGAH, OKLAHOMA		
DESCRIPTION: Landfill Northeast Perimeter Stormwater Ditch. General Photo, Typical Conditions.

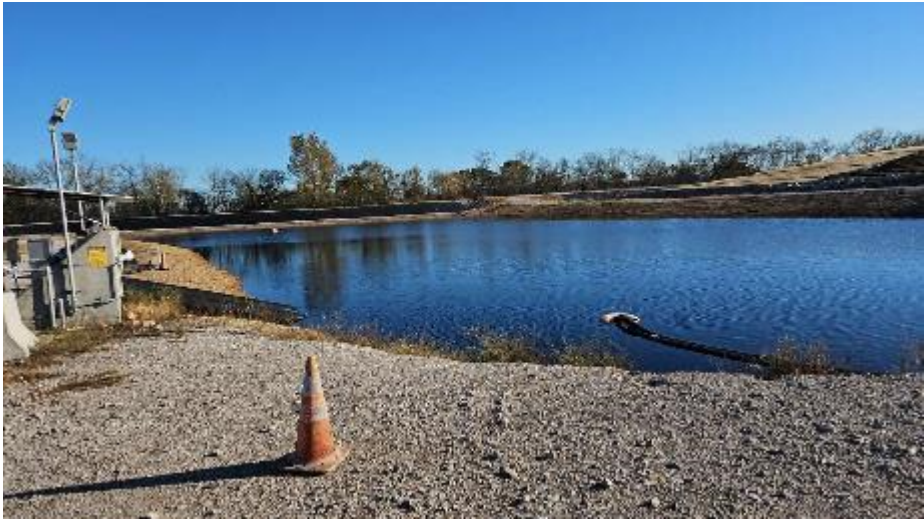
PHOTOGRAPH No: 11	DATE: November 6, 2024 3:22 PM	LATITUDE: 36.41856553	LONGITUDE: -95.69502457
DIRECTION: 38°		SITE LOCATION: OOLOGAH, OKLAHOMA	
DESCRIPTION: Landfill Leachate Impoundment. General Photo, Typical Conditions.

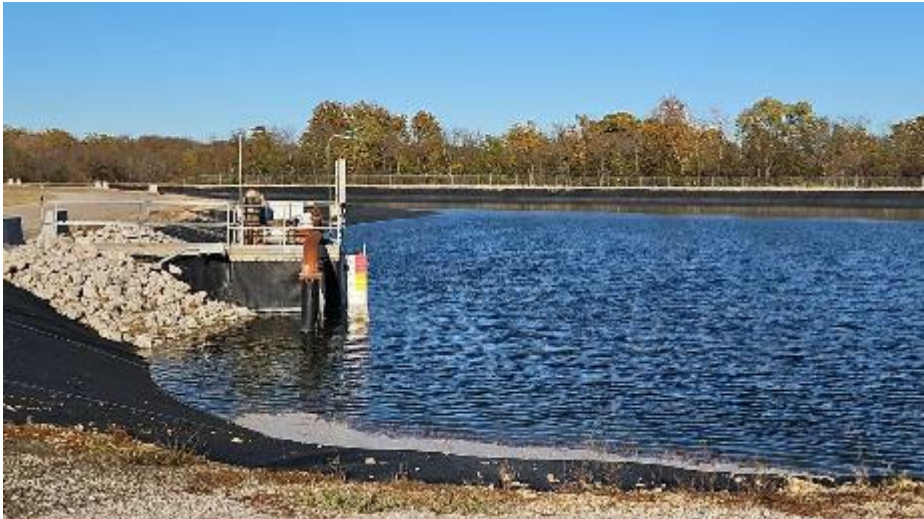
PHOTO BY: GEI CONSULTANTS, INC.			
PHOTOGRAPH No: 12	DATE: November 6, 2024 3:23 PM	LATITUDE: 36.41861784	LONGITUDE: -95.69496813
DIRECTION: 317°		SITE LOCATION: OOLOGAH, OKLAHOMA	
DESCRIPTION: Landfill Stormwater Pond Basic C. General Photo, Typical Conditions.

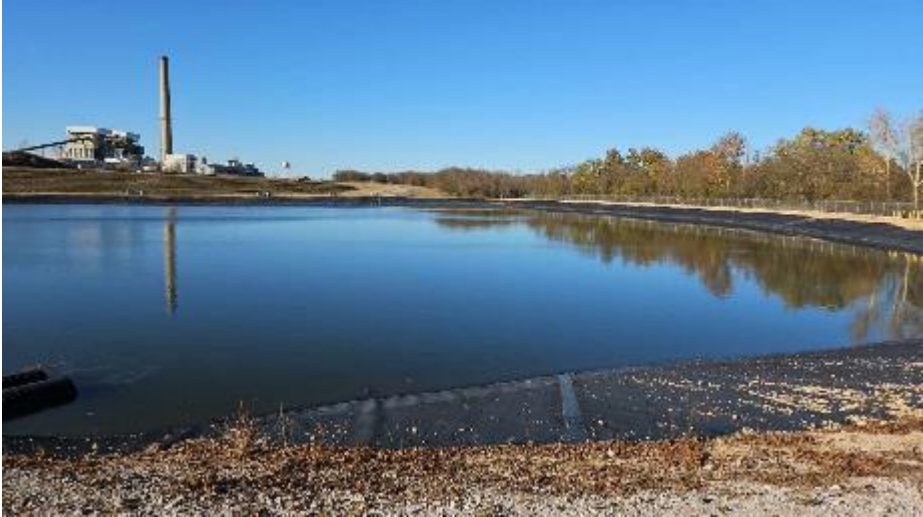
The landfill stormwater pond (Basin C) is in good condition. No rips, tears, holes, or deterioration was observed on the exposed liner and the vegetation along the upstream shoreline was maintained to 12-inches or less as shown in Photograph No. 13 and No. 14. The outfall structure was clear of any blockages as shown in Photograph No. 12. A wooded area with larger diameter timber exists beyond the toe of the downstream slope of the stormwater pond as shown in Photograph No. 15. AEP should consider maintaining the vegetation to 12-inches or less within 25-feet of the dike's toe of slope in accordance with internal Dam and Dike Maintenance Recommendations published in their Circular Letter.

<p>PHOTOGRAPH No: 13</p>	<p>DATE: November 6, 2024 3:27 PM</p>	<p>LATITUDE: 36.41815068</p>	<p>LONGITUDE: -95.69335103</p>
<p>DIRECTION: 270°</p>		<p>SITE LOCATION: OOLOGAH, OKLAHOMA</p>	
<p>DESCRIPTION: Landfill Stormwater Pond Basin C. General Photo, Typical Conditions of Exposed Synthetic liner.</p>

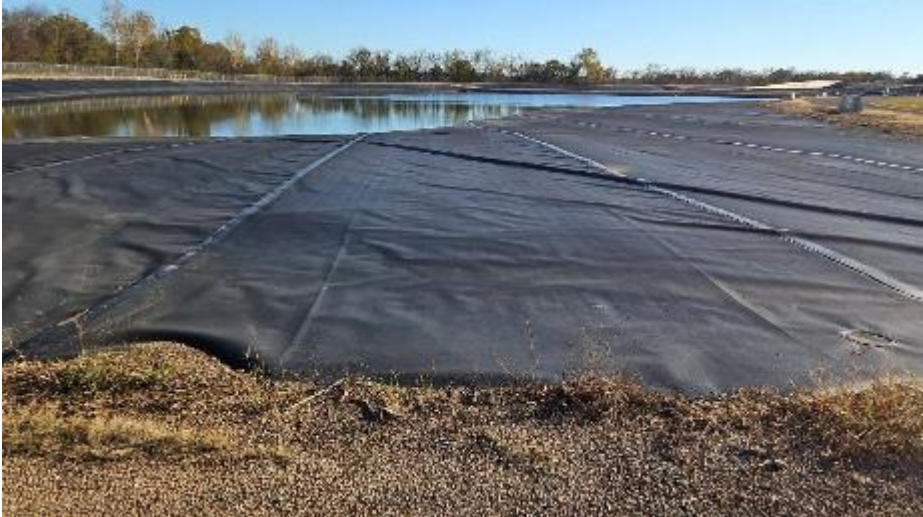
<p>PHOTO BY: GEI CONSULTANTS, INC.</p>			
<p>PHOTOGRAPH No: 14</p>	<p>DATE: November 6, 2024 3:33 PM</p>	<p>LATITUDE: 36.42039106</p>	<p>LONGITUDE: -95.69387416</p>
<p>DIRECTION: 70°</p>		<p>SITE LOCATION: OOLOGAH, OKLAHOMA</p>	
<p>DESCRIPTION: Landfill Stormwater Pond Basin C. General Photo, Typical Conditions.</p>

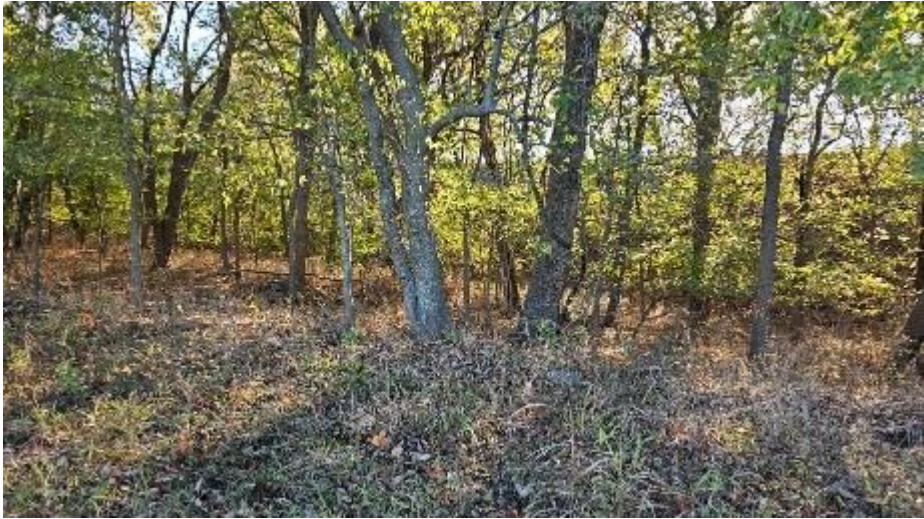
PHOTOGRAPH No: 15	DATE: November 6, 2024 3:36 PM	LATITUDE: 36.42016853	LONGITUDE: -95.69240162
DIRECTION: 109°	SITE LOCATION: OOLOGAH, OKLAHOMA		
<p>DESCRIPTION:</p> <p>Landfill Stormwater Pond Basin C. Downstream Toe of Slope - General Photo, Typical Conditions.</p> <p>Consider maintaining vegetation to 12-inches or less within 25-feet of the downstream toe of slope.</p>

- Continue to maintain minor erosion rills before they become significant. Focus maintenance efforts at tie-in locations where the Wind Defender® interim cover meets riprap outfall channels.
- Continue to check site culverts, ditches, outfall structures for debris/blockages to allow the site stormwater to flow as it was designed.
- Consider maintaining vegetation to 12-inches or less within 25-feet of the downstream toe of slope of the stormwater pond dike.

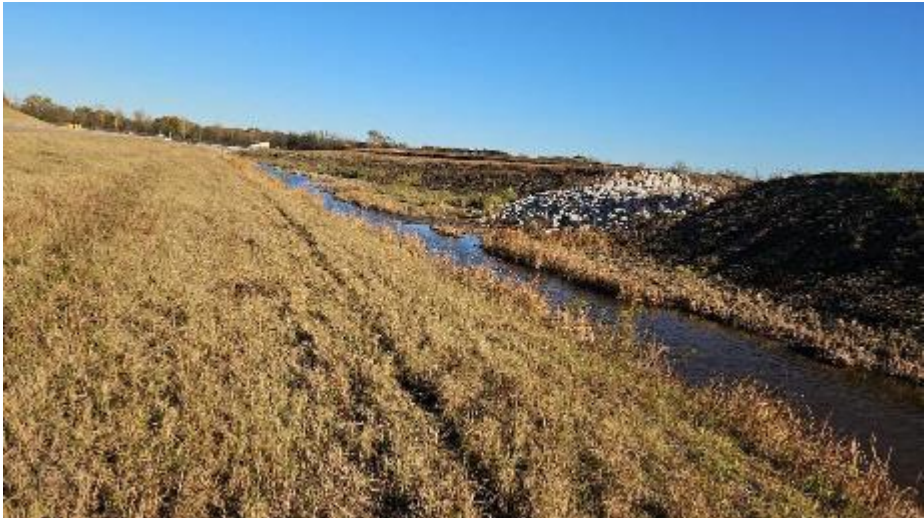
<p>PHOTO BY:</p> <p>GEI CONSULTANTS, INC.</p>			
PHOTOGRAPH No: 16	DATE: November 6, 2024 3:41 PM	LATITUDE: 36.41822599	LONGITUDE: -95.69762745
DIRECTION: 4°	SITE LOCATION: OOLOGAH, OKLAHOMA		
<p>DESCRIPTION:</p> <p>Landfill North Perimeter Ditch. General Photo, Typical Conditions.</p> <p>Standing water due to 6-8 inches of rain that the site received in the week leading up to the annual inspection.</p>
