FGD Stackout Pad Area 2024 Annual Landfill Inspection Report

H.W. Pirkey Power Plant, Hallsville, Texas

Project 2305686

AEP Document ID: GEVR-24-003

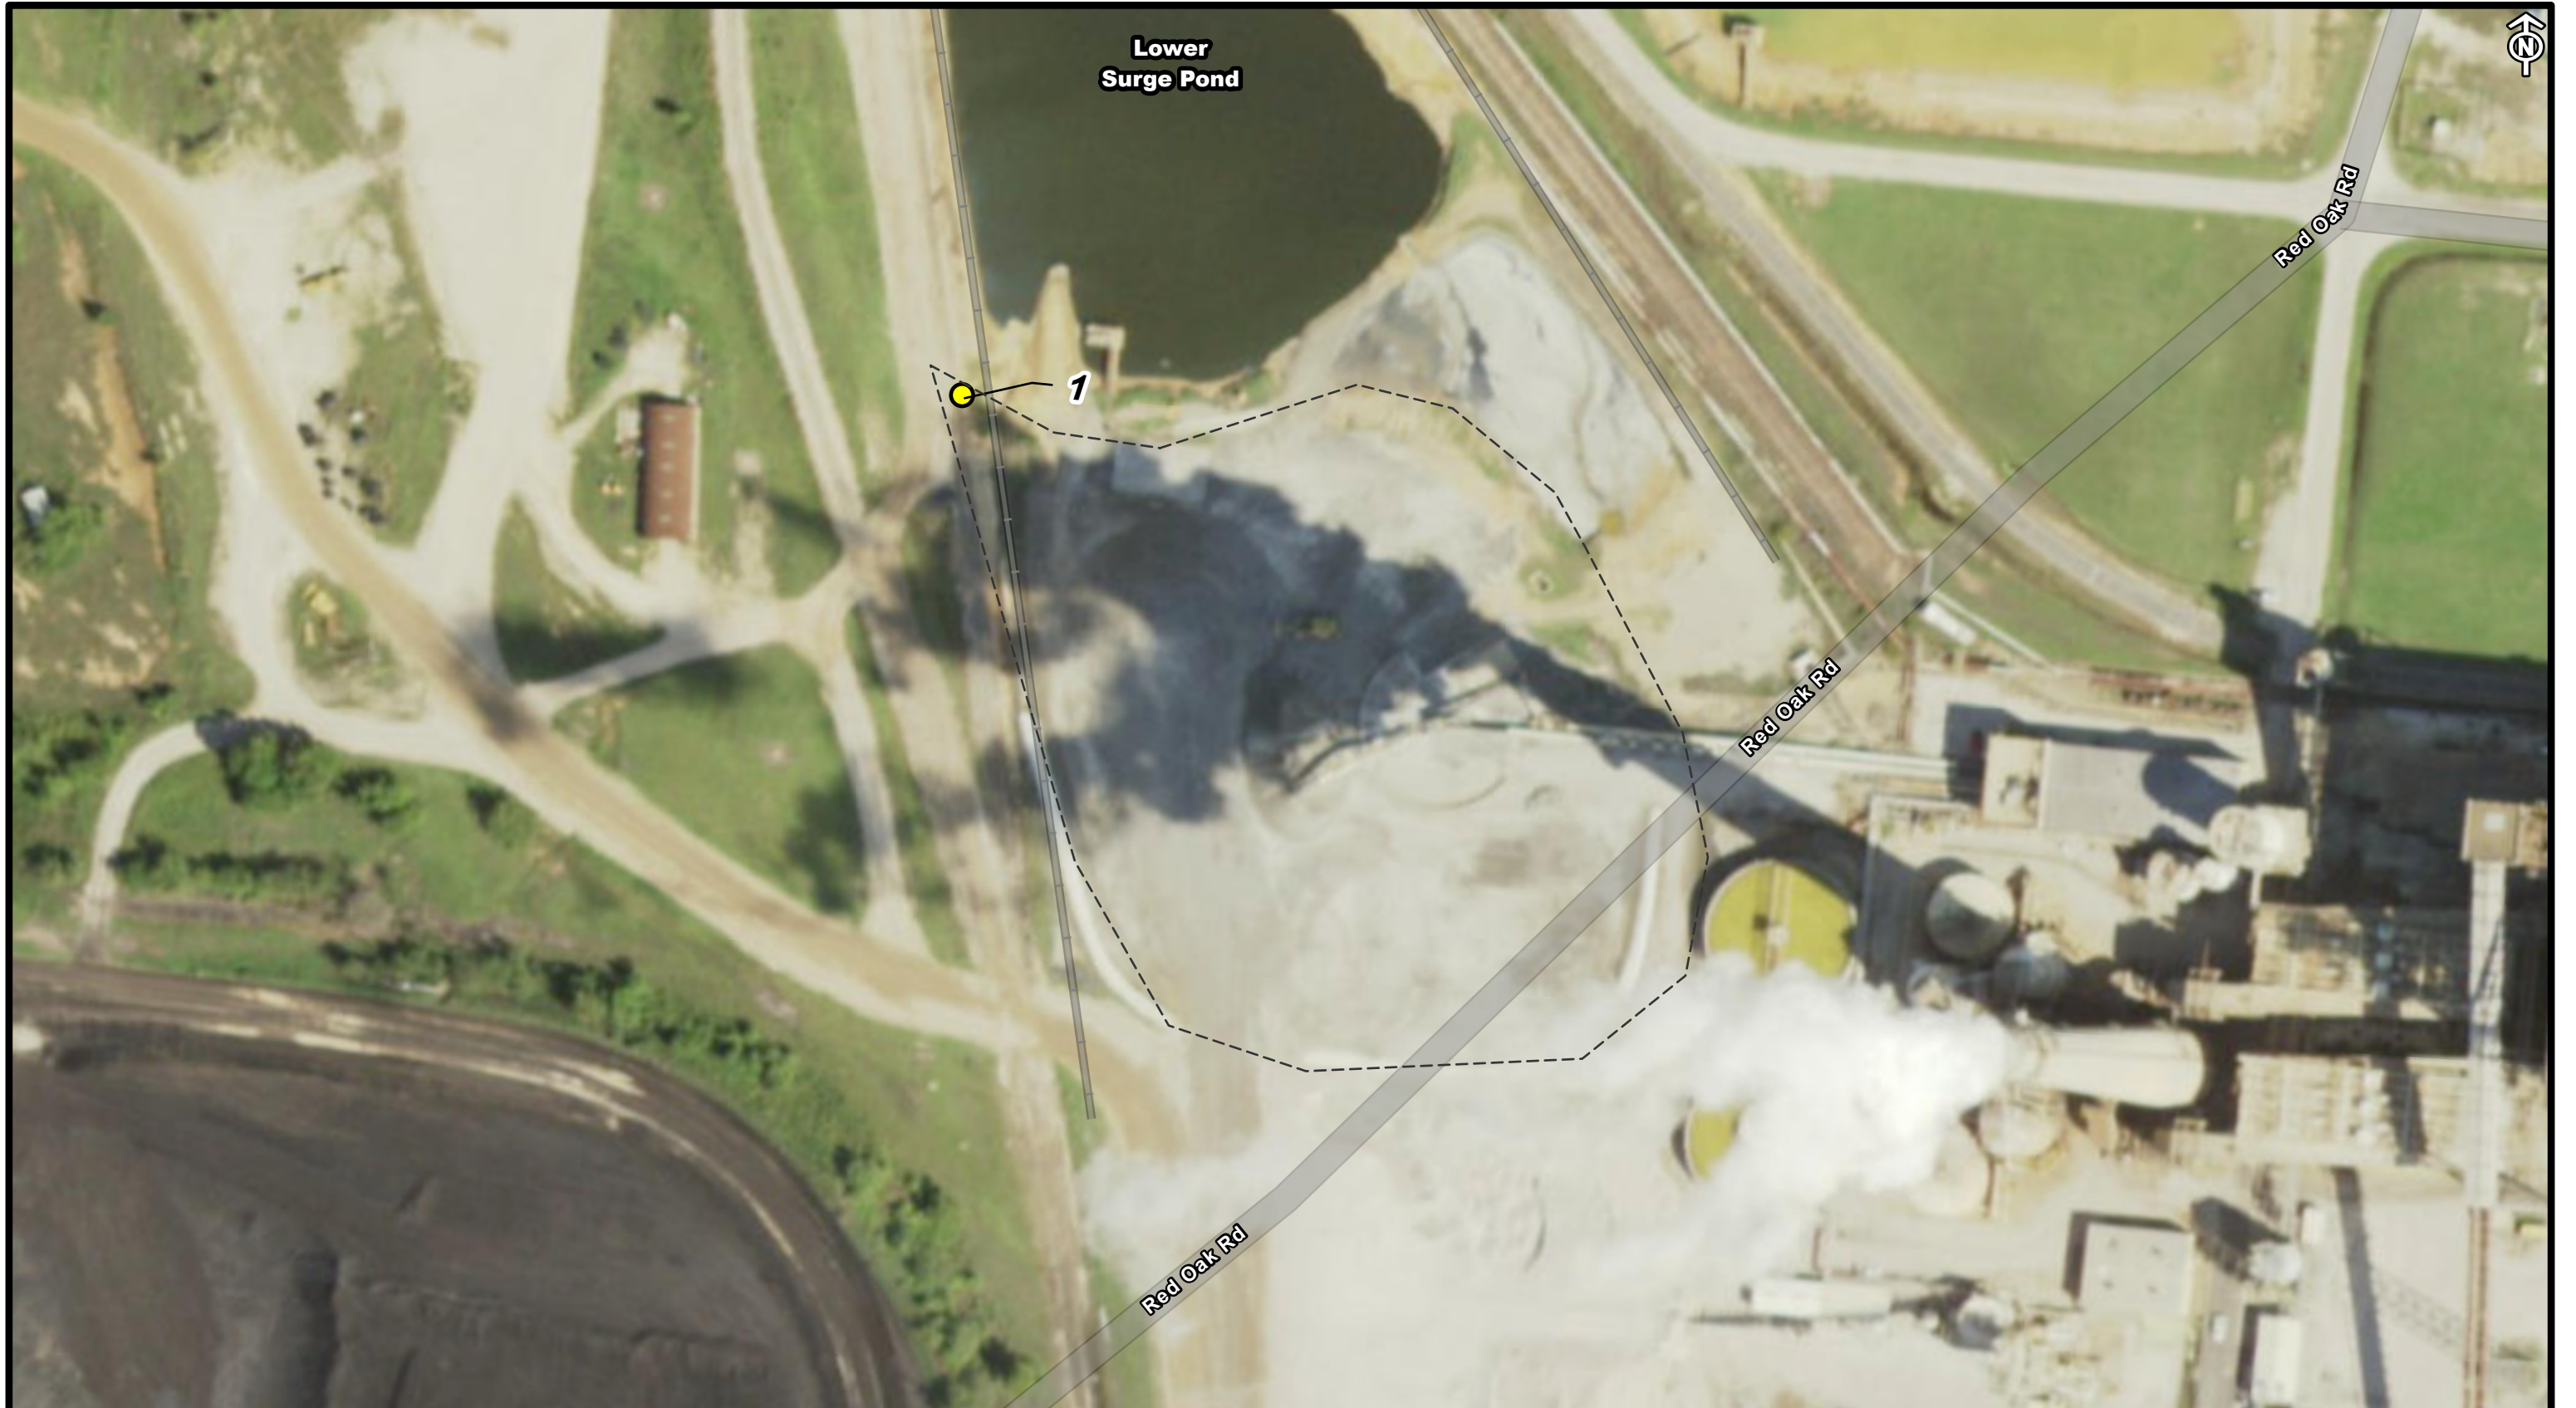
Figure 4 – Items to be Monitored

- Item 1 – Monitor the FGD Stackout Pad Area Ditch for wet conditions.

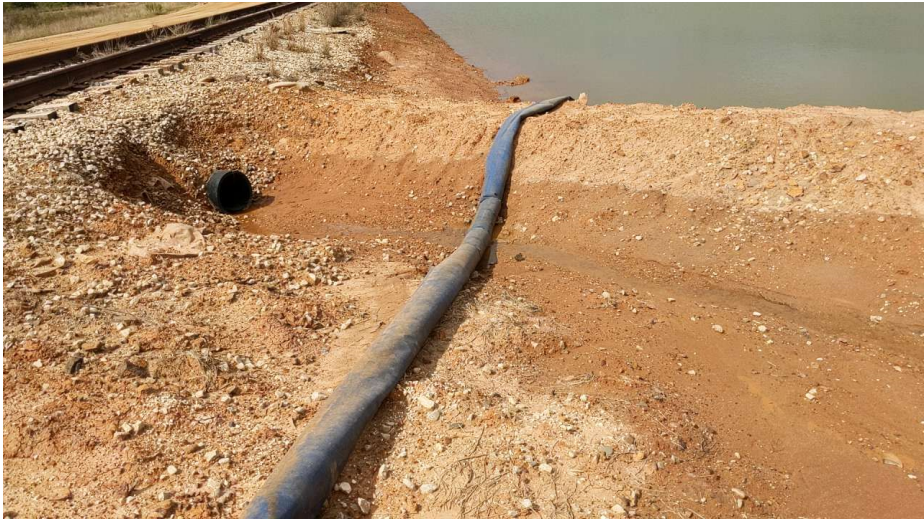
PHOTOGRAPH NO: 1	DATE: March 20, 2024 3:24 PM	LATITUDE: 32.46225774	LONGITUDE: -94.48789602
SITE LOCATION: HALLSVILLE, TEXAS			
DESCRIPTION: Toe Ditch of Stackout Area, FGD Pad. Looking Northwest. Wet Area, Monitor Conditions.

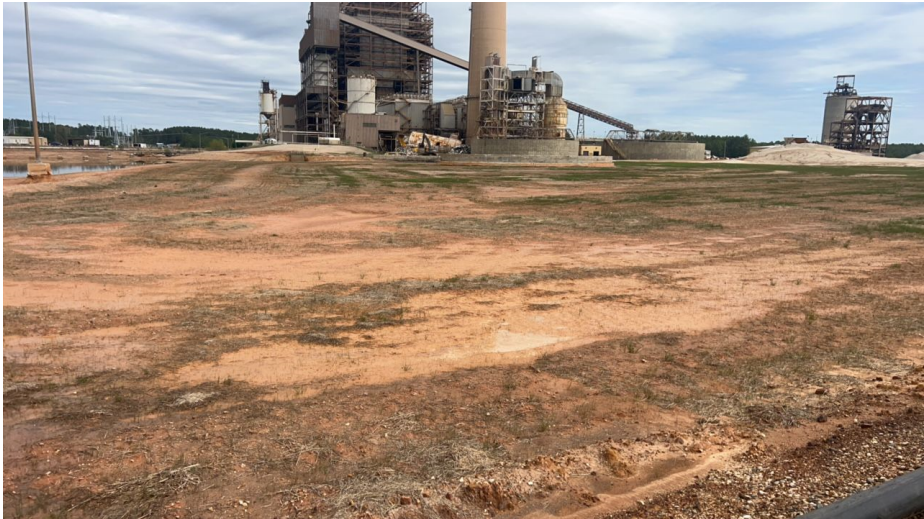
PHOTO BY: GEI CONSULTANTS, INC.			
PHOTOGRAPH NO: 2	DATE: March 20, 2024 3:21 PM	LATITUDE: 32.4621712975198	LONGITUDE: -94.4878871356651
SITE LOCATION: HALLSVILLE, TEXAS			
DESCRIPTION: Stackout Area, FGD Pad. Looking East. General Photo, Typical Conditions.

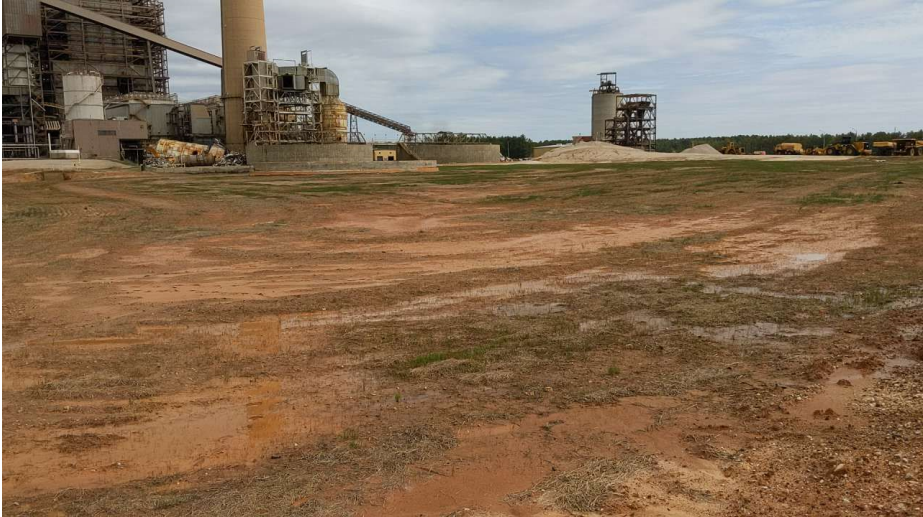
PHOTOGRAPH NO: 3	DATE: March 20, 2024 3:20 PM	LATITUDE: 32.46214471	LONGITUDE: -94.48789725
SITE LOCATION: HALLSVILLE, TEXAS			
DESCRIPTION: Stackout Pad. Looking Southeast. General Photo, Typical Conditions.
