## Landfill

# 2024 Annual Inspection Report

H.W. Pirkey Power Plant, Hallsville, Texas

AEP Document ID: GEVR-24-004

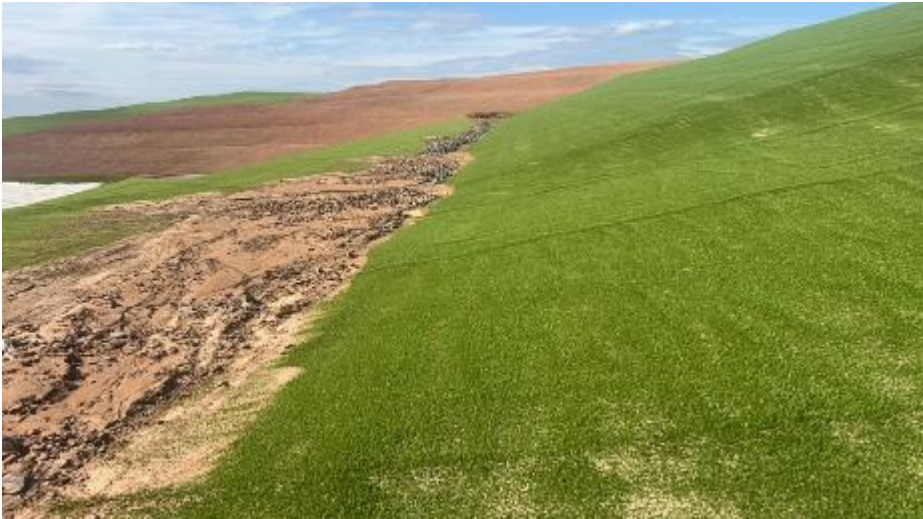
<b>PHOTOGRAPH NO: 1</b>	<b>DATE:</b> March 20, 2024 4:30 PM	<b>LATITUDE:</b> 32.4515967387587	<b>LONGITUDE:</b> -94.4937333281564
<b>SITE LOCATION:</b> HALLSVILLE, TEXAS			
<b>DESCRIPTION:</b>  Near SE Corner, Downstream Slope. Looking Northwest. General Photo, Typical Conditions.

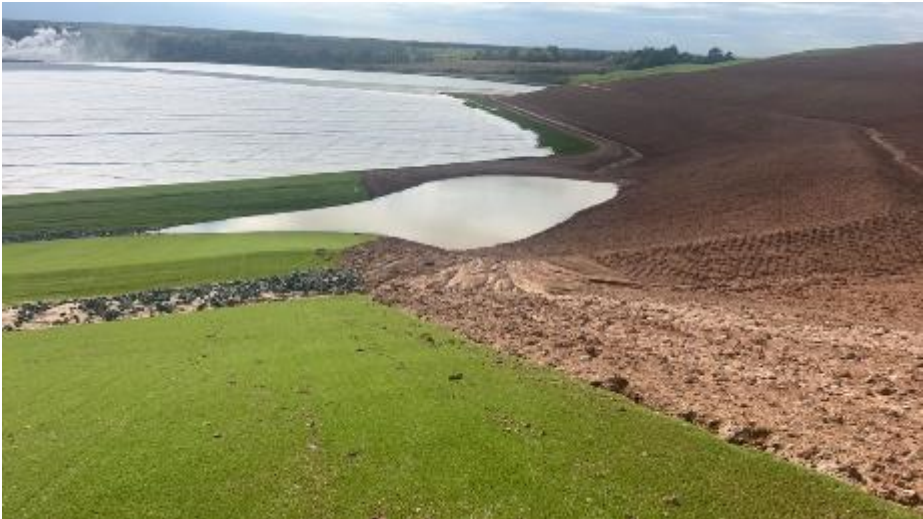
<b>PHOTO BY:</b>  GEI CONSULTANTS, INC.			
<b>PHOTOGRAPH NO: 2</b>	<b>DATE:</b> March 20, 2024 4:33 PM	<b>LATITUDE:</b> 32.4524798252591	<b>LONGITUDE:</b> -94.4941003391347
<b>SITE LOCATION:</b> HALLSVILLE, TEXAS			
<b>DESCRIPTION:</b>  South Side, Downstream Slope. Looking East. Wet Area, Typical Conditions.

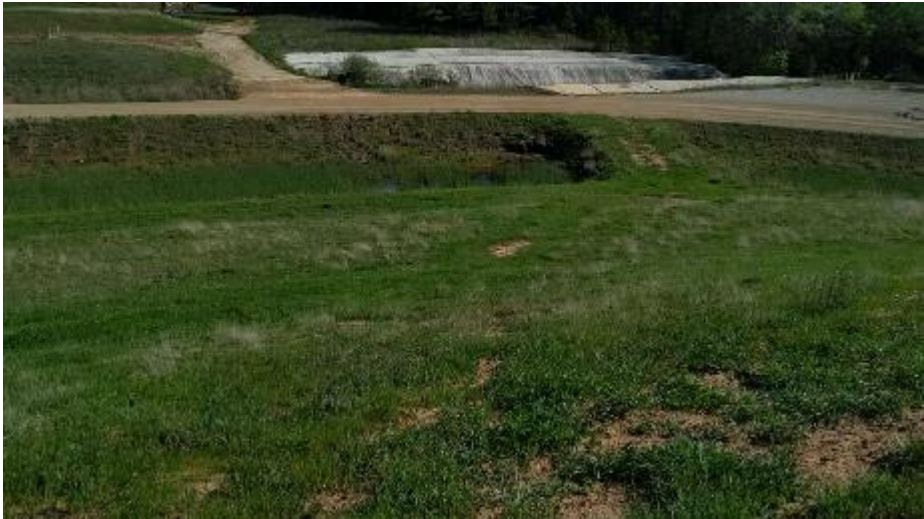
<b>PHOTOGRAPH NO: 3</b>	<b>DATE:</b> March 20, 2024 4:19 PM	<b>LATITUDE:</b> 32.45188567	<b>LONGITUDE:</b> -94.49337891
<b>SITE LOCATION:</b> HALLSVILLE, TEXAS			
<b>DESCRIPTION:</b>  East area, Toe Ditch. Looking Southeast. Wet Area, Typical Conditions.

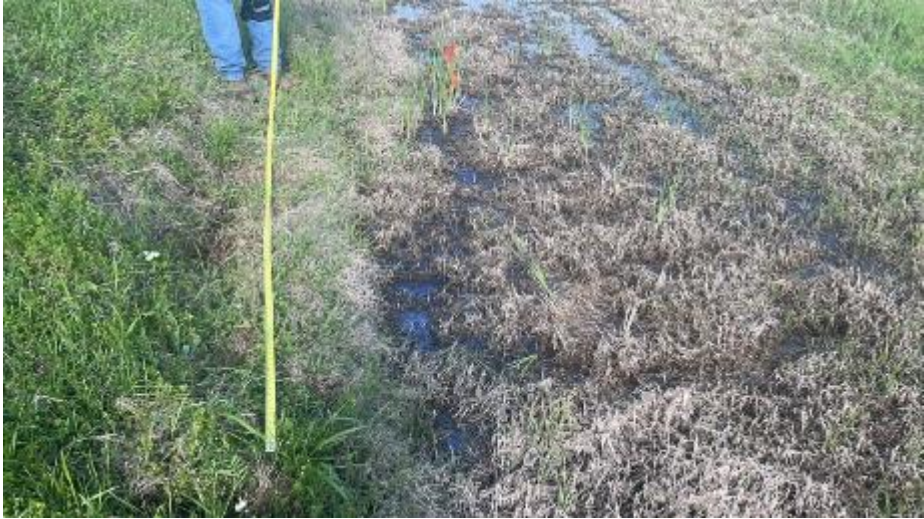
<b>PHOTO BY:</b>  GEI CONSULTANTS, INC.			
<b>PHOTOGRAPH NO: 4</b>	<b>DATE:</b> March 20, 2024 4:24 PM	<b>LATITUDE:</b> 32.451675609878	<b>LONGITUDE:</b> -94.4930338893701
<b>SITE LOCATION:</b> HALLSVILLE, TEXAS			
<b>DESCRIPTION:</b>  South area on east slope, Lower Bench. Looking North. Sloughed area, Please Repair.

- Item 4 – Southeast toe of landfill slope. Address sloughed area.
- Item 31 – Northeast midslope drainage inlet missing drainage grate. Please replace.

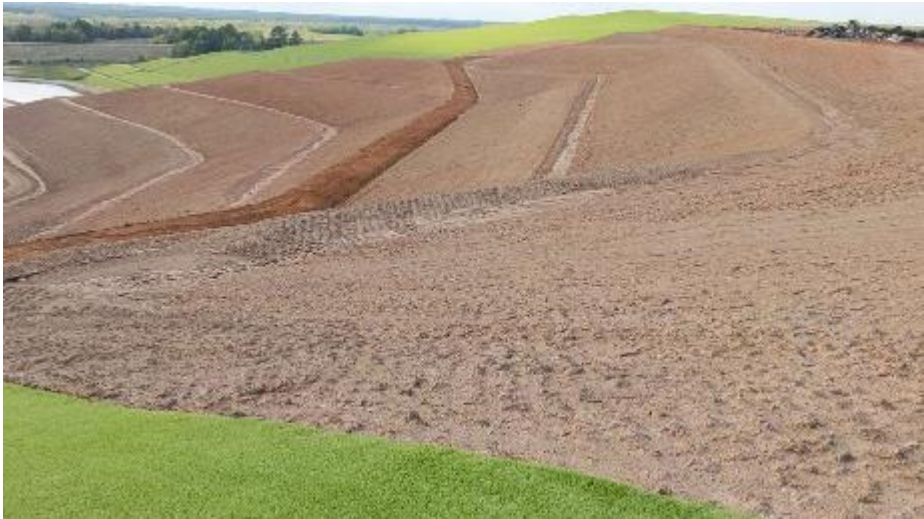
<b>PHOTOGRAPH NO: 7</b>	<b>DATE:</b> March 20, 2024 4:23 PM	<b>LATITUDE:</b> 32.45263016	<b>LONGITUDE:</b> -94.49334567
<b>SITE LOCATION:</b> HALLSVILLE, TEXAS			
<b>DESCRIPTION:</b>  South area, Interim Cover. Active Cell Back Slope Looking West. Subgrade prepped for ClosureTurf, Typical Conditions.

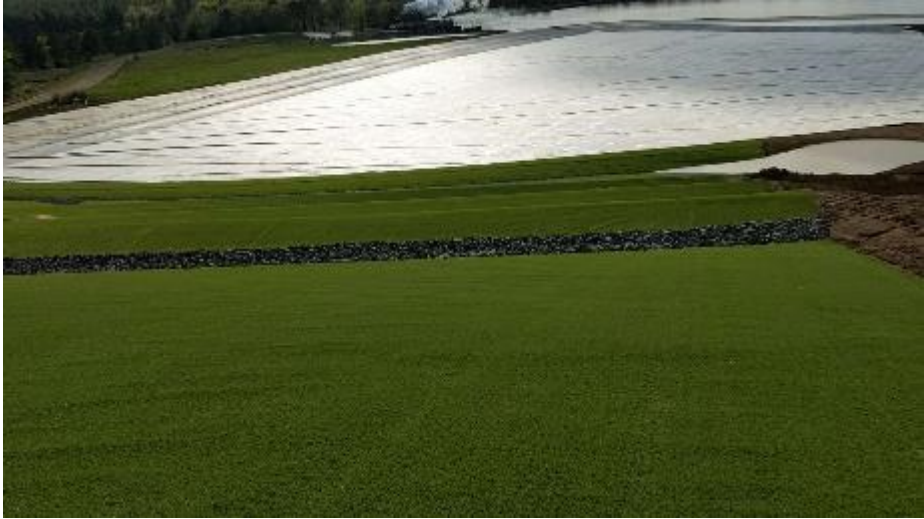
<b>PHOTO BY:</b>  GEI CONSULTANTS, INC.			
<b>PHOTOGRAPH NO: 8</b>	<b>DATE:</b> March 20, 2024 4:25 PM	<b>LATITUDE:</b> 32.45263158	<b>LONGITUDE:</b> -94.49334171
<b>SITE LOCATION:</b> HALLSVILLE, TEXAS			
<b>DESCRIPTION:</b>  South area, Active Cell. Looking Southeast. Ground Cover, Typical Conditions.

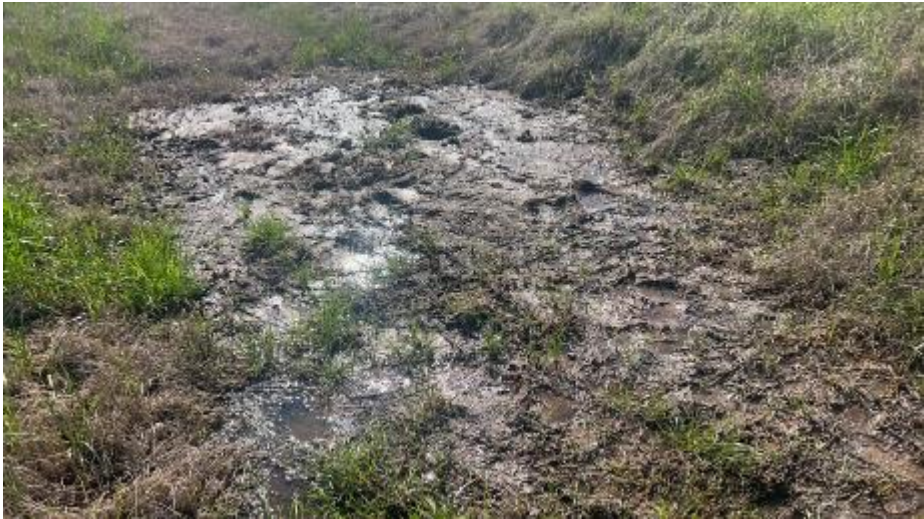
<b>PHOTOGRAPH NO: 9</b>	<b>DATE:</b> March 20, 2024 4:19 PM	<b>LATITUDE:</b> 32.4520238019255	<b>LONGITUDE:</b> -94.4925509442536
<b>SITE LOCATION:</b> HALLSVILLE, TEXAS			
<b>DESCRIPTION:</b>  South area (east slope), Downstream Slope Toe Ditch. Looking West. Wet Area, Typical Conditions.

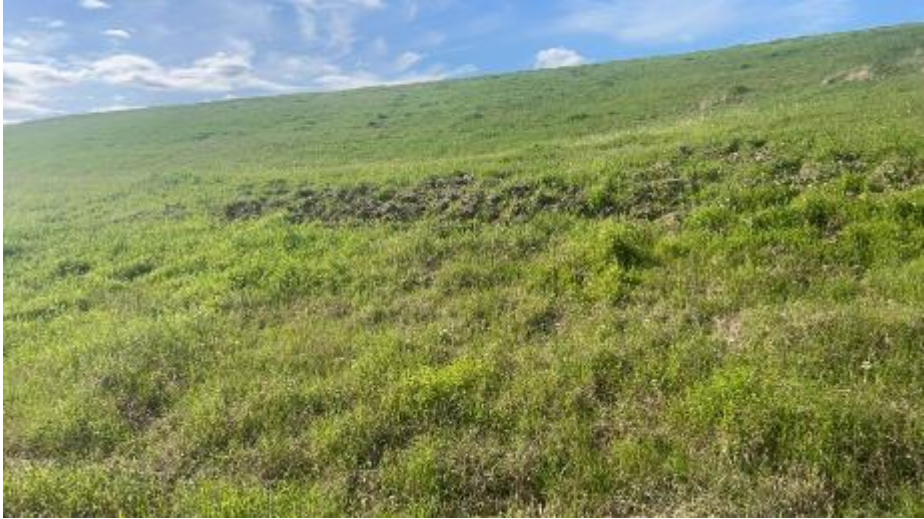
<b>PHOTO BY:</b>  GEI CONSULTANTS, INC.			
<b>PHOTOGRAPH NO: 10</b>	<b>DATE:</b> March 20, 2024 4:18 PM	<b>LATITUDE:</b> 32.4521353748832	<b>LONGITUDE:</b> -94.4924018294953
<b>SITE LOCATION:</b> HALLSVILLE, TEXAS			
<b>DESCRIPTION:</b>  East Side, Downstream Slope. Looking Northwest. Hog activity, Monitor Conditions.

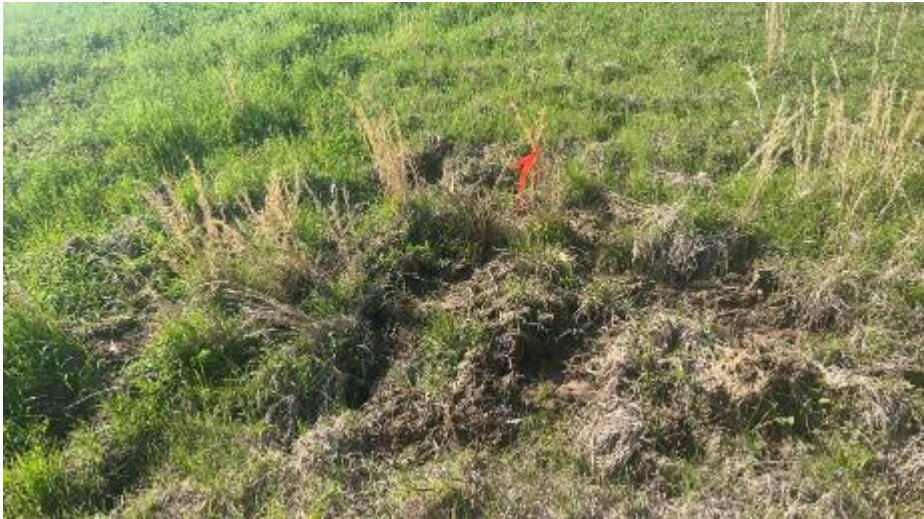
<b>PHOTOGRAPH No: 11</b>	<b>DATE:</b> March 20, 2024 4:16 PM	<b>LATITUDE:</b> 32.4526047010506	<b>LONGITUDE:</b> -94.4917842664844
<b>SITE LOCATION:</b> HALLSVILLE, TEXAS			
<b>DESCRIPTION:</b>  East Area, Downstream Slope. Looking Northwest. Animal Burrow, Monitor Conditions.

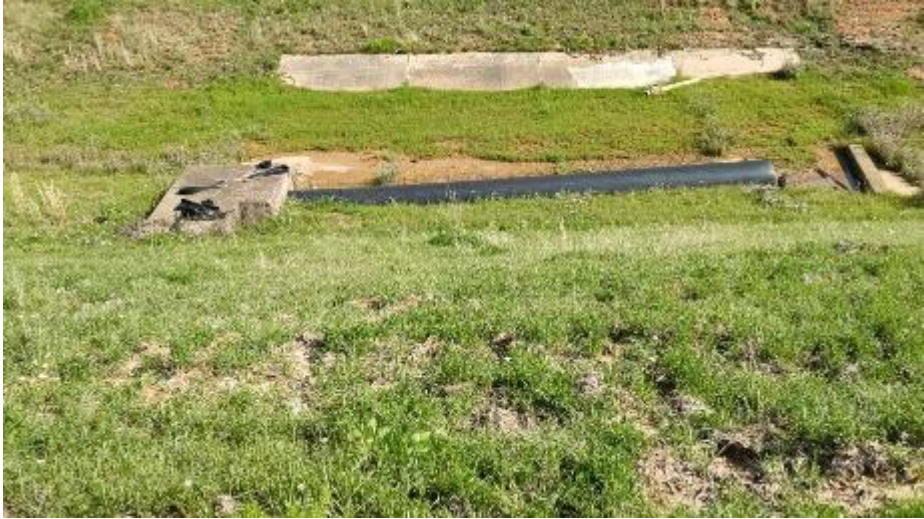
<b>PHOTO BY:</b>  GEI CONSULTANTS, INC.			
<b>PHOTOGRAPH No: 12</b>	<b>DATE:</b> March 20, 2024 4:14 PM	<b>LATITUDE:</b> 32.45256124	<b>LONGITUDE:</b> -94.4916276
<b>SITE LOCATION:</b> HALLSVILLE, TEXAS			
<b>DESCRIPTION:</b>  Outlet Works area, Toe at Outlet Pipe. Looking East. Drain, Typical Conditions.

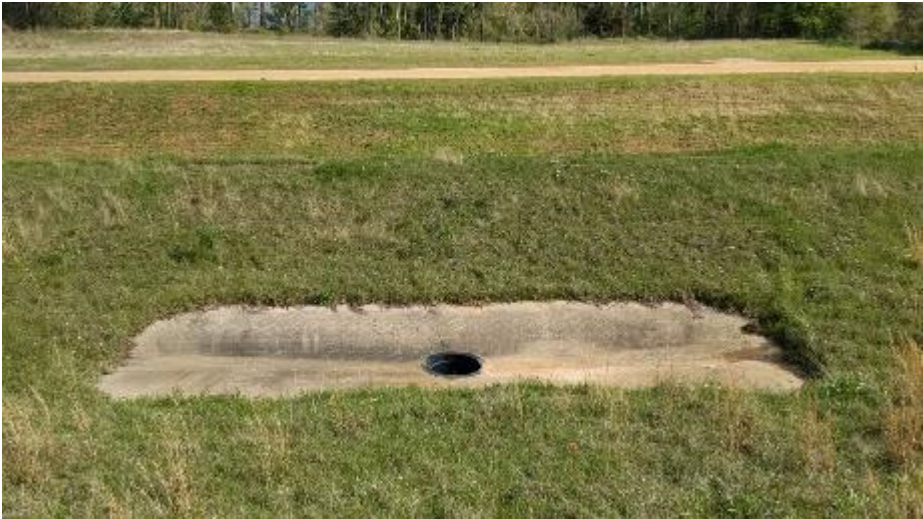
<b>PHOTOGRAPH No: 13</b>	<b>DATE:</b> March 20, 2024 4:11 PM	<b>LATITUDE:</b> 32.45284699	<b>LONGITUDE:</b> -94.49193738
<b>SITE LOCATION:</b> HALLSVILLE, TEXAS			
<b>DESCRIPTION:</b>  East area, Upper Bench Drainage Feature. Looking East. Typical Conditions.

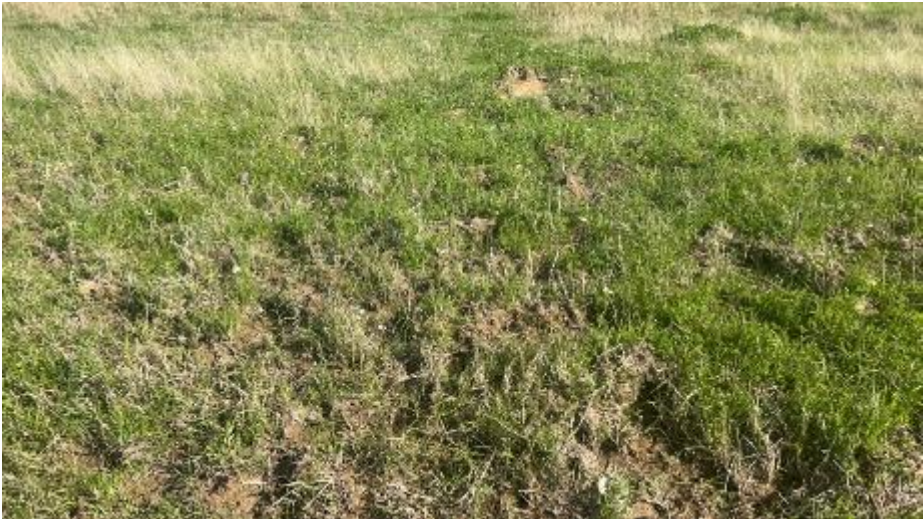
<b>PHOTO BY:</b>  GEI CONSULTANTS, INC.			
<b>PHOTOGRAPH No: 14</b>	<b>DATE:</b> March 20, 2024 4:14 PM	<b>LATITUDE:</b> 32.4527879105679	<b>LONGITUDE:</b> -94.4914703265628
<b>SITE LOCATION:</b> HALLSVILLE, TEXAS			
<b>DESCRIPTION:</b>  South area, Downstream Slope. Looking . Animal Burrow, Monitor Conditions.

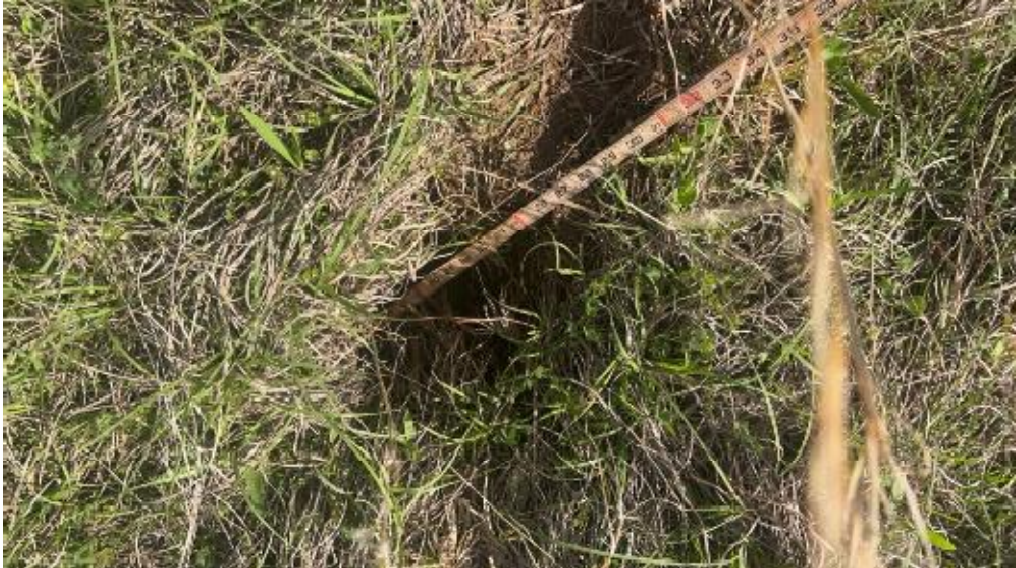
<b>PHOTOGRAPH No: 15</b>	<b>DATE:</b> March 20, 2024 4:12 PM	<b>LATITUDE:</b> 32.4531341850856	<b>LONGITUDE:</b> -94.4912780090617
<b>SITE LOCATION:</b> HALLSVILLE, TEXAS			
<b>DESCRIPTION:</b>  South area, Downstream Slope. Looking Northwest. Animal Burrow. Monitor Conditions.

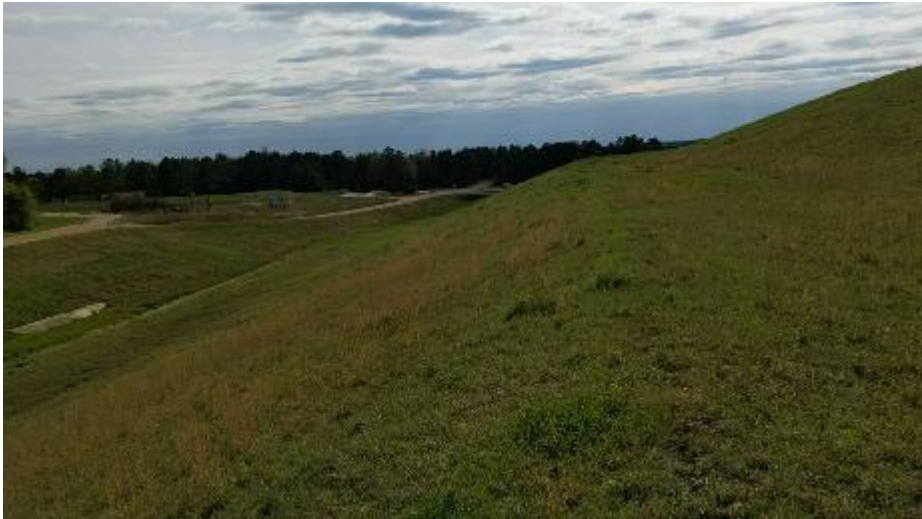
<b>PHOTO BY:</b>  GEI CONSULTANTS, INC.			
<b>PHOTOGRAPH No: 16</b>	<b>DATE:</b> March 20, 2024 4:08 PM	<b>LATITUDE:</b> 32.45324096	<b>LONGITUDE:</b> -94.4912124
<b>SITE LOCATION:</b> HALLSVILLE, TEXAS			
<b>DESCRIPTION:</b>  East area, Upper Bench Final Cover. Looking South. Ground Cover, Typical Conditions.

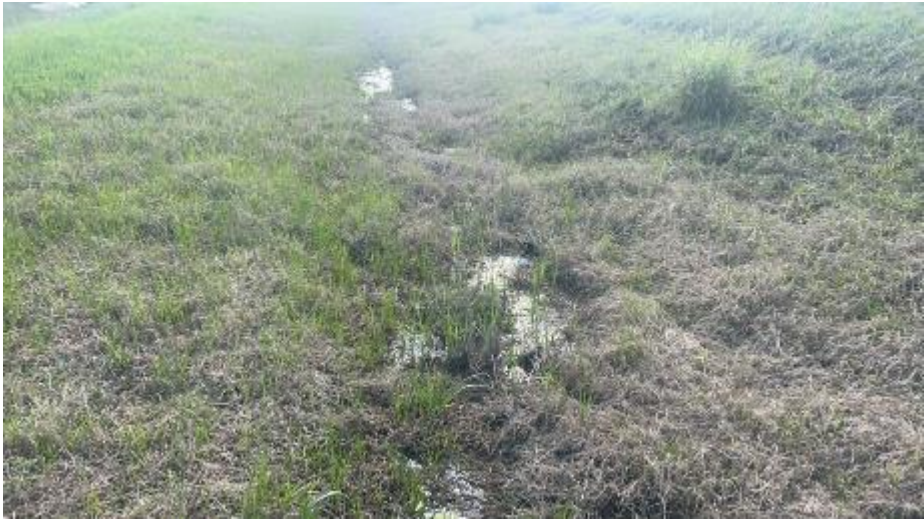
<b>PHOTOGRAPH No: 17</b>	<b>DATE:</b> March 20, 2024 4:11 PM	<b>LATITUDE:</b> 32.4531578808813	<b>LONGITUDE:</b> -94.4910316677106
<b>SITE LOCATION:</b> HALLSVILLE, TEXAS			
<b>DESCRIPTION:</b>  East area (near gas well), Downstream Slope. Looking West. Wet Area.

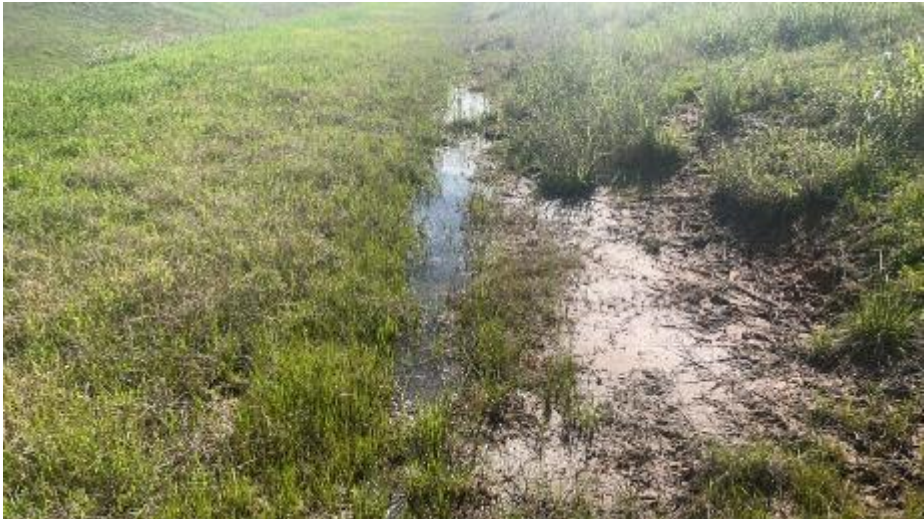
<b>PHOTO BY:</b>  GEI CONSULTANTS, INC.			
<b>PHOTOGRAPH No: 18</b>	<b>DATE:</b> March 20, 2024 4:09 PM	<b>LATITUDE:</b> 32.4533225953068	<b>LONGITUDE:</b> -94.4908358759034
<b>SITE LOCATION:</b> HALLSVILLE, TEXAS			
<b>DESCRIPTION:</b>  East area, Downstream Slope. Looking West. Wet Area.

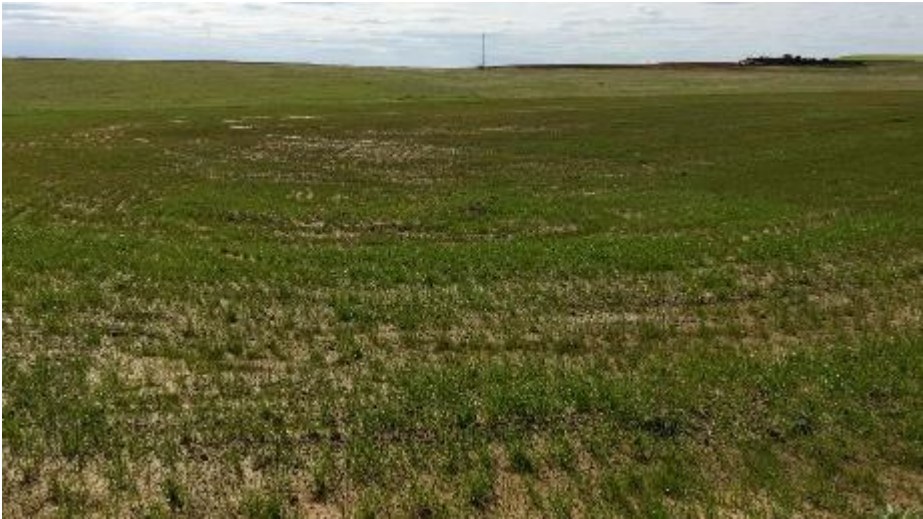
<b>PHOTOGRAPH No: 19</b>	<b>DATE:</b> March 20, 2024 4:06 PM	<b>LATITUDE:</b> 32.45348227	<b>LONGITUDE:</b> -94.49154771
<b>SITE LOCATION:</b> HALLSVILLE, TEXAS			
<b>DESCRIPTION:</b>  East area, Top of Landfill. Looking Southwest. Ground Cover, Typical Conditions.

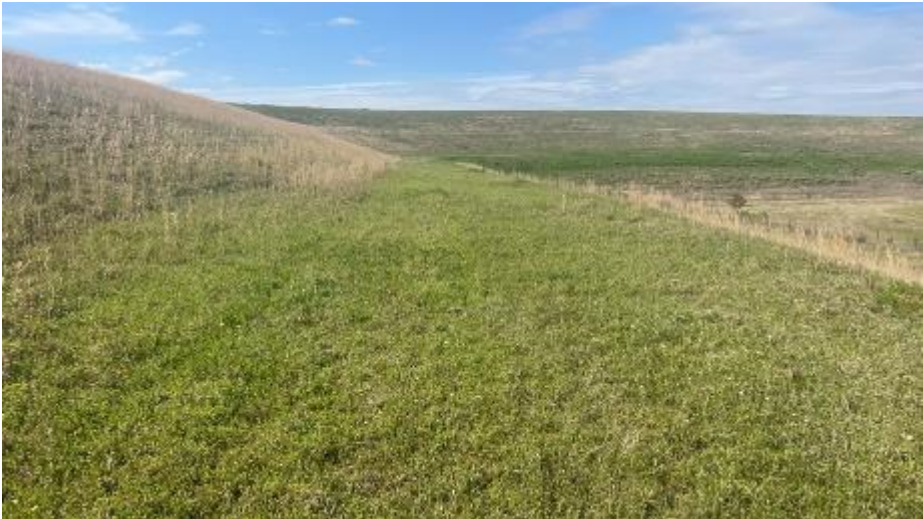
<b>PHOTO BY:</b>  GEI CONSULTANTS, INC.			
<b>PHOTOGRAPH No: 20</b>	<b>DATE:</b> March 20, 2024 4:07 PM	<b>LATITUDE:</b> 32.4536942767979	<b>LONGITUDE:</b> -94.4909962992104
<b>SITE LOCATION:</b> HALLSVILLE, TEXAS			
<b>DESCRIPTION:</b>  East area, Downstream Slope. Looking West (south of gas well). General Photo, Typical Conditions.

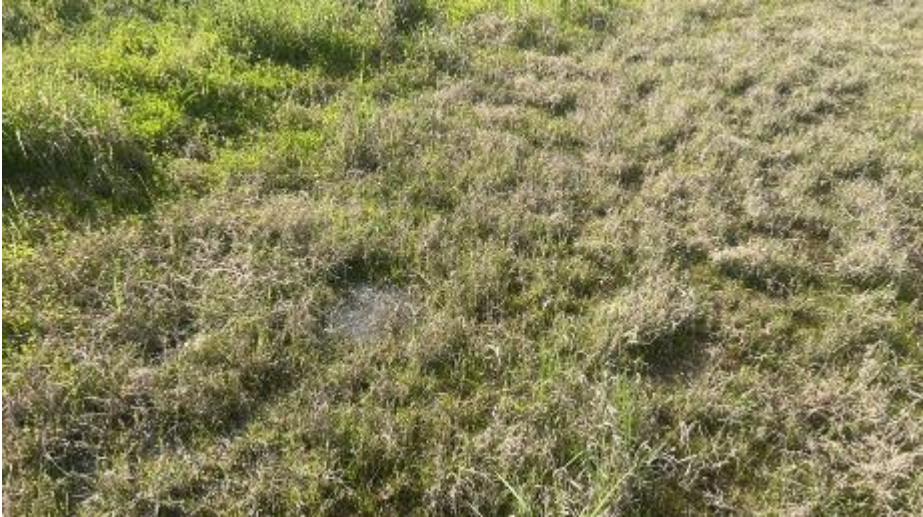
<b>PHOTOGRAPH No: 21</b>	<b>DATE:</b> March 20, 2024 4:03 PM	<b>LATITUDE:</b> 32.4547371755253	<b>LONGITUDE:</b> -94.492146333971
<b>SITE LOCATION:</b> HALLSVILLE, TEXAS			
<b>DESCRIPTION:</b>  East area, Downstream Slope. Looking Northwest. Wet Area, 20ft by 10ft. Monitor Conditions.

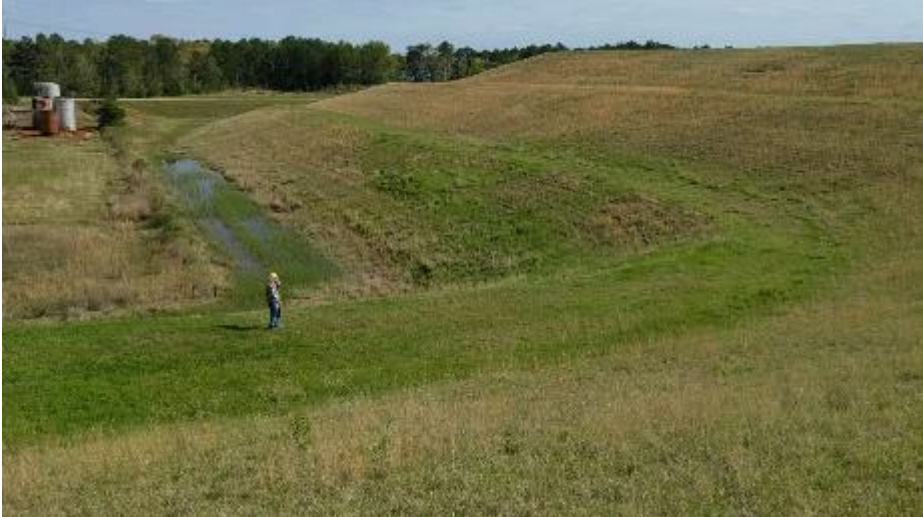
<b>PHOTO BY:</b>  GEI CONSULTANTS, INC.			
<b>PHOTOGRAPH No: 22</b>	<b>DATE:</b> March 20, 2024 4:01 PM	<b>LATITUDE:</b> 32.45514083	<b>LONGITUDE:</b> -94.49221555
<b>SITE LOCATION:</b> HALLSVILLE, TEXAS			
<b>DESCRIPTION:</b>  East Central Area (near gas well), Toe of Final Cover. Looking East. Wet Area, Monitor Conditions.

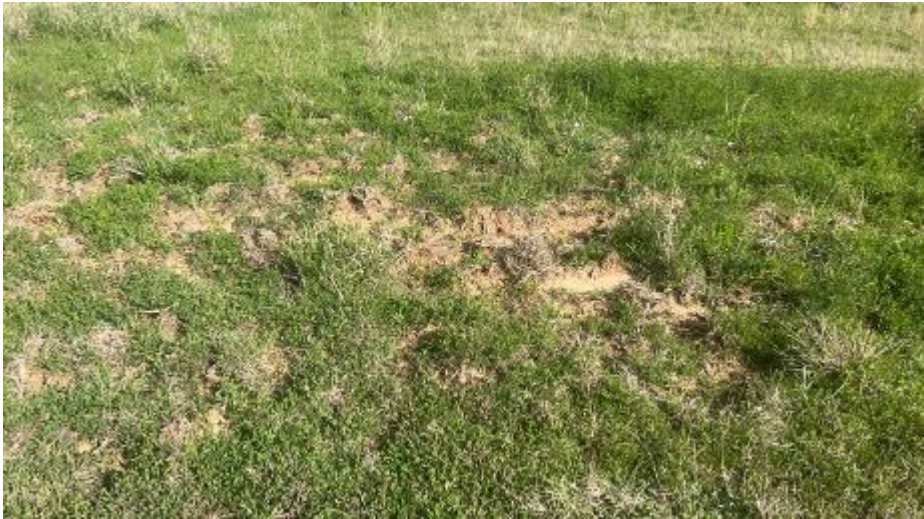
<b>PHOTOGRAPH No: 23</b>	<b>DATE:</b> March 20, 2024 4:00 PM	<b>LATITUDE:</b> 32.4553822558445	<b>LONGITUDE:</b> -94.4915864379352
<b>SITE LOCATION:</b> HALLSVILLE, TEXAS			
<b>DESCRIPTION:</b>  East area, Downstream Slope. Looking East. Animal Burrow, Typical Conditions.

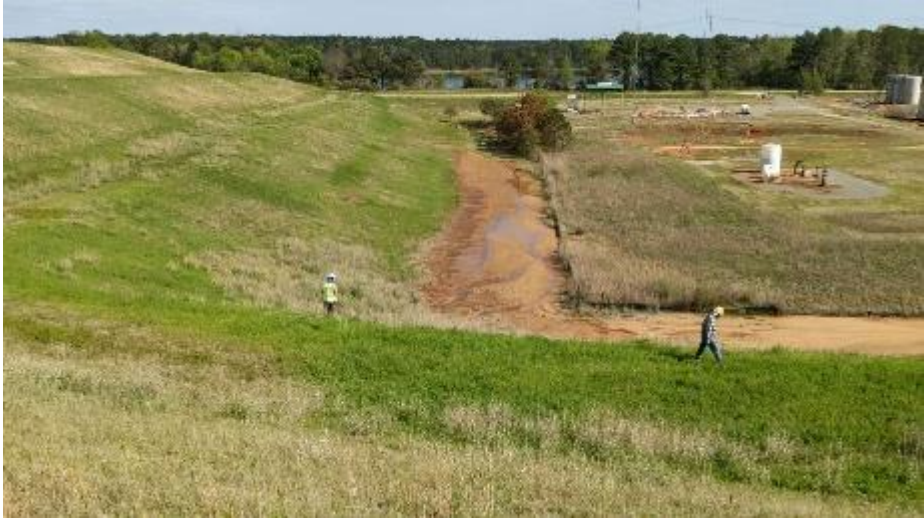
<b>PHOTO BY:</b>  GEI CONSULTANTS, INC.			
<b>PHOTOGRAPH No: 24</b>	<b>DATE:</b> March 20, 2024 3:58 PM	<b>LATITUDE:</b> 32.45556575	<b>LONGITUDE:</b> -94.49172703
<b>SITE LOCATION:</b> HALLSVILLE, TEXAS			
<b>DESCRIPTION:</b>  East area, Toe Ditch. Looking Southeast. Wet Area, Typical Conditions.

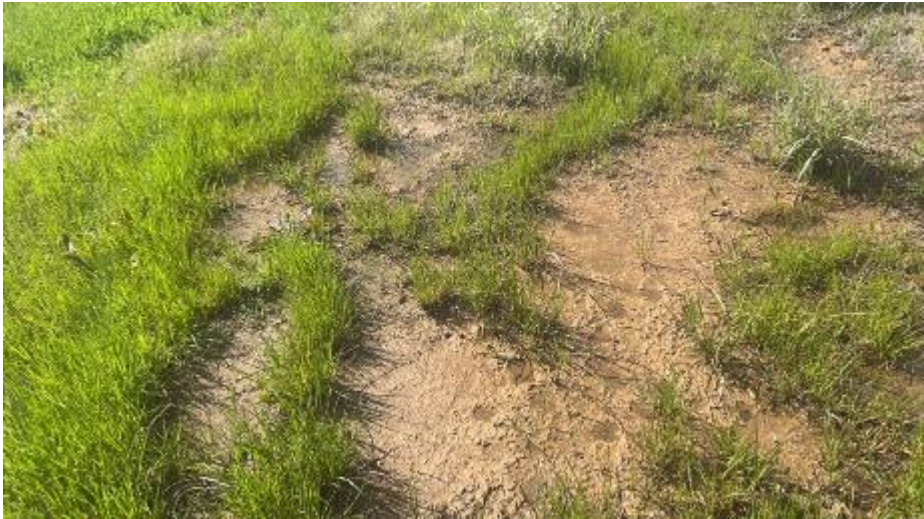
<b>PHOTOGRAPH No: 25</b>	<b>DATE:</b> March 20, 2024 3:57 PM	<b>LATITUDE:</b> 32.4555268154923	<b>LONGITUDE:</b> -94.4910912799079
<b>SITE LOCATION:</b> HALLSVILLE, TEXAS			
<b>DESCRIPTION:</b>  East area, along Bench. Looking West. Wet Area, Typical Conditions.

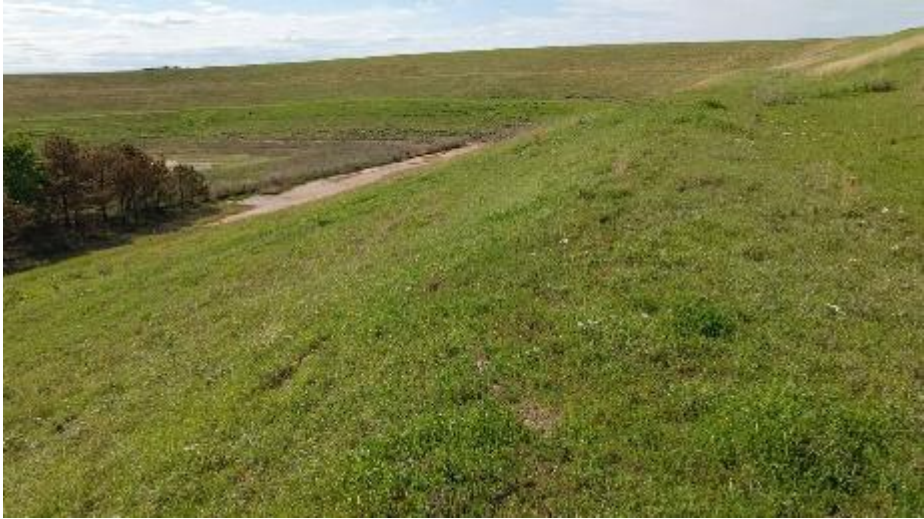
<b>PHOTO BY:</b>  GEI CONSULTANTS, INC.			
<b>PHOTOGRAPH No: 26</b>	<b>DATE:</b> March 20, 2024 3:48 PM	<b>LATITUDE:</b> 32.45499094	<b>LONGITUDE:</b> -94.48956703
<b>SITE LOCATION:</b> HALLSVILLE, TEXAS			
<b>DESCRIPTION:</b>  East area (north of gas well), Upper Bench to Downstream Slope and Toe. Looking West. Wet Area.

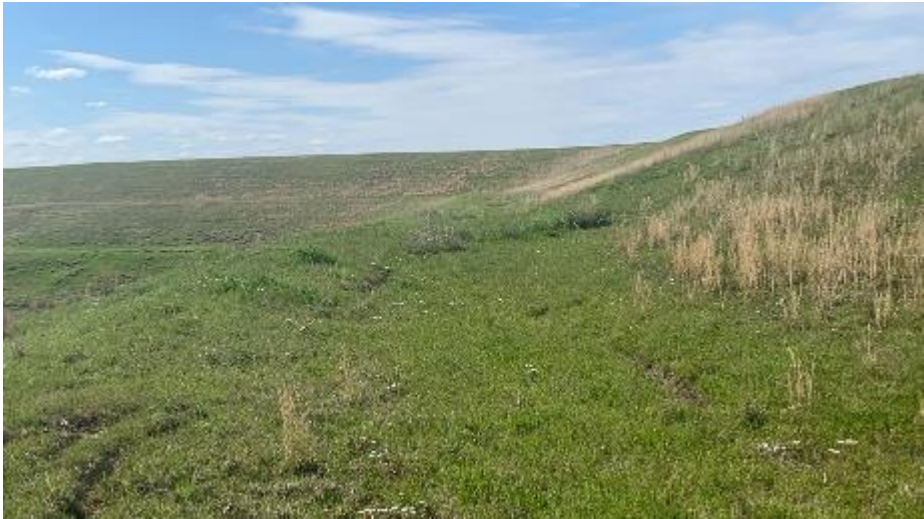
<b>PHOTOGRAPH No: 27</b>	<b>DATE:</b> March 20, 2024 3:48 PM	<b>LATITUDE:</b> 32.4549720109978	<b>LONGITUDE:</b> -94.4895474308701
<b>SITE LOCATION:</b> HALLSVILLE, TEXAS			
<b>DESCRIPTION:</b>  East area (north of gas well) , Downstream Slope. Looking West. General Photo, Typical Conditions.

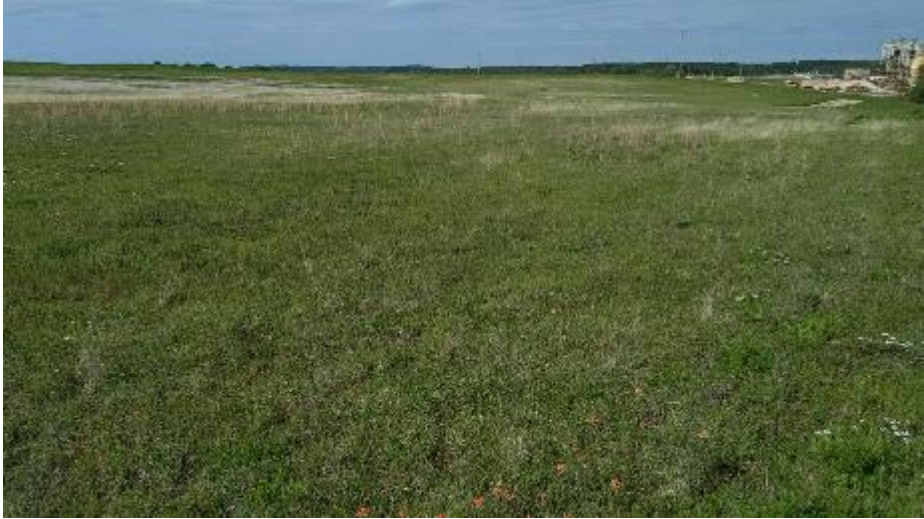
<b>PHOTO BY:</b>  GEI CONSULTANTS, INC.			
<b>PHOTOGRAPH No: 28</b>	<b>DATE:</b> March 20, 2024 3:53 PM	<b>LATITUDE:</b> 32.45527824	<b>LONGITUDE:</b> -94.48972701
<b>SITE LOCATION:</b> HALLSVILLE, TEXAS			
<b>DESCRIPTION:</b>  Top of Landfill, Final Cover. Looking Northwest. Typical Conditions.

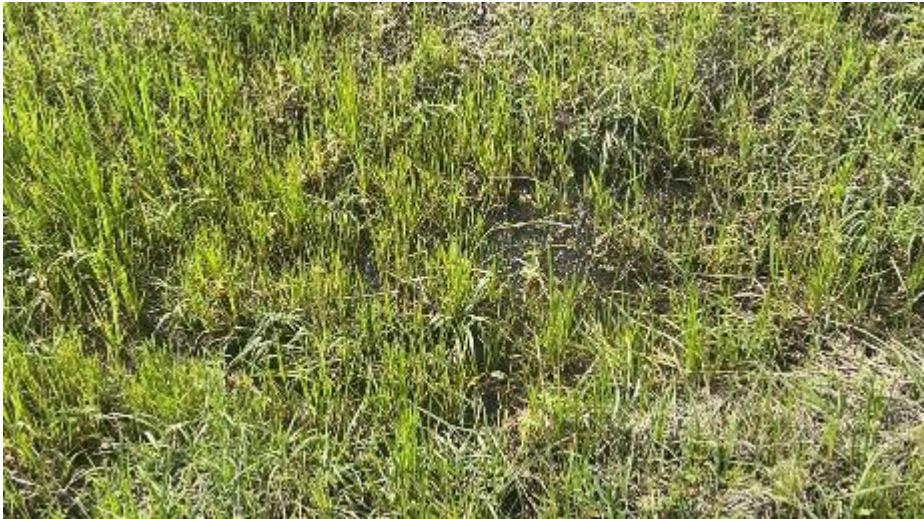
<b>PHOTOGRAPH No: 33</b>	<b>DATE:</b> March 20, 2024 3:40 PM	<b>LATITUDE:</b> 32.4566082102924	<b>LONGITUDE:</b> -94.4888297388226
<b>SITE LOCATION:</b> HALLSVILLE, TEXAS			
<b>DESCRIPTION:</b>  East area, Downstream Slope. Looking West. Wet Area, Typical Conditions.

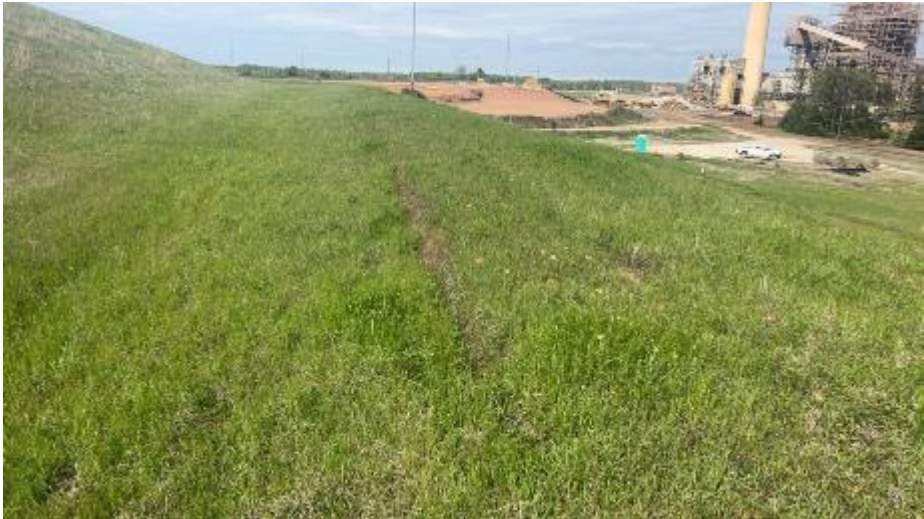
<b>PHOTO BY:</b>  GEI CONSULTANTS, INC.			
<b>PHOTOGRAPH No: 34</b>	<b>DATE:</b> March 20, 2024 3:38 PM	<b>LATITUDE:</b> 32.4568494258173	<b>LONGITUDE:</b> -94.4887759649057
<b>SITE LOCATION:</b> HALLSVILLE, TEXAS			
<b>DESCRIPTION:</b>  East area, Downstream Slope. Looking North. Ruts, Typical Conditions.

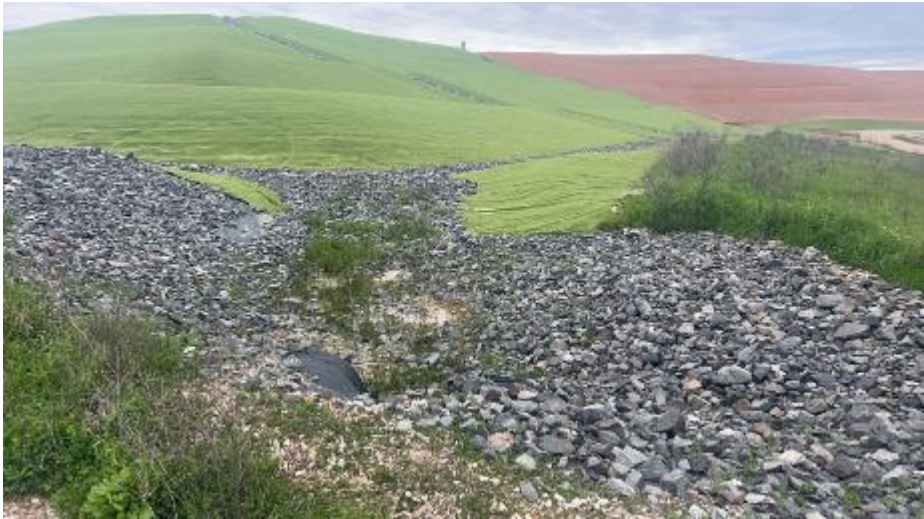
<b>PHOTOGRAPH No: 35</b>	<b>DATE:</b> March 20, 2024 5:36 PM	<b>LATITUDE:</b> 32.4570218303318	<b>LONGITUDE:</b> -94.4876059863091
<b>SITE LOCATION:</b> HALLSVILLE, TEXAS			
<b>DESCRIPTION:</b>  Southwest corner (north of landfill stormwater pond), Toe, Drainage Feature. Looking Northeast. General Photo, Typical Conditions.

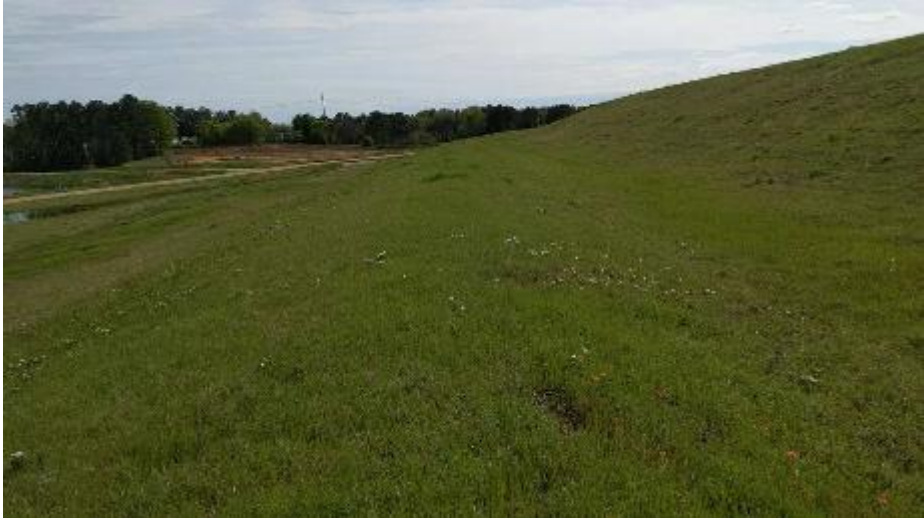
<b>PHOTO BY:</b>  GEI CONSULTANTS, INC.			
<b>PHOTOGRAPH No: 36</b>	<b>DATE:</b> March 20, 2024 3:35 PM	<b>LATITUDE:</b> 32.45739792	<b>LONGITUDE:</b> -94.48867159
<b>SITE LOCATION:</b> HALLSVILLE, TEXAS			
<b>DESCRIPTION:</b>  East area, Downstream Slope of Final Cover. Looking South. Ground Cover, Typical Conditions.

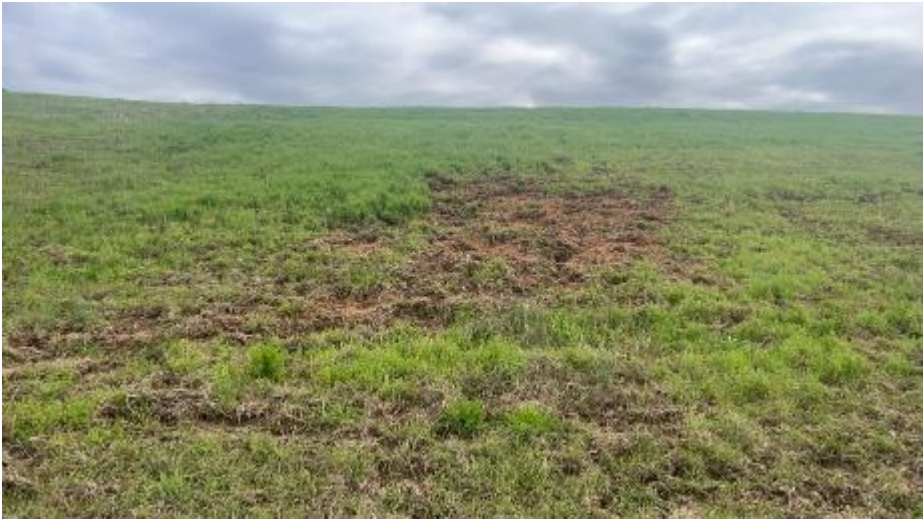
<b>PHOTOGRAPH No: 39</b>	<b>DATE:</b> March 20, 2024 5:20 PM	<b>LATITUDE:</b> 32.4577802707263	<b>LONGITUDE:</b> -94.4901005782071
<b>SITE LOCATION:</b> HALLSVILLE, TEXAS			
<b>DESCRIPTION:</b>  North area, Toe. Looking South. Animal Burrowing, Monitor Conditions.

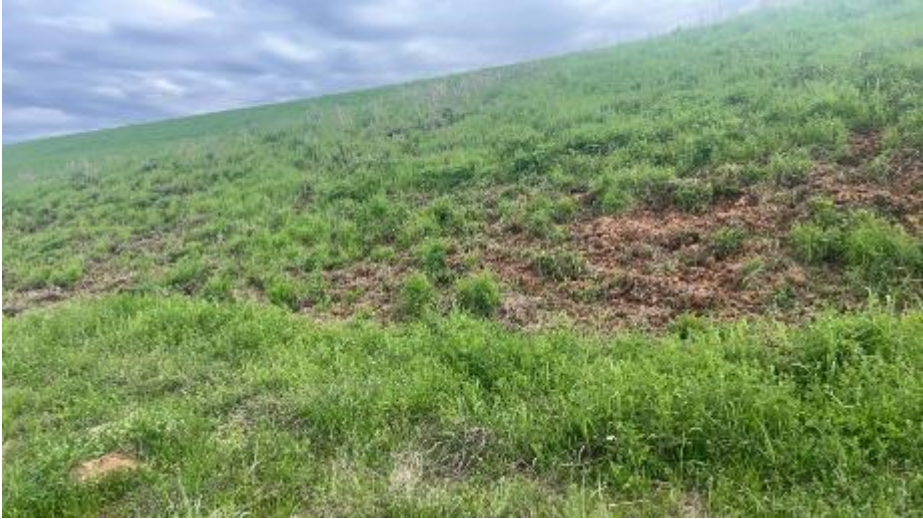
<b>PHOTO BY:</b>  GEI CONSULTANTS, INC.			
<b>PHOTOGRAPH No: 40</b>	<b>DATE:</b> March 20, 2024 5:17 PM	<b>LATITUDE:</b> 32.4581311288465	<b>LONGITUDE:</b> -94.4919193891163
<b>SITE LOCATION:</b> HALLSVILLE, TEXAS			
<b>DESCRIPTION:</b>  North area, Downstream Slope. Looking Northwest. Animal Burrowing, Monitor Conditions.

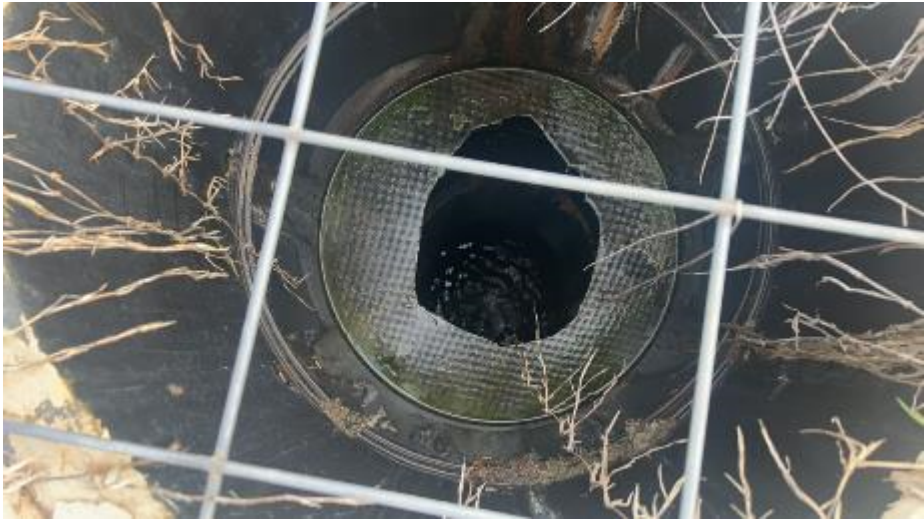
<p><b>PHOTOGRAPH No: 41</b></p>	<p><b>DATE:</b> March 20, 2024 5:10 PM</p>	<p><b>LATITUDE:</b> 32.4596940629106</p>	<p><b>LONGITUDE:</b> -94.4958733747015</p>
<p><b>SITE LOCATION:</b> HALLSVILLE, TEXAS</p>			
<p><b>DESCRIPTION:</b>  North area, Toe. Looking Southeast. Drain, Typical Conditions.</p>

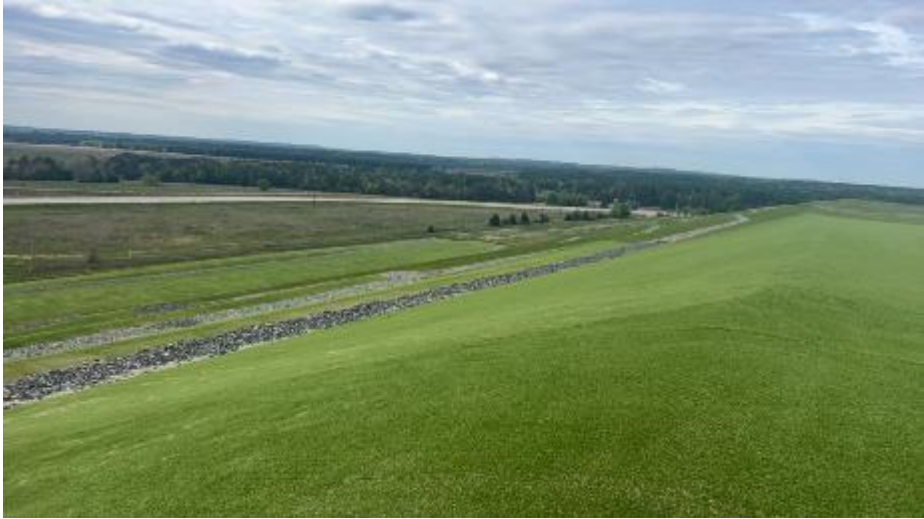
<p><b>PHOTO BY:</b>  GEI CONSULTANTS, INC.</p>			
<p><b>PHOTOGRAPH No: 42</b></p>	<p><b>DATE:</b> March 20, 2024 5:02 PM</p>	<p><b>LATITUDE:</b> 32.4557041563735</p>	<p><b>LONGITUDE:</b> -94.4970369281184</p>
<p><b>SITE LOCATION:</b> HALLSVILLE, TEXAS</p>			
<p><b>DESCRIPTION:</b>  West area, Crest pf Final Cover. Looking Northwest. General Photo, Typical Conditions.</p>

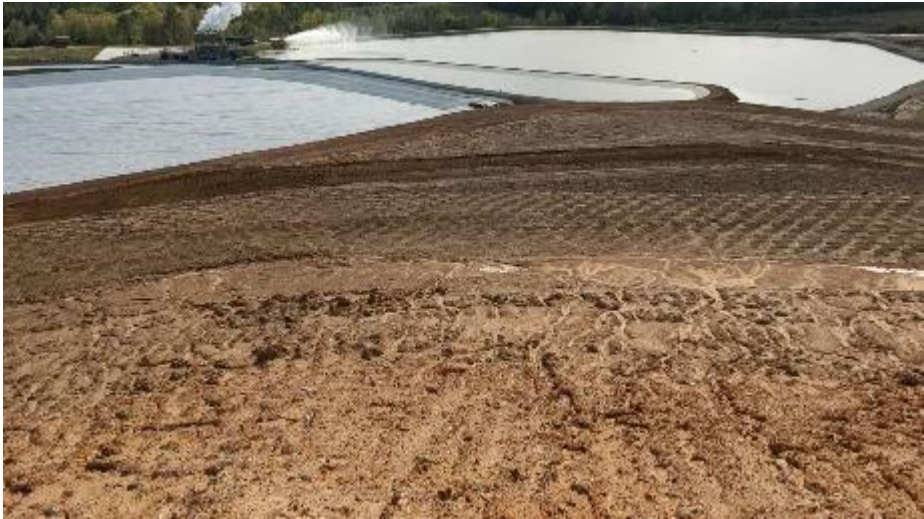
<b>PHOTOGRAPH No: 45</b>	<b>DATE:</b> March 20, 2024 4:31 PM	<b>LATITUDE:</b> 32.45410084	<b>LONGITUDE:</b> -94.49520039
<b>SITE LOCATION:</b> HALLSVILLE, TEXAS			
<b>DESCRIPTION:</b>  West area, Back Slope of Active Cell. Looking Southwest. Monitor erosion on ClosureTurf subgrade.

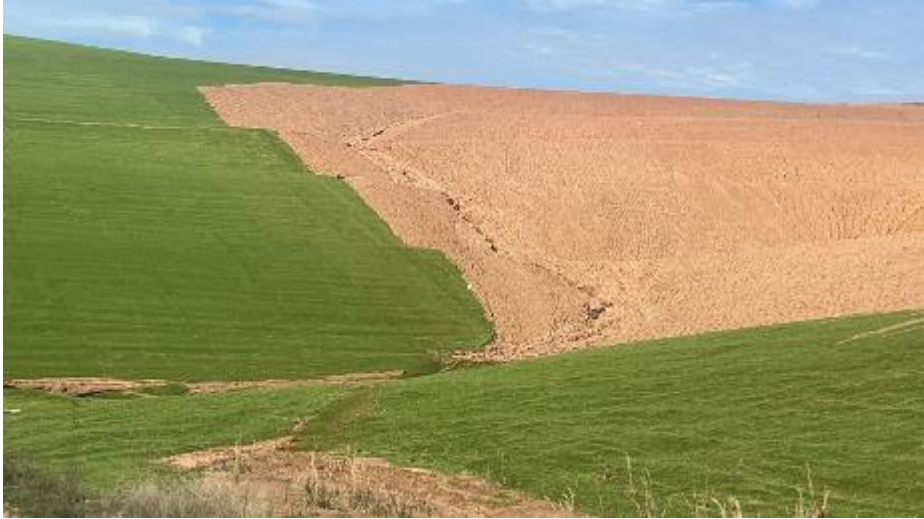
<b>PHOTO BY:</b>  GEI CONSULTANTS, INC.			
<b>PHOTOGRAPH No: 46</b>	<b>DATE:</b> March 20, 2024 4:45 PM	<b>LATITUDE:</b> 32.4530806334196	<b>LONGITUDE:</b> -94.4972664421887
<b>SITE LOCATION:</b> HALLSVILLE, TEXAS			
<b>DESCRIPTION:</b>  South area, Downstream Slope. Looking North. ClosureTurf subgrade, Typical Conditions.

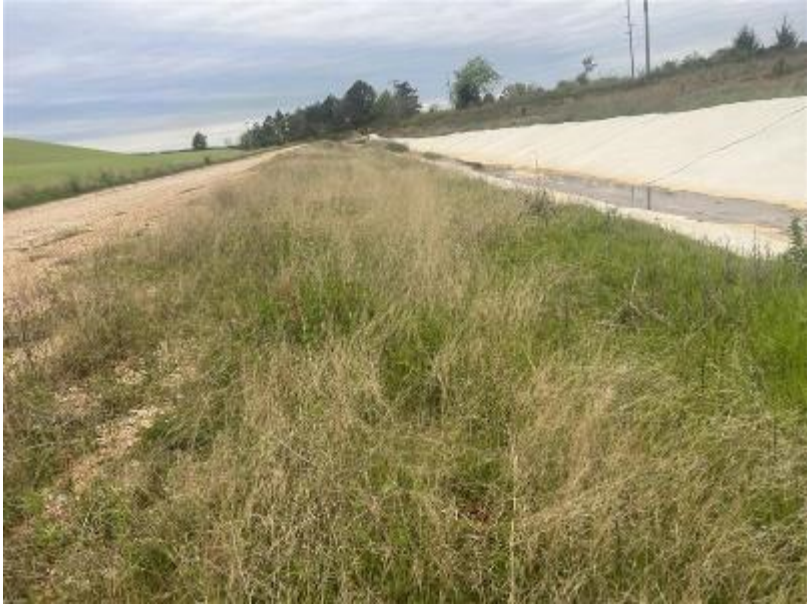
<p><b>PHOTOGRAPH No: 49</b></p>	<p><b>DATE:</b> March 20<sup>th</sup>, 2024</p>	<p><b>LATITUDE:</b></p>	<p><b>LONGITUDE:</b></p>
<p><b>SITE LOCATION:</b> HALLSVILLE, TEXAS</p>			
<p><b>DESCRIPTION:</b></p> <p>West area, non-contact stormwater ditch along Toe of Landfill. Looking Southeast, Typical.</p>

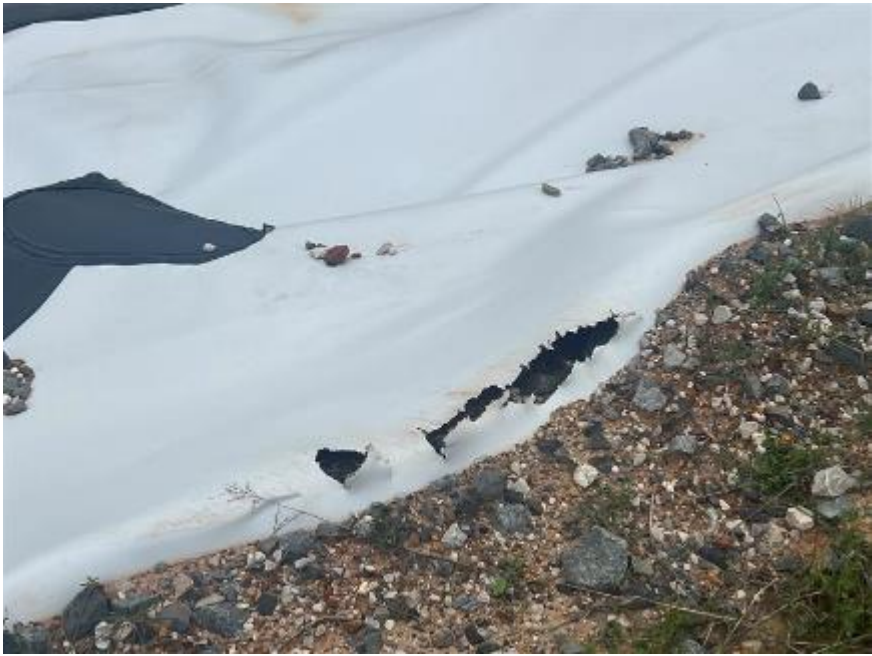
<p><b>PHOTO BY:</b></p> <p><b>GEI CONSULTANTS, INC.</b></p>			
<p><b>PHOTOGRAPH No: 50</b></p>	<p><b>DATE:</b> March 20<sup>th</sup>, 2024</p>	<p><b>LATITUDE:</b></p>	<p><b>LONGITUDE:</b></p>
<p><b>SITE LOCATION:</b> HALLSVILLE, TEXAS</p>			
<p><b>DESCRIPTION:</b></p> <p>West area, Downstream Slope and Toe of Landfill. Looking West. Non-contact stormwater ditch.</p>

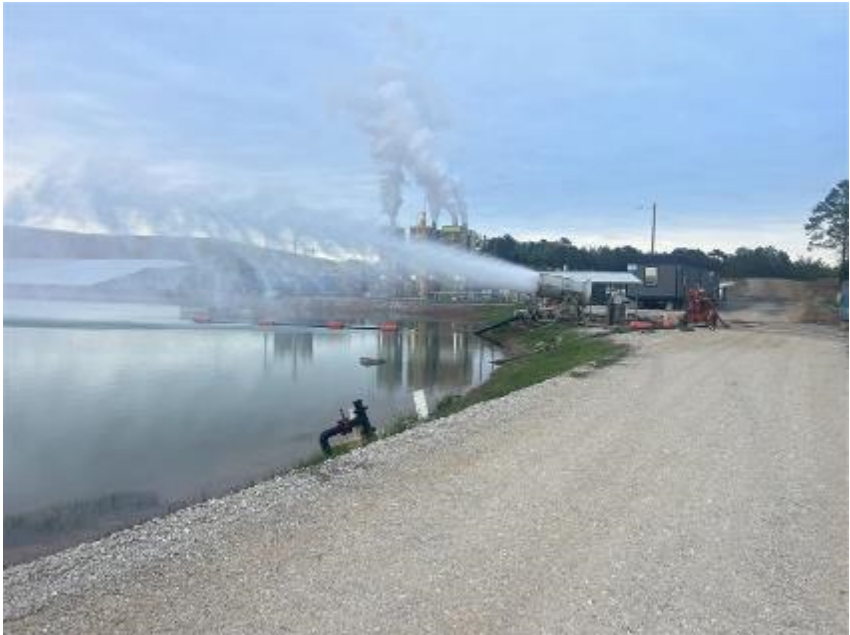
<b>PHOTOGRAPH NO: 64</b>	<b>DATE:</b> March 20 <sup>th</sup> , 2024	<b>LATITUDE:</b>	<b>LONGITUDE:</b>
<b>SITE LOCATION:</b> HALLSVILLE, TEXAS			
<b>DESCRIPTION:</b>  South area, Crest of Landfill Stormwater Pond. Water Mist Spray Fog Cannon. Looking Northeast. Typical Conditions.
