**Ash Pond  
Initial Dam and Dike Inspection  
Report**

Cabin Creek Power Plant Cabin Creek, West Virginia

# 2024 Annual Inspection Report

## Ash Pond Cabin Creek Power Plant

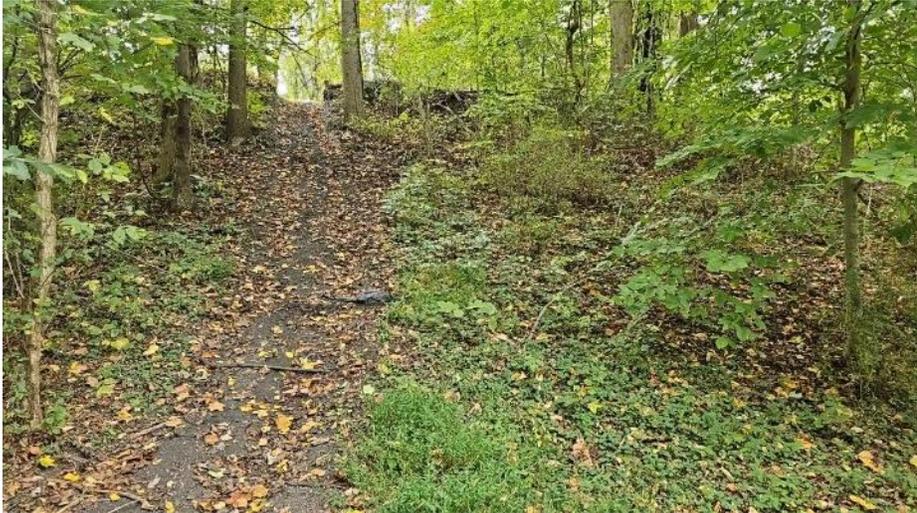
The downstream slope of the dam is in fair condition. The slope is overgrown with woody vegetation. AEP should consider identifying the unit boundary so vegetation on the downstream slope can be addressed/maintained to 12-inches or less as shown in Photograph No. 1, 2, 3, 5, 7, 8, 9, 12, 13, 14, 18, 19, 20, and 22.

<b>PHOTOGRAPH NO: 1</b>	<b>DATE:</b> October 14, 2024 12:14 PM	<b>LATITUDE:</b> 38.19899322	<b>LONGITUDE:</b> -81.48067534
<b>DIRECTION:</b> 210°		<b>SITE LOCATION:</b> CABIN CREEK, WEST VIRGINIA	
<b>DESCRIPTION:</b>  Downstream Slope. Maintain vegetation to 12-inches or less within 25-feet of the toe of the downstream slope.  AEP to review existing drawings to determine limits of the downstream slope / toe of slope.

- Address/maintain vegetation to 12-inches or less on the upstream and downstream slopes. AEP to review the existing drawings to determine the top and toe of the slopes. Applies to Item 1, 2, 3, 5, 7, 8, 9, 12-20, and 22.

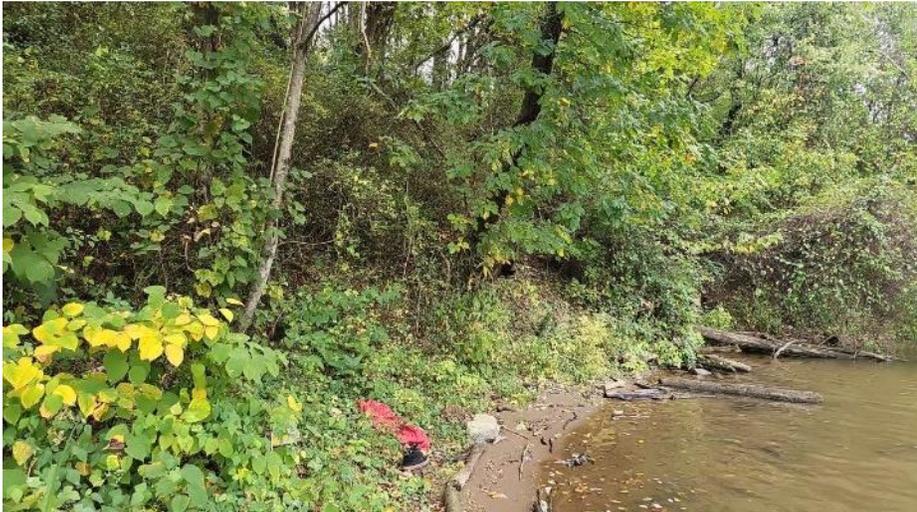
<b>PHOTO BY:</b>  GEI CONSULTANTS, INC.			
<b>PHOTOGRAPH NO: 2</b>	<b>DATE:</b> October 14, 2024 12:25 PM	<b>LATITUDE:</b> 38.19894563	<b>LONGITUDE:</b> -81.4832945
<b>DIRECTION:</b> 250°		<b>SITE LOCATION:</b> CABIN CREEK, WEST VIRGINIA	
<b>DESCRIPTION:</b>  Downstream Slope. Maintain vegetation to 12-inches or less within 25-feet of the toe of the downstream slope.  AEP to review existing drawings to determine limits of the downstream slope / toe of slope.

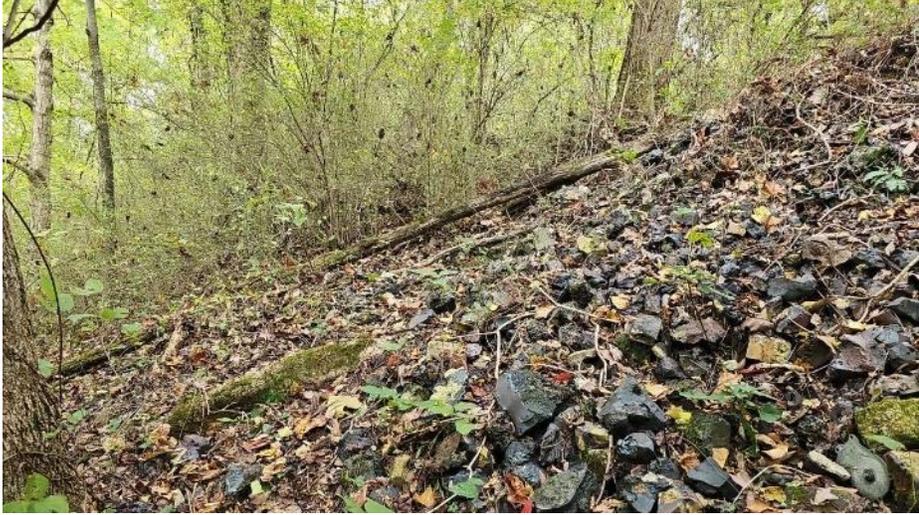
<b>PHOTOGRAPH NO: 5</b>	<b>DATE:</b> October 14, 2024 12:36 PM	<b>LATITUDE:</b> 38.19876106	<b>LONGITUDE:</b> -81.48460932
<b>DIRECTION:</b> 80°		<b>SITE LOCATION:</b> CABIN CREEK, WEST VIRGINIA	
<b>DESCRIPTION:</b>  Downstream Slope. Maintain vegetation to 12-inches or less within 25-feet of the toe of the downstream slope.  AEP to review existing drawings to establish limits of the downstream slope / toe of slope.

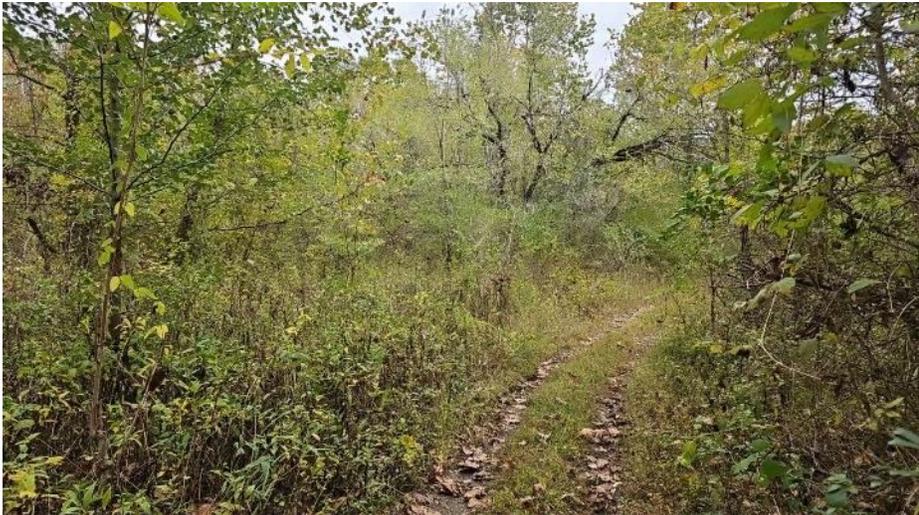
The interior of the site is in fair condition. It is heavily vegetated as shown in Photograph No. 4, 6, 15, 16, and 17. AEP should consider addressing/maintaining the vegetation to 12-inches or less in the pond's interior in preparation to comply with upcoming Legacy CCR Surface Impoundment requirements.

<b>PHOTO BY:</b>  GEI CONSULTANTS, INC.			
<b>PHOTOGRAPH NO: 6</b>	<b>DATE:</b> October 14, 2024 12:41 PM	<b>LATITUDE:</b> 38.1987975	<b>LONGITUDE:</b> -81.4846117
<b>DIRECTION:</b> 90°		<b>SITE LOCATION:</b> CABIN CREEK, WEST VIRGINIA	
<b>DESCRIPTION:</b>  Ash Pond Interior. General Photo, Typical Conditions.

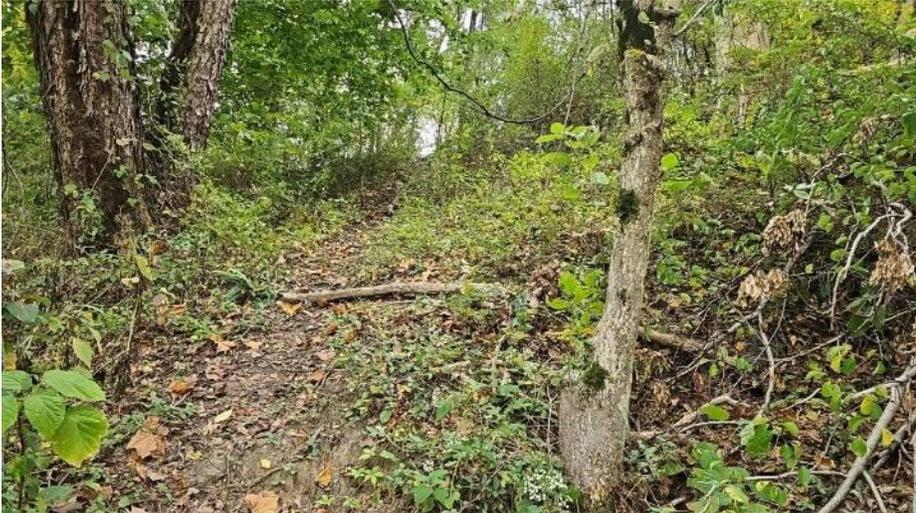
PHOTOGRAPH NO: 7	DATE: October 14, 2024 12:51 PM	LATITUDE: 38.19845812	LONGITUDE: -81.48493232
DIRECTION: 180°		SITE LOCATION: CABIN CREEK, WEST VIRGINIA	
<p><b>DESCRIPTION:</b></p> <p>Downstream Slope. Maintain vegetation to 12-inches or less within 25-feet of the toe of the downstream slope.</p> <p>AEP to review existing drawings to establish limits of the downstream slope / toe of slope.</p>

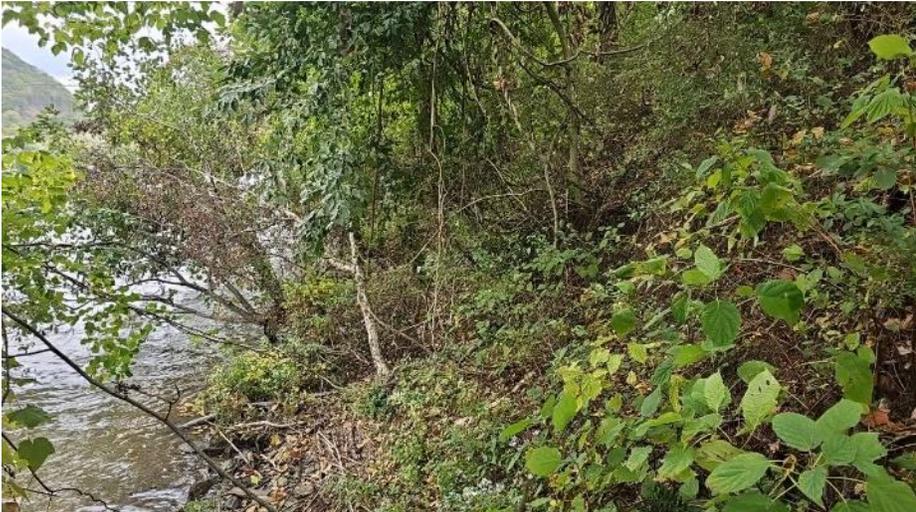
<p>PHOTO BY:</p> <p>GEI CONSULTANTS, INC.</p>			
PHOTOGRAPH NO: 8	DATE: October 14, 2024 12:54 PM	LATITUDE: 38.19869542	LONGITUDE: -81.4850167
DIRECTION: 90°		SITE LOCATION: CABIN CREEK, WEST VIRGINIA	
<p><b>DESCRIPTION:</b></p> <p>Downstream Slope. Maintain vegetation to 12-inches or less within 25-feet of the toe of the downstream slope.</p> <p>AEP to review existing drawings to establish limits of the downstream slope / toe of slope.</p>

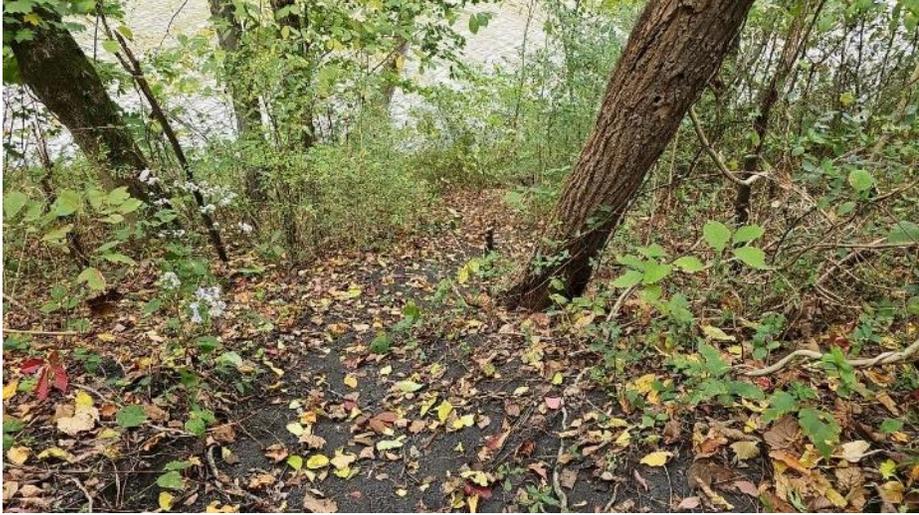
<b>PHOTOGRAPH NO: 9</b>	<b>DATE:</b> October 14, 2024 1:05 PM	<b>LATITUDE:</b> 38.19809249	<b>LONGITUDE:</b> -81.4874134
<b>DIRECTION: 0°</b>	<b>SITE LOCATION: CABIN CREEK, WEST VIRGINIA</b>		
<b>DESCRIPTION:</b>  Downstream Slope. Maintain vegetation to 12-inches or less within 25-feet of the toe of the downstream slope.  AEP to review existing drawings to establish limits of the downstream slope / toe of slope.

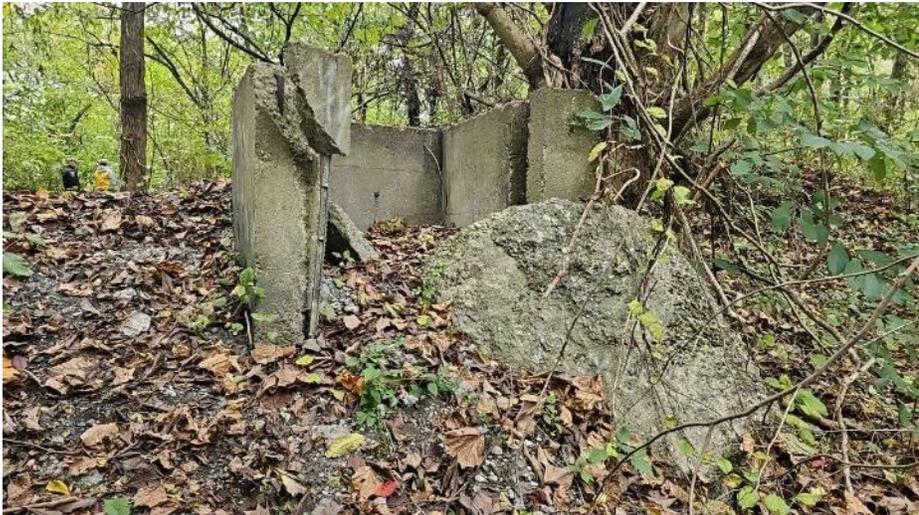
The Ash Pond outlet structure appears to be abandoned as shown in Photograph No. 10 and No. 11. AEP should review its existing documentation to confirm its abandonment.

<b>PHOTO BY:</b>  GEI CONSULTANTS, INC.			
<b>PHOTOGRAPH NO: 10</b>	<b>DATE:</b> October 14, 2024 1:08 PM	<b>LATITUDE:</b> 38.19786114	<b>LONGITUDE:</b> -81.48779331
<b>DIRECTION: 0°</b>	<b>SITE LOCATION: CABIN CREEK, WEST VIRGINIA</b>		
<b>DESCRIPTION:</b>  Outlet Works, Concrete Structure. Consider documenting abandonment.

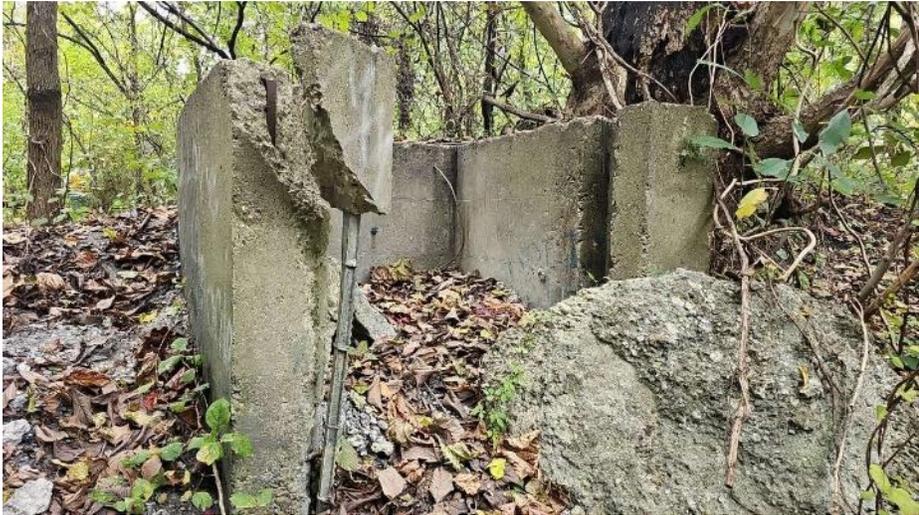
<b>PHOTOGRAPH NO: 11</b>	<b>DATE:</b> October 14, 2024 1:10 PM	<b>LATITUDE:</b> 38.19787966	<b>LONGITUDE:</b> -81.487761
<b>DIRECTION:</b> 20°		<b>SITE LOCATION:</b> CABIN CREEK, WEST VIRGINIA	
<b>DESCRIPTION:</b>  Outlet Works, Concrete Debris. Consider documenting abandonment.

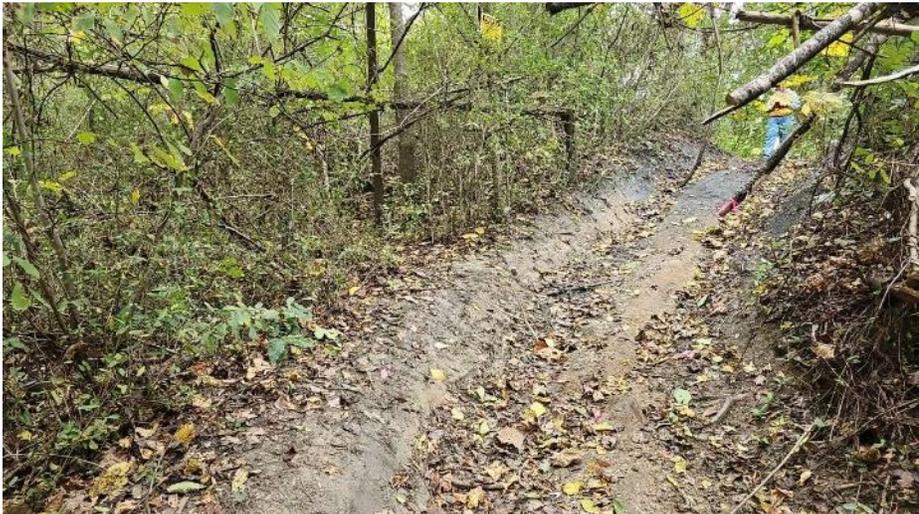
Isolated area of the downstream slope was observed to have heavy foot traffic as shown in Photograph No. 12. AEP should consider improving site security to protect public health and the environment.

<b>PHOTO BY:</b>  GEI CONSULTANTS, INC.			
<b>PHOTOGRAPH NO: 12</b>	<b>DATE:</b> October 14, 2024 1:12 PM	<b>LATITUDE:</b> 38.19797764	<b>LONGITUDE:</b> -81.48808339
<b>DIRECTION:</b> 165°		<b>SITE LOCATION:</b> CABIN CREEK, WEST VIRGINIA	
<b>DESCRIPTION:</b>  Downstream Slope. Maintain vegetation to 12-inches or less within 25-feet of the toe of the downstream slope.  AEP to review existing drawings to establish limits of the downstream slope / toe of slope.  Secure site/ limit traffic

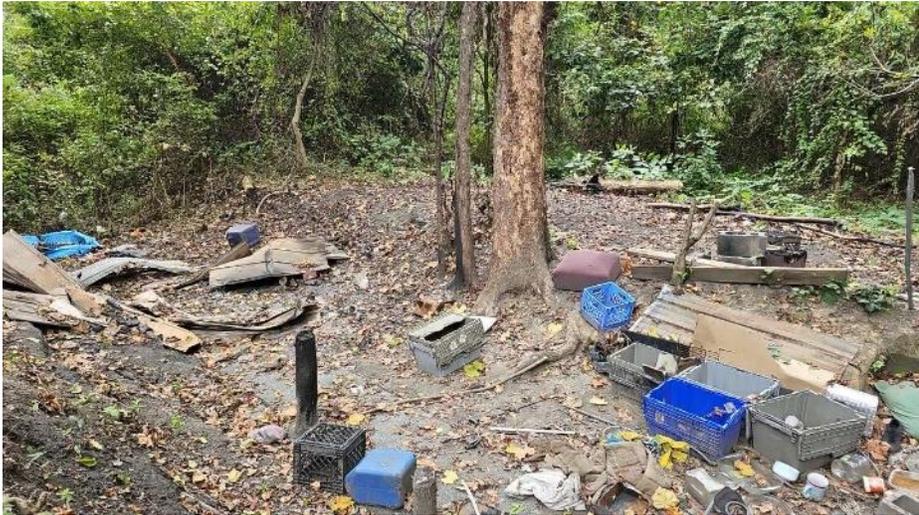
Debris, trash, and possible encampment were documented as shown in Photograph No. 15, 16, and 17. AEP should consider removing the trash and improving/addressing site security.

<b>PHOTOGRAPH No: 15</b>	<b>DATE:</b> October 14, 2024 1:24 PM	<b>LATITUDE:</b> 38.19781866	<b>LONGITUDE:</b> -81.48718805
<b>DIRECTION:</b> 45°		<b>SITE LOCATION:</b> CABIN CREEK, WEST VIRGINIA	
<b>DESCRIPTION:</b>  Ash Pond Interior. Address site access / secure site.

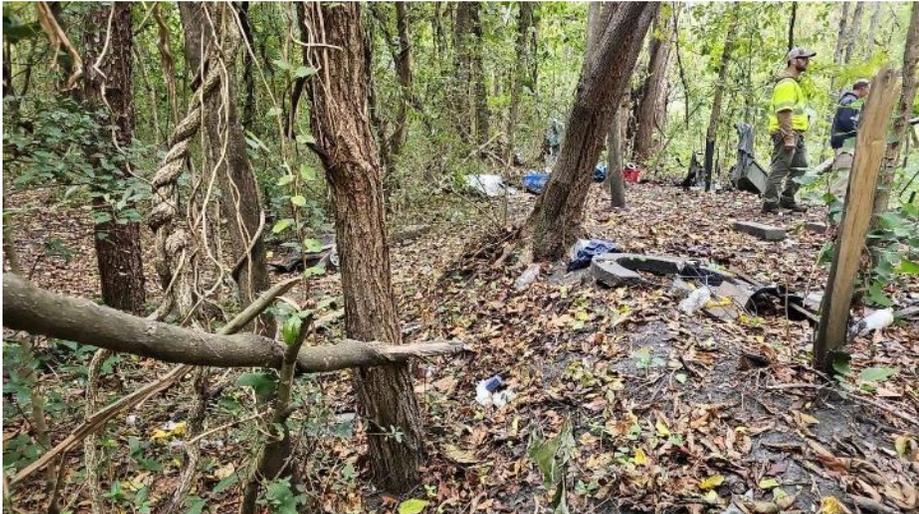
<b>PHOTO BY:</b>  GEI CONSULTANTS, INC.			
<b>PHOTOGRAPH No: 16</b>	<b>DATE:</b> October 14, 2024 1:28 PM	<b>LATITUDE:</b> 38.19781268	<b>LONGITUDE:</b> -81.48611718
<b>DIRECTION:</b> 270°		<b>SITE LOCATION:</b> CABIN CREEK, WEST VIRGINIA	
<b>DESCRIPTION:</b>  Ash Pond Interior. Address site access / secure site.

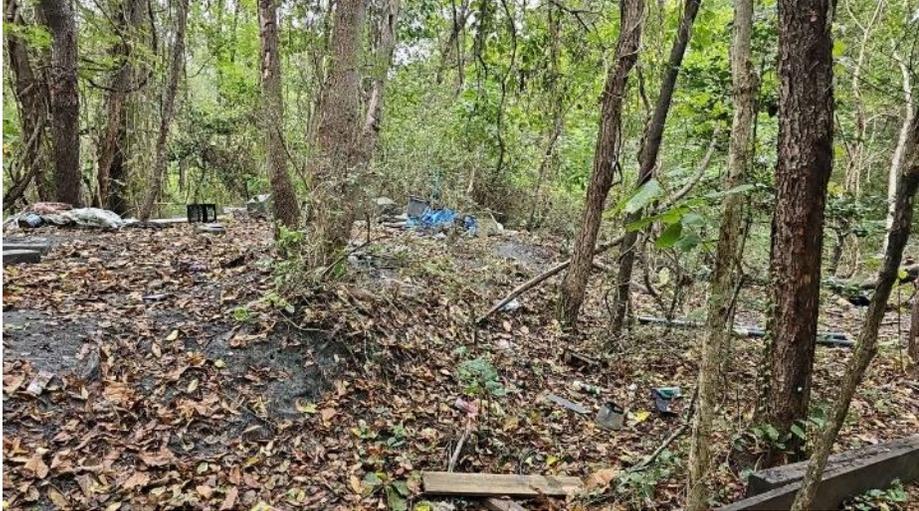
<b>PHOTOGRAPH NO: 17</b>	<b>DATE:</b> October 14, 2024 1:33 PM	<b>LATITUDE:</b> 38.19776877	<b>LONGITUDE:</b> -81.48612718
<b>DIRECTION:</b> 70°		<b>SITE LOCATION:</b> CABIN CREEK, WEST VIRGINIA	
<b>DESCRIPTION:</b>  Ash Pond Interior. Address site access / secure site.

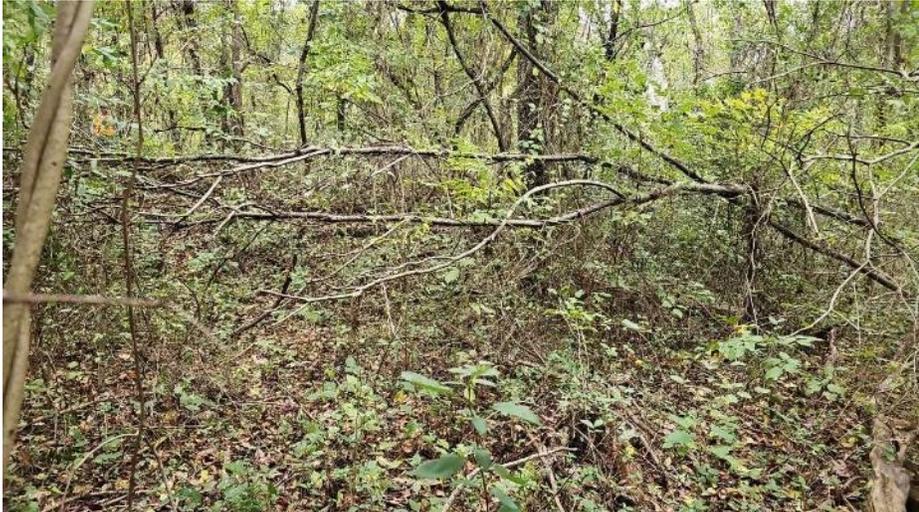
<b>PHOTO BY:</b>  GEI CONSULTANTS, INC.			
<b>PHOTOGRAPH NO: 18</b>	<b>DATE:</b> October 14, 2024 1:44 PM	<b>LATITUDE:</b> 38.19697451	<b>LONGITUDE:</b> -81.48437706
<b>DIRECTION:</b> 15°		<b>SITE LOCATION:</b> CABIN CREEK, WEST VIRGINIA	
<b>DESCRIPTION:</b>  Downstream Slope. Maintain vegetation to 12-inches or less within 25-feet of the toe of the downstream slope.  AEP to review existing drawings to establish limits of the downstream slope / toe of slope.

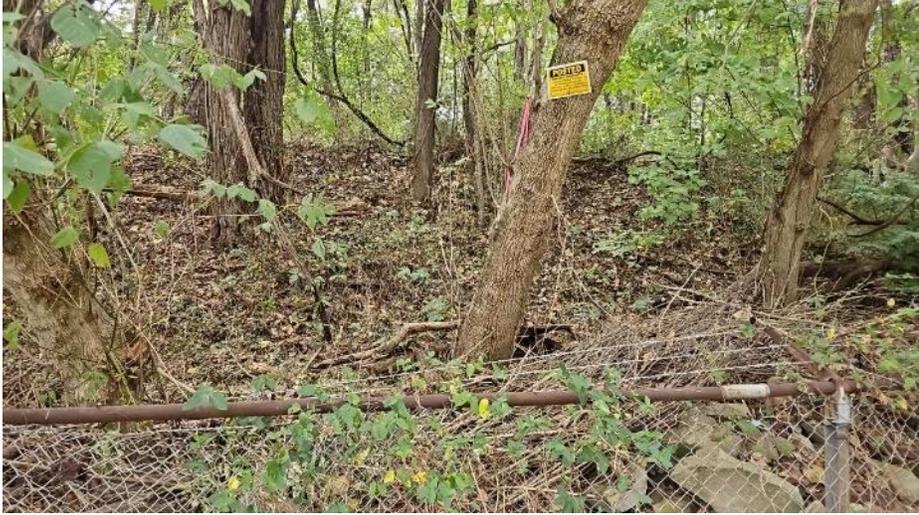
<b>PHOTOGRAPH No: 19</b>	<b>DATE:</b> October 14, 2024 2:10 PM	<b>LATITUDE:</b> 38.19666215	<b>LONGITUDE:</b> -81.48537819
<b>DIRECTION:</b> 10°		<b>SITE LOCATION:</b> CABIN CREEK, WEST VIRGINIA	
<b>DESCRIPTION:</b>  Downstream Slope. Maintain vegetation to 12-inches or less within 25-feet of the toe of the downstream slope. Secure the site.  AEP to review existing drawings to establish limits of the downstream slope / toe of slope.

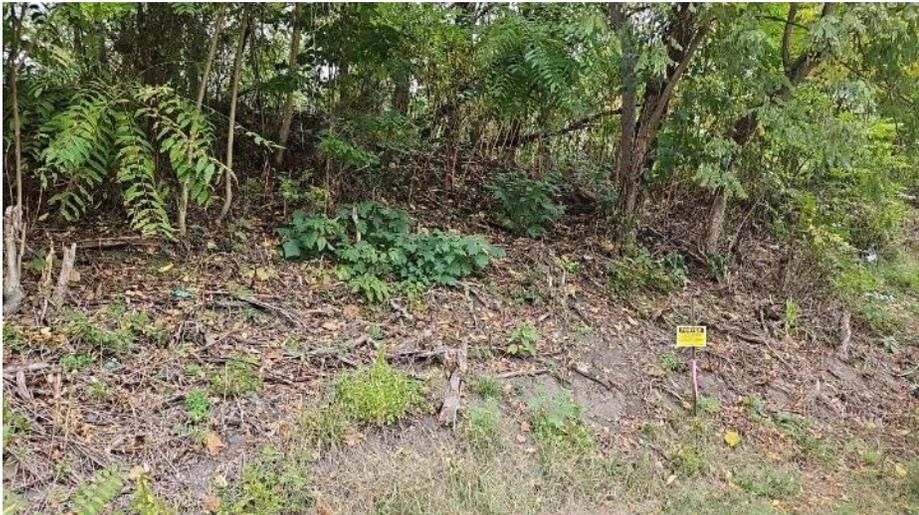
<b>PHOTO BY:</b>  GEI CONSULTANTS, INC.			
<b>PHOTOGRAPH No: 20</b>	<b>DATE:</b> October 14, 2024 2:12 PM	<b>LATITUDE:</b> 38.19693521	<b>LONGITUDE:</b> -81.48388105
<b>DIRECTION:</b> 15°		<b>SITE LOCATION:</b> CABIN CREEK, WEST VIRGINIA	
<b>DESCRIPTION:</b>  Downstream Slope. Maintain vegetation to 12-inches or less within 25-feet of the toe of the downstream slope.  AEP to review existing drawings to establish limits of the downstream slope / toe of slope.

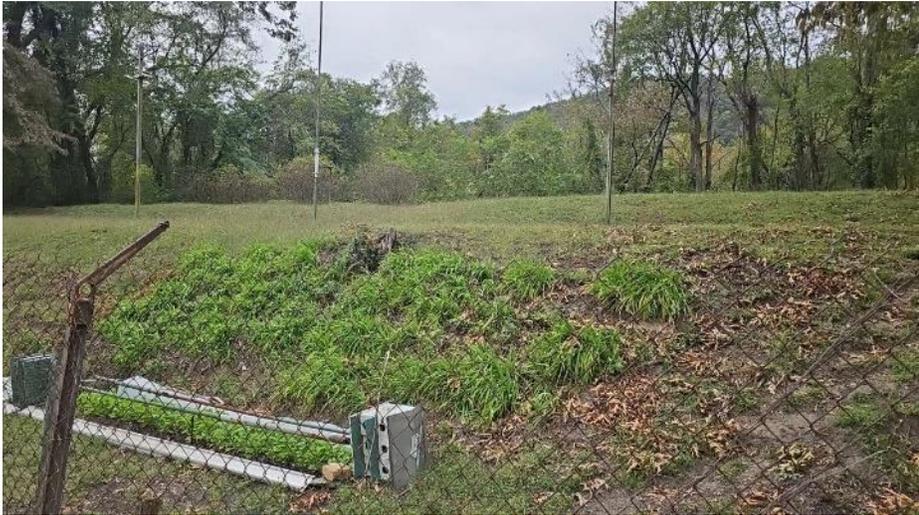
<b>PHOTOGRAPH NO: 21</b>	<b>DATE:</b> October 14, 2024 2:14 PM	<b>LATITUDE:</b> 38.19735906	<b>LONGITUDE:</b> -81.48263986
<b>DIRECTION:</b> 320°		<b>SITE LOCATION:</b> CABIN CREEK, WEST VIRGINIA	
<b>DESCRIPTION:</b>  Downstream Slope. General Photo, Typical Conditions. Secure the site.

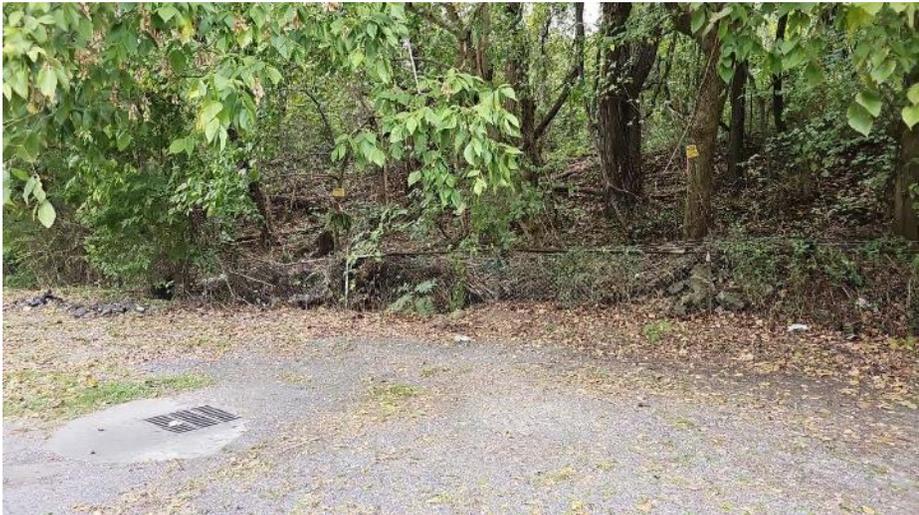
<b>PHOTO BY:</b>  GEI CONSULTANTS, INC.			
<b>PHOTOGRAPH NO: 22</b>	<b>DATE:</b> October 14, 2024 2:17 PM	<b>LATITUDE:</b> 38.19725545	<b>LONGITUDE:</b> -81.48285299
<b>DIRECTION:</b> 320°		<b>SITE LOCATION:</b> CABIN CREEK, WEST VIRGINIA	
<b>DESCRIPTION:</b>  Downstream Slope. Maintain vegetation to 12-inches or less within 25-feet of the toe of the downstream slope.  AEP to review existing drawings to establish limits of the downstream slope / toe of slope.
