**Ash Pond
Initial Dam and Dike Inspection
Report**

Kammer Power Plant, Marshall County, WV

January 2025
Project 2407654

2024 Annual Inspection Report

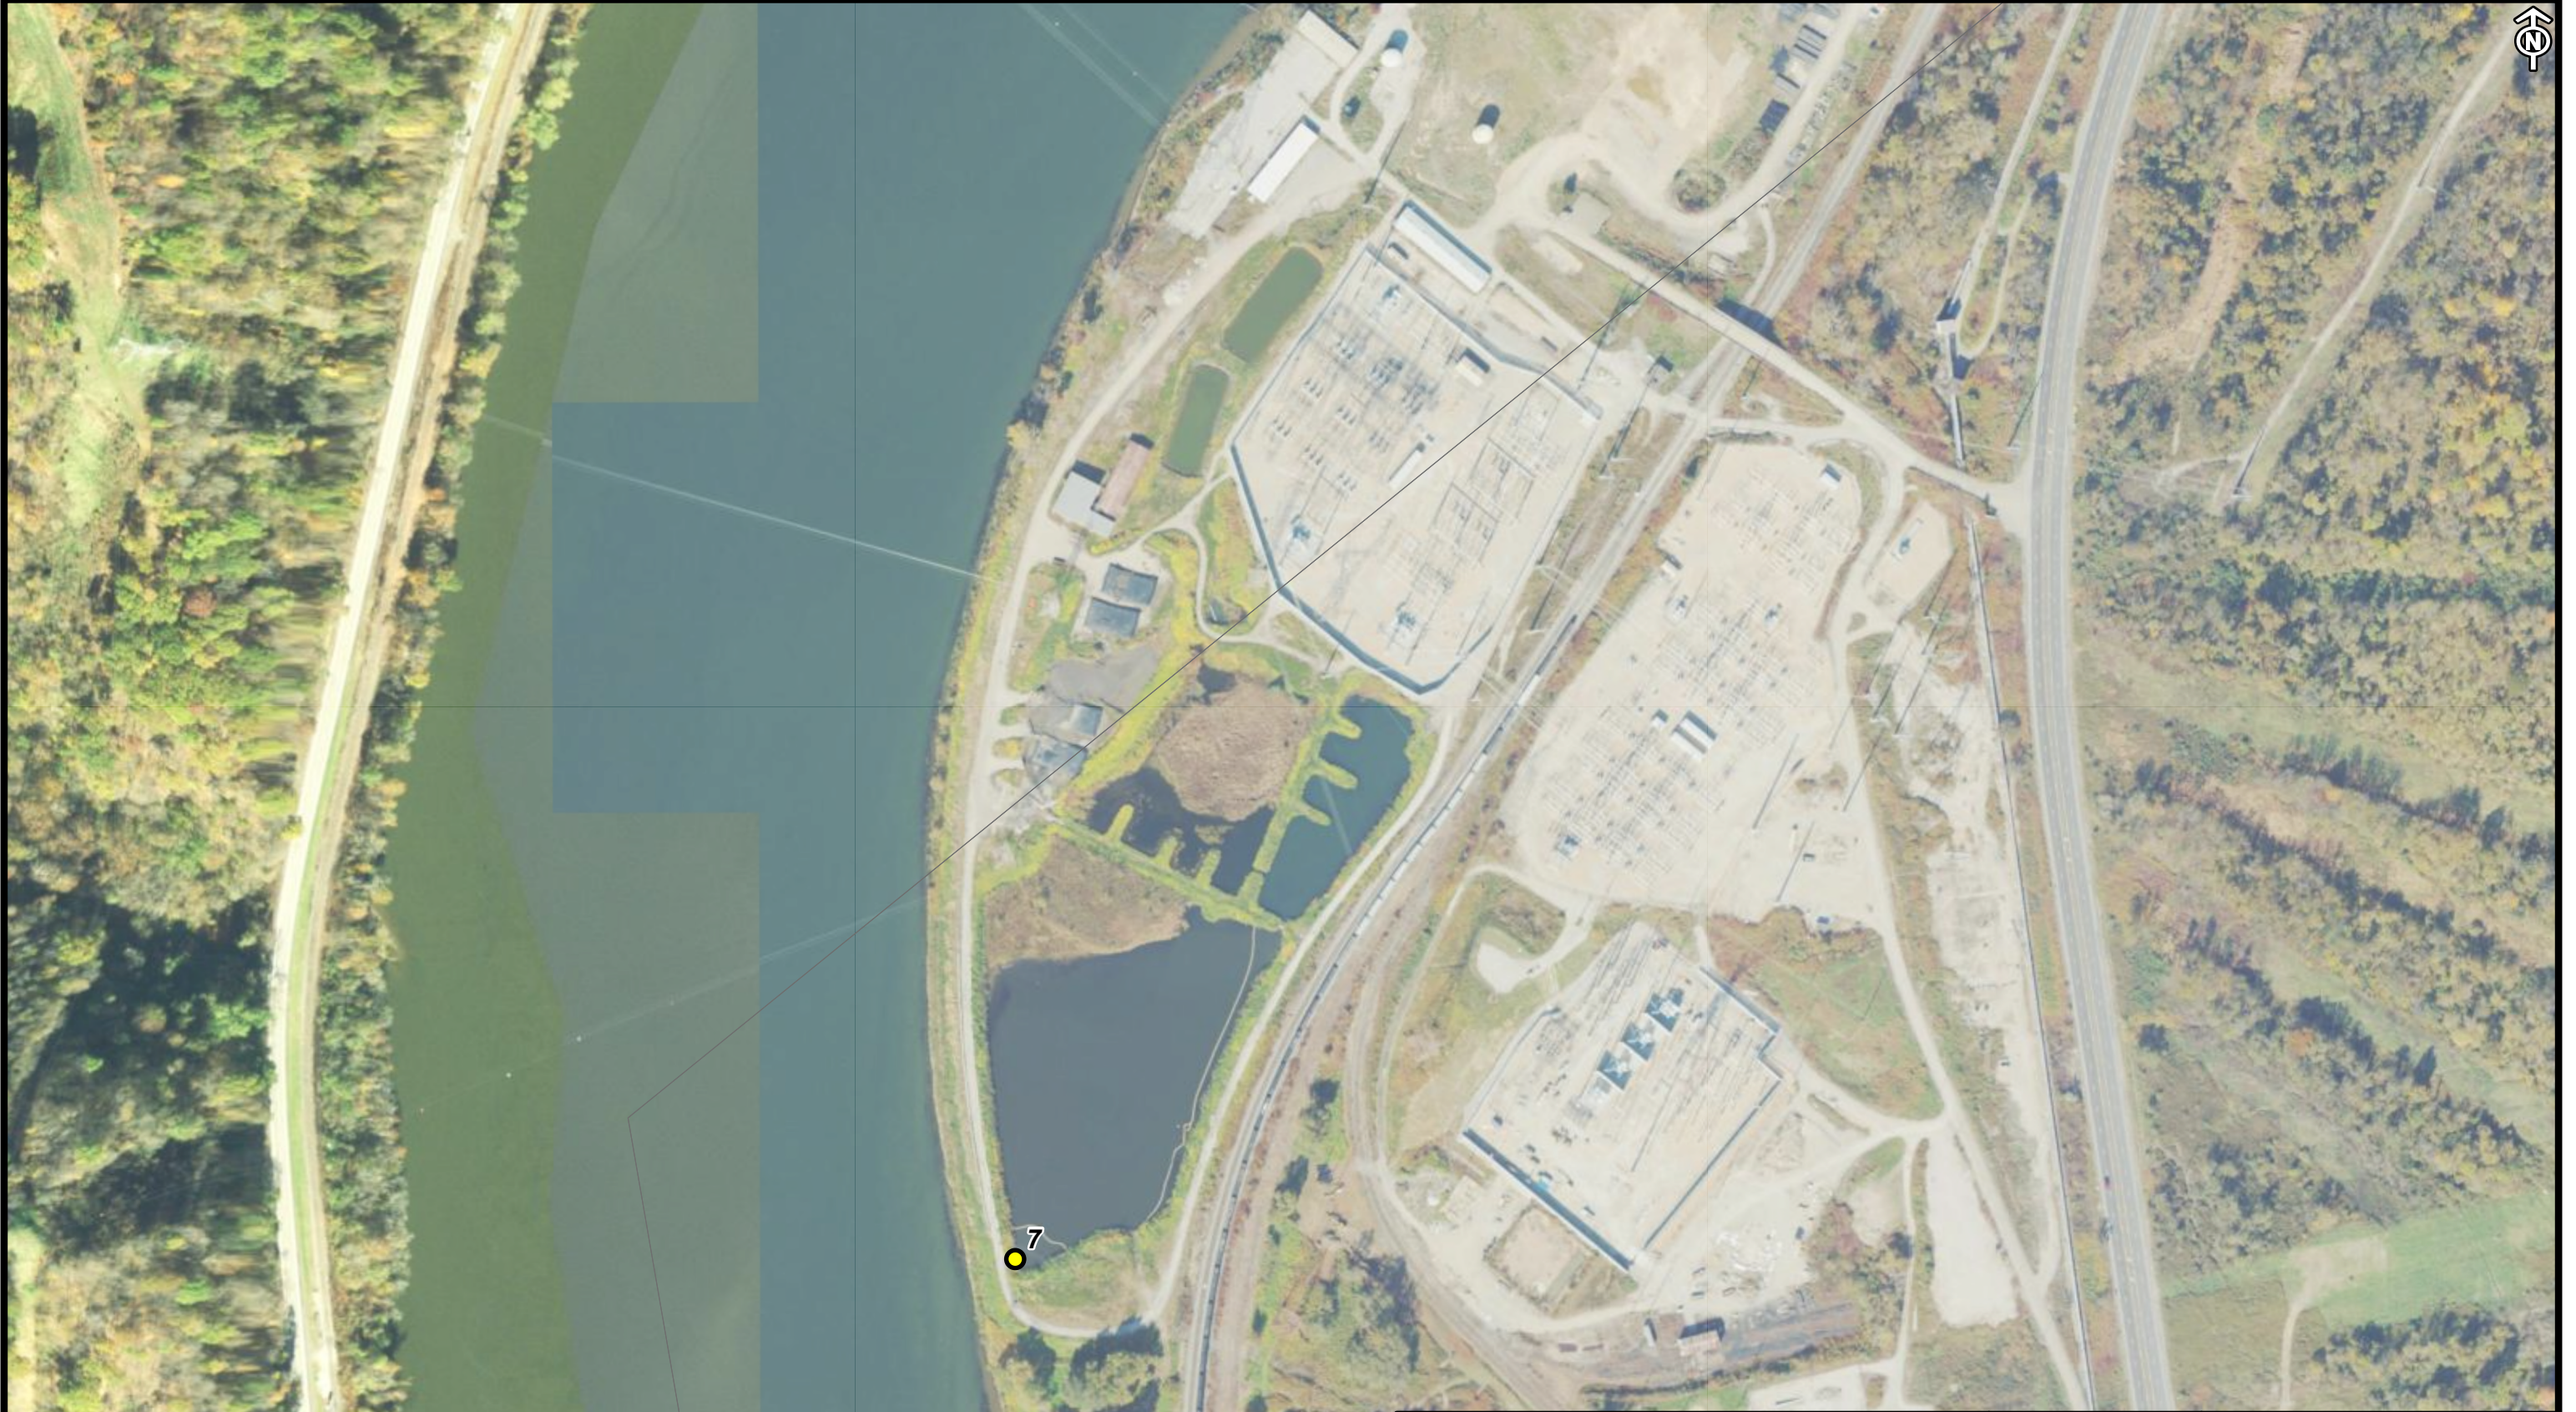
Figure 4 – Items to be Monitored

Item 7 – Monitor oil boom, replace as necessary.

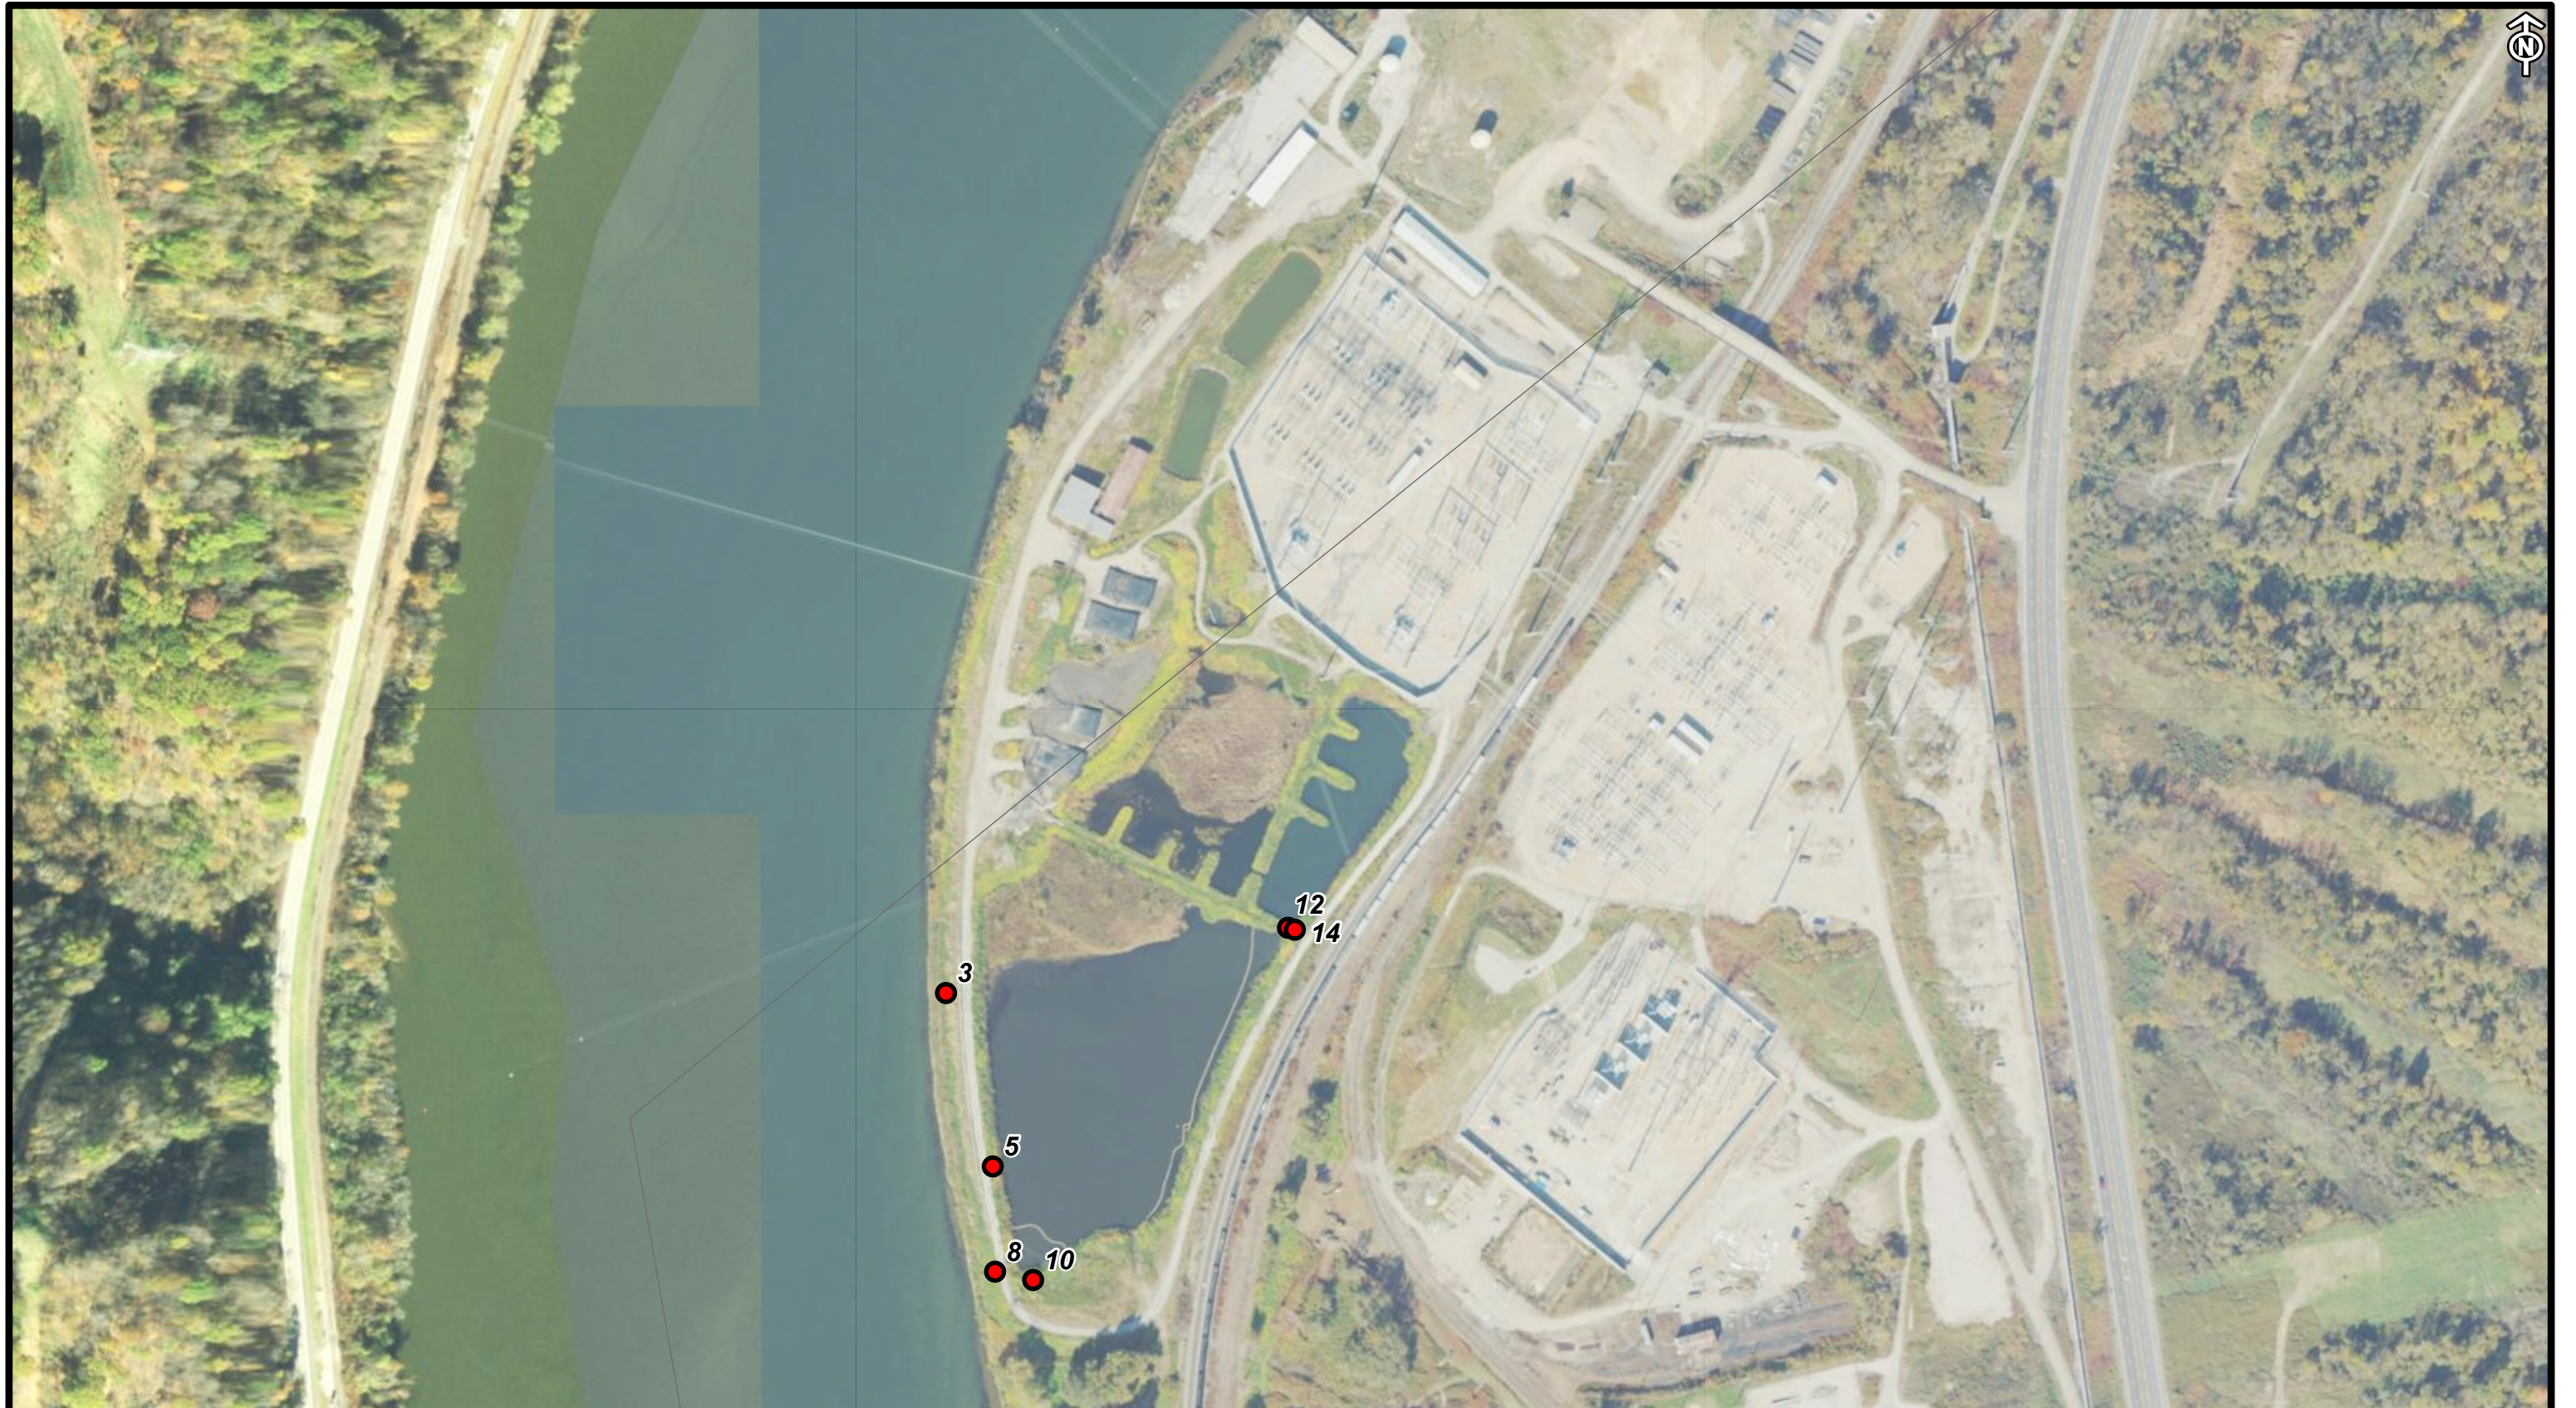
Figure 5 – Items to be Addressed

Item 3, 5, 8, and 10 – Address/maintain the vegetation to 12-inches or less on the upstream and downstream slopes.

Item 12 – Address/replace oil boom

Item 14 – Address minor blockage to allow the structure to operate as it was designed.

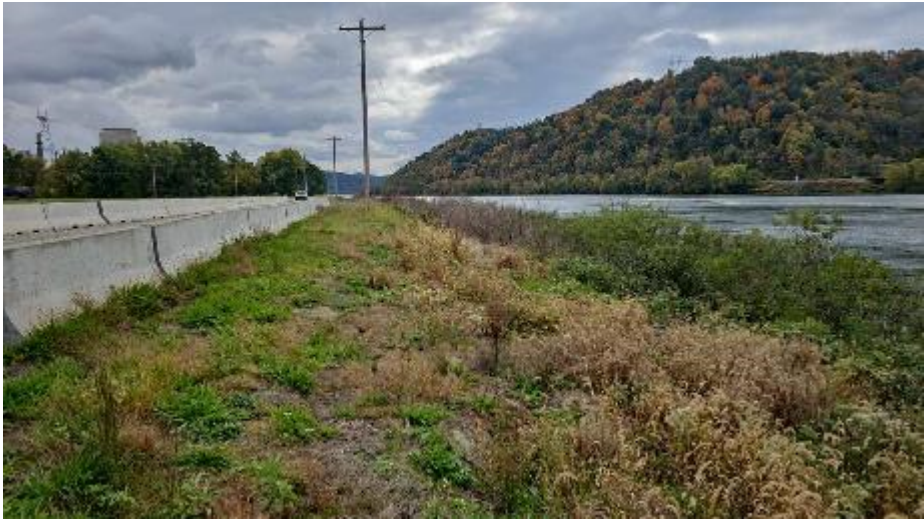
PHOTOGRAPH NO: 1	DATE: October 16, 2024 1:33 PM	LATITUDE: 39.84121588	LONGITUDE: -80.82334409
DIRECTION: 317°	SITE LOCATION: MOUNDSVILLE, WEST VIRGINIA		
DESCRIPTION: Ash Pond, Downstream Slope. General Photo, Typical Conditions.

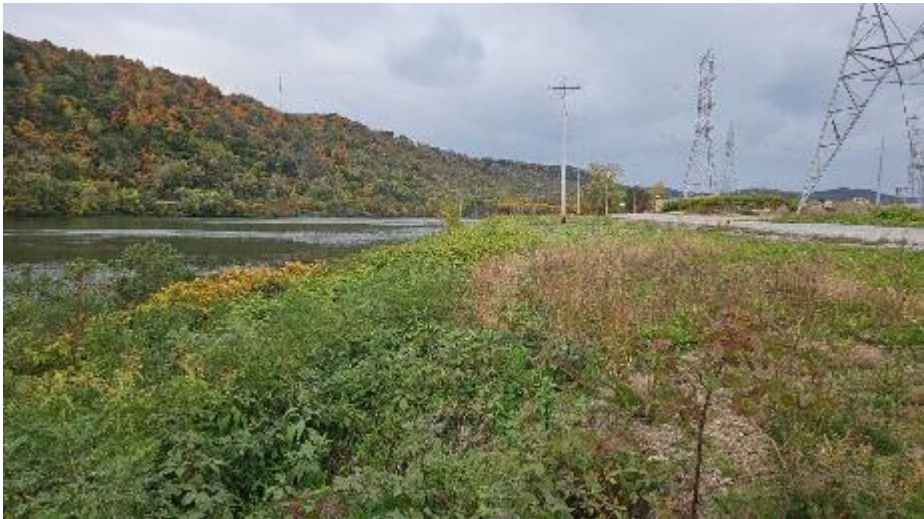
PHOTO BY: GEI CONSULTANTS, INC.			
PHOTOGRAPH NO: 2	DATE: October 16, 2024 1:39 PM	LATITUDE: 39.84060519	LONGITUDE: -80.82374669
DIRECTION: 345°	SITE LOCATION: MOUNDSVILLE, WEST VIRGINIA		
DESCRIPTION: Ash Pond, Downstream Slope. General Photo, Typical Conditions.

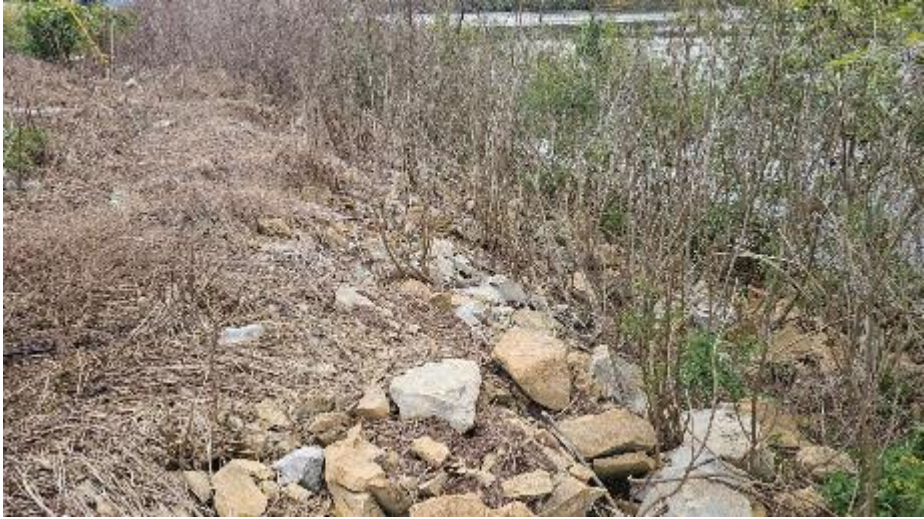
The downstream slope of the dam is in fair to good condition with no observed erosion. The slope is overgrown with vegetation that should be maintained to 12-inches or less as shown in Photograph No. 3 and 8. Ideally, the dead woody vegetation from herbicide applications should be mowed to present better conditions for visual observations.

PHOTOGRAPH NO: 3	DATE: October 16, 2024 1:41 PM	LATITUDE: 39.84030401	LONGITUDE: -80.82380052
DIRECTION: 356°	SITE LOCATION: MOUNDSVILLE, WEST VIRGINIA		
<p>DESCRIPTION:</p> <p>Ash Pond, Downstream Slope. Riprap Ground Cover, Typical Conditions.</p> <p>Address/Maintain vegetation to 12-inches or less on the downstream slope.</p>

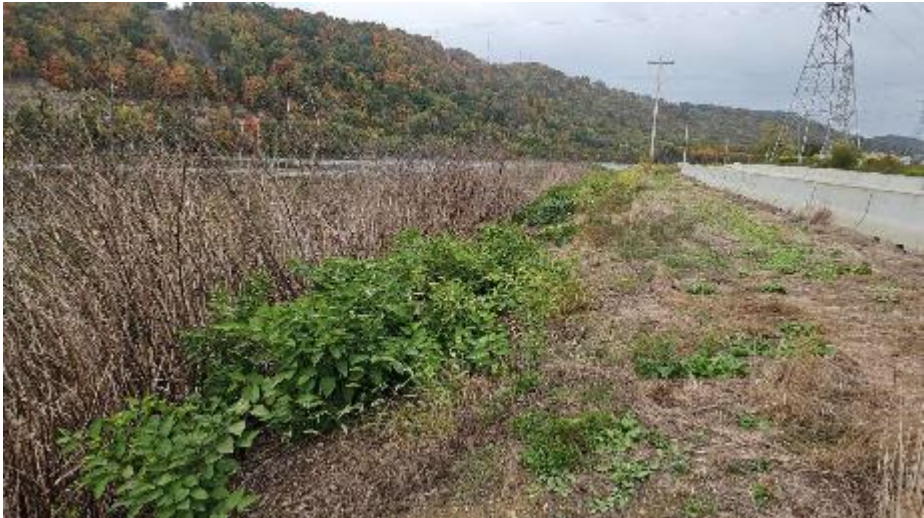
<p>PHOTO BY:</p> <p>GEI CONSULTANTS, INC.</p>			
PHOTOGRAPH NO: 4	DATE: October 16, 2024 1:43 PM	LATITUDE: 39.83964386	LONGITUDE: -80.82368444
DIRECTION: 312°	SITE LOCATION: MOUNDSVILLE, WEST VIRGINIA		
<p>DESCRIPTION:</p> <p>Ash Pond, Downstream Slope. Ground Cover, Typical Conditions.</p>

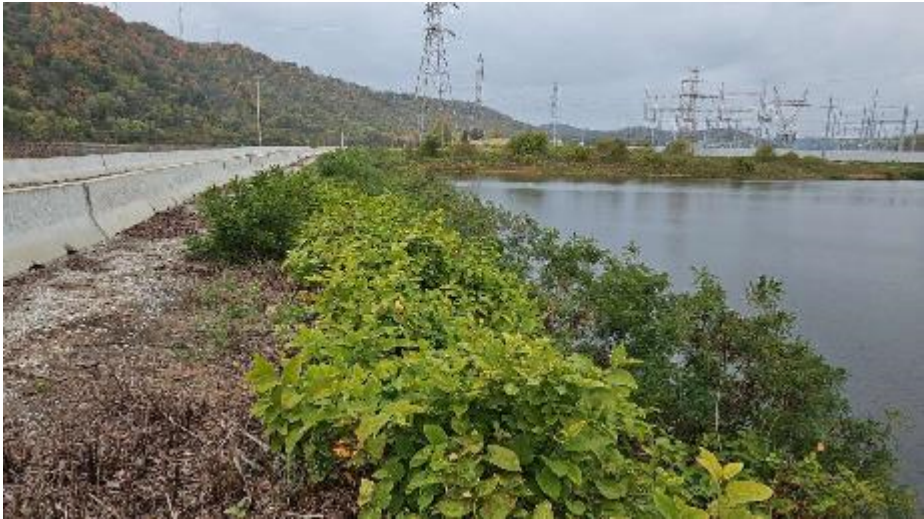
The upstream of the dam is in fair to good condition with no observed erosion. The slope is overgrown with vegetation that should be maintained to 12-inches or less as shown in Photograph No. 5 and 10. Ideally, the dead woody vegetation from herbicide applications should be mowed to present better conditions for visual observations.

PHOTOGRAPH NO: 5	DATE: October 16, 2024 1:46 PM	LATITUDE: 39.83940852	LONGITUDE: -80.82348962
DIRECTION: 322°		SITE LOCATION: MOUNDSVILLE, WEST VIRGINIA	
DESCRIPTION: Ash Pond Upstream Slope. Ground Cover, Typical Conditions. Address/Maintain vegetation to 12-inches or less on the upstream slope.

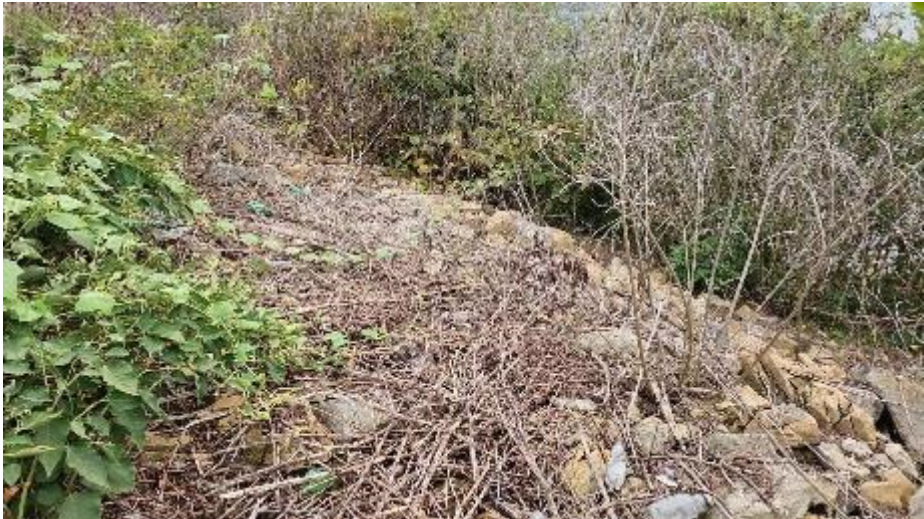
PHOTO BY: GEI CONSULTANTS, INC.			
PHOTOGRAPH NO: 6	DATE: October 16, 2024 1:47 PM	LATITUDE: 39.83918955	LONGITUDE: -80.82362169
DIRECTION: 46°		SITE LOCATION: MOUNDSVILLE, WEST VIRGINIA	
DESCRIPTION: Ash Pond, Downstream Slope. Riprap Ground Cover, Typical Conditions.

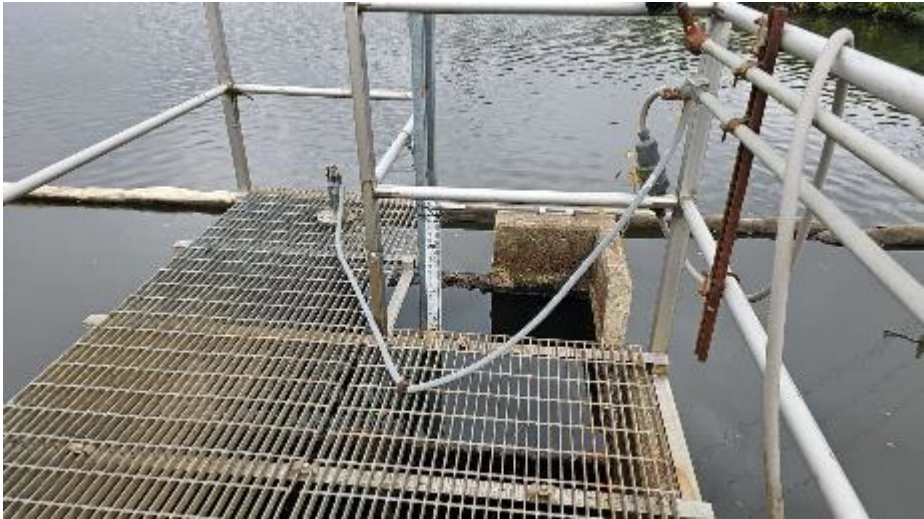
The outfall structure of the dam is in good condition with no observed blockages. We recommend AEP monitor the oil boom, shown in Photograph No. 7 and 10, for signs of failure including but not limited to critical accumulation of material, sheens on downstream side, anchor failure, and submergence. AEP should replace the oil boom as needed.

PHOTOGRAPH NO: 7	DATE: October 16, 2024 1:49 PM	LATITUDE: 39.83893356	LONGITUDE: -80.82333988
DIRECTION: 343°	SITE LOCATION: MOUNDSVILLE, WEST VIRGINIA		
DESCRIPTION: Ash Pond, Upstream Outfall Structure. General Photo, Typical Conditions. Monitor the oil boom / replace as needed.

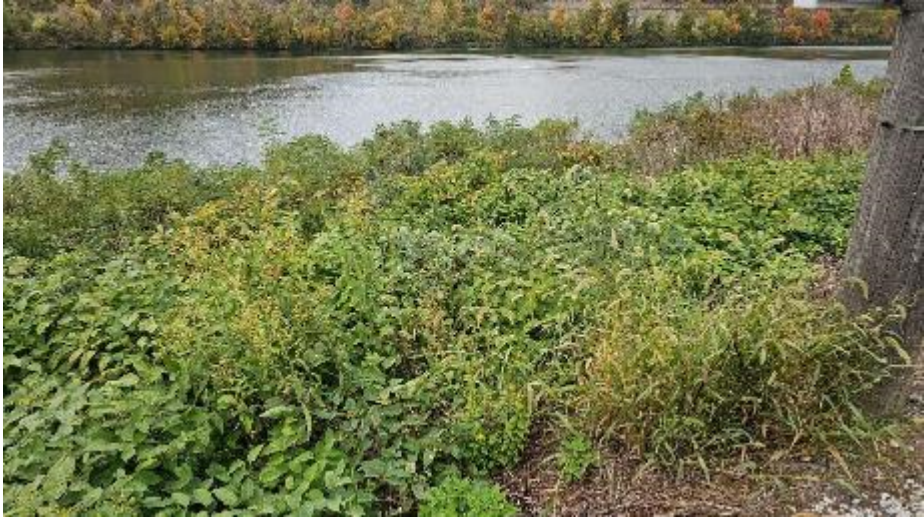
PHOTOGRAPH NO: 8	DATE: October 16, 2024 1:51 PM	LATITUDE: 39.83886517	LONGITUDE: -80.82347555
DIRECTION: 1°	SITE LOCATION: MOUNDSVILLE, WEST VIRGINIA		
DESCRIPTION: Ash Pond, Downstream Outfall Structure. Pipe not observed. Address/maintain vegetation to 12-inches or less.

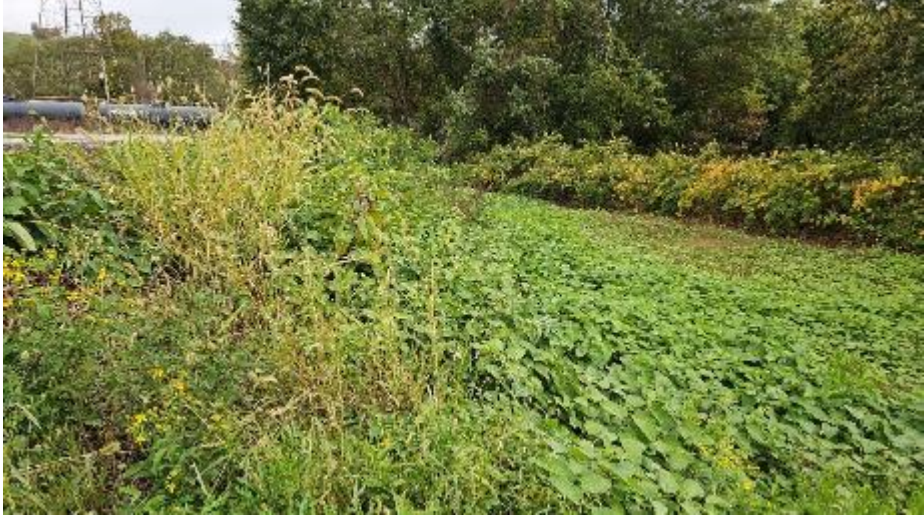
PHOTOGRAPH NO: 9	DATE: October 16, 2024 1:54 PM	LATITUDE: 39.83860274	LONGITUDE: -80.82334528
DIRECTION: 17°	SITE LOCATION: MOUNDSVILLE, WEST VIRGINIA		
DESCRIPTION: Ash Pond, Downstream Slope. General Photo, Typical Conditions.

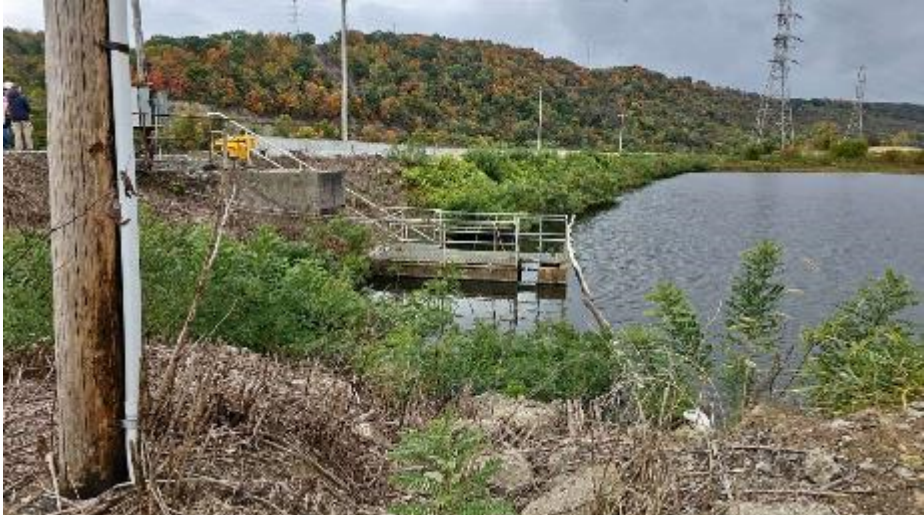
PHOTO BY: GEI CONSULTANTS, INC.			
PHOTOGRAPH NO: 10	DATE: October 16, 2024 1:55 PM	LATITUDE: 39.83882214	LONGITUDE: -80.82322094
DIRECTION: 338°	SITE LOCATION: MOUNDSVILLE, WEST VIRGINIA		
DESCRIPTION: Ash Pond, Upstream Outfall Structure. General Photo, Typical Conditions. Address/Maintain vegetation to 12-inches or less on the upstream slope.

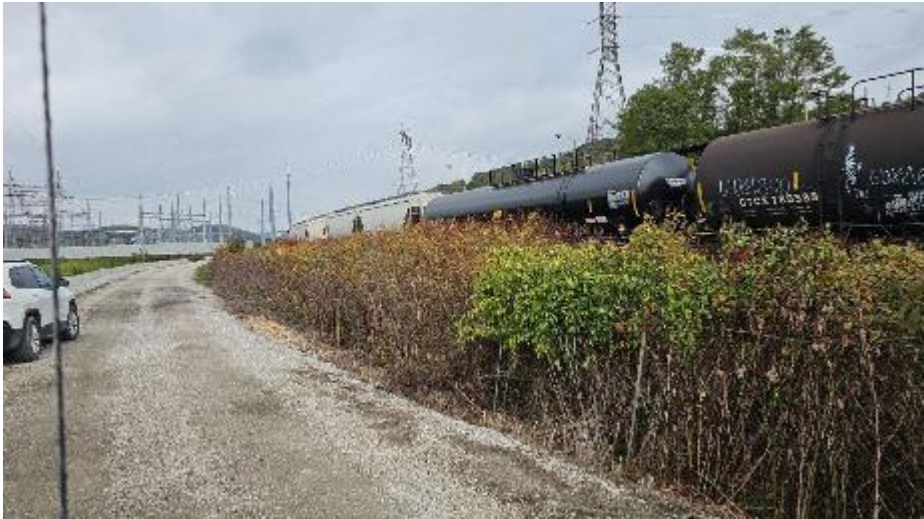
PHOTOGRAPH No: 11	DATE: October 16, 2024 2:00 PM	LATITUDE: 39.83911744	LONGITUDE: -80.82220055
DIRECTION: 337°	SITE LOCATION: MOUNDSVILLE, WEST VIRGINIA		
DESCRIPTION: Ash Pond, Downstream Slope. Ground Cover, Typical Conditions.

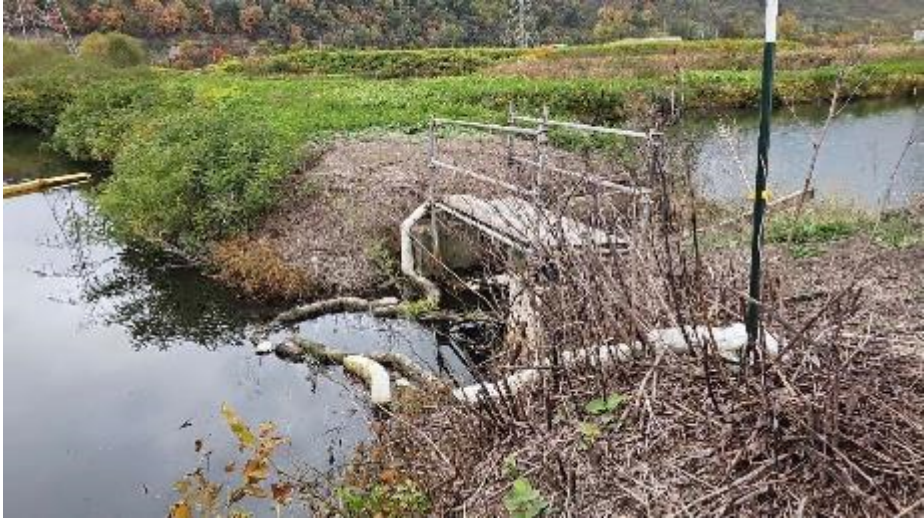
The interior control structure is in fair condition. A minor blockage/debris was observed in the structure and should be addressed/removed to allow the structure to operate as it was designed. See Photograph No. 12 and 14.

PHOTO BY: GEI CONSULTANTS, INC.			
PHOTOGRAPH No: 12	DATE: October 16, 2024 2:03 PM	LATITUDE: 39.8406373	LONGITUDE: -80.82150994
DIRECTION: 76°	SITE LOCATION: MOUNDSVILLE, WEST VIRGINIA		
DESCRIPTION: Ash Pond, Interior Control Structure. General Photo, Typical Conditions. Address/replace oil boom.

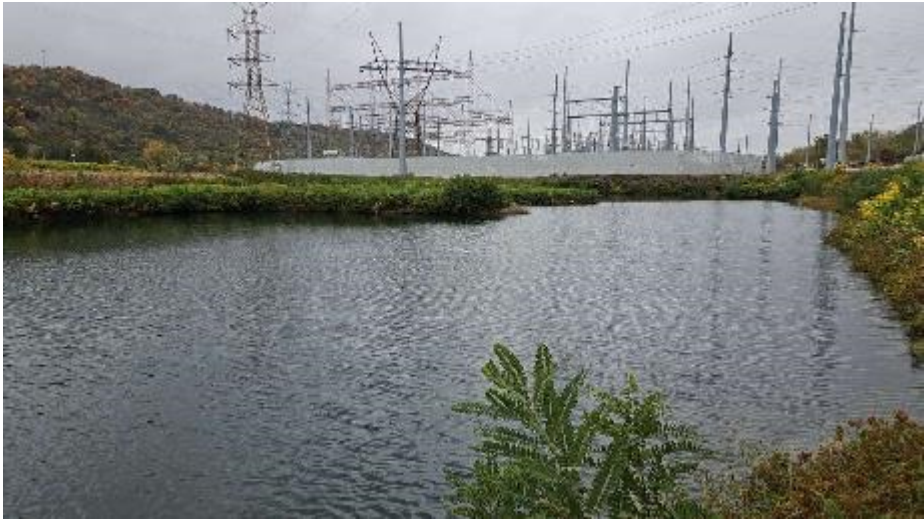
PHOTOGRAPH No: 13	DATE: October 16, 2024 2:04 PM	LATITUDE: 39.84076959	LONGITUDE: -80.82134308
DIRECTION: 303°		SITE LOCATION: MOUNDSVILLE, WEST VIRGINIA	
DESCRIPTION: Ash Pond Upstream Slope. General Photo, Typical Conditions.

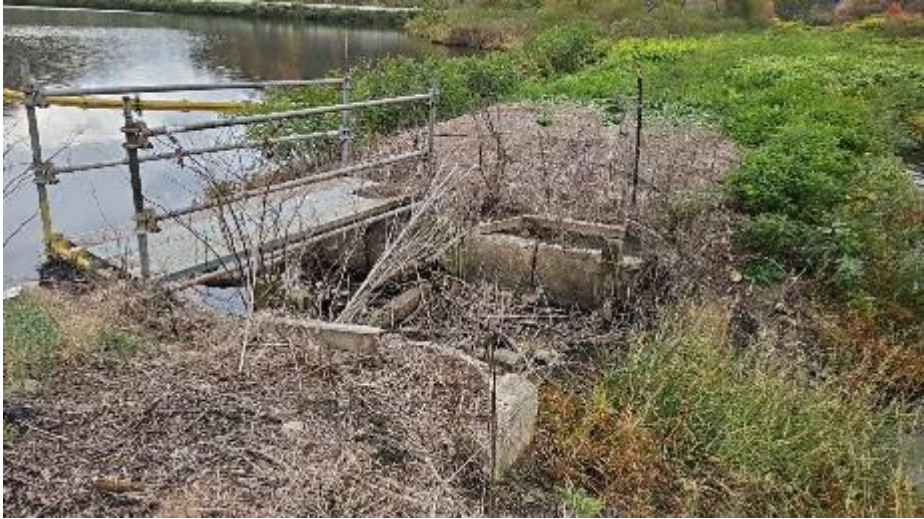
PHOTO BY: GEI CONSULTANTS, INC.			
PHOTOGRAPH No: 14	DATE: October 16, 2024 2:05 PM	LATITUDE: 39.84062751	LONGITUDE: -80.82146418
DIRECTION: 116°		SITE LOCATION: MOUNDSVILLE, WEST VIRGINIA	
DESCRIPTION: Ash Pond, Interior Control Structure. Address minor blockage to allow the structure to operate as it was designed.

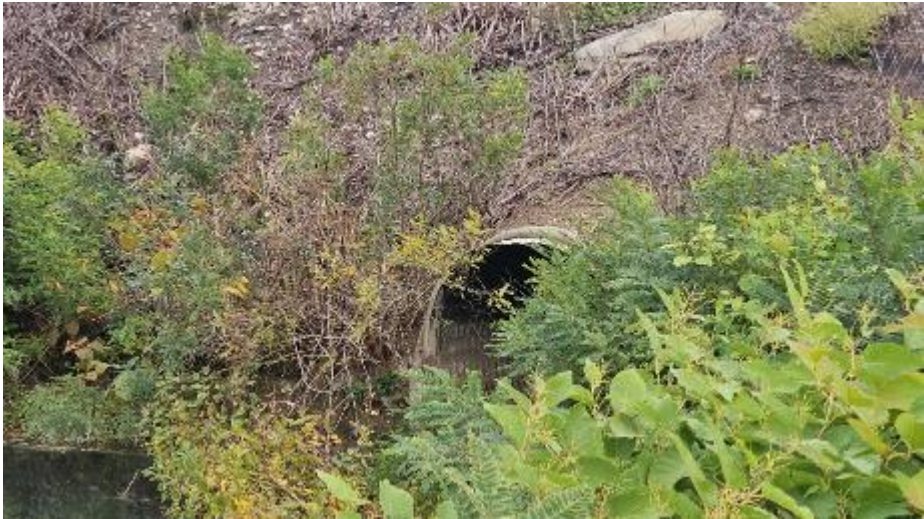
The stormwater inlet appears to be in satisfactory condition, with no debris or blockages covering the inlet as shown on Photograph No. 15.

PHOTOGRAPH No: 15	DATE: October 16, 2024 2:10 PM	LATITUDE: 39.84154779	LONGITUDE: -80.82070543
DIRECTION: 319°	SITE LOCATION: MOUNDSVILLE, WEST VIRGINIA		
DESCRIPTION: Ash Pond Stormwater Inlet Structure. General Photo, Typical Conditions.

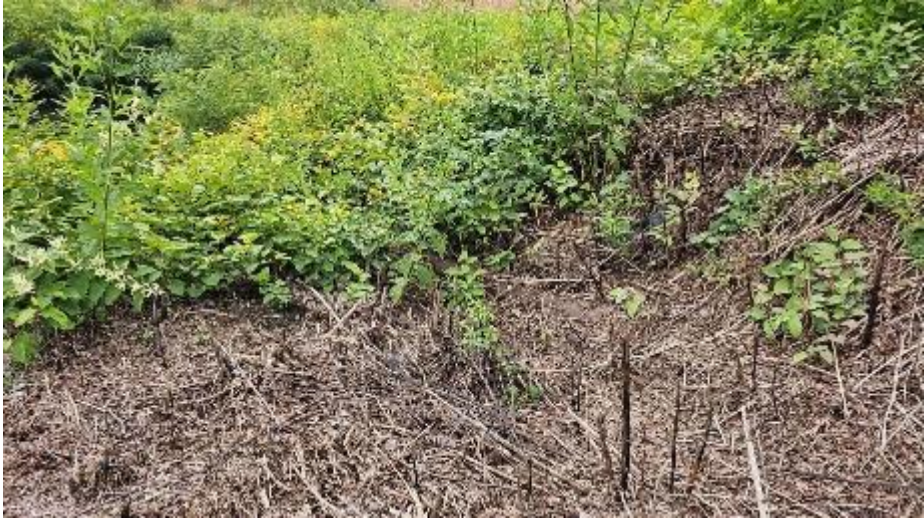
PHOTO BY: GEI CONSULTANTS, INC.			
PHOTOGRAPH No: 16	DATE: October 16, 2024 2:13 PM	LATITUDE: 39.84188966	LONGITUDE: -80.82103507
DIRECTION: 333°	SITE LOCATION: MOUNDSVILLE, WEST VIRGINIA		
DESCRIPTION: Ash Pond, Ash Sluice Pipe Inlet. General Photo, Typical Conditions.
