East Fly Ash Pond Initial Dam and Dike Inspection Report

Kanawha River Power Plant, Hansford, West Virginia

January 2025
Project 2407654

2024 Annual Inspection Report

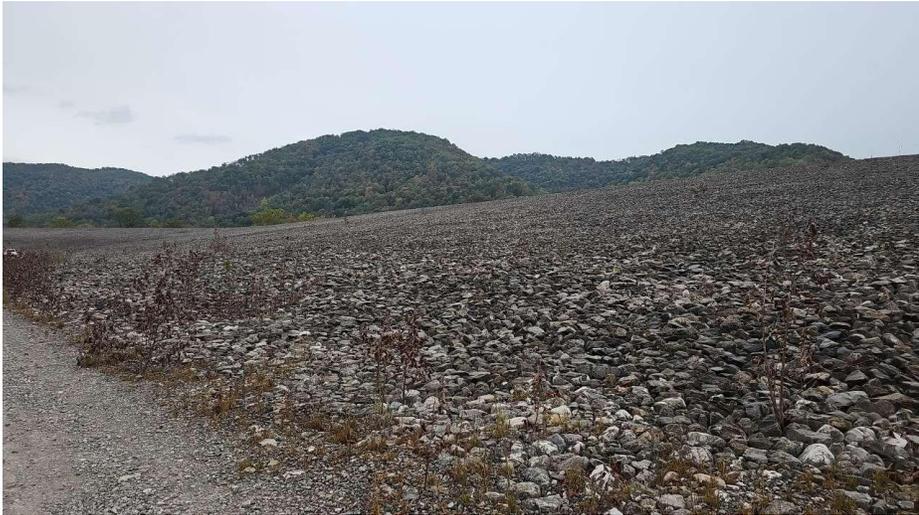
The rip rap cover/slopes of the East Fly Ash Pond are in good condition. The vegetation on the cover was maintained to 12-inches or less and no erosion was observed as shown in Photograph No. 1-4, 8, 9, and 28.

PHOTOGRAPH NO: 1	DATE: October 15, 2024 8:23 AM	LATITUDE: 38.2052376	LONGITUDE: -81.41540835
DIRECTION: 27°	SITE LOCATION: HANSFORD, WEST VIRGINIA		
DESCRIPTION: Toe. Riprap Coverage, General Photo, Typical Conditions.

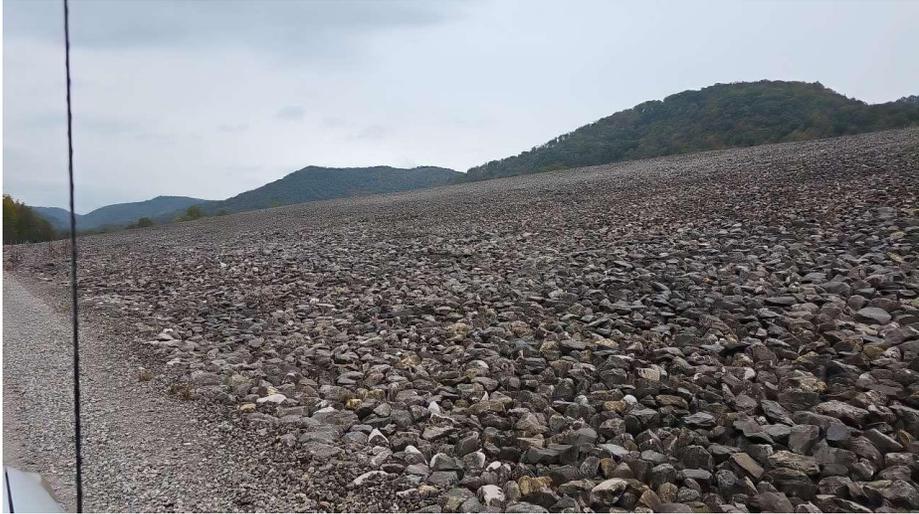
PHOTO BY: GEI CONSULTANTS, INC.			
PHOTOGRAPH NO: 2	DATE: October 15, 2024 8:24 AM	LATITUDE: 38.20503185	LONGITUDE: -81.414017
DIRECTION: 112°	SITE LOCATION: HANSFORD, WEST VIRGINIA		
DESCRIPTION: Toe. Riprap Coverage, General Photo, Typical Conditions.

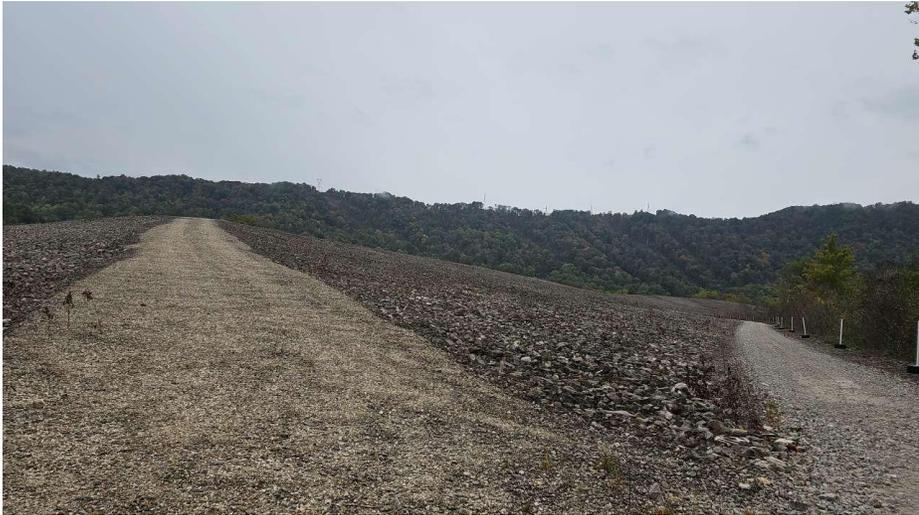
PHOTOGRAPH NO: 3	DATE: October 15, 2024 8:25 AM	LATITUDE: 38.20511924	LONGITUDE: -81.4125599
DIRECTION: 156°	SITE LOCATION: HANSFORD, WEST VIRGINIA		
DESCRIPTION: Toe. Riprap Coverage, General Photo, Typical Conditions.

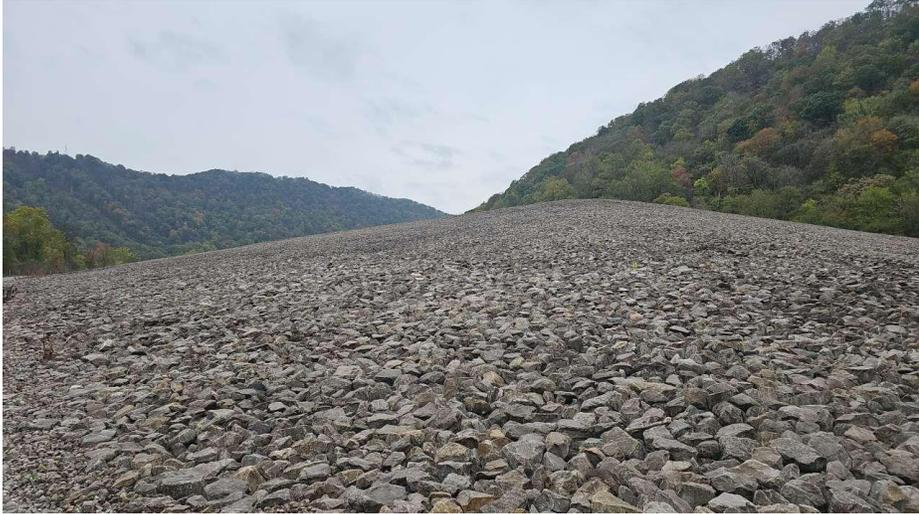
PHOTO BY: GEI CONSULTANTS, INC.			
PHOTOGRAPH NO: 4	DATE: October 15, 2024 8:27 AM	LATITUDE: 38.20529889	LONGITUDE: -81.4096075
DIRECTION: 176°	SITE LOCATION: HANSFORD, WEST VIRGINIA		
DESCRIPTION: Toe. Riprap Coverage, General Photo, Typical Conditions.

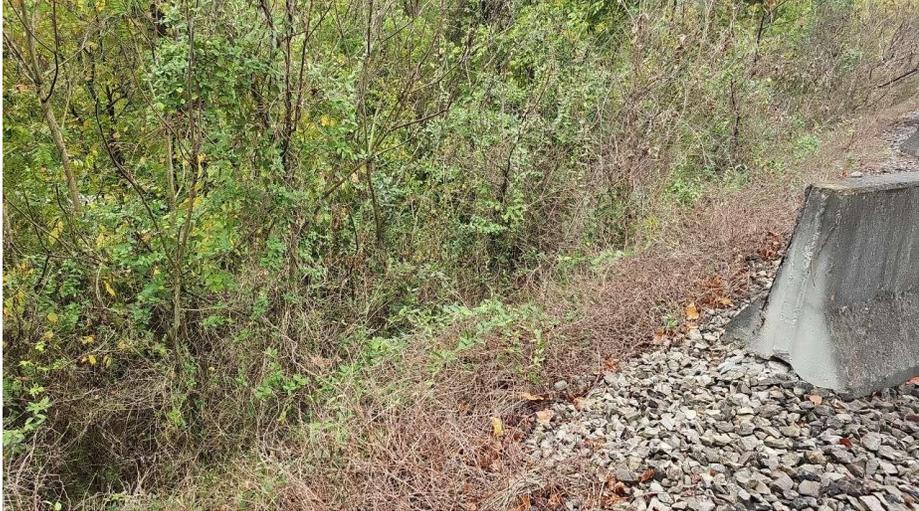
The downstream slope of the dam is in fair to poor condition as its overgrown with woody vegetation that should be addressed/maintained to 12-inches or less as shown in Photograph Nos. 5, 6, 7, 10, 13-27, 30, and 31. Isolated areas of the downstream slope showed signs of significant erosion. These areas should be addressed as shown in Photograph No. 16-21, 30, and 31. AEP may want to consider alternative drainage patterns to distribute stormwater off of the riprap cover to multiple downchute locations.

PHOTOGRAPH NO: 5	DATE: October 15, 2024 8:33 AM	LATITUDE: 38.20451903	LONGITUDE: -81.409609
DIRECTION: 55°	SITE LOCATION: HANSFORD, WEST VIRGINIA		
DESCRIPTION: Downstream Slope. General Photo, Typical Conditions.

- Address/maintain vegetation to 12-inches or less on the downstream slopes. Applies to Item 5, 6, 7, 13-27, 30 and 31.
- Address significant/major erosion. Applies to Item 16-21, 30 and 31.

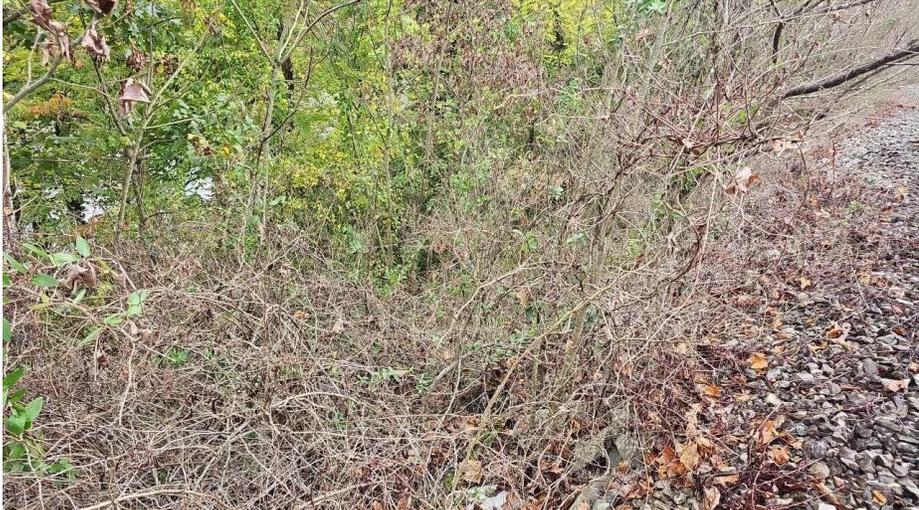
PHOTO BY: GEI CONSULTANTS, INC.			
PHOTOGRAPH NO: 6	DATE: October 15, 2024 8:35 AM	LATITUDE: 38.20444611	LONGITUDE: -81.4097488
DIRECTION: 54°	SITE LOCATION: HANSFORD, WEST VIRGINIA		
DESCRIPTION: Downstream Slope. Ground Cover, Typical Conditions.

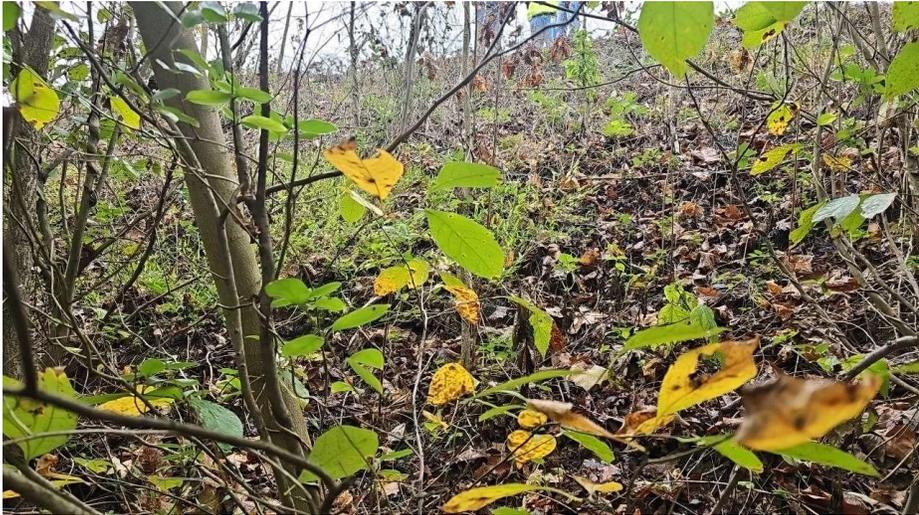
PHOTOGRAPH NO: 7	DATE: October 15, 2024 8:39 AM	LATITUDE: 38.20440965	LONGITUDE: -81.40979113
DIRECTION: 353°	SITE LOCATION: HANSFORD, WEST VIRGINIA		
DESCRIPTION: Downstream Slope. General Photo, Typical Conditions.

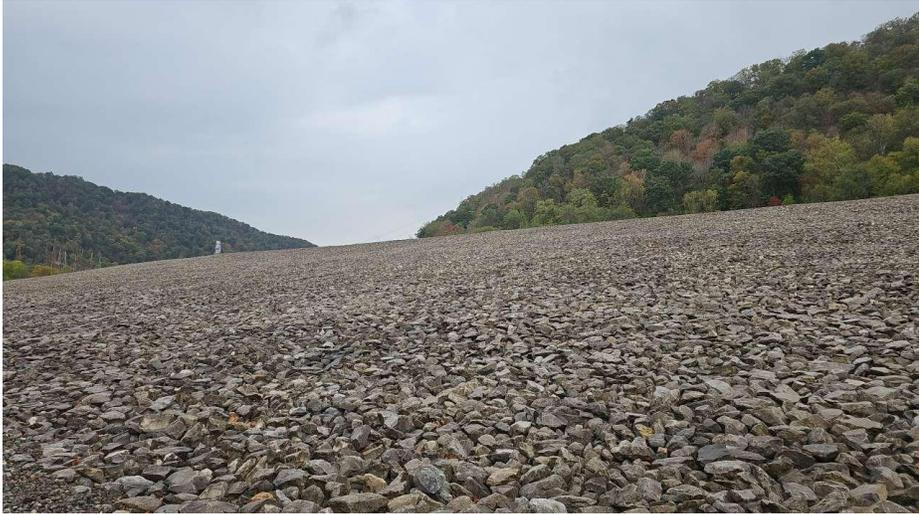
PHOTO BY: GEI CONSULTANTS, INC.			
PHOTOGRAPH NO: 8	DATE: October 15, 2024 8:45 AM	LATITUDE: 38.20419036	LONGITUDE: -81.41131974
DIRECTION: 10°	SITE LOCATION: HANSFORD, WEST VIRGINIA		
DESCRIPTION: Toe. Ground Cover Riprap, Typical Conditions.

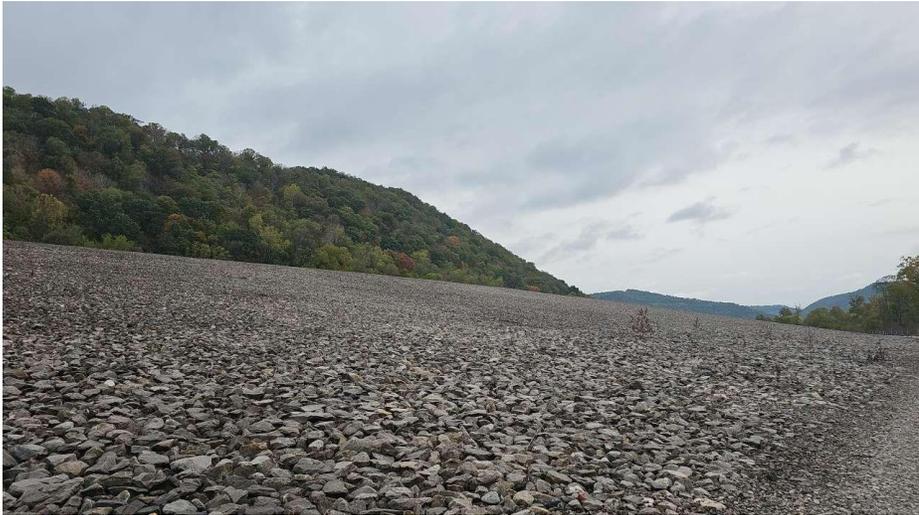
The crest of the dam is in good condition and is used as an access road as shown in Photograph No. 9 and 28.

PHOTOGRAPH NO: 9	DATE: October 15, 2024 8:46 AM	LATITUDE: 38.2039017	LONGITUDE: -81.41363549
DIRECTION: 359°	SITE LOCATION: HANSFORD, WEST VIRGINIA		
DESCRIPTION: Toe. Ground Cover Riprap, Typical Conditions.

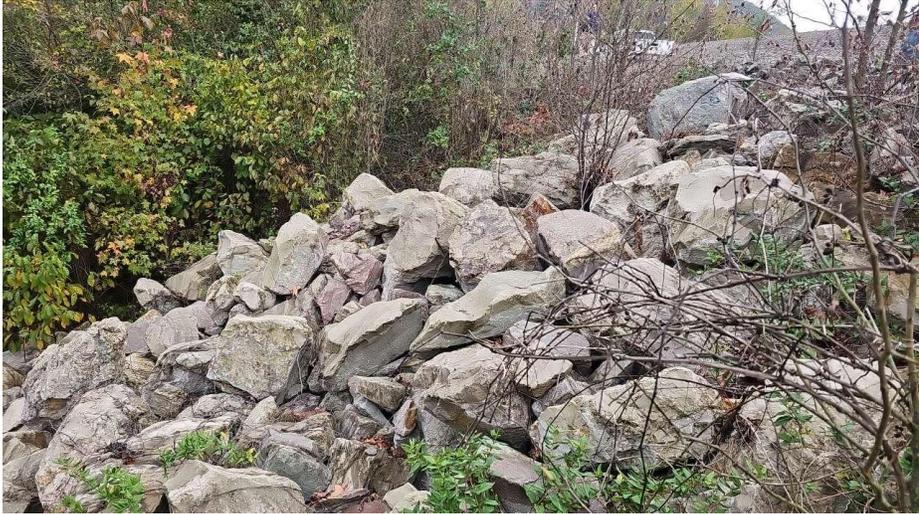
PHOTO BY: GEI CONSULTANTS, INC.			
PHOTOGRAPH NO: 10	DATE: October 15, 2024 8:49 AM	LATITUDE: 38.20377294	LONGITUDE: -81.41537027
DIRECTION: 318°	SITE LOCATION: HANSFORD, WEST VIRGINIA		
DESCRIPTION: Downstream Slope. Ground Cover, Monitor Conditions. Previously repaired erosion.

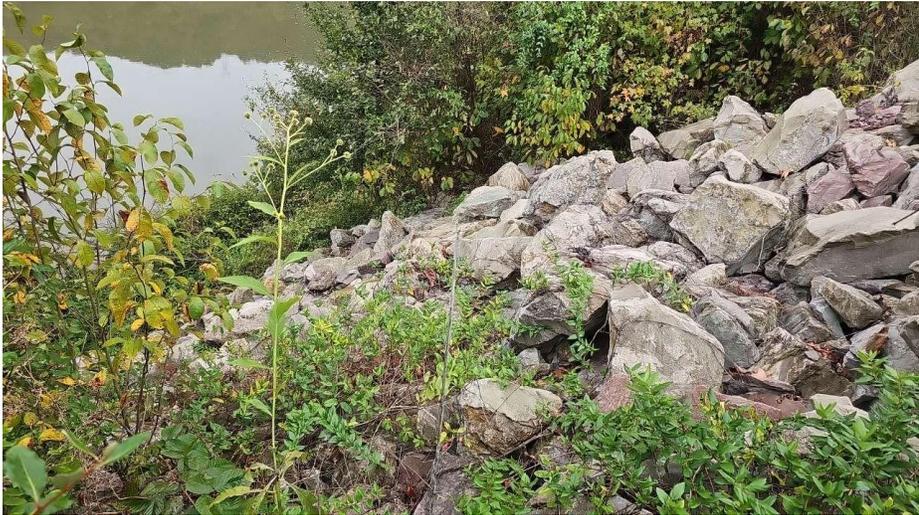
Photograph No. 11 and 12 show an area where significant erosion was previously repaired. This area should continue to be monitored, and erosion should be addressed before it becomes significant.

PHOTOGRAPH No: 11	DATE: October 15, 2024 8:50 AM	LATITUDE: 38.20374402	LONGITUDE: -81.41533356
DIRECTION: 104°	SITE LOCATION: HANSFORD, WEST VIRGINIA		
DESCRIPTION: Downstream Slope. Other, Monitor Conditions. Previously repaired erosion area.

- Item 11 – Monitor conditions of previously repair erosion area.
- Item 12 – Monitor conditions of previously repair erosion area.

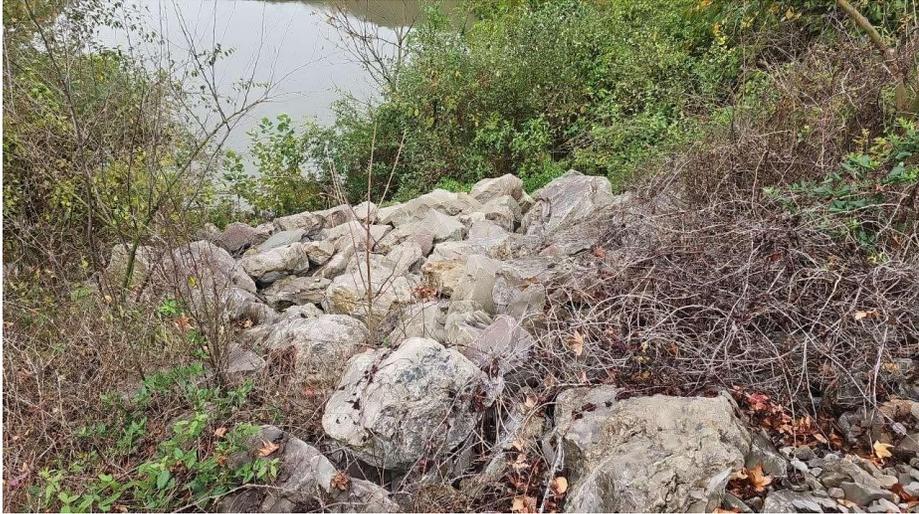
PHOTO BY: GEI CONSULTANTS, INC.			
PHOTOGRAPH No: 12	DATE: October 15, 2024 8:51 AM	LATITUDE: 38.20376201	LONGITUDE: -81.4155972
DIRECTION: 81°	SITE LOCATION: HANSFORD, WEST VIRGINIA		
DESCRIPTION: Downstream Slope. Ground Cover, Monitor Conditions. Previously repaired erosion area.

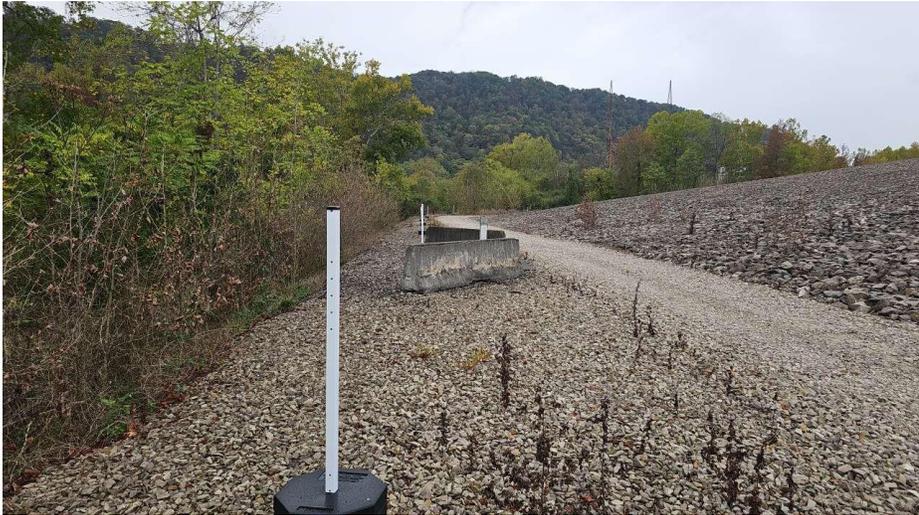
PHOTOGRAPH No: 13	DATE: October 15, 2024 8:54 AM	LATITUDE: 38.20378878	LONGITUDE: -81.41570883
DIRECTION: 286°	SITE LOCATION: HANSFORD, WEST VIRGINIA		
DESCRIPTION: Downstream Slope. General Photo, Typical Conditions.

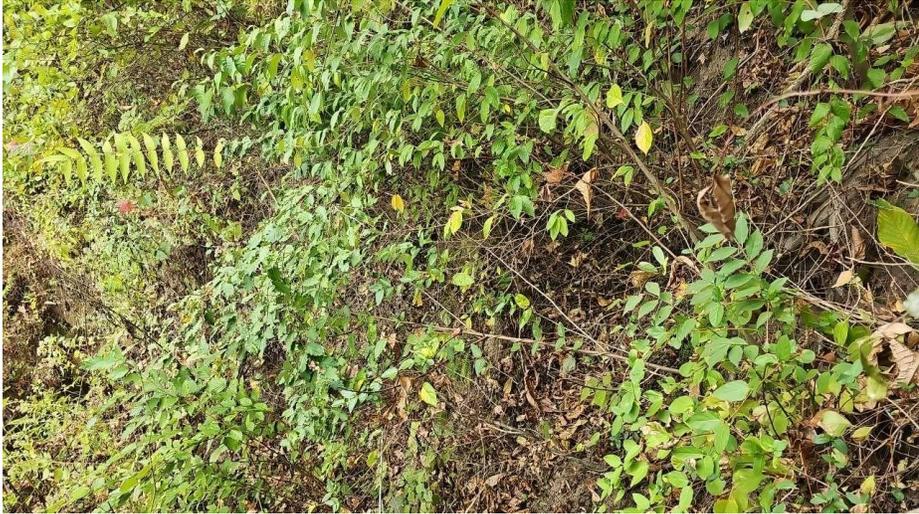
Areas of significant erosion/scarp conditions were found on the downstream slope. These areas are shown in Photograph No. 14, 15, 18, 23, 24, 25, 26, and 27 and should be addressed before conditions deteriorate.

PHOTO BY: GEI CONSULTANTS, INC.			
PHOTOGRAPH No: 14	DATE: October 15, 2024 8:59 AM	LATITUDE: 38.20367094	LONGITUDE: -81.41597274
DIRECTION: 293°	SITE LOCATION: HANSFORD, WEST VIRGINIA		
DESCRIPTION: Downstream Slope. Slide, Slough, Scarp, Monitor Conditions. Photo is hard to get - area of a significant erosion channel - somewhat healed but needs monitoring.

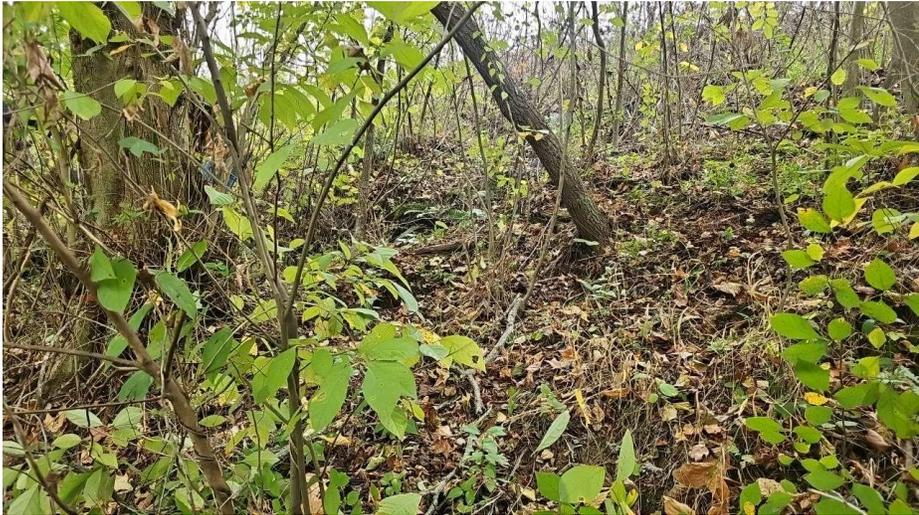
PHOTOGRAPH No: 15	DATE: October 15, 2024 9:00 AM	LATITUDE: 38.20364359	LONGITUDE: -81.4159944
DIRECTION: 294°	SITE LOCATION: HANSFORD, WEST VIRGINIA		
DESCRIPTION: Downstream Slope. Slide, Slough, Scarp, Monitor Erosion issues.

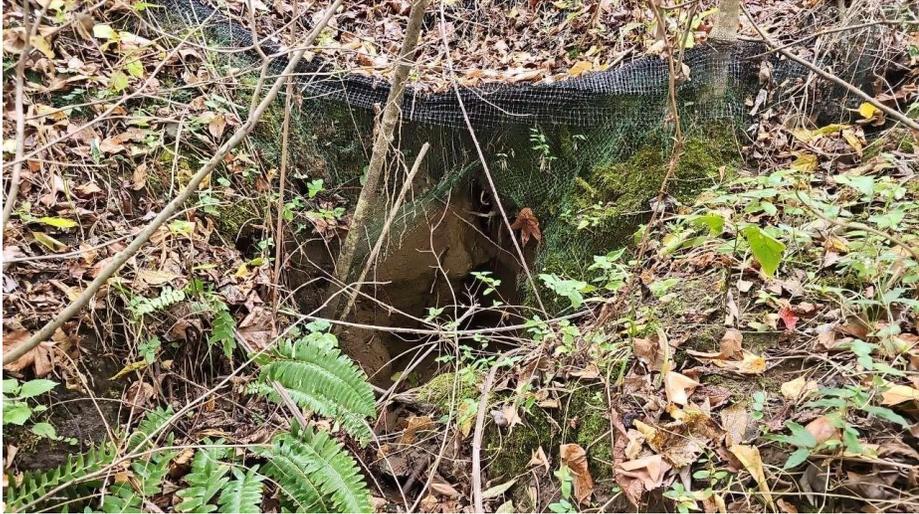
PHOTO BY: GEI CONSULTANTS, INC.			
PHOTOGRAPH No: 16	DATE: October 15, 2024 9:02 AM	LATITUDE: 38.20371381	LONGITUDE: -81.41603427
DIRECTION: 303°	SITE LOCATION: HANSFORD, WEST VIRGINIA		
DESCRIPTION: Downstream Slope. Major Erosion, Please Repair.

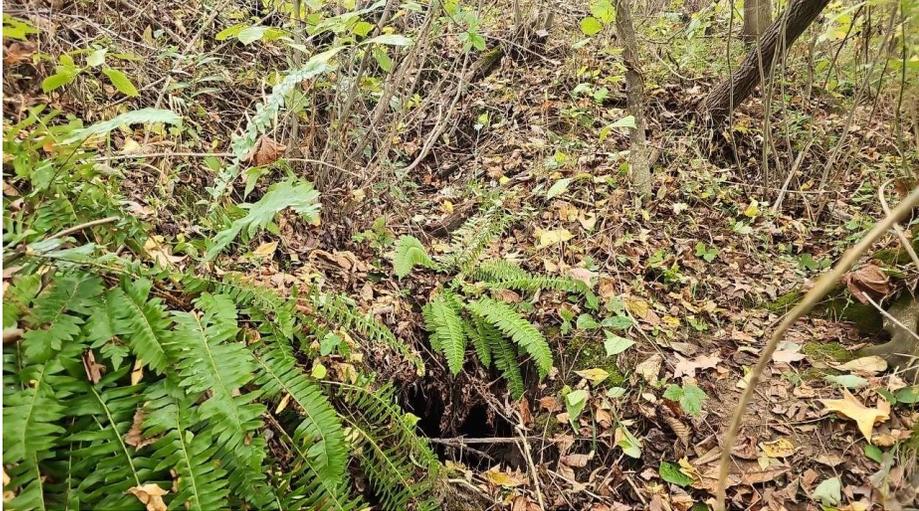
PHOTOGRAPH No: 17	DATE: October 15, 2024 9:03 AM	LATITUDE: 38.20370112	LONGITUDE: -81.41603644
DIRECTION: 314°	SITE LOCATION: HANSFORD, WEST VIRGINIA		
DESCRIPTION: Downstream Slope. Major Erosion, Please Repair.

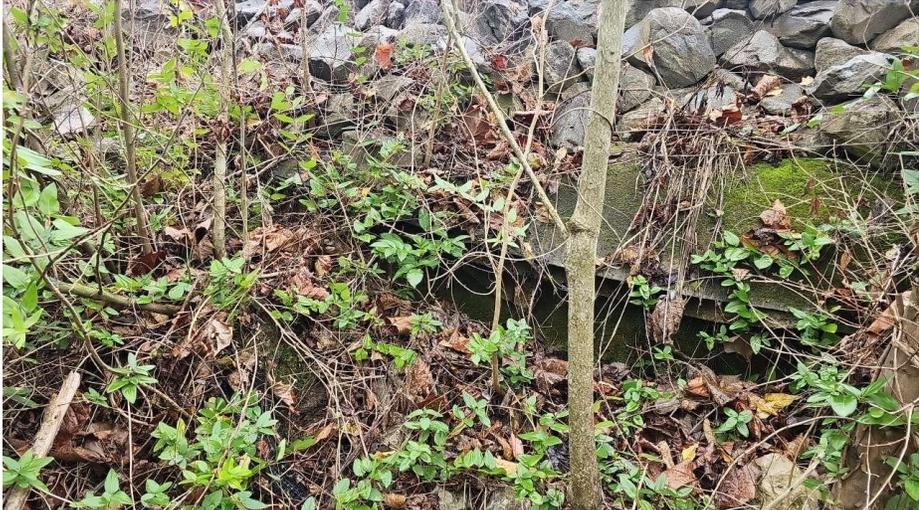
PHOTO BY: GEI CONSULTANTS, INC.			
PHOTOGRAPH No: 18	DATE: October 15, 2024 9:04 AM	LATITUDE: 38.20372133	LONGITUDE: -81.4160744
DIRECTION: 301°	SITE LOCATION: HANSFORD, WEST VIRGINIA		
DESCRIPTION: Downstream Slope. Sink Hole and Erosion, Please Repair.

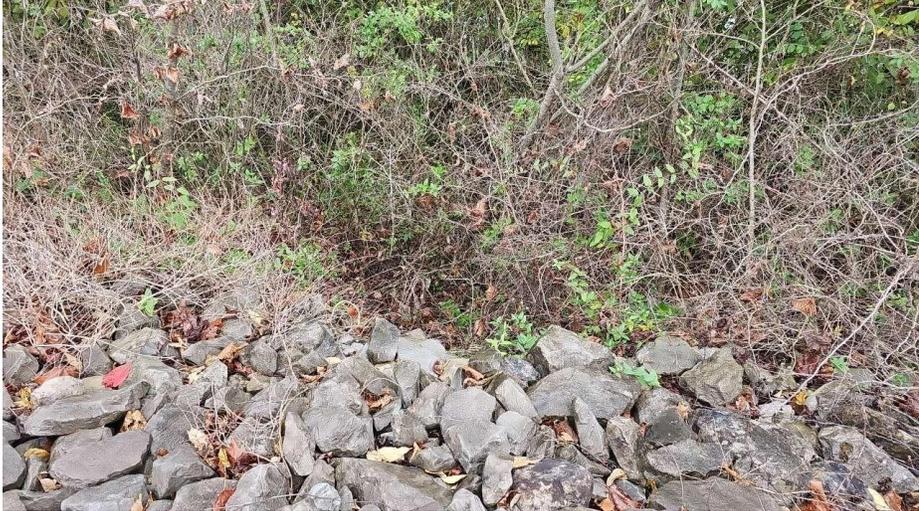
PHOTOGRAPH No: 19	DATE: October 15, 2024 9:05 AM	LATITUDE: 38.20376727	LONGITUDE: -81.41616675
DIRECTION: 96°	SITE LOCATION: HANSFORD, WEST VIRGINIA		
DESCRIPTION: Downstream Slope. Major Erosion, Please Repair.

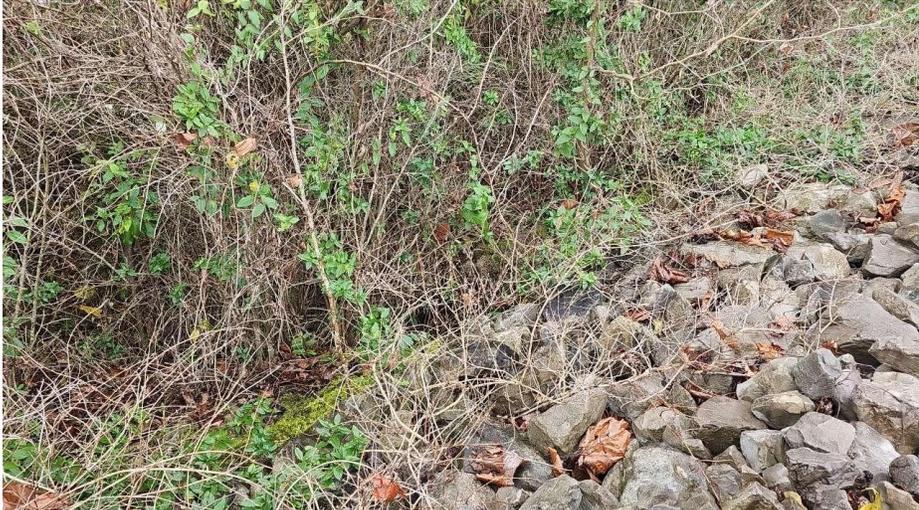
PHOTO BY: GEI CONSULTANTS, INC.			
PHOTOGRAPH No: 20	DATE: October 15, 2024 9:06 AM	LATITUDE: 38.20374408	LONGITUDE: -81.41634537
DIRECTION: 111°	SITE LOCATION: HANSFORD, WEST VIRGINIA		
DESCRIPTION: Downstream Slope. Major Erosion, Please Repair.

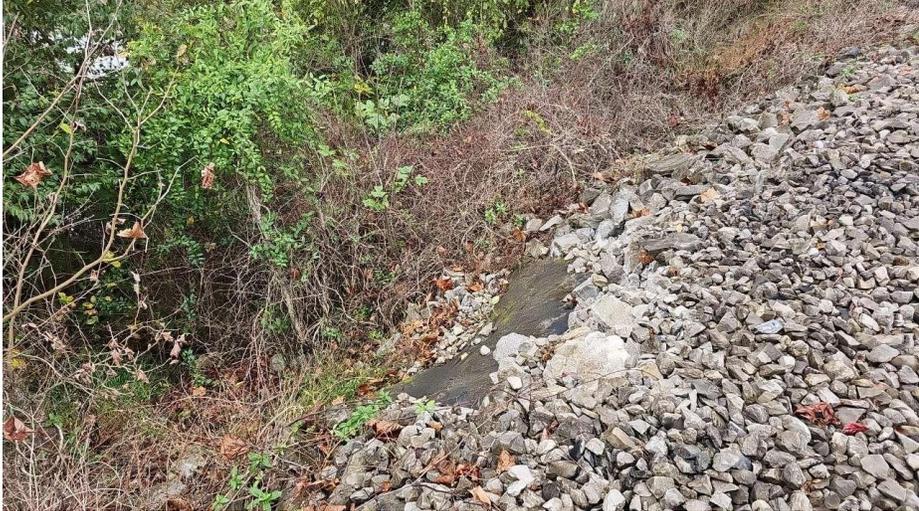
PHOTOGRAPH No: 21	DATE: October 15, 2024 9:06 AM	LATITUDE: 38.20375949	LONGITUDE: -81.41644462
DIRECTION: 96°	SITE LOCATION: HANSFORD, WEST VIRGINIA		
DESCRIPTION: Downstream Slope. Major Erosion, Please Repair.

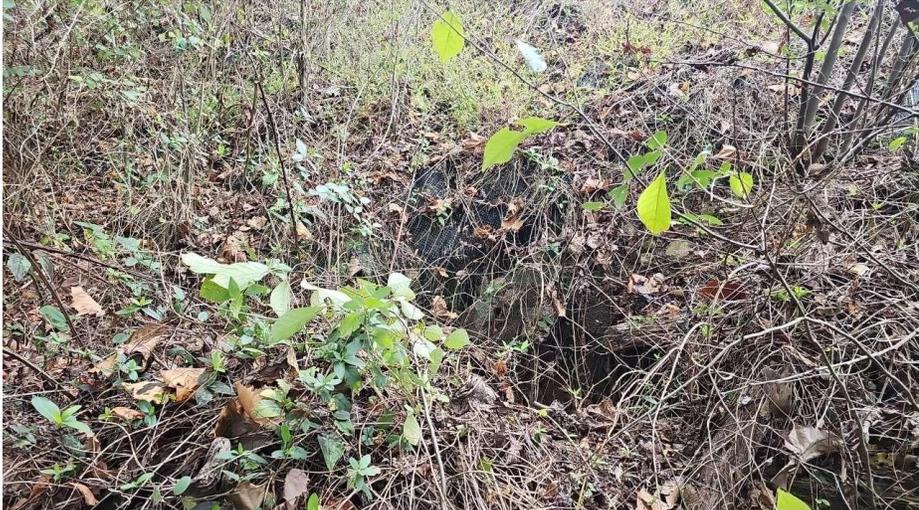
PHOTO BY: GEI CONSULTANTS, INC.			
PHOTOGRAPH No: 22	DATE: October 15, 2024 9:10 AM	LATITUDE: 38.2037161	LONGITUDE: -81.41657701
DIRECTION: 295°	SITE LOCATION: HANSFORD, WEST VIRGINIA		
DESCRIPTION: Downstream Slope. Major Erosion, Please Repair. Downed tre.

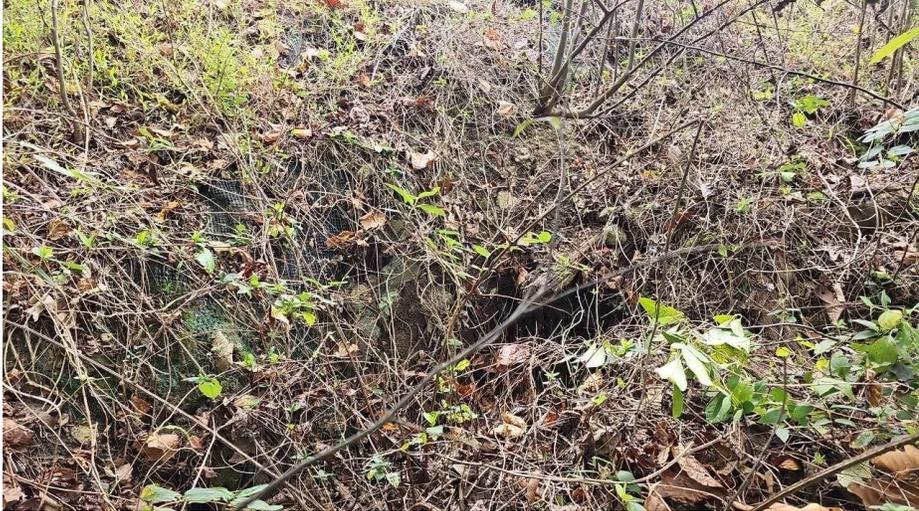
PHOTOGRAPH No: 23	DATE: October 15, 2024 9:11 AM	LATITUDE: 38.2037037	LONGITUDE: -81.41657955
DIRECTION: 315°	SITE LOCATION: HANSFORD, WEST VIRGINIA		
DESCRIPTION: Downstream Slope. Slide, Slough, Scarp, Please Repair. Downed tree.

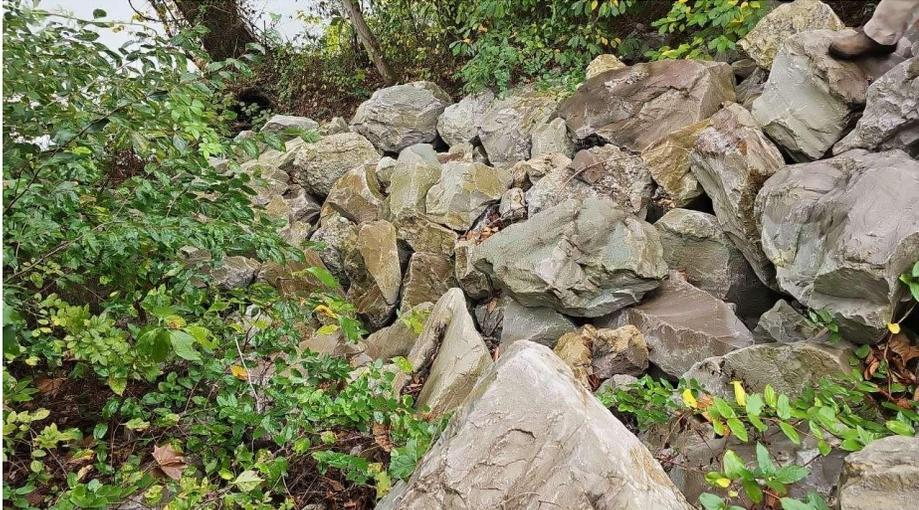
PHOTO BY: GEI CONSULTANTS, INC.			
PHOTOGRAPH No: 24	DATE: October 15, 2024 9:14 AM	LATITUDE: 38.20371848	LONGITUDE: -81.41670213
DIRECTION: 115°	SITE LOCATION: HANSFORD, WEST VIRGINIA		
DESCRIPTION: Downstream Slope. Slide, Slough, Scarp, Monitor Conditions. Settlement of former repair.

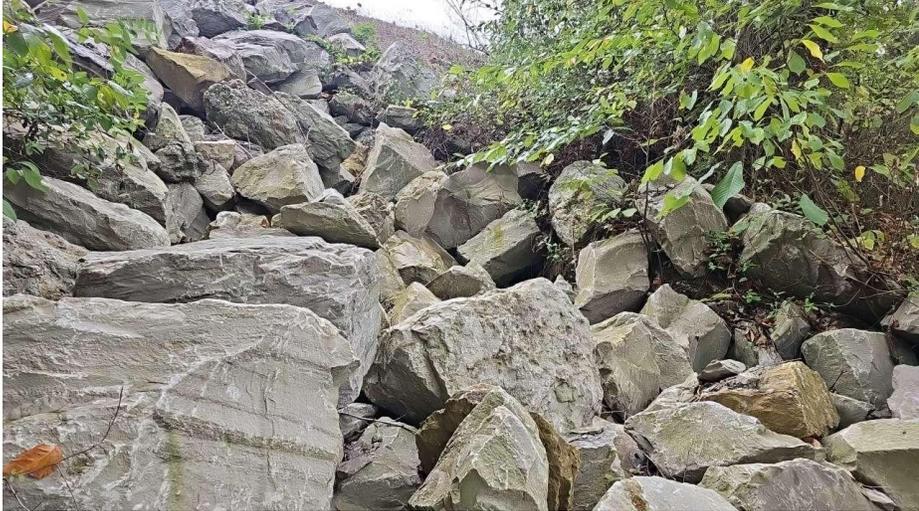
PHOTOGRAPH No: 25	DATE: October 15, 2024 9:15 AM	LATITUDE: 38.20375586	LONGITUDE: -81.41672523
DIRECTION: 328°	SITE LOCATION: HANSFORD, WEST VIRGINIA		
DESCRIPTION: Downstream Slope. Sink Hole, Monitor Conditions. Settlement of rip rap.

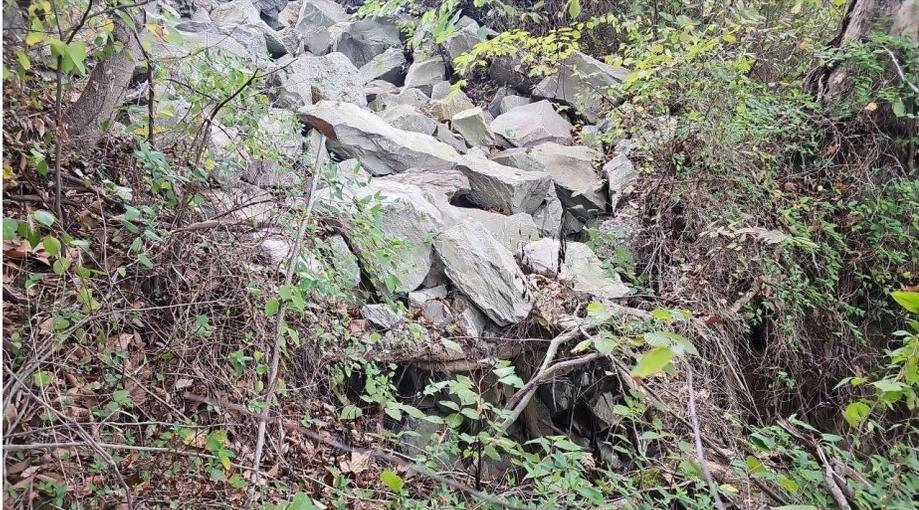
PHOTO BY: GEI CONSULTANTS, INC.			
PHOTOGRAPH No: 26	DATE: October 15, 2024 9:20 AM	LATITUDE: 38.20366235	LONGITUDE: -81.41678676
DIRECTION: 311°	SITE LOCATION: HANSFORD, WEST VIRGINIA		
DESCRIPTION: Downstream Slope. Sink Hole, Monitor Conditions.

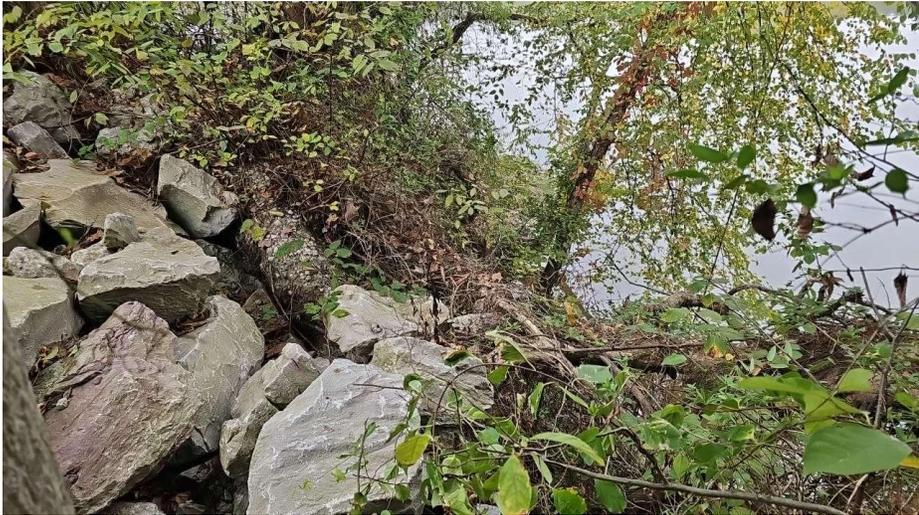
PHOTOGRAPH No: 27	DATE: October 15, 2024 9:20 AM	LATITUDE: 38.20366082	LONGITUDE: -81.41679212
DIRECTION: 48°	SITE LOCATION: HANSFORD, WEST VIRGINIA		
DESCRIPTION: Downstream Slope. Sink Hole, Monitor Conditions.

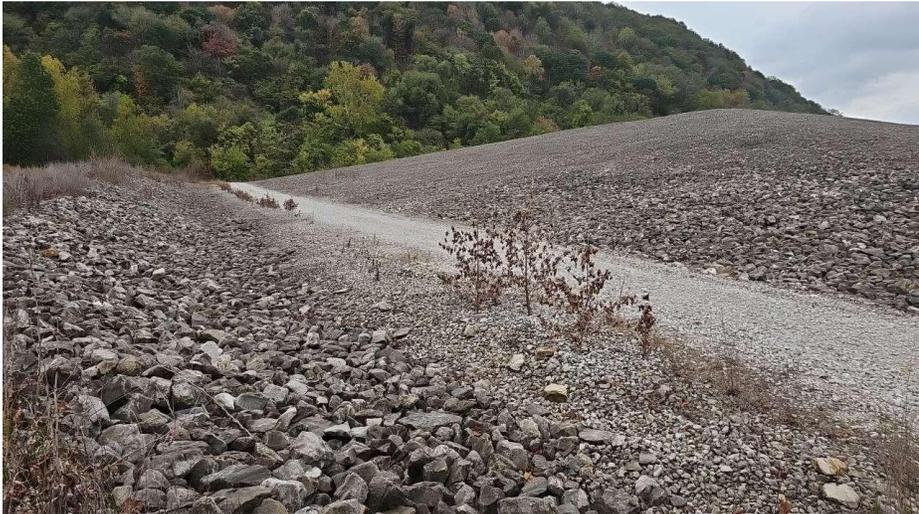
PHOTO BY: GEI CONSULTANTS, INC.			
PHOTOGRAPH No: 28	DATE: October 15, 2024 9:23 AM	LATITUDE: 38.20392858	LONGITUDE: -81.41681352
DIRECTION: 308°	SITE LOCATION: HANSFORD, WEST VIRGINIA		
DESCRIPTION: Downstream Slope. Riprap, General Photo, Typical Conditions.

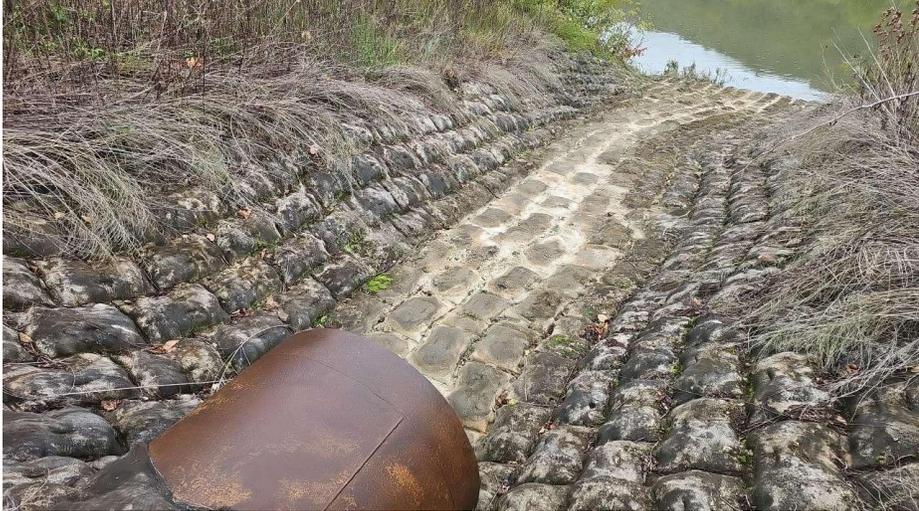
The stormwater outfall is in good condition as shown in Photograph No. 29.

The East Fly Ash Pond stormwater outlet was in good condition, free of any obstructions, and showed no signs of erosion.

PHOTOGRAPH No: 29	DATE: October 15, 2024 9:24 AM	LATITUDE: 38.20382418	LONGITUDE: -81.41710027
DIRECTION: 54°		SITE LOCATION: HANSFORD, WEST VIRGINIA	
DESCRIPTION: Outlet Works. Stormwater outlet. Typical.

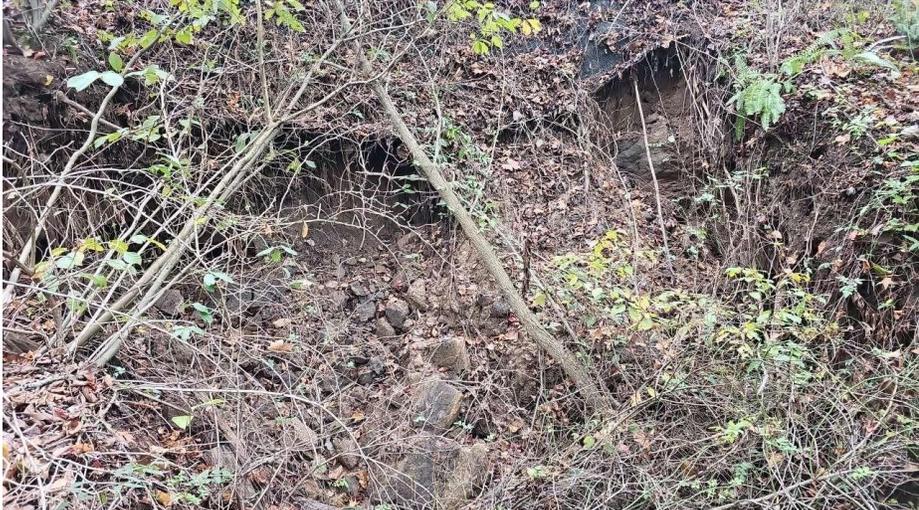
PHOTO BY: GEI CONSULTANTS, INC.			
PHOTOGRAPH No: 30	DATE: October 15, 2024 9:32 AM	LATITUDE: 38.20371535	LONGITUDE: -81.4146265
DIRECTION: 318°		SITE LOCATION: HANSFORD, WEST VIRGINIA	
DESCRIPTION: Downstream Slope. Major Erosion, Please Repair.

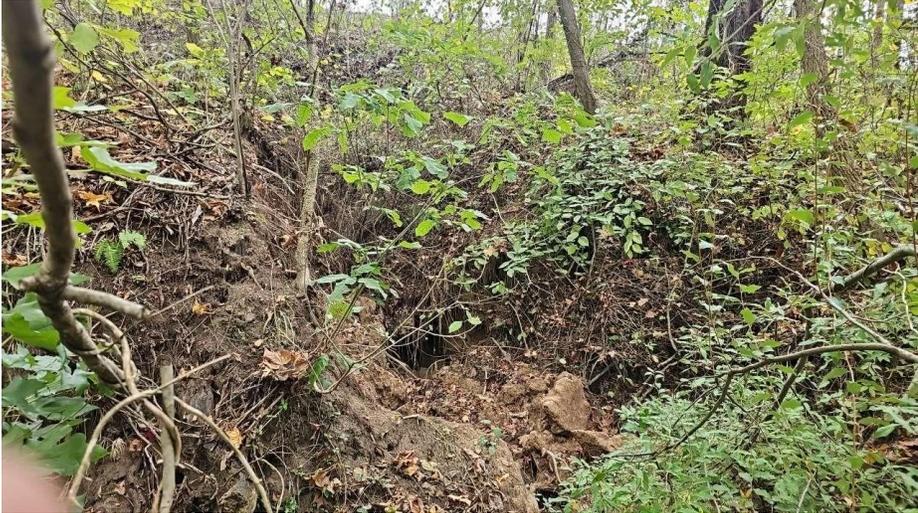
PHOTOGRAPH No: 31	DATE: October 15, 2024 9:33 AM	LATITUDE: 38.20368139	LONGITUDE: -81.41463335
DIRECTION: 294°	SITE LOCATION: HANSFORD, WEST VIRGINIA		
DESCRIPTION: Downstream Slope. Major Erosion, Please Repair.
