## Bottom Ash Pond Complex Initial Dam and Dike Inspection Report

Former Philo Power Plant, Muskingum County, Ohio

January 2025  
Project 2407654

# 2024 Annual Inspection Report

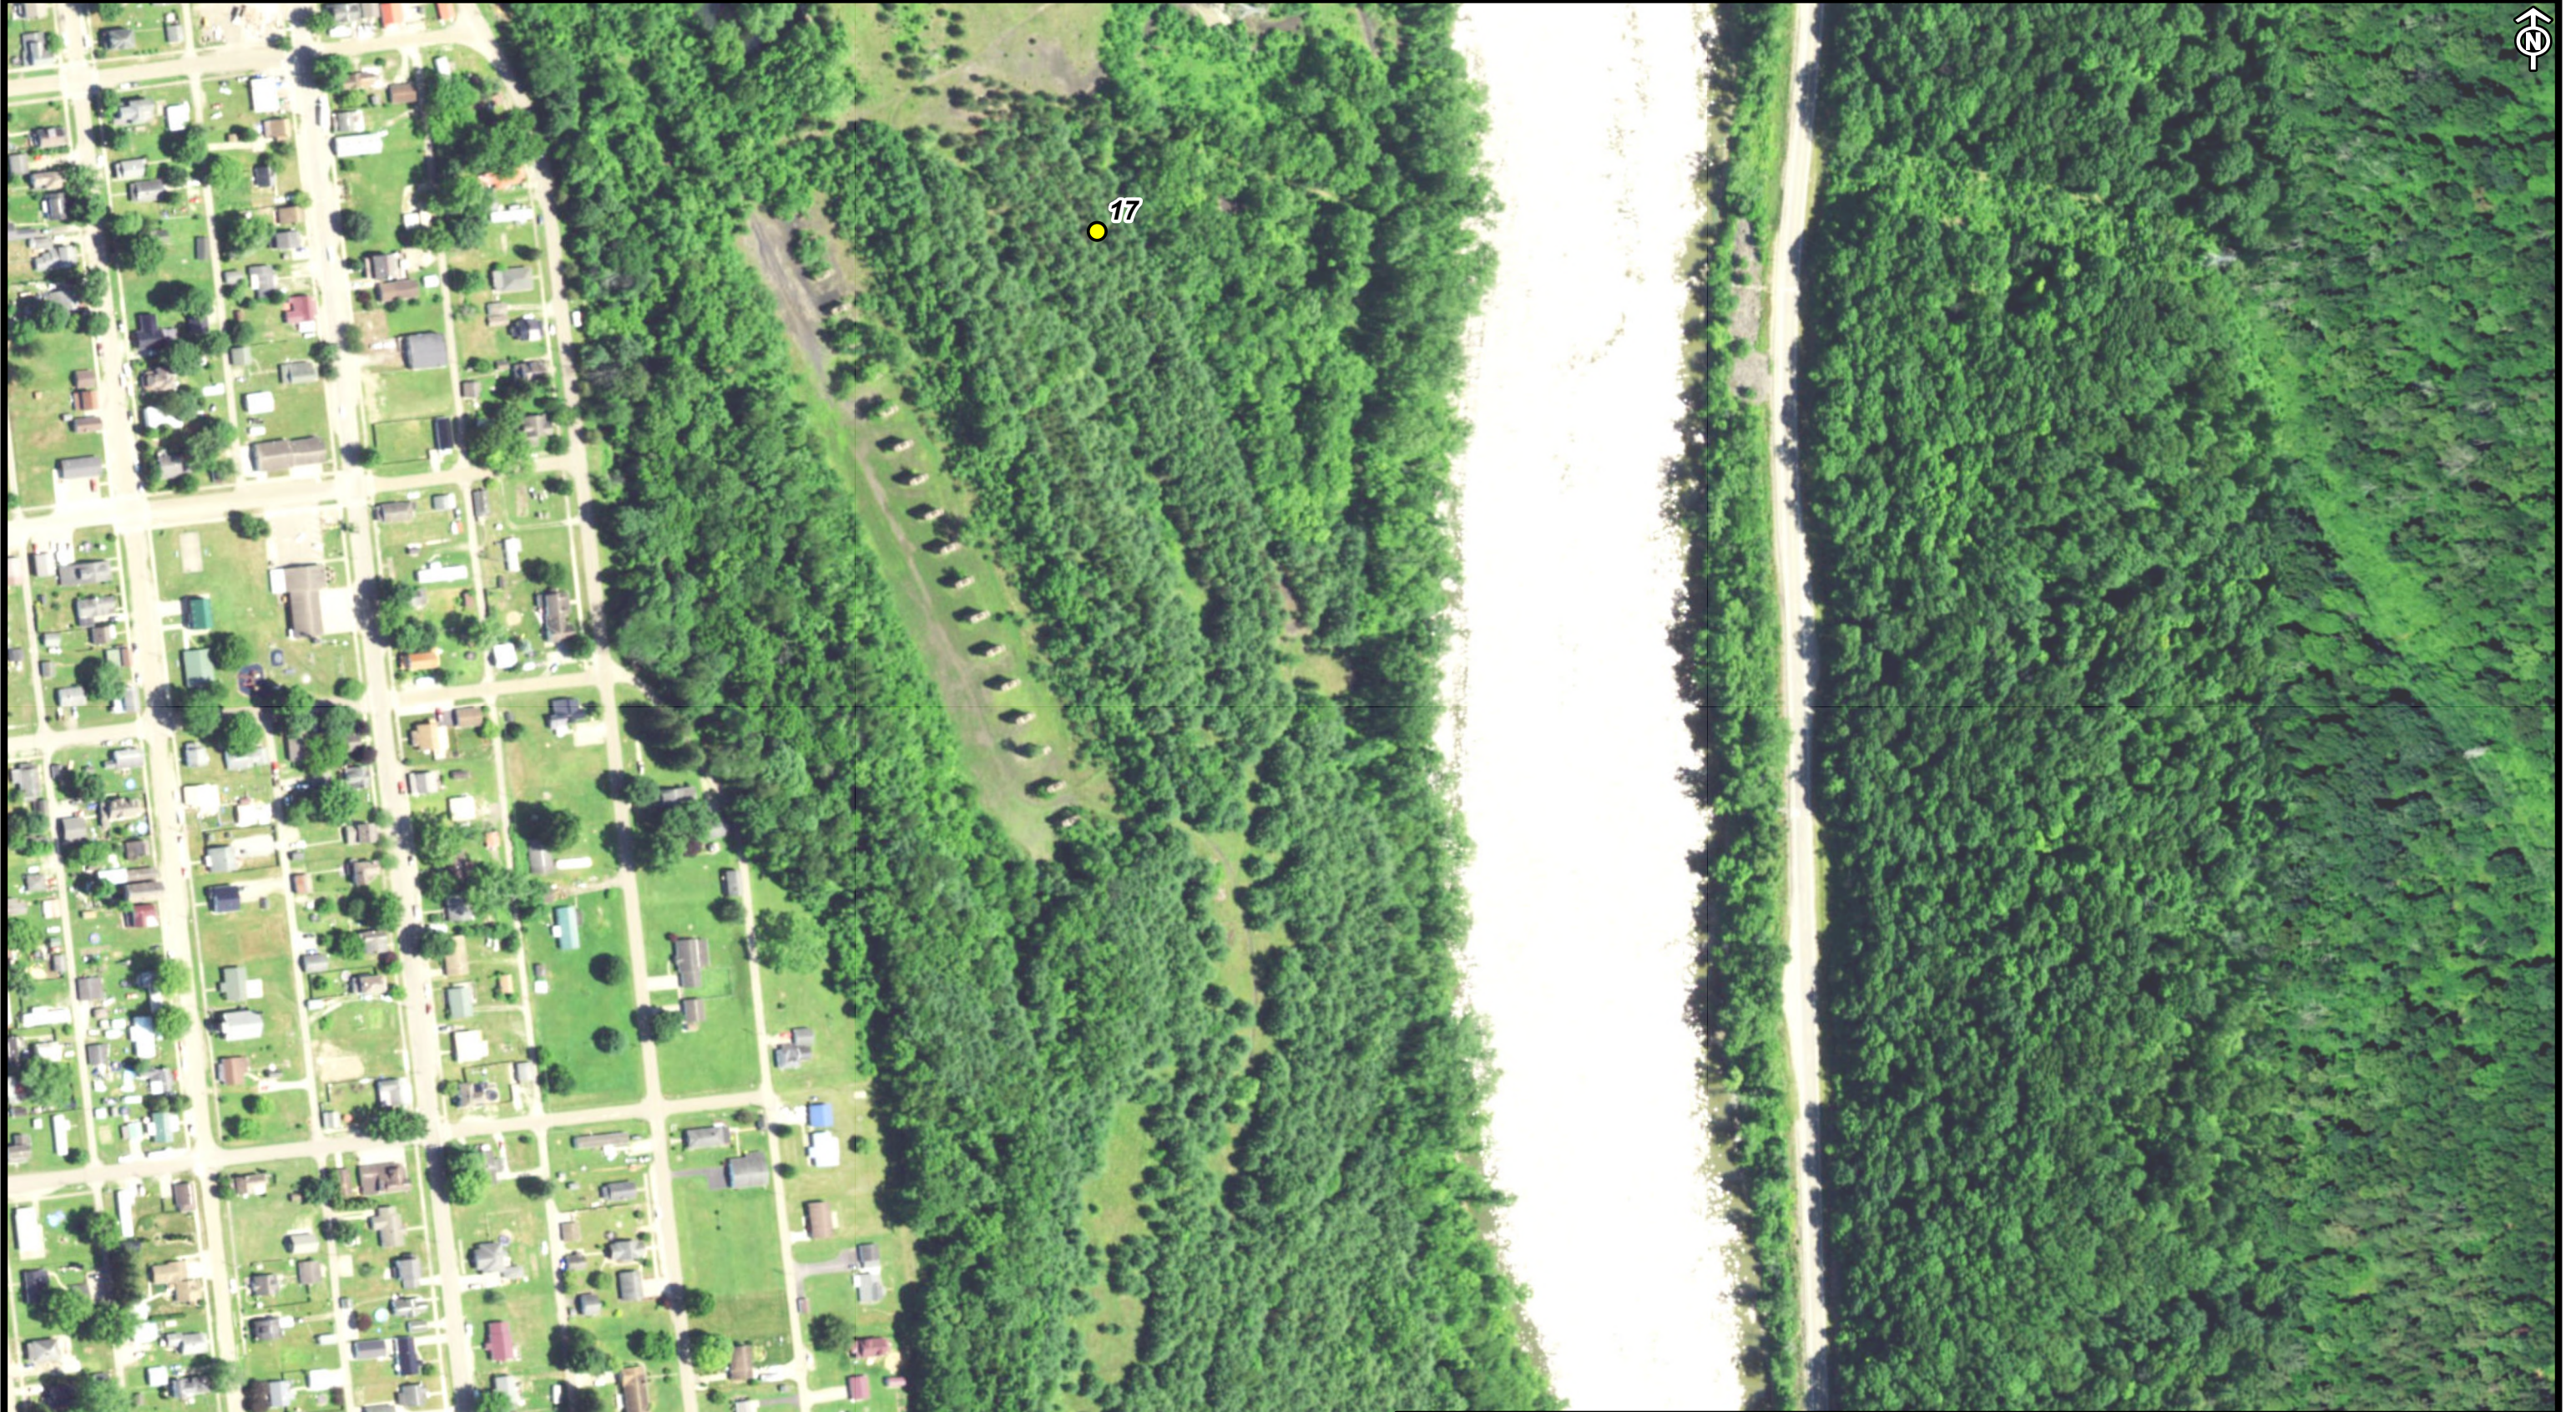
ITEMS TO BE MONITORED

Item 17 – Monitor the depression near the Pond B inlet.

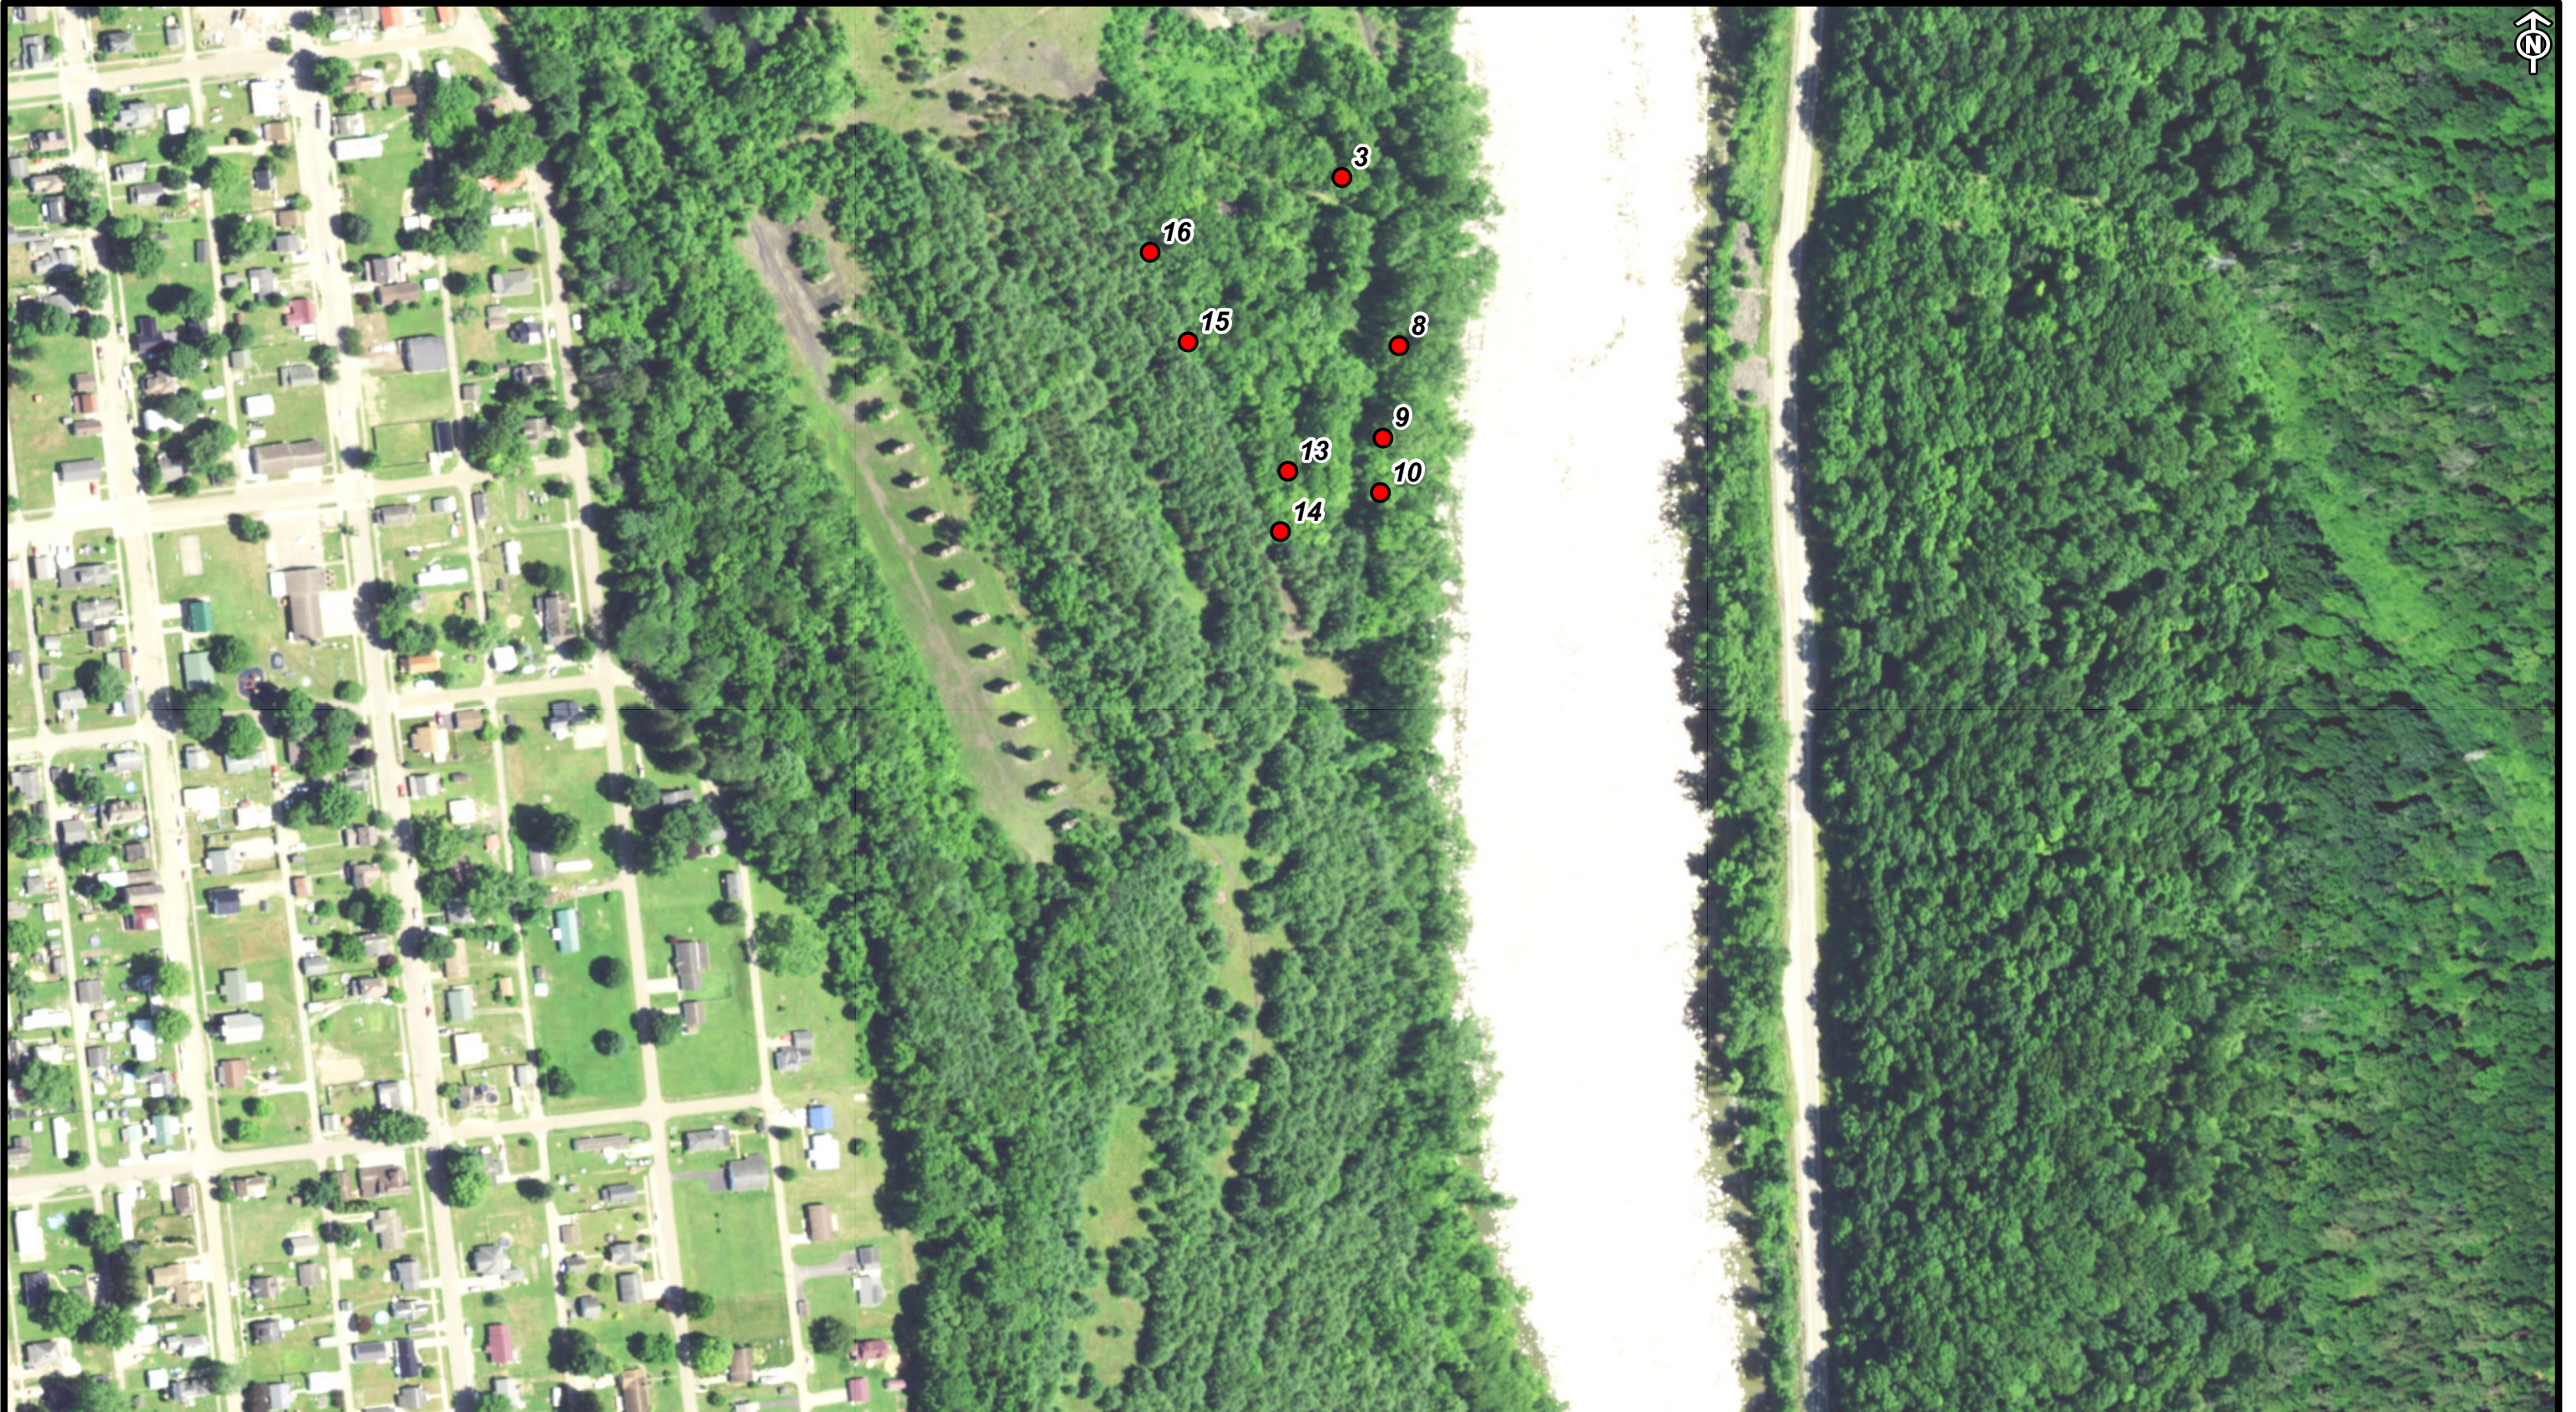
ITEMS TO BE ADDRESSED

- Address/maintain vegetation to 12-inches or less within 25-feet of the limits of the embankments. AEP should consider identifying the unit boundary to establish limits where the vegetation should be maintained. Applies to Item 3, 8, 9, 10, 14, 15, and 16.

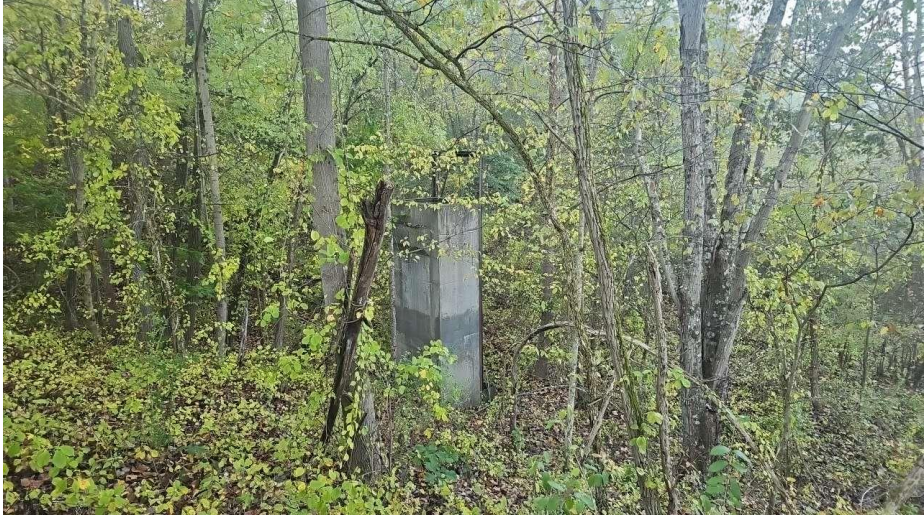
Multiple decant structures were observed as shown in Photograph Nos. 1, 2, 5, 6, 11, 12, and 13. Additional drainage structures were observed as shown in Photograph Nos. 4, 7, 8, and 16. It was unknown if any of these structures are still functional. AEP should review its existing documentation to confirm if any of these structures were properly abandoned. If AEP determined that these structures are no longer required, they should be removed or properly abandoned.

<b>PHOTOGRAPH NO: 1</b>	<b>DATE:</b> October 16, 2024 7:12 AM	<b>LATITUDE:</b> 39.86326694	<b>LONGITUDE:</b> -81.90206407
<b>DIRECTION:</b> 113°	<b>SITE LOCATION:</b> PHILO, OHIO		
<b>DESCRIPTION:</b>  Decant Structure. General Photo, Monitor Conditions.

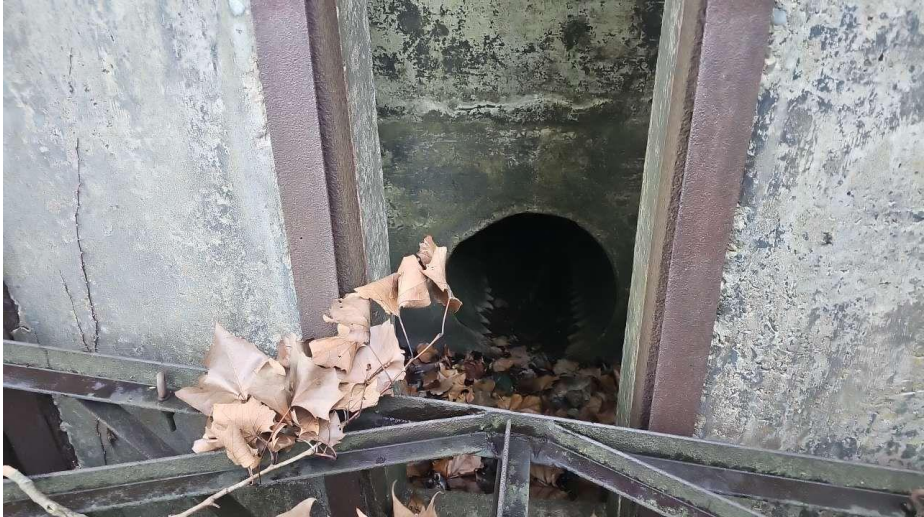
<b>PHOTO BY:</b>  GEI CONSULTANTS, INC.			
<b>PHOTOGRAPH NO: 2</b>	<b>DATE:</b> October 16, 2024 7:14 AM	<b>LATITUDE:</b> 39.86319897	<b>LONGITUDE:</b> -81.90224042
<b>DIRECTION:</b> 86°	<b>SITE LOCATION:</b> PHILO, OHIO		
<b>DESCRIPTION:</b>  Outlet Works. General Photo, Monitor Conditions.

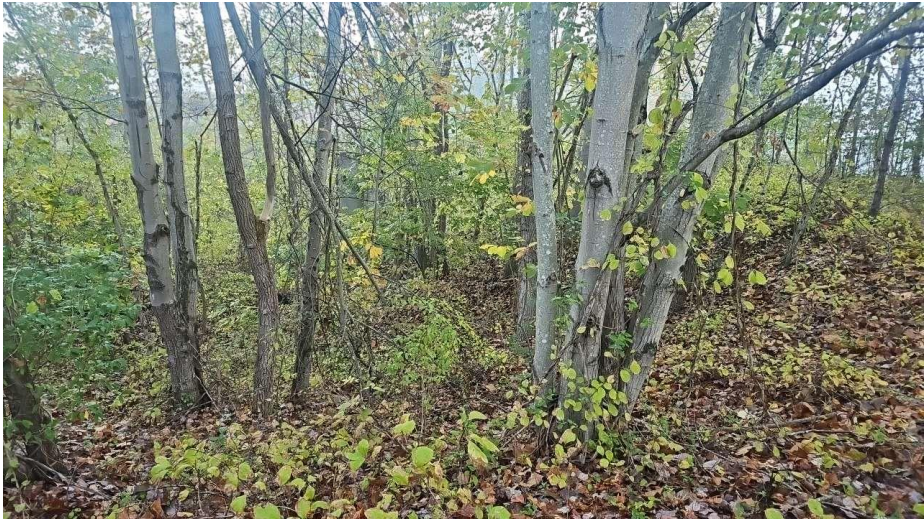
The upstream slope of the dam is in fair condition. The vegetation on the slope is overgrown with woody vegetation as shown in Photograph Nos. 3, 14, 15, and 16. AEP should consider identifying the unit boundary so vegetation on the upstream slope can be addressed/maintained to 12-inches or less.

<b>PHOTOGRAPH NO: 3</b>	<b>DATE:</b> October 16, 2024 7:20 AM	<b>LATITUDE:</b> 39.86298142	<b>LONGITUDE:</b> -81.90214484
<b>DIRECTION:</b> 344°	<b>SITE LOCATION:</b> PHILO, OHIO		
<b>DESCRIPTION:</b>  Upstream Slope. Ground Cover, Typical Conditions.

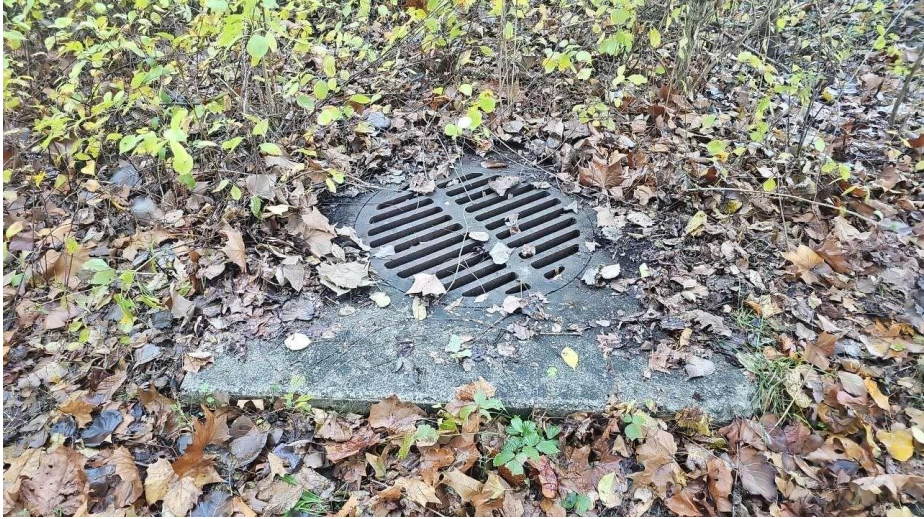
<b>PHOTO BY:</b>  GEI CONSULTANTS, INC.			
<b>PHOTOGRAPH NO: 4</b>	<b>DATE:</b> October 16, 2024 7:23 AM	<b>LATITUDE:</b> 39.86311988	<b>LONGITUDE:</b> -81.9020795
<b>DIRECTION:</b> 142°	<b>SITE LOCATION:</b> PHILO, OHIO		
<b>DESCRIPTION:</b>  Outlet Works. General Photo, Typical Conditions.

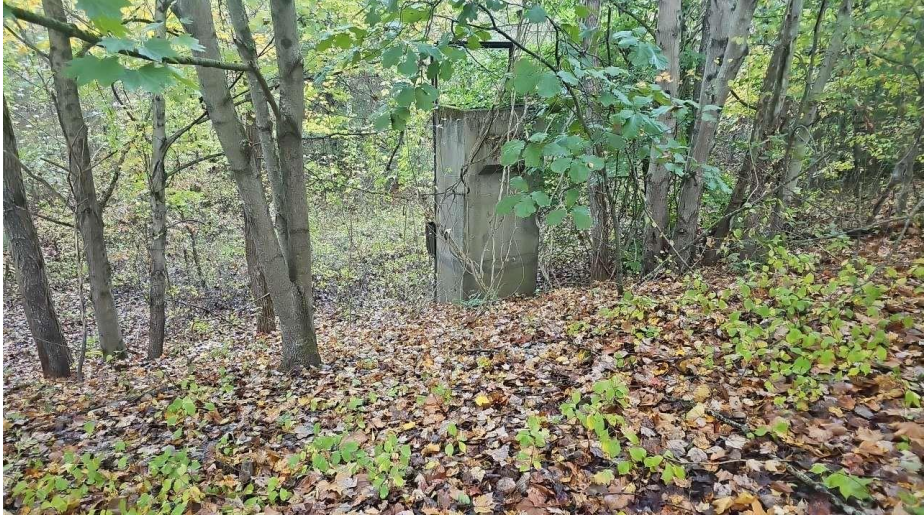
<b>PHOTOGRAPH NO: 5</b>	<b>DATE:</b> October 16, 2024 7:26 AM	<b>LATITUDE:</b> 39.86256205	<b>LONGITUDE:</b> -81.90201288
<b>DIRECTION: 110°</b>	<b>SITE LOCATION: PHILO, OHIO</b>		
<b>DESCRIPTION:</b>  Decant Structure. General Photo, Typical Conditions. Basin B.

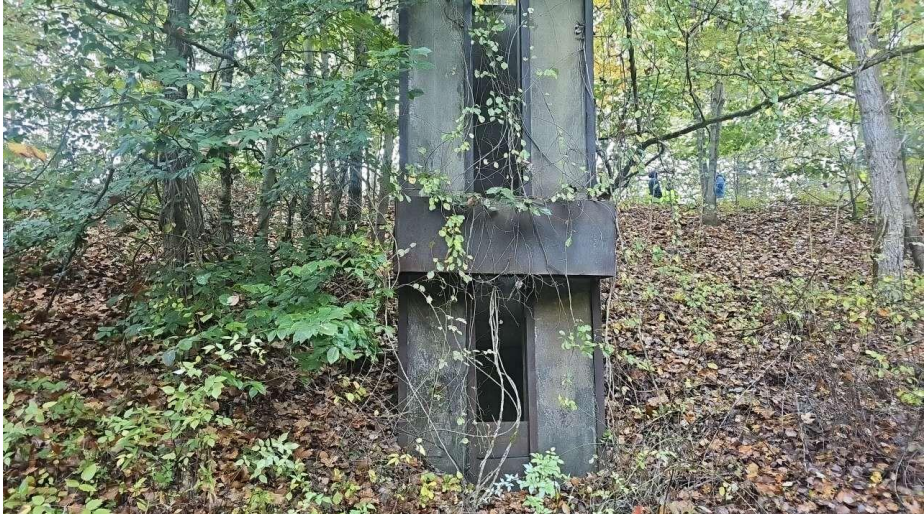
<b>PHOTO BY:</b>  GEI CONSULTANTS, INC.			
<b>PHOTOGRAPH NO: 6</b>	<b>DATE:</b> October 16, 2024 7:28 AM	<b>LATITUDE:</b> 39.86261871	<b>LONGITUDE:</b> -81.90230538
<b>DIRECTION: 47°</b>	<b>SITE LOCATION: PHILO, OHIO</b>		
<b>DESCRIPTION:</b>  Decant Structure. General Photo, Typical Conditions. Pond B.

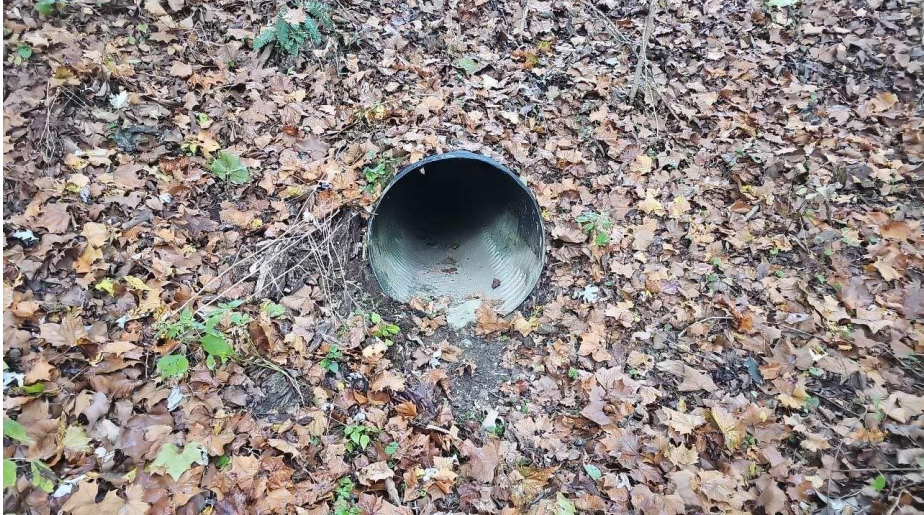
PHOTOGRAPH NO: 7	DATE: October 16, 2024 7:32 AM	LATITUDE: 39.86230919	LONGITUDE: -81.90182479
DIRECTION: 133°	SITE LOCATION: PHILO, OHIO		
DESCRIPTION:  Outlet Works. General Photo, Typical Conditions.

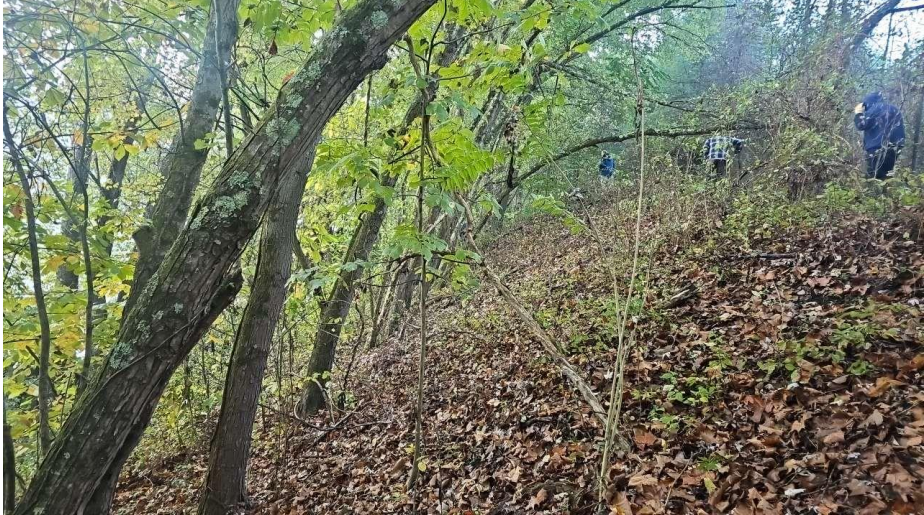
The downstream slope of the dam is in fair condition. The vegetation on the slope is overgrown with woody vegetation as shown in Photograph Nos. 8, 9, and 10. AEP should consider identifying the unit boundary so vegetation on the downstream slope can be addressed/maintained to 12-inches or less.

<b>PHOTOGRAPH NO: 9</b>	<b>DATE:</b> October 16, 2024 7:39 AM	<b>LATITUDE:</b> 39.86191376	<b>LONGITUDE:</b> -81.90191315
<b>DIRECTION:</b> 89°	<b>SITE LOCATION:</b> PHILO, OHIO		
<b>DESCRIPTION:</b>  Downstream Slope. General Photo, Monitor Conditions. Note trees leaning upslope.

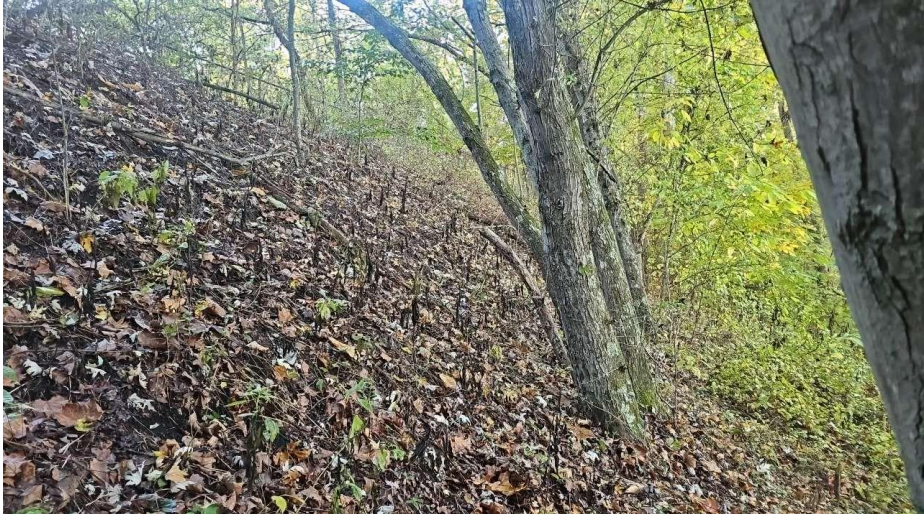
<b>PHOTO BY:</b>  GEI CONSULTANTS, INC.			
<b>PHOTOGRAPH NO: 10</b>	<b>DATE:</b> October 16, 2024 7:44 AM	<b>LATITUDE:</b> 39.86168915	<b>LONGITUDE:</b> -81.90192397
<b>DIRECTION:</b> 104°	<b>SITE LOCATION:</b> PHILO, OHIO		
<b>DESCRIPTION:</b>  Downstream Slope. Slide, Slough, Scarp, Monitor Conditions. Note trees leaning upslope.

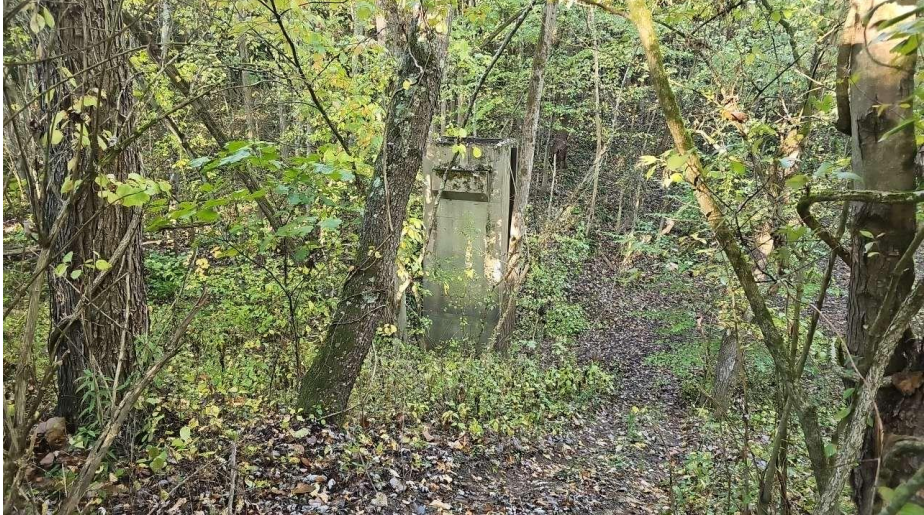
<b>PHOTOGRAPH No: 11</b>	<b>DATE:</b> October 16, 2024 8:01 AM	<b>LATITUDE:</b> 39.86175849	<b>LONGITUDE:</b> -81.90223272
<b>DIRECTION:</b> 113°	<b>SITE LOCATION:</b> PHILO, OHIO		
<b>DESCRIPTION:</b>  Decant Structure. General Photo, Monitor Conditions. Pond C.

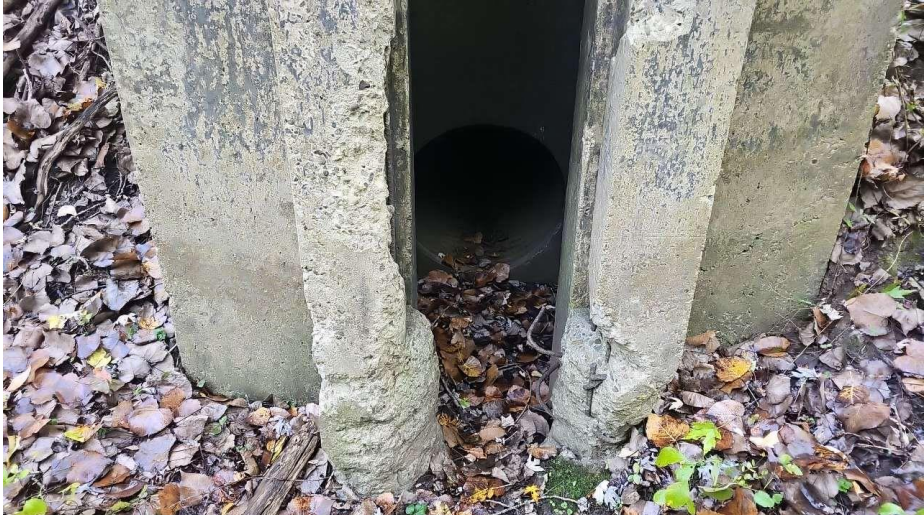
<b>PHOTO BY:</b>  GEI CONSULTANTS, INC.			
<b>PHOTOGRAPH No: 12</b>	<b>DATE:</b> October 16, 2024 8:02 AM	<b>LATITUDE:</b> 39.86175172	<b>LONGITUDE:</b> -81.90242982
<b>DIRECTION:</b> 63°	<b>SITE LOCATION:</b> PHILO, OHIO		
<b>DESCRIPTION:</b>  Decant Structure. General Photo, Monitor Conditions. Pond C.

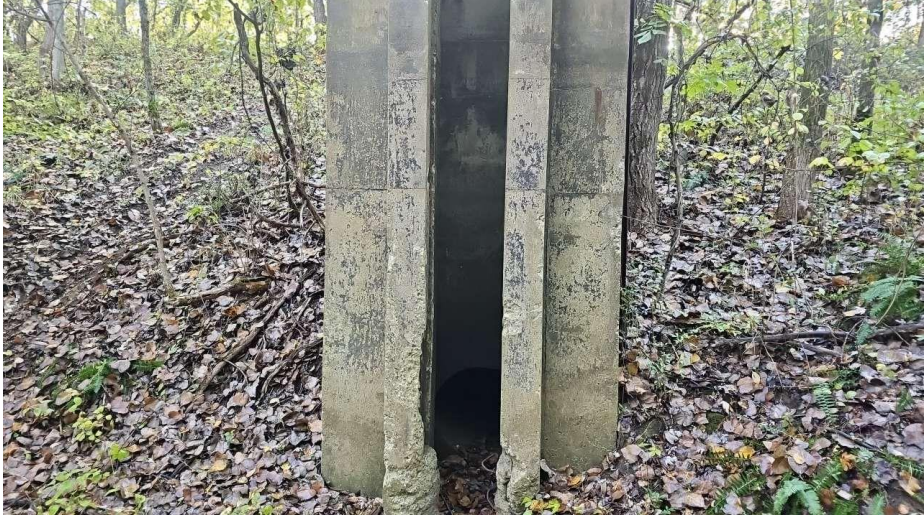
<b>PHOTOGRAPH No: 13</b>	<b>DATE:</b> October 16, 2024 8:03 AM	<b>LATITUDE:</b> 39.86177367	<b>LONGITUDE:</b> -81.90241861
<b>DIRECTION:</b> 45°	<b>SITE LOCATION:</b> PHILO, OHIO		
<b>DESCRIPTION:</b>  Decant Structure. General Photo, Monitor Conditions.

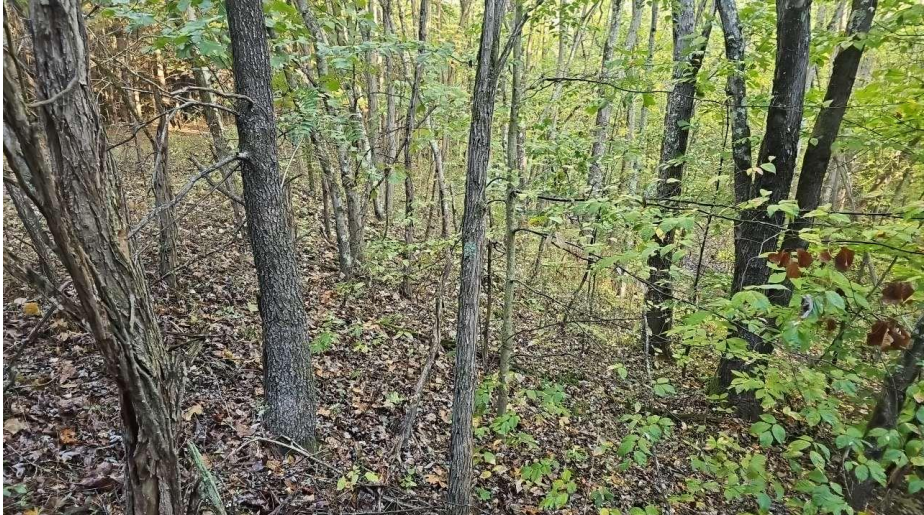
<b>PHOTO BY:</b>  GEI CONSULTANTS, INC.			
<b>PHOTOGRAPH No: 14</b>	<b>DATE:</b> October 16, 2024 8:07 AM	<b>LATITUDE:</b> 39.86152364	<b>LONGITUDE:</b> -81.90245294
<b>DIRECTION:</b> 132°	<b>SITE LOCATION:</b> PHILO, OHIO		
<b>DESCRIPTION:</b>  Upstream Slope. General Photo, Typical Conditions.
