Fly Ash Pond Initial Dam and Dike Inspection Report

Former Philo Power Plant, Muskingum County, Ohio

January 2025
Project 2407654

2024 Annual Inspection Report

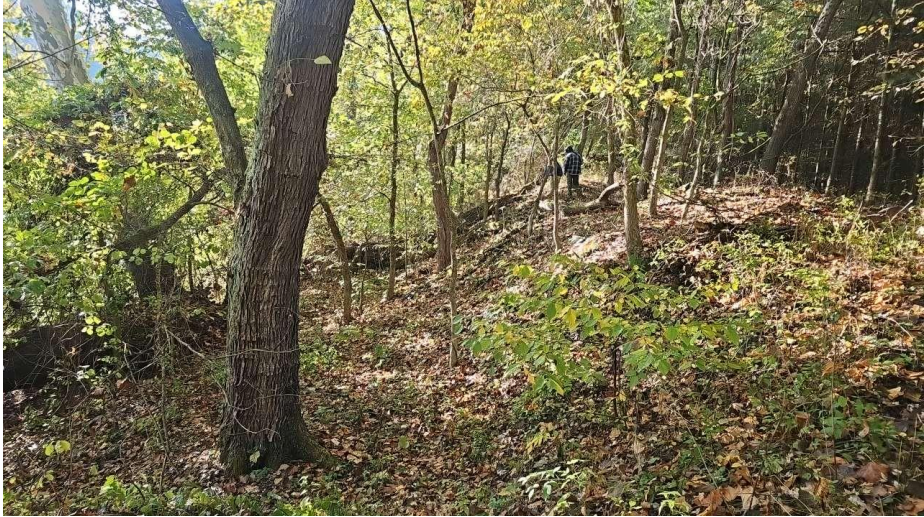
The downstream slope of the dam is in fair condition. The slope vegetative cover is overgrown with woody vegetation that should be maintained to 12-inches or less as shown in Photograph Nos. 1-6, 10-14, and 167. AEP should consider identifying the unit boundary to establish limits where the vegetation should be maintained.

PHOTOGRAPH NO: 1	DATE: October 16, 2024 8:30 AM	LATITUDE: 39.85886526	LONGITUDE: -81.90159684
DIRECTION: 346°	SITE LOCATION: PHILO, OHIO		
DESCRIPTION: Downstream Slope. Ground Cover, Typical Conditions.

- Address/maintain vegetation to 12-inches or less within 25-feet of the limits of the embankments. AEP should consider identifying the unit boundary to establish limits where the vegetation should be maintained. Applies to Items 1-6 and 10-16.

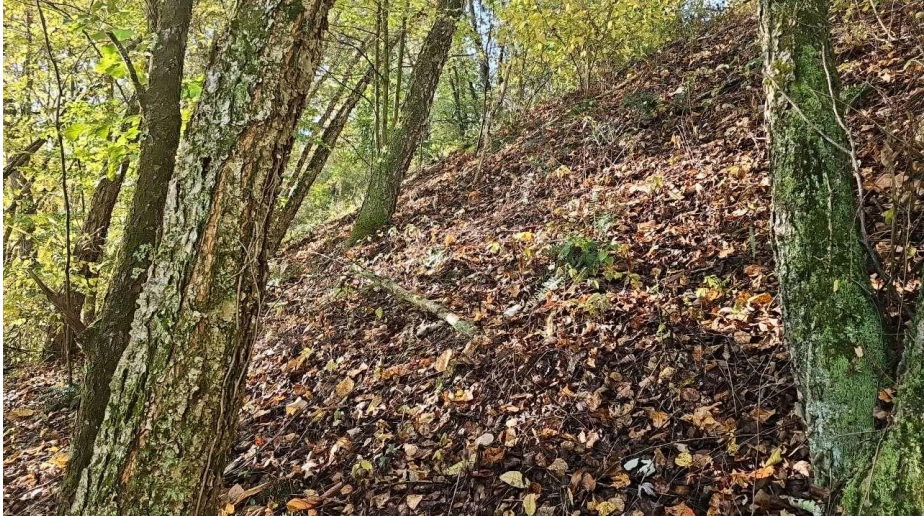
PHOTO BY: GEI CONSULTANTS, INC.			
PHOTOGRAPH NO: 2	DATE: October 16, 2024 8:38 AM	LATITUDE: 39.8581628	LONGITUDE: -81.90132668
DIRECTION: 315°	SITE LOCATION: PHILO, OHIO		
DESCRIPTION: Downstream Slope. Slide, Slough, Scarp, Monitor Conditions.

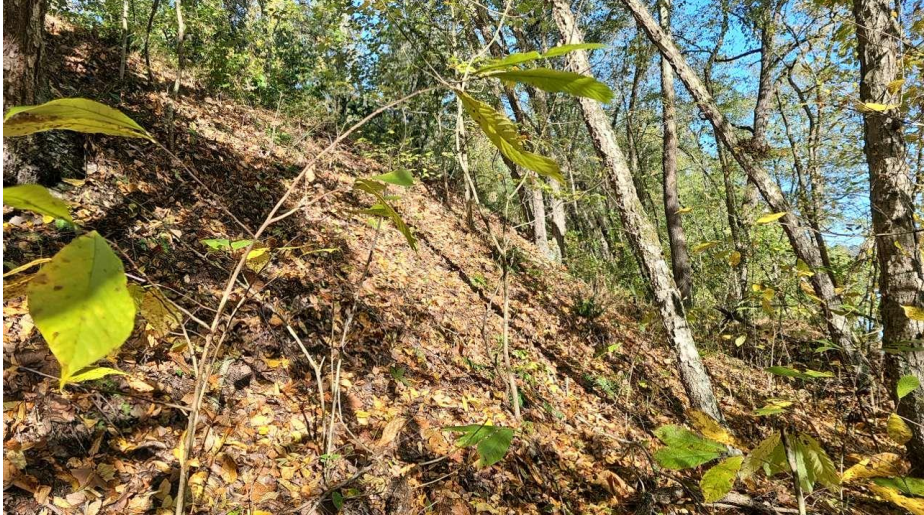
PHOTOGRAPH NO: 3	DATE: October 16, 2024 8:43 AM	LATITUDE: 39.85761265	LONGITUDE: -81.90105482
DIRECTION: 293°	SITE LOCATION: PHILO, OHIO		
DESCRIPTION: Downstream Slope. Slide, Slough, Scarp, Monitor Conditions.

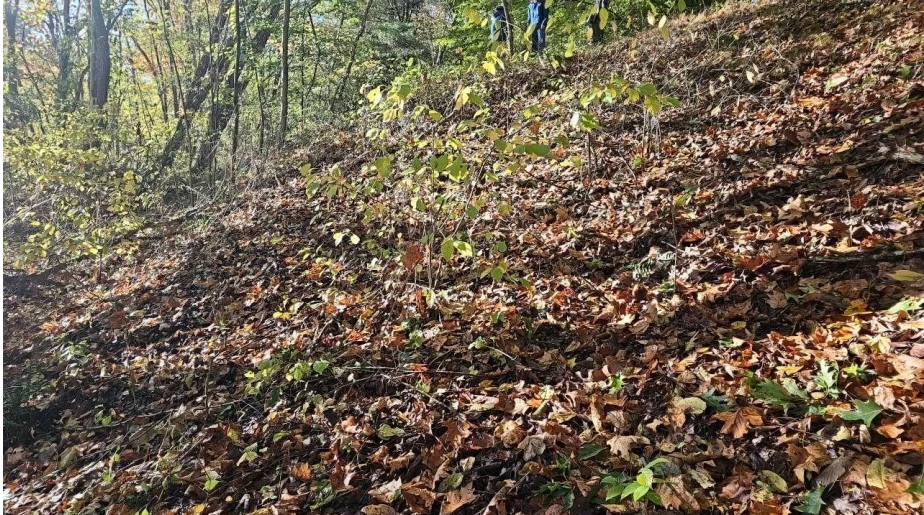
PHOTO BY: GEI CONSULTANTS, INC.			
PHOTOGRAPH NO: 4	DATE: October 16, 2024 8:45 AM	LATITUDE: 39.85738631	LONGITUDE: -81.90103619
DIRECTION: 310°	SITE LOCATION: PHILO, OHIO		
DESCRIPTION: Downstream Slope. Possible drill rig access.

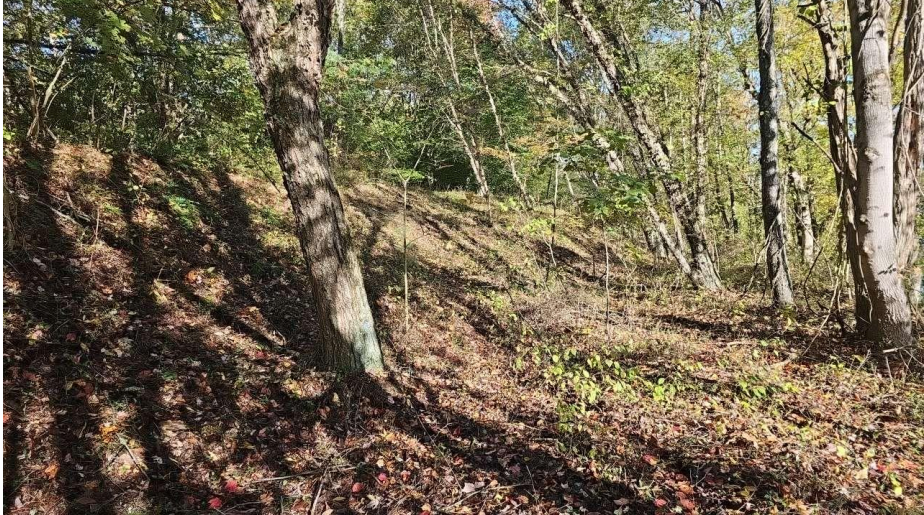
PHOTOGRAPH NO: 5	DATE: October 16, 2024 8:48 AM	LATITUDE: 39.85688206	LONGITUDE: -81.90089489
DIRECTION: 294°		SITE LOCATION: PHILO, OHIO	
DESCRIPTION: Toe. Slide, Slough, Scarp, Monitor Conditions.

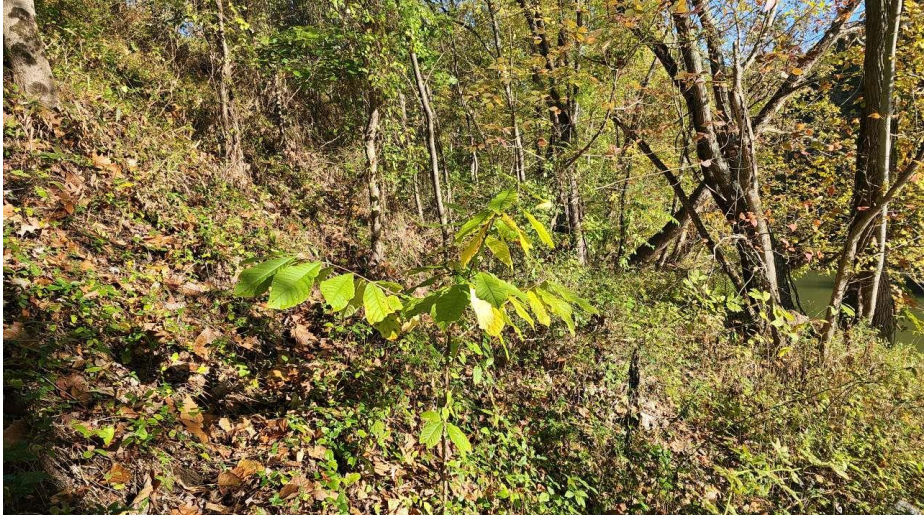
PHOTO BY: GEI CONSULTANTS, INC.			
PHOTOGRAPH NO: 6	DATE: October 16, 2024 9:03 AM	LATITUDE: 39.85526981	LONGITUDE: -81.90101224
DIRECTION: 309°		SITE LOCATION: PHILO, OHIO	
DESCRIPTION: Downstream Slope. Ground Cover, Monitor Conditions.

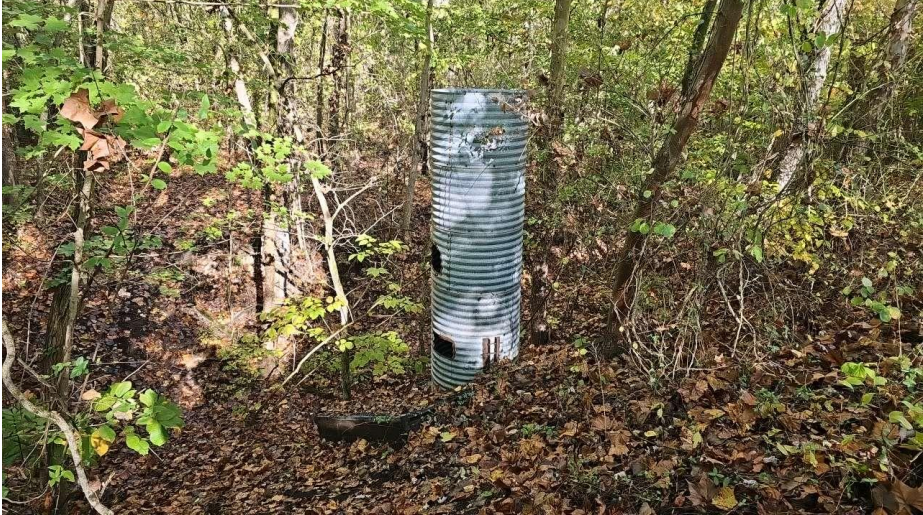
One decant structure was observed as shown in Photograph Nos. 7, 8, and 9. No outlet for this structure was found and it is unknown if this structure is still functional. If AEP determines that

PHOTOGRAPH NO: 7	DATE: October 16, 2024 9:07 AM	LATITUDE: 39.85453293	LONGITUDE: -81.90144902
DIRECTION: 299°		SITE LOCATION: PHILO, OHIO	
DESCRIPTION: Decant Structure. General Photo, Typical Conditions.

this structure is no longer required, the structure should be removed, or proper abandonment should be documented.

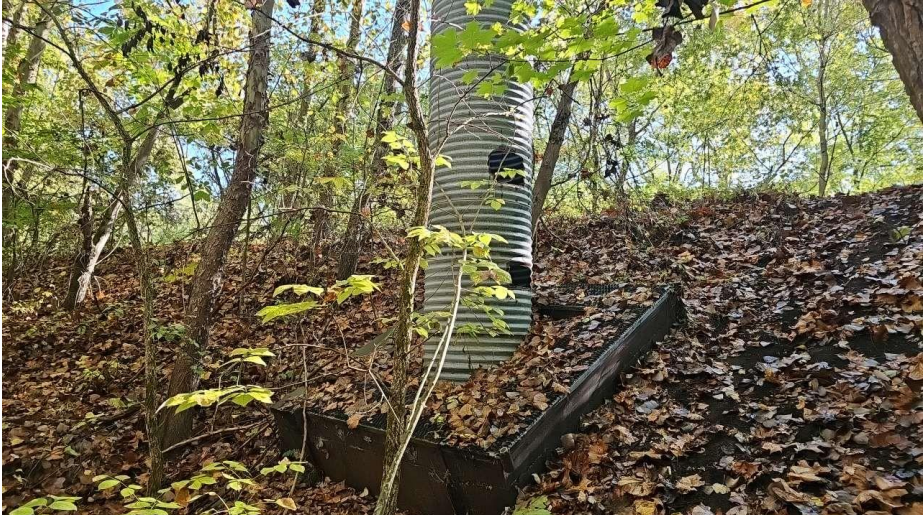
PHOTO BY: GEI CONSULTANTS, INC.			
PHOTOGRAPH NO: 8	DATE: October 16, 2024 9:08 AM	LATITUDE: 39.85457198	LONGITUDE: -81.90154153
DIRECTION: 314°		SITE LOCATION: PHILO, OHIO	
DESCRIPTION: Outlet Works. General Photo, Monitor Conditions.

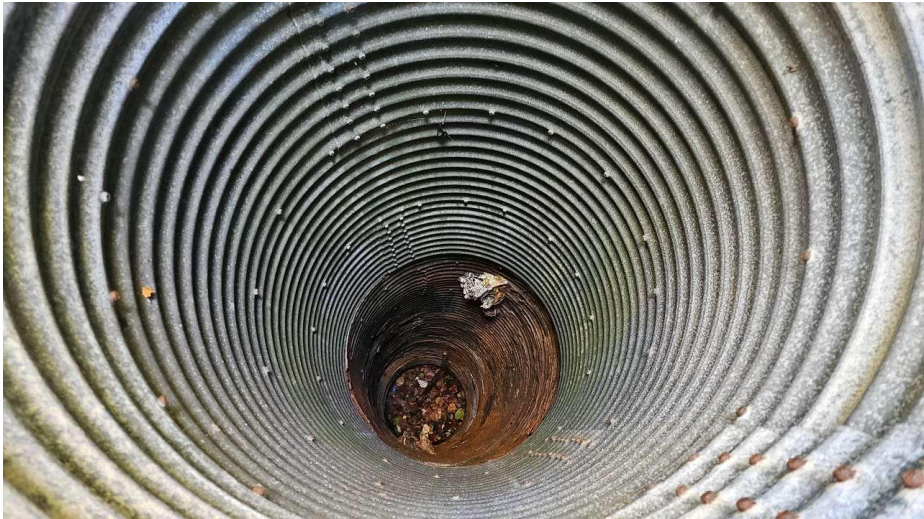
PHOTOGRAPH NO: 9	DATE: October 16, 2024 9:10 AM	LATITUDE: 39.85456682	LONGITUDE: -81.90153938
DIRECTION: 174°	SITE LOCATION: PHILO, OHIO		
DESCRIPTION: Outlet Works. General Photo, Monitor Conditions.

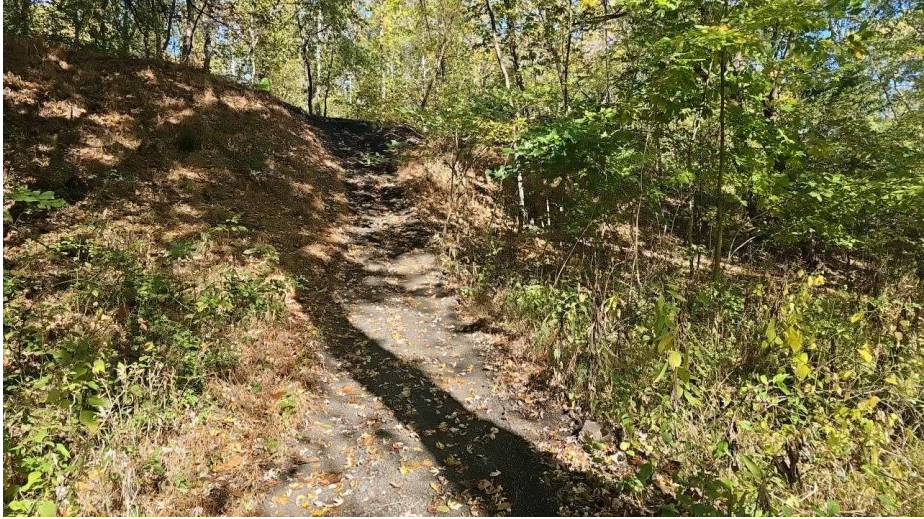
PHOTO BY: GEI CONSULTANTS, INC.			
PHOTOGRAPH NO: 10	DATE: October 16, 2024 9:19 AM	LATITUDE: 39.85438553	LONGITUDE: -81.90125043
DIRECTION: 61°	SITE LOCATION: PHILO, OHIO		
DESCRIPTION: Downstream Slope. Likely location of outfall from pond. No outlet found.

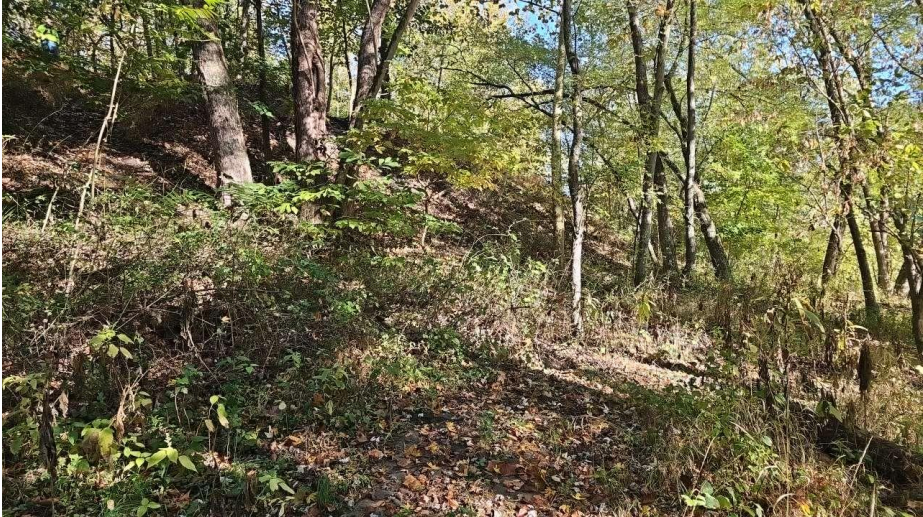
PHOTOGRAPH No: 11	DATE: October 16, 2024 9:20 AM	LATITUDE: 39.85422829	LONGITUDE: -81.90144485
DIRECTION: 10°		SITE LOCATION: PHILO, OHIO	
DESCRIPTION: Downstream Slope. Ground Cover, Typical Conditions.

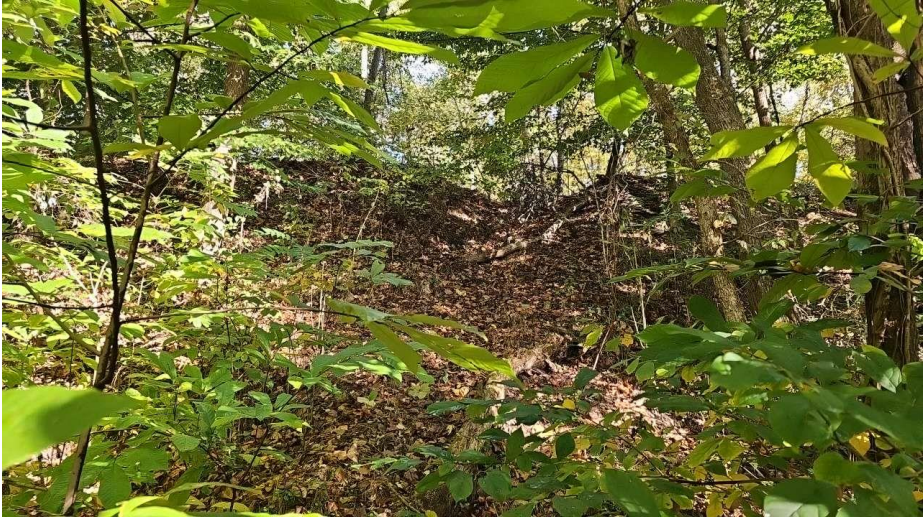
PHOTO BY: GEI CONSULTANTS, INC.			
PHOTOGRAPH No: 12	DATE: October 16, 2024 9:23 AM	LATITUDE: 39.85409202	LONGITUDE: -81.90198384
DIRECTION: 349°		SITE LOCATION: PHILO, OHIO	
DESCRIPTION: Downstream Slope. Vehicle Ruts, Monitor Conditions.

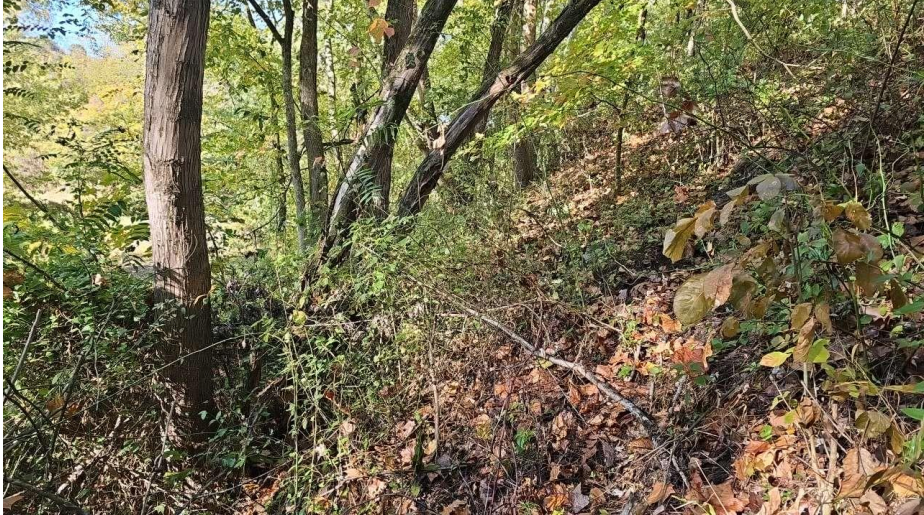
PHOTOGRAPH No: 13	DATE: October 16, 2024 9:25 AM	LATITUDE: 39.85404967	LONGITUDE: -81.90252694
DIRECTION: 75°		SITE LOCATION: PHILO, OHIO	
DESCRIPTION: Outboard Dike. General Photo, Monitor Conditions.

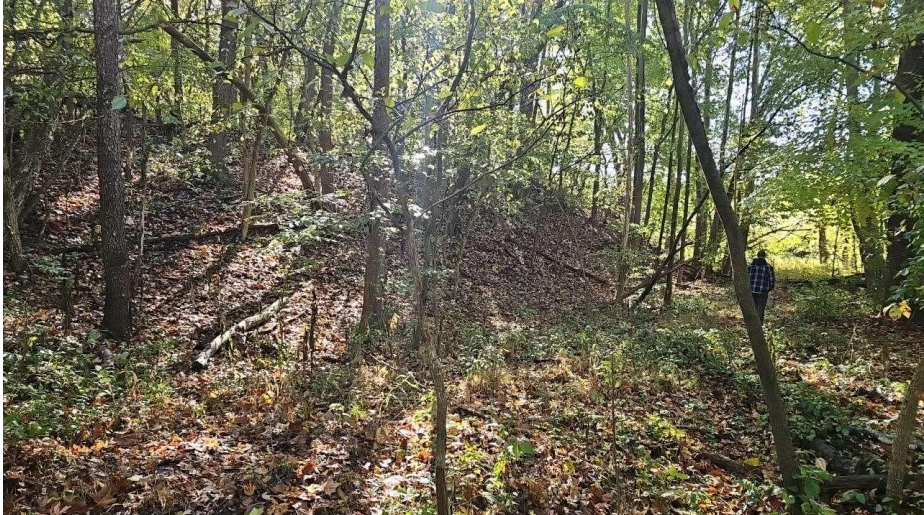
PHOTO BY: GEI CONSULTANTS, INC.			
PHOTOGRAPH No: 14	DATE: October 16, 2024 9:33 AM	LATITUDE: 39.85447256	LONGITUDE: -81.90357579
DIRECTION: 51°		SITE LOCATION: PHILO, OHIO	
DESCRIPTION: Downstream Slope. Ground Cover, Typical Conditions.

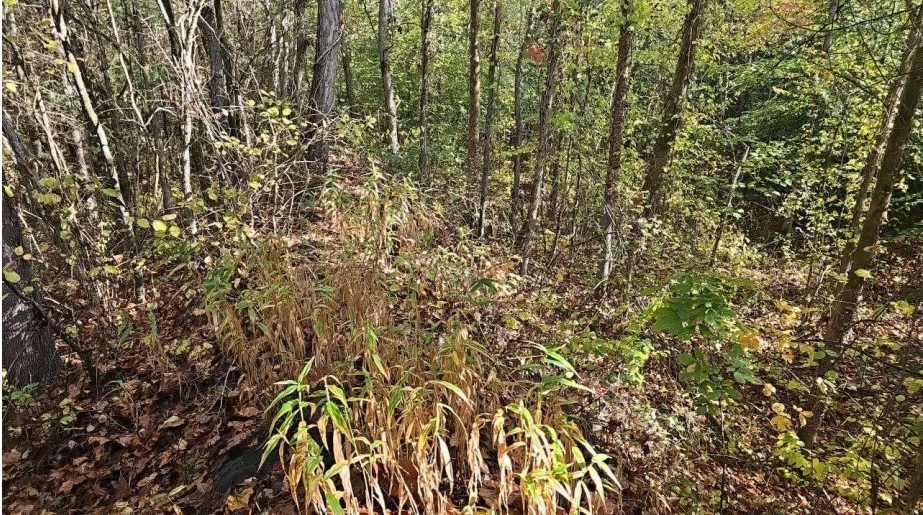
The upstream slope of the dam is in fair condition. The slope vegetative cover is overgrown with woody vegetation that should be maintained to 12-inches or less as shown in Photograph No. 15.

PHOTOGRAPH No: 15	DATE: October 16, 2024 9:38 AM	LATITUDE: 39.85522147	LONGITUDE: -81.90337185
DIRECTION: 50°	SITE LOCATION: PHILO, OHIO		
DESCRIPTION: Upstream Slope. General Photo, Typical Conditions.

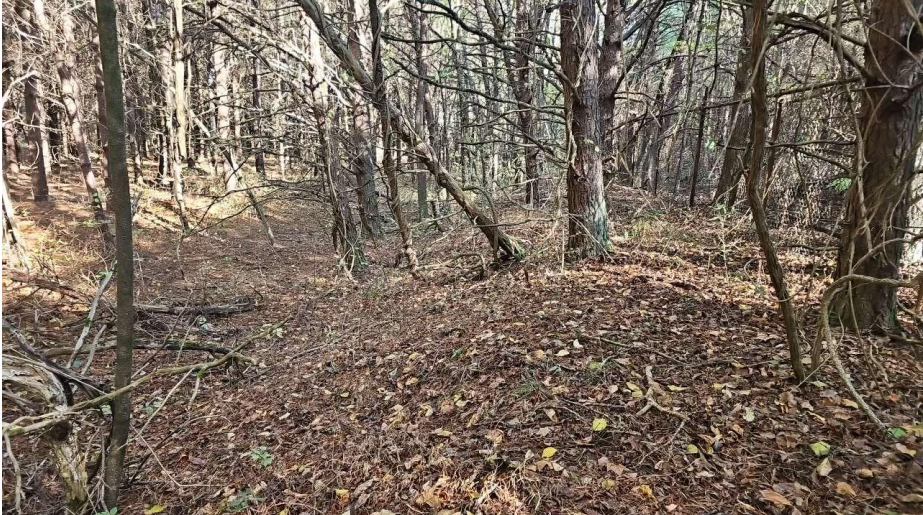
PHOTO BY: GEI CONSULTANTS, INC.			
PHOTOGRAPH No: 16	DATE: October 16, 2024 9:45 AM	LATITUDE: 39.85627643	LONGITUDE: -81.90328313
DIRECTION: 47°	SITE LOCATION: PHILO, OHIO		
DESCRIPTION: Downstream Slope. Ground Cover, Typical Conditions.
