## Ash Pond Initial Dam and Dike Inspection Report

Former Poston Power Plant, Athens County, Ohio

January 2025  
Project 2407654

# 2024 Annual Inspection Report

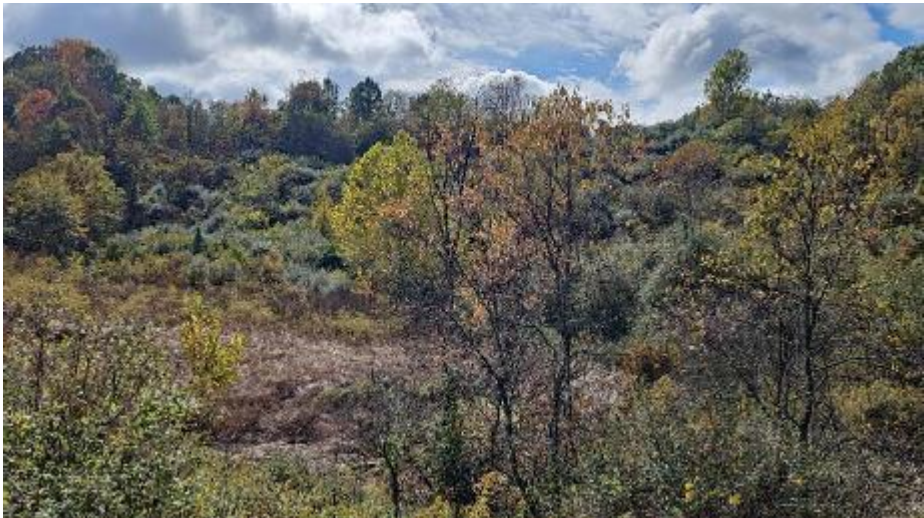
The downstream slope of the dam is in fair condition as it is overgrown with woody vegetation that should to be maintained to 12-inches or less as shown in Photograph No. 1, 2, 3, and 4.

<b>PHOTOGRAPH NO: 1</b>	<b>DATE:</b> October 15, 2024 1:20 PM	<b>LATITUDE:</b> 39.38532089	<b>LONGITUDE:</b> -82.17398209
<b>DIRECTION:</b> 138°		<b>SITE LOCATION:</b> ATHENS, OHIO	
<b>DESCRIPTION:</b>  Ash Pond, Downstream Slope.  Address/maintain vegetation to 12-inches or less within 25-feet of the toe of slope.	 		
<b>PHOTO BY:</b>  GEI CONSULTANTS, INC.			
<b>PHOTOGRAPH NO: 2</b>	<b>DATE:</b> October 15, 2024 1:23 PM	<b>LATITUDE:</b> 39.38815498	<b>LONGITUDE:</b> -82.17572009
<b>DIRECTION:</b> 117°		<b>SITE LOCATION:</b> ATHENS, OHIO	
<b>DESCRIPTION:</b>  Ash Pond, Downstream Slope.  Address/maintain vegetation to 12-inches or less within 25-feet of the toe of slope.

- Address/maintain vegetation to 12-inches or less within 25-feet of the limits of the embankments. AEP should consider identifying the unit boundary to establish limits where the vegetation should be maintained. Applies to Item No. 1-5.
- Address minor spillway blockages. Applies to Item No. 6, 7, and 9.
- Address spillway erosion. Applies to Item No. 10 and 11.

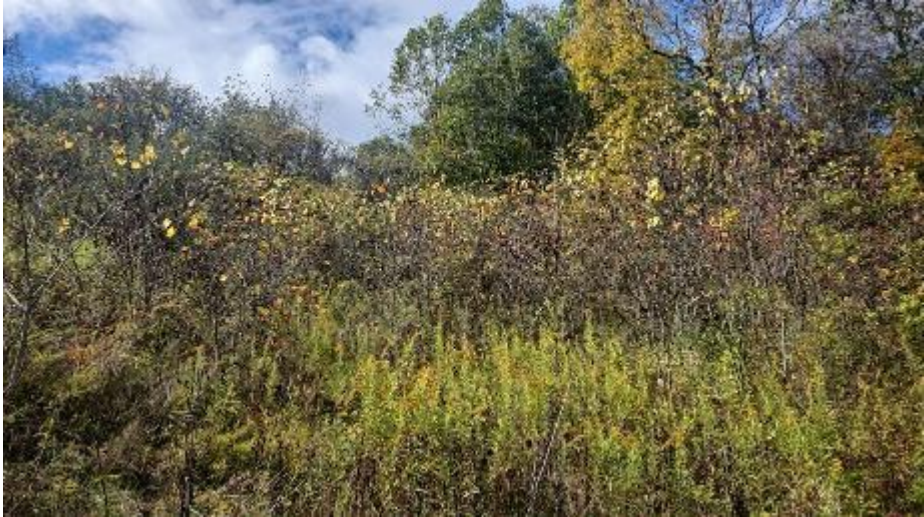
<b>PHOTOGRAPH NO: 3</b>	<b>DATE:</b> October 15, 2024 1:31 PM	<b>LATITUDE:</b> 39.38745851	<b>LONGITUDE:</b> -82.17674642
<b>DIRECTION:</b> 242°	<b>SITE LOCATION:</b> ATHENS, OHIO		
<b>DESCRIPTION:</b>  Ash Pond, Downstream Slope.  Address/maintain vegetation to 12-inches or less within 25-feet of the toe of slope.

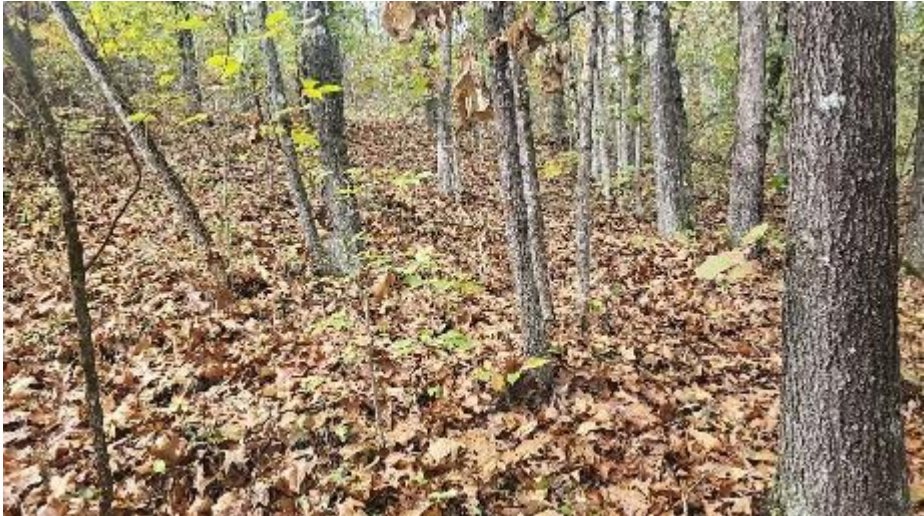
<b>PHOTO BY:</b>  GEI CONSULTANTS, INC.			
<b>PHOTOGRAPH NO: 4</b>	<b>DATE:</b> October 15, 2024 1:37 PM	<b>LATITUDE:</b> 39.38758506	<b>LONGITUDE:</b> -82.17718132
<b>DIRECTION:</b> 285°	<b>SITE LOCATION:</b> ATHENS, OHIO		
<b>DESCRIPTION:</b>  Ash Pond, Downstream Slope.  Address/maintain vegetation to 12-inches or less within 25-feet of the toe of slope.

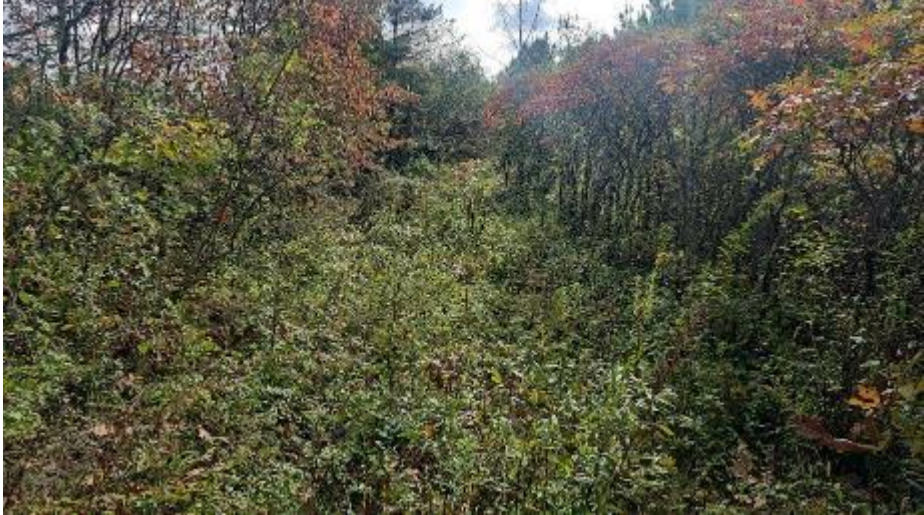
The upstream slope and crest of the dam is in fair condition as it is overgrown with woody vegetation that should to be maintained to 12-inches or less as shown in Photograph No. 5.

<b>PHOTOGRAPH NO: 5</b>	<b>DATE:</b> October 15, 2024 1:39 PM	<b>LATITUDE:</b> 39.38780383	<b>LONGITUDE:</b> -82.17751841
<b>DIRECTION: 70°</b>	<b>SITE LOCATION: ATHENS, OHIO</b>		
<b>DESCRIPTION:</b>  Ash Pond, Crest.  Address/maintain vegetation to 12-inches or less.

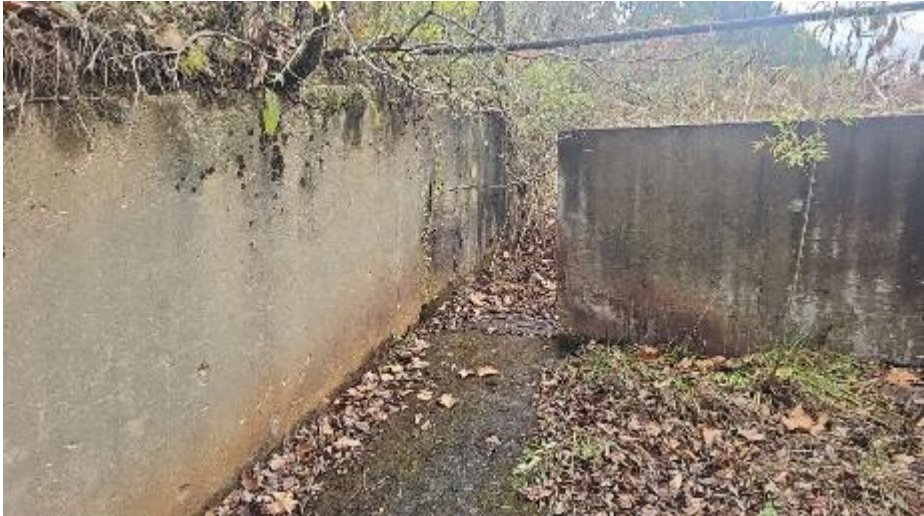
The spillway was in fair condition. Minor vegetation and debris should be addressed/removed to allow the structure to function as it was designed as shown in Photograph Nos. 6, 7, 8, and 9. Major erosion in the spillway should also be addressed as shown in Photograph No. 10.

<b>PHOTOGRAPH NO: 7</b>	<b>DATE:</b> October 15, 2024 1:52 PM	<b>LATITUDE:</b> 39.38888922	<b>LONGITUDE:</b> -82.17768938
<b>DIRECTION:</b> 104°	<b>SITE LOCATION:</b> ATHENS, OHIO		
<b>DESCRIPTION:</b>  Ash Pond, Outfall Structure, Looking upstream.  Address/maintain vegetation to maintain clear drainage pathway.	 		
<b>PHOTO BY:</b>  GEI CONSULTANTS, INC.			
<b>PHOTOGRAPH NO: 8</b>	<b>DATE:</b> October 15, 2024 1:53 PM	<b>LATITUDE:</b> 39.38891214	<b>LONGITUDE:</b> -82.17766035
<b>DIRECTION:</b> 358°	<b>SITE LOCATION:</b> ATHENS, OHIO		
<b>DESCRIPTION:</b>  General Photo, Typical Conditions.

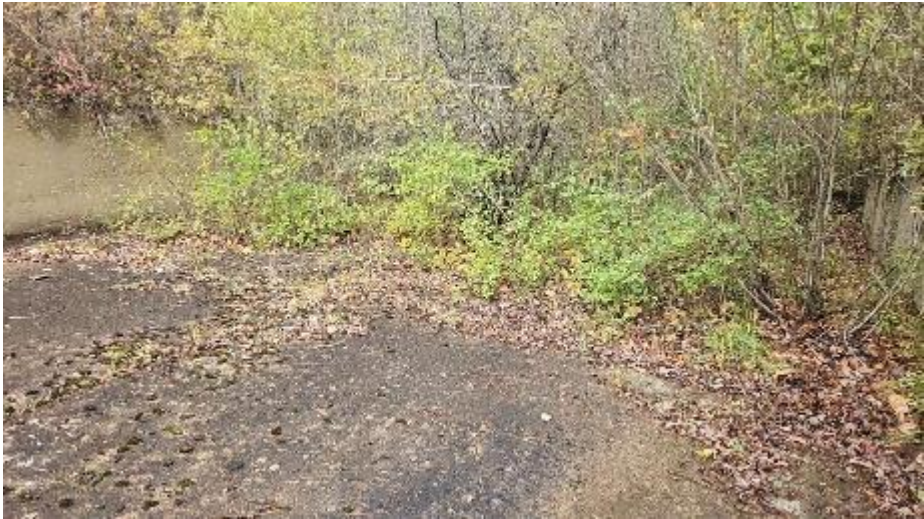
<b>PHOTOGRAPH NO: 9</b>	<b>DATE:</b> October 15, 2024 1:54 PM	<b>LATITUDE:</b> 39.38889134	<b>LONGITUDE:</b> -82.17762026
<b>DIRECTION:</b> 310°	<b>SITE LOCATION:</b> ATHENS, OHIO		
<b>DESCRIPTION:</b>  Ash Pond, Spillway.  Address minor blockage to allow spillway to function as it was designed.

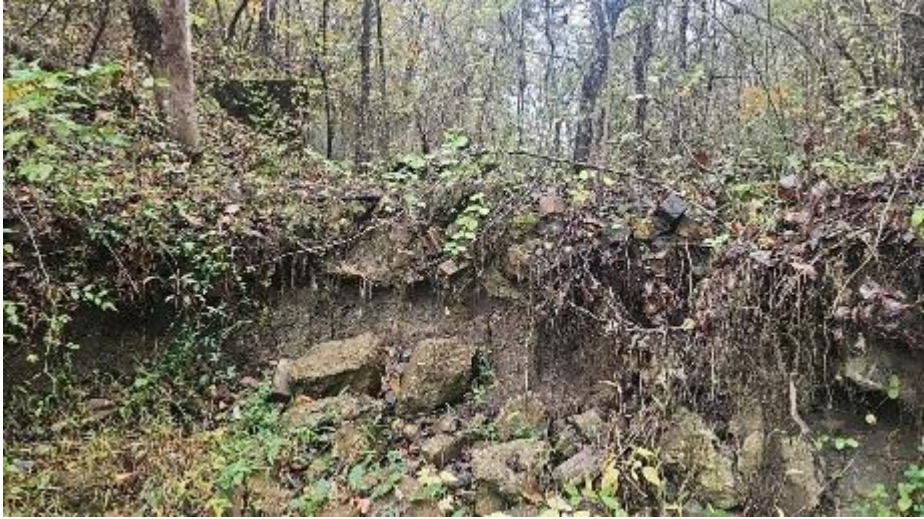
<b>PHOTO BY:</b>  GEI CONSULTANTS, INC.			
<b>PHOTOGRAPH NO: 10</b>	<b>DATE:</b> October 15, 2024 1:59 PM	<b>LATITUDE:</b> 39.38907392	<b>LONGITUDE:</b> -82.17737892
<b>DIRECTION:</b> 291°	<b>SITE LOCATION:</b> ATHENS, OHIO		
<b>DESCRIPTION:</b>  Ash Pond, Spillway, looking upstream.  Address / Maintain Major Erosion.

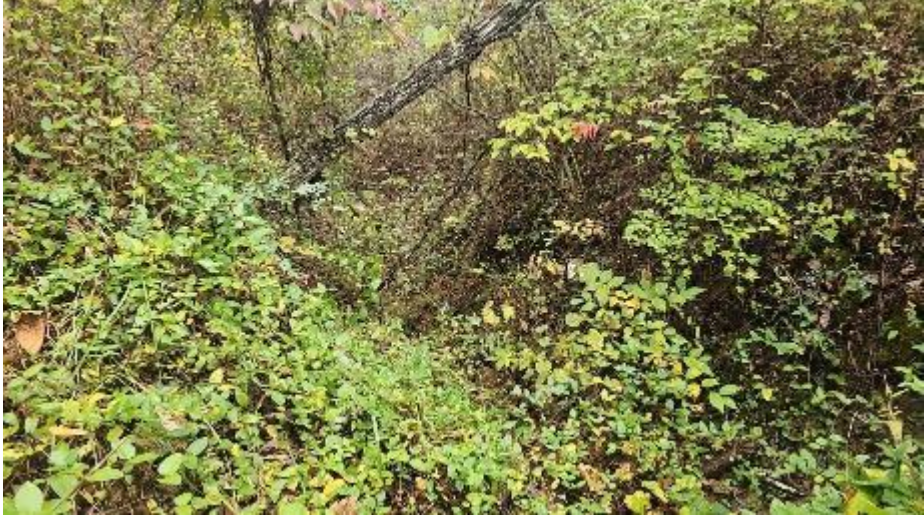
<b>PHOTOGRAPH No: 11</b>	<b>DATE:</b> October 15, 2024 2:00 PM	<b>LATITUDE:</b> 39.38906412	<b>LONGITUDE:</b> -82.17738074
<b>DIRECTION:</b> 41°	<b>SITE LOCATION:</b> ATHENS, OHIO		
<b>DESCRIPTION:</b>  Ash Pond, Spillway, looking downstream.  Address / Maintain Major Erosion.

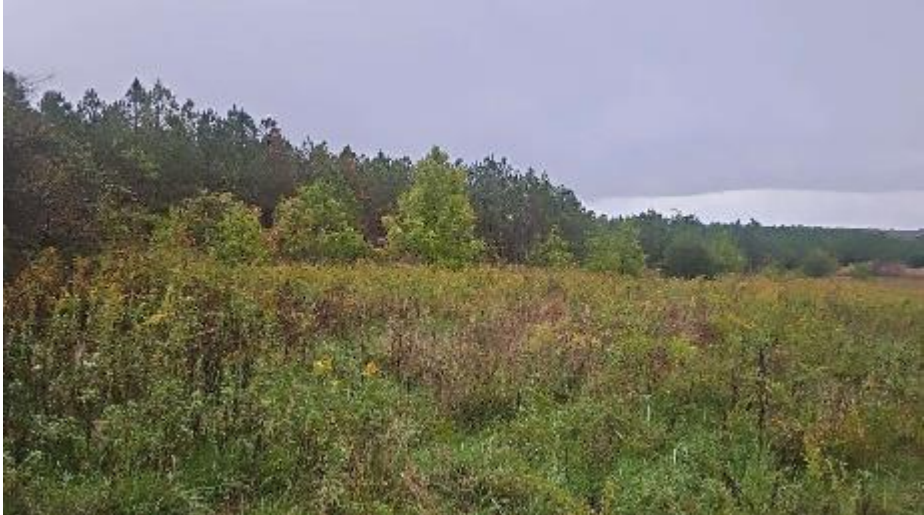
The interior of the Ash Pond is in fair condition. Its vegetation is overgrown as shown on Photograph No. 12, 13, and 14.

<b>PHOTO BY:</b>  GEI CONSULTANTS, INC.			
<b>PHOTOGRAPH No: 12</b>	<b>DATE:</b> October 15, 2024 2:43 PM	<b>LATITUDE:</b> 39.3880584	<b>LONGITUDE:</b> -82.18167523
<b>DIRECTION:</b> 313°	<b>SITE LOCATION:</b> ATHENS, OHIO		
<b>DESCRIPTION:</b>  Finger on Upstream Side. General Photo, Typical Conditions.

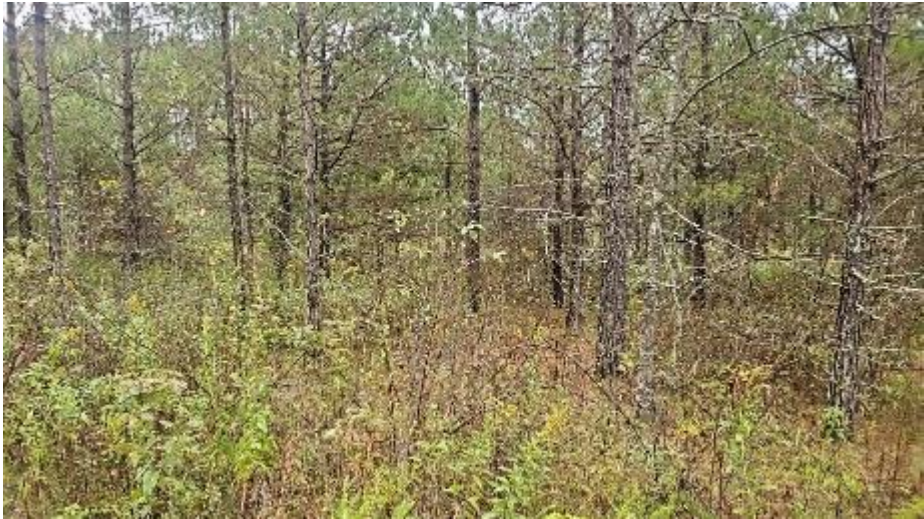
<b>PHOTOGRAPH No: 13</b>	<b>DATE:</b> October 15, 2024 2:44 PM	<b>LATITUDE:</b> 39.38827082	<b>LONGITUDE:</b> -82.18172876
<b>DIRECTION:</b> 311°	<b>SITE LOCATION:</b> ATHENS, OHIO		
<b>DESCRIPTION:</b>  Interior of Pond. Ground Cover, Typical Conditions.

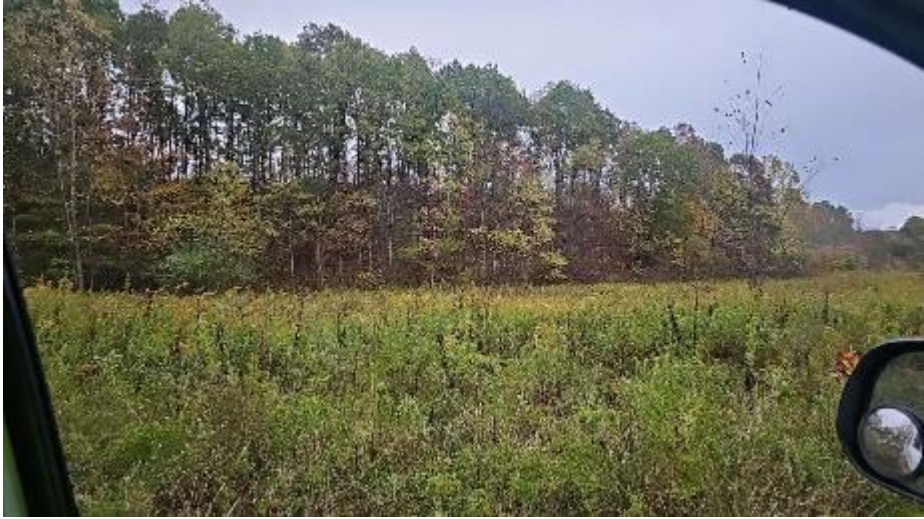
<b>PHOTO BY:</b>  GEI CONSULTANTS, INC.			
<b>PHOTOGRAPH No: 14</b>	<b>DATE:</b> October 15, 2024 2:46 PM	<b>LATITUDE:</b> 39.38969992	<b>LONGITUDE:</b> -82.18207257
<b>DIRECTION:</b> 337°	<b>SITE LOCATION:</b> ATHENS, OHIO		
<b>DESCRIPTION:</b>  Interior. Ground Cover, Typical Conditions.
