Auxiliary Ash Pond Complex Initial Dam and Dike Inspection Report

Glen Lyn Plant, Glen Lyn, Virginia

February 10, 2025
Project 2407654

2024 Annual Inspection Report

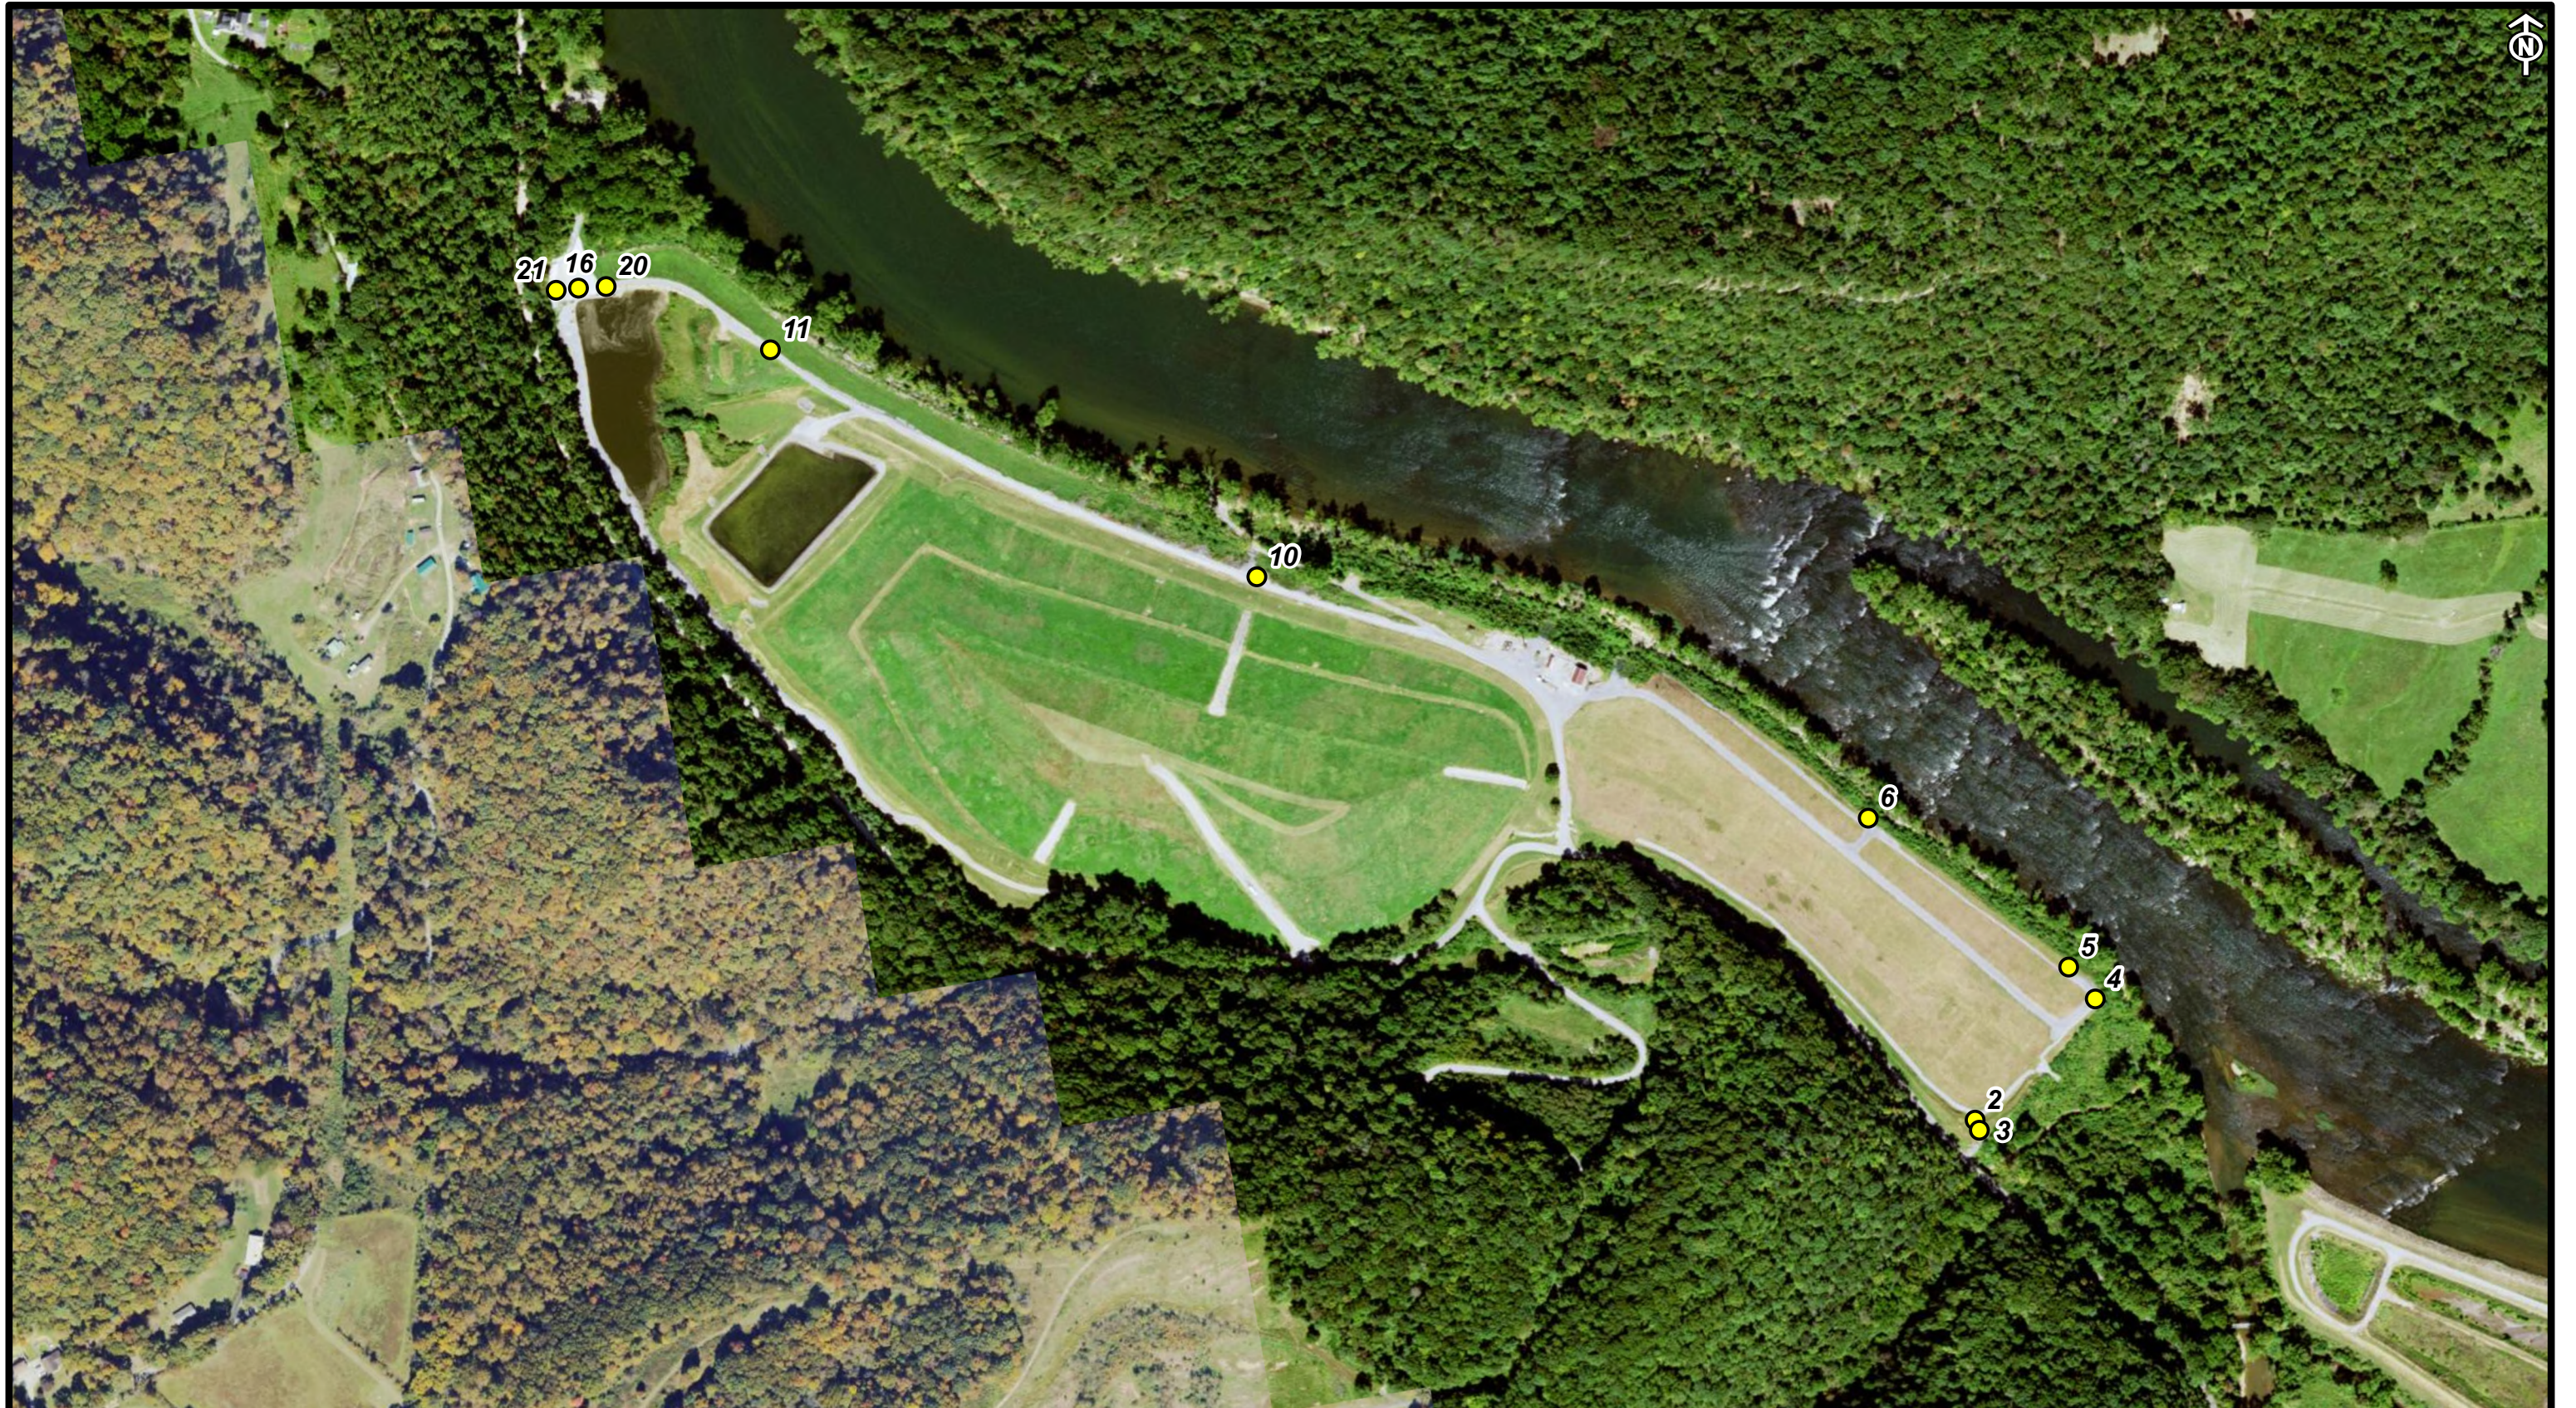
ITEMS TO BE MONITORED

- Items 2-6 - Monitor vegetation and maintain as needed.
- Item 10 and 11- Monitor woody vegetation along river and maintain as needed.
- Item 16 - Monitor for stormwater features for blockages/debris, clear/maintain as needed.
- Item 20 and 21 - Monitor for stormwater ditches for blockages/debris, clear/maintain as needed.

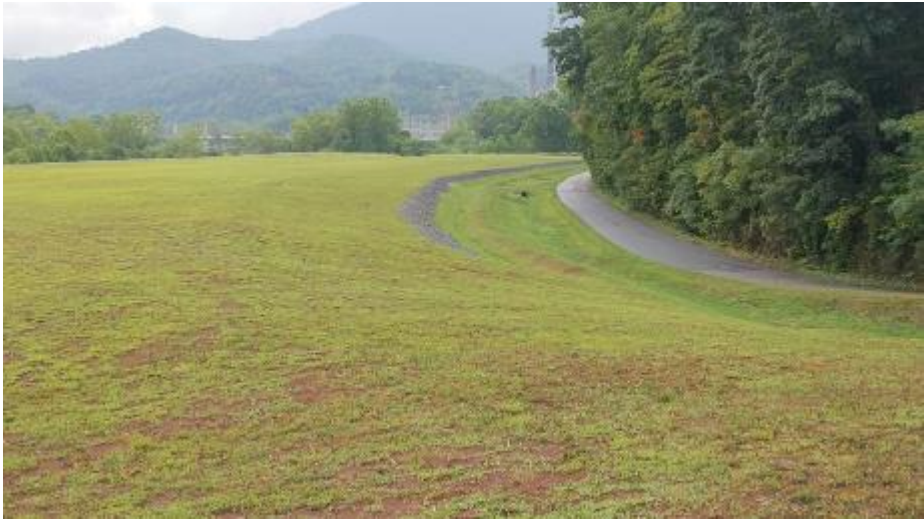
PHOTOGRAPH NO: 1	DATE: July 24, 2024 9:54 AM	LATITUDE: 37.37730753	LONGITUDE: -80.87243676
DIRECTION: 33°	SITE LOCATION: GLEN LYN, VIRGINIA		
DESCRIPTION: Downstream Slope of Perimeter Berm. Perimeter toe ditch and drainage features in good condition.

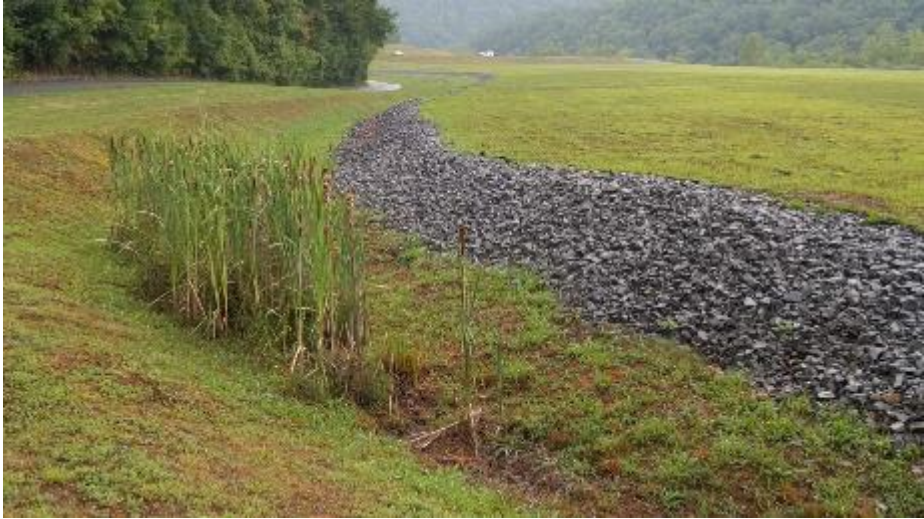
PHOTO BY: GEI CONSULTANTS, INC.			
PHOTOGRAPH NO: 2	DATE: July 24, 2024 10:09 AM	LATITUDE: 37.37460122	LONGITUDE: -80.86946347
DIRECTION: 250°	SITE LOCATION: GLEN LYN, VIRGINIA		
DESCRIPTION: Perimeter ditch. Monitor vegetation and maintain as needed.

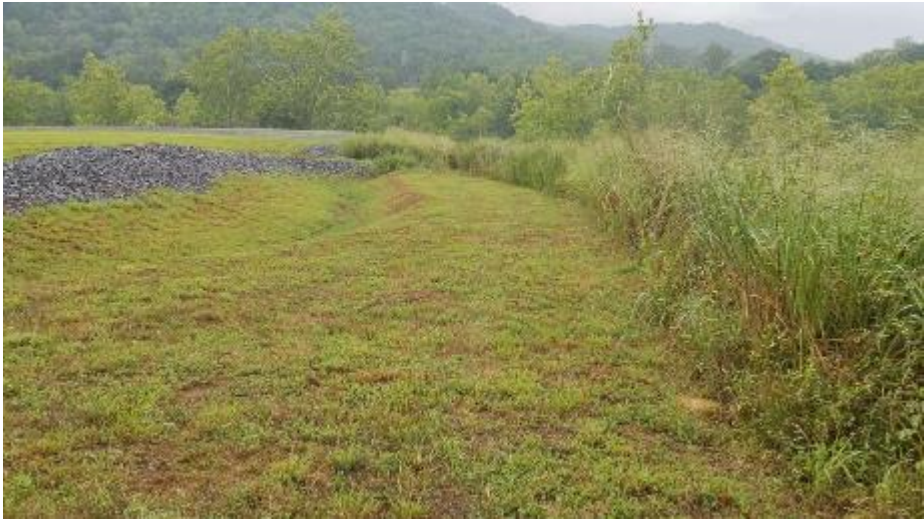
PHOTOGRAPH NO: 3	DATE: July 24, 2024 10:12 AM	LATITUDE: 37.37452523	LONGITUDE: -80.86944048
DIRECTION: 328°	SITE LOCATION: GLEN LYN, VIRGINIA		
DESCRIPTION: Downstream slope of perimeter berm. Monitor vegetation and address as needed.

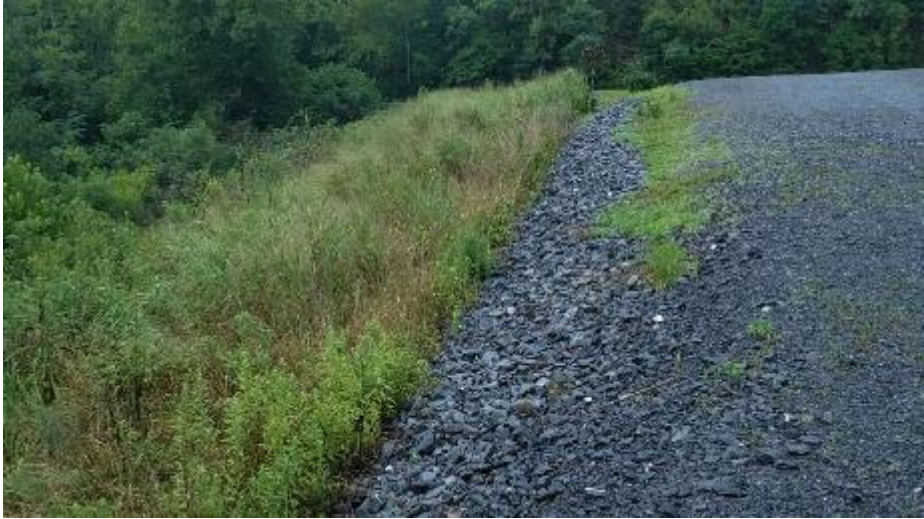
PHOTO BY: GEI CONSULTANTS, INC.			
PHOTOGRAPH NO: 4	DATE: July 24, 2024 10:20 AM	LATITUDE: 37.37528135	LONGITUDE: -80.86826671
DIRECTION: 156°	SITE LOCATION: GLEN LYN, VIRGINIA		
DESCRIPTION: Perimeter Berm. Monitor vegetation and address as needed.

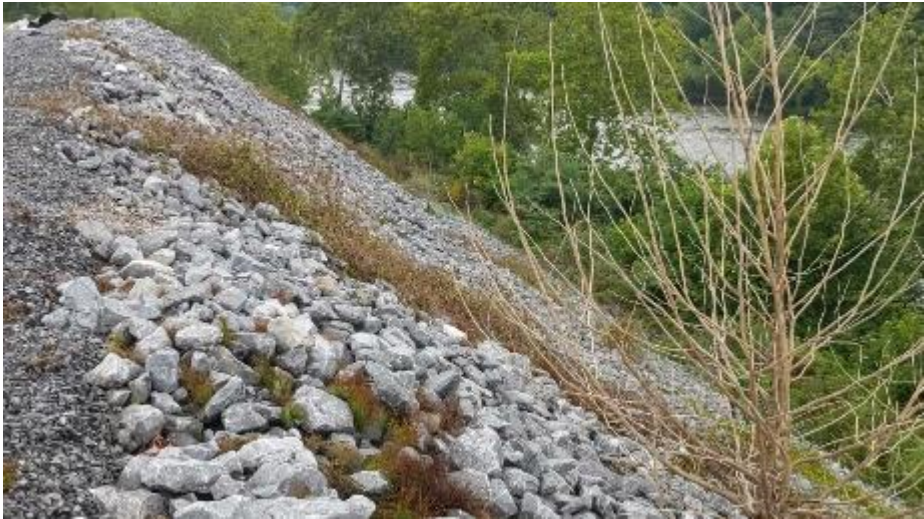
PHOTOGRAPH NO: 7	DATE: July 24, 2024 10:44 AM	LATITUDE: 37.37792164	LONGITUDE: -80.87167
DIRECTION: 256°	SITE LOCATION: GLEN LYN, VIRGINIA		
DESCRIPTION: Downstream slope of Perimeter Berm. Woody vegetation recently sprayed.

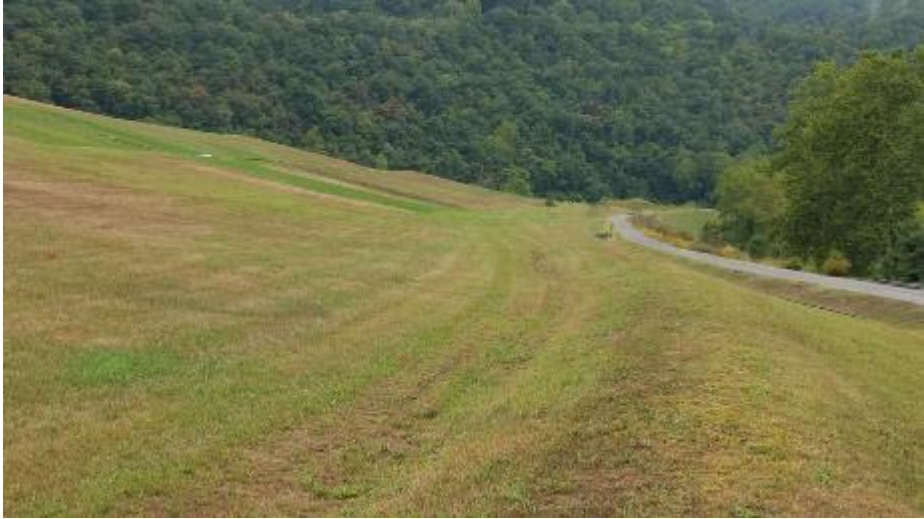
PHOTO BY: GEI CONSULTANTS, INC.			
PHOTOGRAPH NO: 8	DATE: July 24, 2024 10:49 AM	LATITUDE: 37.37811738	LONGITUDE: -80.87294048
DIRECTION: 226°	SITE LOCATION: GLEN LYN, VIRGINIA		
DESCRIPTION: Downstream slope of Landfill. Areas previously repaired. General Photo, Typical Conditions.

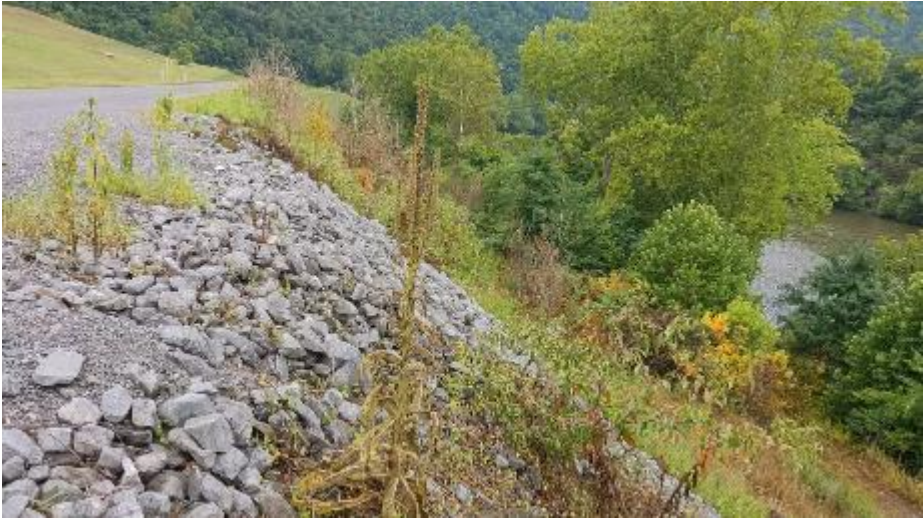
The downstream slope of the dam was in fair to good condition. Vegetation was observed in isolated areas in excess of 12-inches. The vegetation should be monitored and addressed as appropriate as shown in photograph No. 10 and 11. Downstream slopes on other areas of the dam are in good condition with vegetation maintained to 12-inches or less with no seepage observed as shown in Photograph No. 18 and 19.

PHOTOGRAPH NO: 10	DATE: July 24, 2024 10:57 AM	LATITUDE: 37.37911928	LONGITUDE: -80.87477502
DIRECTION: 244°	SITE LOCATION: GLEN LYN, VIRGINIA		
DESCRIPTION: Downstream slope of Dam. Monitor woody vegetation along river and address as needed.

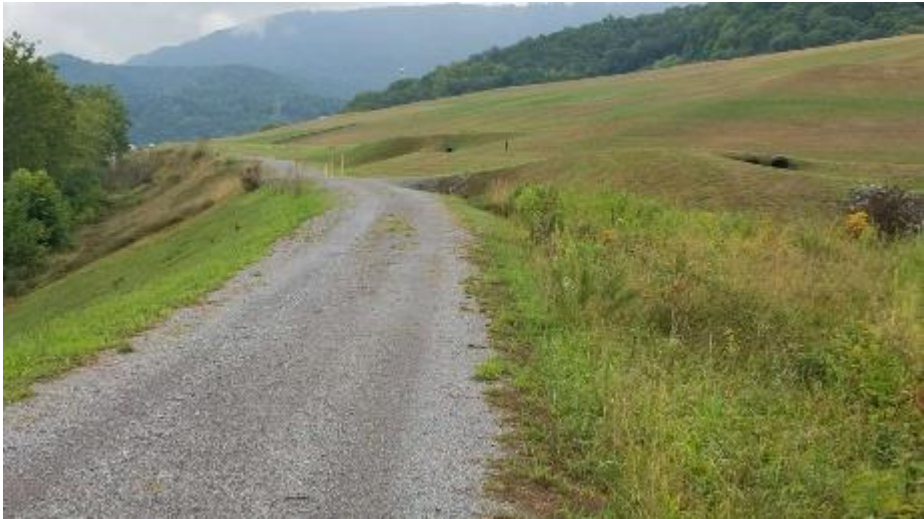
PHOTOGRAPH No: 11	DATE: July 24, 2024 11:11 AM	LATITUDE: 37.38122399	LONGITUDE: -80.87857526
DIRECTION: 48°	SITE LOCATION: GLEN LYN, VIRGINIA		
DESCRIPTION: Downstream Slope. Monitor vegetation on downstream slope of perimeter berm, address as needed.

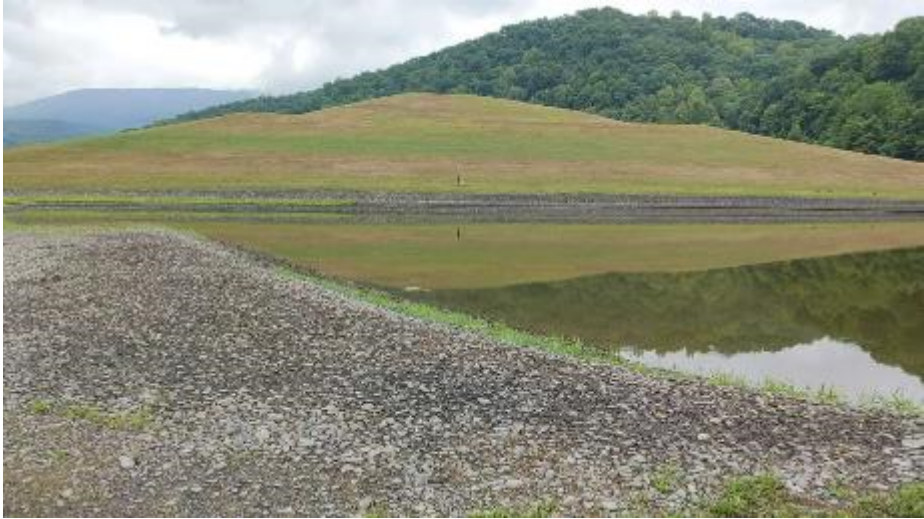
PHOTO BY: GEI CONSULTANTS, INC.			
PHOTOGRAPH No: 12	DATE: July 24, 2024 11:16 AM	LATITUDE: 37.38067261	LONGITUDE: -80.87846416
DIRECTION: 64°	SITE LOCATION: GLEN LYN, VIRGINIA		
DESCRIPTION: Leachate Collection System, Stilling Basin. General Photo, Typical Conditions.

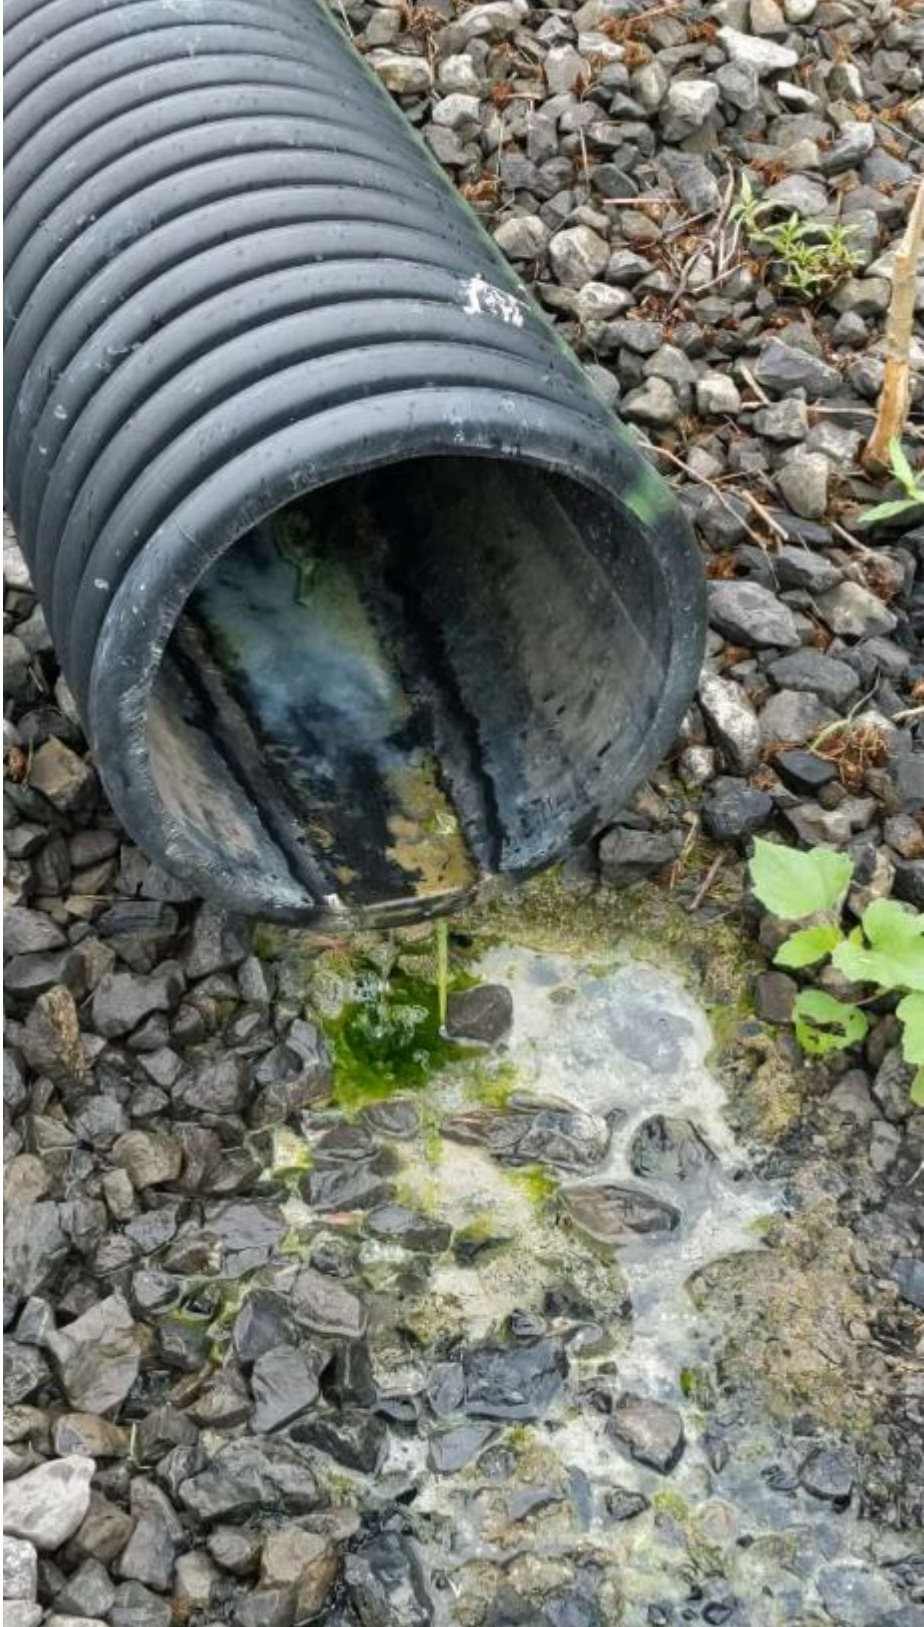
PHOTOGRAPH No: 14	DATE: July 24, 2024 11:22 AM	LATITUDE: 37.37962741	LONGITUDE: -80.87900363
DIRECTION: 209°		SITE LOCATION: GLEN LYN, VIRGINIA	
DESCRIPTION: Leachate Collection System area, Leachate Collection Drain Outlet. Very low flow observed.

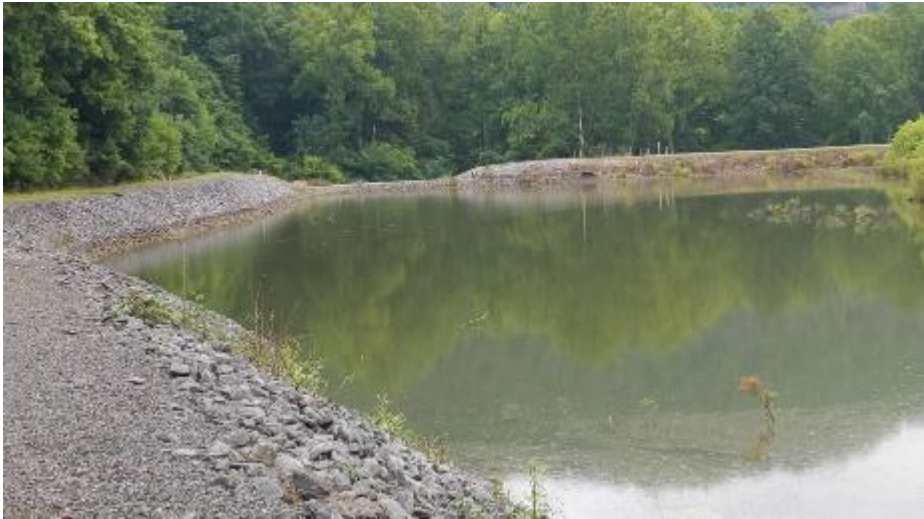
PHOTOGRAPH No: 15	DATE: July 24, 2024 11:28 AM	LATITUDE: 37.38025648	LONGITUDE: -80.88005334
DIRECTION: 286°	SITE LOCATION: GLEN LYN, VIRGINIA		
DESCRIPTION: Upstream Slope of Stormwater Runoff Pond. General Photo, Typical Conditions.

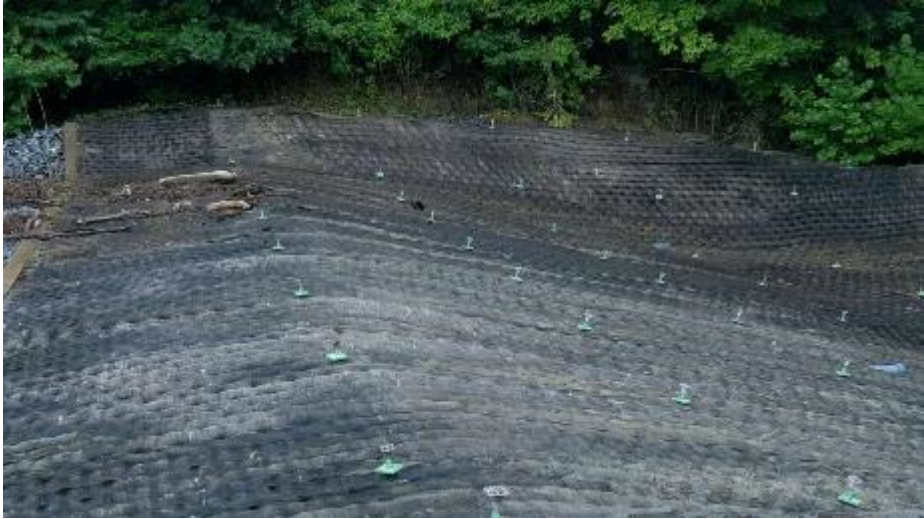
PHOTO BY: GEI CONSULTANTS, INC.			
PHOTOGRAPH No: 16	DATE: July 24, 2024 11:32 AM	LATITUDE: 37.38186493	LONGITUDE: -80.88011865
DIRECTION: 222°	SITE LOCATION: GLEN LYN, VIRGINIA		
DESCRIPTION: Downstream Slope of Spillway Area. General Photo, Monitor for blockages/debris, address as needed.

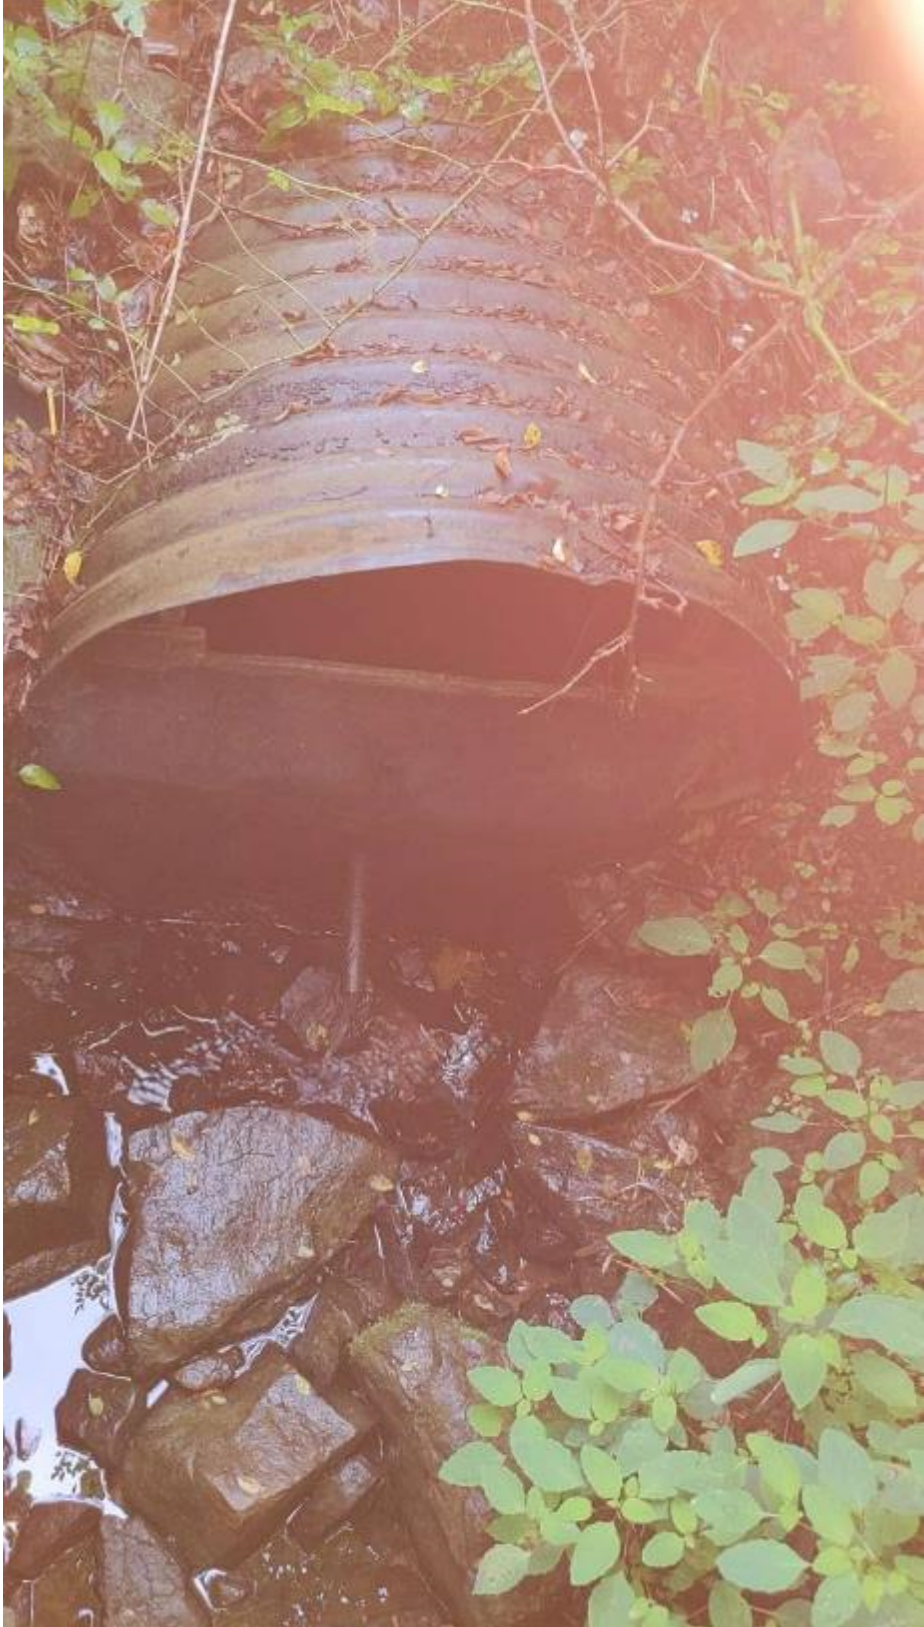
PHOTOGRAPH No: 17	DATE: July 24, 2024 11:35 AM	LATITUDE: 37.38217928	LONGITUDE: -80.87989362
DIRECTION: 174°		SITE LOCATION: GLEN LYN, VIRGINIA	
DESCRIPTION: Outlet Works area, Pipe Culvert Drain. General Photo, Typical Conditions.

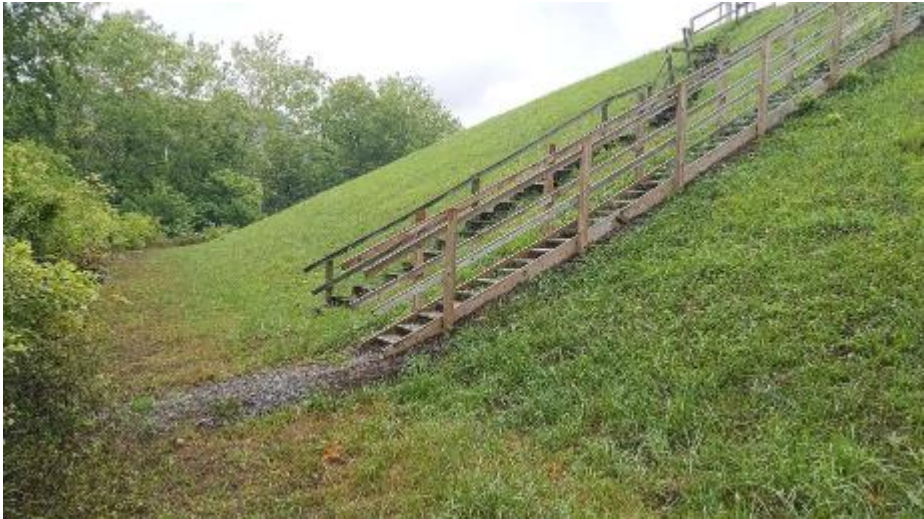
PHOTOGRAPH No: 18	DATE: July 24, 2024 11:37 AM	LATITUDE: 37.38206484	LONGITUDE: -80.87999091
DIRECTION: 23°	SITE LOCATION: GLEN LYN, VIRGINIA		
DESCRIPTION: Downstream Slope of Dam. General Photo, Typical Conditions.

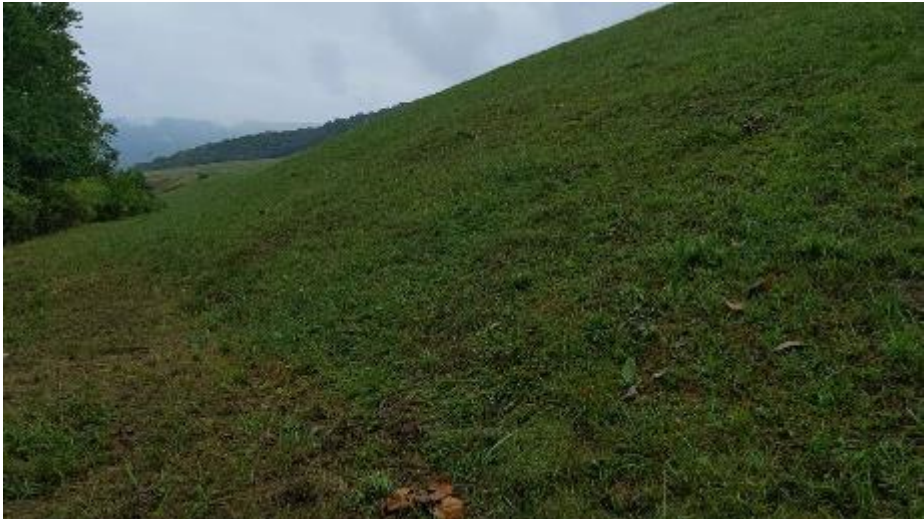
PHOTO BY: GEI CONSULTANTS, INC.			
PHOTOGRAPH No: 19	DATE: July 24, 2024 11:39 AM	LATITUDE: 37.38199396	LONGITUDE: -80.87919087
DIRECTION: 69°	SITE LOCATION: GLEN LYN, VIRGINIA		
DESCRIPTION: Downstream Slope of Dam. General Photo, Typical Conditions.

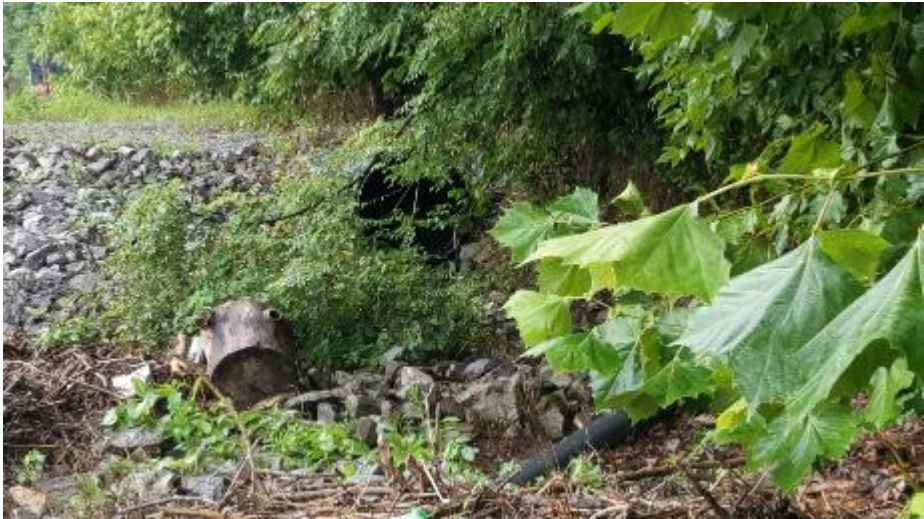
The perimeter berm downstream slope and toe ditch are in good condition. Vegetation is generally maintained to 12-inches or less and with no major blockages observed in the perimeter toe ditch as shown in photograph No. 1-7. One minor ditch blockage was observed in an isolated area. This area should be monitored and addressed if needed as shown in Photograph No. 20.

PHOTOGRAPH No: 20	DATE: July 24, 2024 11:45 AM	LATITUDE: 37.38187512	LONGITUDE: -80.88030911
DIRECTION: 101°	SITE LOCATION: GLEN LYN, VIRGINIA		
DESCRIPTION: Drainage Feature. Overgrown Vegetation, Monitor and Address as needed to prevent Blockage.

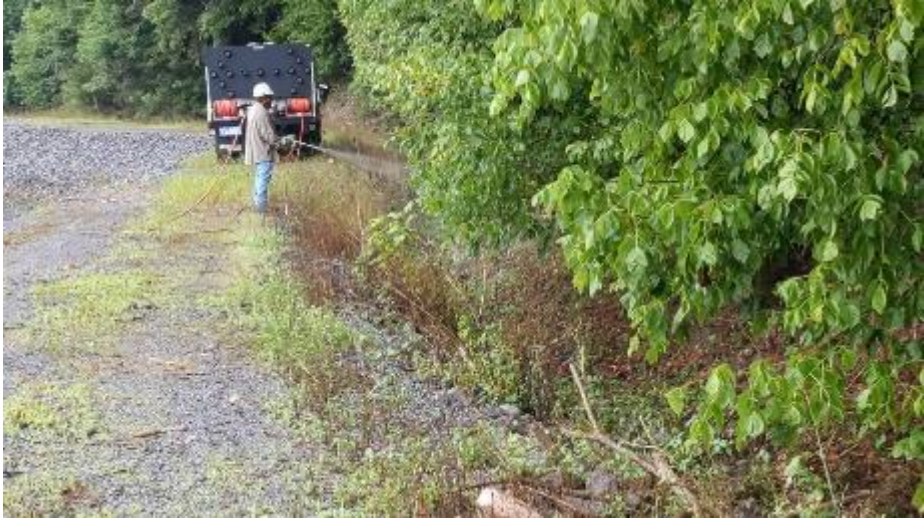
PHOTO BY: GEI CONSULTANTS, INC.			
PHOTOGRAPH No: 21	DATE: July 24, 2024 11:48 AM	LATITUDE: 37.38159224	LONGITUDE: -80.88032952
DIRECTION: 96°	SITE LOCATION: GLEN LYN, VIRGINIA		
DESCRIPTION: Perimeter Ditch. Monitor Accumulation of Debris and Overgrown Vegetation. Address as needed.

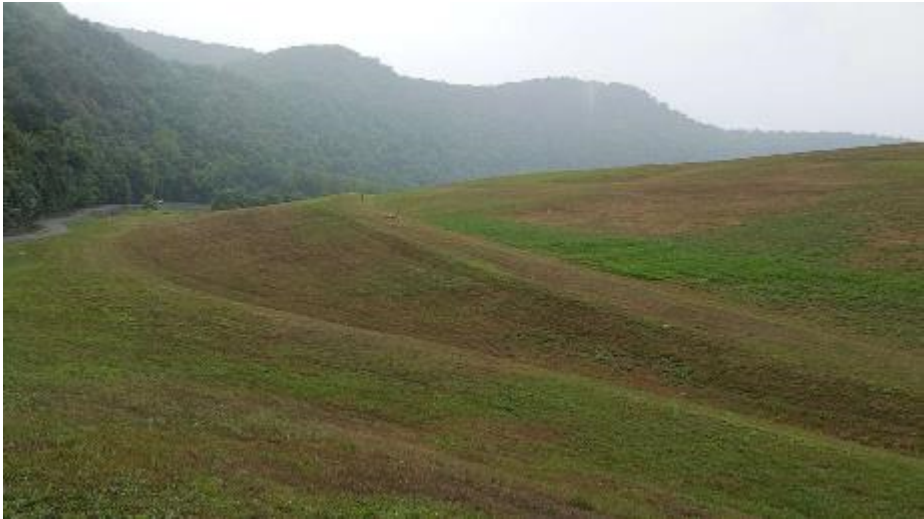
PHOTOGRAPH No: 22	DATE: July 24, 2024 11:57 AM	LATITUDE: 37.37750881	LONGITUDE: -80.87755271
DIRECTION: 275°	SITE LOCATION: GLEN LYN, VIRGINIA		
DESCRIPTION: Final Cover. General Photo, Typical Conditions.

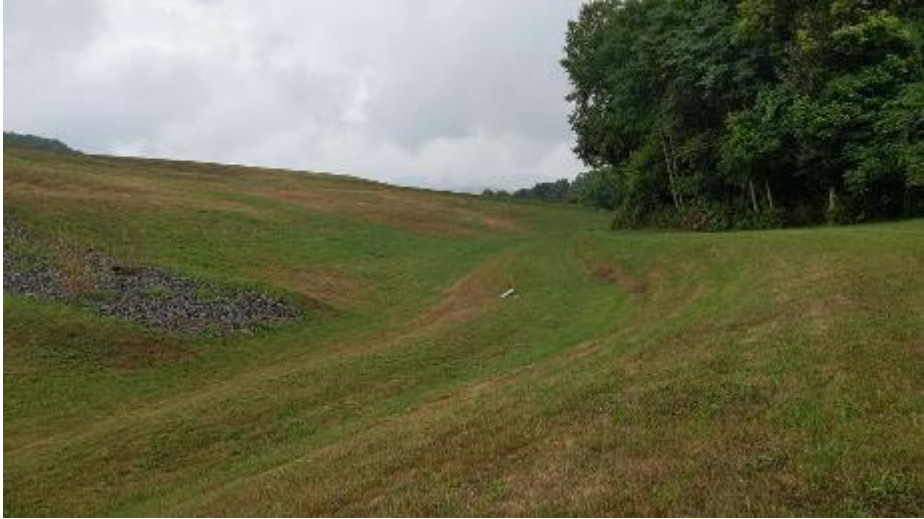
PHOTO BY: GEI CONSULTANTS, INC.			
PHOTOGRAPH No: 23	DATE: July 24, 2024 11:59 AM	LATITUDE: 37.37746496	LONGITUDE: -80.87737871
DIRECTION: 13°	SITE LOCATION: GLEN LYN, VIRGINIA		
DESCRIPTION: Final Cover. General Photo, Downstream Slope Drainage Feature in good condition.

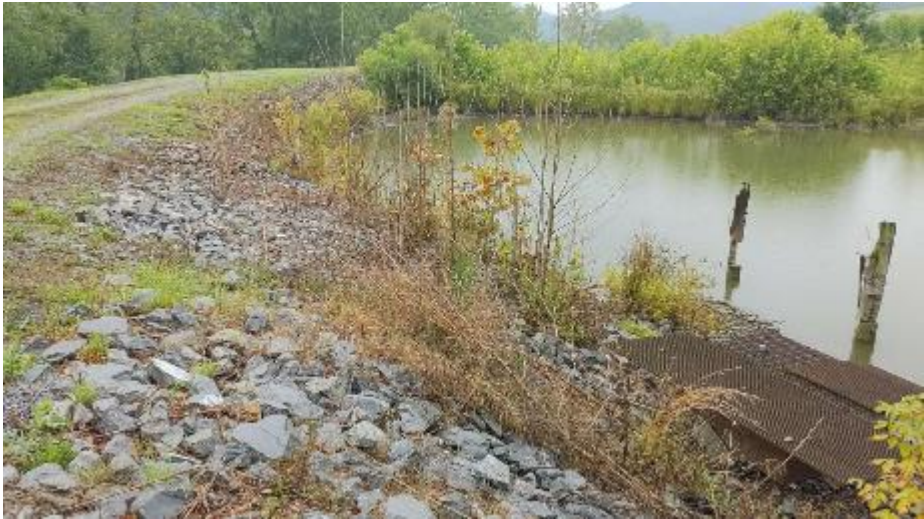
PHOTOGRAPH No: 26	DATE: July 24, 2024 11:42 AM	LATITUDE: 37.38184203	LONGITUDE: -80.87987972
DIRECTION: 16°	SITE LOCATION: GLEN LYN, VIRGINIA		
DESCRIPTION: Decant Structure. General Photo, riprap on upstream slope in good condition.
