## Bottom Ash Pond Complex Initial Dam and Dike Inspection Report

Glen Lyn Plant, Glen Lyn, Virginia

February 6, 2025  
Project 2407654

# 2024 Annual Inspection Report

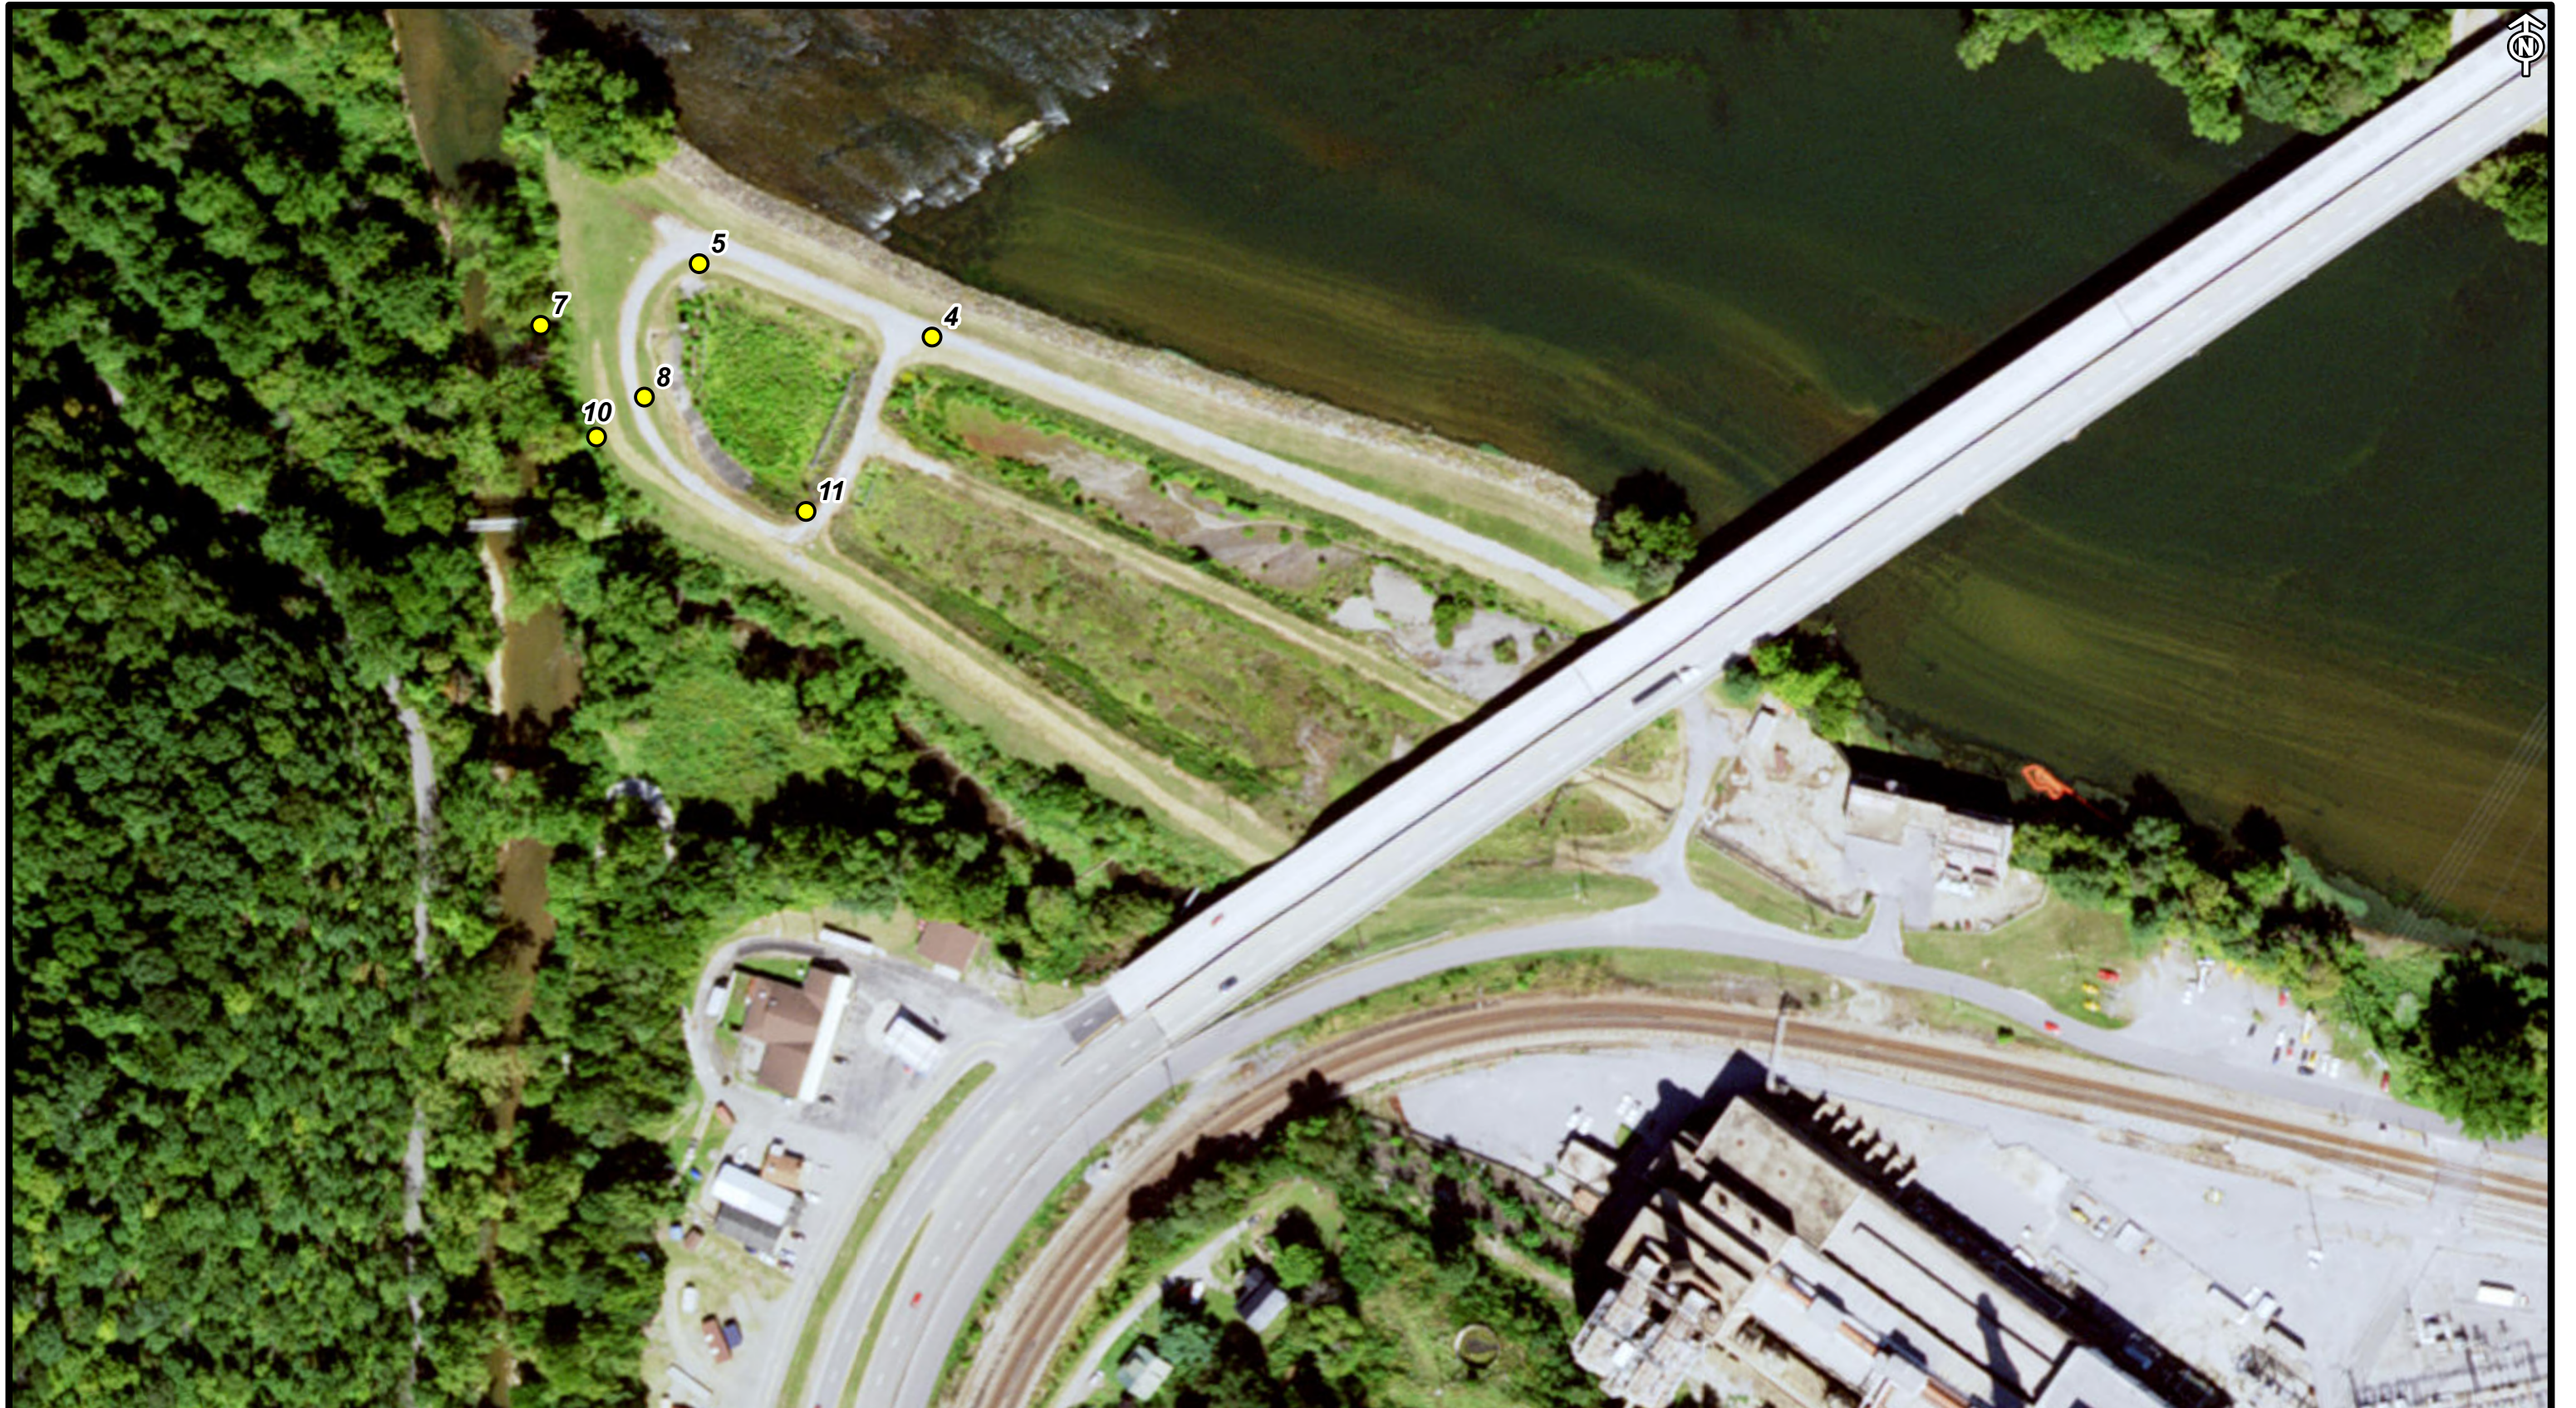
ITEMS TO BE MONITORED

- Items 4, 5, 8, 10, and 11 – Monitor the vegetation within 25-feet of the upstream and downstream side slopes and around drainage features and maintain to a height of 12-inches or less.
- Item 7 – Monitor the inlets and outlets of drainage features and maintain sediment build-up if sediment build-up becomes significant or restricts flow.

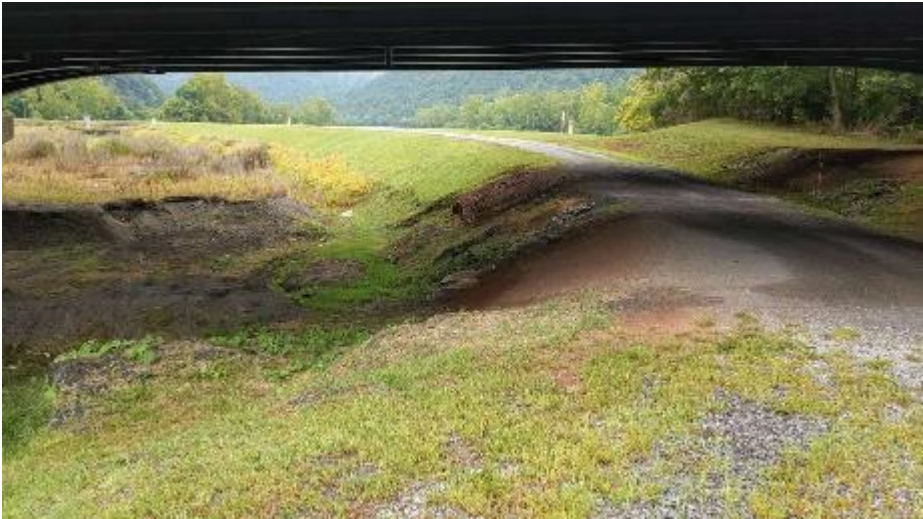
The upstream slopes of the Bottom Ash Pond Complex are in fair condition as shown in Photograph Nos. 1, 2, 5, 11, and 15.

<b>PHOTOGRAPH NO: 1</b>	<b>DATE:</b> July 24, 2024 8:45 AM	<b>LATITUDE:</b> 37.37030537	<b>LONGITUDE:</b> -80.86221625
<b>DIRECTION:</b> 273°		<b>SITE LOCATION:</b> GLEN LYN, VIRGINIA	
<b>DESCRIPTION:</b>  Upstream Slope of Inboard Dike. General Photo, Typical Conditions of Historic Erosion Repair.

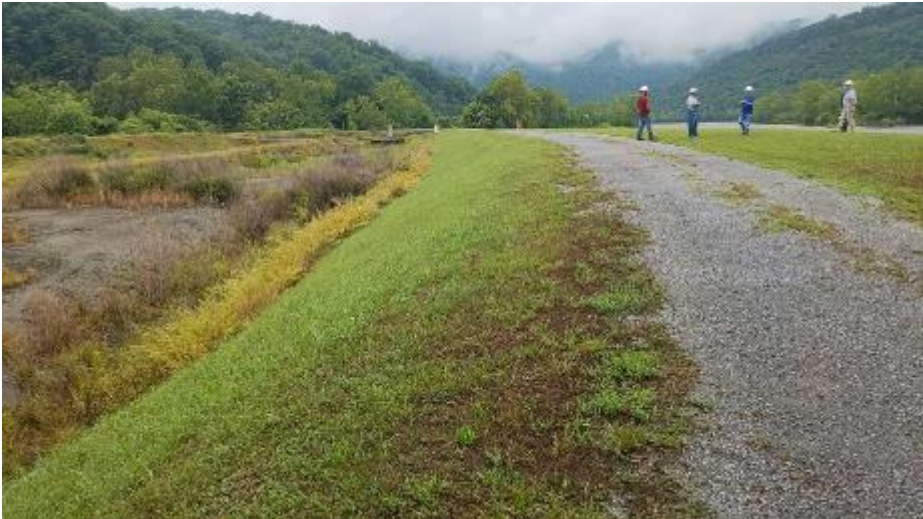
<b>PHOTO BY:</b>  GEI CONSULTANTS, INC.			
<b>PHOTOGRAPH NO: 2</b>	<b>DATE:</b> July 24, 2024 8:50 AM	<b>LATITUDE:</b> 37.37217351	<b>LONGITUDE:</b> -80.86402125
<b>DIRECTION:</b> 235°		<b>SITE LOCATION:</b> GLEN LYN, VIRGINIA	
<b>DESCRIPTION:</b>  Upstream Slope of Dam. Note Gravel Surface on Dam Crest Access Road.

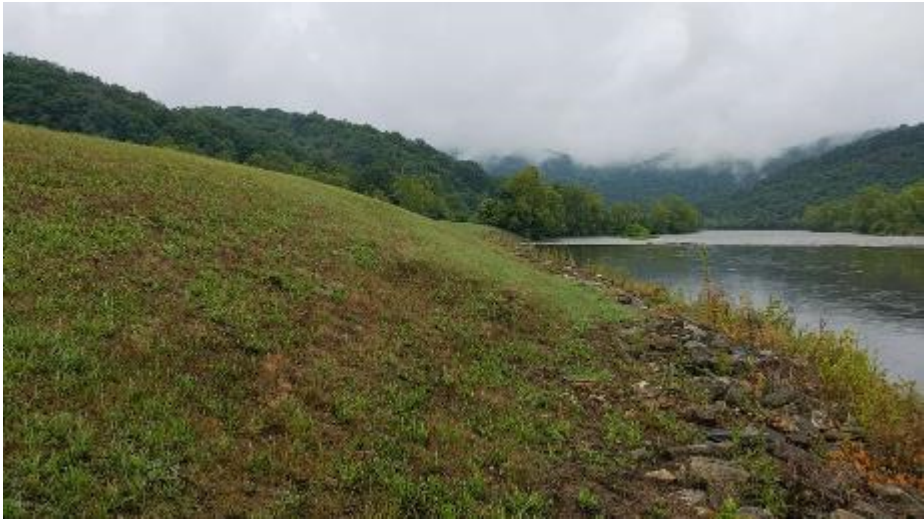
The downstream slope of the dam is in fair condition as shown in Photograph Nos. 3, 6, 9, 10 and 13.

<b>PHOTOGRAPH NO: 3</b>	<b>DATE:</b> July 24, 2024 8:53 AM	<b>LATITUDE:</b> 37.37236843	<b>LONGITUDE:</b> -80.86408915
<b>DIRECTION:</b> 235°	<b>SITE LOCATION:</b> GLEN LYN, VIRGINIA		
<b>DESCRIPTION:</b>  Downstream Slope of Dam. General Photo, Typical Conditions.

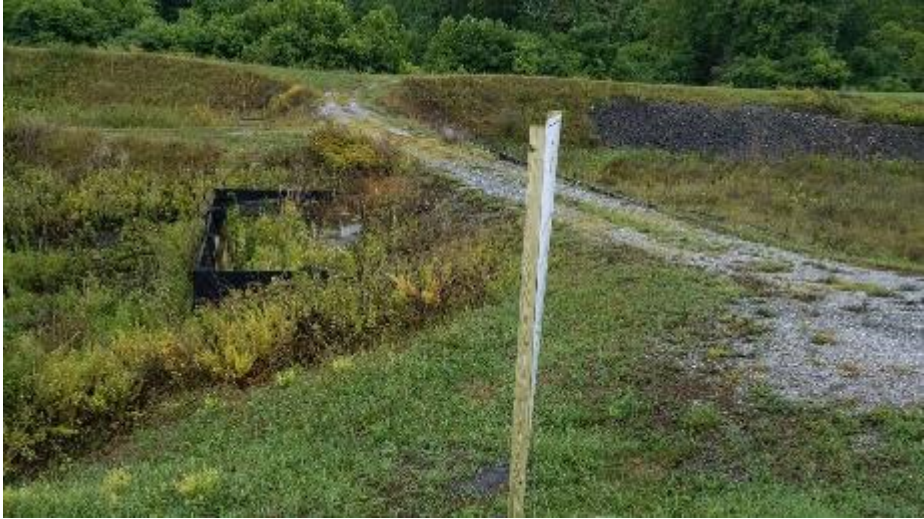
The stormwater structures were in fair condition. Areas around the structures have vegetation that should be maintained to 12-inches or less as shown in Photographs No. 4 and No. 5. A minor blockage was observed at a culvert outlet. Sediment build-up around drainage structures should be monitored and addressed as needed as shown in Photograph No. 7.

<b>PHOTO BY:</b>  GEI CONSULTANTS, INC.			
<b>PHOTOGRAPH NO: 4</b>	<b>DATE:</b> July 24, 2024 8:59 AM	<b>LATITUDE:</b> 37.37318878	<b>LONGITUDE:</b> -80.86599641
<b>DIRECTION:</b> 158°	<b>SITE LOCATION:</b> GLEN LYN, VIRGINIA		
<b>DESCRIPTION:</b>  Drainage Feature Overflow Structure. Overgrown, Monitor Conditions and Address as Appropriate.

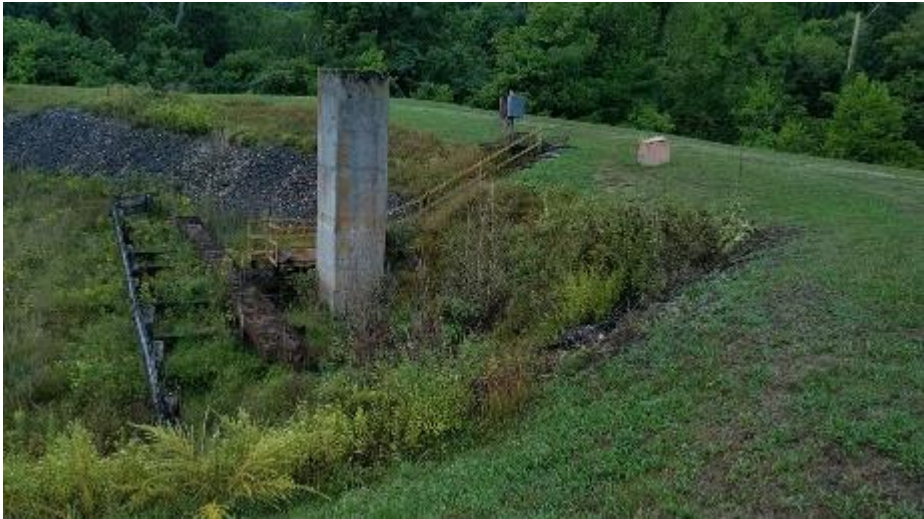
<b>PHOTOGRAPH NO: 5</b>	<b>DATE:</b> July 24, 2024 9:03 AM	<b>LATITUDE:</b> 37.37347732	<b>LONGITUDE:</b> -80.8666989
<b>DIRECTION: 142°</b>	<b>SITE LOCATION: GLEN LYN, VIRGINIA</b>		
<b>DESCRIPTION:</b>  Upstream Slope of Inactive Area. Overgrown Vegetation, Address as Appropriate in and around Overflow Structure.

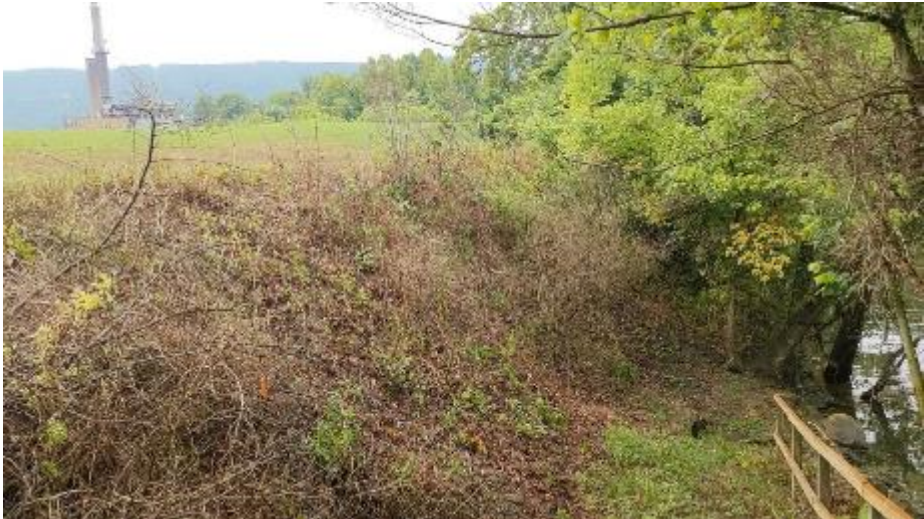
<b>PHOTO BY:</b>  GEI CONSULTANTS, INC.			
<b>PHOTOGRAPH NO: 6</b>	<b>DATE:</b> July 24, 2024 9:09 AM	<b>LATITUDE:</b> 37.3734601	<b>LONGITUDE:</b> -80.86724511
<b>DIRECTION: 70°</b>	<b>SITE LOCATION: GLEN LYN, VIRGINIA</b>		
<b>DESCRIPTION:</b>  Downstream Slope of Dam. Note Overgrown Brush and Vegetation, Recently Sprayed.

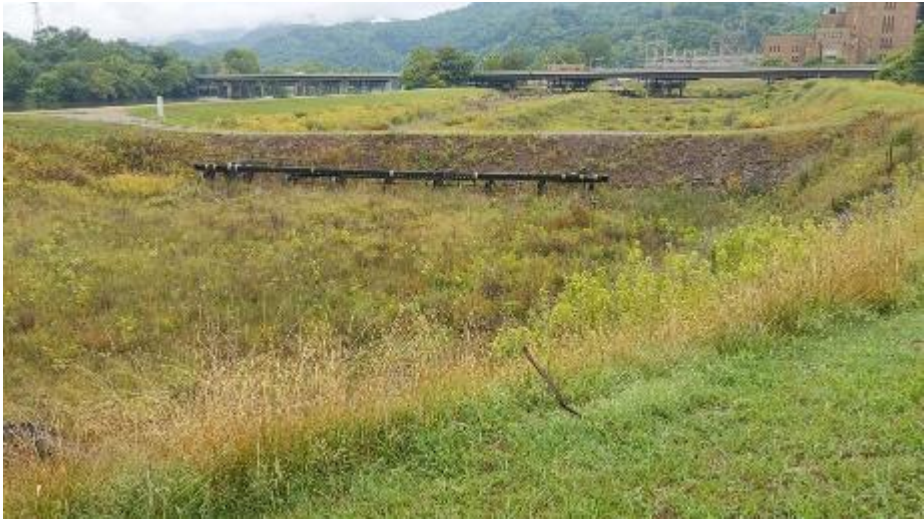
<b>PHOTOGRAPH NO: 8</b>	<b>DATE:</b> July 24, 2024 9:18 AM	<b>LATITUDE:</b> 37.37316136	<b>LONGITUDE:</b> -80.86694678
<b>DIRECTION: 19°</b>	<b>SITE LOCATION: GLEN LYN, VIRGINIA</b>		
<b>DESCRIPTION:</b>  Upstream Slope of Splitter Dike. Note Overgrown Vegetation Recently Sprayed. Address Additional Vegetation Growth as needed.

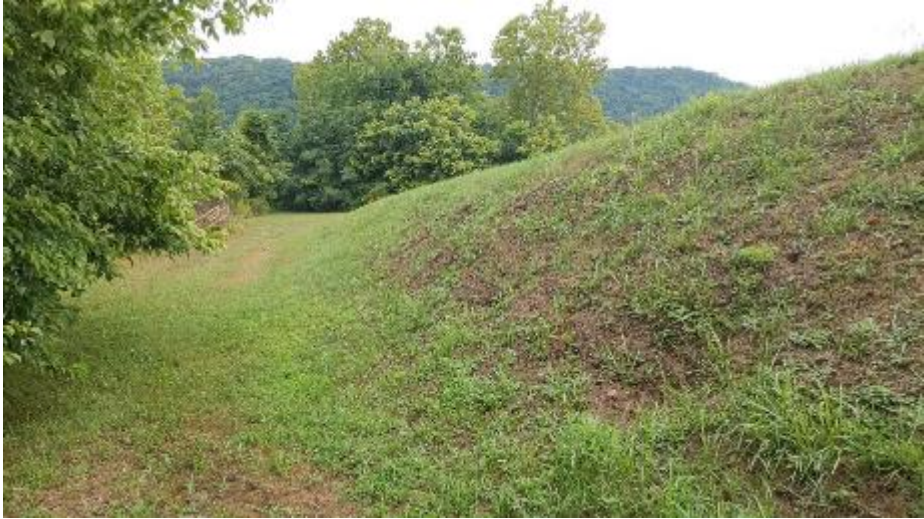
<b>PHOTO BY:</b>  GEI CONSULTANTS, INC.			
<b>PHOTOGRAPH NO: 9</b>	<b>DATE:</b> July 24, 2024 9:21 AM	<b>LATITUDE:</b> 37.37303993	<b>LONGITUDE:</b> -80.86712447
<b>DIRECTION: 293°</b>	<b>SITE LOCATION: GLEN LYN, VIRGINIA</b>		
<b>DESCRIPTION:</b>  Downstream Slope of Dam. Ground Cover, Typical Conditions.

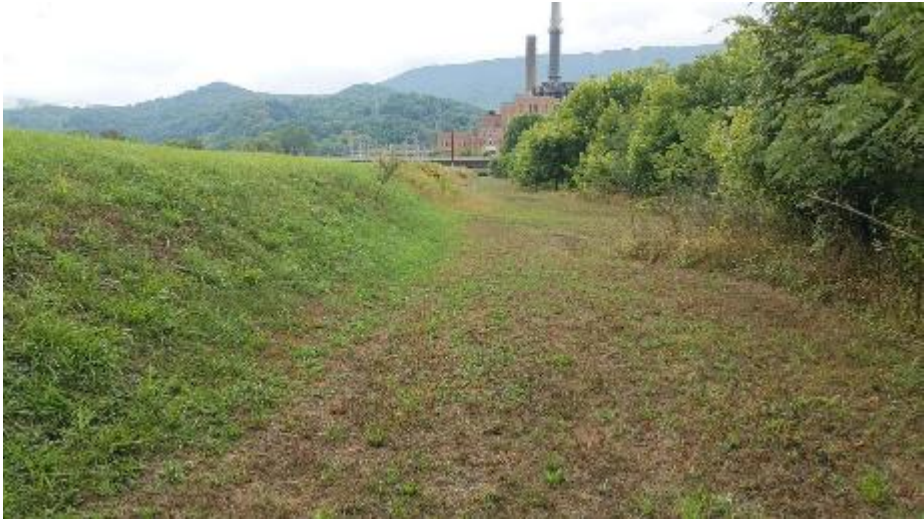
<b>PHOTOGRAPH No: 10</b>	<b>DATE:</b> July 24, 2024 9:22 AM	<b>LATITUDE:</b> 37.3730807	<b>LONGITUDE:</b> -80.86712031
<b>DIRECTION:</b> 39°	<b>SITE LOCATION:</b> GLEN LYN, VIRGINIA		
<b>DESCRIPTION:</b>  Downstream Slope of Dam. Note Small Trees and Brush, Address Overgrown Vegetation as needed.

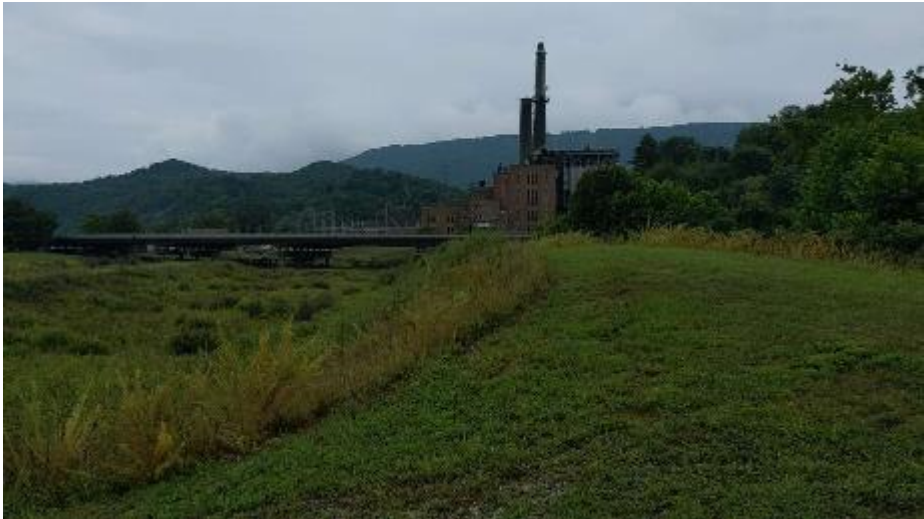
<b>PHOTO BY:</b>  GEI CONSULTANTS, INC.			
<b>PHOTOGRAPH No: 11</b>	<b>DATE:</b> July 24, 2024 9:25 AM	<b>LATITUDE:</b> 37.3728014	<b>LONGITUDE:</b> -80.86649406
<b>DIRECTION:</b> 40°	<b>SITE LOCATION:</b> GLEN LYN, VIRGINIA		
<b>DESCRIPTION:</b>  Upstream Slope of Dam. Note overgrown vegetation recently sprayed, General Photo, Monitor Conditions. Address overgrown vegetation as needed.

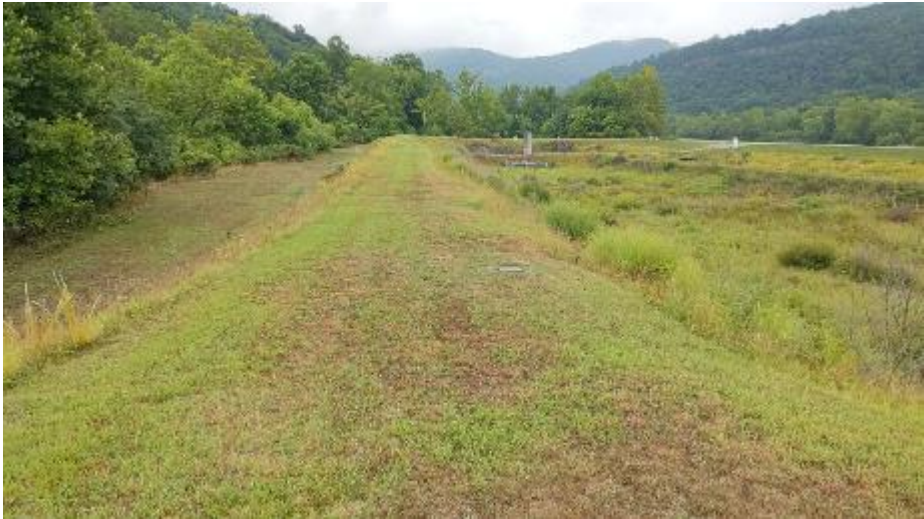
The crest of the dam is in fair condition and is used as an access road as shown in Photograph No. 12.

<b>PHOTOGRAPH No: 12</b>	<b>DATE:</b> July 24, 2024 9:28 AM	<b>LATITUDE:</b> 37.37273233	<b>LONGITUDE:</b> -80.86649703
<b>DIRECTION:</b> 253°	<b>SITE LOCATION:</b> GLEN LYN, VIRGINIA		
<b>DESCRIPTION:</b>  Crest of Dam. General Photo, Typical Conditions.

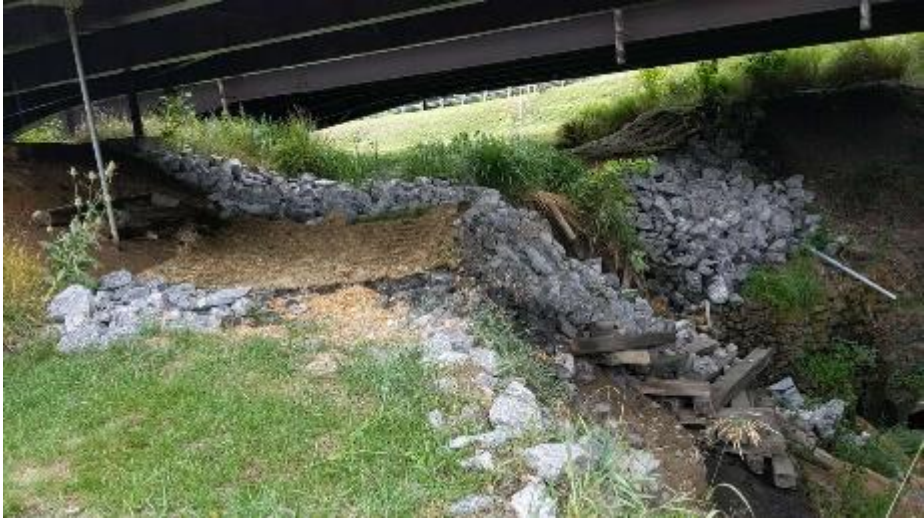
<b>PHOTO BY:</b>  GEI CONSULTANTS, INC.			
<b>PHOTOGRAPH No: 13</b>	<b>DATE:</b> July 24, 2024 9:32 AM	<b>LATITUDE:</b> 37.37150354	<b>LONGITUDE:</b> -80.86525236
<b>DIRECTION:</b> 39°	<b>SITE LOCATION:</b> GLEN LYN, VIRGINIA		
<b>DESCRIPTION:</b>  Downstream Slope of Drainage Feature. General Photo, Typical Conditions showing recent erosion repair.

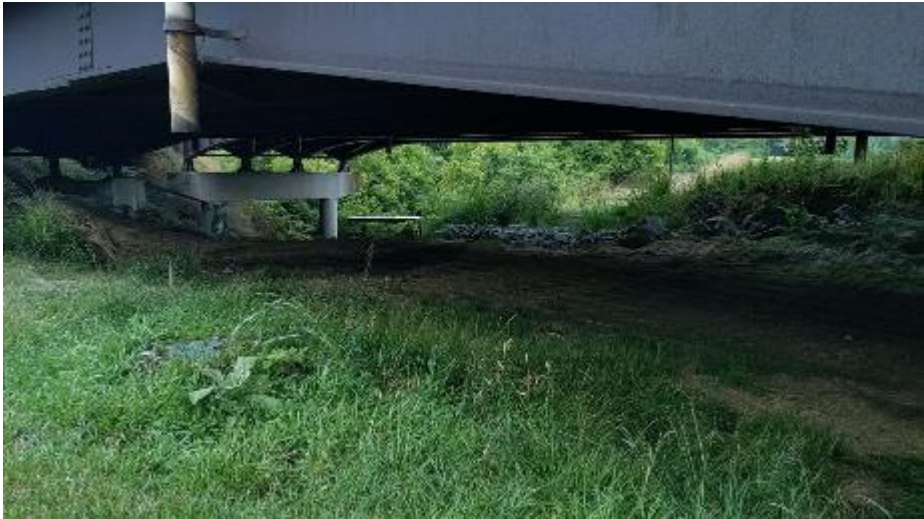
<b>PHOTOGRAPH No: 14</b>	<b>DATE:</b> July 24, 2024 9:36 AM	<b>LATITUDE:</b> 37.37154276	<b>LONGITUDE:</b> -80.8649388
<b>DIRECTION:</b> 217°	<b>SITE LOCATION:</b> GLEN LYN, VIRGINIA		
<b>DESCRIPTION:</b>  West of Highway Crossing, General Photo, Typical Conditions.

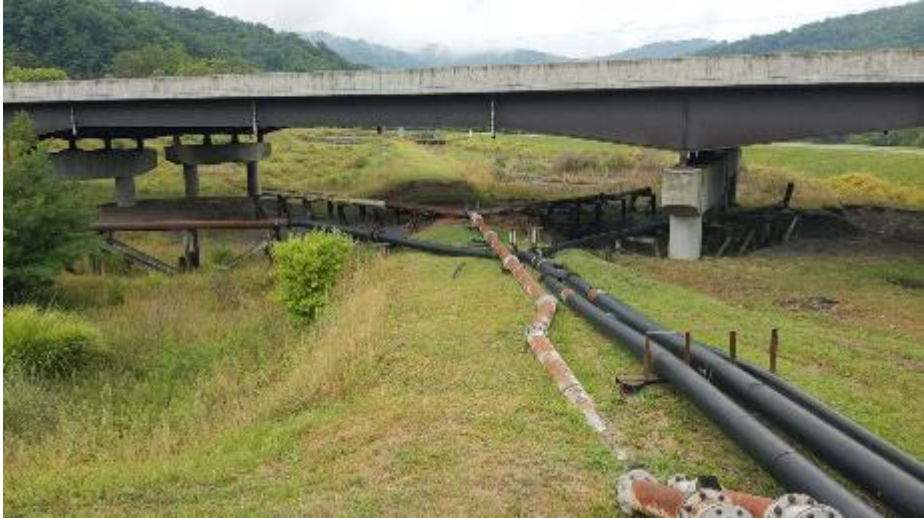
<b>PHOTO BY:</b>  GEI CONSULTANTS, INC.			
<b>PHOTOGRAPH No: 15</b>	<b>DATE:</b> July 24, 2024 9:41 AM	<b>LATITUDE:</b> 37.37163777	<b>LONGITUDE:</b> -80.86393594
<b>DIRECTION:</b> 239°	<b>SITE LOCATION:</b> GLEN LYN, VIRGINIA		
<b>DESCRIPTION:</b>  Upstream Slope of Perimeter Berm. General Photo, Note Splitter Dike between East / West Bottom Ash Ponds.
